**Re: An Application by Newfoundland and Labrador Hydro (Hydro) pursuant to Subsection 41 (3) of the Act for approval of a capital project to refurbish the marine terminal at the Holyrood Thermal Generating Station**

**AND IN THE MATTER OF** an Application by Newfoundland and Labrador Hydro pursuant to Subsections 41(3) of the Act, for the approval of refurbishment of the marine terminal at the Holyrood Thermal Generating Station.

Newfoundland and Labrador Hydro -  
Holyrood Marine Terminal 10 Year Life Extension Study  
Final Report - April 29, 2011

Holyrood Thermal Generating Station Marine Terminal -  
Jetty Structural Analysis  
- June 16, 2010

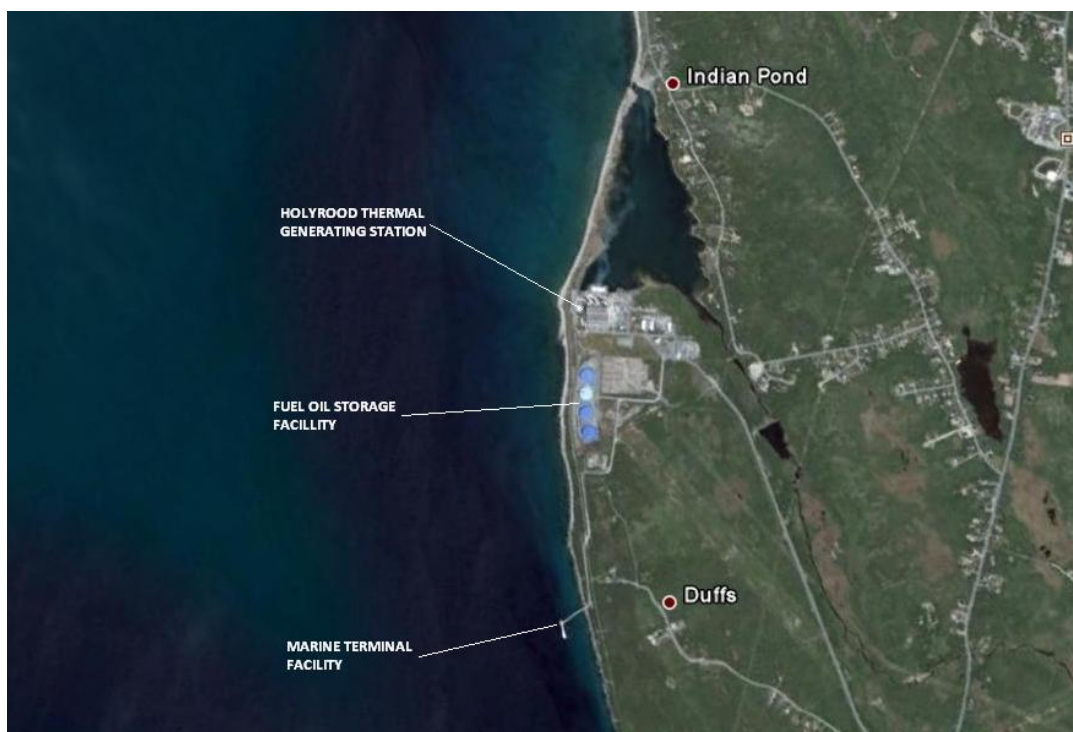
**Figure 7 – Holyrood Site Layout**

When a vessel arrives and is secured at the Marine Terminal, fuel oil is offloaded from the vessel into the fuel oil offloading arms located on the jetty and pumped through a pipeline into the fuel oil storage facility which is located approximately one kilometer from the Marine Terminal (see Figure 7 below).
