**A REPORT TO
THE BOARD OF COMMISSIONERS OF PUBLIC UTILITIES**

NEWFOUNDLAND AND LABRADOR HYDRO

Gas Turbine Failure Analysis

Final Report

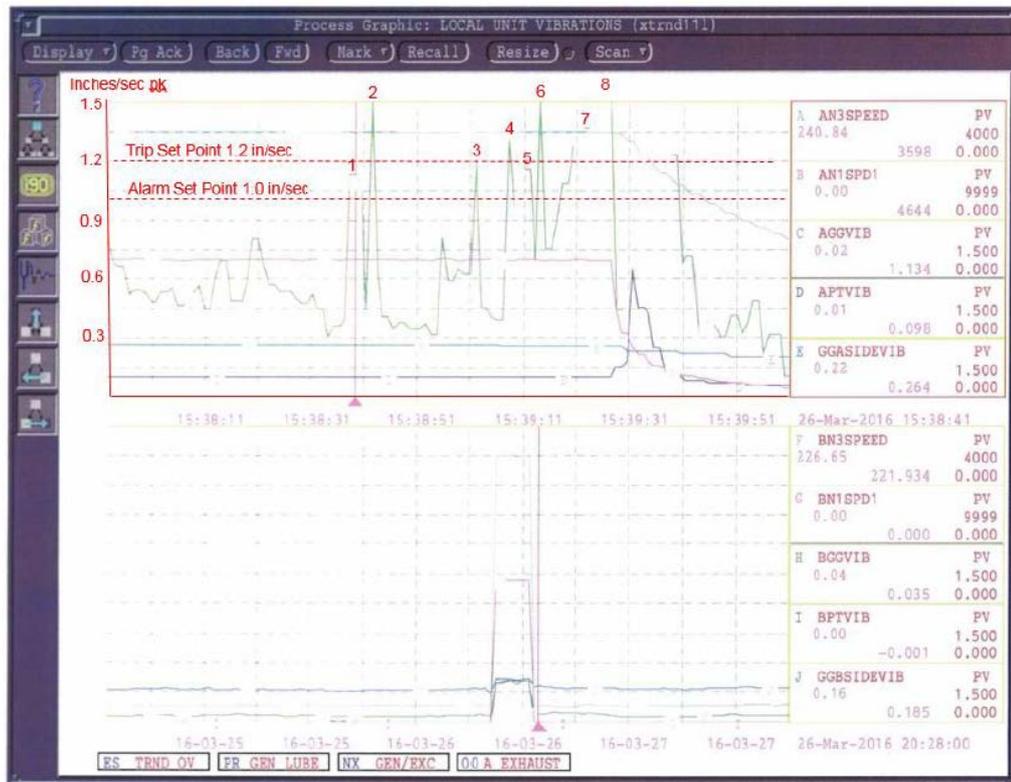
Given the above and the extensive damage incurred before the GG finally tripped, there is unquestionably a serious concern on the design or operation of the vibration detection system.

The trend graph below shows the sudden change in vibration level and pattern and the multiple alarm and trip level spikes leading up to the trip activation (recorded in the Events Log at 15:39:27 pm). Analysis of the GG Vibration Trend along with the operation Events Log are contained for reference in Appendix 8

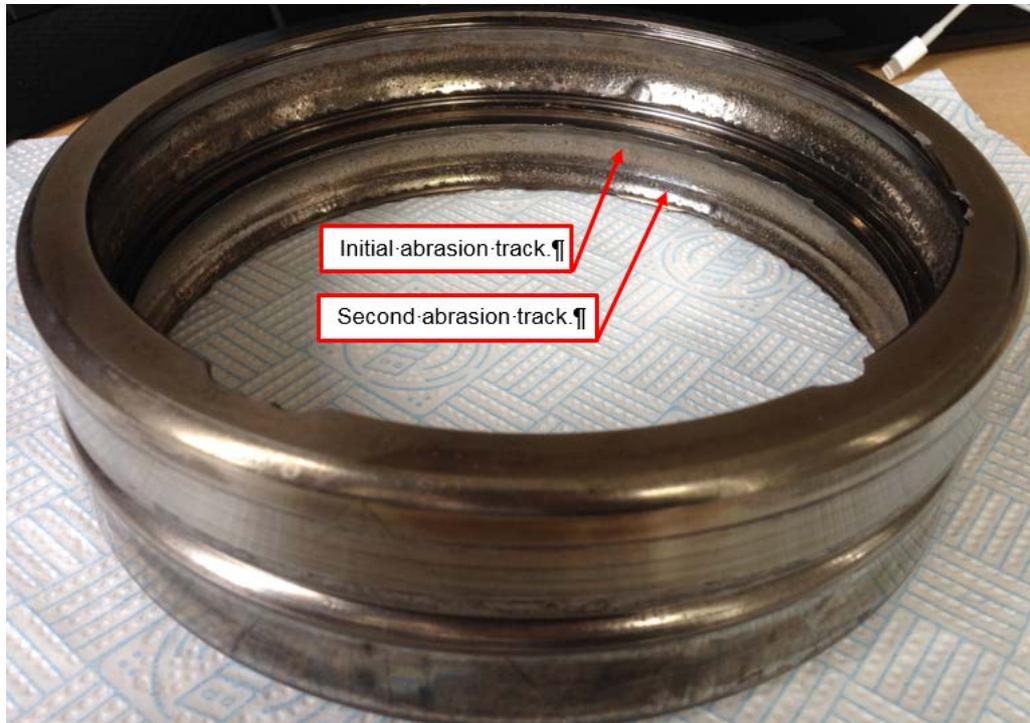
The photo below shows the extensive damage and metal loss at the bearing outer races ball grooves, particularly on the forward side (bottom side in photo) resulting from the axially biased abrasion process due to the LP Compressor Rotor thrust forward.

The arrowed areas in the above photo show two distinct abrasion track rings in the axial direction that are thought to indicate two phases of wear. The initial track ring was early in the failure process where the LP Compressor Rotor was moving forward within its build axial clearance. The second track ring is where the Rotor came into contact with neighbouring static components which caused an increased resistance to the Rotor forward movement resulting in the distinctive change in ring pattern.

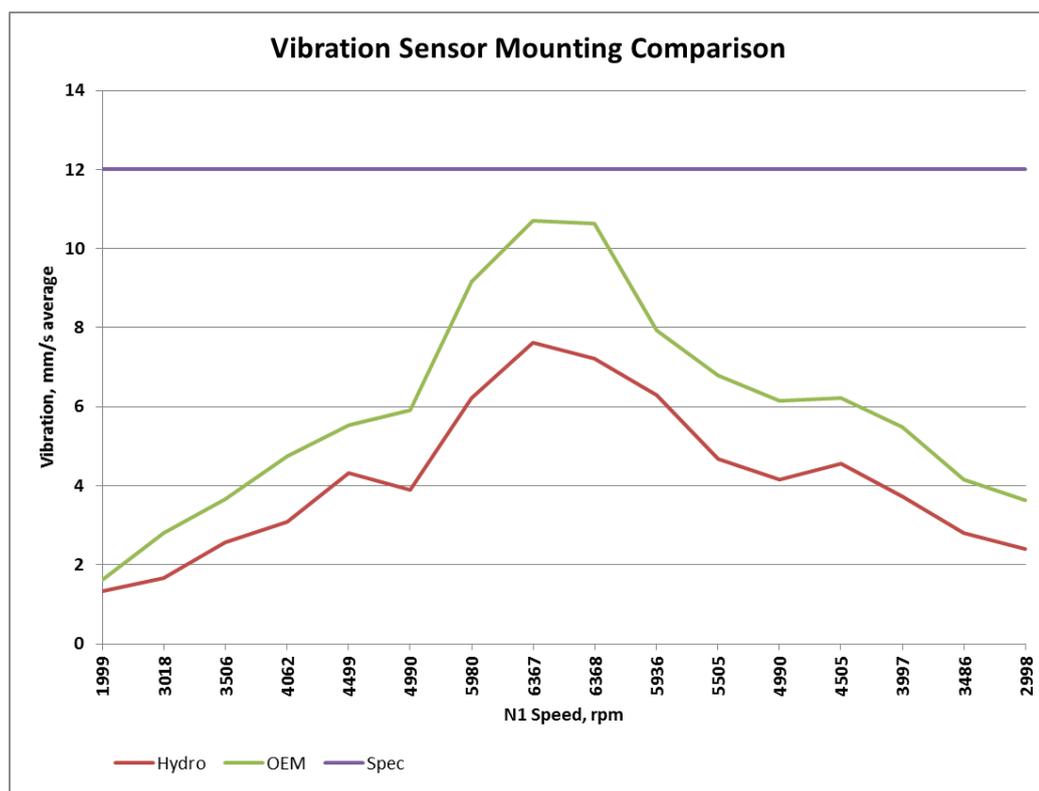
PI believe there is a question/doubt on the ability of a single transducer to provide effective coverage and protection for the seven main line bearings over the 3.6 metre long GG. We arranged with Alba to conduct a test during post engine build performance tests (November 2016) to compare vibration levels measured at different axial positions in order to test transducer sensitivity/effectiveness.

Alba were unable to carry out tests over the length of the engine as we requested. However, tests were carried out comparing the Hydro transducer position (Intermediate Casing front flange) with the RR recommended position (Delivery Casing front flange). The test results showed consistent significant differences in vibration levels measured, with the RR position showing the higher amplitudes/sensitivity. The comparison test results, presented below, appear to support PI's doubt of the ability of a single transducer to provide effective sensitivity/coverage over the length of the engine.

PI have presented budget proposals to Hydro for review and potential upgrade of the vibration system to provide improved coverage and protection.)

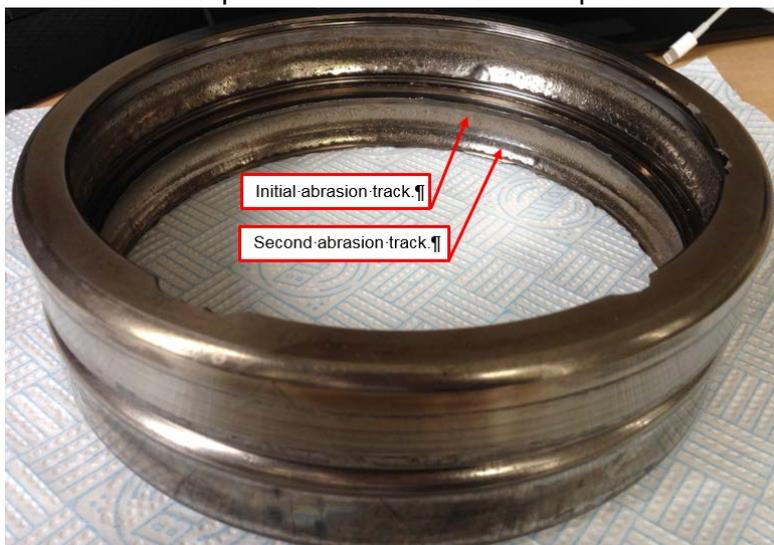
Photo 1 below shows the extensive damage and metal loss at the bearing outer races ball grooves, particularly on the forward side (bottom side in photo) resulting from the axially biased abrasion process due to the LP Compressor Rotor thrust forward.

The arrowed areas in the above photo showing two distinct abrasion track rings in the axial direction are thought to indicate two phases of wear. The initial track ring was early in the failure process where the LP Comp Rotor was moving forward within its build axial clearance. The second track ring is where the Rotor came into running contact with

adjacent static components which caused an increased resistance to the Rotor forward movement resulting in the distinctive change in pattern.

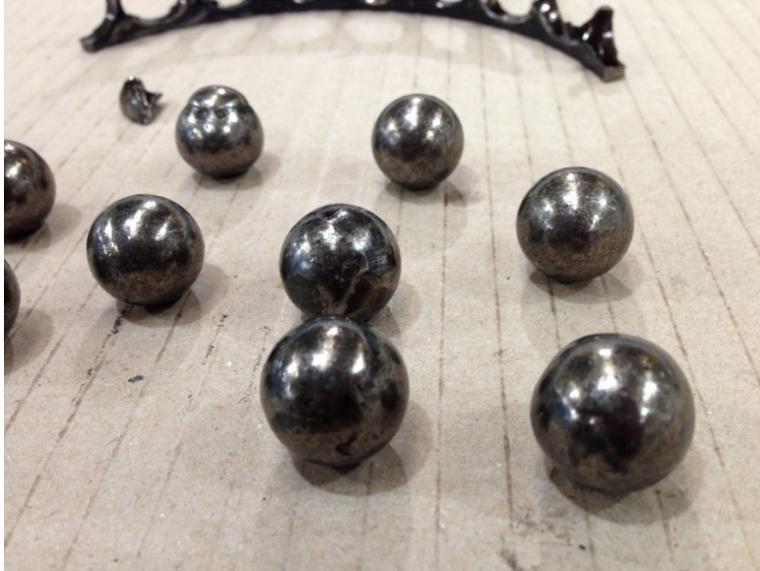
Photo 2 below shows the multi-faceted flat surfaces and misshape of the bearing balls, clearly resulting from lock-up and metal to metal skidding abrasion in many contact positions over an indeterminate but apparently considerable period of time leading up to the mechanical failure of the bearing by the break-up of the cage, pieces shown in the background. (Confirmation by Hydro of the last MCD's inspection date before the bearing failure would help to determine the approximate time period of the failure process.)

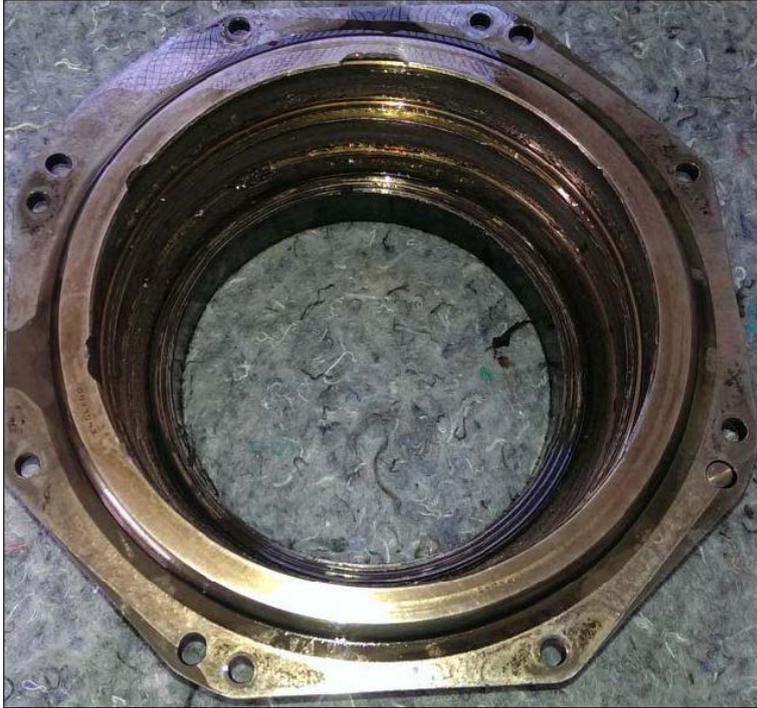
Figure 3 – Housing ‘as received’ with both outer rings in place. The Front bearing is uppermost in the photo.

Photo 4 below from the SKF Report shows the bearing assembly (from the rear side) as received with the outer races still stuck in the housing. SKF denote the “Front bearing” as uppermost in the photo - it’s actually the rear bearing. Note the damage scallops on the race (rear) face for reference further below.

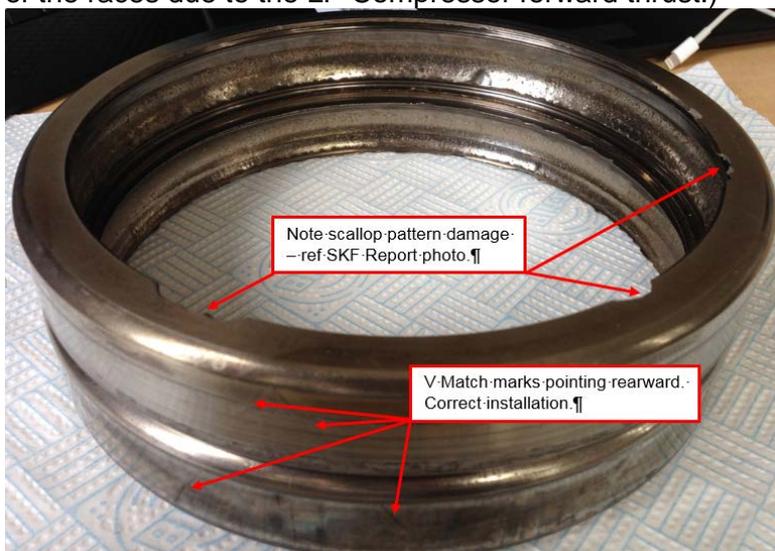
Photo 5 below shows the outer races removed from the housing after SKF returned the bearing to Alba. The V match mark is only just visible spanning across the two races, pointing in a rearward direction per the installation drawing further above. It can be seen that the annotated damage scallops on the rear face of the rear race are as in the above SKF photo of the as received condition, demonstrating that the races were installed correctly. Also note the ball grooves worst abrasion damage being at the front (bottom) side of the races due to the LP Compressor forward thrust.)

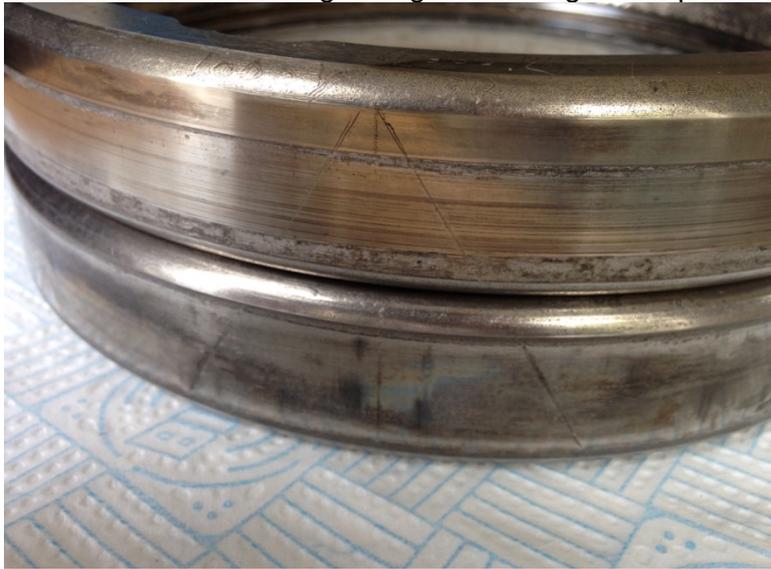
Photo 6 below shows the V match marks on the outer races more clearly, albeit the rear race (top) part of the V is somewhat faded due to circumferential scoring caused by rotation of the race in the housing during the bearing failure process.

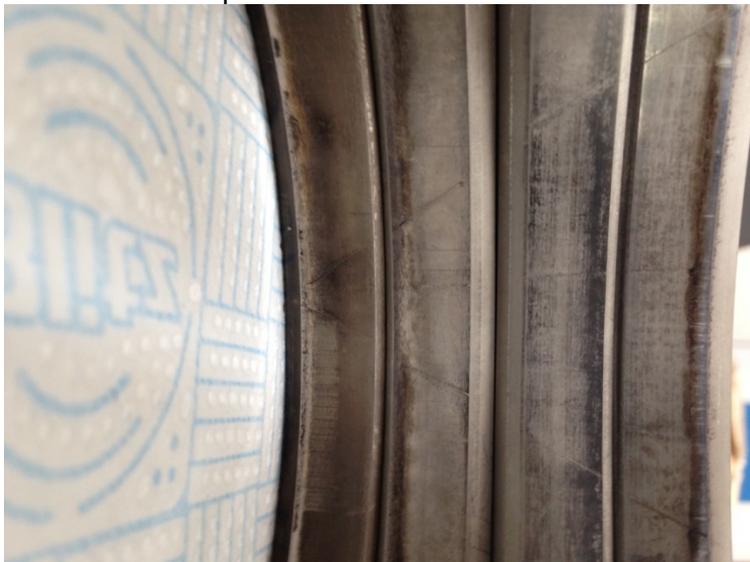
Photo 7 below shows the two inner races (pair). The V match mark is clearly visible spanning across the four half-races. PI witnessed the removal of the races from the GG as being in the correct order and orientation with the V pointing in a forward direction per the installation drawing further above, thus confirming the bearing assembly and installation were correct to specification.

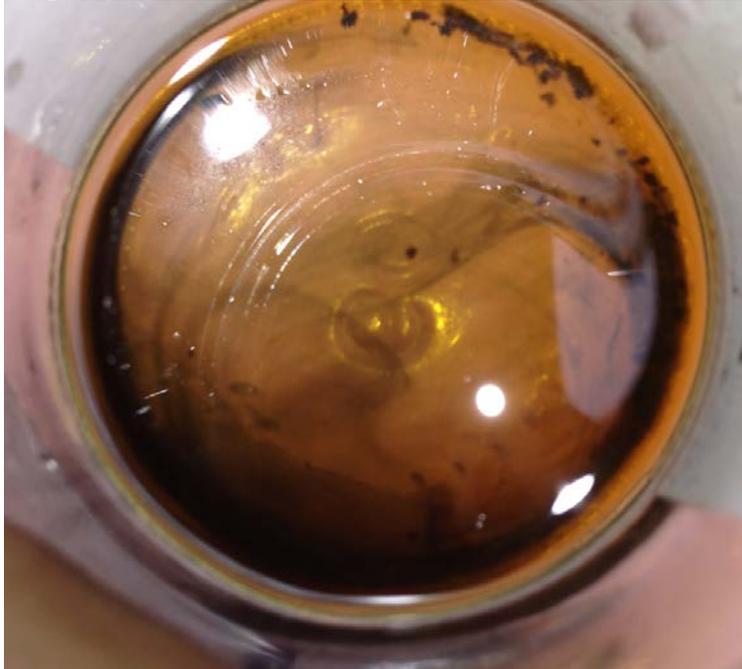
Photo 8 below shows residual lube oil taken from the Pressure Filter. Metal particles and fines (cloud swirls) are clearly visible. The metal particles and the fines were found to be magnetic thus ferrous based and had resulted from the bearing damage.

PI carried out a simple pour test of the oil through the Pressure Filter which showed that many particles passed through the mesh. **The test thus demonstrated that the Filter is not sufficiently rated to protect the GG bearings from potentially damaging contaminants in the oil. The test also indicated the particles must have been recirculating around the oil system and through the GG bearings, with the scavenge return oil filter having failed or its bypass activated.**

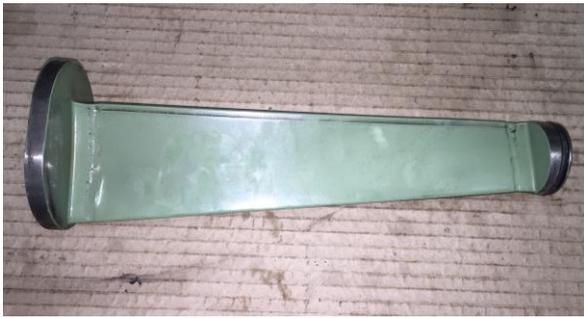
Rub damage around the rear air/oil seal location

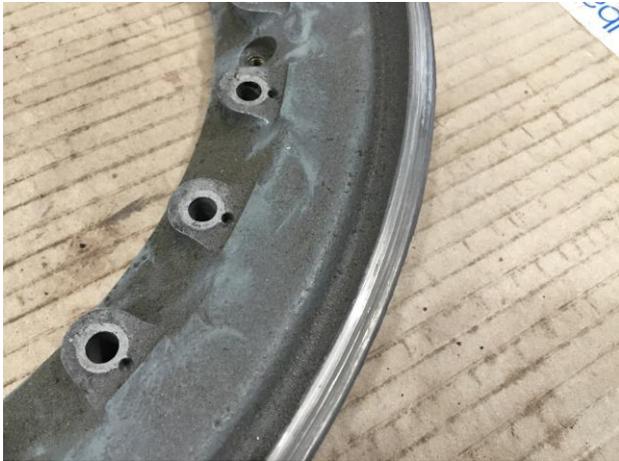
The rear support ring for the entry guide vanes was rejected due to excessive wear and rub damage, caused by the LP rotor.

<p>No 1 bearing</p>	<p>Rub damage on rear support ring</p>

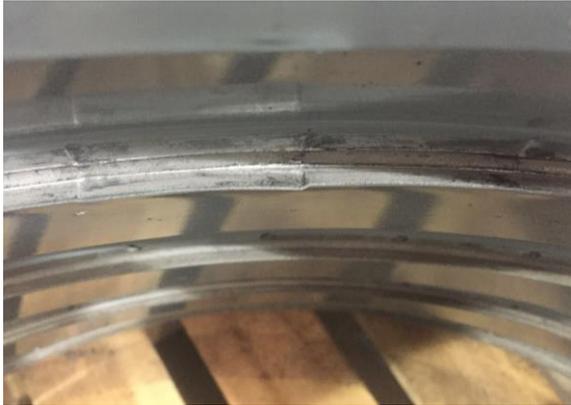
<p>Detailed inspection of the LP compressor casings found these to have retained their protective coatings, however distortion was apparent on the Stage '4' stator vane location lands.</p> <p>The distortion has been caused as a result of the stage '5' Rotor blades moving forward and contacting the stage '4' vanes.</p> <p>The stage 1' stator vanes have retained their protective coatings and display no obvious defects.</p> <p>The stage '2' – '3' stator vanes display no significant defects at this stage however, the stage '4' stator vanes display significant impact damage, due to the stage '5' LP blades contacting the aerofoil sections.</p> <p>As a result all stage '4' stator vanes have been rejected from further service.</p>

<p>Distortion at the stage '4' stator vane location</p>

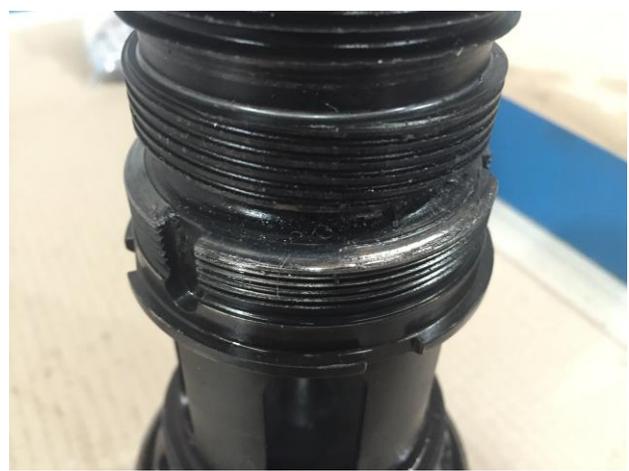
LP front shaft rub damage

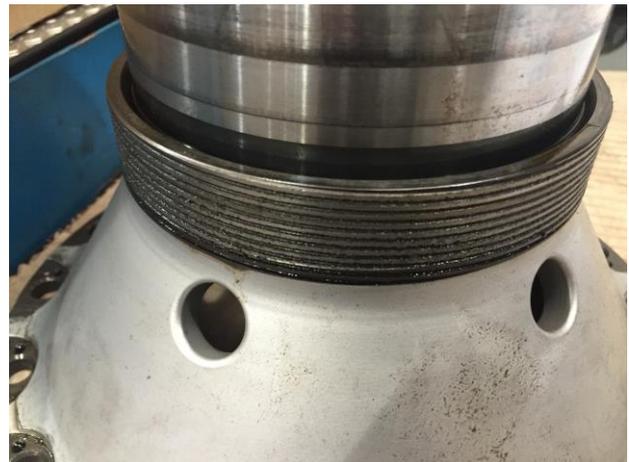
Rub damage on the rear shaft seal fins

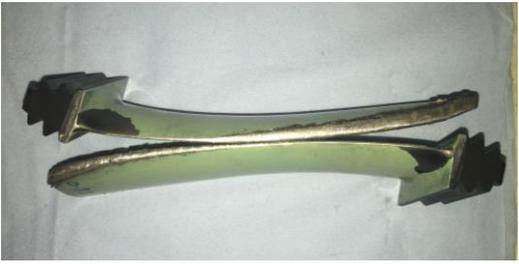
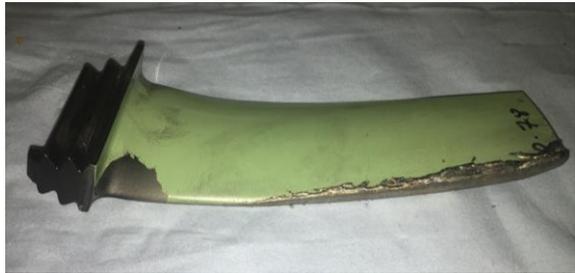
The stage '5' LP compressor rotor blades are found in a poor condition and display significant Impact damage and distortion due to contact with the stage'4' stator vanes, which was caused by movement of the LP rotor.

Stage '5' LP rotor blade distortion and impact damage	Stage '5' LP rotor blade distortion and impact damage

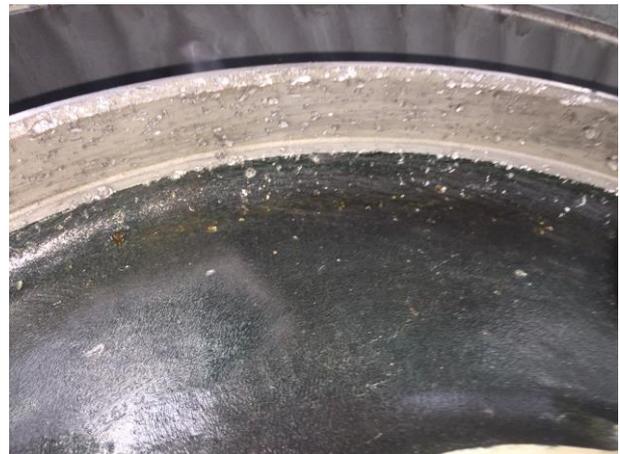
Impact damage and scoring on the intermediate casing

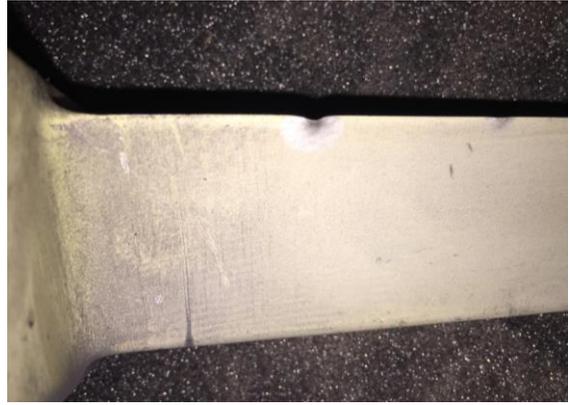
Impact damage on the entry guide vane

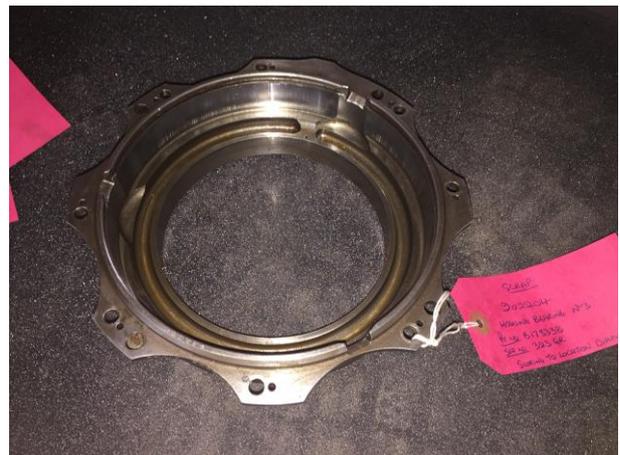
Inspection of the No 3 bearing housing identified this to be suffering from scoring and wear on the location diameter, therefore this was rejected from service.

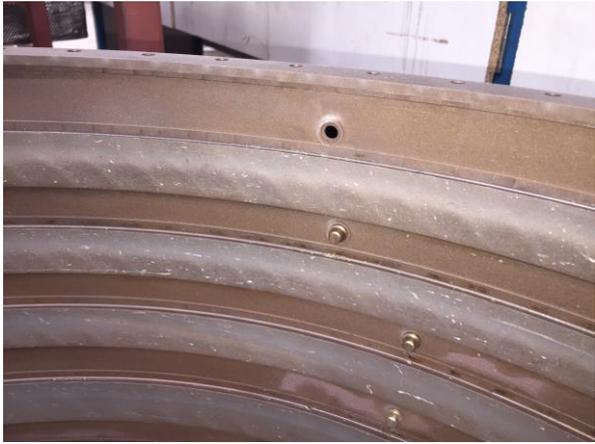
<p>Detailed inspection of the HP compressor casings identified these to have retained the protective coatings external, however the internal surfaces did display minor impact damage and scoring which is considered to be recoverable during overhaul processing.</p> <p>The stage '1' – '7' stator vanes displayed varying degrees of impact damage affecting the aerofoil sections. This resulted in the following belong rejected from further service: -</p> <ul style="list-style-type: none"> • 3 x stage '1' stator vanes • 1 x stage '2' stator vane • 3 x stage '3' stator vanes • 9 x stage '4' stator vanes • 4 x stage '5' stator vanes • 5 x stage '6' stator vanes • 1 x stage '7' stator vane <p>It is expected that the remaining vanes will be recoverable during the overhaul processing.</p>

<p>Impact damage on the internal surfaces of the HP compressor casings</p>

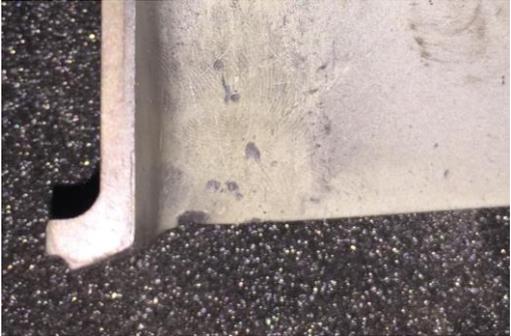
<p>Impact damage on stage '3' stator vane</p>

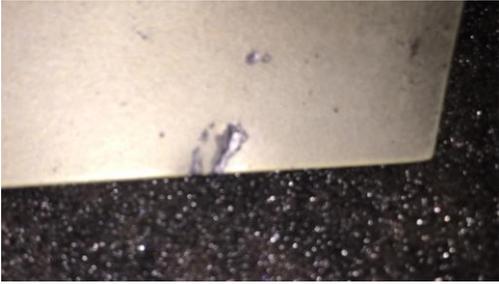
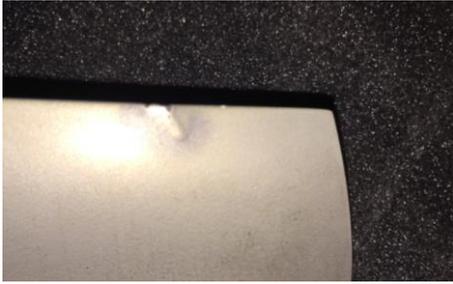
Impact damage on stage '2' stator vane	Impact damage on stage '2' stator vane

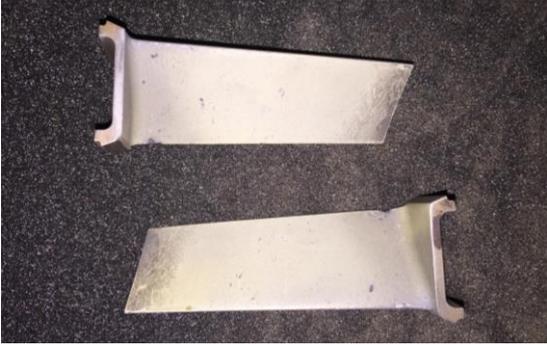
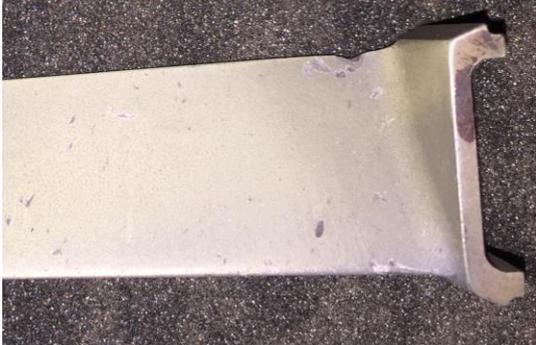
Stage '3' stator vane	Impact damage on stage '3' stator vane

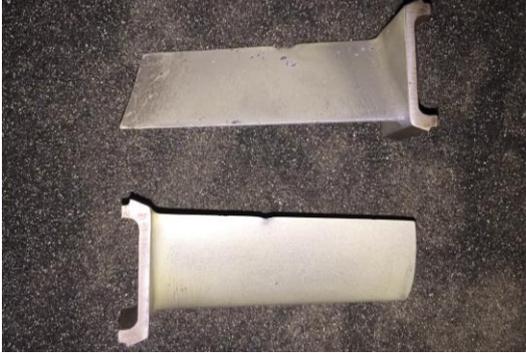
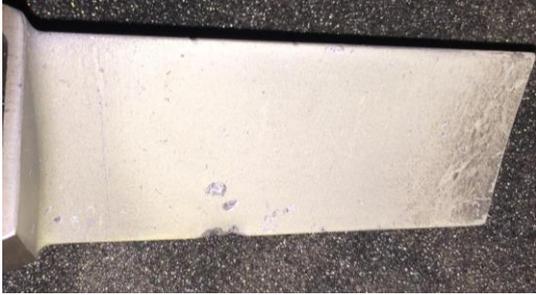
Stage '4' stator vane	Impact damage on stage '4' stator vane

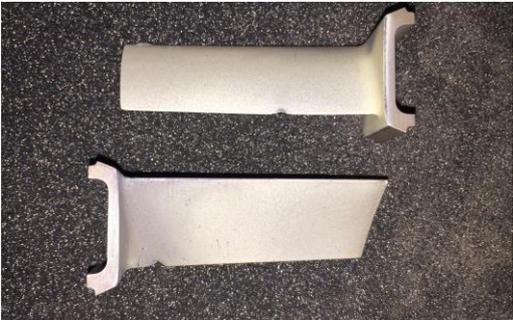
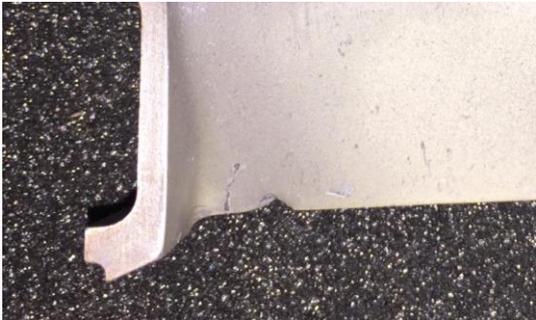
Stage '5' stator vane	Impact damage on stage '5' stator vane

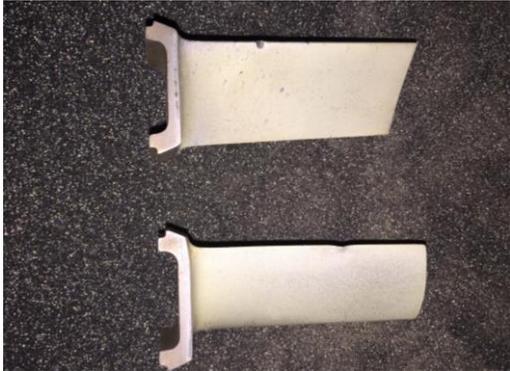
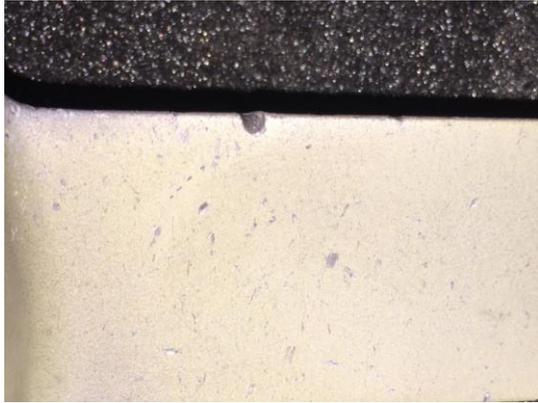
<p>Stage '6' stator vane</p>	<p>Impact damage on stage '6' stator vane</p>

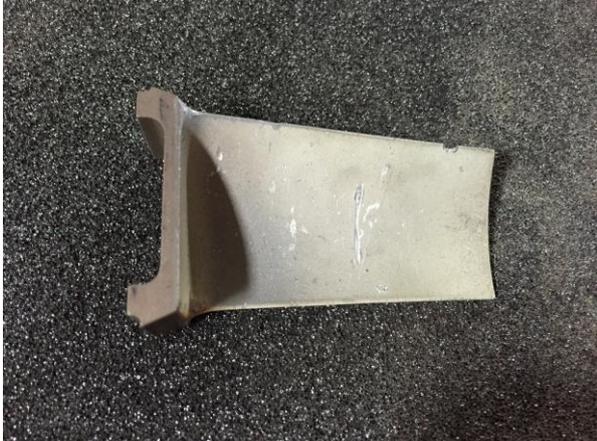
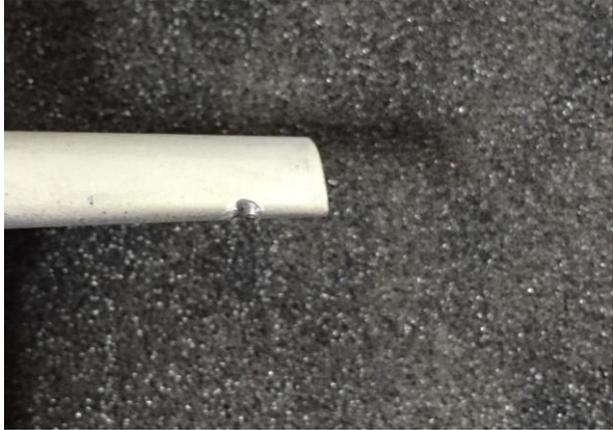
<p>Stage '7' stator vane</p>	<p>Impact damage on stage '7' stator vane</p>

Description	Part Number	Quantity	Reason
Stage '1' HP stator vane	B204544	3	Impact damage out with acceptable limits
Stage '2' HP stator vane	B204545	1	Impact damage out with acceptable limits
Stage '3' HP stator vane	B204546	3	Impact damage out with acceptable limits
Stage '4' HP stator vane	B204547	9	Impact damage out with acceptable limits
Stage '5' HP stator vane	B204548	4	Impact damage out with acceptable limits
Stage '6' HP stator vane	B204549	5	Impact damage out with acceptable limits
Stage '7' HP stator vane	B204760	1	Impact damage out with acceptable limits

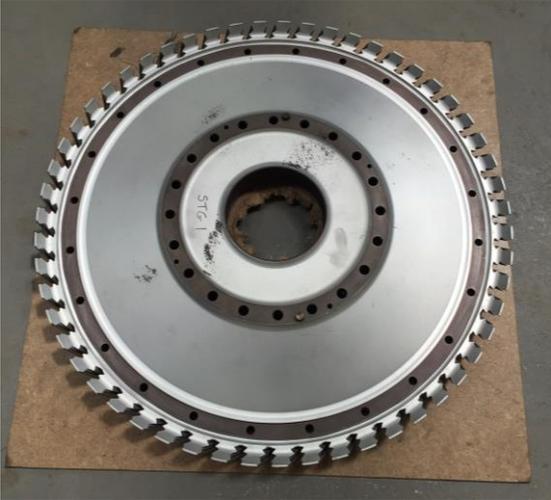
<p>Stage '1' HP compressor disc</p>

<p>Detailed inspection of the HP compressor discs and spacers identified these to be in a reasonable condition with no obvious defects identified. All components had retained the protective coatings.</p> <p>Detailed inspection of the blades, did however identify a number of these to be rejected due to impact damage out with acceptable limits., as detailed below:</p> <ul style="list-style-type: none"> • 4 x stage '1' HP rotor blades • 4 x stage '2' HP rotor blades • 8 x stage '3' HP rotor blades • 2 x stage '4' HP rotor blades • 5 x stage '5' HP rotor blades • 6 x stage '6' HP rotor blades • 6 x stage '7' HP rotor blades <p>The remainder of the HP rotor blades are expected to be fully recoverable during the overhaul process.</p> <p>The oil thrower was rejected from further service due to rub damage caused by the LP rotor movement</p>

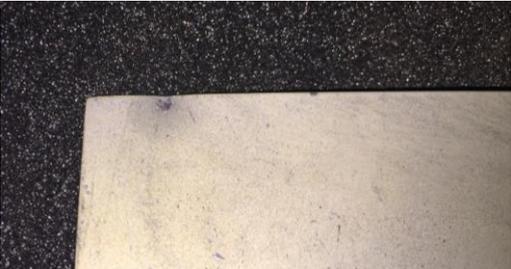
<p>Typical impact damage on stage '1' rotor blades</p>

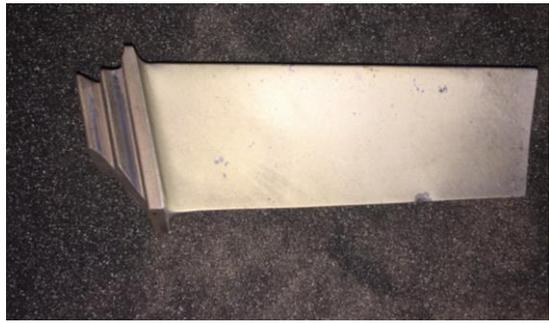
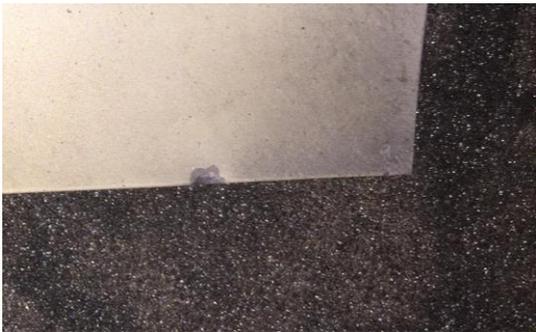
<p>Stage '2' HP rotor blade</p>	<p>Typical impact damage on stage '2' rotor blades</p>

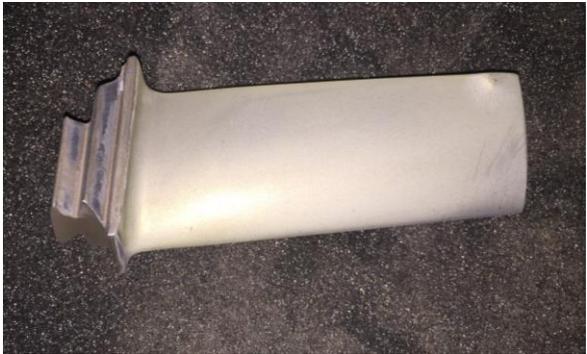
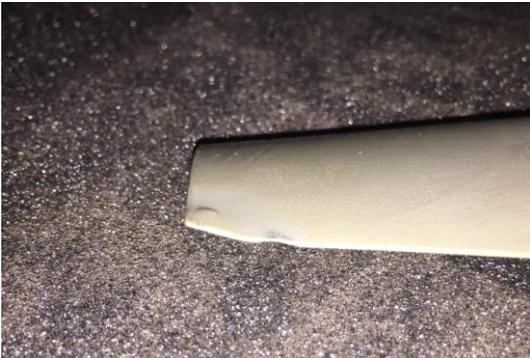
<p>Stage '3' HP rotor blade</p>	<p>Typical impact damage on stage '3' rotor blades</p>

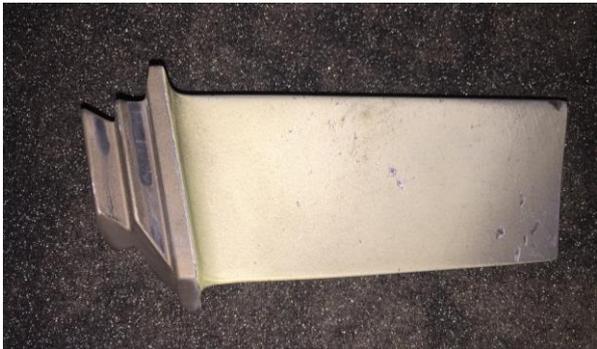
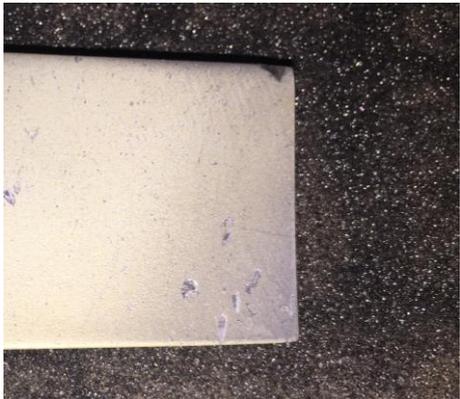
<p>Stage '4' HP rotor blade</p>	<p>Typical impact damage on stage '4' rotor blades</p>

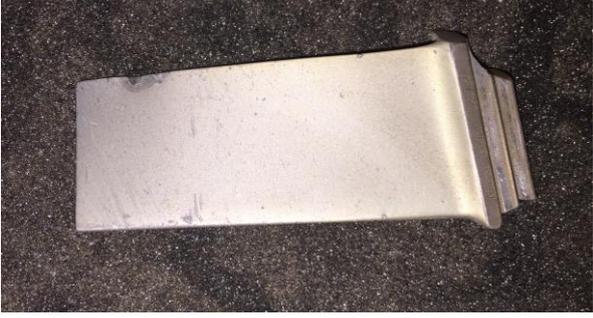
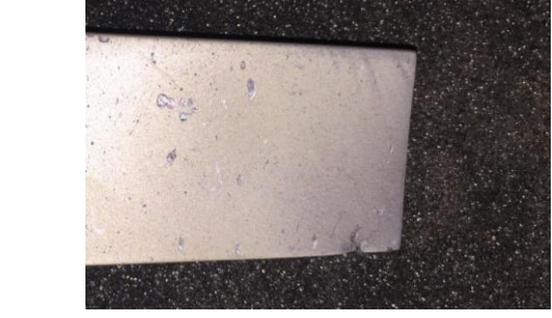
<p>Stage '5' HP rotor blade</p>	<p>Typical impact damage on stage '5' rotor blades</p>

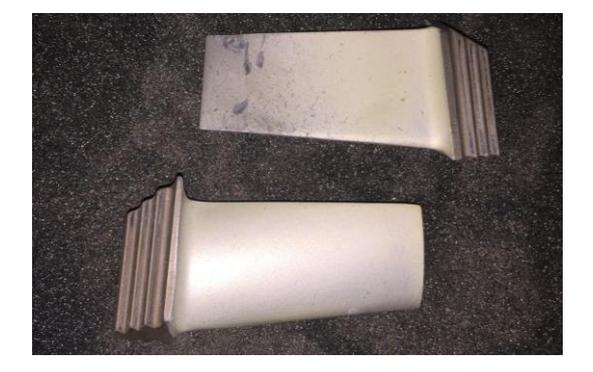
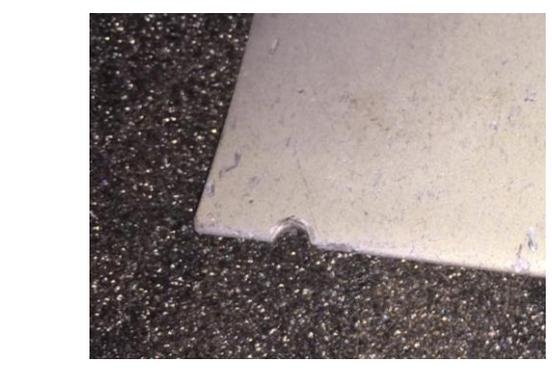
<p>Stage '6' HP rotor blade</p>	<p>Typical impact damage on stage '6' rotor blades</p>

Description	Part Number	Quantity	Reason
Stage '1' HP rotor blade	BDC1297	4	Impact damage out with acceptable limits
Stage '2' HP rotor blade	B204538	4	Impact damage out with acceptable limits
Stage '3' HP rotor blade	B204539	8	Impact damage out with acceptable limits
Stage '4' HP rotor blade	B204540	2	Impact damage out with acceptable limits
Stage '5' HP rotor blade	BDC1313	5	Impact damage out with acceptable limits
Stage '6' HP rotor blade	B204542	6	Impact damage out with acceptable limits
Stage '7' HP rotor blade	BDC8464	6	Impact damage out with acceptable limits
Oil thrower	B258495	1	Rub damage

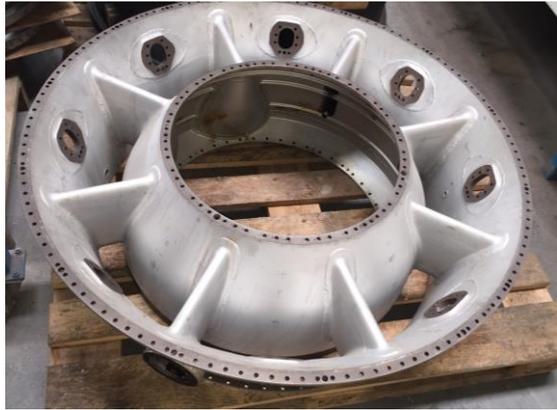
<p style="text-align: center;">Delivery Casing</p>

<p>The Delivery casing is found to be in a reasonable condition with no obvious defects noted. The protective coating has remained intact.</p> <p>The No 4 was found to be in a reasonable condition with no obvious defects noted however this will be replaced during the course of the workscope.</p> <p>The No 5 bearing is found to have a deteriorated surface finish and will be replaced during the course of the workscope</p>

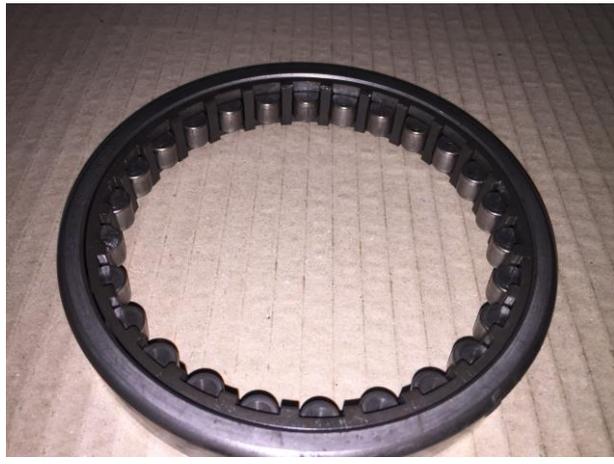
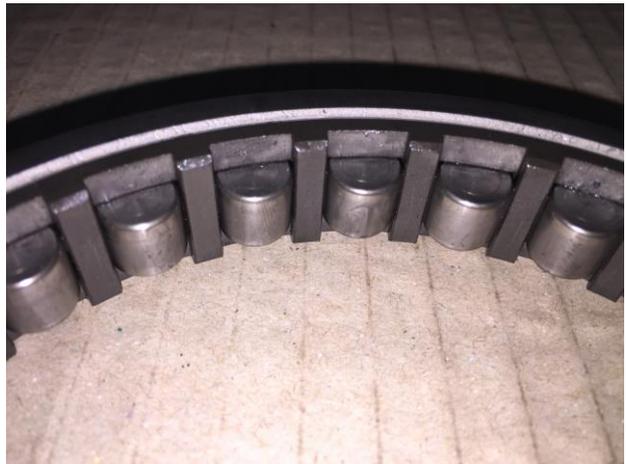
<p style="text-align: center;">No 5 Bearing</p>	<p style="text-align: center;">No 5 bearing rollers</p>

Description	Part Number	Quantity	Reason
No 4 bearing	BDA5928		Contamination
No 5 bearing	B217985		Surface finish deterioration/contamination
Housing	BDA9039	1	Rub damage to seal fins

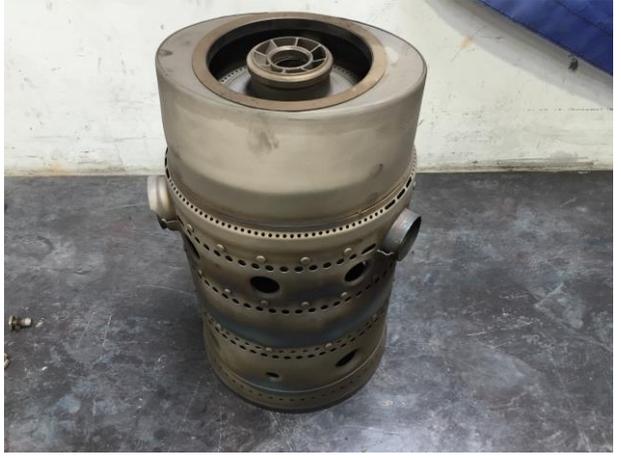
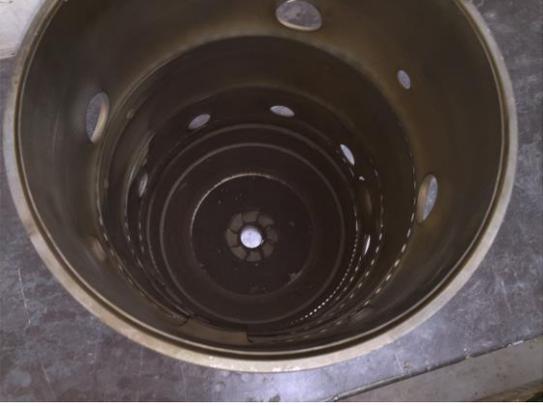
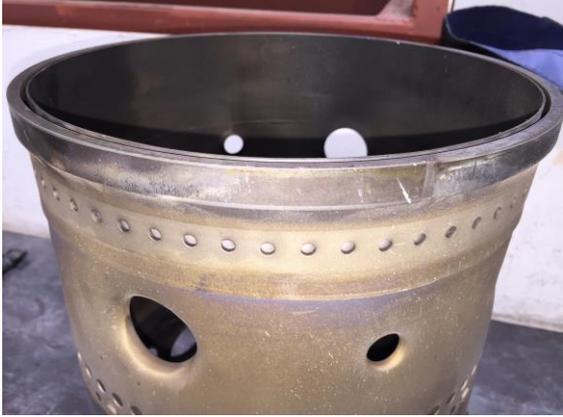
<p>Detailed inspection of the combustion chambers found these to be in a reasonable condition, however carbon build up was noted on the internal surfaces</p> <p>In addition to the above typical witness marks were noted around snout/rear location diameters.</p> <p>The air intake snouts again display light witness marks on the location diameters, however no further defects were identified.</p>

<p>Internal condition</p>	<p>Light witness marks on location diameter</p>

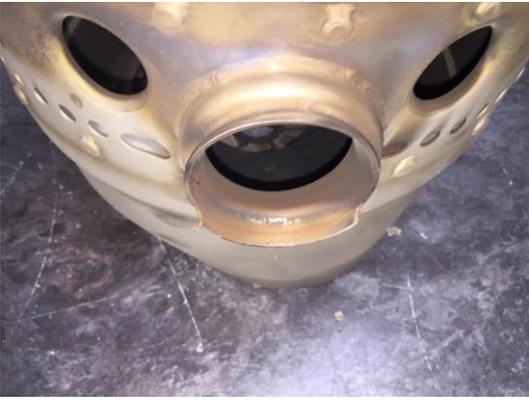
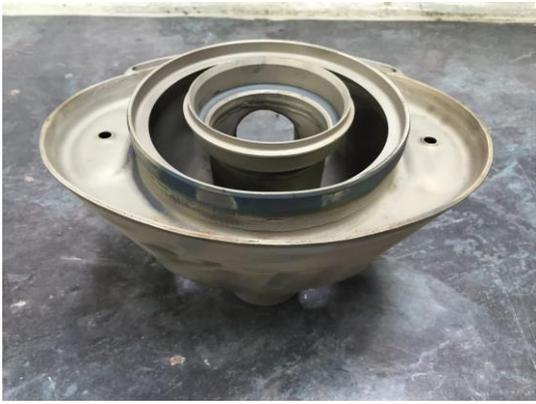
<p>Light witness marks on interconnectors</p>	<p>Air intake snout</p>

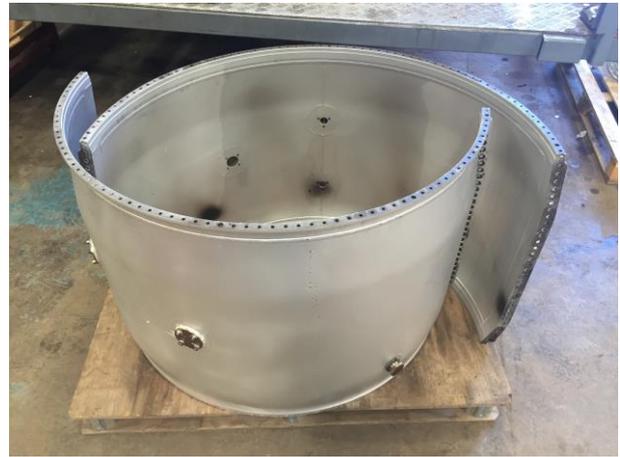
Combustion casings

Detailed inspection of the combustion casings confirmed these to be in a reasonable condition with only minor hot spots and discoloration noted.

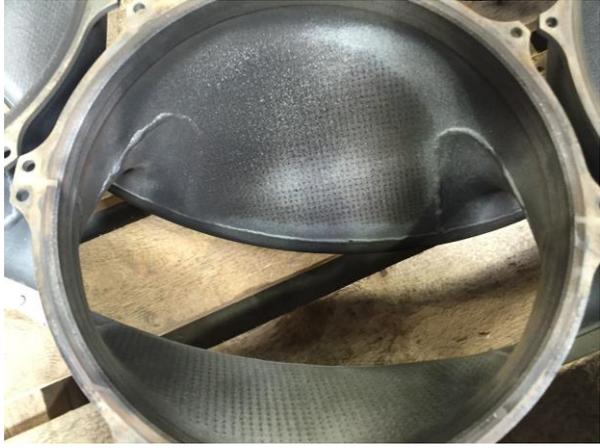
<p style="text-align: center;">Turbine entry duct</p>

<p>The turbine entry duct displays aluminium spatter on the internal surfaces./ At this stage no obvious cracking or defects are noted, however further chemical cleaning an NDT inspection will be required to confirm this.</p>

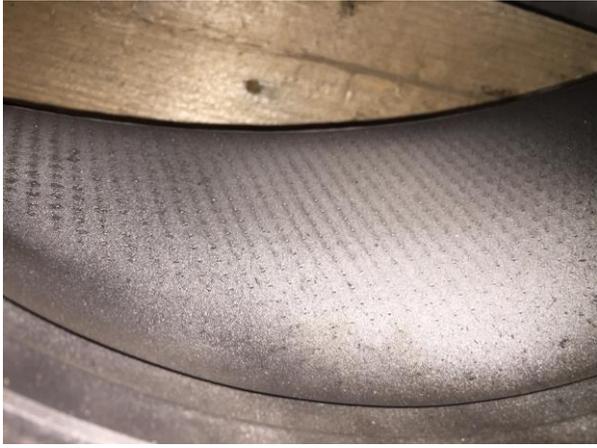
<p style="text-align: center;">Aluminium spatter on internal surfaces</p>

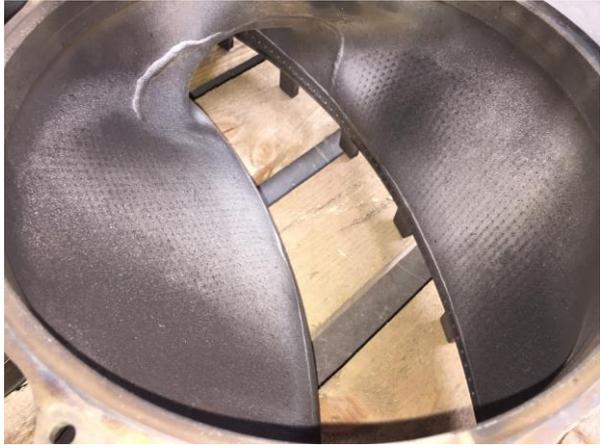
<p style="text-align: center;">Aluminium spatter on internal surfaces</p>

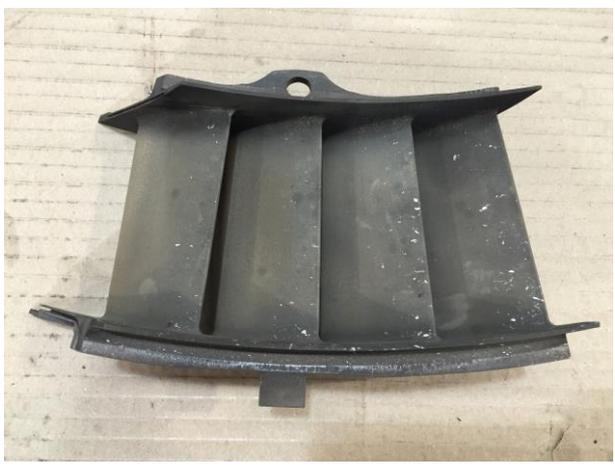
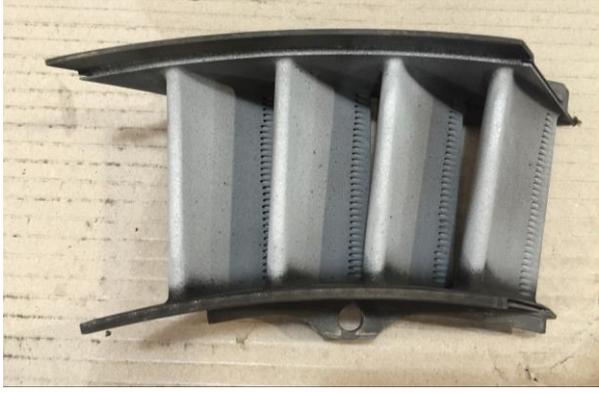
<p>Detailed inspection of the HP and LP nozzle guide vanes found these to be in reasonable condition with no obvious cracking or wear noted. All vanes did display aluminium spatter on the aerofoil sections.</p> <p>The HP turbine blades display aluminium spatter on the aerofoil sections however no further defects are noted at this stage.</p> <p>The LP turbine blades display light rub damage on the inner shroud platform and seal plates, caused by the LP rotor/turbine movement forward. This allowed the LP blades to contact the LP nozzle guide vane retaining bolts. The extent of rub damage is expected to be recoverable during the overhaul process.</p> <p>The HP and LP turbine discs and shaft assemblies have retained the protective coating and appear in good condition.</p> <p>The No7 and No 8 bearings were found in a reasonable condition with no significant defects noted and considered typical condition for service run components</p> <p>The rear bearing turbine seal was rejected due to turbine seal</p>

<p>Aluminium spatter on the HP nozzle guide vanes</p>

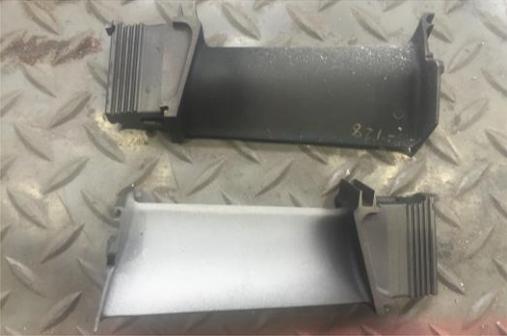
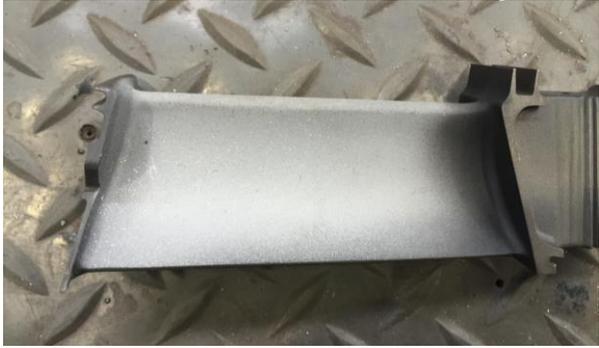
<p>HP turbine blades</p>	<p>Aluminium spatter on the HP blades</p>

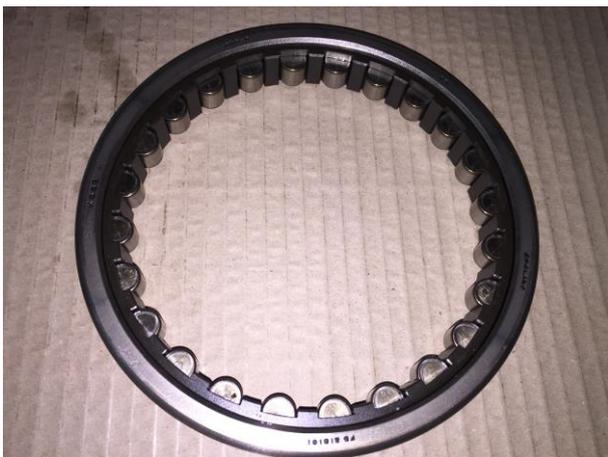
Description	Part Number	Quantity	Reason
Washer	B119875	1	Worn retaining lugs
Rear bearing turbine seal	BDD9632	1	Rub damage on seal fins
No 7 bearing	FB218101		Contamination
No 8 bearing	FB217987		Contamination

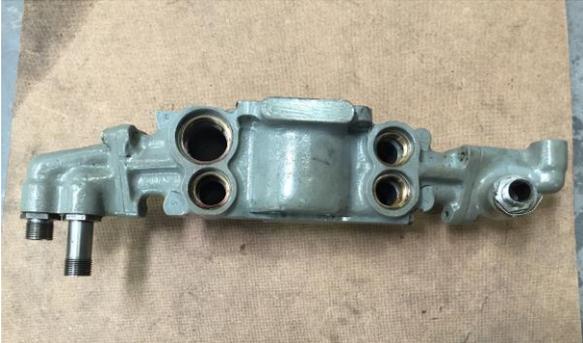
<p>Oil sump and pump</p>

<p>Cooling and Lubricating pipework appears in good condition, however all will require further cleaning and flushing throughout the workscope.</p> <p>The Nose Bullet appears in good condition having retained the protective coating.</p> <p>The oil pump and sump assembly were found to have scoring and contamination throughout the assemblies. They will require full overhaul and function testing prior to re-fitment.</p> <p>The electric starter, fuel pumps and anti-icing valve appear in good condition at this stage with no defects noted.</p>

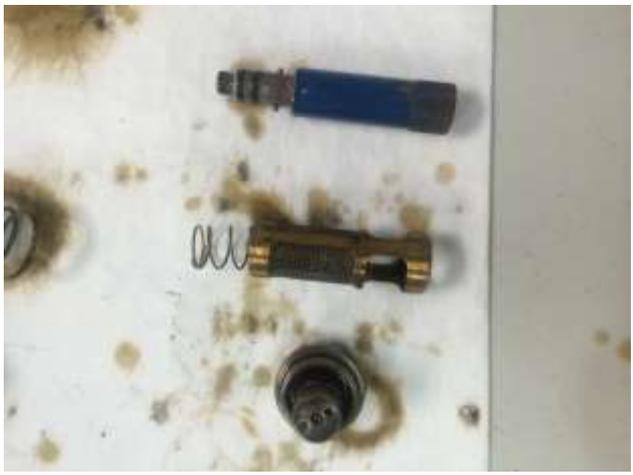
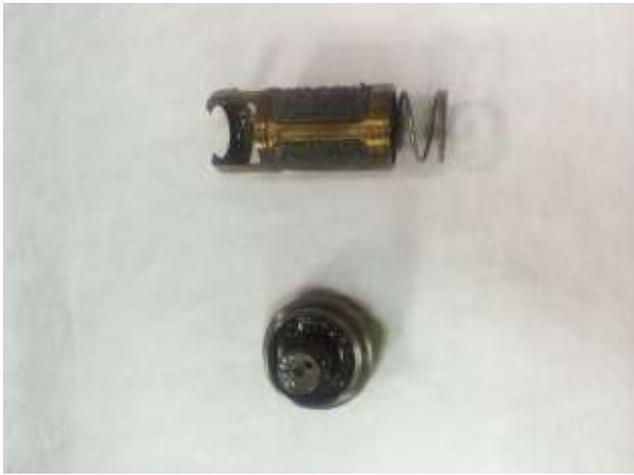
<p>No.1 (Blue) Bearing magnetic chip detector and basket.</p>	<p>No.2 and 3 (Green) Bearing magnetic chip detector basket showing excessive debris.</p>
