**A REPORT TO
THE BOARD OF COMMISSIONERS OF PUBLIC UTILITIES**

NEWFOUNDLAND AND LABRADOR HYDRO

Gas Turbine Failure Analysis

Final Report

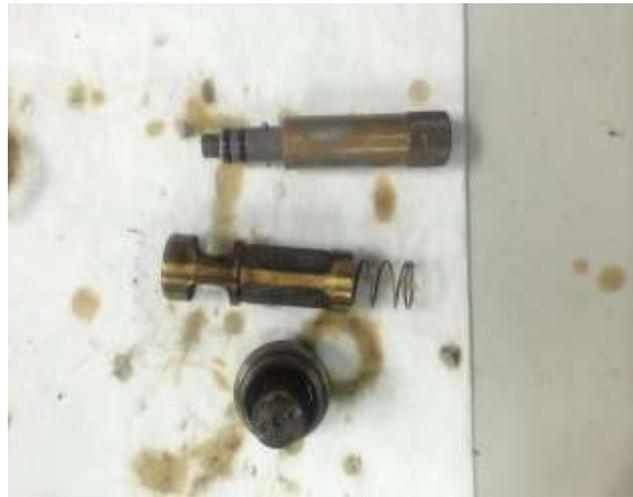
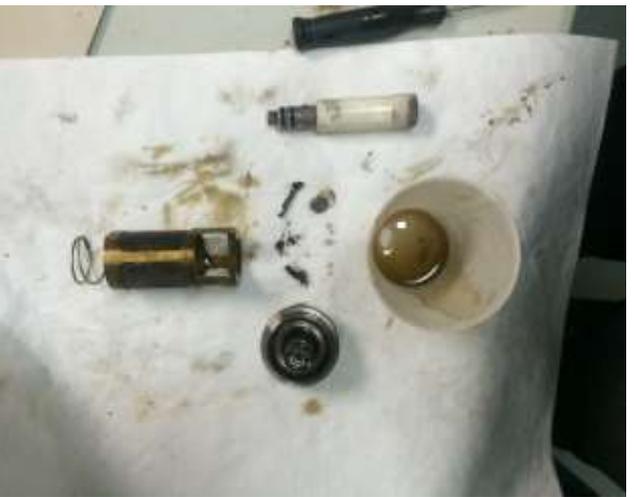
<p>No. 4 and 5 (Aluminium) Bearing magnetic chip detector and basket</p>	<p>No. 7 (White) Bearing magnetic chip detector and basket showing several large pieces of debris.</p>

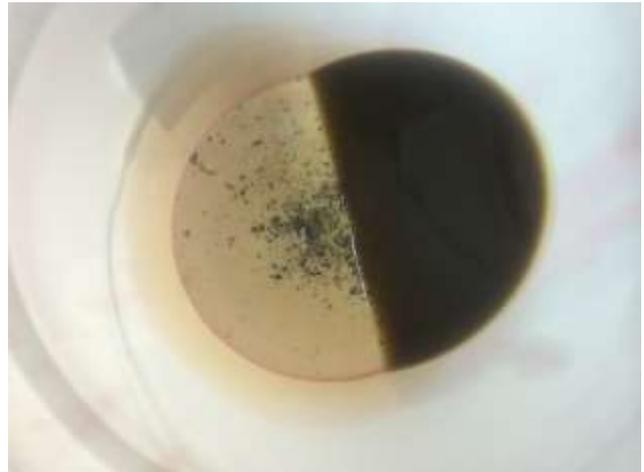
Oil and debris drained from the removal of the No. 2 and 3 (Green) Bearings magnetic chip detector basket showing contaminated burnt oil and excessive debris.

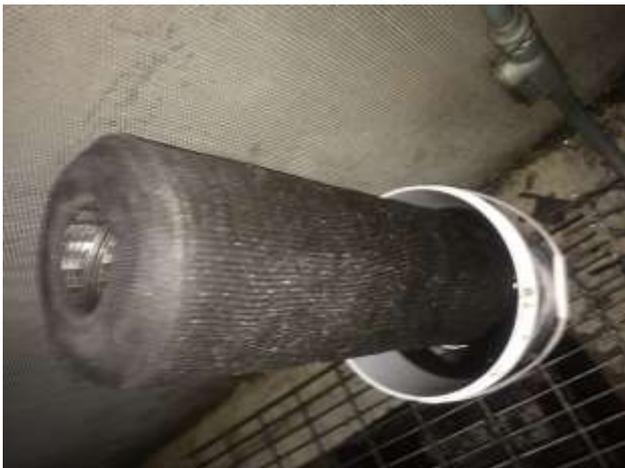
Oil Tank scavenge filter showing large quantities of metallic debris.

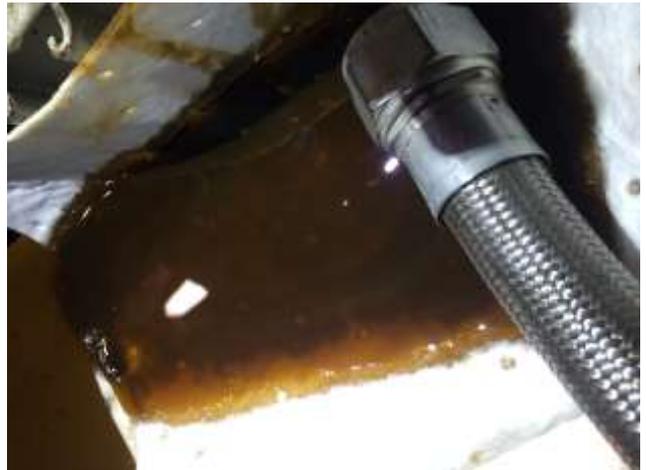
Oil feed pipe from the oil tank to the Olympus showing contaminated and discoloured oil through excessive heat.

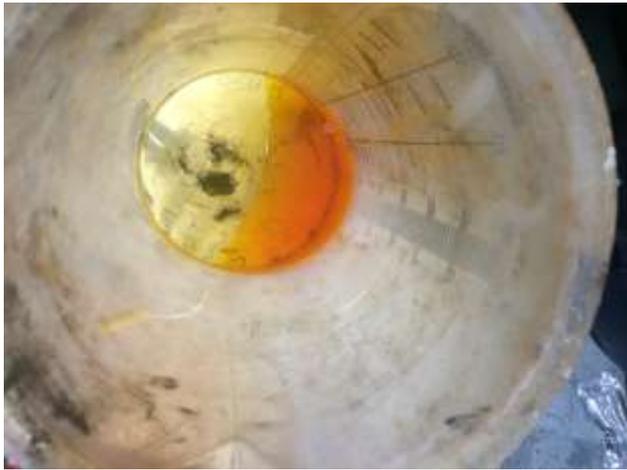
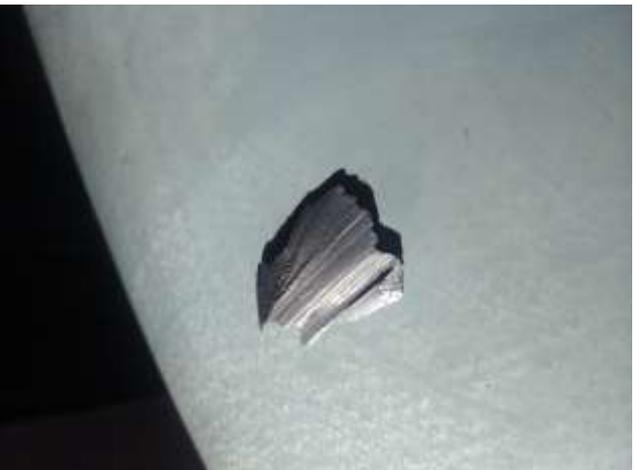
<p>Fresh oil pumped from the oil drum used for the Olympus gas turbines showing its colour and cleanliness.</p>	<p>Piece of debris removed from between the LP compressor rotor and the intake casing.</p>

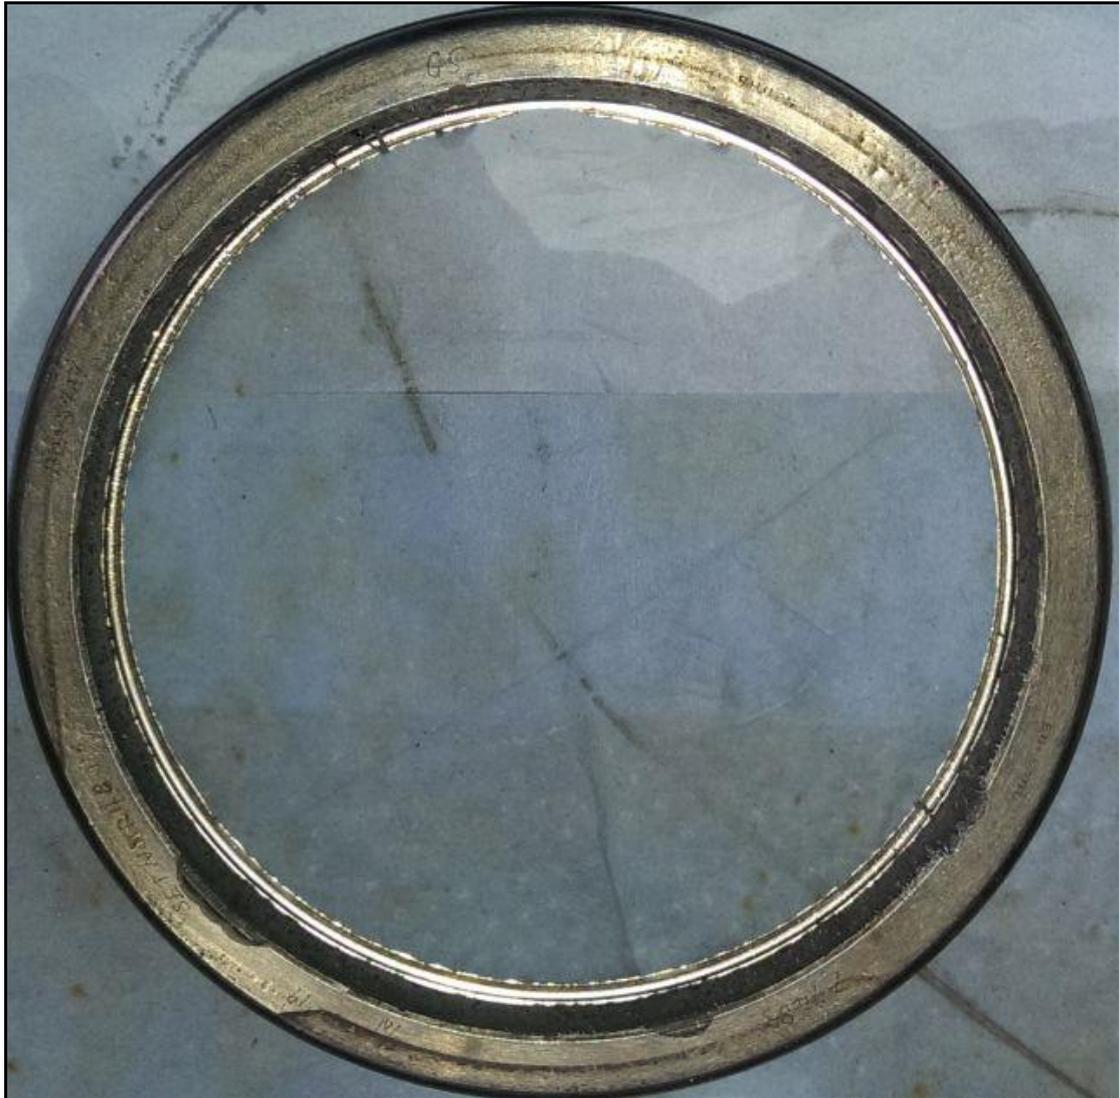
Figure 4 – Outer ring side face #1 'as received'.

The bearing was received disassembled – the outer ring shown above and the inner ring (Figure 5 overleaf) split in two halves.

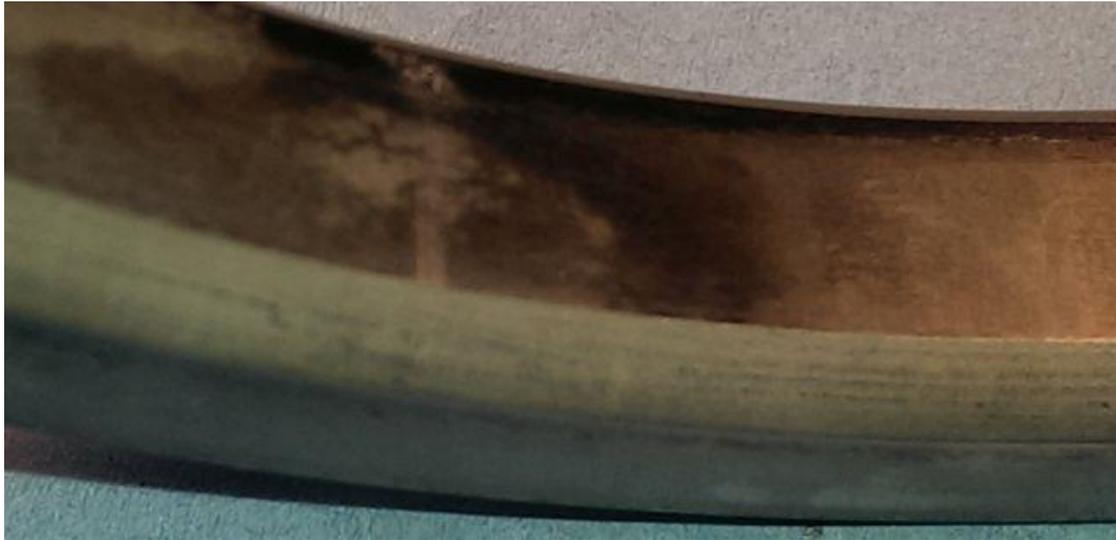
Figure 8 – detail of inner ring bore.

Staining and heat damage noted.

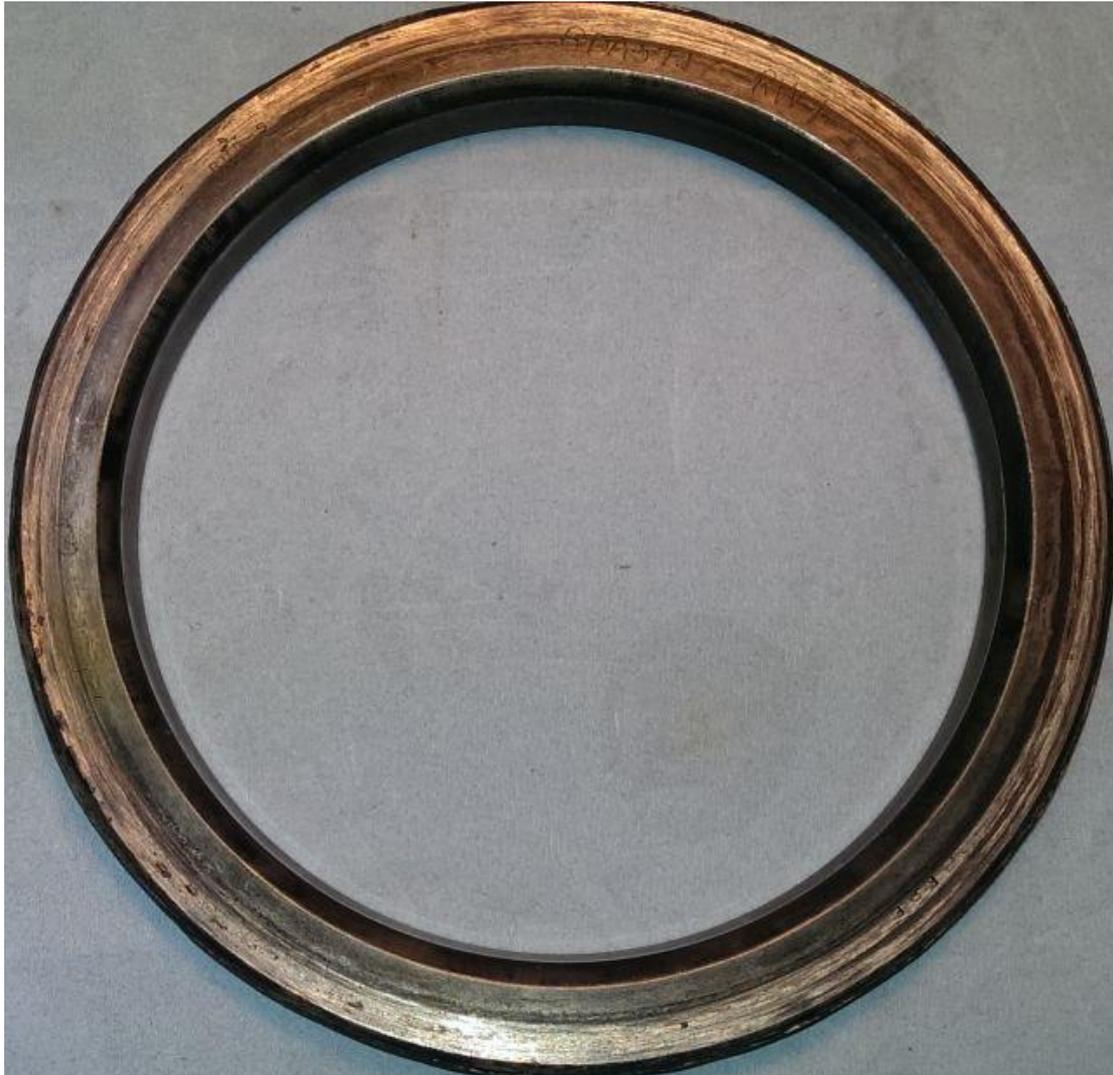
Figure 9 – *Inner ring #1 side face 1.*

Circumferential scoring, staining and blueing noted.

Adhesive wear (ISO 5.2.3 – Appendix A, Table A1) was noted on the front bearing inner ring #1 side face 1 (Figure 9), rear bearing inner ring #1 side face 1 (Figure 31), rear bearing inner ring #2 side face 1 (Figure 33), front bearing rolling element (Figure 25) and housing interior (Figure 49). Some causes of adhesive wear include acceleration of bearing components, skidding/smearing of rolling elements, excessive frictional heat and too light loading.

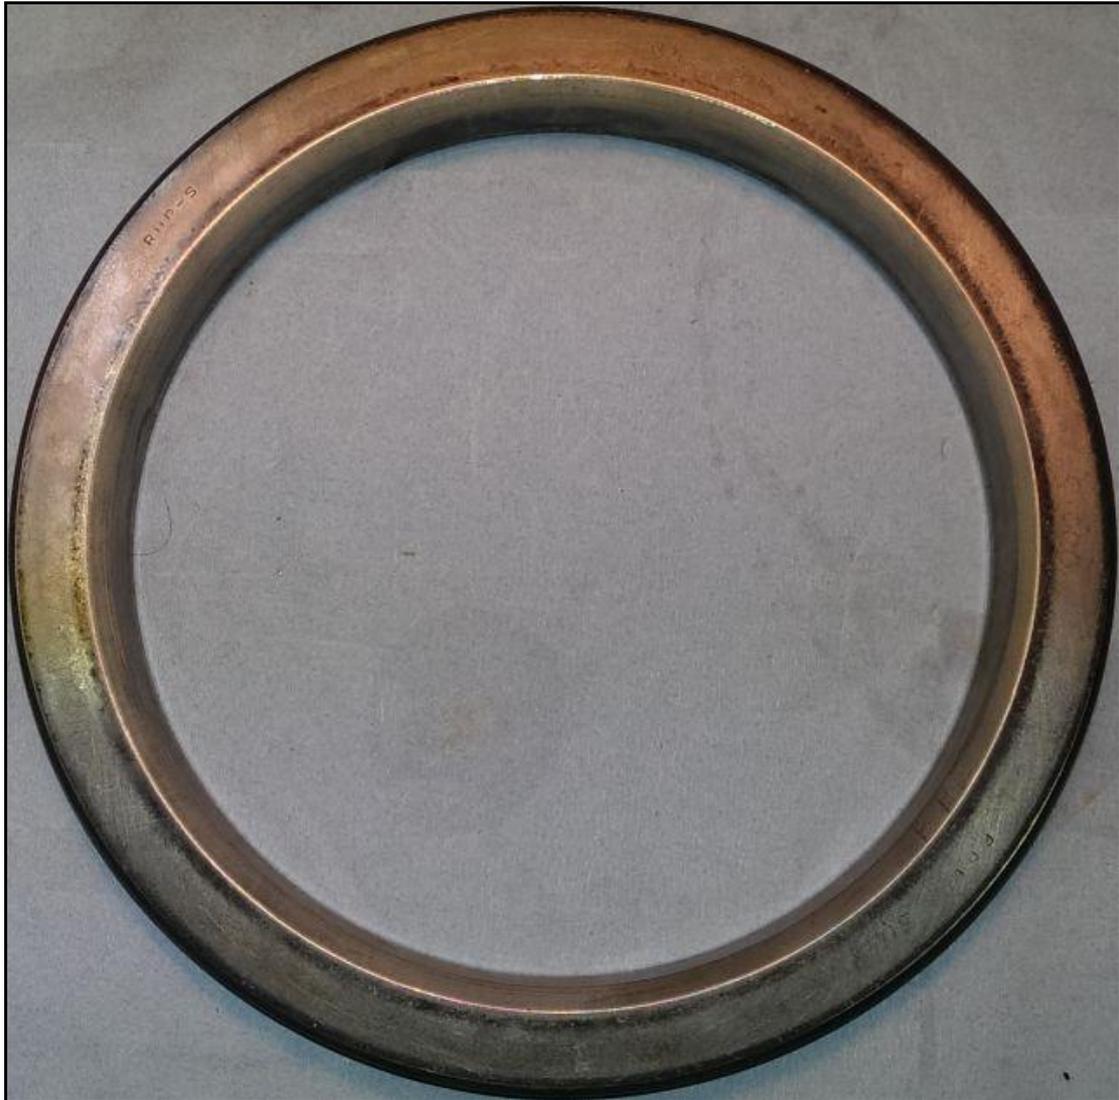
Figure 11 – Inner ring #2 side face 1.

Light staining noted.

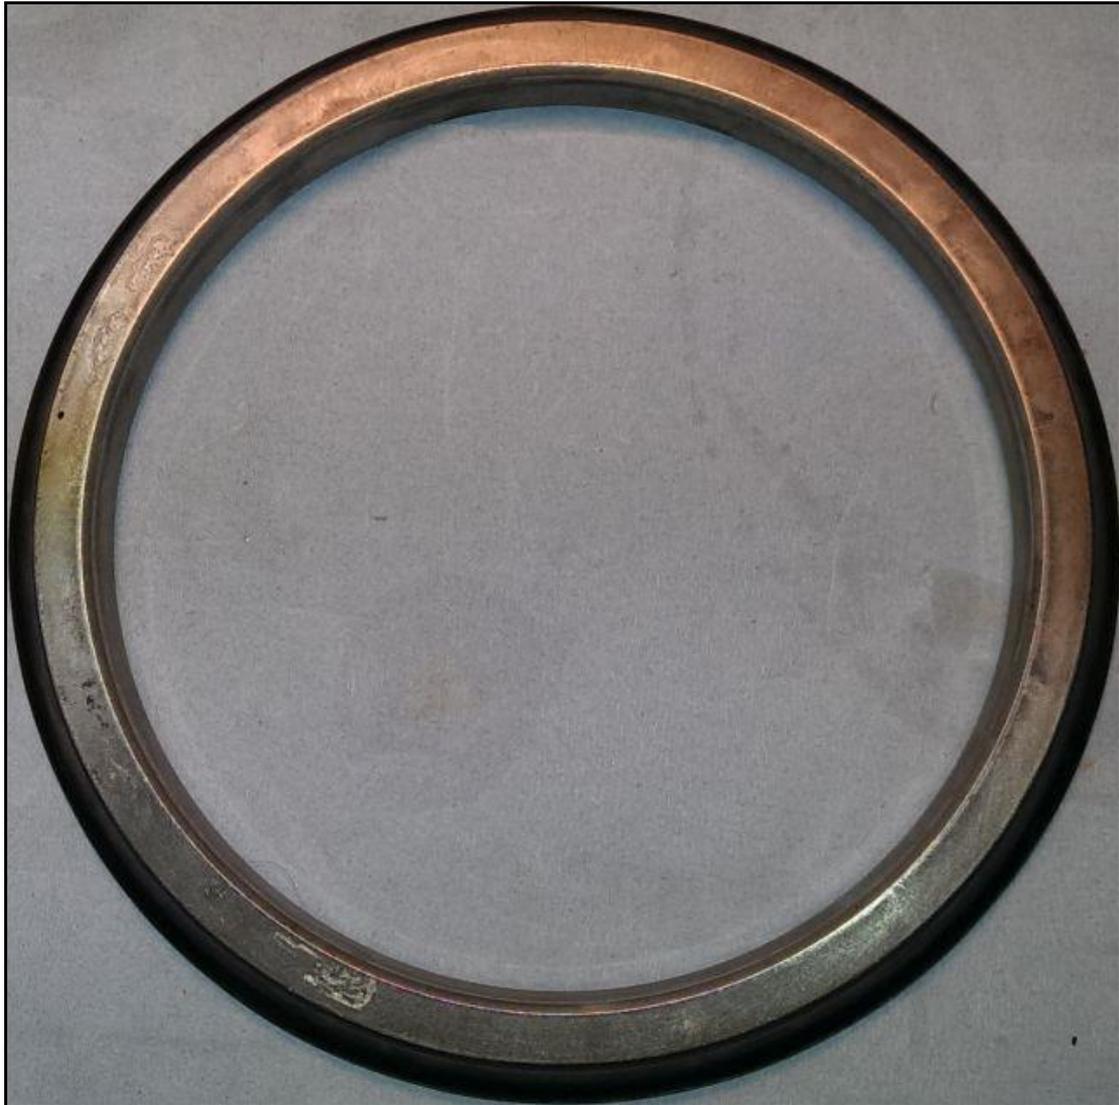
Figure 12 – Inner ring #2 side face2.

Fretting corrosion and surface damage noted. The surface damage (lower left of photo) appears relatively fresh and may have occurred during dismounting.

Fretting corrosion (ISO 5.3.3.2 – Appendix A, Table A1) was noted on front bearing inner ring #2 side face 2 (Figure 12), front bearing outer ring OD (Figure 13), the rear bearing outer ring OD (Figure 35) and interior of bearing housing (Figure 49). This type of damage is commonly caused by micro-movements between mating parts in load transmitting interfaces.

In order to avoid fretting corrosion, or slow the process, the tolerances (fit) should be adjusted. Some manufacturers recommend the application of an anti-fretting paste or compound. SKF, however, does not recommend the use of specially formulated adhesives to avoid fretting corrosion; a 'precision' fit should always be sought.

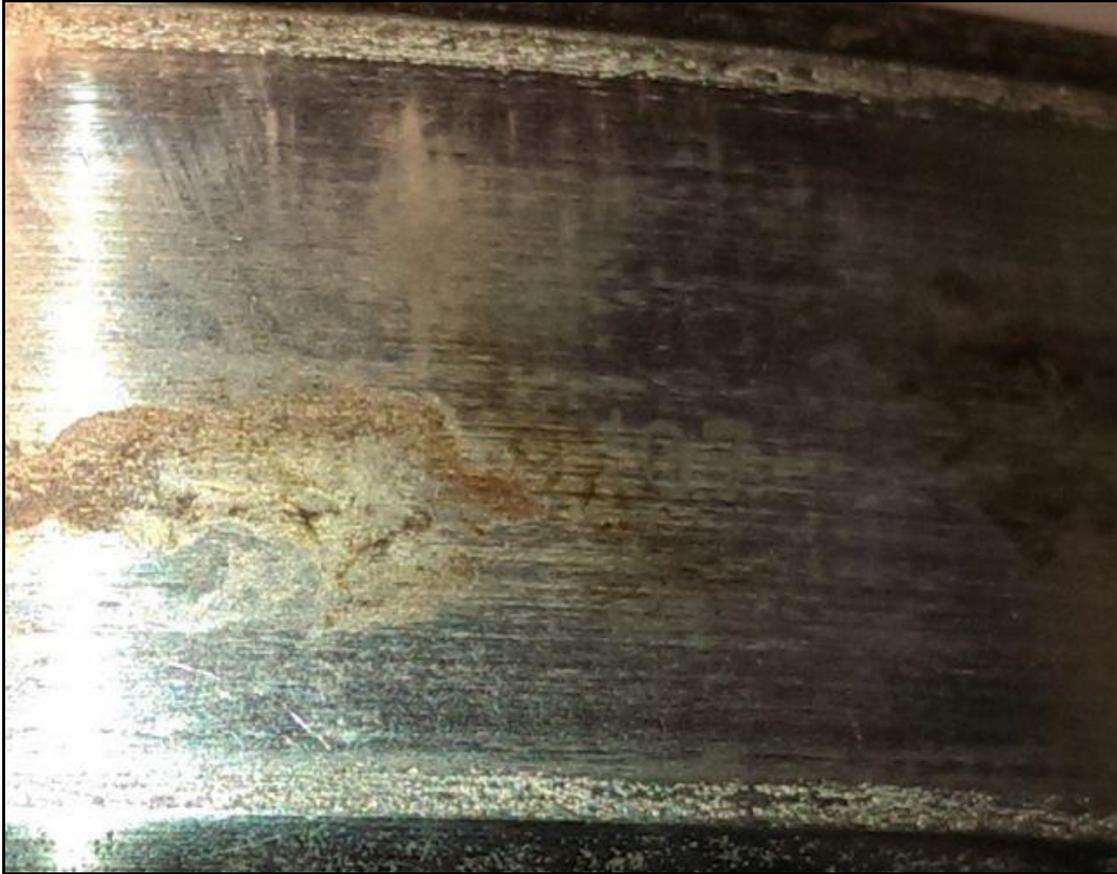
Figure 13 – detail of outer ring OD.

Moisture corrosion, fretting corrosion and circumferential scratches noted.

Moisture corrosion (ISO 5.3.2 – Appendix A, Table A1) was noted on front bearing outer ring OD (Figure 13) and rear bearing outer ring OD (Figure 35). For this type of corrosion to occur the component surfaces need to be exposed to moisture and oxygen when at stand-still for prolonged periods.

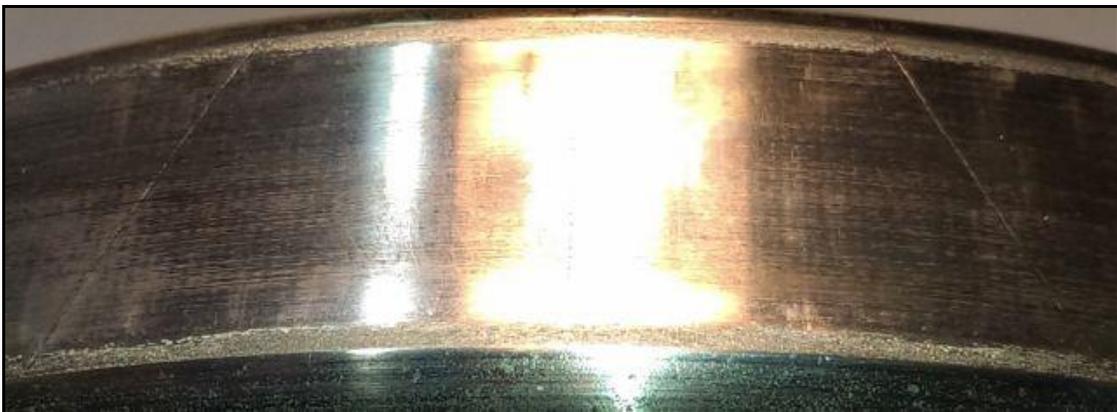
Figure 14 – detail of outer ring OD. Note "V-shaped" marking which indicates how the matched bearing set should be mounted to obtain the proper preload in the set (see matching marks on the rear bearing shown in Figure 36).

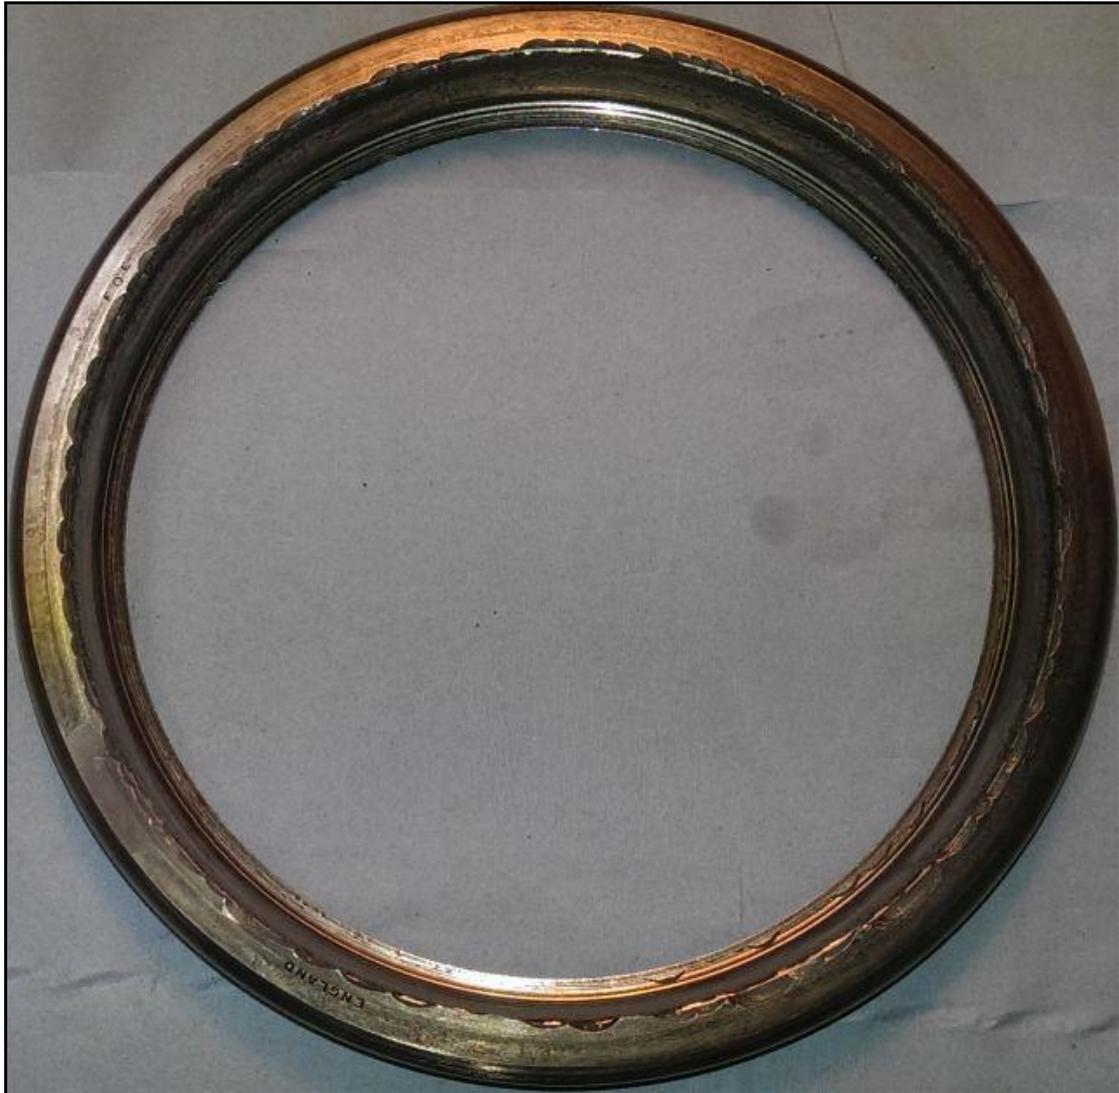
Figure 15 – *Outer ring side face 1.*

Circumferential scoring, staining and fractures to the inner lip noted.

Fractures (ISO 5.6.1 – Appendix A, Table A1) were noted on front bearing outer ring side face 1 (Figure 15), front bearing outer ring raceway shoulder (Figure 18), front cage (Figure 20), rear bearing outer ring side face 1 (Figure 37), rear bearing inner ring raceway (Figure 39), rear bearing outer ring raceway (Figure 40) and rear cage (Figure 41). These are the result of the tensile strength of the material being exceeded and probably occurred following loss of bearing integrity.

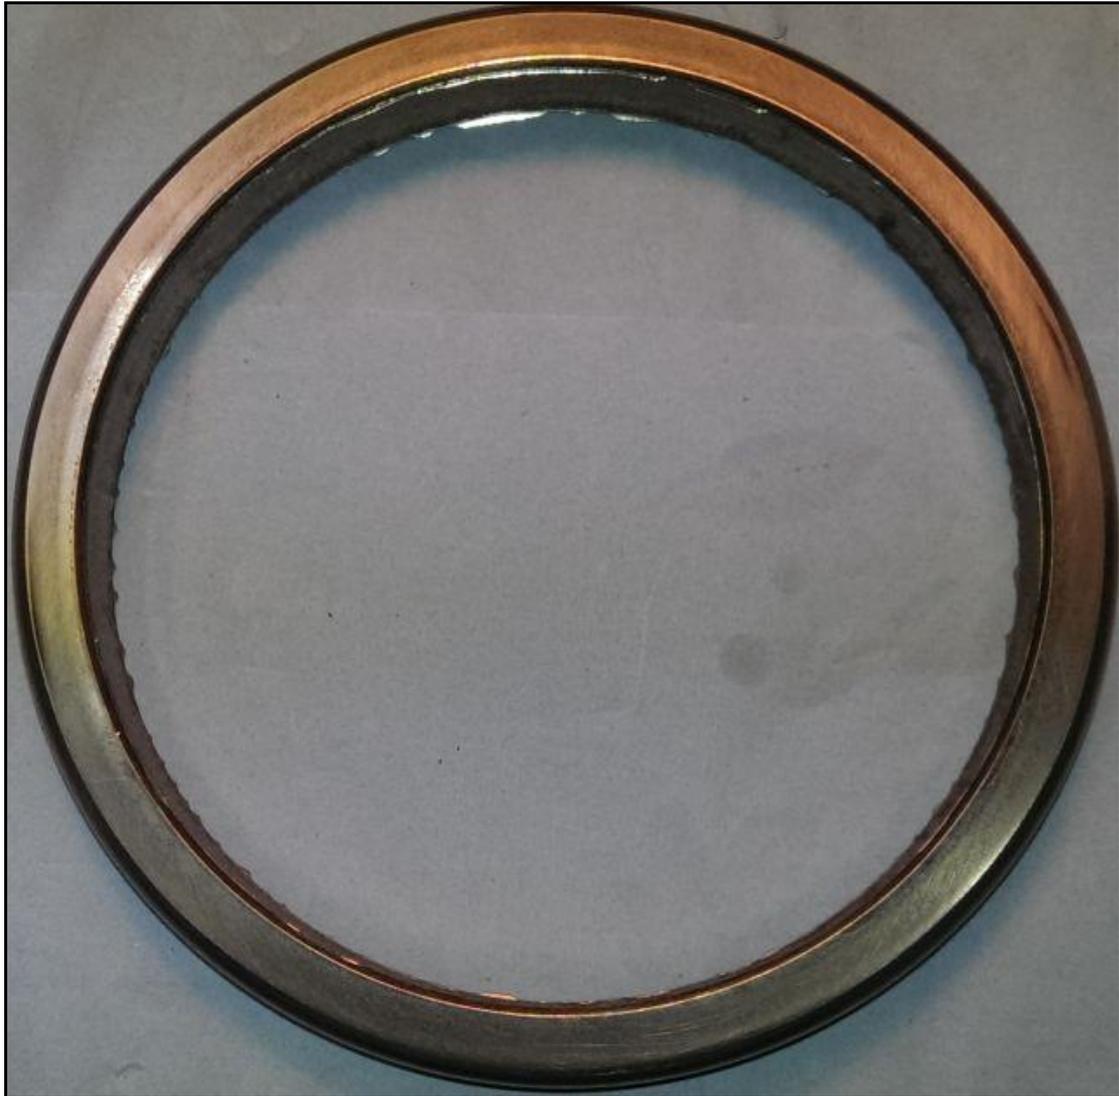
Figure 16 – *Outer ring side face 2.*

Light staining noted.

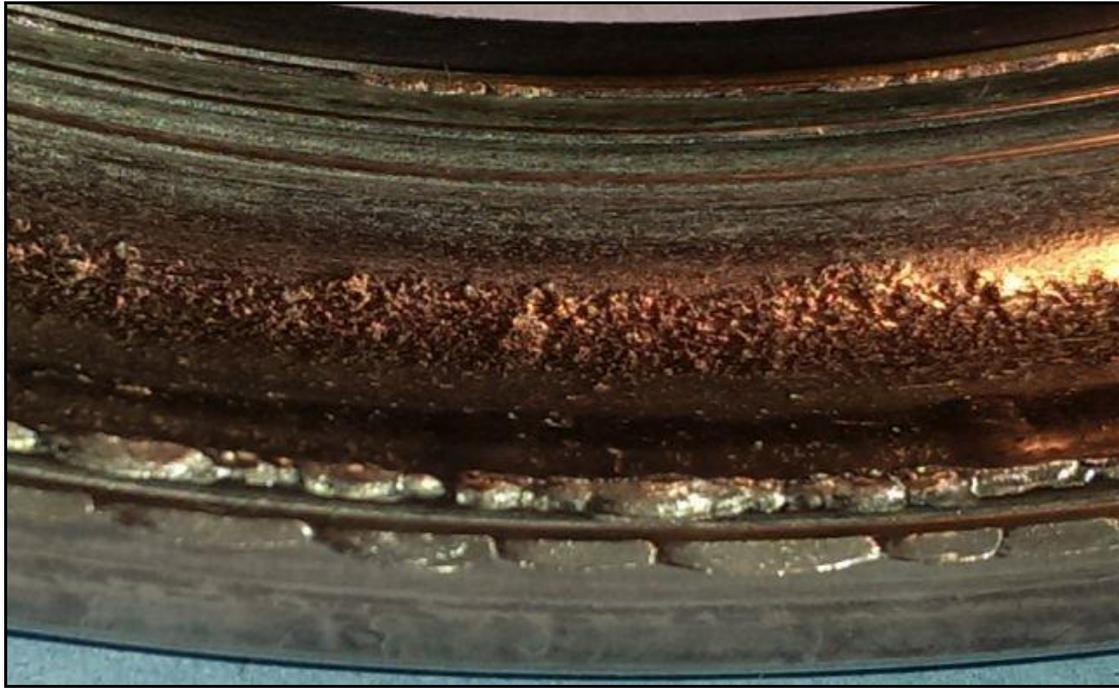
Figure 18 – Detail of outer ring raceway.

Heavy spalling, circumferential scoring, staining and fractures noted.

Spalling (ISO 5.1.1 – Appendix A, Table A1) was noted on both front and rear inner and outer raceways - Figure 17, Figure 18, Figure 19, Figure 39, Figure 40 & Figure 41. This type of fatigue is caused by repeated stresses between rolling elements and raceways and is often attributed to lubrication issues.

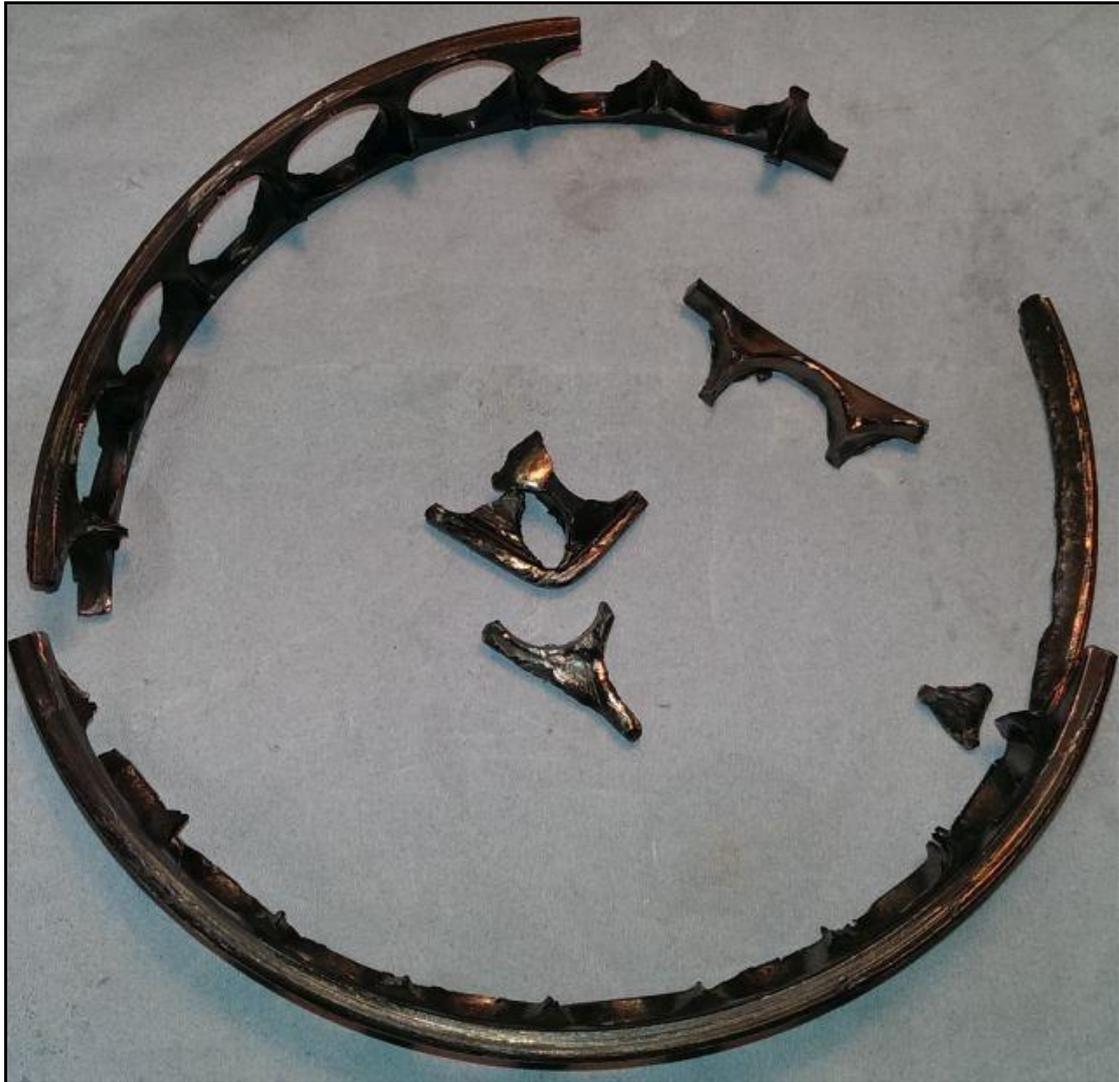
Figure 20 – cage fragments after cleaning.

A quantity of the cage was found to be absent when re-construction attempted.

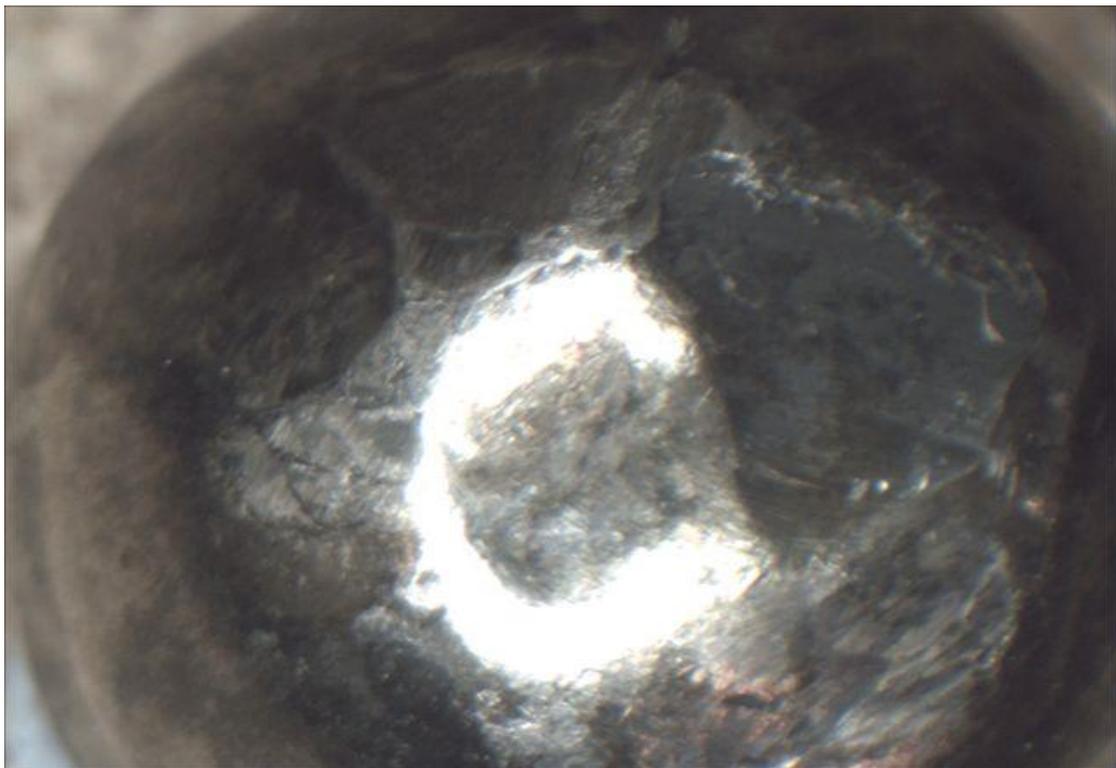
An accumulation of 'flat spots' are illustrated in Figure 24 (overleaf).

Figure 24 – an accumulation of 'flat spots' (deformation) on rolling element.

Overload (ISO 5.5.2 – Appendix A, Table A1) was noted on front bearing outer race raceway (Figure 19), front bearing cage (Figure 21), Front bearing rolling elements (Figure 22, Figure 23 & Figure 24), rear bearing cage (Figure 42 & Figure 43) and rear bearing rolling elements (Figure 45 & Figure 46). Common causes include static/shock loading of components, handling damage and surface damage caused by hard/sharp objects.

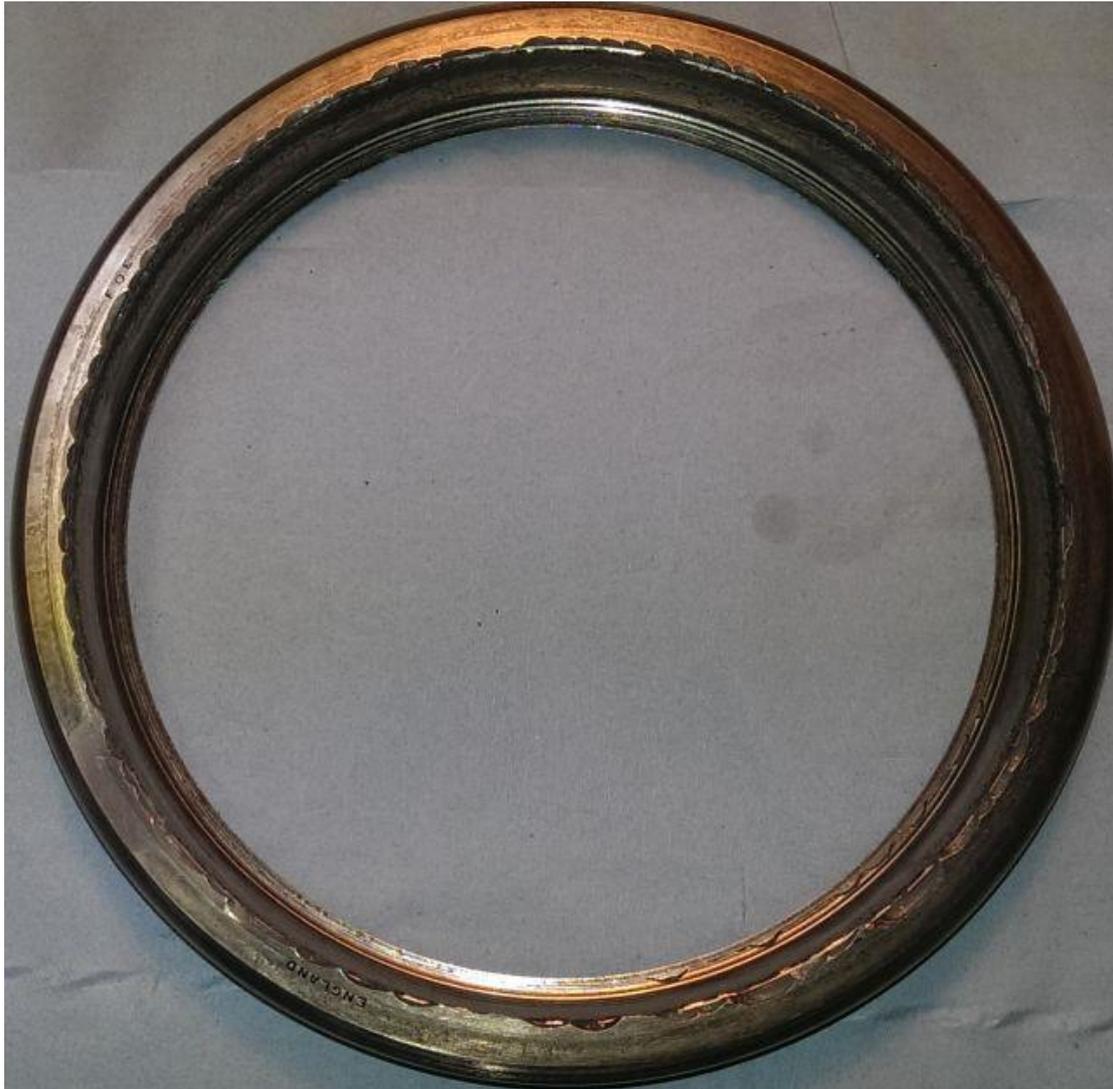
Figure 26 – *Outer ring side face #1 'as received'.*

The bearing was received disassembled – the outer ring shown above and the inner ring (Figure 27 overleaf) split in two halves.

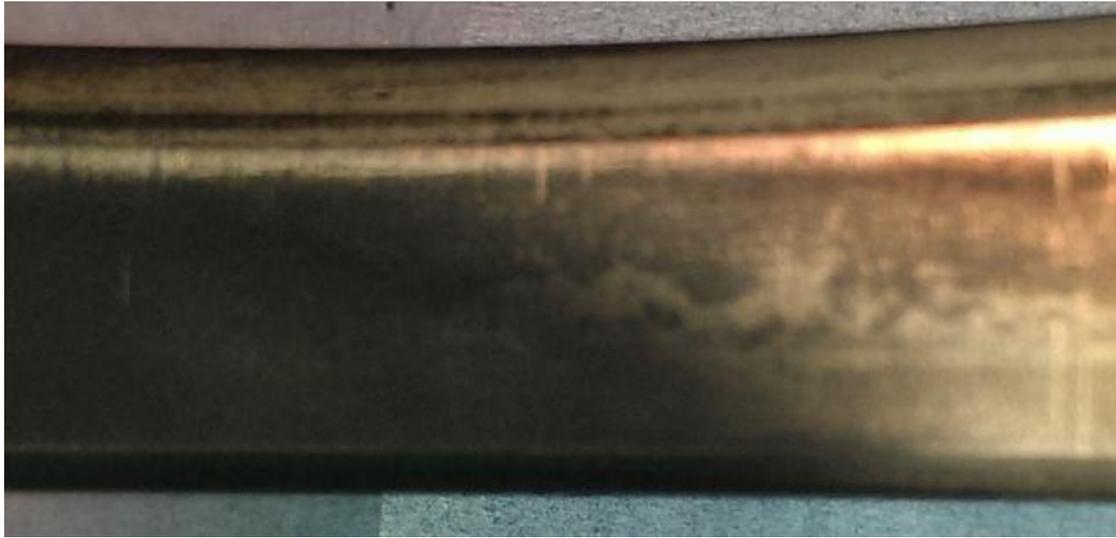
Figure 30 – detail of inner ring bore.

Staining and heat damage noted.

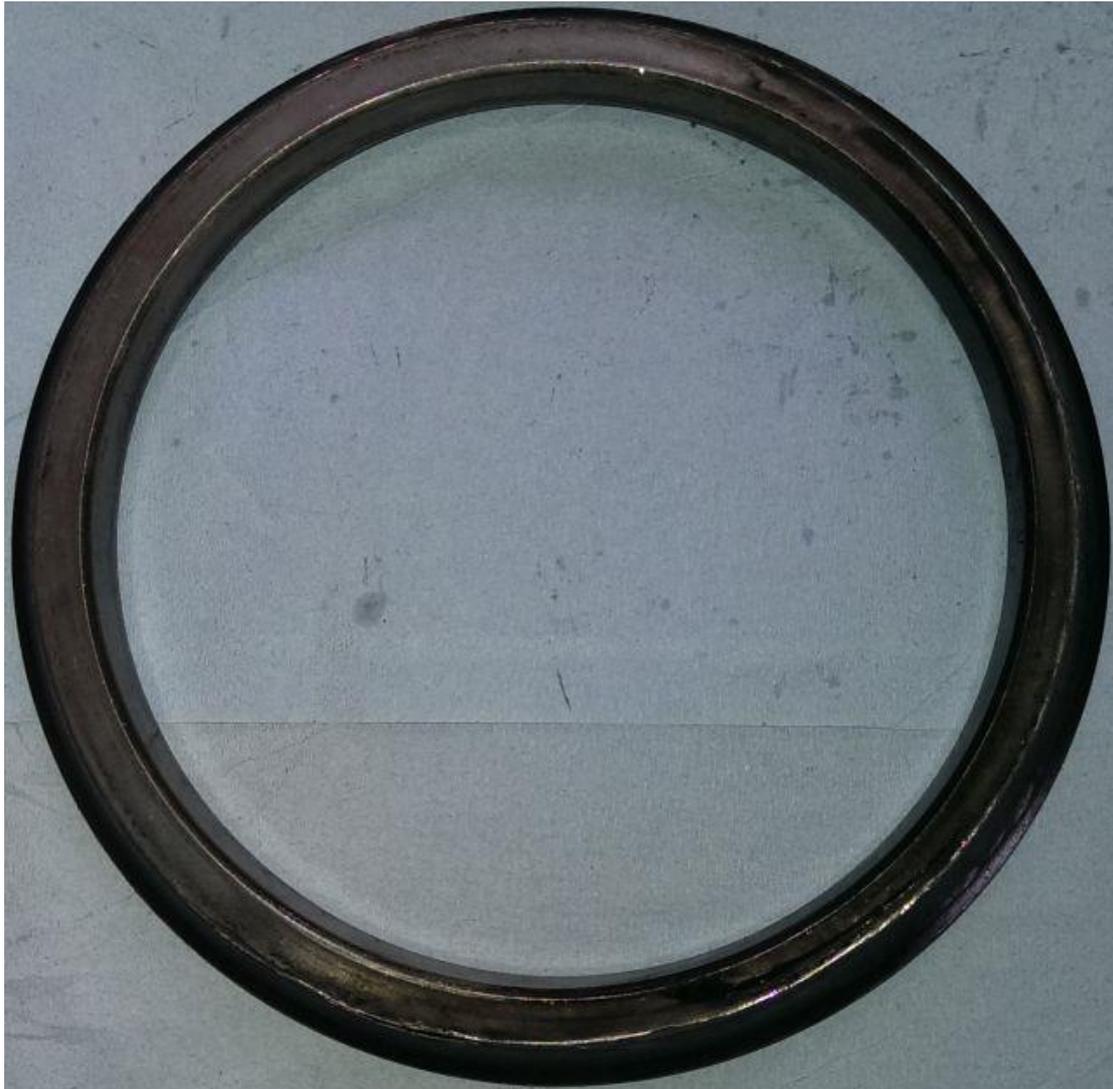
Figure 31 – *Inner ring #1 side face 1.*

Circumferential scoring, staining and blueing noted.

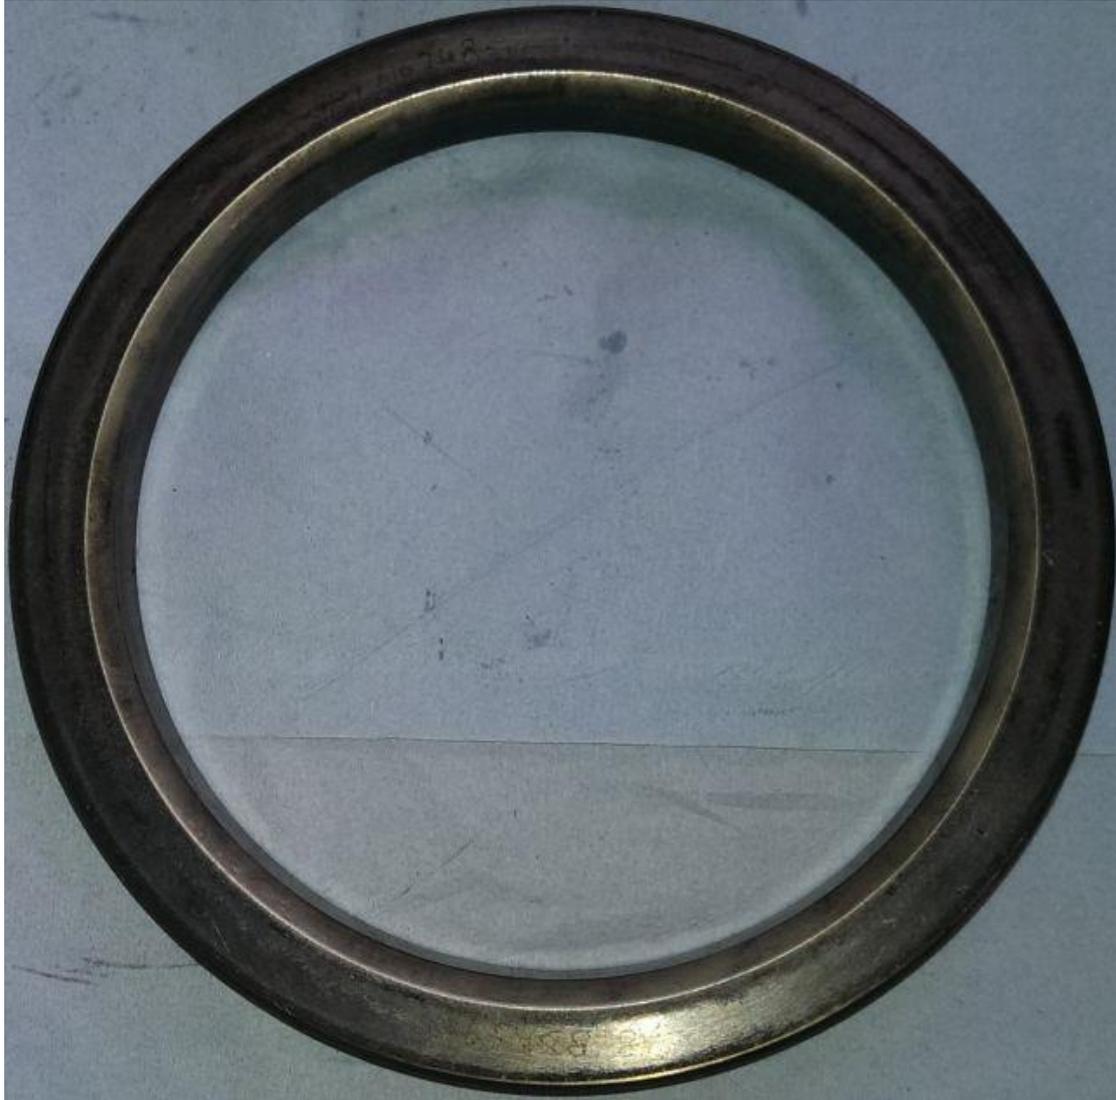
Figure 32 – *Inner ring #1 side face 2.*

Staining and bluing noted.

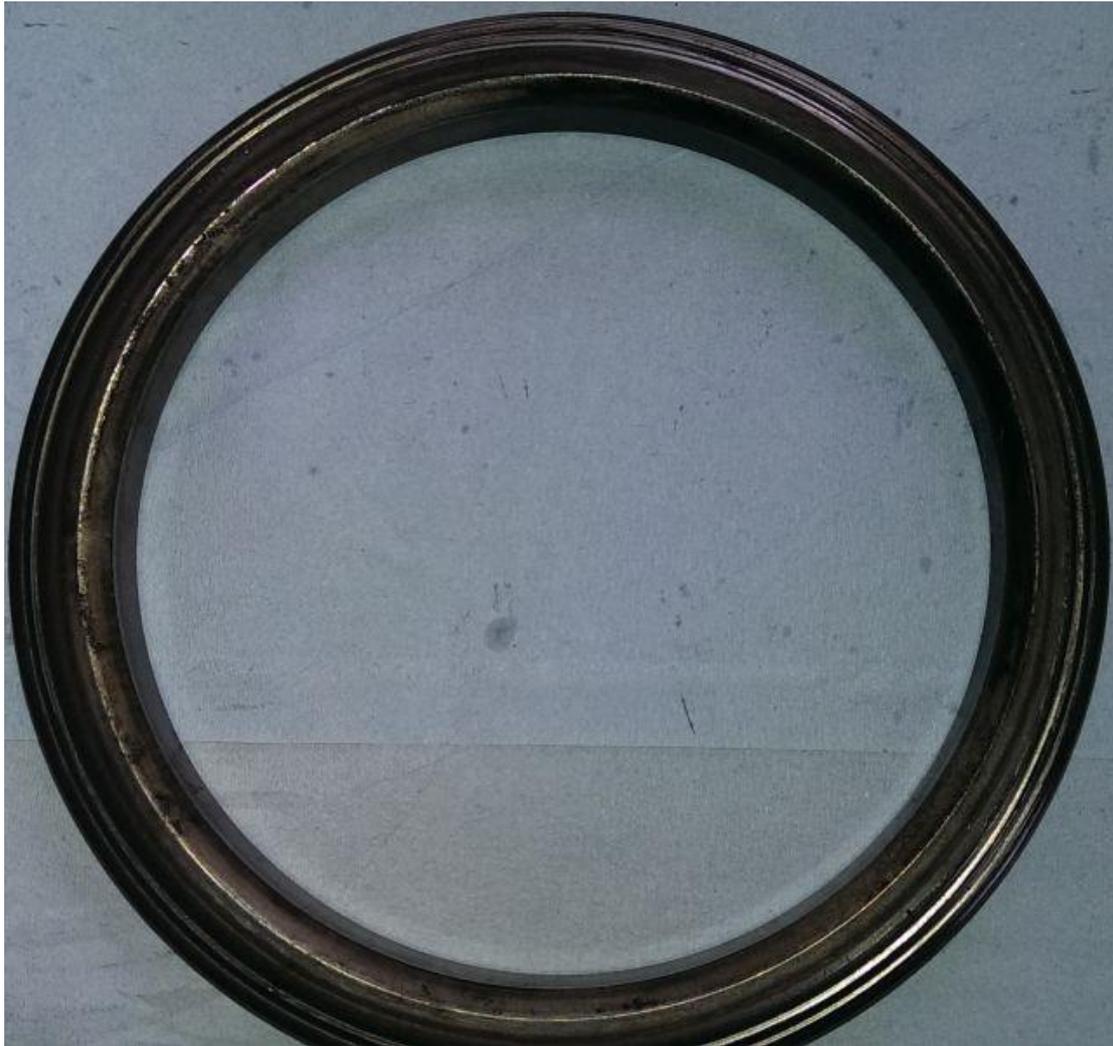
Figure 33 – Inner ring #2 side face 1.

Heavy circumferential damage, heat damage and staining noted.

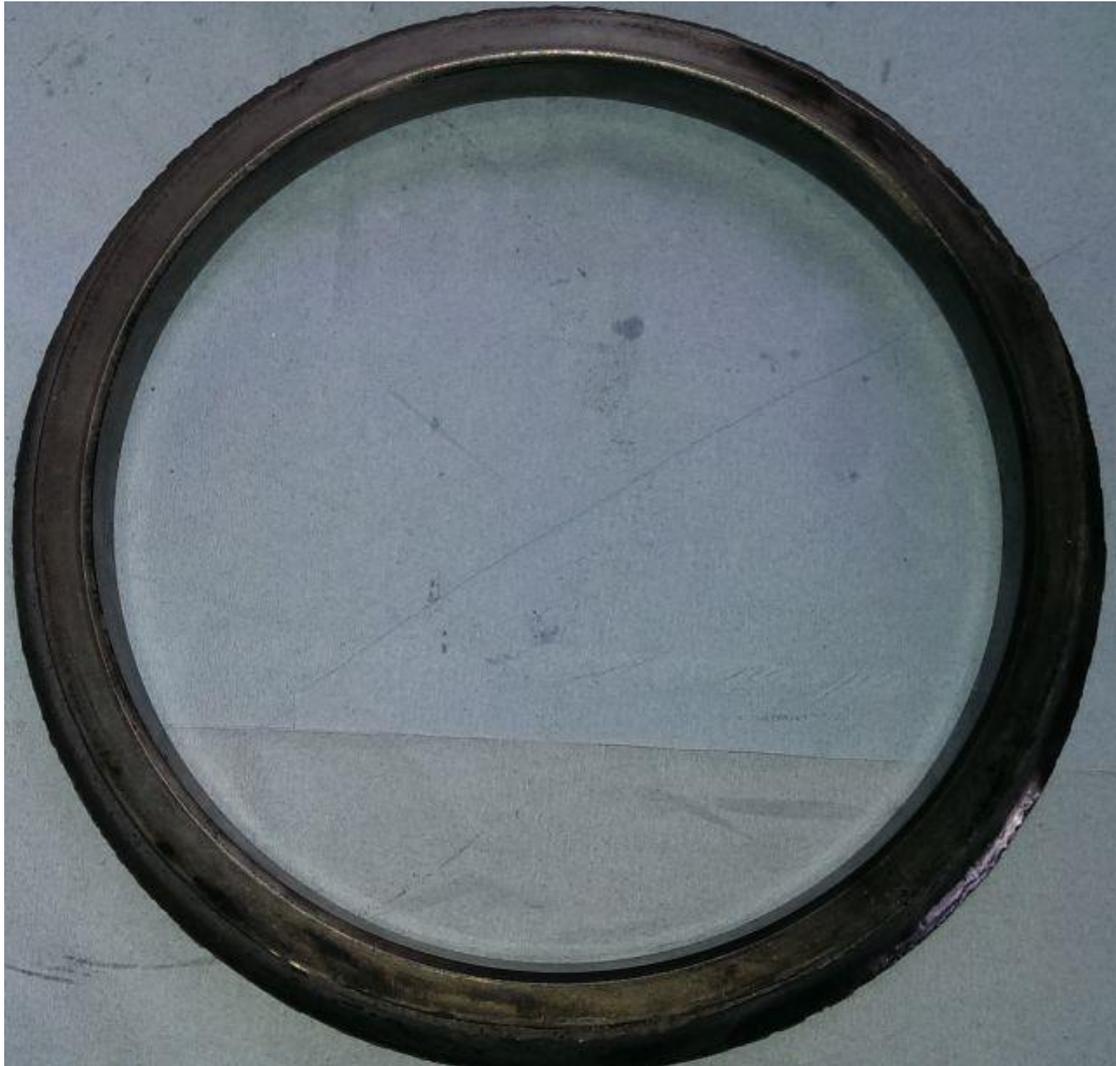
Figure 34 – Inner ring #2 side face2.

Heat damage and staining noted.
