**A REPORT TO
THE BOARD OF COMMISSIONERS OF PUBLIC UTILITIES**

NEWFOUNDLAND AND LABRADOR HYDRO

Gas Turbine Failure Analysis

Final Report

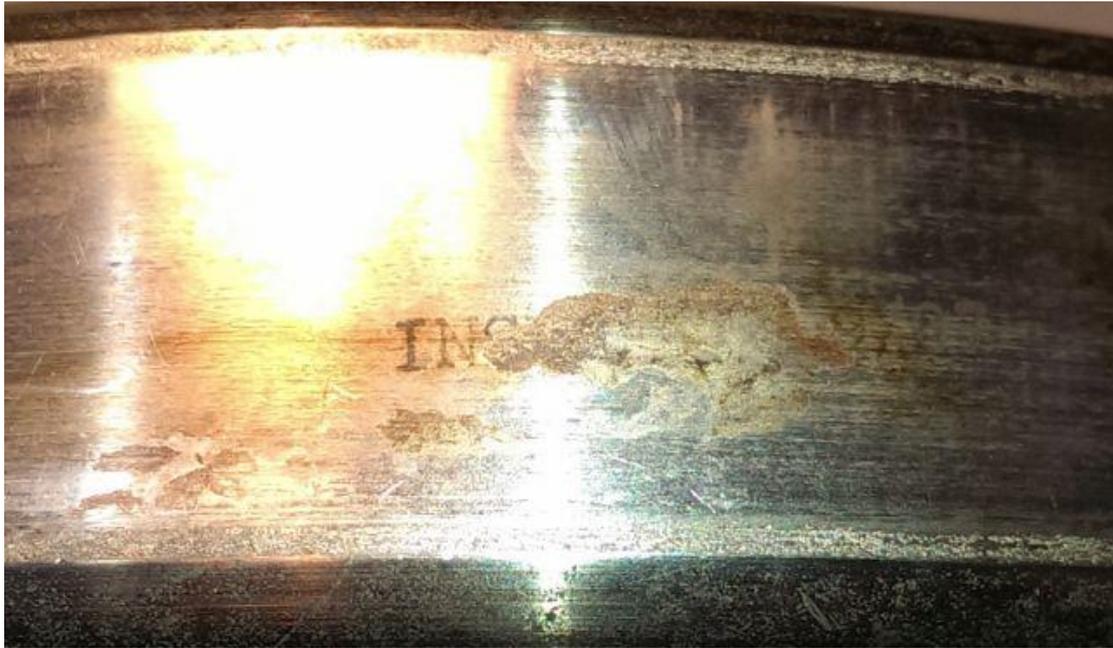
Figure 35 – detail of outer ring OD.

Moisture corrosion, fretting corrosion and circumferential scratches noted.

Scoring noted across OD – see Figure 36 (overleaf).

Moisture corrosion (ISO 5.3.2 – Appendix A, Table A1) was noted on front bearing outer ring OD (Figure 13) and rear bearing outer ring OD (Figure 35). For this type of corrosion to occur the component surfaces need to be exposed to moisture and oxygen when at stand-still for prolonged periods.

Fretting corrosion (ISO 5.3.3.2 – Appendix A, Table A1) was noted on front bearing inner ring #2 side face 2 (Figure 12), front bearing outer ring OD (Figure 13), the rear bearing outer ring OD (Figure 35) and interior of bearing housing (Figure 49). This type of damage is commonly caused by micro-movements between mating parts in load transmitting interfaces.

In order to avoid fretting corrosion, or slow the process, the tolerances (fit) should be adjusted. Some manufacturers recommend the application of an anti-fretting paste or compound. SKF, however, does not recommend the use of specially formulated adhesives to avoid fretting corrosion; a 'precision' fit should always be sought.

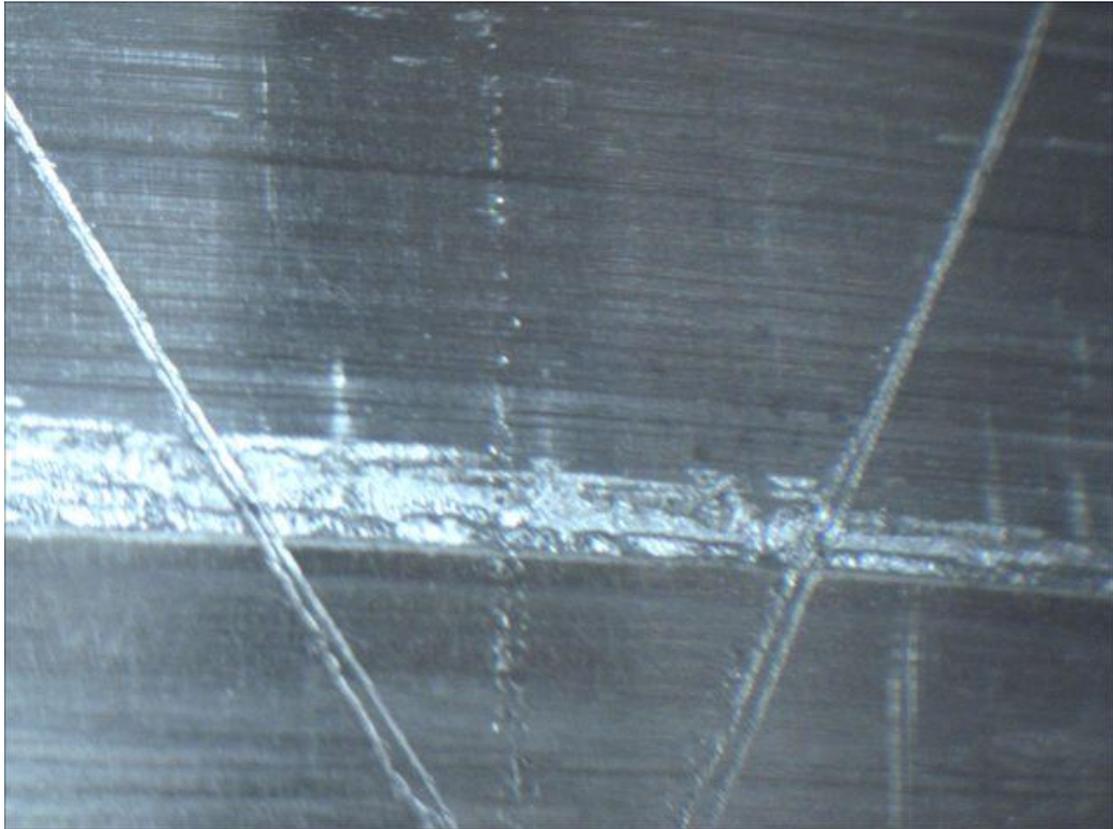
Figure 36 – detail of outer ring OD. Note "V-shaped" marking which indicates how the matched bearing set should be mounted to obtain the proper preload in the set (see matching marks on the rear bearing shown in Figure 14).

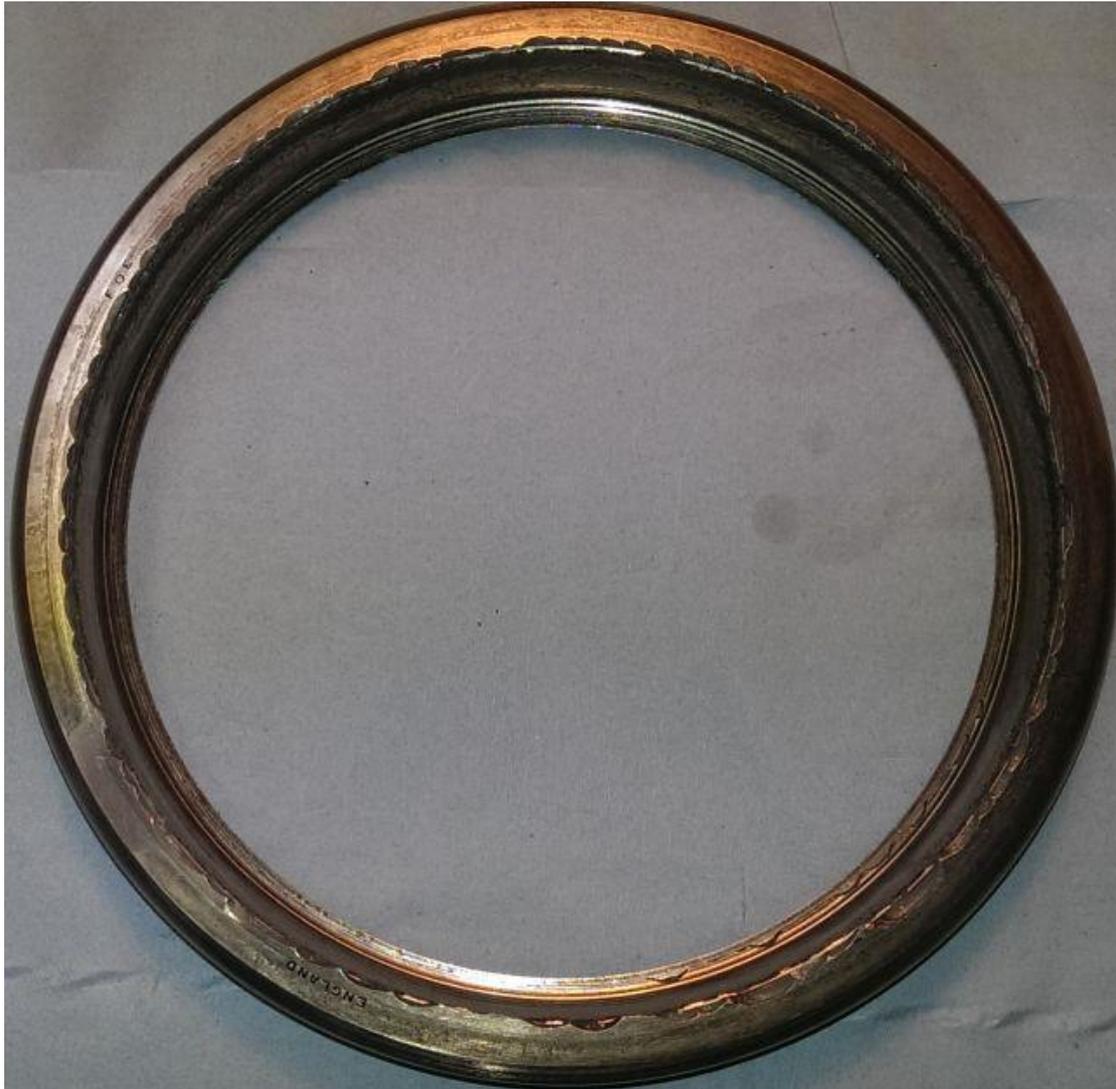
Figure 37 – *Outer ring side face 1.*

Circumferential scoring, staining and fractures to the inner lip noted.

Fractures (ISO 5.6.1 – Appendix A, Table A1) were noted on front bearing outer ring side face 1 (Figure 15), front bearing outer ring raceway shoulder (Figure 18), front cage (Figure 20), rear bearing outer ring side face 1 (Figure 37), rear bearing inner ring raceway (Figure 39), rear bearing outer ring raceway (Figure 40) and rear cage (Figure 41). These are the result of the tensile strength of the material being exceeded and probably occurred following loss of bearing integrity.

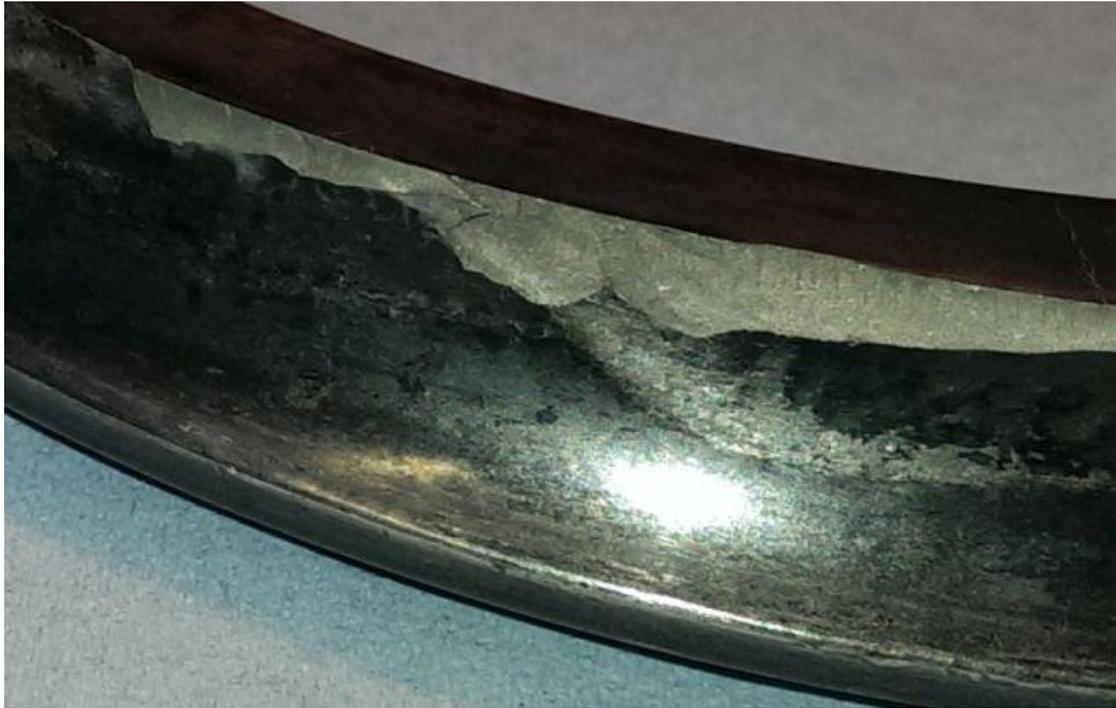
Figure 39 – Detail of inner ring raceway.

Spalling and fractures noted.

Spalling (ISO 5.1.1 – Appendix A, Table A1) was noted on both front and rear inner and outer raceways - Figure 17, Figure 18, Figure 19, Figure 39, Figure 40 & Figure 41. This type of fatigue is caused by repeated stresses between rolling elements and raceways and is often attributed to lubrication issues.

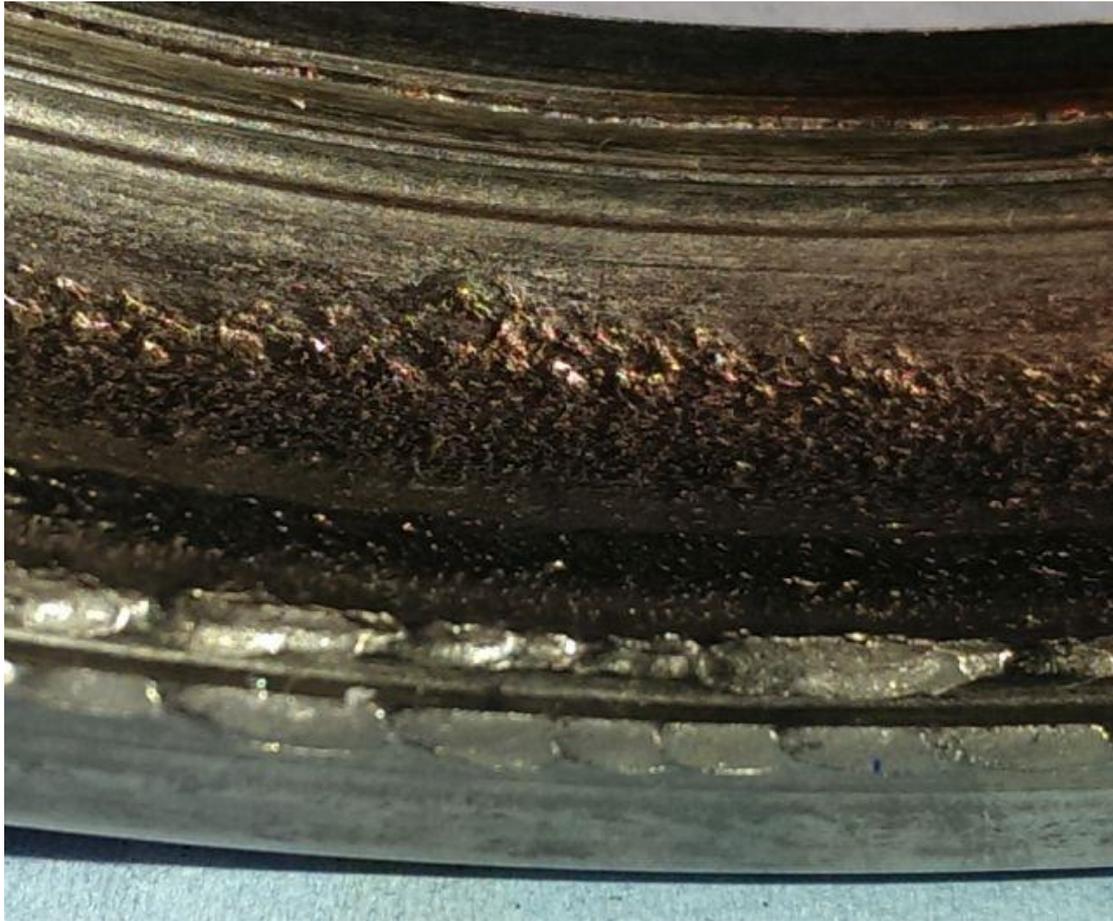
Figure 40 – Detail of outer ring raceway.

Heavy spalling, circumferential scoring, staining and fractures noted.

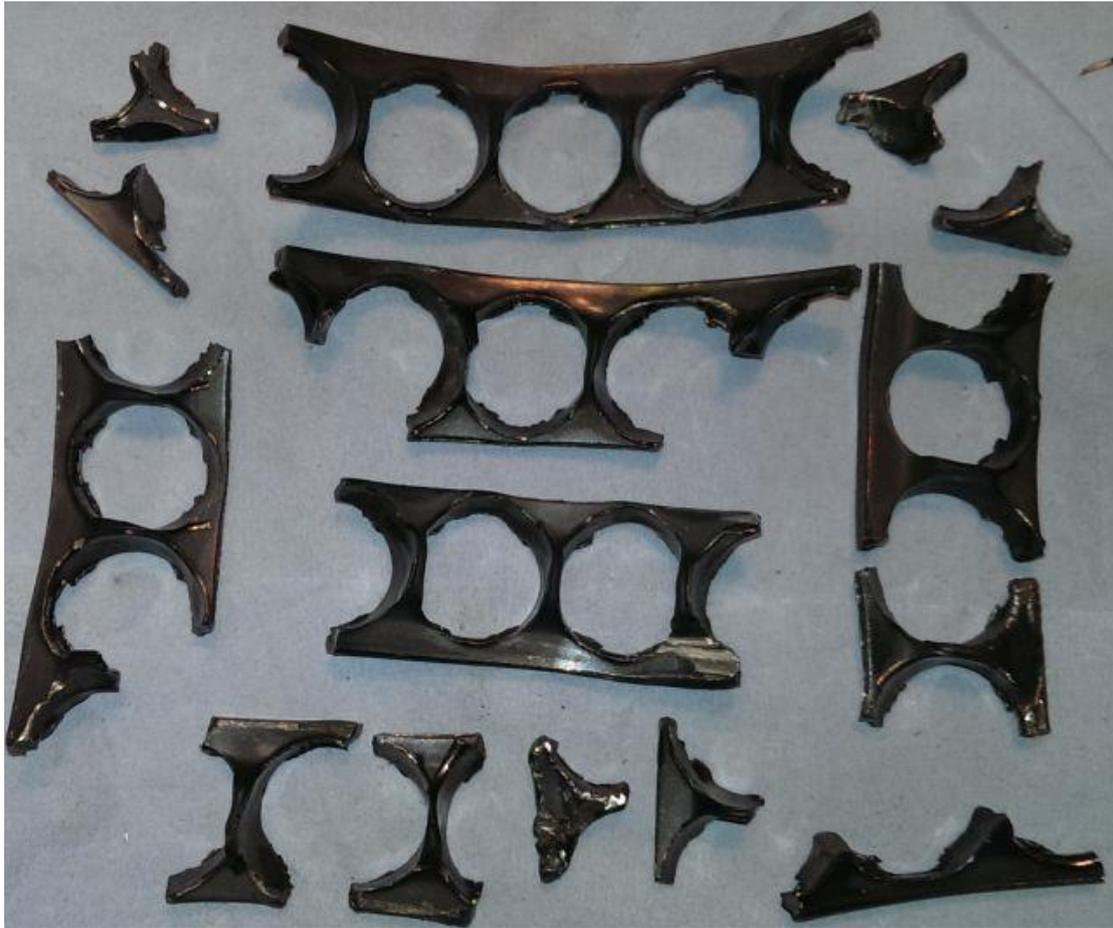
Figure 41 – cage fragments after cleaning.

A quantity of the cage was found to be absent when re-construction attempted.

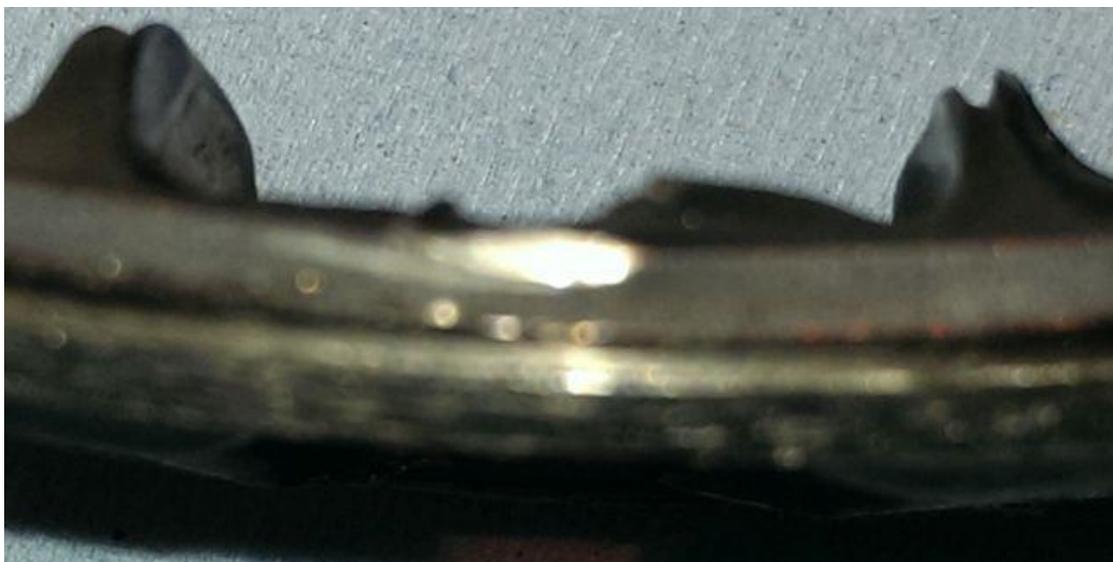
Figure 43 – side view of cage fragment. Note extended pocket margins.

Overload (ISO 5.5.2 – Appendix A, Table A1) was noted on front bearing outer race raceway (Figure 19), front bearing cage (Figure 21), Front bearing rolling elements (Figure 22, Figure 23 & Figure 24), rear bearing cage (Figure 42 & Figure 43) and rear bearing rolling elements (Figure 45 & Figure 46). Common causes include static/shock loading of components, handling damage and surface damage caused by hard/sharp objects.

Both cages have fractured/separated probably as a result of excessive heat. The significant amount of separation noted between rolling element and cage pocket (Figure 44) and the distortion of pocket geometry (Figure 43) suggest running with sub-optimal lubrication conditions.

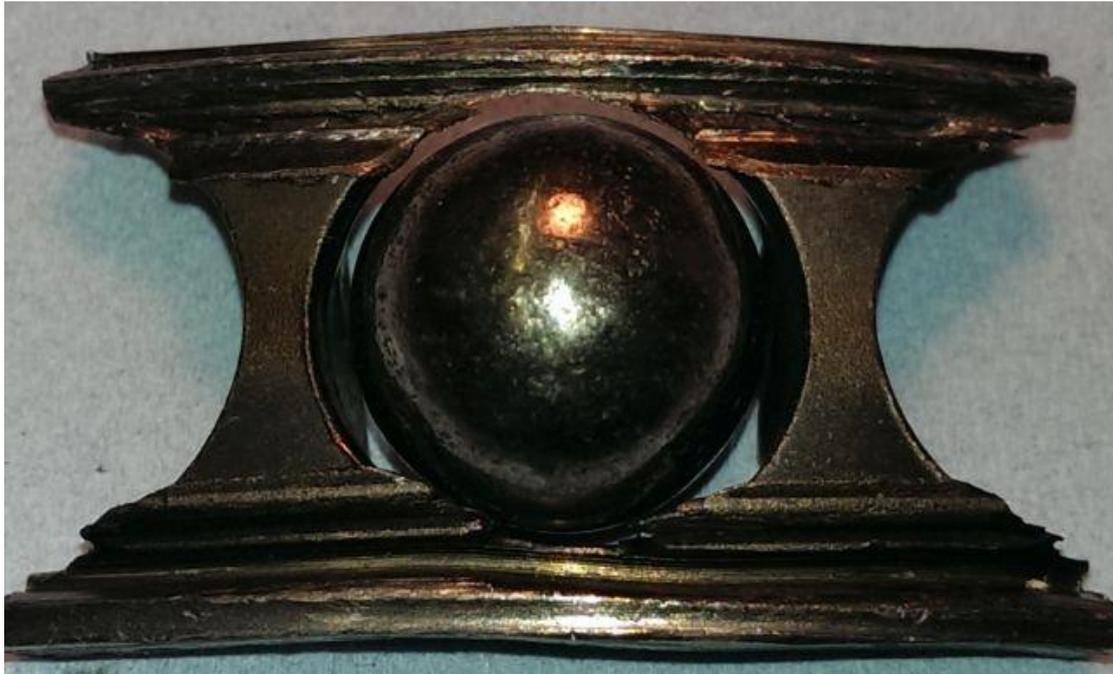
Figure 44 – example of damage to exterior of cage. Also note amount of clearance around the rolling element.

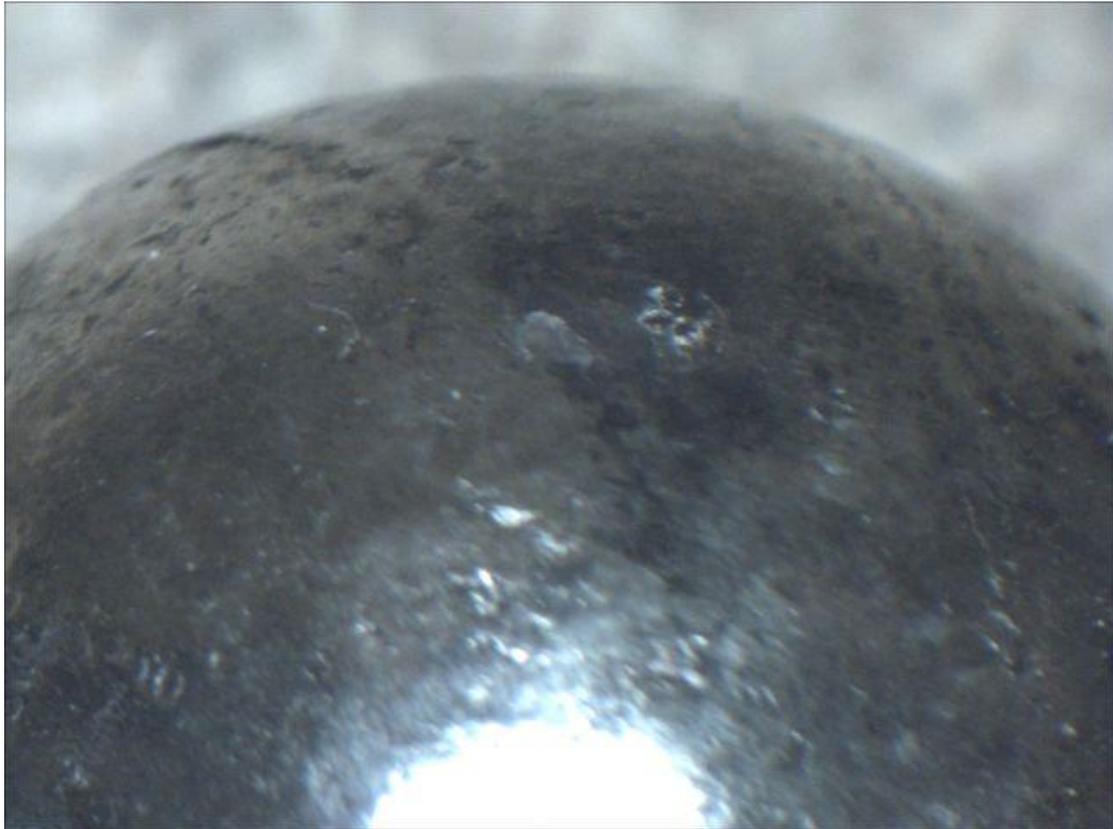
Figure 45 – example of typical ball condition.

Rolling elements were in poor condition with a variety of defects noted.

Over-rolling of steel debris often produces indentation with rounded bottoms like those seen on the rolling elements (Figures 45 and 46).

A review of bearing selection criteria might be beneficial to ensure that state-of-the-art quality bearings are being utilised. Hybrid bearings (with specialist coatings) are available which can help mitigate against early wear effects and lubricant contamination.

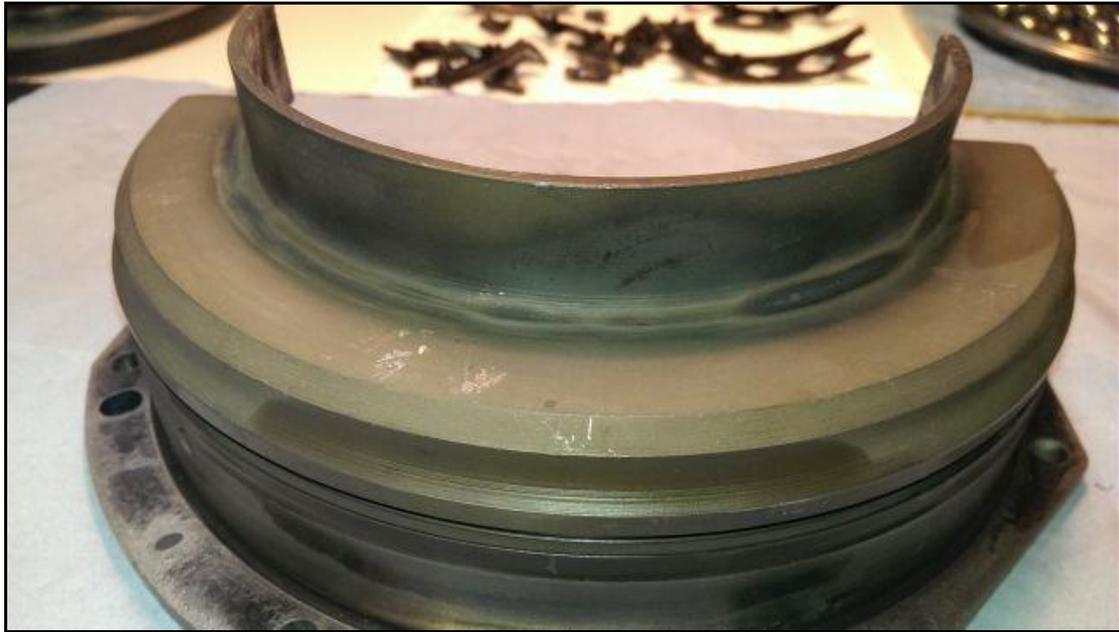
The exterior of the housing also showed evidence of having been subjected to high localised heat – see Figure 48 (overleaf).

Figure 48 – one half of housing exterior after cleaning. Note areas of 'blueing' (centre right of photo).

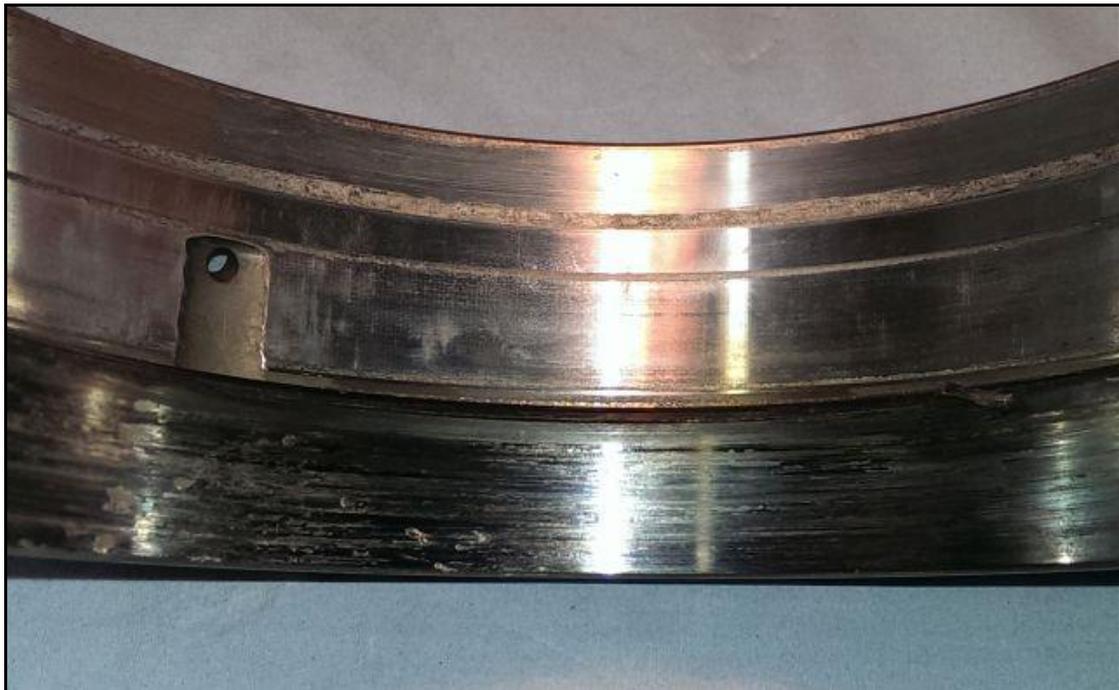
Figure 49 – one half of housing interior.

Circumferential wear was noted on the housing interior – see upper section of Figure 49.

Significant amounts of wear noted in shaft aperture – see lower section of Figure 49.

Adhesive wear (ISO 5.2.3 – Appendix A, Table A1) was noted on the front bearing inner ring #1 side face 1 (Figure 9), rear bearing inner ring #1 side face 1 (Figure 31), rear bearing inner ring #2 side face 1 (Figure 33), front bearing rolling element (Figure 25) and housing interior (Figure 49). Some causes of adhesive wear include acceleration of bearing components, skidding/smearing of rolling elements, excessive frictional heat and too light loading.

The fretting corrosion around the inside of the housing (Figures 49) suggest poor fit between components. The wear and 'blueing' (Figure 47) is probably secondary damage caused by rotating contact due to increasing clearance between cage and rolling elements.

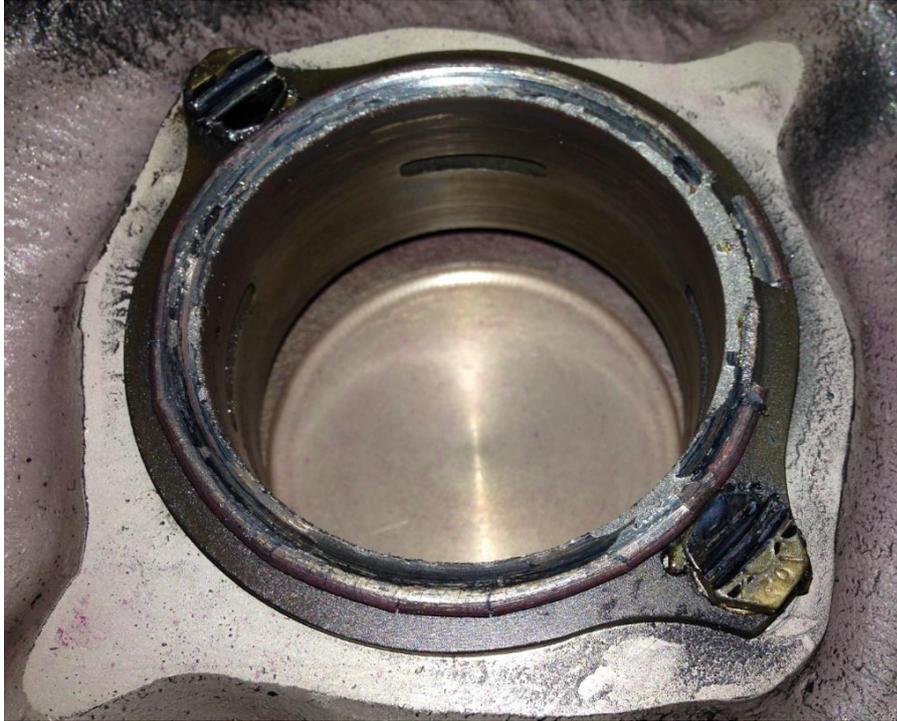
Photo 1 below: shows LP Compressor shaft front end labyrinth seal bush damage from running contact with the shaft lock nut.

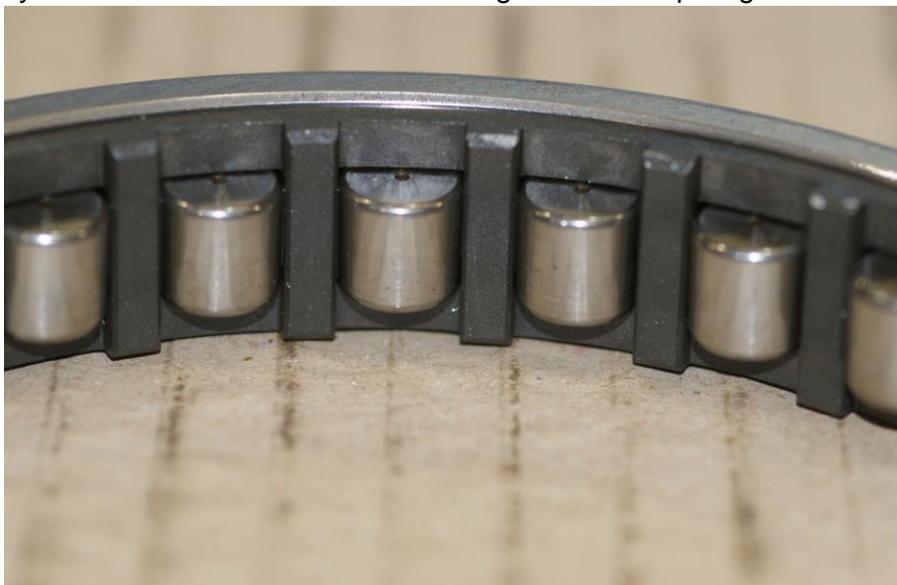
Photo 2 below: shows matt micro pitted surfaces of No 1 bearing rollers caused by lube oil system contamination. Also shows larger corrosion pitting.

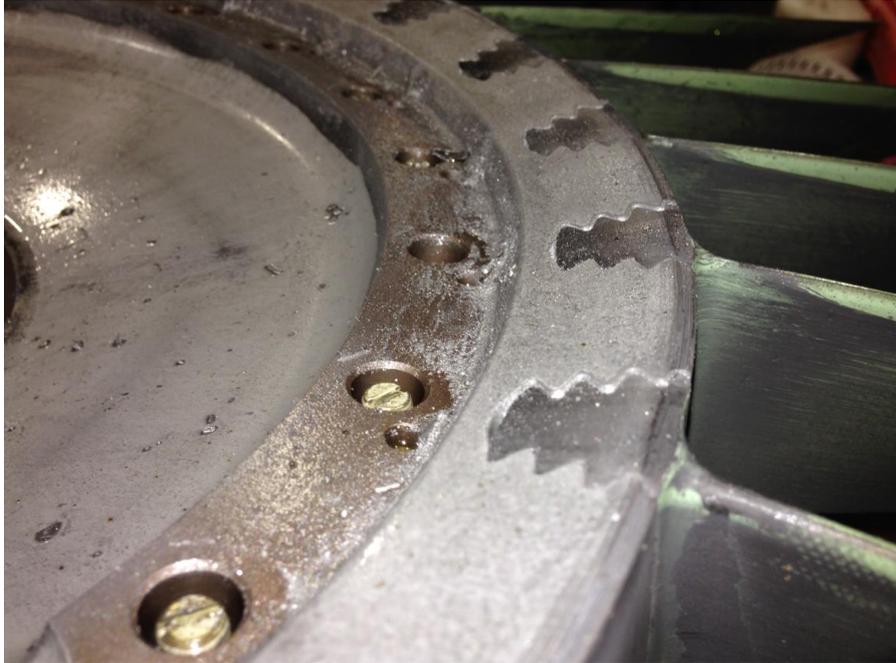
Photo 3 below: shows LP Compressor 1st stage blades platforms front edge deep abrasion metal loss (to flush with disc) from running contact with Inlet Guide Vanes platform segments.

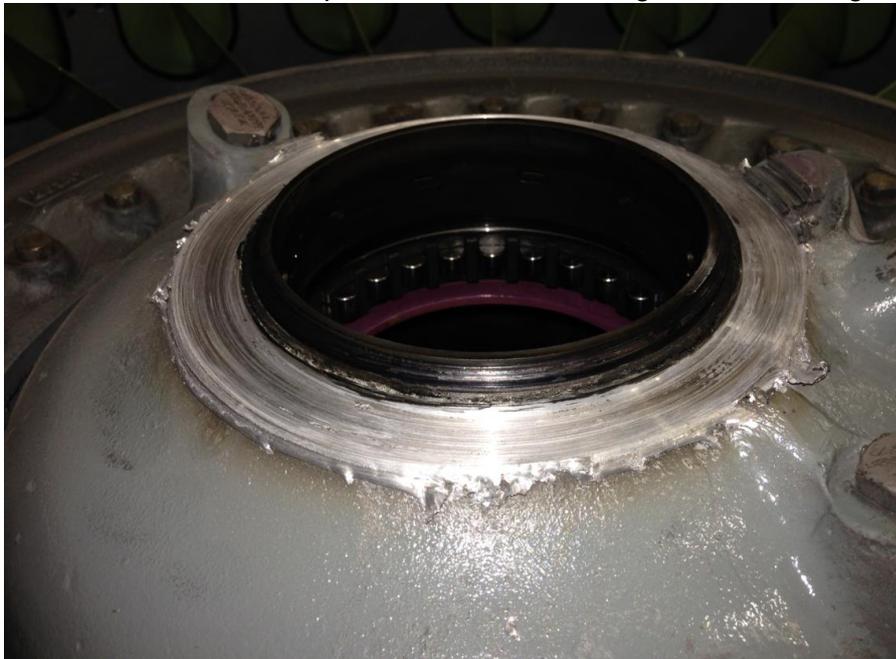
Photo 4a below: shows No 1 bearing housing rear face deep abrasion metal loss from running contact with the LP Compressor Rotor 1st/2nd stage discs retaining bolts.

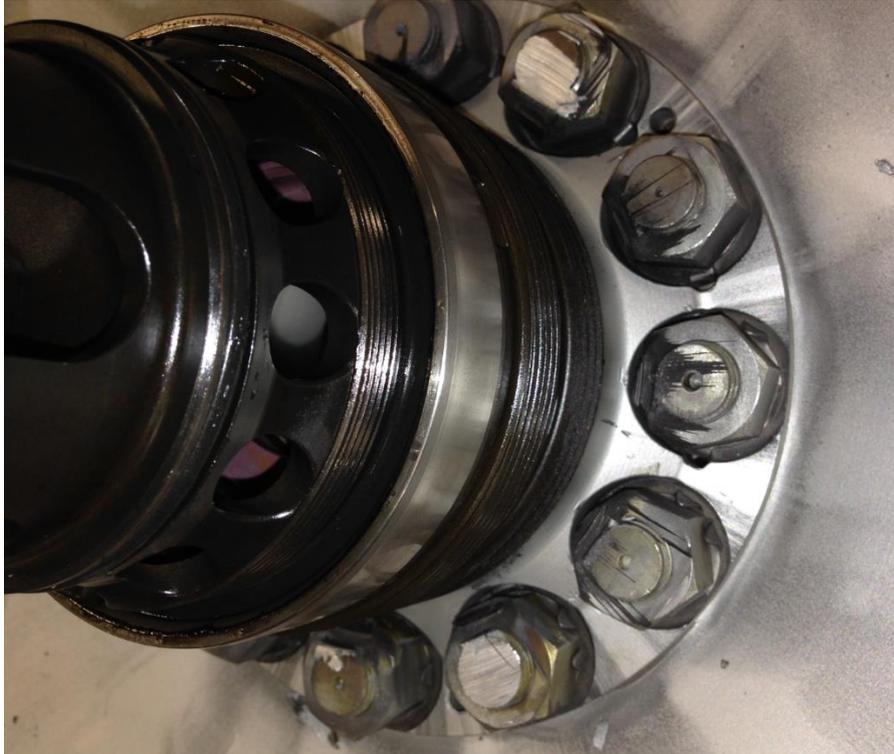
Photo 4b below: shows the LP Rotor 1st/2nd stage discs retaining bolts that caused the bearing housing damage in the photo above. Aluminium pick-up shows on two prominent bolts.

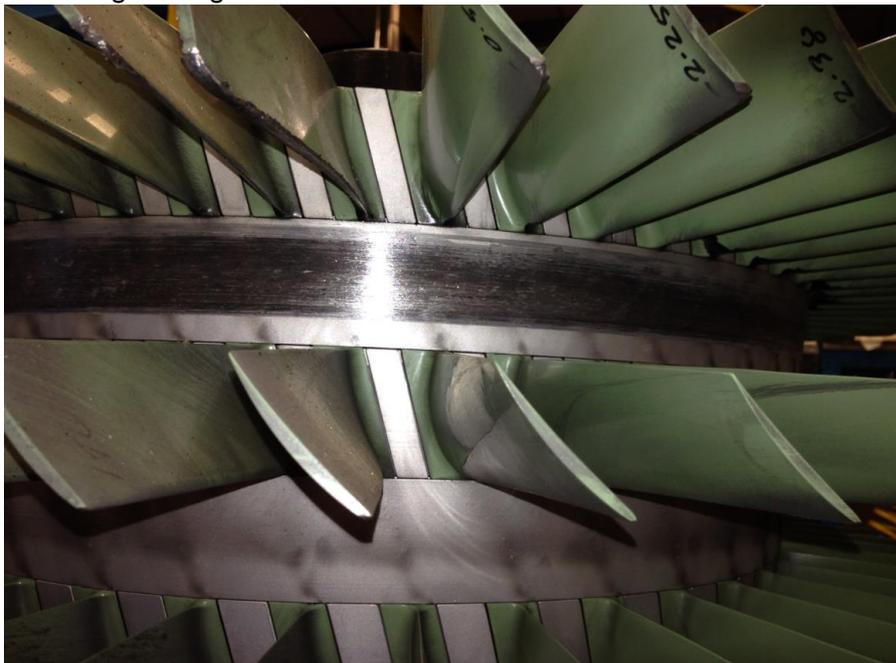
Photo 5a below: shows LP Compressor Rotor 5th stage blades heavy damage from running contact with stator guide vanes. Deep rotational scoring is also seen on the inter-stage disc from running contact with the IGV's tips due to the rotor having dropped as a result of the No 2 bearing damage.

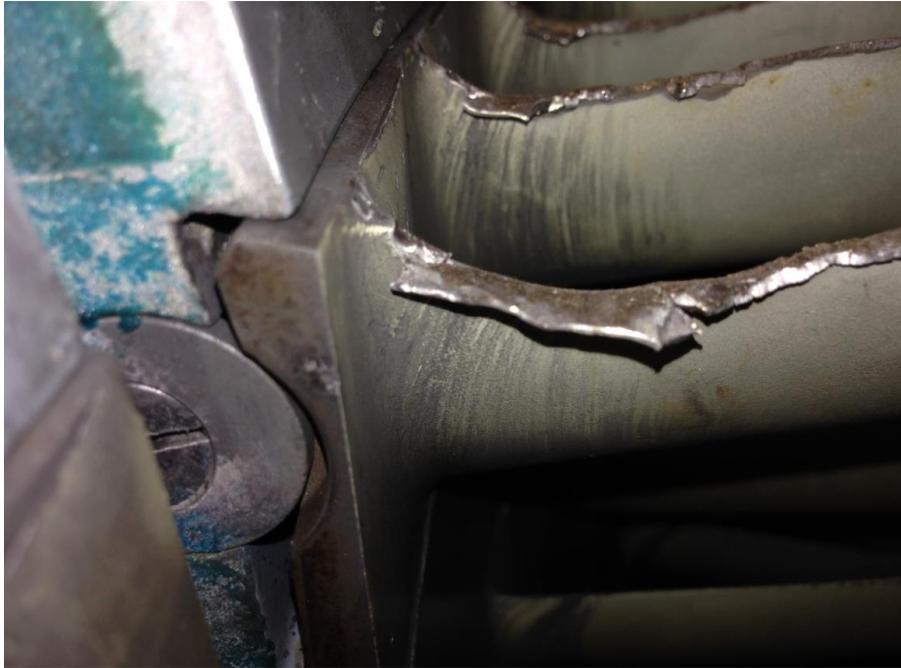
Photo 5b below: shows LP Compressor 5th stage stator vanes damage corresponding with the blades damage shown in the photo above. The open gap at the top of the vanes slot shows that the LP Compressor casing has distorted at that area due to running contact force.

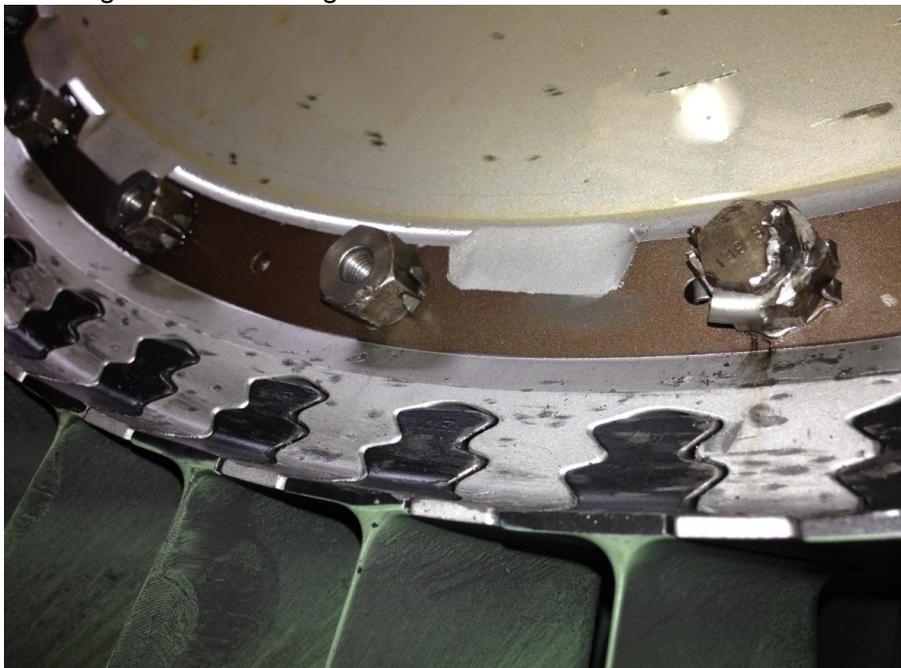
Photo 6a below: shows LP Compressor 5th stage disc rear side & bolting damage caused by two released stud/nut heads that had snapped off due to stress at the No 2 bearing housing resulting from the bearing failure.

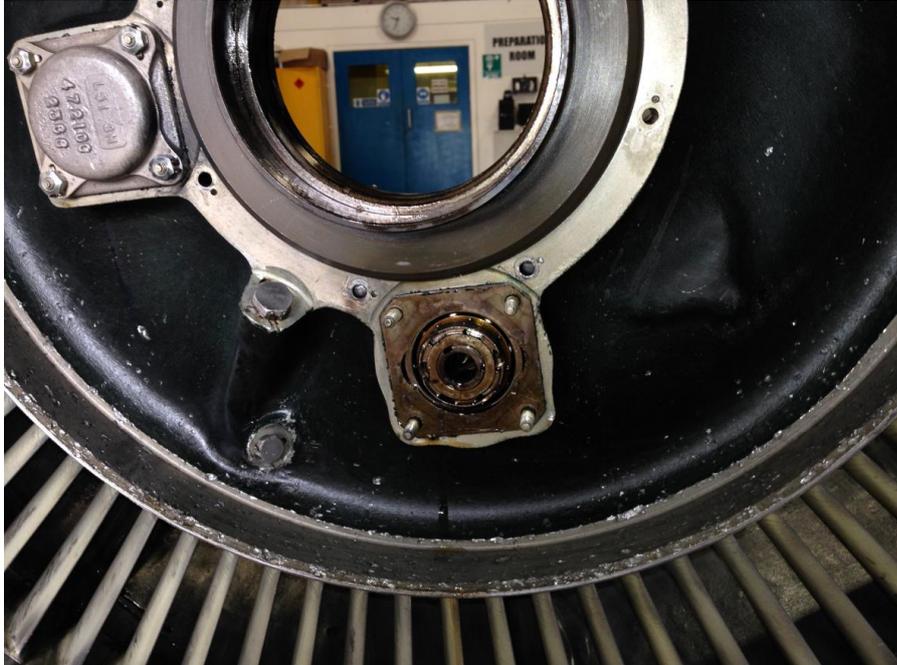
Photo 6b below: shows Intermediate Casing damage also caused by two the two released stud heads. The two broken studs can be seen just above the removed cover at bottom.

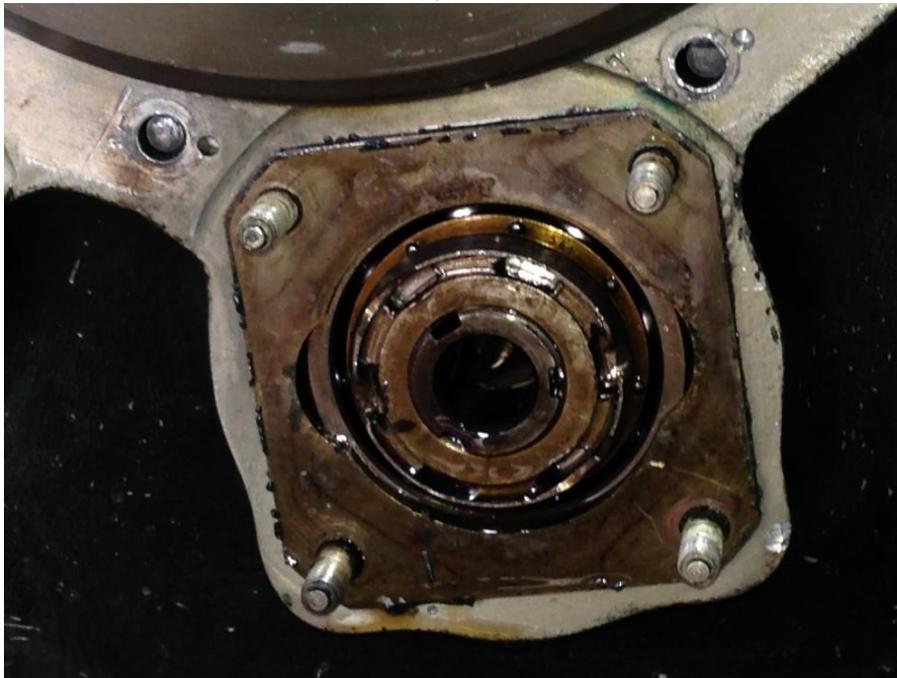
Photo 6c below: shows a close-up of the two broken studs.

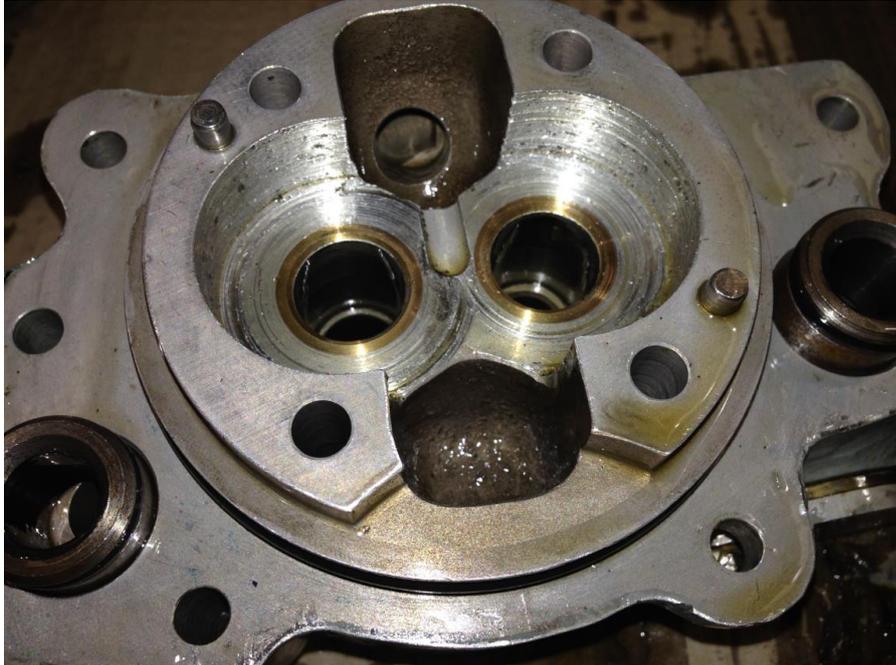
Photo 7 below: shows scavenge lube oil pump gears housing diameter deep abrasion metal loss caused by debris from No 2 bearing damage. (The pump was still operational.)

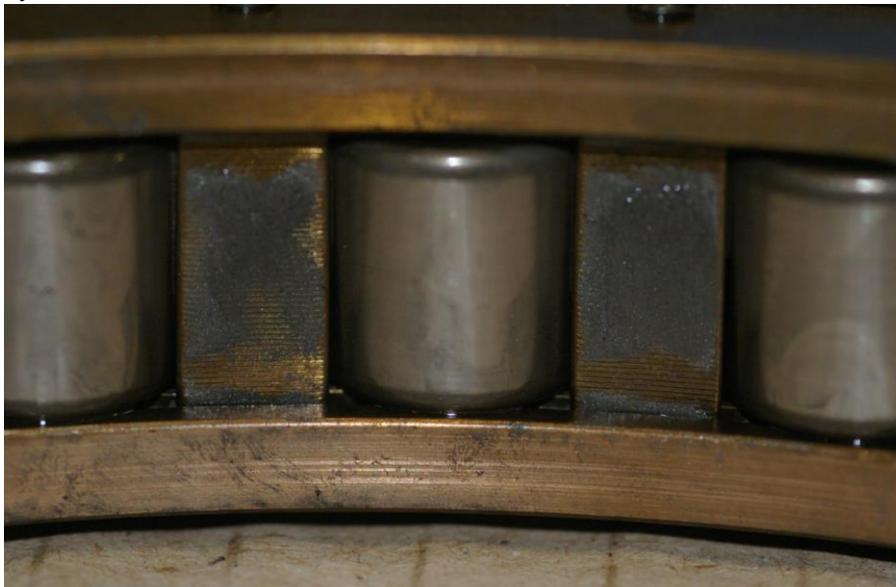
Photo 8 below: shows matt micro pitted surfaces of No 3 bearing rollers caused by lube oil system contamination, also visible.

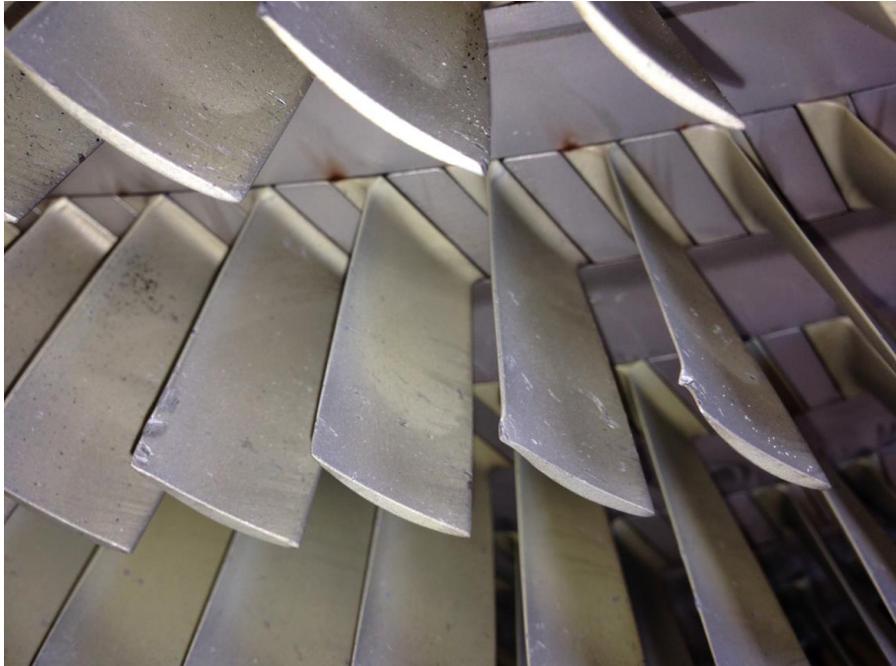
Photo 9 below: shows HP Compressor Rotor blades impact damage caused by debris from LP Compressor front end damage released into the compressor air stream. The damage is typical of that seen throughout the HP Compressor stages.

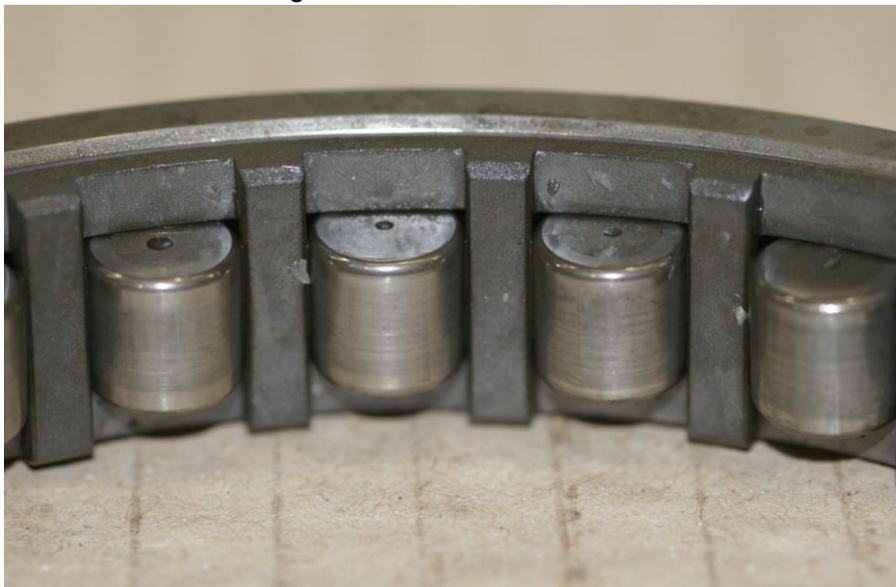
Photo 10a below: shows matt micro pitted surfaces of No 5 bearing rollers caused by lube oil system contamination. Also shows larger corrosion pitting, along with metal flake fragments from oil thrower damage.

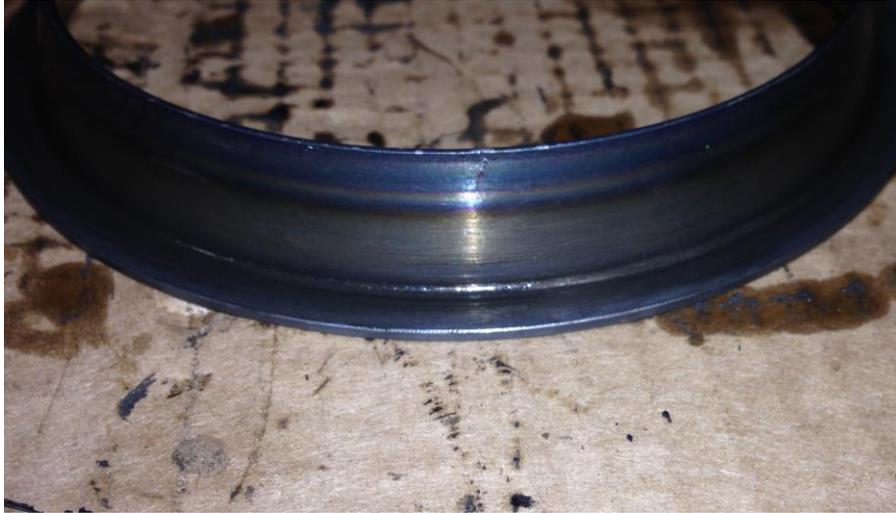
Photo 10b below: shows No 5 bearing oil thrower high friction/heat and crack initiation damage from running contact with the LP Compressor Rotor drive coupling hub.

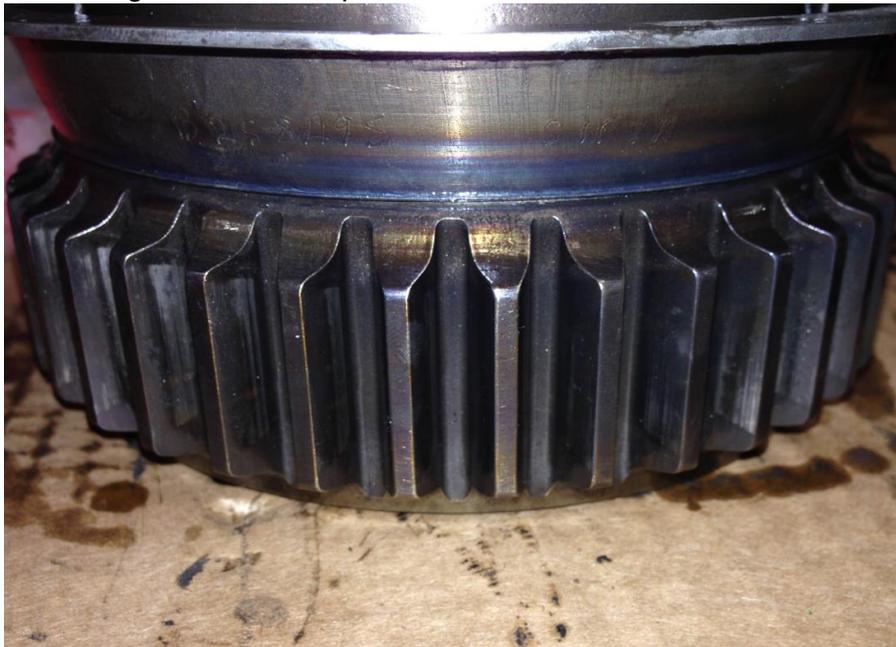
Photo 10c below: shows LP Compressor Rotor drive coupling hub damage corresponding with the damage shown in the photo above.

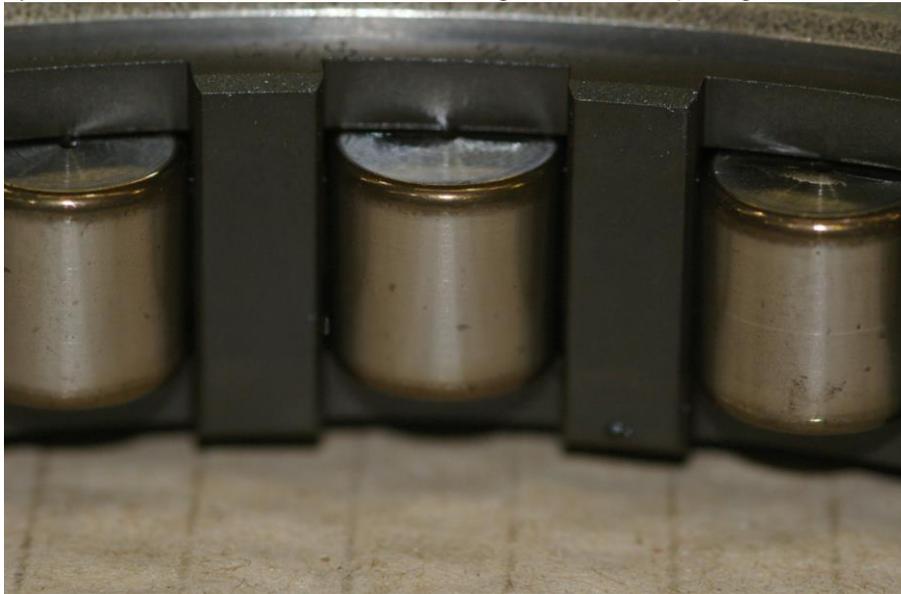
Photo 11 below: shows matt micro pitted surfaces of No 7 bearing rollers caused by lube oil system contamination. Also shows larger corrosion pitting.

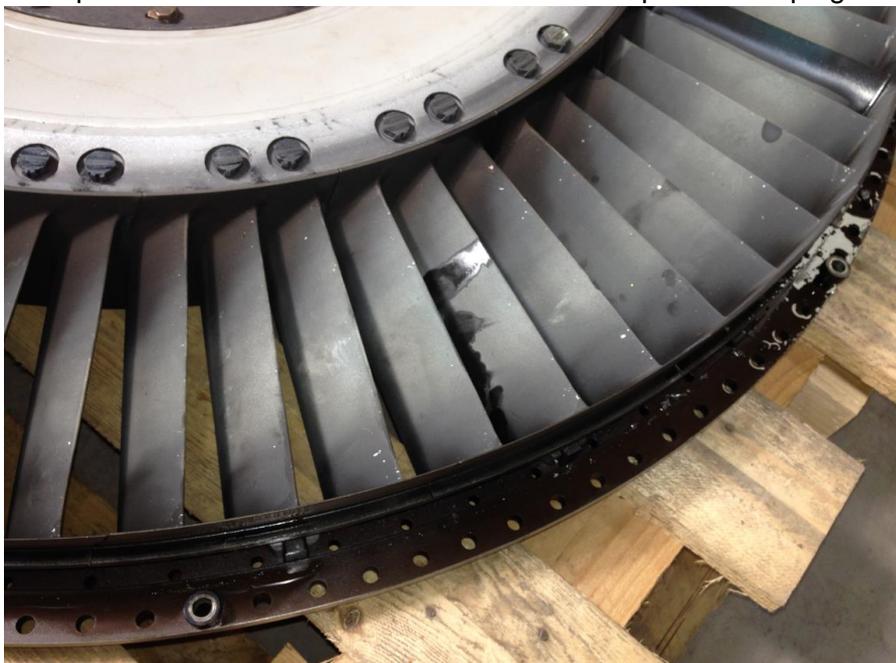
Photo 12a below: shows LP Turbine Nozzle Guide Vanes segments retaining bolts heads damage from running contact with Turbine Rotor blades fir tree roots lock tabs. Also shows examples of minor aluminium melt spatter impingement on the vanes.

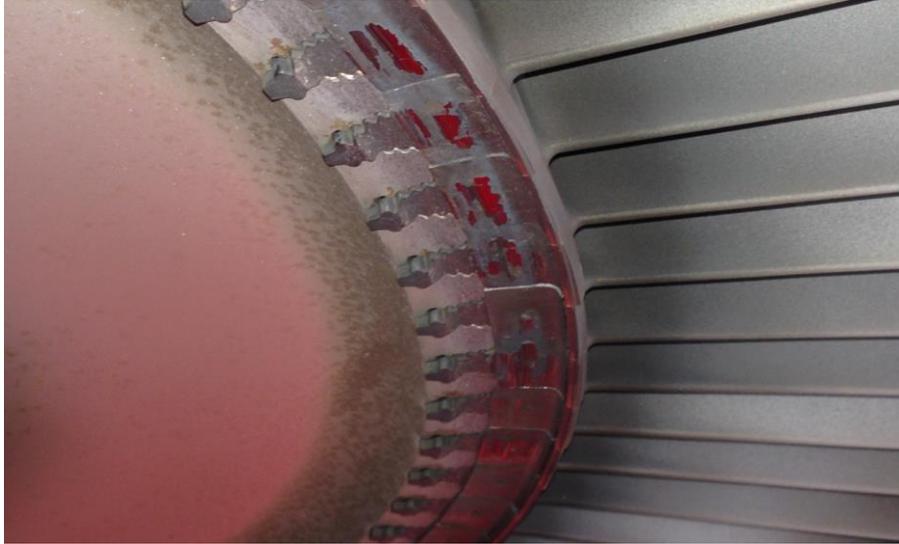
Photo 12b below: shows LP Turbine Rotor blades fir tree roots lock tabs damage corresponding with the damage shown in the photo above.
