**A REPORT TO
THE BOARD OF COMMISSIONERS OF PUBLIC UTILITIES**

NEWFOUNDLAND AND LABRADOR HYDRO

Gas Turbine Failure Analysis

Final Report

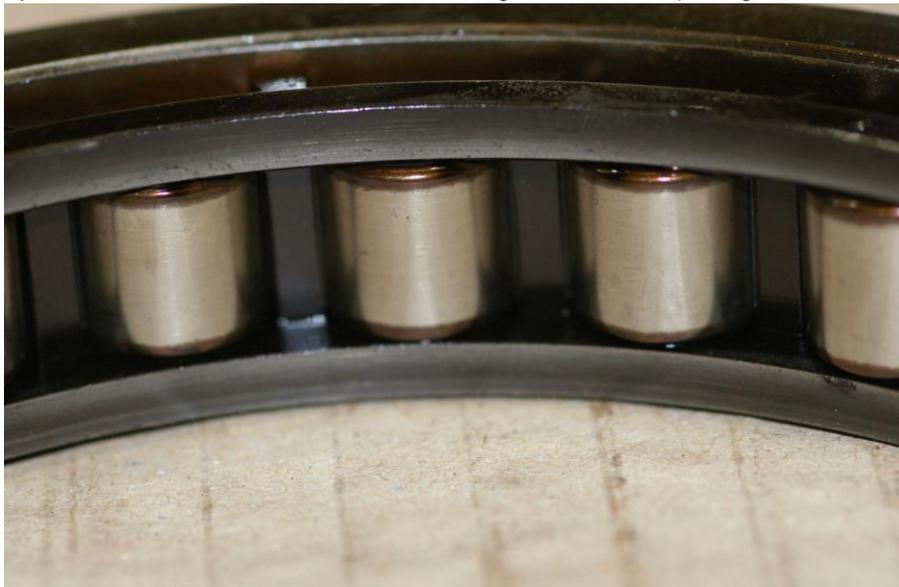
Photo 13 below: shows matt micro pitted surfaces of No 8 bearing rollers caused by lube oil system contamination. Also shows larger corrosion pitting.

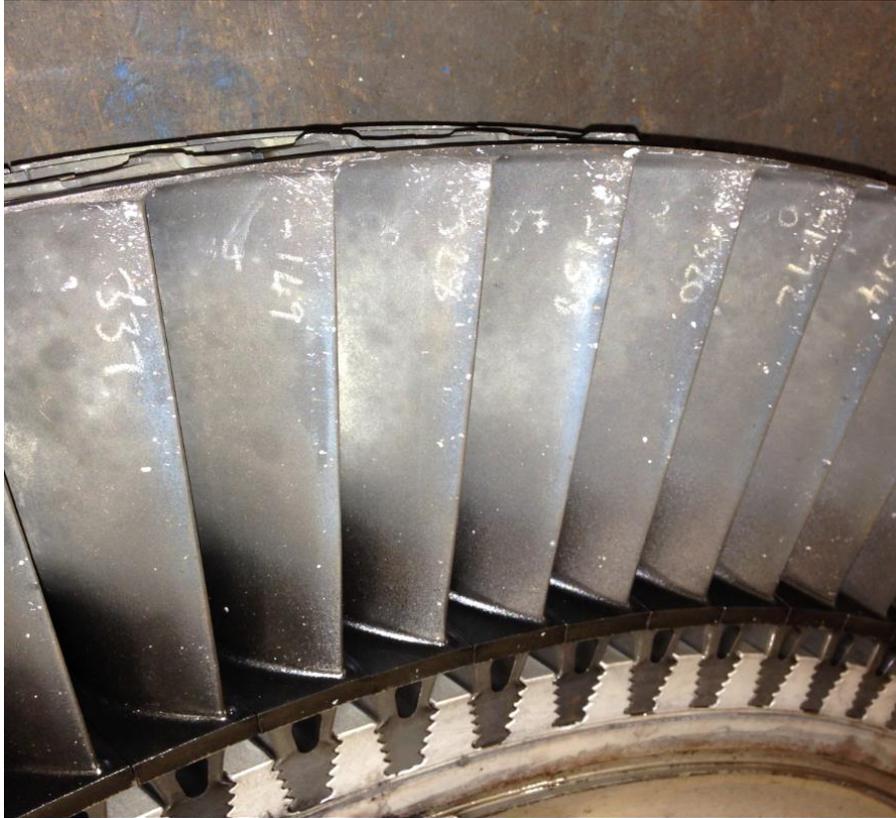
It was also observed during strip inspections that re-solidified aluminium melt spatter had impinged on the turbine section nozzle guide vanes and rotor blades. This had resulted from LP Compressor front end damage debris released into the compressor air stream and carried through the combustion system.

Photo 14 below shows a typical example of the aluminium melt spatter found on the turbine blades.

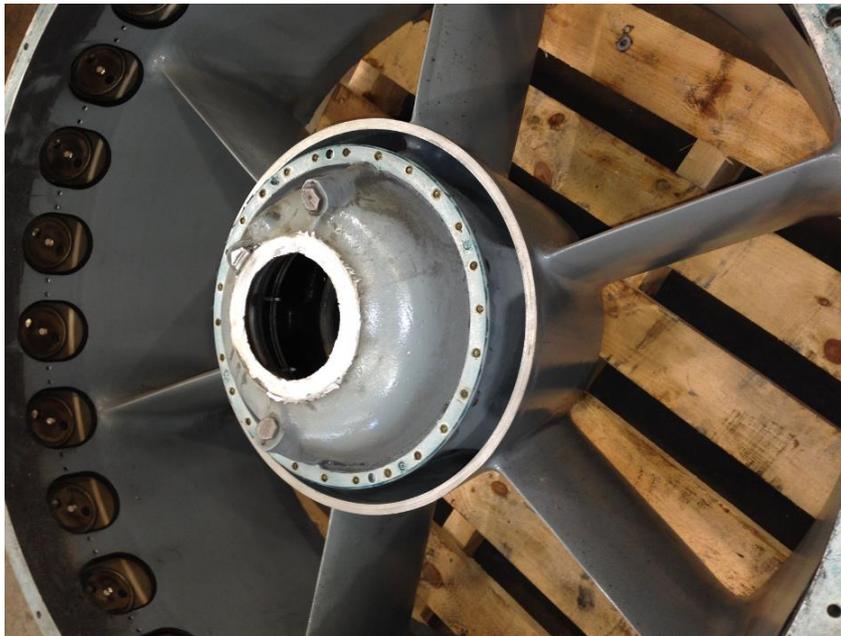
1. **Intake Casing:** previous updates have already reported the deep running contact damage at the LP Compressor front bearing (GG No 1 bearing) housing rear face, where the face had to be treated with a hand grinder to remove the bearing. In discussion with Alba, it is apparently more cost effective and a quicker turnaround to replace the casing with a spare unit that Alba have available in stock, rather than assign to a repair scheme. (Alba/Hydro need to review the unit "exchange" commercial arrangement.)

Photo below shows the stripped casing and the deeply damaged face. (It was established today by measurements that the LP Rotor had moved forward by approx. 5.5 mm.)

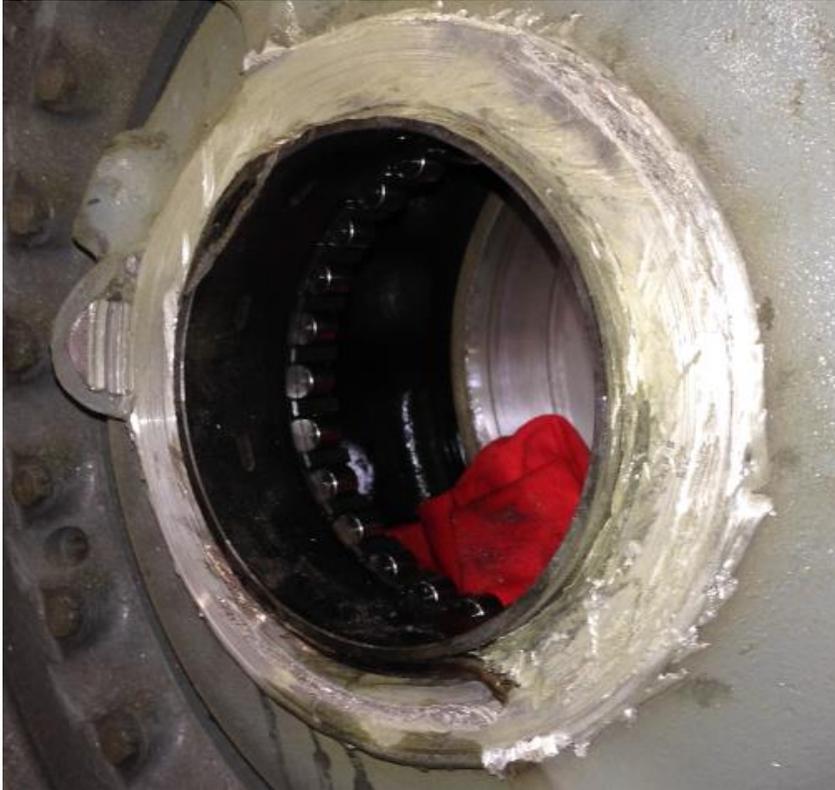
Below is close-up of damaged face in process of hand grinding to free the bearing (as previously reported).

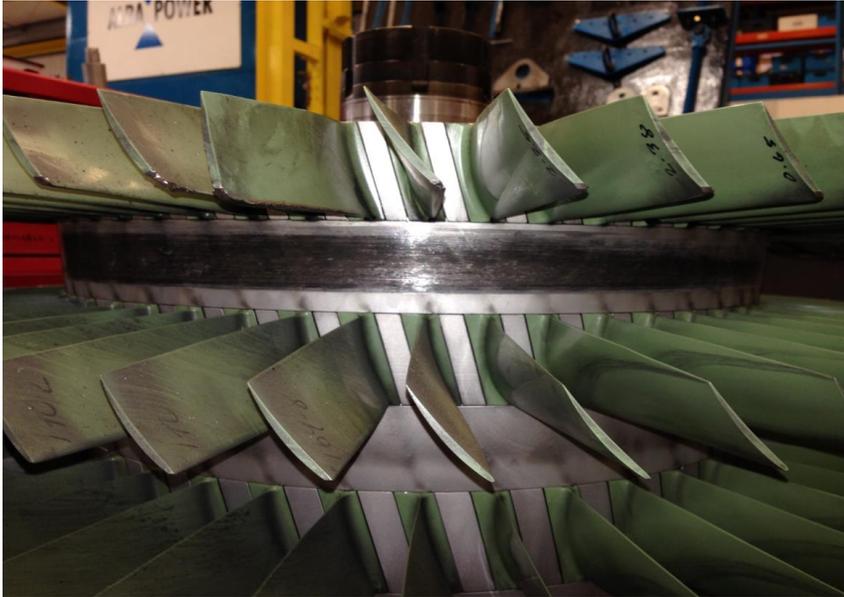
2. **LP Compressor:** as previously reported, the LP Rotor moving forward resulted in the leading edges of the 5th stage blades coming into very heavy running contact with the stator vanes trailing edges causing serious damage to both sets. Therefore, we can expect Alba to declare all 5th stage blades and vanes as scrap.

Photo below shows typical rotor blades leading edge damage. Also shows scoring of the 4th/5th inter-stage spacer from contact with the stator vanes tips due to No 2 bearing failure abrasion wear.

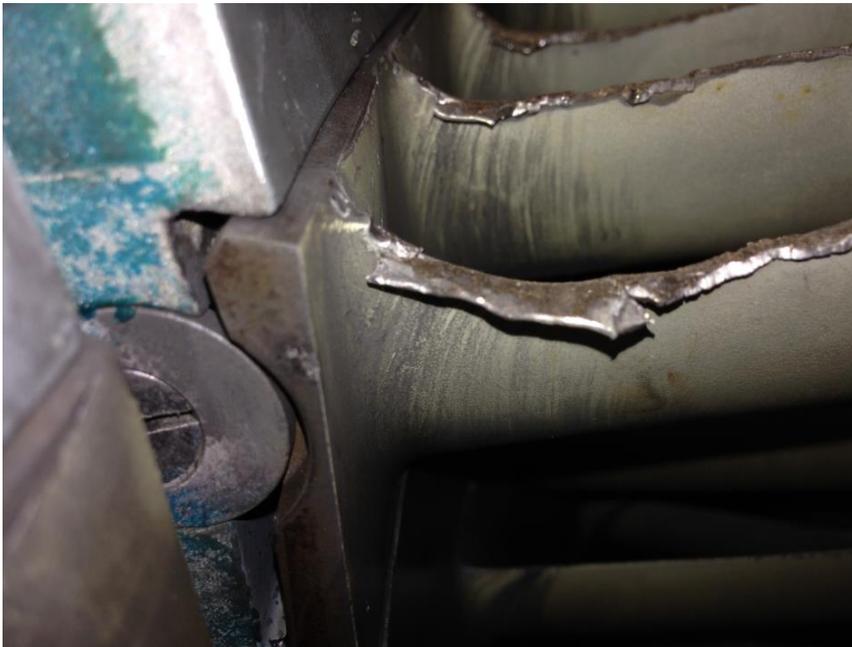
Additionally, detail inspection today revealed that the force of the running contact between the 5th stage blades and vanes caused the stator vanes dovetail slot to distort open, causing the vanes to become extremely loose in the slot (normally a snug fit), which also means the casing itself at that area has flared out. This damage has no repair scheme and so it is expected that Alba will declare the LP Compressor Casing as scrap, to be replaced by a spare unit they have available in stock.

Photo below shows typical stator vanes trailing edge damage. Also note the distortion gap at the top of the dovetail slot.

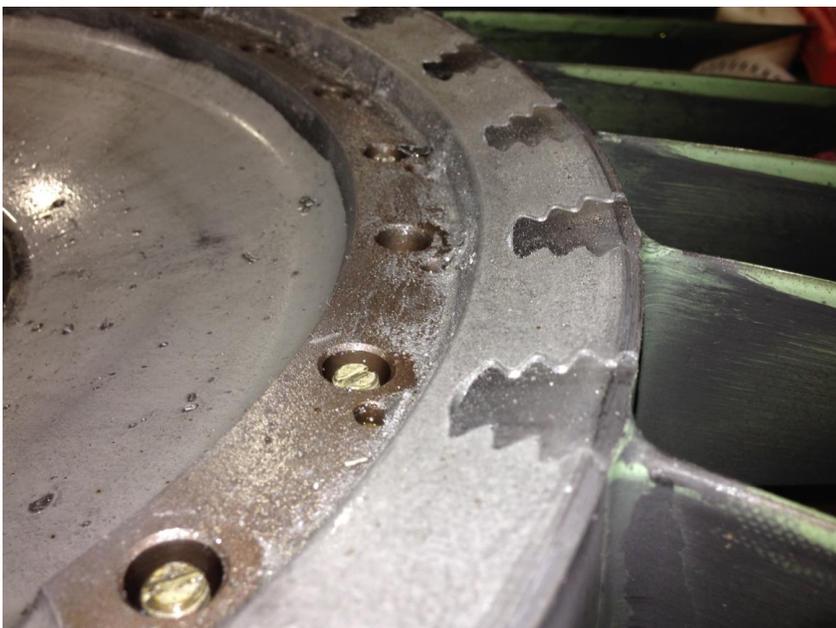
Photo below shows abrasion wear at the 1st stage rotor blades forward platform edges from running contact with the Inlet Guide Vanes platform. It is thought that a repair scheme is perhaps not available for this damage - Alba to confirm. Note also the debris from the No 1 bearing housing rear face damage, caught on the disc shoulder from being centrifuged out into the compressor air path.

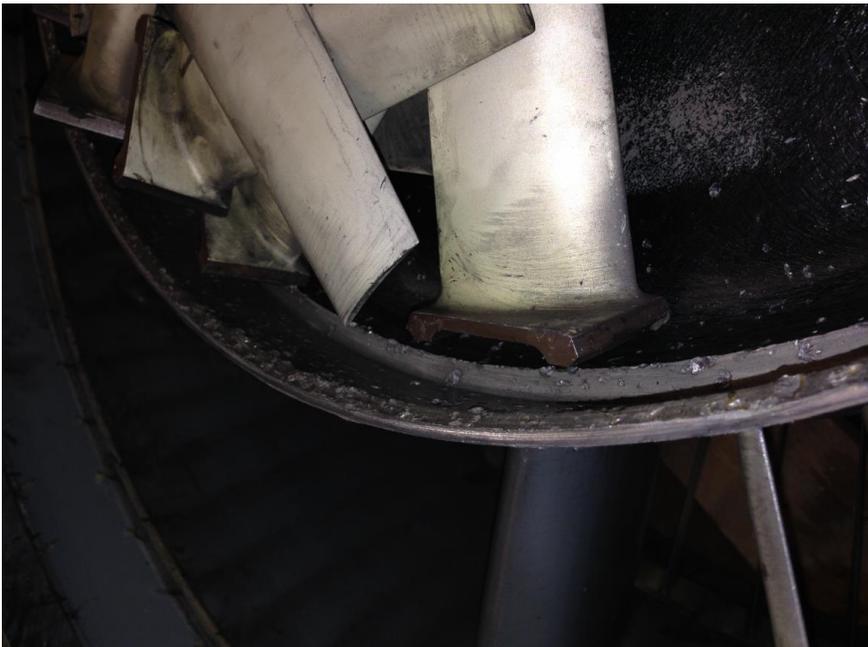
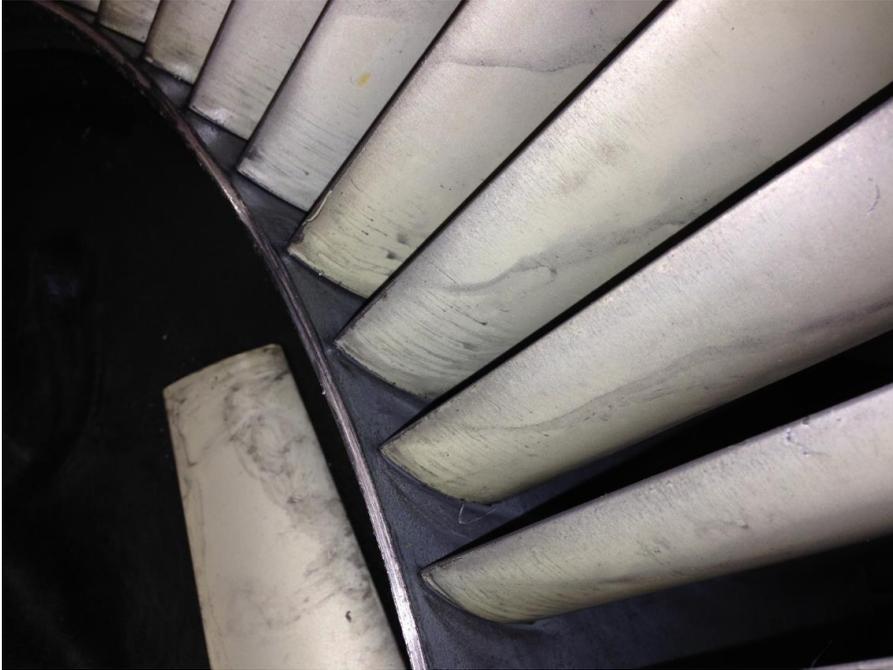
A notable reporting point is that the Intermediate Casing is expected to be rejected for reuse due to the secondary damage incurred.

Photos below show the Intermediate casing with secondary damage resulting from the No 2 bearing failure. Also, a few guide vane aerofoils exhibited light impact damage which appears repairable for reuse.

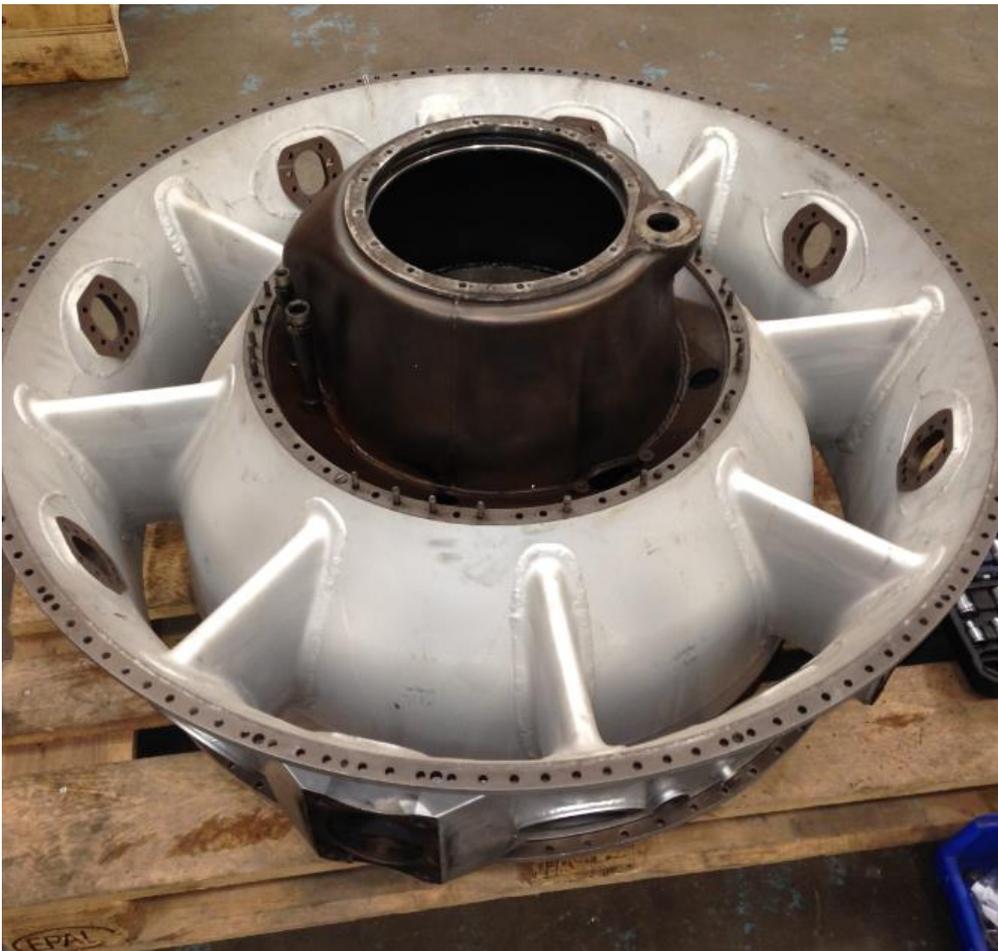
Components appeared to be undamaged on initial visual inspection. Detail inspection and NDT check routines remain to be carried out. Casing is shown below.

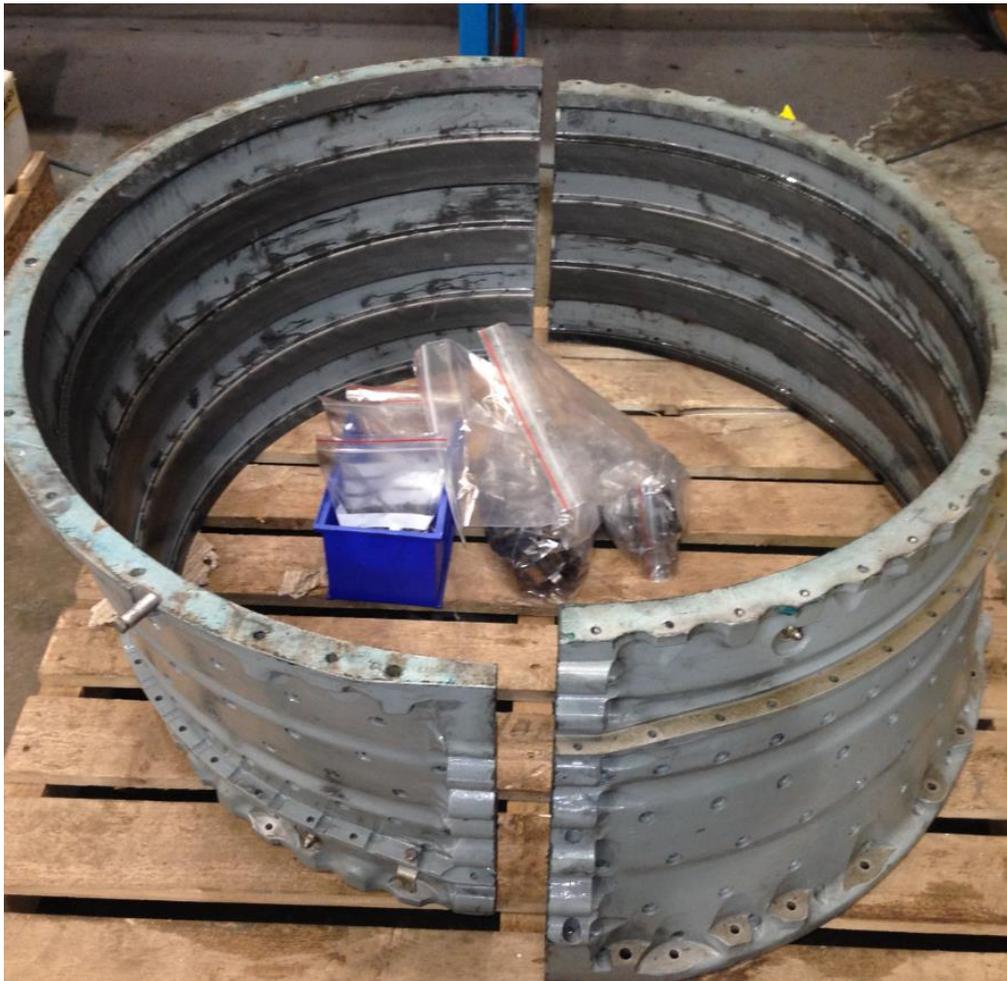
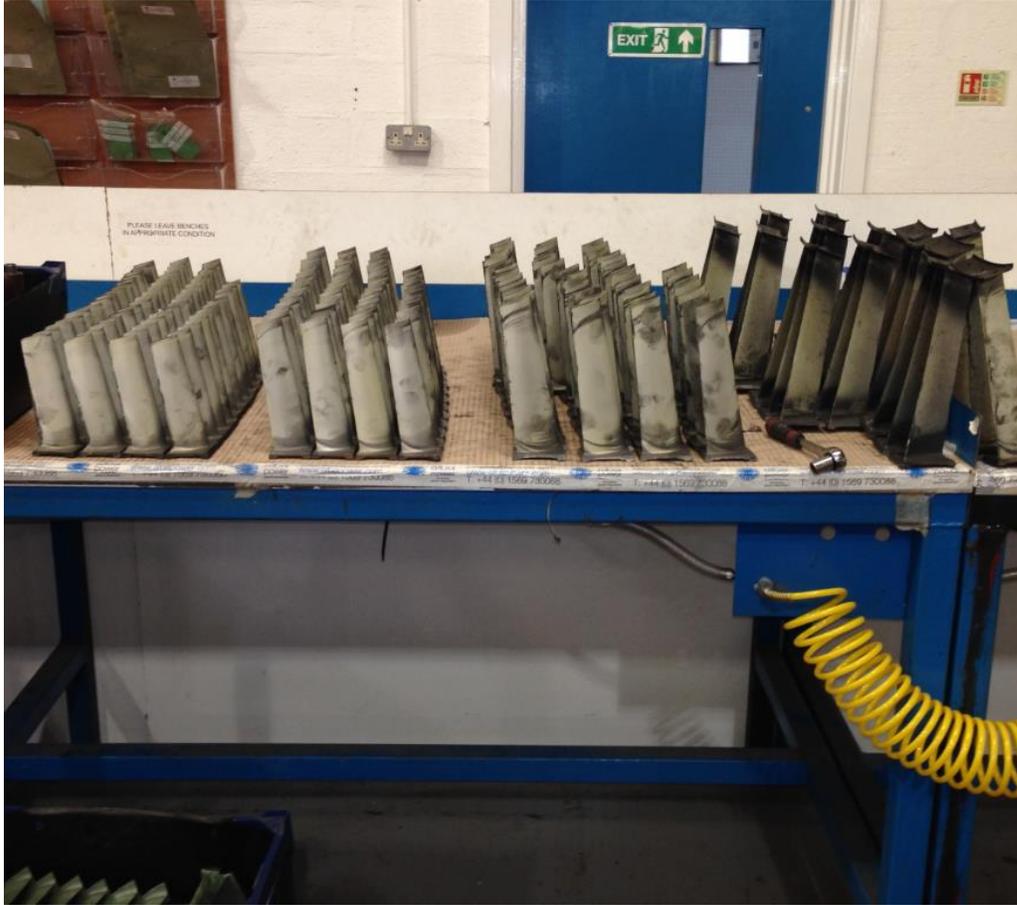
No additional damage was evident on initial inspection further to the damage previously reported – ie 4th stage stator vanes from running contact with LP Comp Rotor 5th stage blades, and casing local distortion at the vanes dovetail slots.

The removed stator vanes were too dirty for close inspection but no obvious damage was apparent on the samples checked. The vanes are to be cleaned for detail inspection and review for repair. Photos below show the stripped half-casings and vanes stages set out.

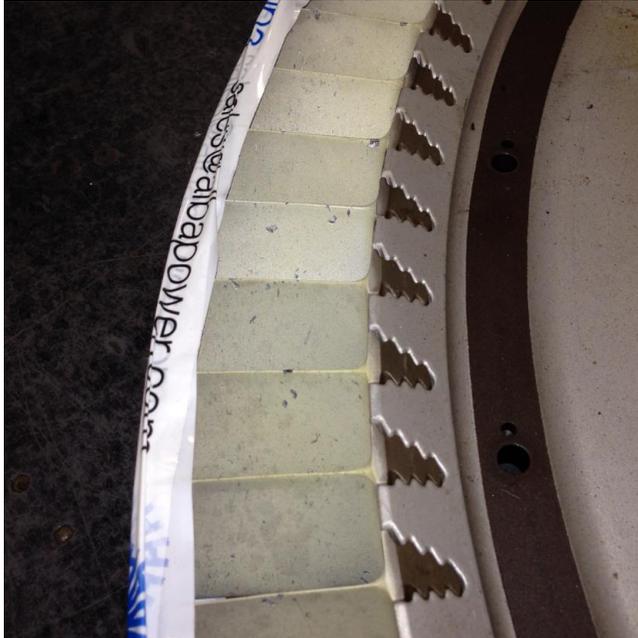
The HP Compressor Rotor and Casing detail strips were completed today. Although uncertain due to the generally dirty condition of the blades, initial visual inspection indicated that approx. 50% of the rotor blades have impact damage penetrating the protective coating through to the core material. Regardless, as mentioned above, all the blades are sent for inspection, repair and recoat as standard practice.

The photo below shows a removed compressor stage disc and blades with typical impact damage through the protective coating. The blades are suitable for reuse in this condition but their service life would be drastically reduced by corrosion undermining at the coating break-through points.

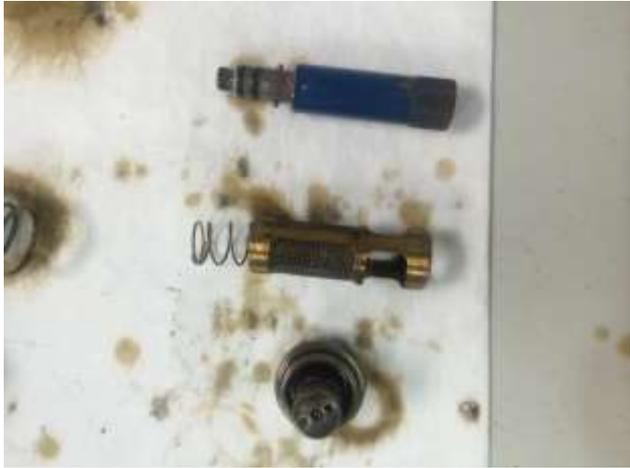
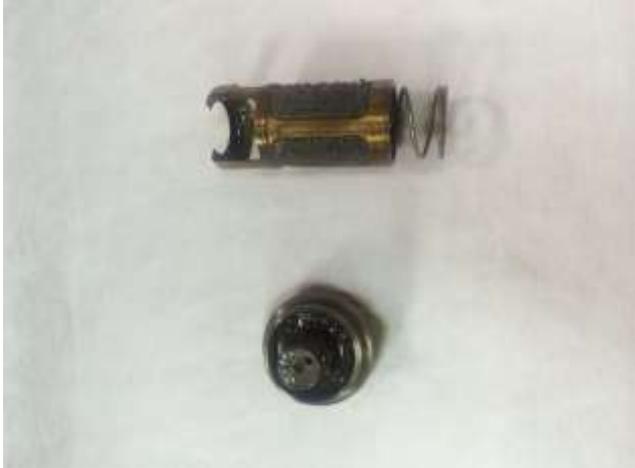
<p>No.1 (Blue) Bearing magnetic chip detector and basket.</p>	<p>No.2 and 3 (Green) Bearing magnetic chip detector basket showing excessive debris.</p>

All oil filters and magnetic chip detectors have been examined and excessive amounts of debris found in the No. 2 and 3 (Green) magnetic chip detector basket. This debris appears to be bearing material.

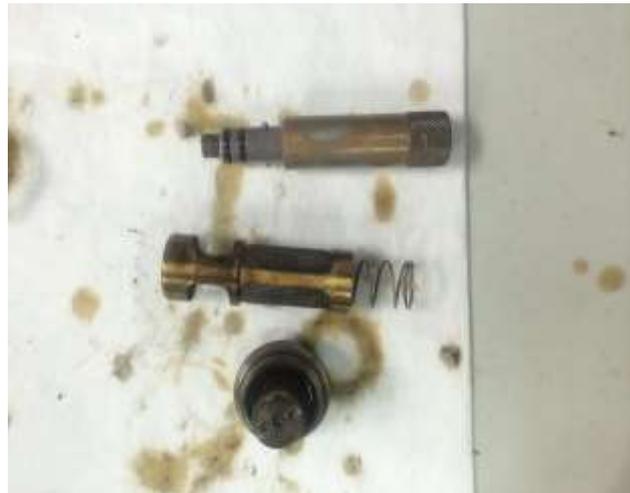
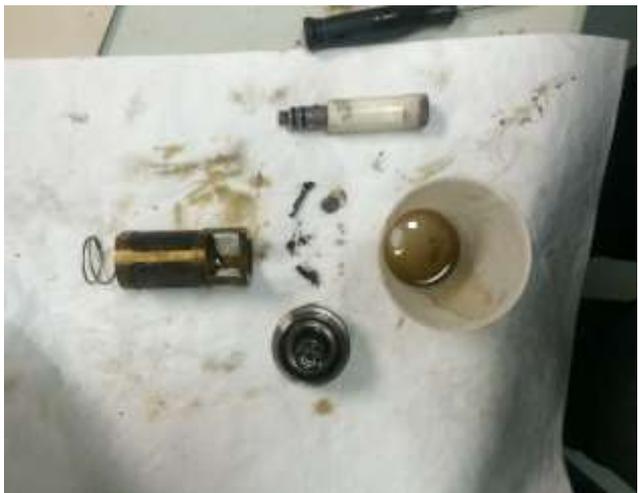
<p>No. 4 and 5 (Aluminium) Bearing magnetic chip detector and basket</p>	<p>No. 7 (White) Bearing magnetic chip detector and basket showing several large pieces of debris.</p>

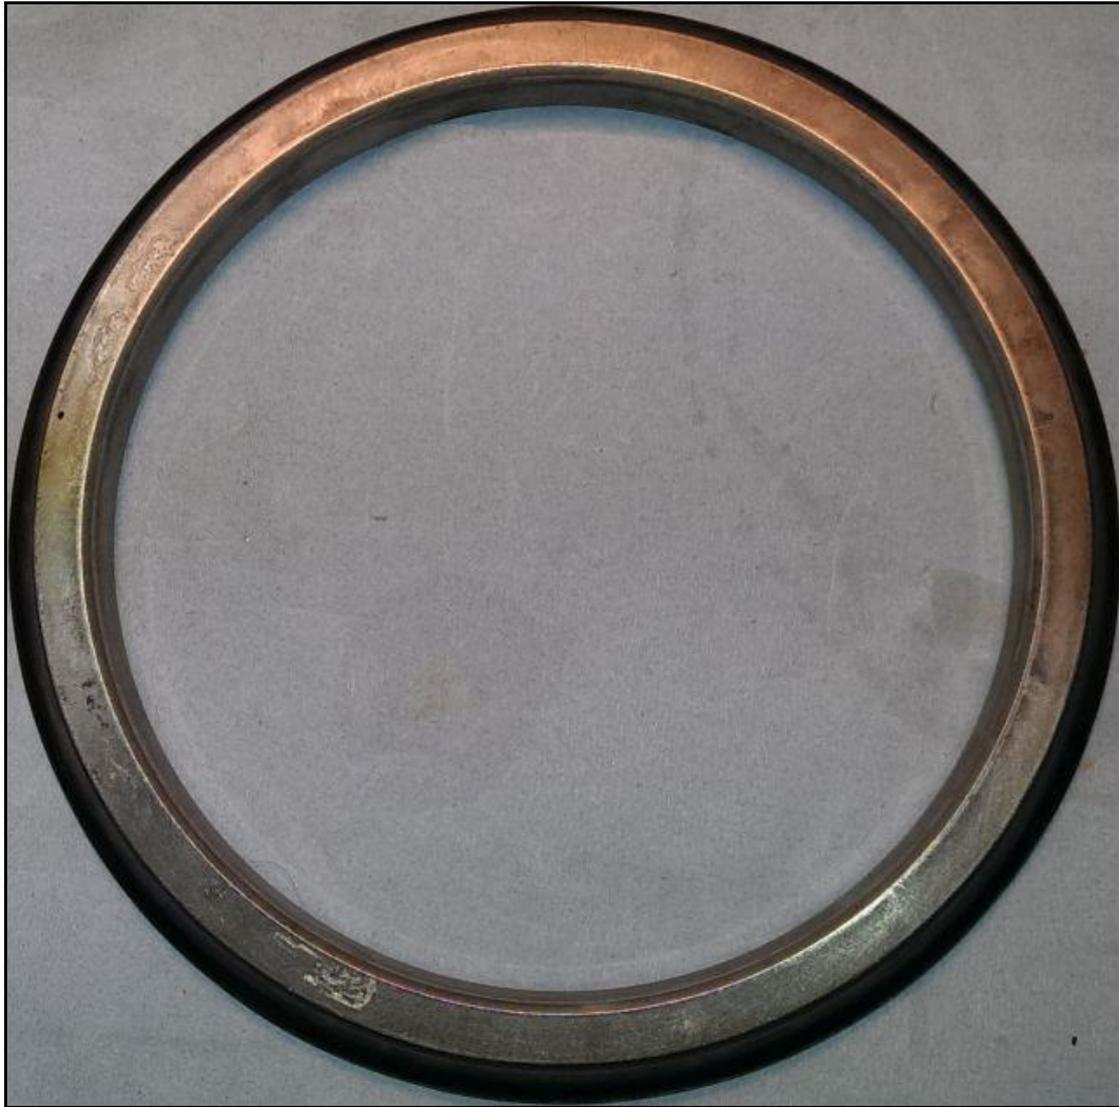
Figure 12 – Inner ring #2 side face2.

Fretting corrosion and surface damage noted. The surface damage (lower left of photo) appears relatively fresh and may have occurred during dismounting.

Fretting corrosion (ISO 5.3.3.2 – Appendix A, Table A1) was noted on front bearing inner ring #2 side face 2 (Figure 12), front bearing outer ring OD (Figure 13), the rear bearing outer ring OD (Figure 35) and interior of bearing housing (Figure 49). This type of damage is commonly caused by micro-movements between mating parts in load transmitting interfaces.

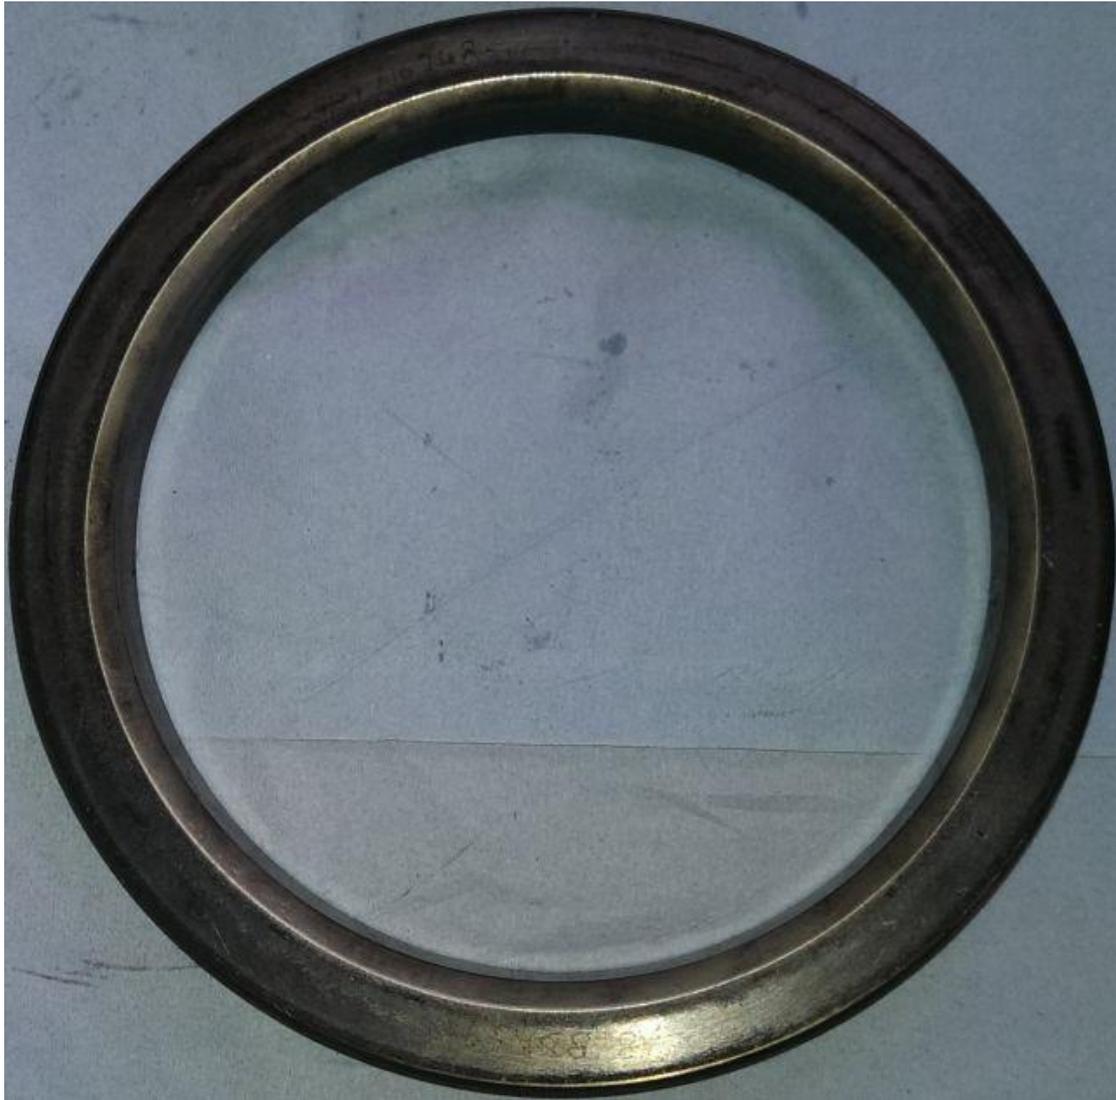
Figure 32 – *Inner ring #1 side face 2.*

Staining and bluing noted.

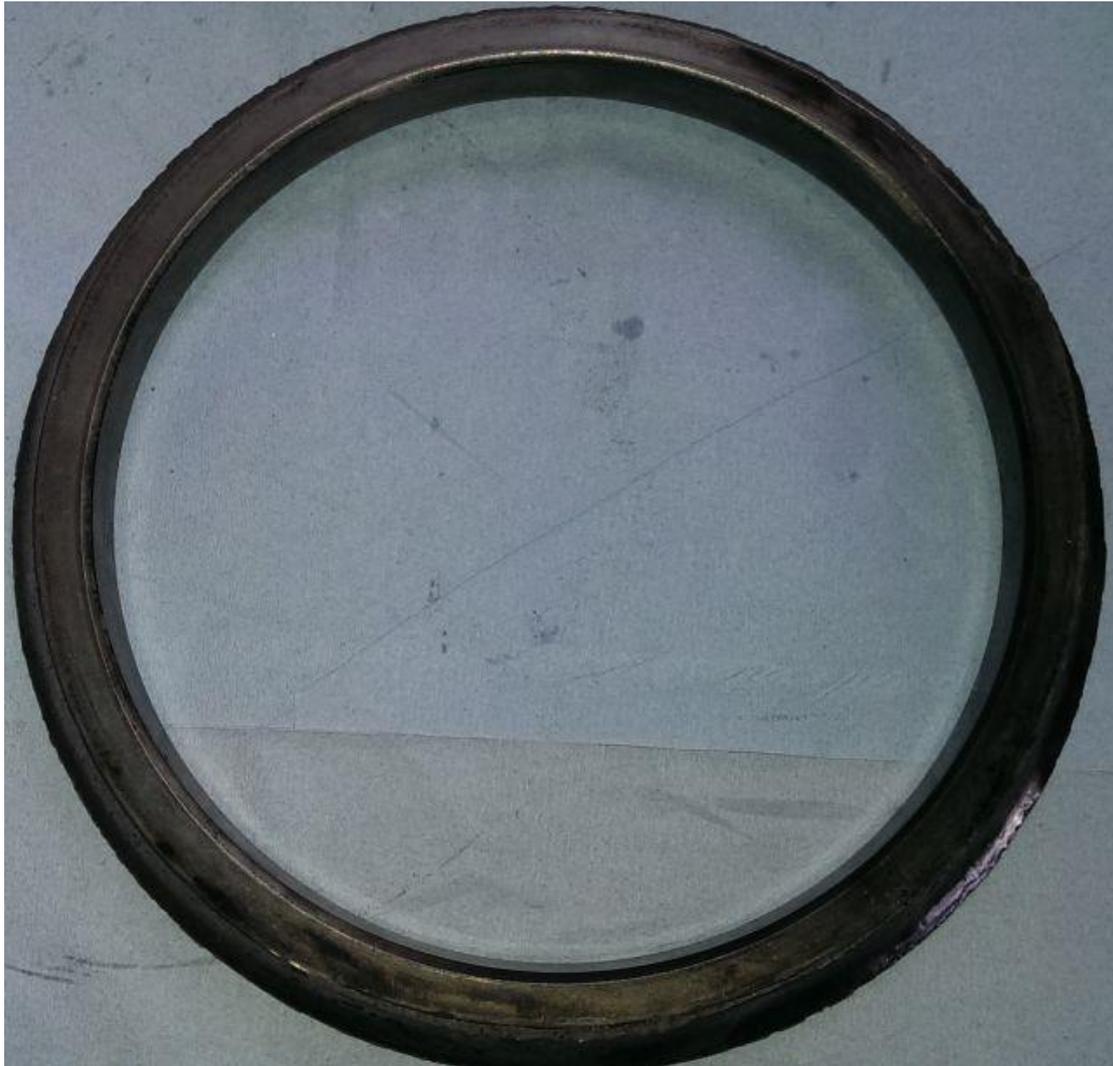
Figure 34 – Inner ring #2 side face2.

Heat damage and staining noted.

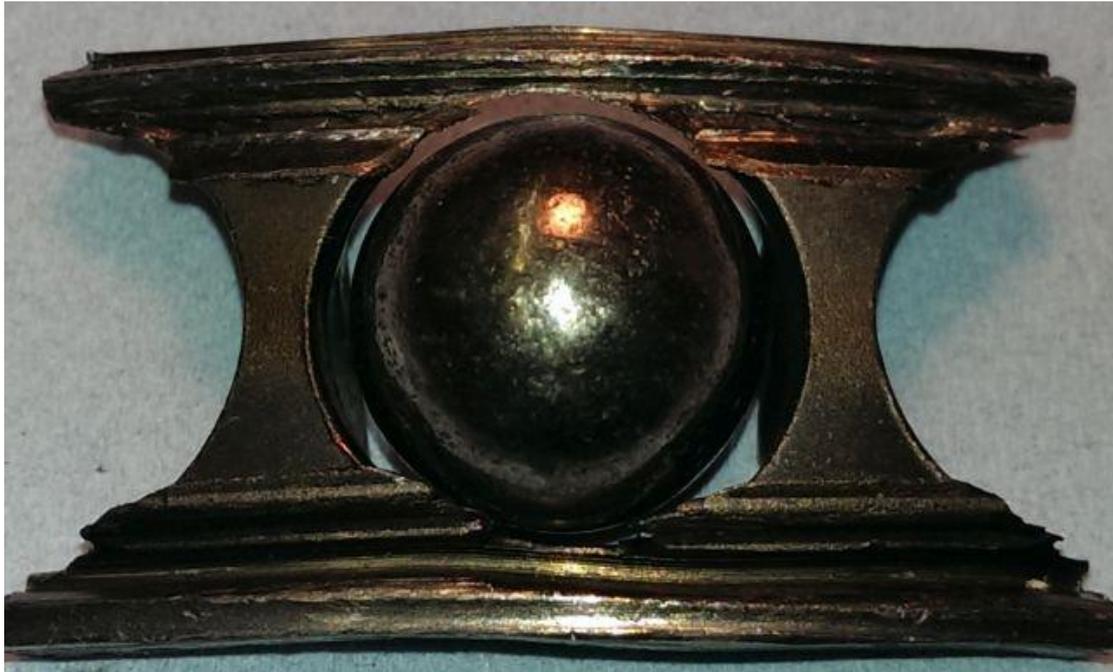
Figure 44 – example of damage to exterior of cage. Also note amount of clearance around the rolling element.

Both cages have fractured/separated probably as a result of excessive heat. The significant amount of separation noted between rolling element and cage pocket (Figure 44) and the distortion of pocket geometry (Figure 43) suggest running with sub-optimal lubrication conditions.

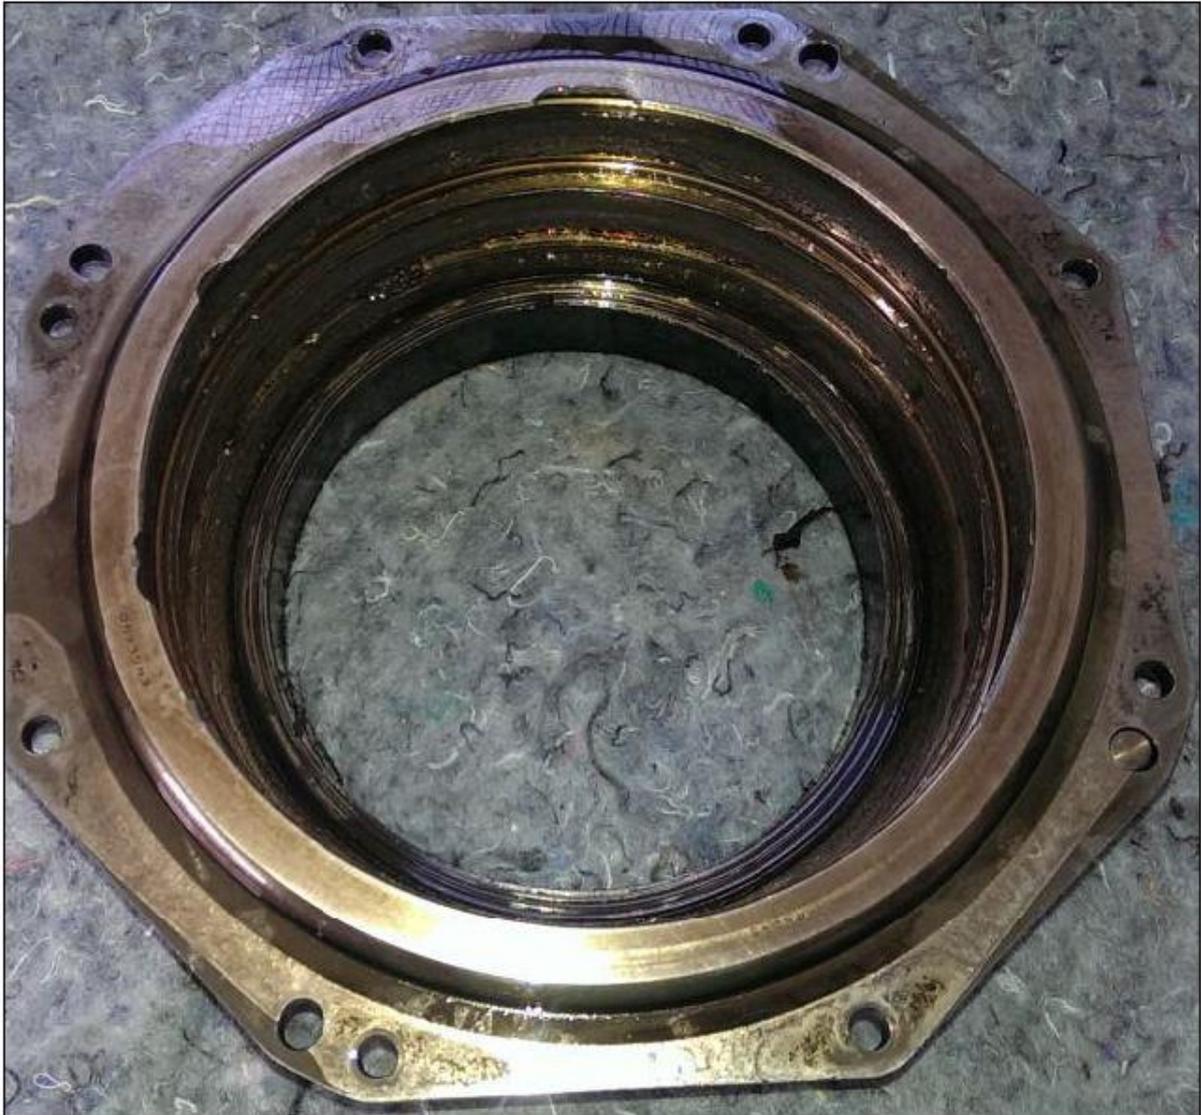
Figure 3 – Housing 'as received' with both outer rings in place. The Front bearing is uppermost in the photo.

The photo below from SKF Report shows the bearing assembly from the rear side, as received at SKF with the outer races stuck in the housing. SKF denote the uppermost race as the front bearing whereas it's actually the rear bearing. Note the damage scallops on the race face for reference further below.

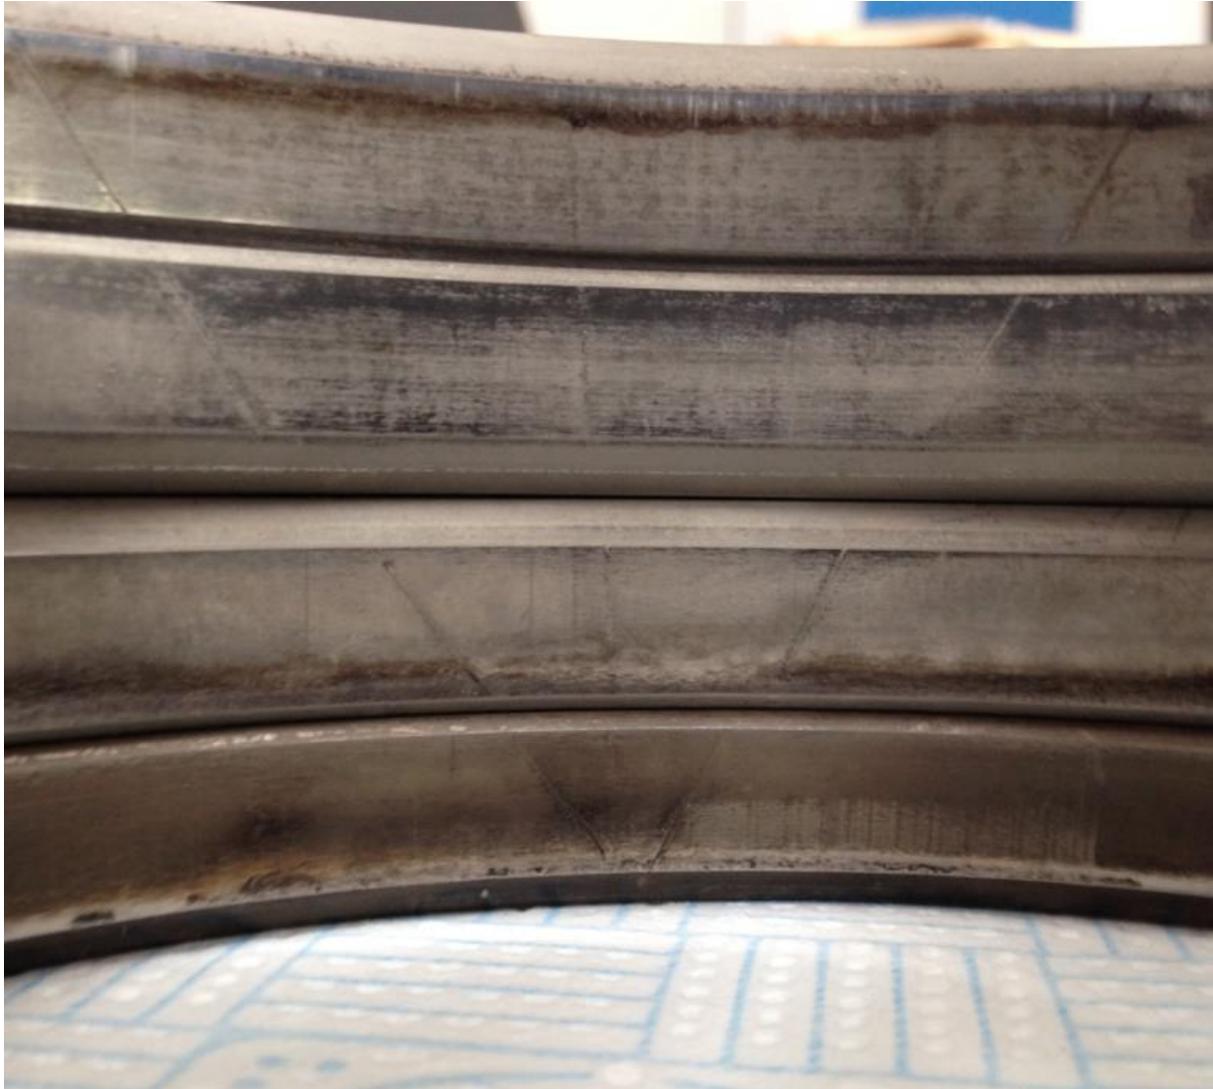
Photo below shows the two inner races (split pair). The V match mark is clearly visible spanning across the four half-races. PI witnessed the removal of the races from the GG as being in this correct order and orientation with the V pointing in a forward direction per the installation drawing further above, thus confirming the bearing assembly and installation were correct to specification.

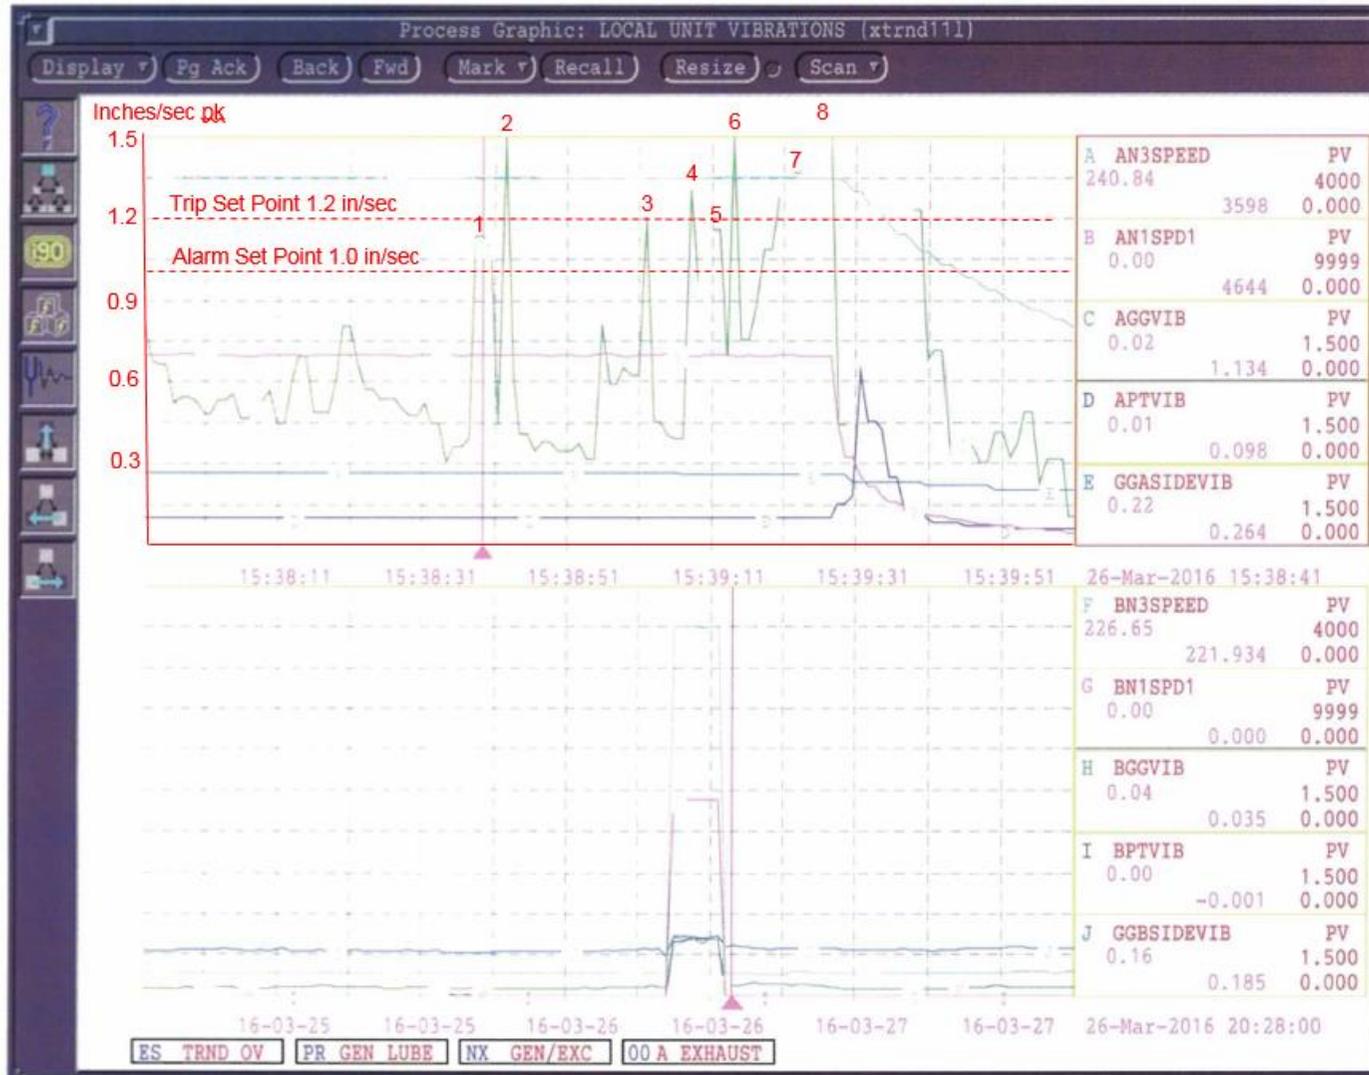
The Trend Graph below shows the high vibration and spikes in better resolution than does the above Graph. All the numbered spikes have amplitudes above the high vibration alarm set point 1.0 in/sec peak. Spikes 2, 4, 6, 7 and 8 are above the high vibration trip set point 1.2 inches/sec peak. Yet, there is only one alarm recorded in the Turbine Events Log at 15:39:23 which is only four seconds before the turbine finally tripped and appears to have been part of the same/final spike event. The turbine should have tripped at Spike 2 at approx. 15:38:45 (assuming there is no time delay in the trip function).

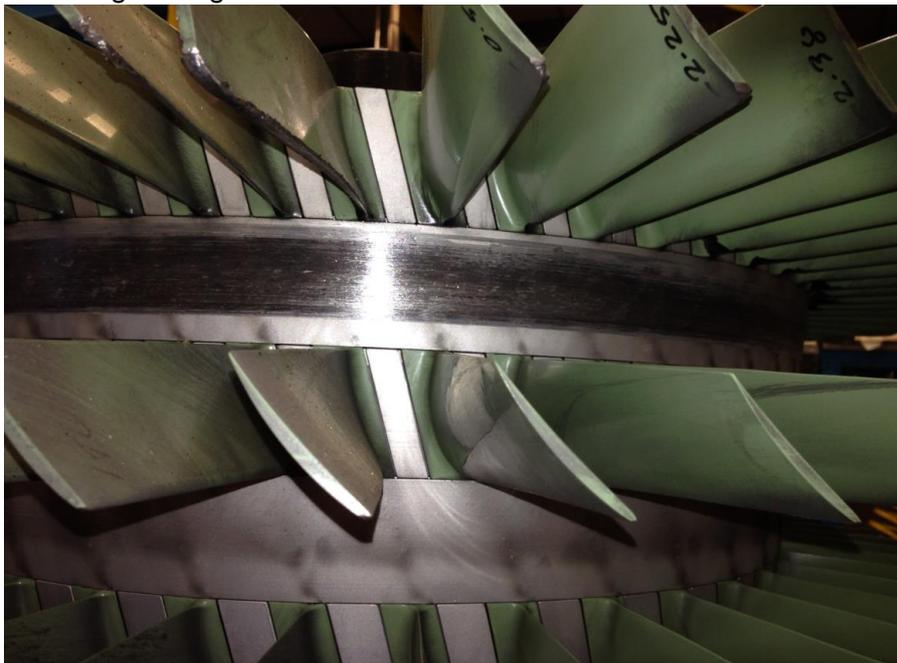
Photo 5a below: shows LP Compressor Rotor 5th stage blades heavy damage from running contact with stator guide vanes. Deep rotational scoring is also seen on the inter-stage disc from running contact with the IGV's tips due to the rotor having dropped as a result of the No 2 bearing damage.

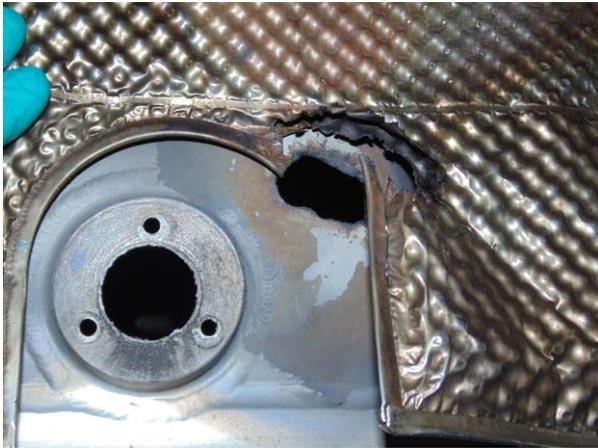
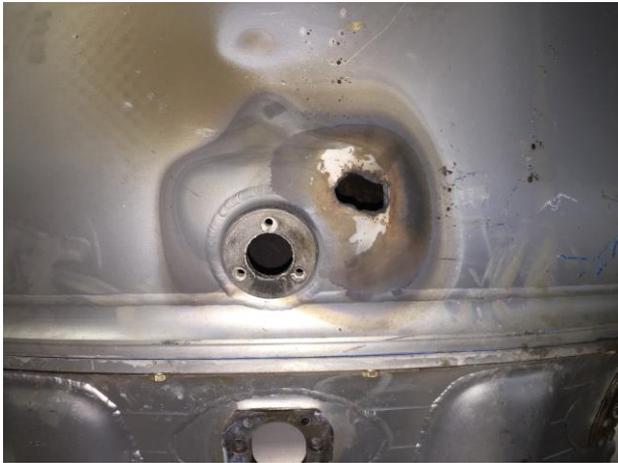
During the receipt inspection, significant damage was noted to the external combustion casings and associated heatshields.

<p>Holed section of heat shield and combustion chamber</p>	<p>Holed section of combustion chamber</p>

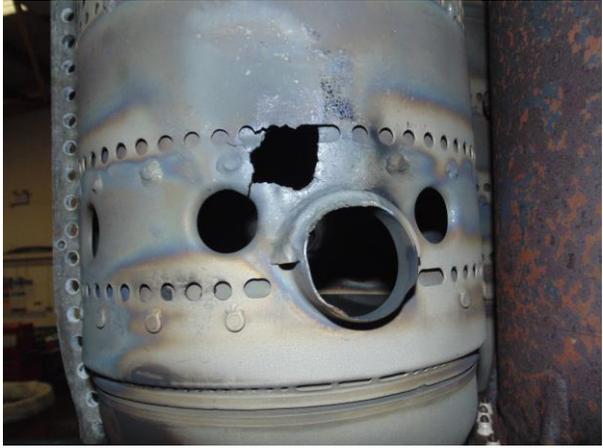
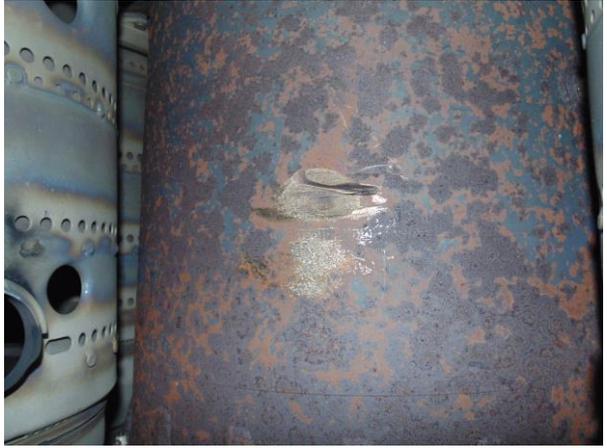
<p>Material loss on adjacent combustion chamber</p>	<p>Fretting on No 7 bearing housing support</p>

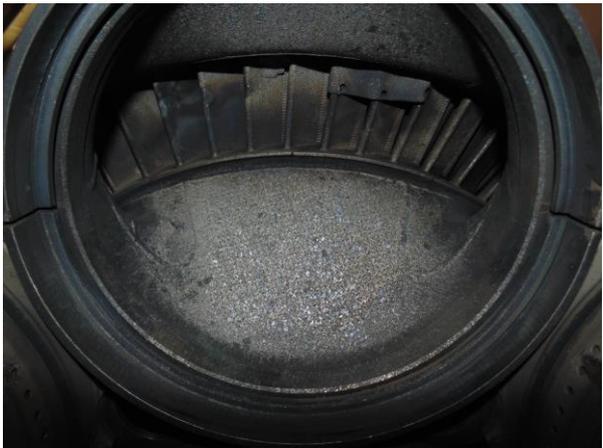
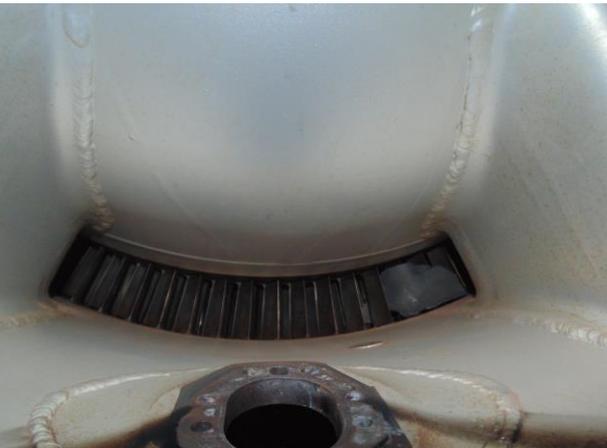
<p>Damage and detached combustion chamber parts located at HP NGV's</p>	<p>Detached material located in the delivery casing</p>
