**A REPORT TO
THE BOARD OF COMMISSIONERS OF PUBLIC UTILITIES**

NEWFOUNDLAND AND LABRADOR HYDRO

Gas Turbine Failure Analysis

Final Report

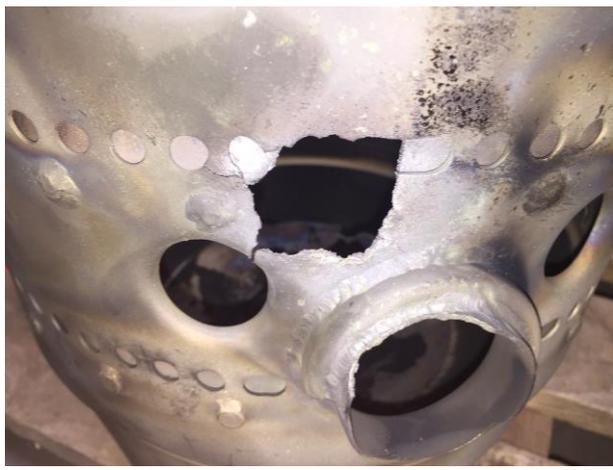
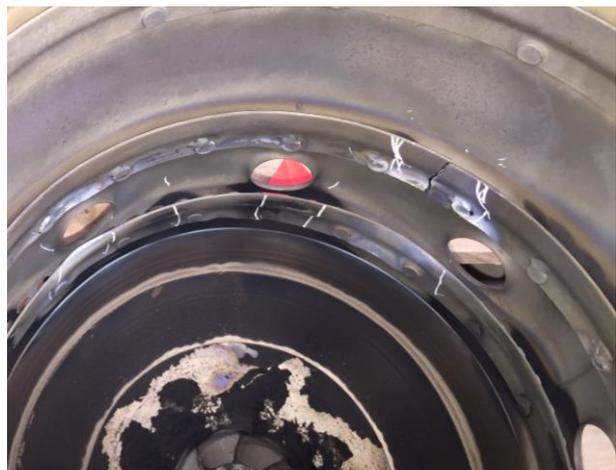
The inspection of the combustion chambers identified these to be suffering from varying degrees of cracking, resulting in complete material detachment on 2 components.

<p>Material loss on No 7 combustion chamber</p>	<p>Cracking on internal surfaces</p>

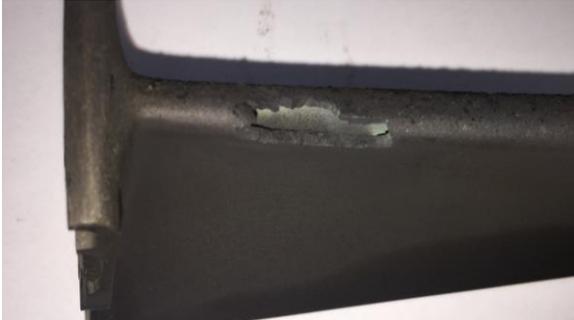
<p>Impact damage on the HP turbine blades</p>	<p>Fretting on LP blade outer shrouds</p>

In addition to the above, significant fretting was also observed on the LP turbine blade, outer shroud and the Turbine Entry Duct.

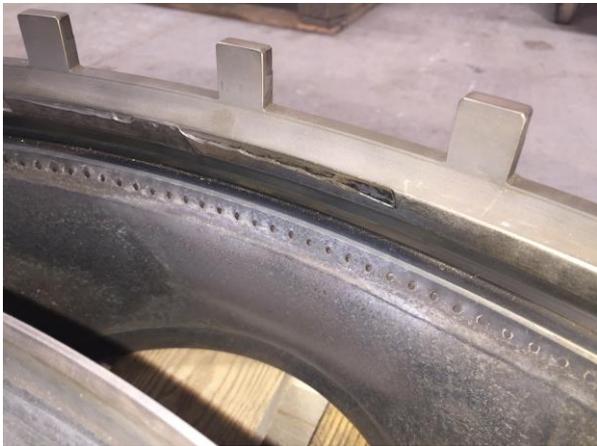
<p>Fretting on the TED on the HP NGV location rails</p>	<p>Wear on the air intake snouts</p>

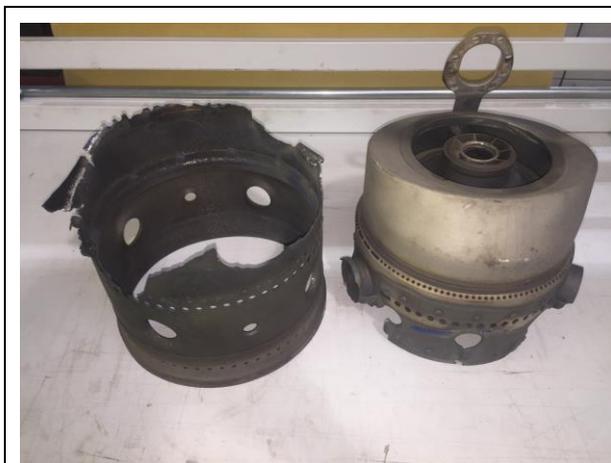
Combustion chamber No 6

- The combustion can had been manufactured from suitable heat resistant material with no manufacturing defects noted
- Bluing and a black carbonaceous deposit possibly from ignition was present on the outer surface.
- The hardness results of the combustion can was typical for the material in the annealed condition.
- Microscopic examination and the hardness results indicated the material was in the annealed condition and showed no undesirable micro structural features that could have caused failure.
- Visual examination showed the presence of a hot spots in the central combustion zone where significant overheating and oxidation of the cooling strip had occurred
- Failure of the combustion can is thought to have been caused by hot spots due to flame impingement and/or overheating.

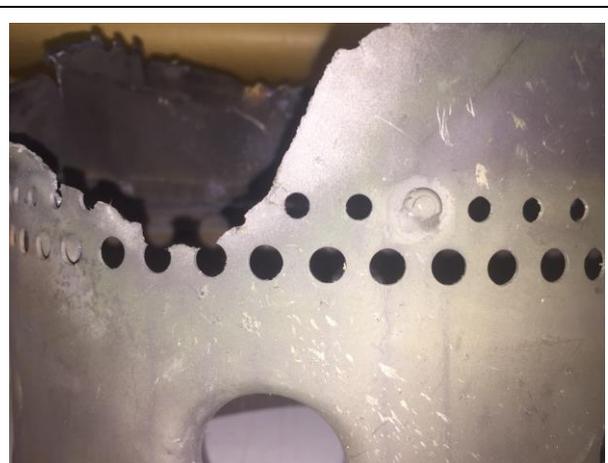
Combustion chamber failed section

As shown above the burner was not available for review. Due to this the burner cannot be disregarded as a potential cause of the can deterioration. Any contamination or defect in the exit nozzle could have affected the flame pattern and caused overheating of the combustion chamber.

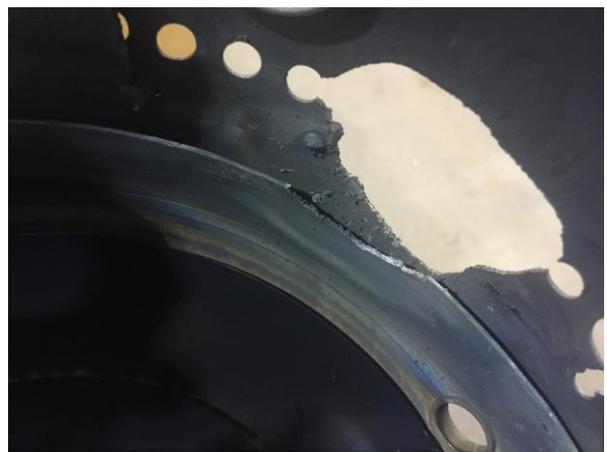
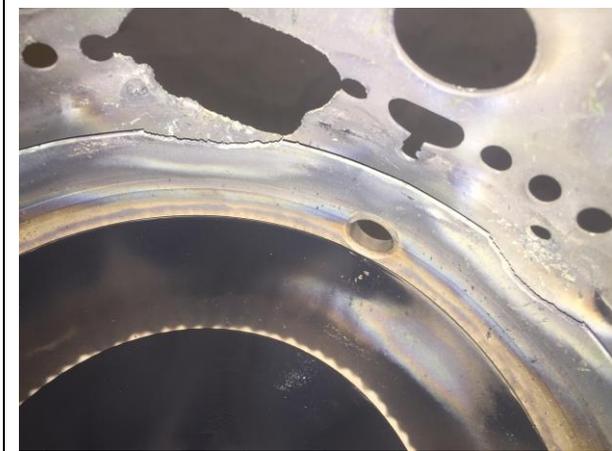
Inner flare burning

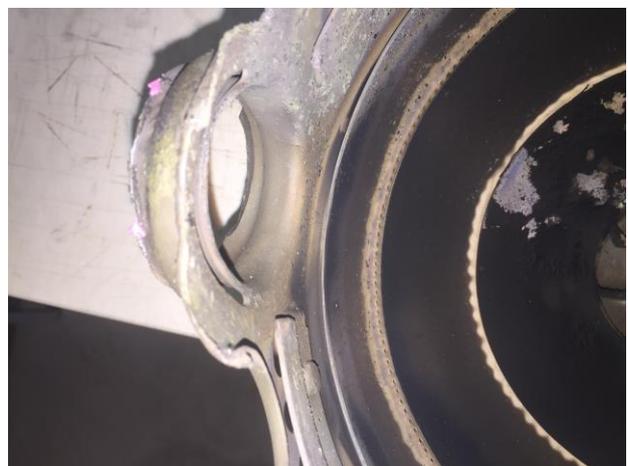
Failed front section
