Re: *Reliability and Resource Adequacy Study Review - Assessment to Determine the Potential Long-Term Viability of the Holyrood Thermal Generating Station*

Holyrood Thermal Generating Station Condition Assessment

**Newfoundland and Labrador Hydro
HTGS Condition Assessment and Life Extension Study
Executive Summary**

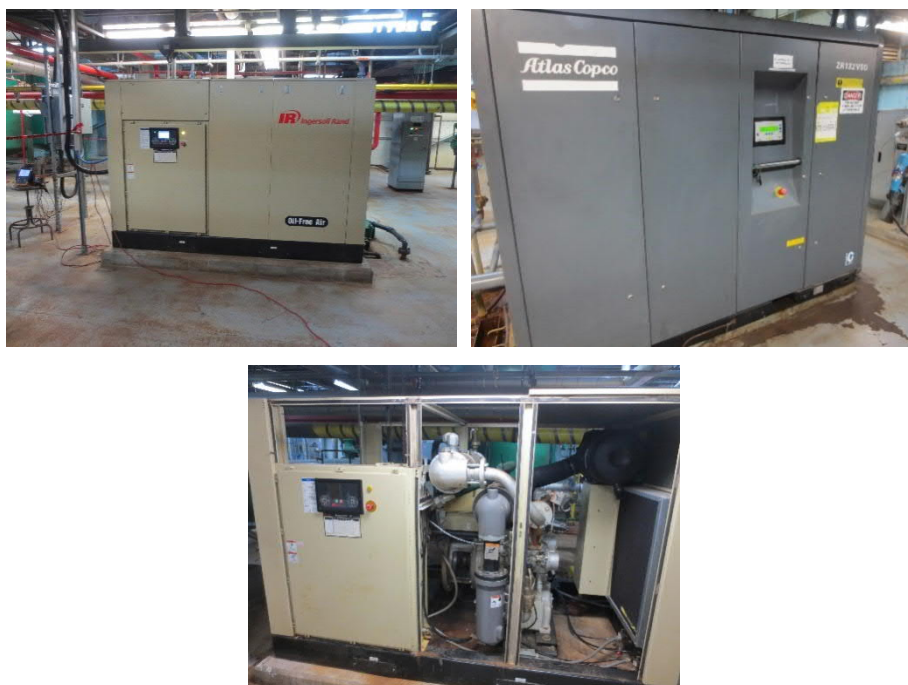
Figure 5-1: Air Compressors

on the instrument air filtration and drying systems. The annual inspection reports did not show any indications of significant degradation or regulatory/maintenance issues.

For a continued operation of HTGS or to be used a backup facility, Hatch envisions no additional work on top of the regular inspections and planned maintenance. Based on Hatch's assessment for the life extension, it is recommended that the current regular inspections, PMs, and maintenance systems continue to be implemented and no additional Level II inspections were identified or required. No capital works were identified or required at this time, although beyond 2023 it is possible that annual inspections may identify requirements for a receiver replacement or refurbishment considering the age of the pressure vessels and this should be considered in the capital budget planning.

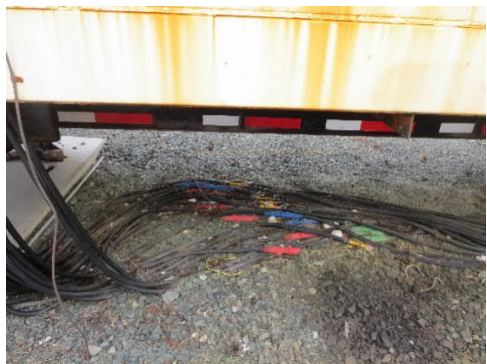
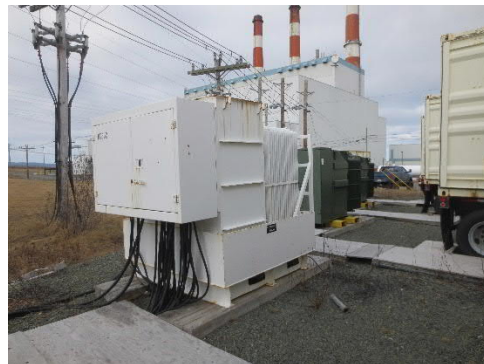
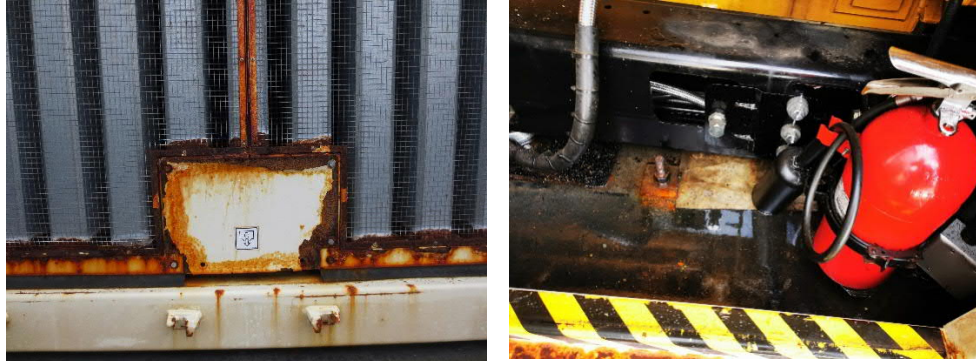
1. Cables connecting the black start diesel generators to their step-up transformers and other services are run on the ground and sitting on the gravel under the genset enclosure, which is more typical of a temporary installation. For permanent installation, cables should be routed in cable trays or cable trenches.
2. Walkways over cables between the black start diesel generators and their step-up transformers were facilitated with stacked wood and plywood. These walkways / crossings should be improved for a permanent installation. There are modular cable trench sections with trench covers available that could be considered.
3. Rust and deterioration of the enclosures were noticed, and some water was seen to be present on the floor in some of the enclosures. Maintenance on the enclosures should be considered.

Figure 5-4: Black Start Diesel Generators Cable Connections to Transformers and Enclosures

The implementation of the noted improvements and suggested maintenance will protect the installation and improve safety for this asset which is critical to starting the HTGS in the event of a loss of power.

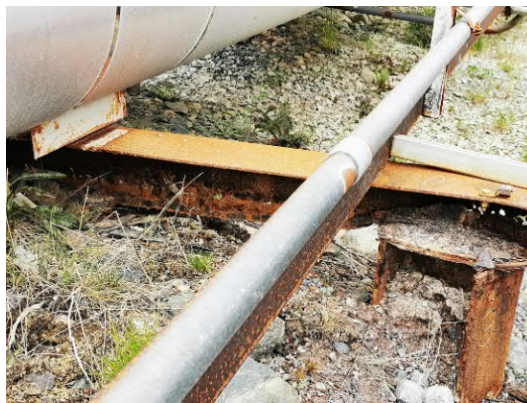
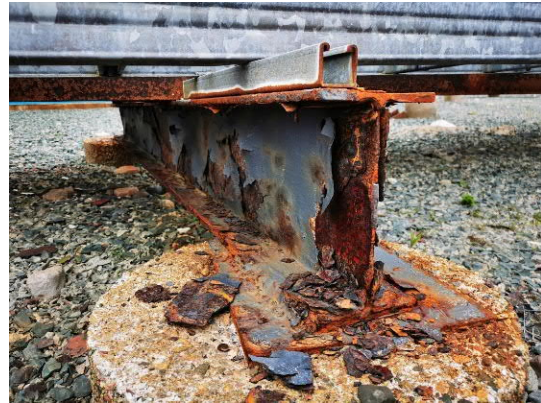
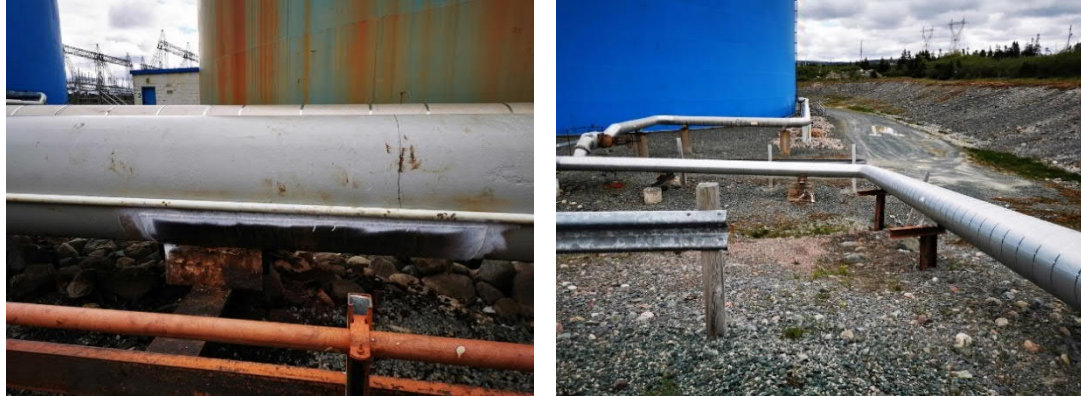
During our review significant deterioration of pipe supports on the HFO pipeline header, which transfers fuel from the main tanks to the day tank by gravity feed, was identified. Evidence of previous patching works on this section of piping was also identified and NLH noted that leaks had developed previously and platework had been welded on to the affected areas to return the pipeline to service.

Figure 5-5: HTGS Tank Farm HFO Piping Observations

NLH advised that the pipe support issues had been noted previously and plans are being developed to replace and refurbish the affected supports. It is evident that this exterior piping system has been subject to greater deterioration than other areas of the plant, which is typical of outdoor piping and pipe supports subject to coastal climates. To ensure reliable operation, the deteriorated pipe supports at minimum will require replacement, and this system will require additional focus and monitoring under the HTGS piping inspection and maintenance program. It is noted that the failure occurred at a welded pipe shoe location where the pipe is subject to both support loads and residual stress from welding the pipe shoe.

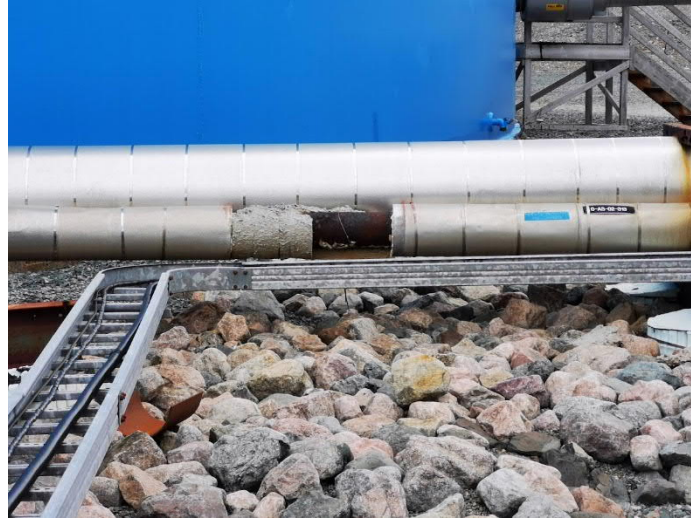
Figure 5-6: Auxiliary Steam Line in Tank Farm Facility Observed with Insulation Removed

Previous condition assessment reports indicate an inspection by TEAM Industrial Services was completed in 2017 which identified significant corrosion on certain sections of this system in the tank farm area.

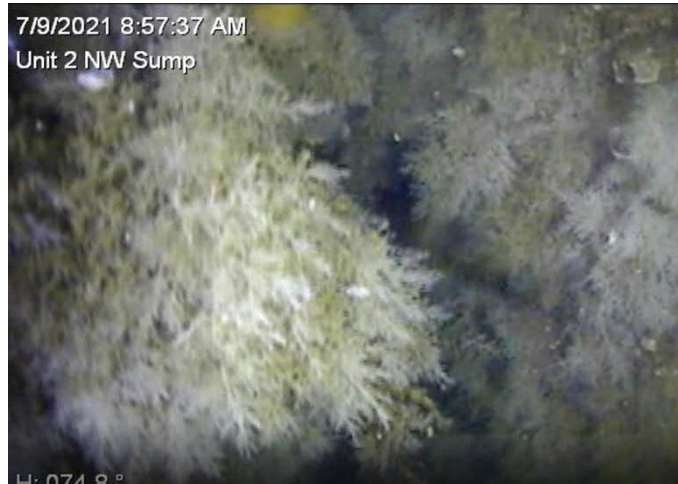
Pumphouses 1 and 2 Cooling Water Sumps were regularly cleaned (every 6 years) until (approximately) 2014. Due to concerns with ceiling concrete deterioration, personnel access has been restricted to the sumps and they have not been cleaned since. As a result of the lack of regular cleaning, there is extensive marine growth beneath the water line on the sump floors and walls. Areas under the waterline that were not covered in marine growth and were visible appeared to be in good condition. Video files of the ROV inspection were available for

Figure 5-7: Marine Growth Found in Cooling Water Sumps (typical to All 4 Units)

It is recommended that Pumphouse 1 and Pumphouse 2 sumps should be monitored and inspected (via drone or equivalent) on an annual basis going forward. Regarding the remaining areas (North and South Sumps) showing delaminated concrete, single corroded rebar, spalled concrete, and cracks, it is recommended that no immediate action is required at this time. These areas should continue to be monitored going forward to determine if further deterioration occurs, which may warrant future recommendations. Further details of

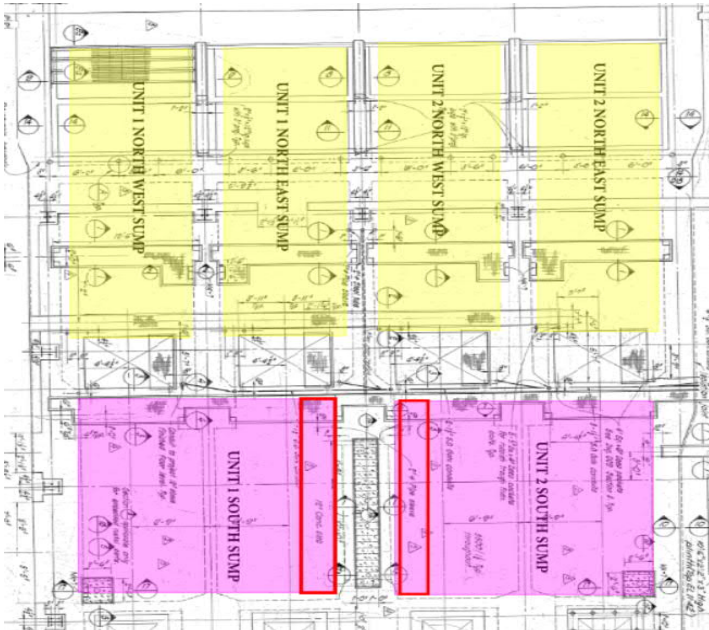
There are significant cracks in the interior beams of all four South Sumps. The general location of these cracks is shown in Figure 5-8 and Figure 5-9. Photos showing details of these cracks are shown in Figure 5-10 through Figure 5-22. Figure 5-23 shows an area with damage that has exposed several parallel rebar. Pump House 1 and Pump House 2 sumps have restricted personnel access. Due to the deteriorating conditions in the beams of the south sumps, it is recommended these areas be limited to foot traffic. These areas should not be used for laydown, storage, or staging of equipment. Going forward, if these areas are not restricted to foot traffic and are intended to be used per their original design, it is recommended that repairs should be made to the Pump House 1 and 2 south sump beams. These repairs would include dewatering the sumps, temporarily supporting the sump beams/ceiling, and removing and replacing the deteriorated concrete, all while giving consideration to the safety requirements for the confined space access. Due to the limited scope of the ROV and Drone inspection conducted in this assessment, it is not currently possible to determine the remaining strength capacity of these beams.

Figure 5-8: Pump House 1 South Sumps: Location of Significant Cracking in Interior Beams

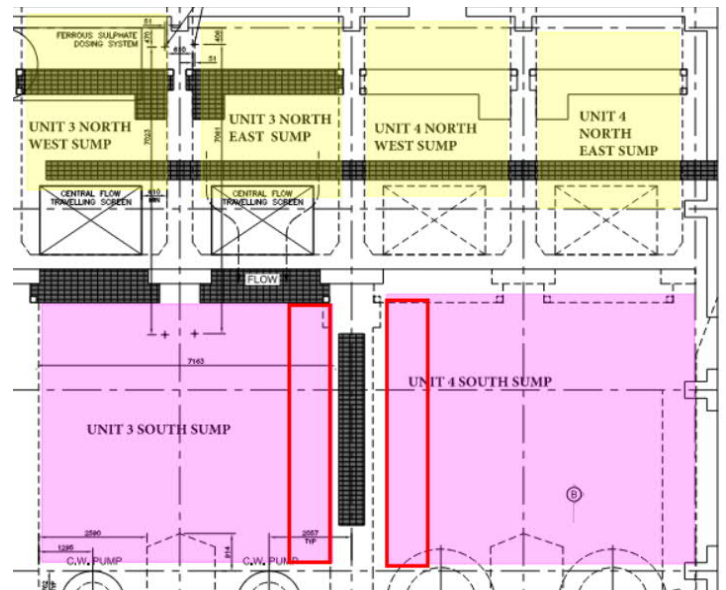
Figure 5-9: Pump House 2 South Sumps - Location of Significant Cracking in Interior Beams

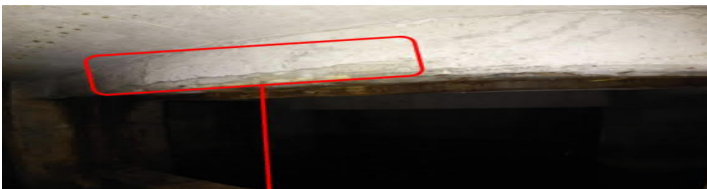
Figure 5-10: Unit 1 South Sump East Crack Location

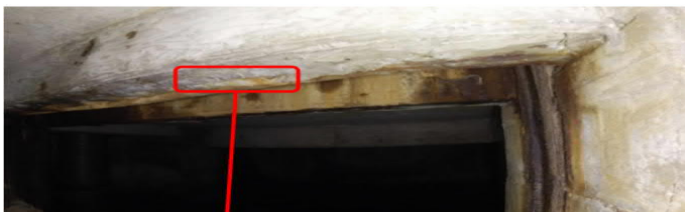
Figure 5-12: Unit 2 South Sump in West Beam Crack Location

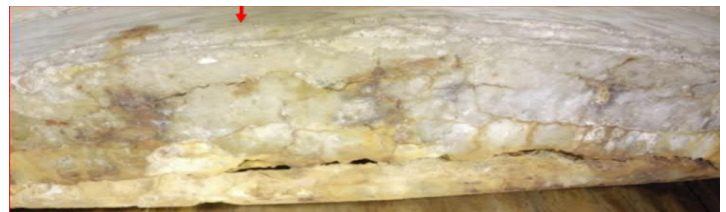
Figure 5-13: Unit 2 South Sump Crack in West Beam

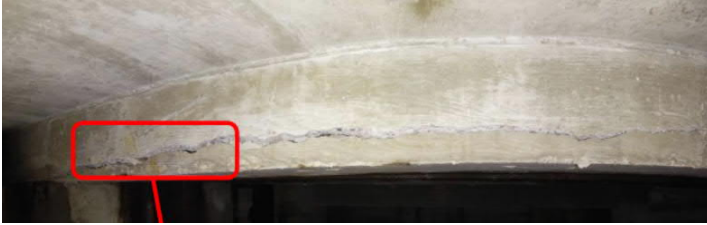
Figure 5-14: Unit 3 South Sump Crack in East Beam

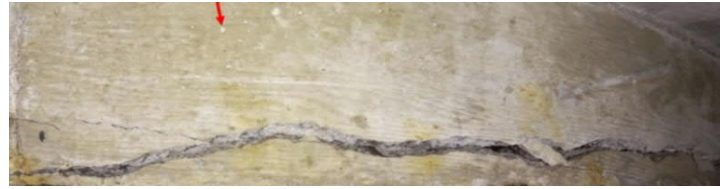
Figure 5-15: Unit 3 South Sump Crack in East Beam

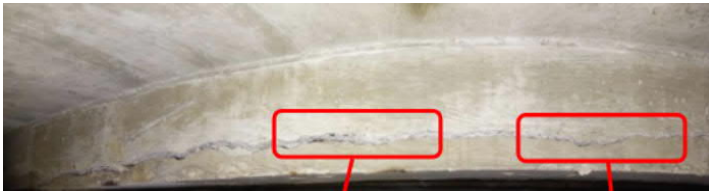
Figure 5-16: Unit 3 South Sump Crack in East Beam

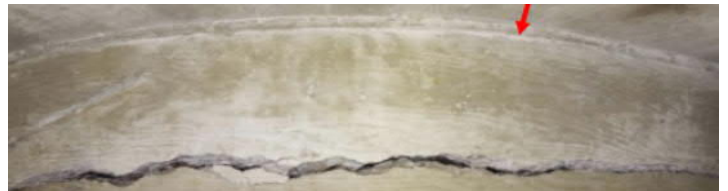
Figure 5-17: Unit 3 South Sump Crack in East Beam

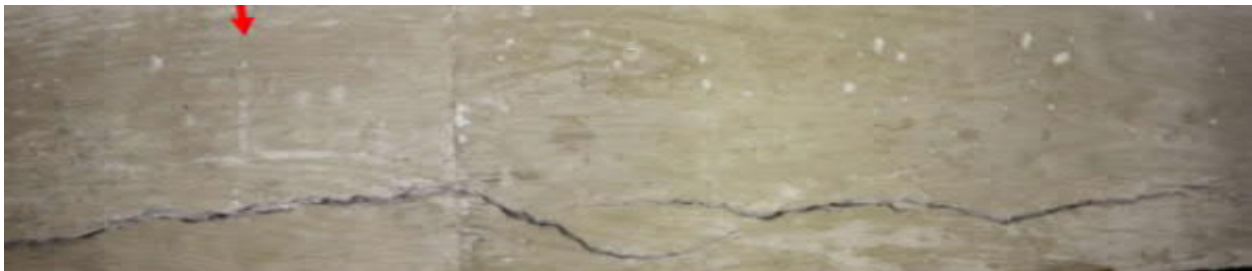
Figure 5-18: Unit 3 South Sump Crack in East Beam

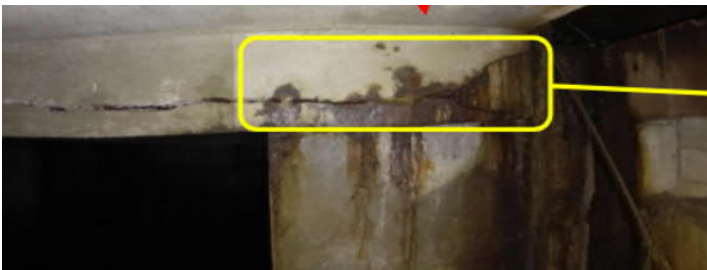
Figure 5-19: Unit 4 South Sump Crack in West Beam

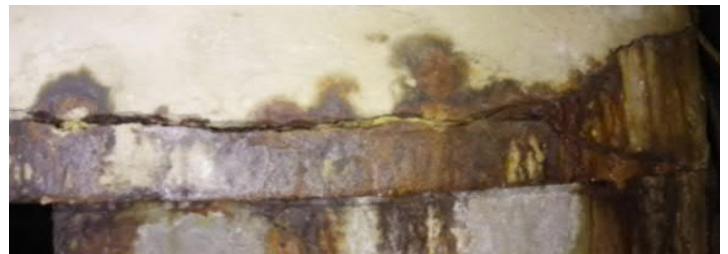
Figure 5-20: Unit 4 South Sump Crack in West Beam

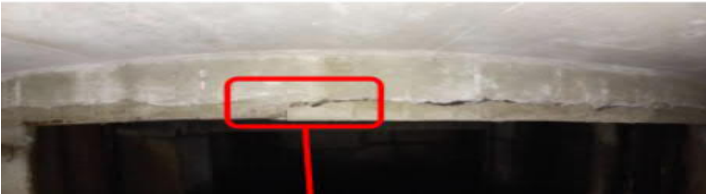
Figure 5-21: Unit 4 South Sump Crack in West Beam

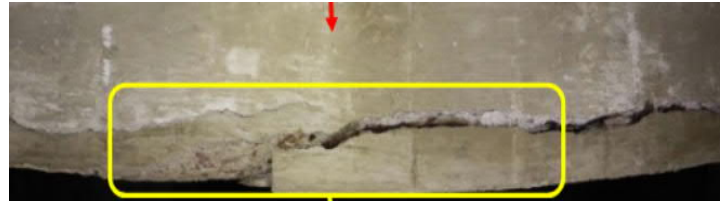
Figure 5-22: Unit 4 South Sump Crack in West Beam

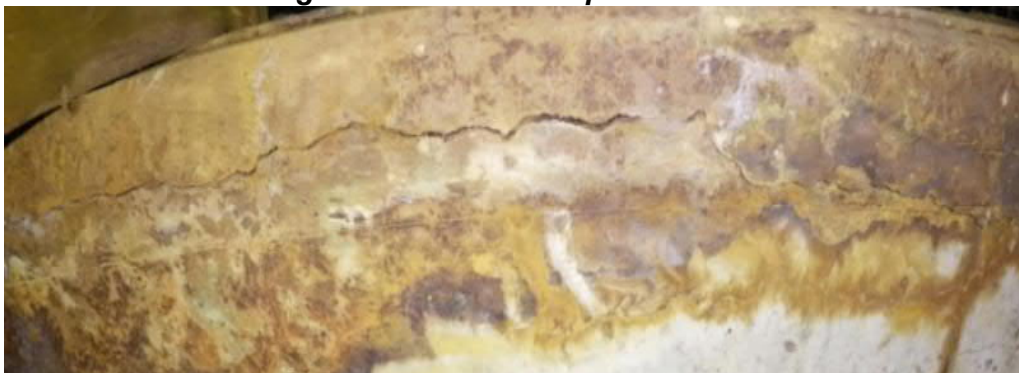
Figure 5-24: Unit 1 North West Sump – Crack on East Side

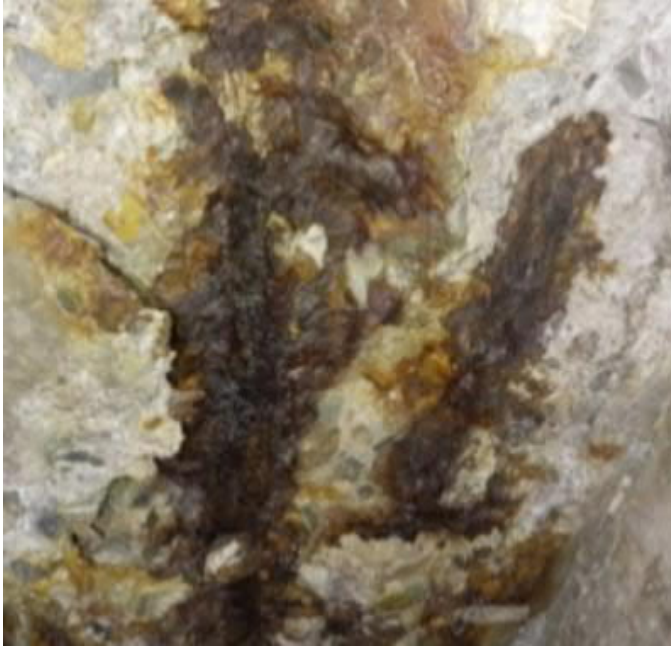
Figure 5-25: Unit 1 North West Sump - Ceiling near Traveling Screen

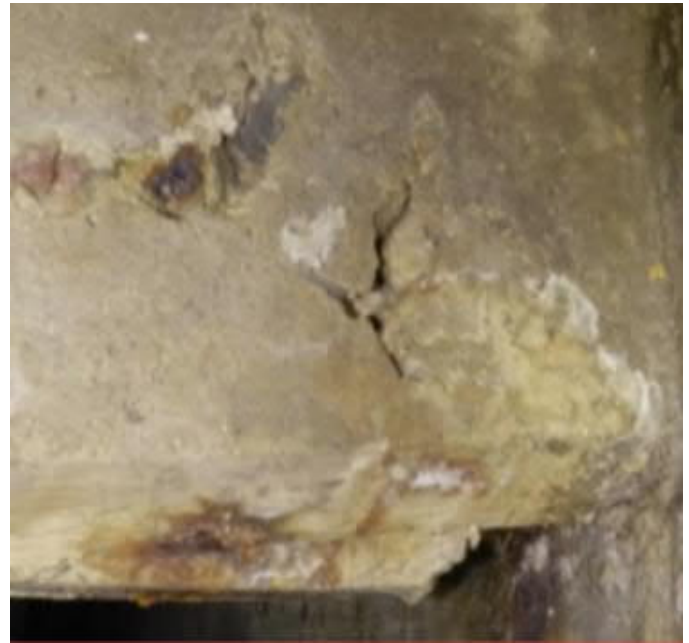
Figure 5-26: Unit 1 North West Sump - Crack in Southwest Corner

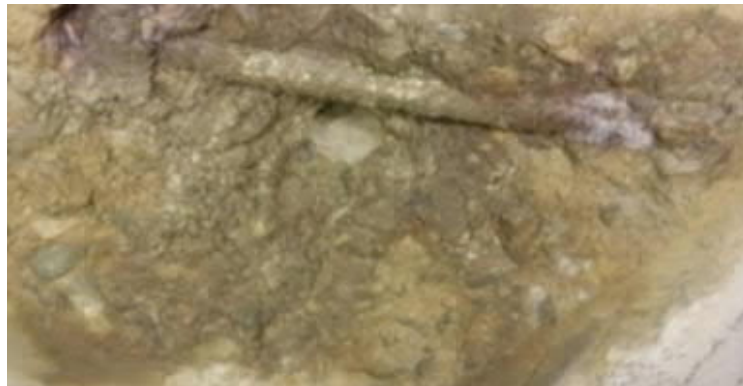
Figure 5-27: Unit 1 North East Sump - Exposed Rebar North End of Sump

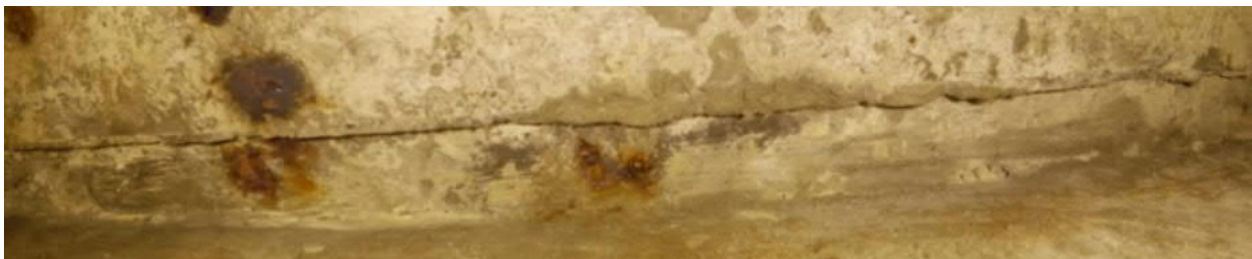
Figure 5-28: Unit 1 North East Sump - Crack in Ceiling Along West Wall

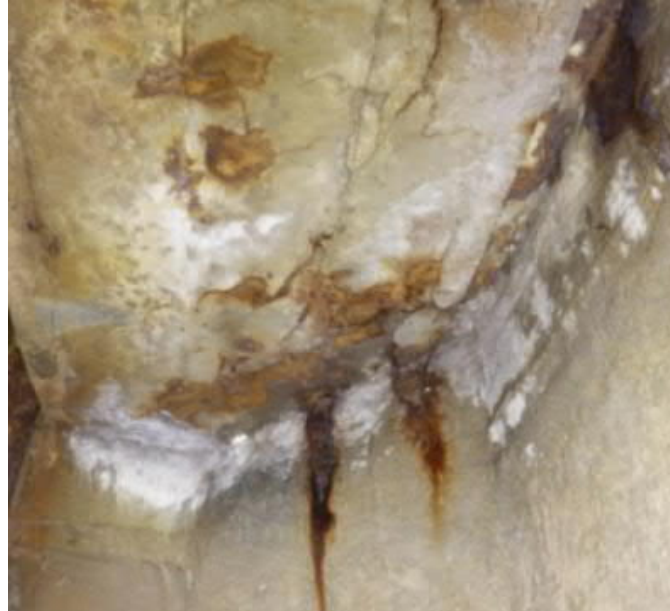
Figure 5-29: Unit 1 North East Sump: Deterioration of Concrete in Ceiling Near Traveling Screens

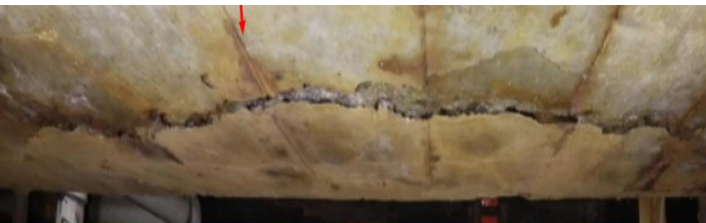
Figure 5-32: Unit 1 South Sump - Crack in North End Beam

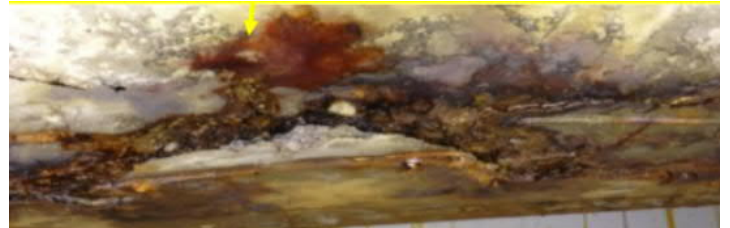
Figure 5-33: Unit 2 North West Sump - Deterioration of Ceiling Near South End

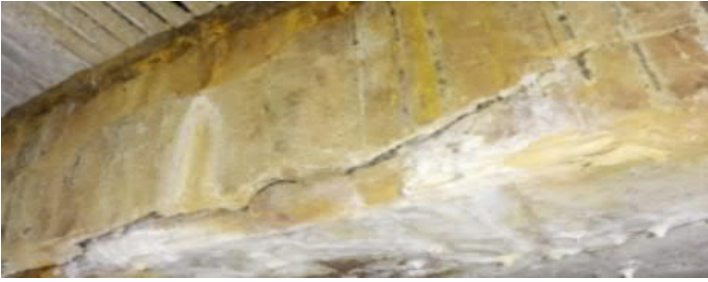
Figure 5-34: Unit 2 North West Sump - Crack Near South Stop Log Guides

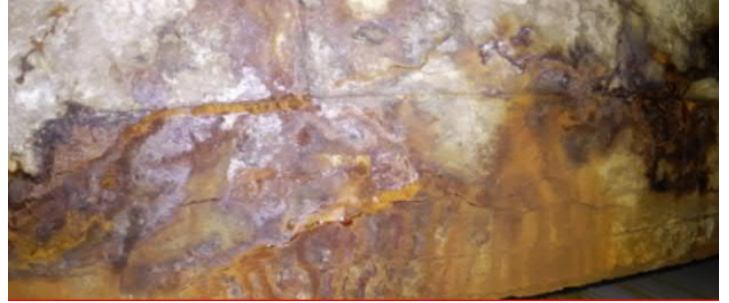
Figure 5-35: Unit 2 North West Sump: Deterioration of Concrete on Ceiling Near Travelling Screens

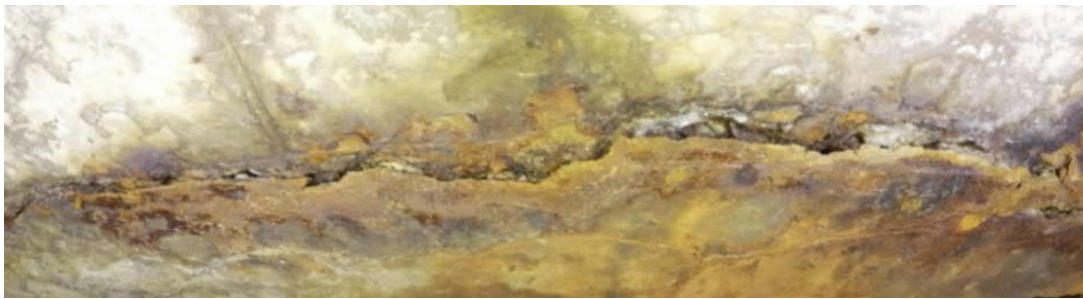
Figure 5-36: Unit 2 North East Sump - Crack in Ceiling Near Travelling Screen

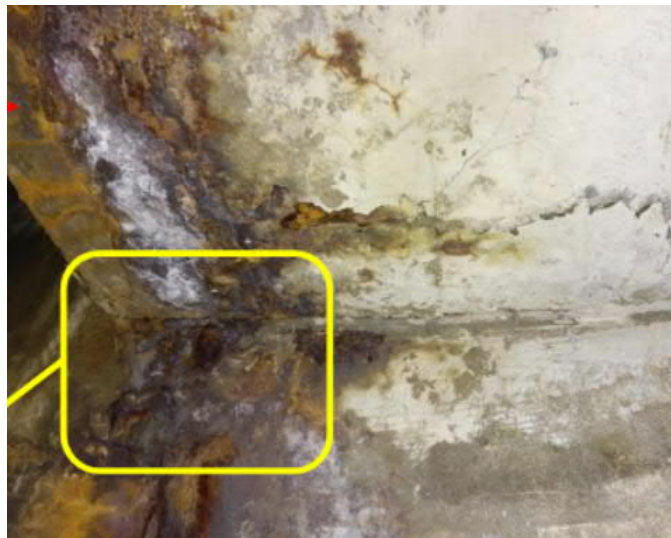
Figure 5-37: Unit 2 North East Sump - Deterioration in Southwest Corner

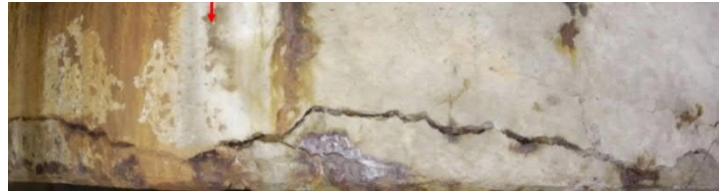
Figure 5-39: Unit 2 South Sump - Crack in Beam Near Southwest Access Point

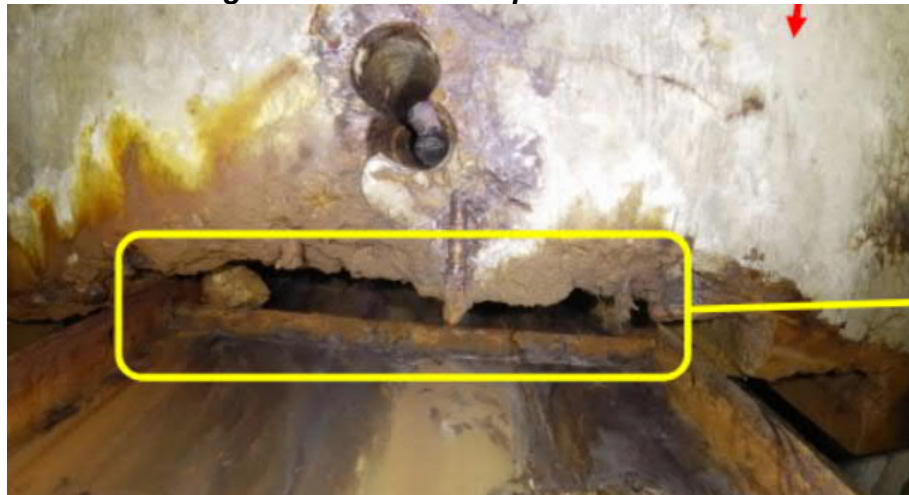
Figure 5-40: Unit 3 North West Sump - Deterioration in Ceiling Near Travelling Screen

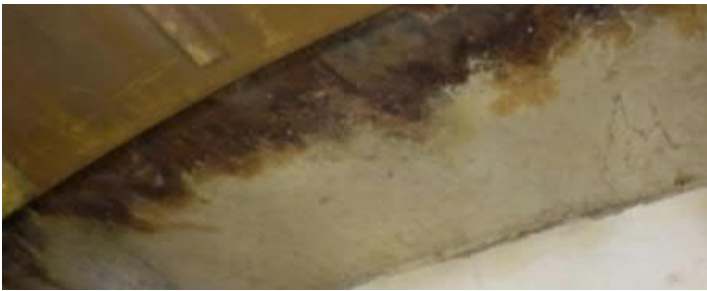
Figure 5-41: Unit 3 North East Sump

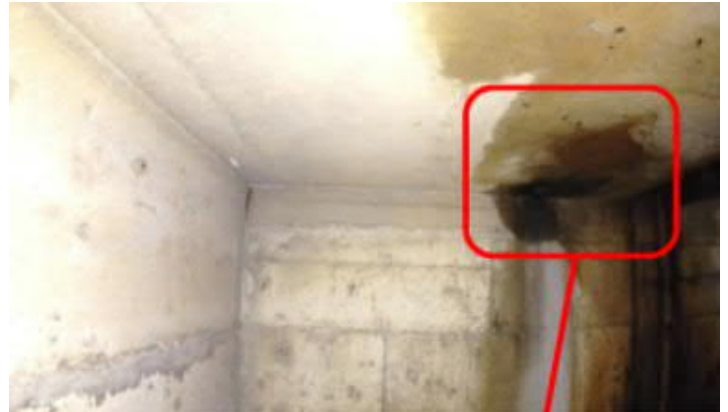
Figure 5-42: North East Sump - Near South Access Grating

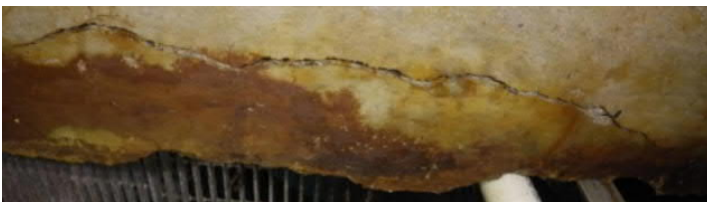
Figure 5-43: Unit 3 North East Sump - North End

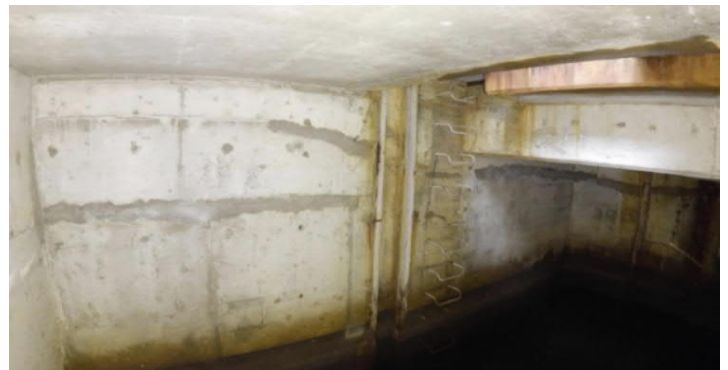
Figure 5-44: Unit 3 South Sump - Crack in Ceiling Near North Access Grating

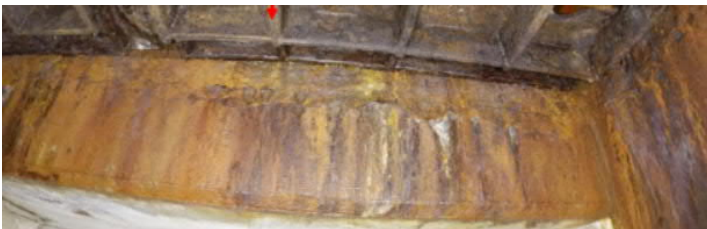
Figure 5-45: Unit 4 North West Sump West Side

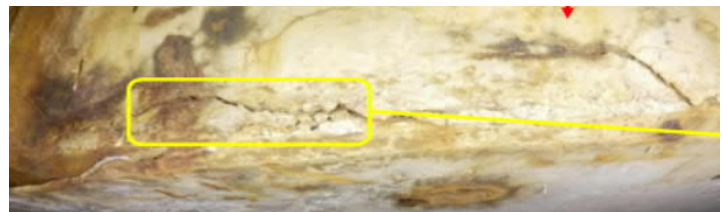
Figure 5-46: Unit 4 North West Sump - Ceiling South End Near Traveling Screens

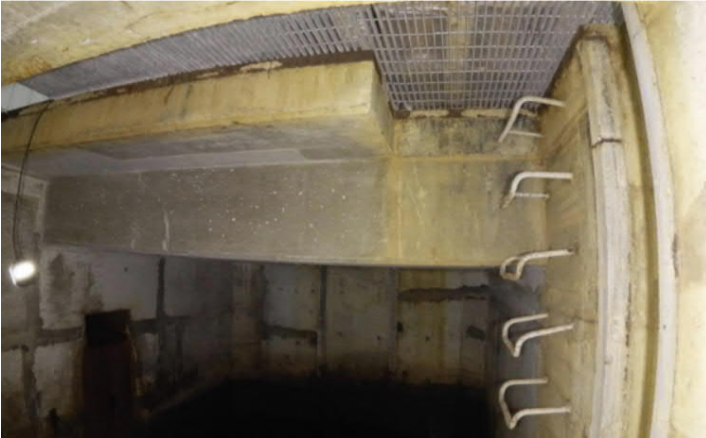
Figure 5-47: Unit 4 North West Sump - Crack Near South Access Grating

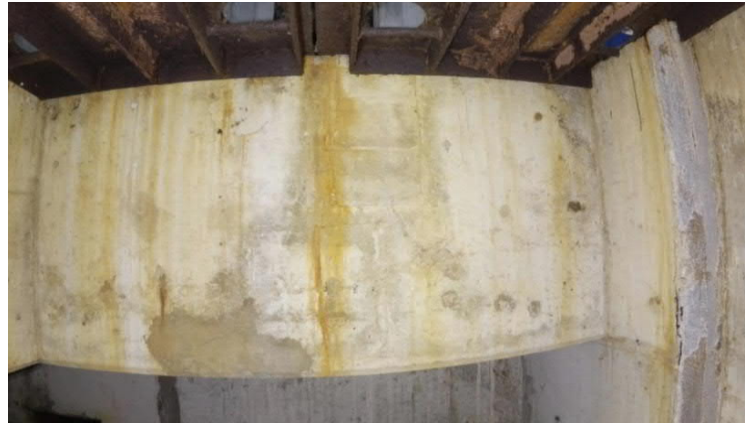
Figure 5-48: Unit 4 North East Sump Looking North

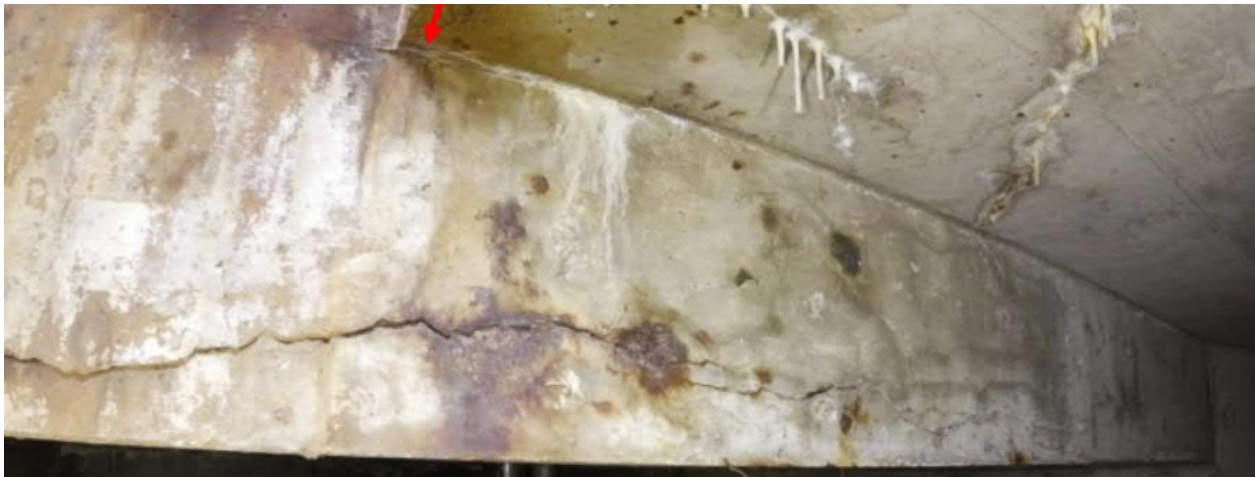
Figure 5-49: Unit 4 North East Looking South

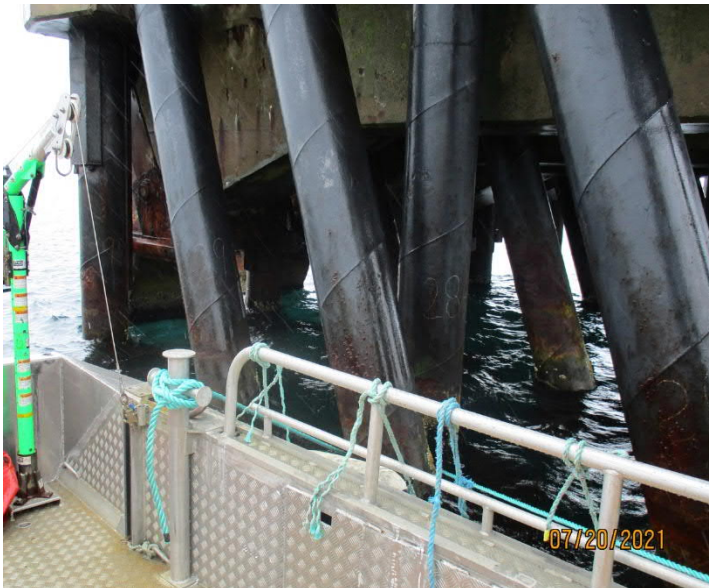
Figure 5-51: Berthing Jetty Facing Southwest

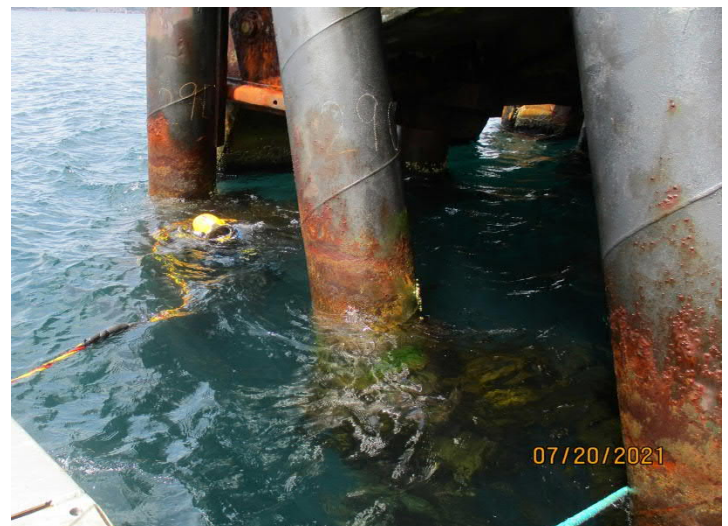
A significant number of piles have corrosion present at the splash zone. Above the splash zone, near the upper portion of the piles, the coating is in generally good condition. There is significant marine growth (barnacles, coral, etc.) on the piles under the water surface. Visual inspection below the water line was limited due to the excessive growth. In areas where there was visible coating, the coating appears in generally good condition. Areas that were scraped clean for previous inspection are still visible and remained in good condition. The remaining life condition of the anodes at the surface, mid and bottom level of the pile were also assessed. The anodes condition varies, ranging from 0% remaining (anode completely gone) to 100% remaining (anode showing no deterioration). The remaining condition on adjacent anodes varied significantly in each location, there were several locations where one anode was completely consumed, and the adjacent was entirely intact. During the inspection it was noted that some anodes on the north end showed signs of damage due to ice contact in Winter 2017. It is recommended that the piles and anodes undergo a visual (diving) inspection again within a 5-year time frame.

**Figure 5-52: Typical Pile Condition Above Water Line
(Jetty South End)**

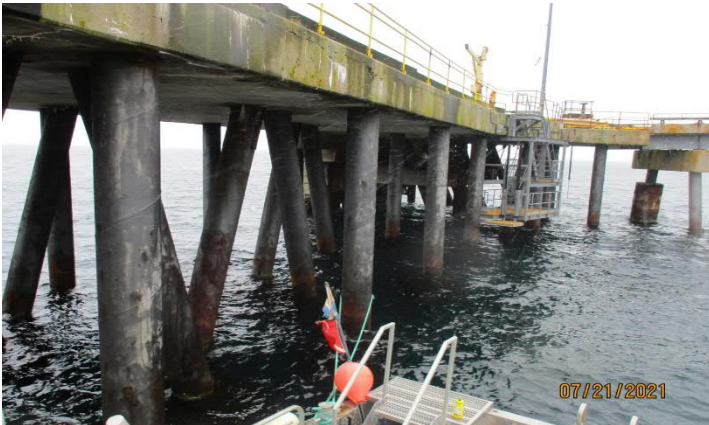
**Figure 5-53: Typical Corrosion Present at Water Line on
Jetty Piles (Piles 29B, 29C, 29D Jetty South End)**

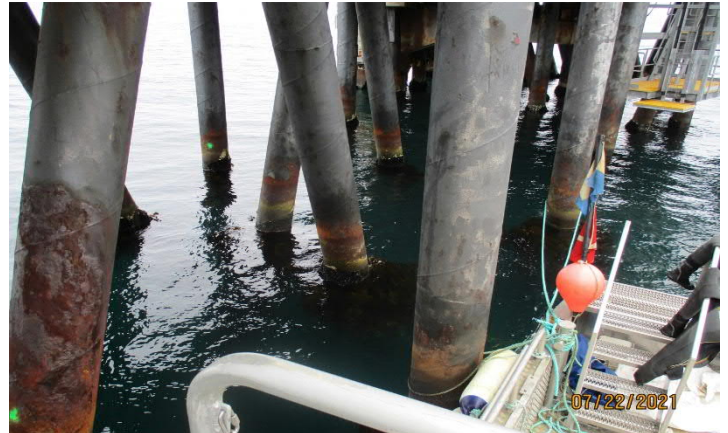
Figure 5-54: Typical Pile Condition (Facing Northwest)

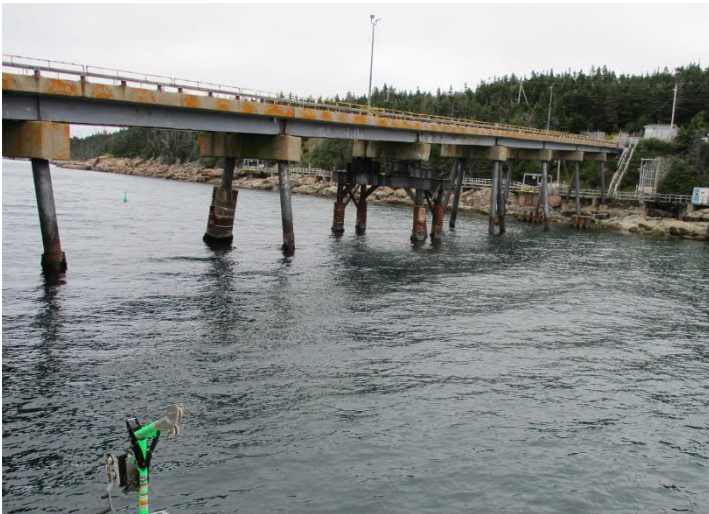
Figure 5-55: Typical Pile Condition (Facing Northwest)

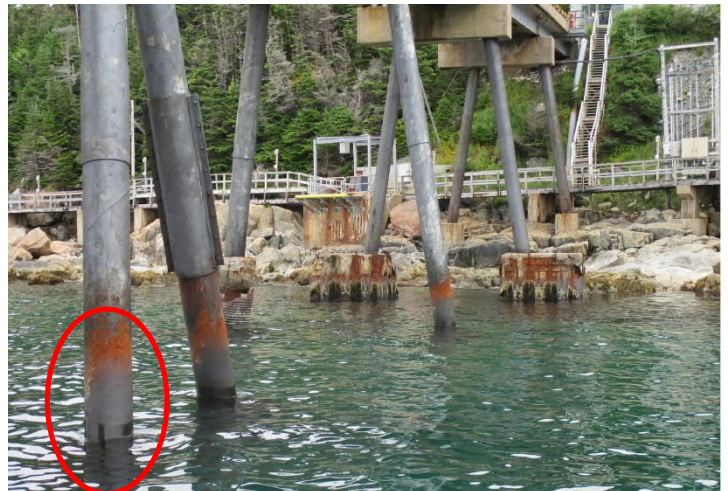
Figure 5-56: Jetty Shore Arm (Facing Northeast)

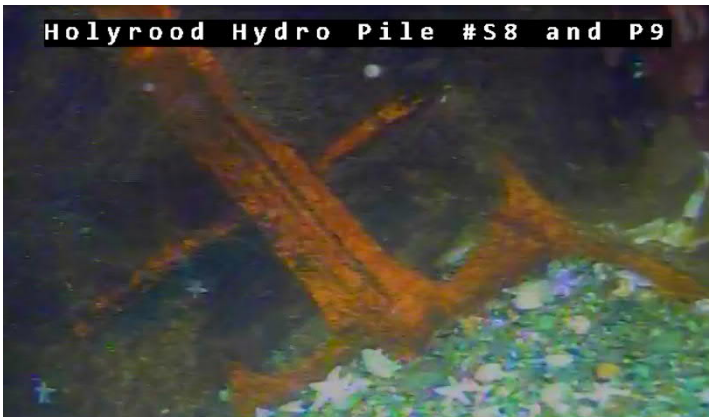
Figure 5-57: Jetty Shore Arm (Facing East)

(Note: Pile S8 has Steel Cover and Concrete are Severely Deteriorated with Exposed Rebar. Pile S9 and P10 Concrete has Washed Away Below Water Line)

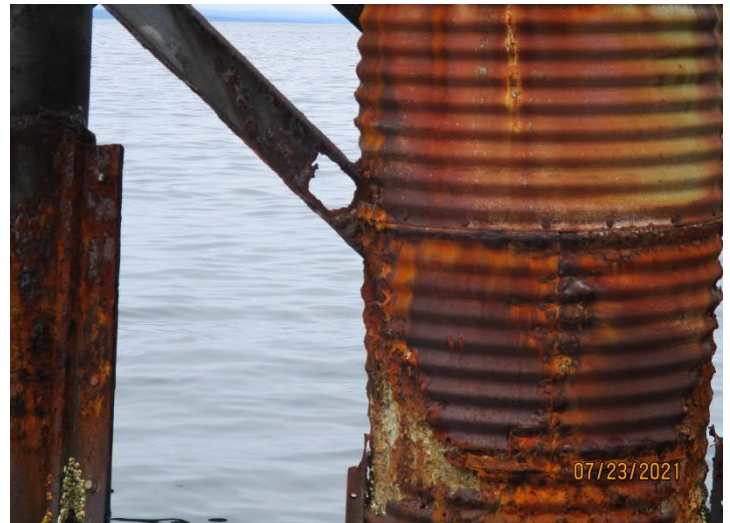
Figure 5-58: Pile P9 Concrete Jacket completely Deteriorated beneath the Water Line. Typical for Pile S8 and P9

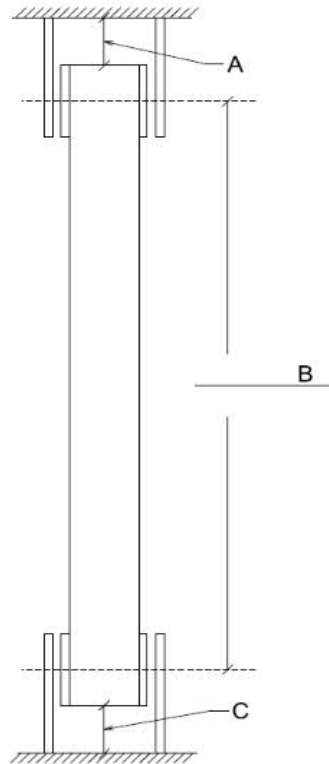
Figure 5-60: Jetty Fender Arm and Pin Measurement

The Fender Pins and support arms have undergone several inspections and repairs since 2008. Support arm measurements have been previously taken in 2008, 2013, and 2016. During the 2021 inspection scaffolding was erected to provide access to the fender support arms and pins. Measurements were taken using vernier calipers and measuring tapes and compared against previous measurements. The location of the measurements is shown in Figure 5-60. Fenders #1 and #7 are stuck in the retracted position. Their measurements were

Based on the 2021 inspection results, it was recommended that #3 and #8 Fender Support Arms be immediately replaced before the next scheduled tanker arrival. The level of material wear since the last inspection is of concern. NL Hydro have proceeded with replacing the #3 and #8 fender arms and pins under a separate contract.

It is further recommended that the Support Arm and Fender Pin measurements continue to be inspected for wear within a 5-year period.

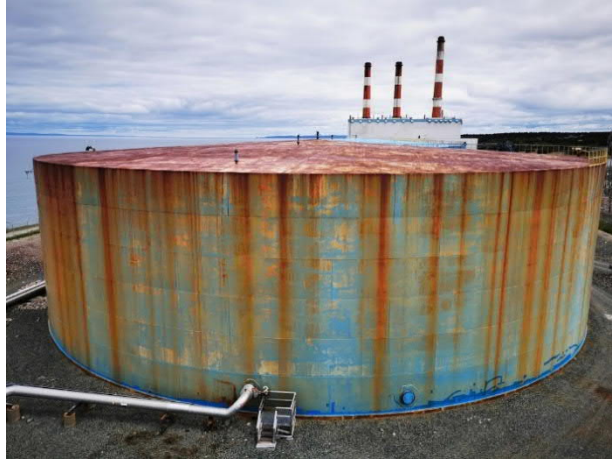
HOIT data indicates that an out of service inspection of Tank 2 is required to be completed in 2023 for continued operation. During site visits performed by Hatch the coating on this tank was observed to have deteriorated. Painting has been deferred but the tank paint is recommended to be repaired as per the API 653 In Service Inspection. See Figure 5-61 below. As noted above, an investigation for the tank stairs is ongoing as of March 2022. Recommendations for repair from this investigation will be implemented during the 2022 maintenance season.

Figure 5-61: HFO Tank 2 with Deteriorating Coating

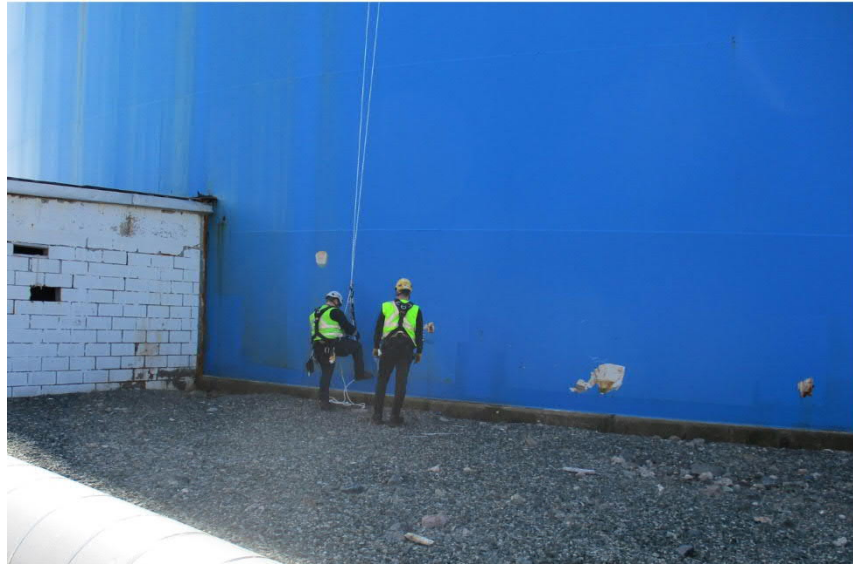
Figure 5-62: Fuel Tank #3 North Quadrant Localized Paint Deterioration

The paint deterioration is consistent with the findings from the 2018 and 2021 API 653 In Service Inspection Report. Areas with coating failure should be properly cleaned and repainted to meet the specified dry film thicknesses per Specification 2003-24630.

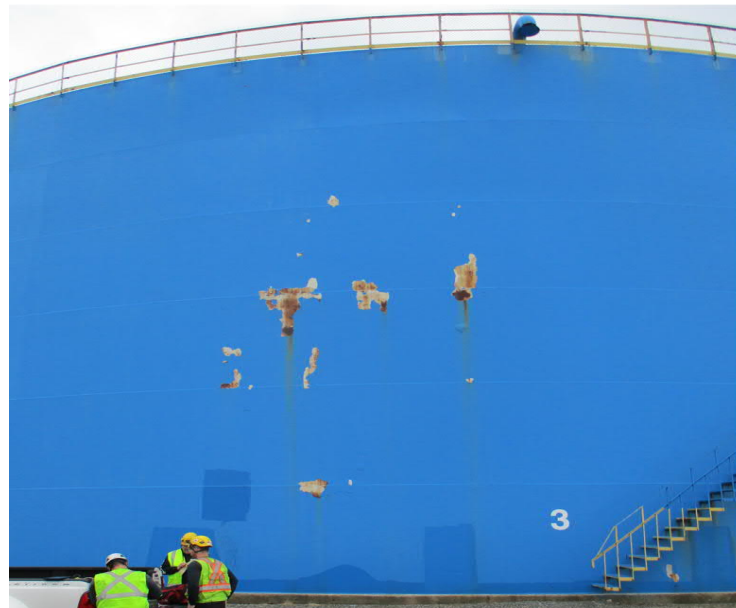
Figure 5-63: Fuel Tank #3 East Quadrant – Localized Paint Deterioration

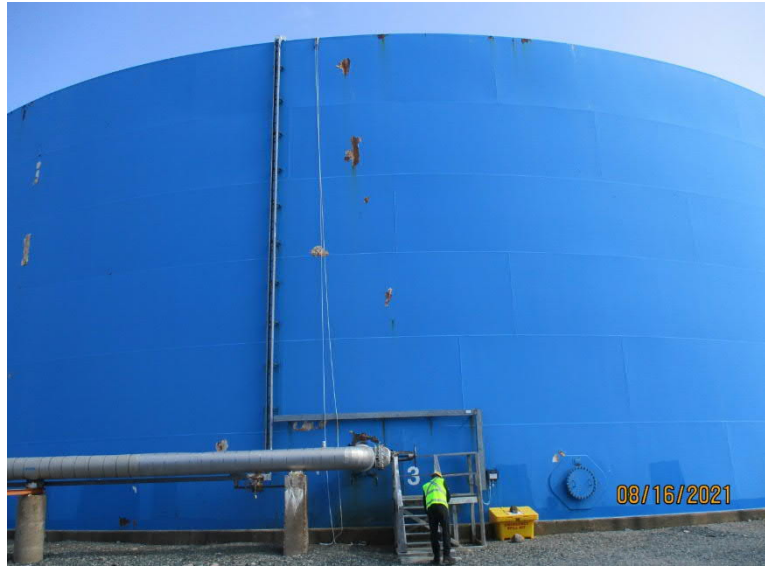
Figure 5-64: Fuel Tank #3 South Quadrant Localized Paint Deterioration

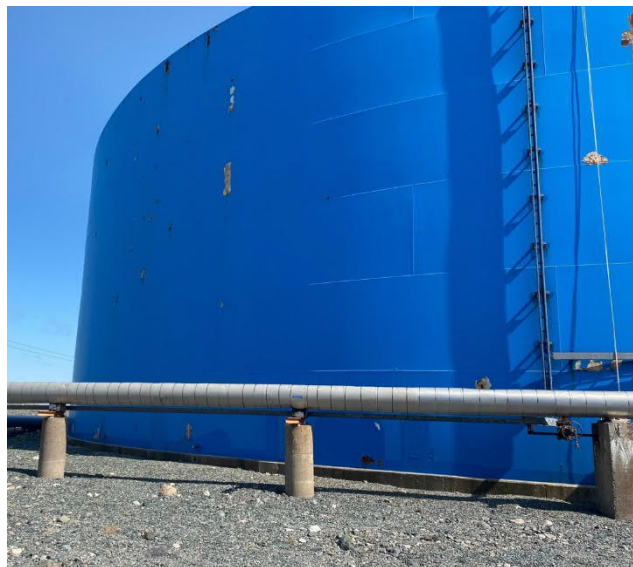
Figure 5-65: No. 3 Fuel Tank Southwest Quadrant Localized Paint Deterioration

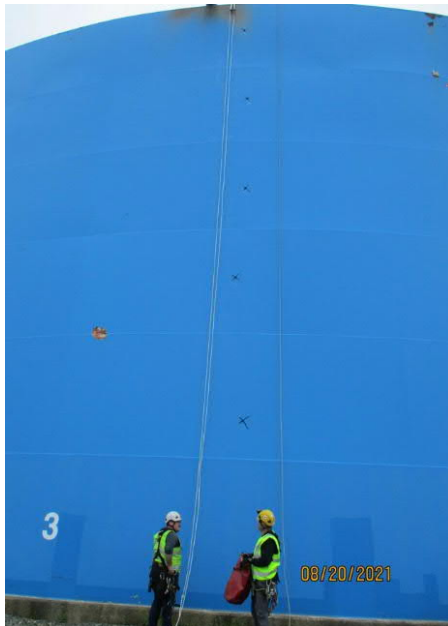
Figure 5-66: No. 3 Fuel Tank Location of Adhesion Test

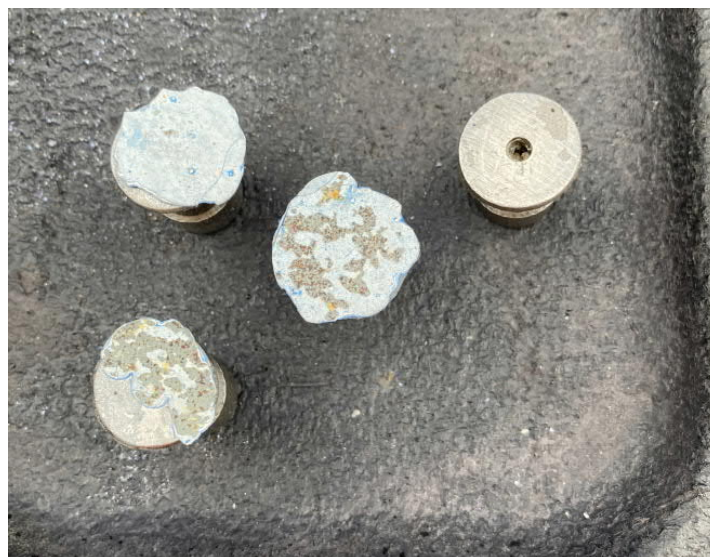
Hatch oversaw the coating inspection on the #3 Fuel Tank conducted by Acuren. The inspection consisted of dry film thickness testing and adhesion testing, conducted on the six shell courses, at the North, South, East, and West quadrants of the tank. A summary of the dry film thickness readings is detailed in Appendix I. The #3 Fuel Tank had been painted in accordance with Specification 2003-24630 and the specified dry film thickness for the tank ranges from 16-20 mils. A summary of the actual measured dry film thicknesses is detailed in Table 5-10. Adhesion testing was conducted on the #2, 3, 4, 5, and 6 shell courses on the East and West sides of the #3 Fuel Tank. After an approximate 1 hour waiting period, all 10 test dollies were easily removed from the tank by hand, removing 3 layers of the paint coating at the local testing site. This can be seen in Figure 5-67.

Figure 5-67: Paint Adhesion Test Sample Results
