Re: *Reliability and Resource Adequacy Study Review - Assessment to Determine the Potential Long-Term Viability of the Holyrood Thermal Generating Station*

Holyrood Thermal Generating Station Condition Assessment

**Newfoundland and Labrador Hydro
HTGS Condition Assessment and Life Extension Study
Executive Summary**

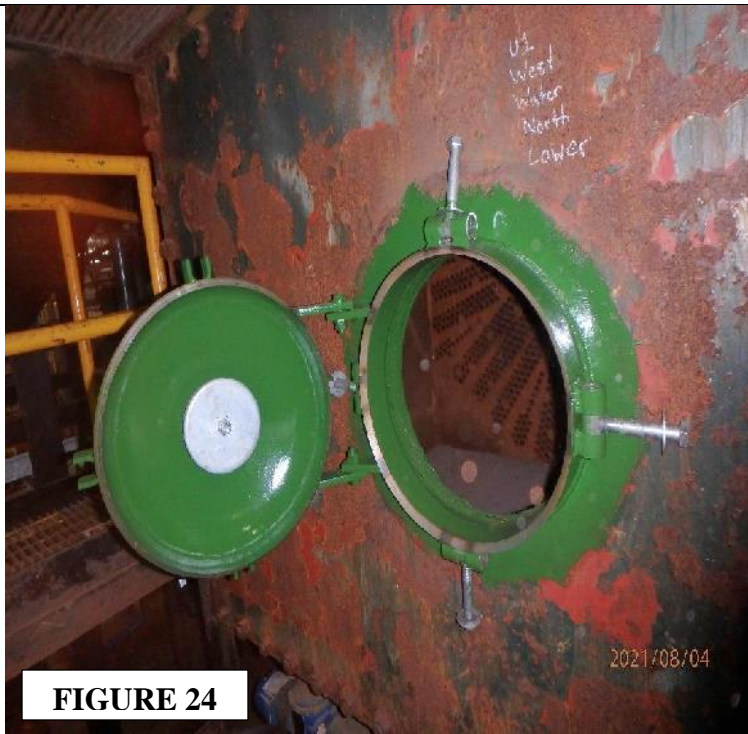
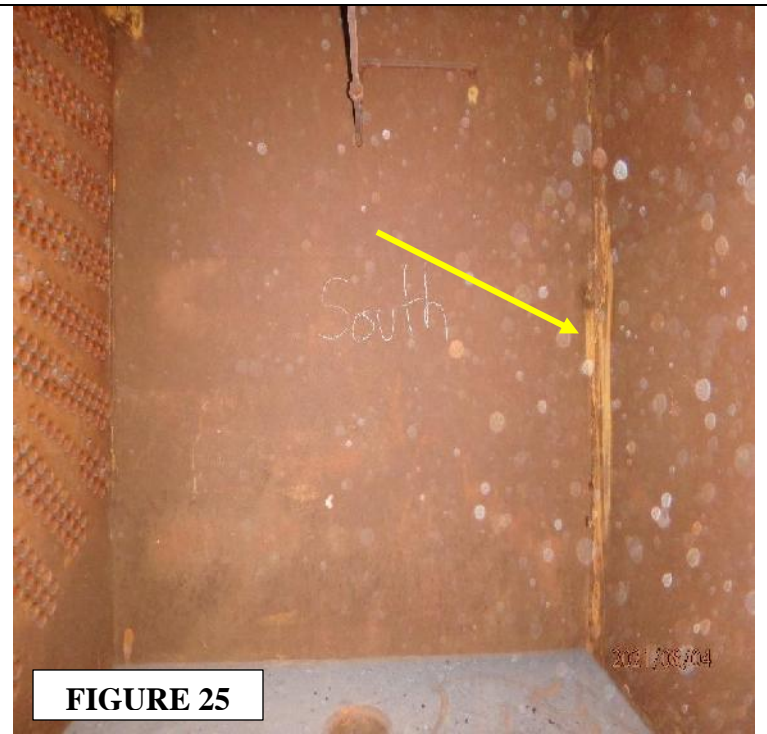
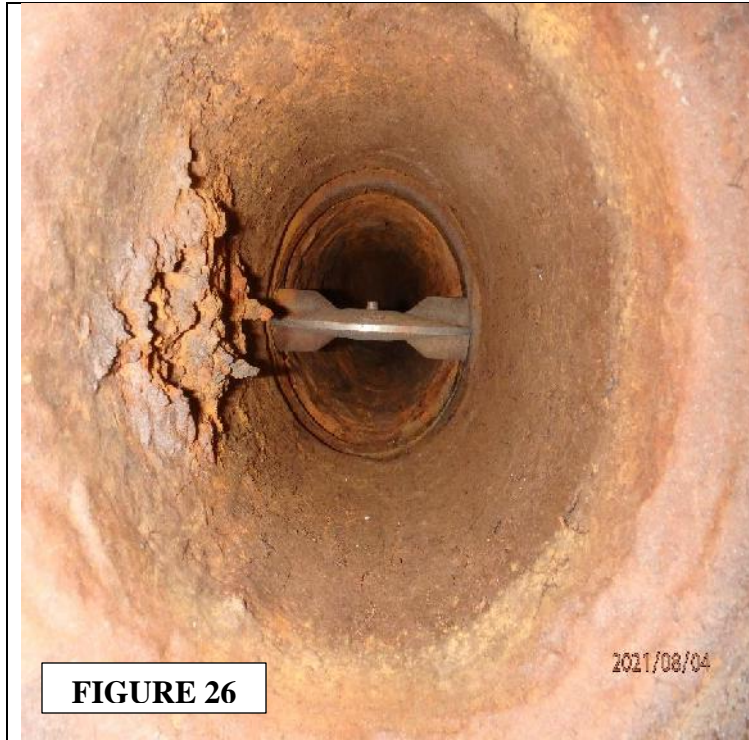
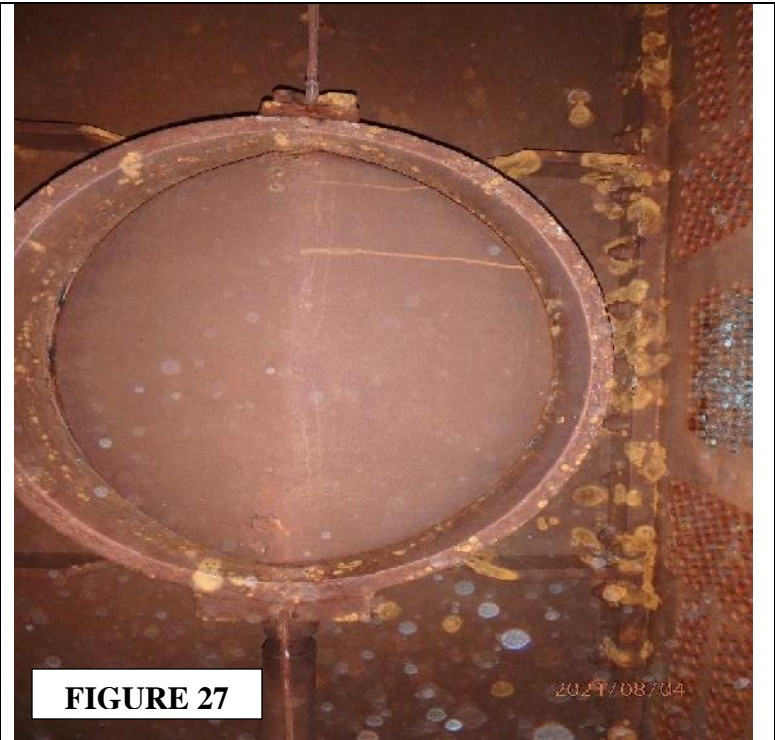
2.2 West Side – North Inlet Box

- The box was generally in good condition with minor coating breakdown and corrosion throughout (**Figure 27**)
- Coating had mainly failed between the side walls and back walls as noted in previous inspections (**Figure 25**)
- Anodes in satisfactory condition
- No corrosion of tubesheet was observed
- Manway door recently refurbished with new anode installed (**Figure 24**)
- Corrosion was noted in drain pipe (**Figure 26**)
- Inspection of inlet piping not obtainable as valve was in closed position

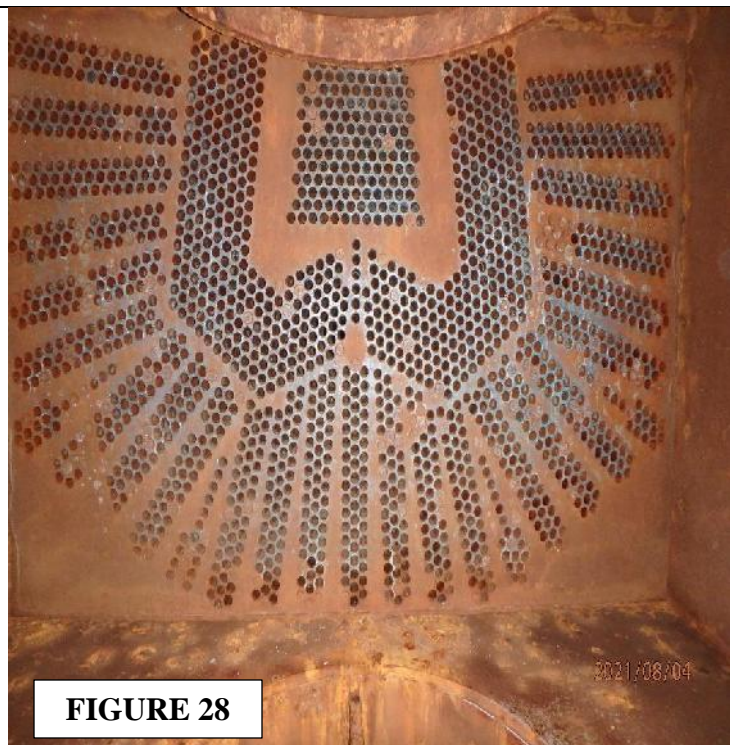
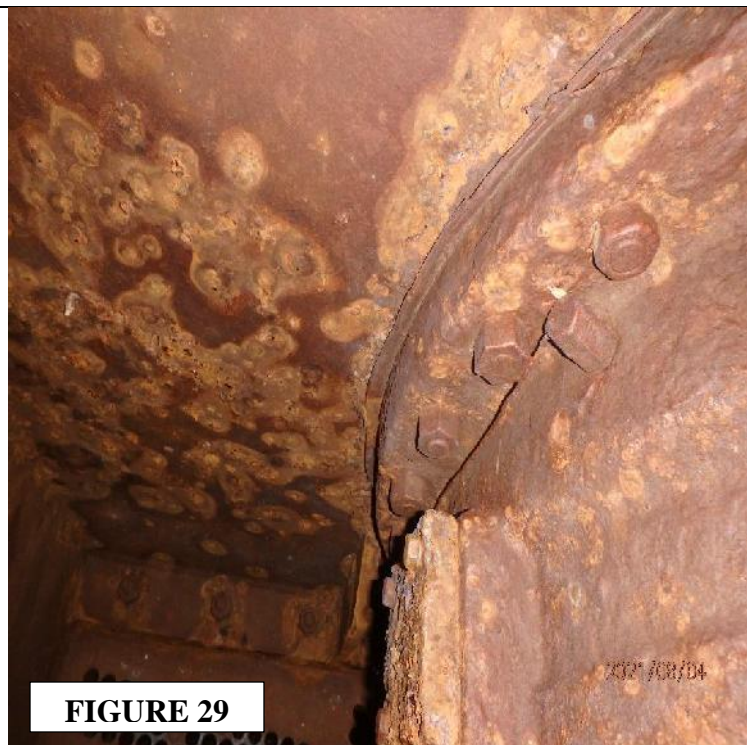
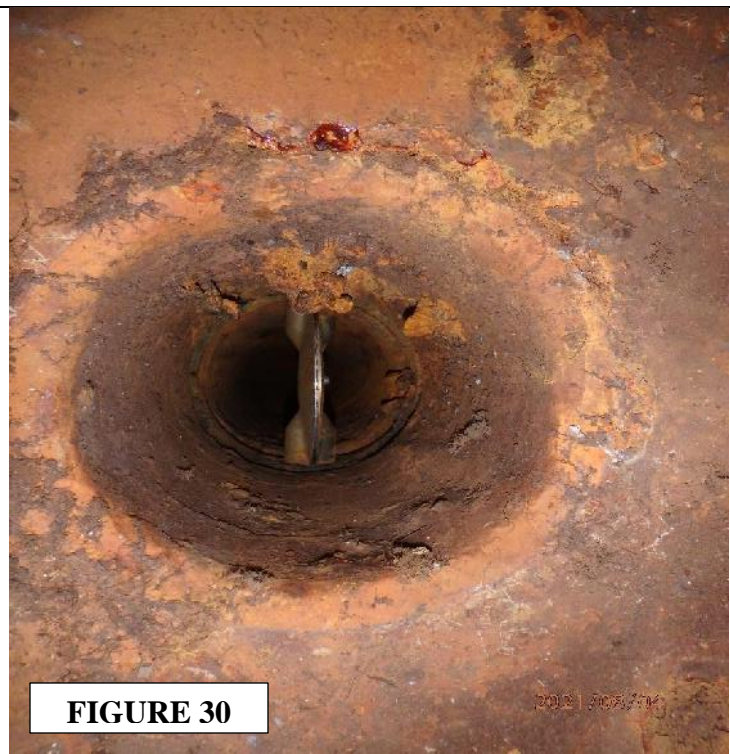
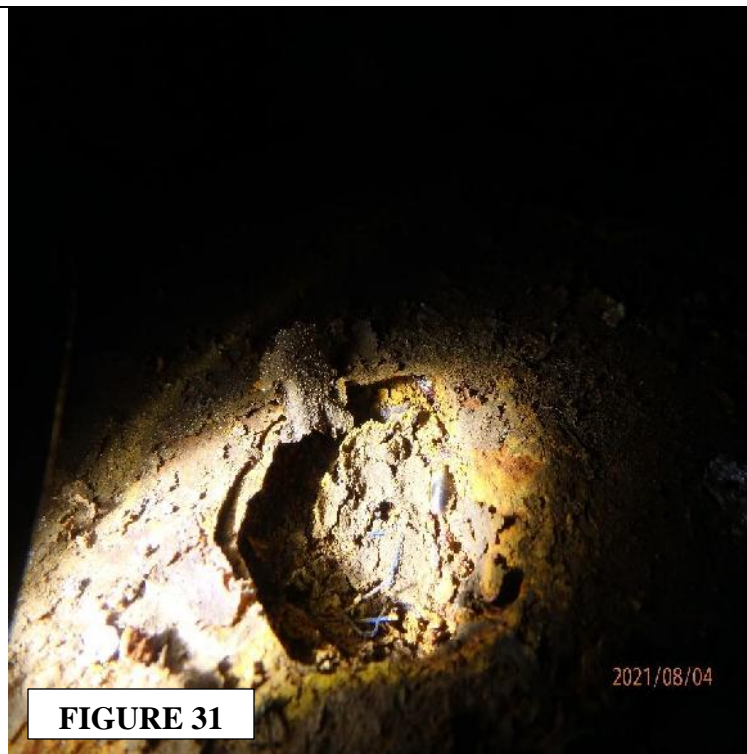
2.3 West Side – South Inlet Box

- The box was generally in good condition with minor coating breakdown and corrosion throughout, especially in corners, however, a few deep pits were observed (**Figures 28, 29, 31-33**)
- Corrosion noted in drain pipe (**Figure 30**)
- Anodes in satisfactory condition
- No corrosion of tubesheet was observed
- Inspection of inlet piping not obtainable as valve was in closed position

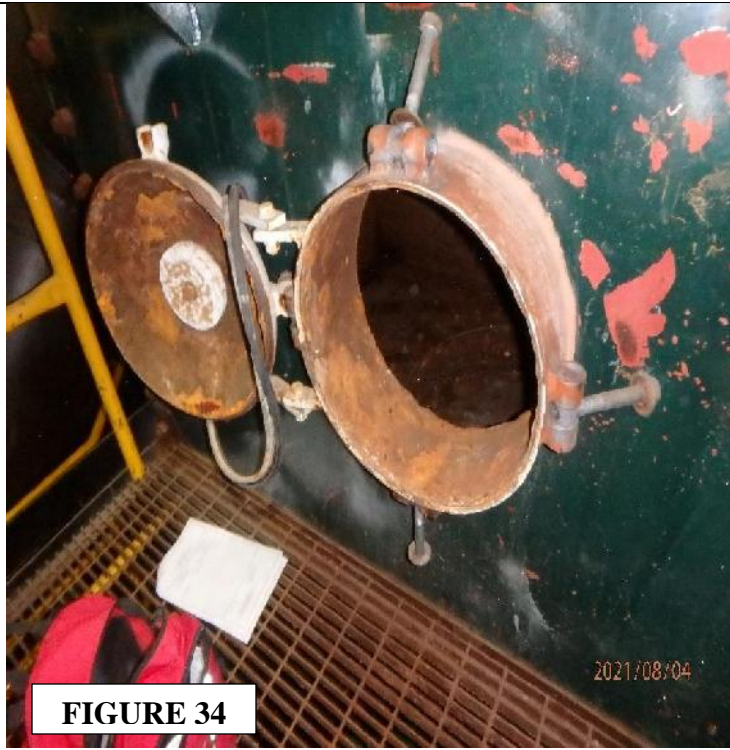
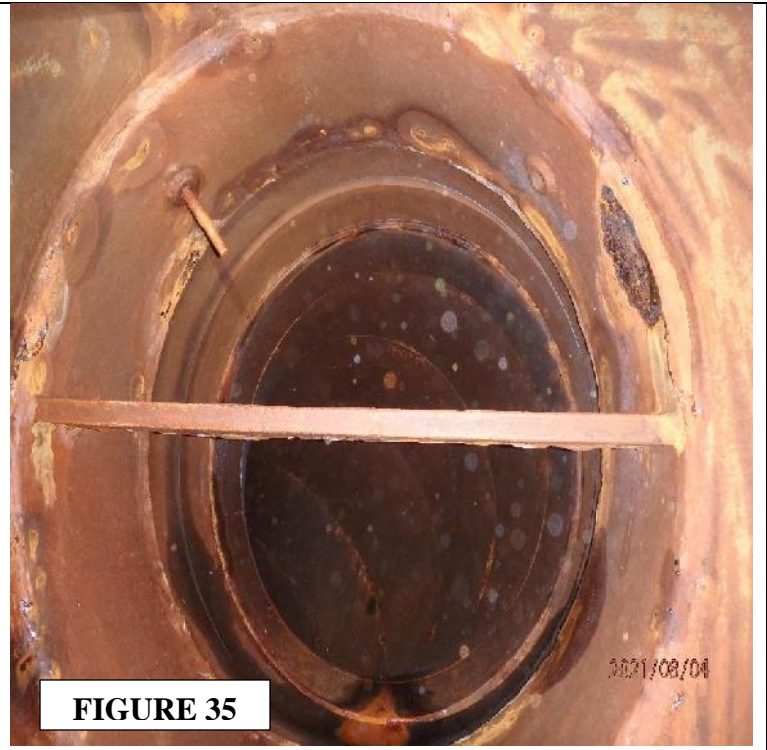
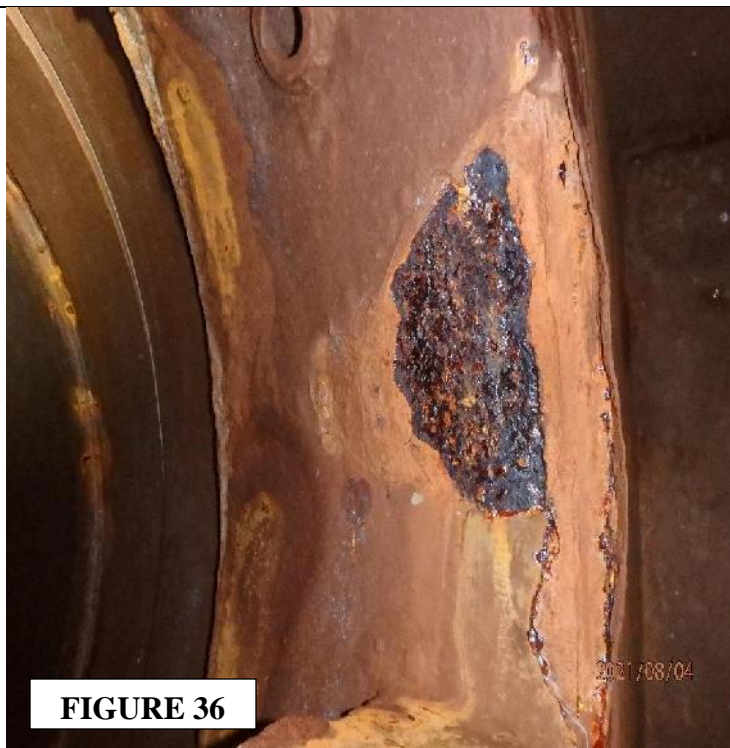
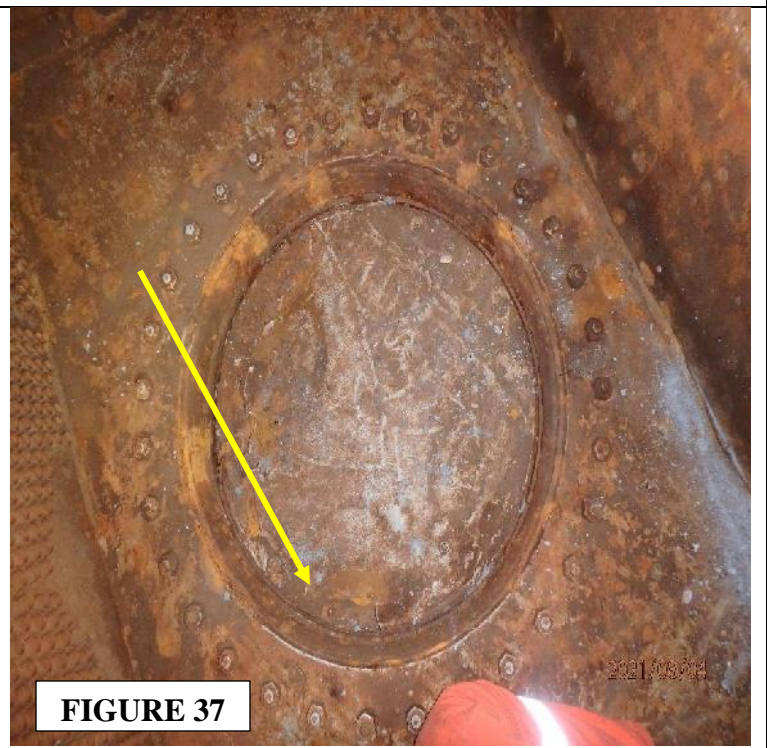
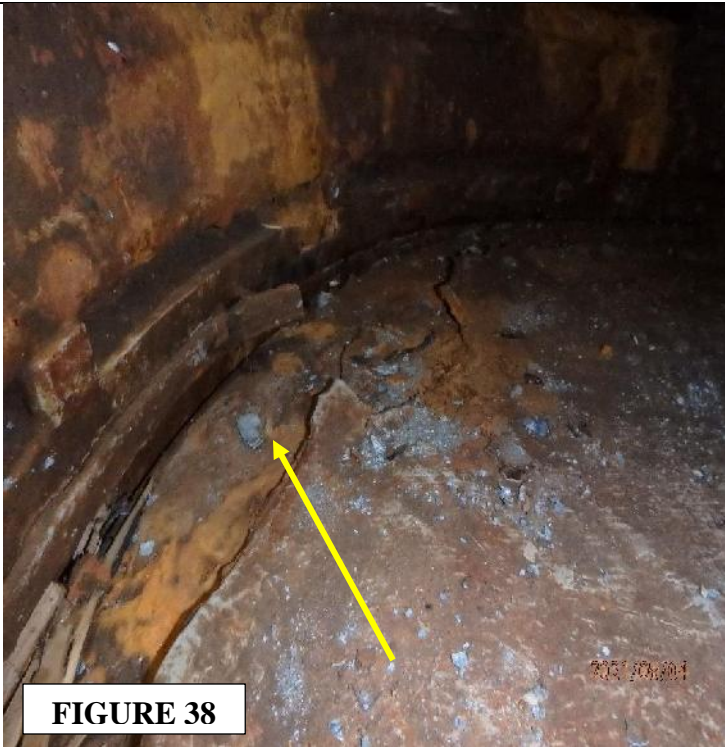
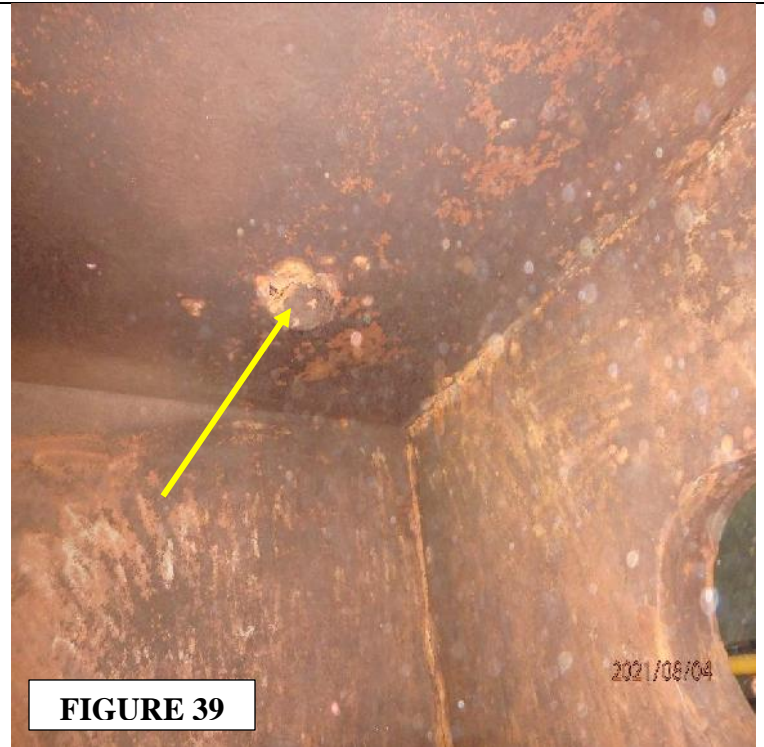
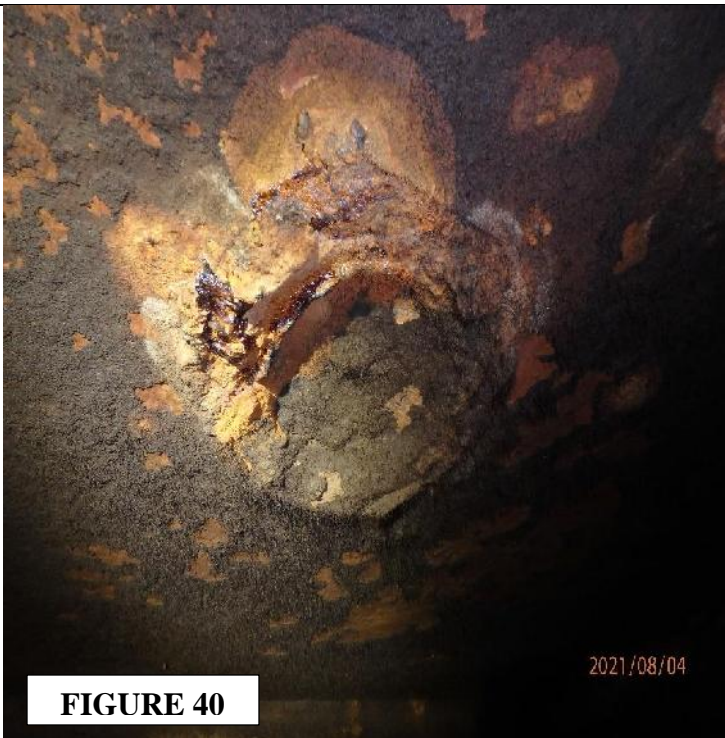
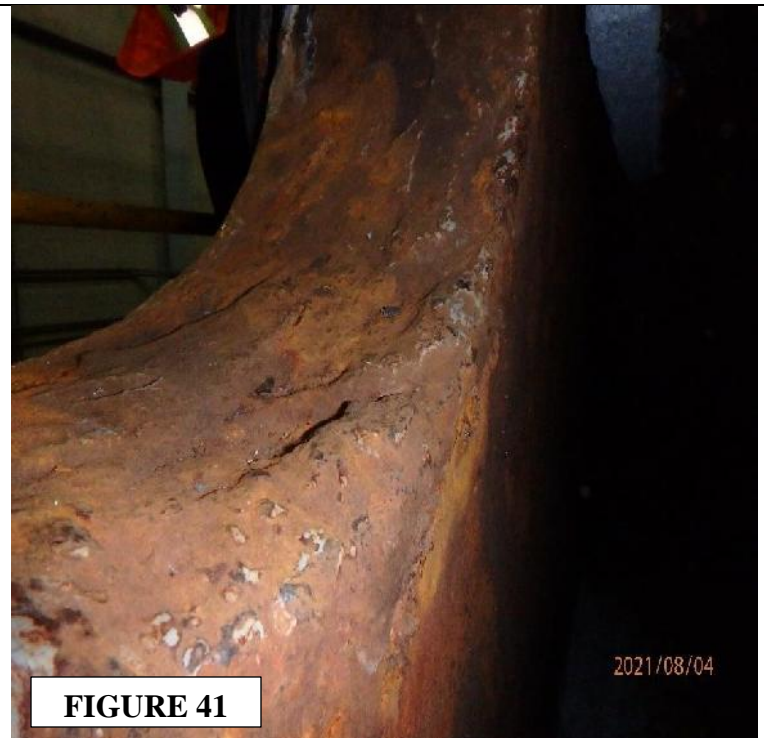
2.4 West Side – North Outlet Box

- The box was generally in good condition with minor coating breakdown and corrosion throughout, especially in corners, as seen in adjacent boxes. As well, a few pits were observed (**Figures 36, 39-40**)
- Manway heavily corroded (**Figures 34, 41**)
- Butterfly valve disc coating failure and corrosion noted (**Figures 37, 38**)
- Anodes in satisfactory condition
- No corrosion of tubesheet was observed
- Minor corrosion noted in discharge piping (**Figure 35**)

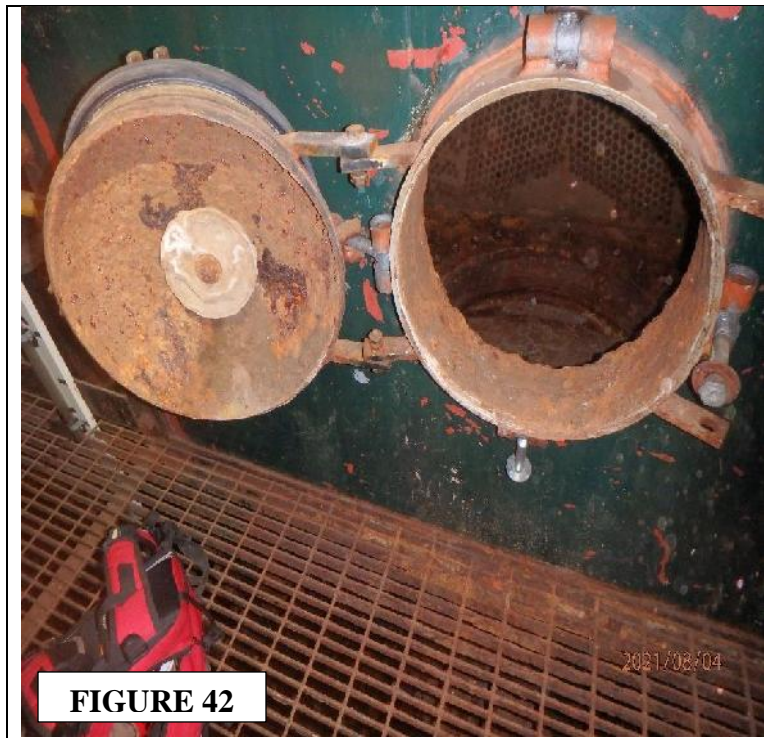
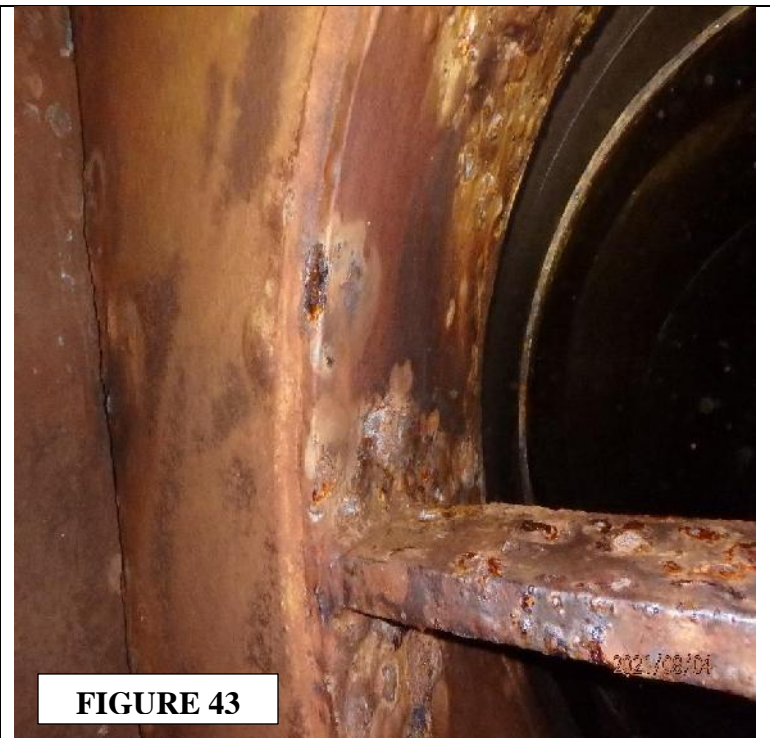
2.5 West Side – South Outlet Box

- The box was generally in good condition with minor coating breakdown and corrosion throughout, especially in corners, as seen in adjacent boxes. As well, a few pits were observed (**Figure 47**)
- Manway heavily corroded (**Figure 42**)
- Butterfly valve disc coating failure and corrosion noted (**Figures 45-46**)
- Anodes – breakdown of door anode noted, internal anode found to be satisfactory (**Figure 42**)
- No corrosion of tubesheet was observed
- Minor corrosion noted in discharge piping
- Corrosion and blistering noted at inlet to discharge piping (**Figures 43-44**)

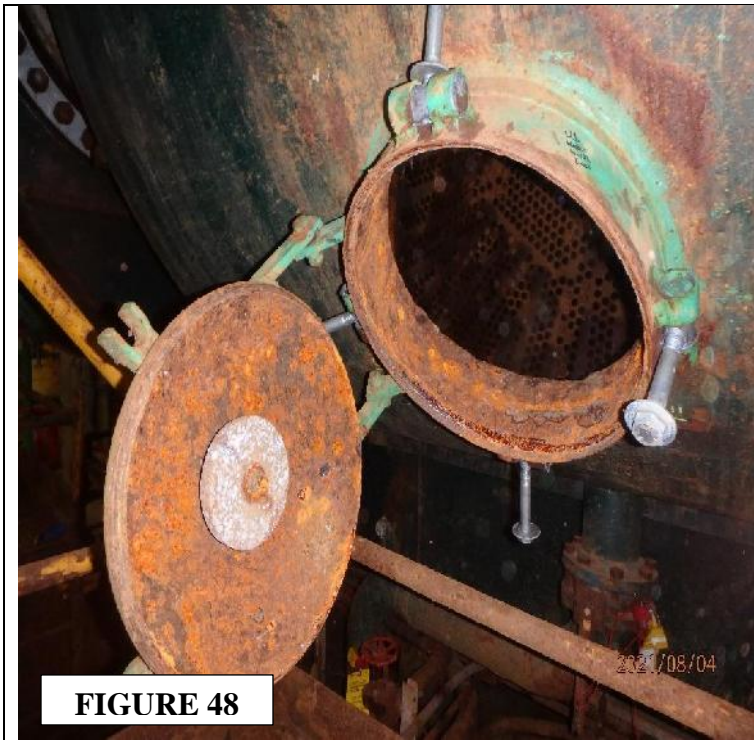
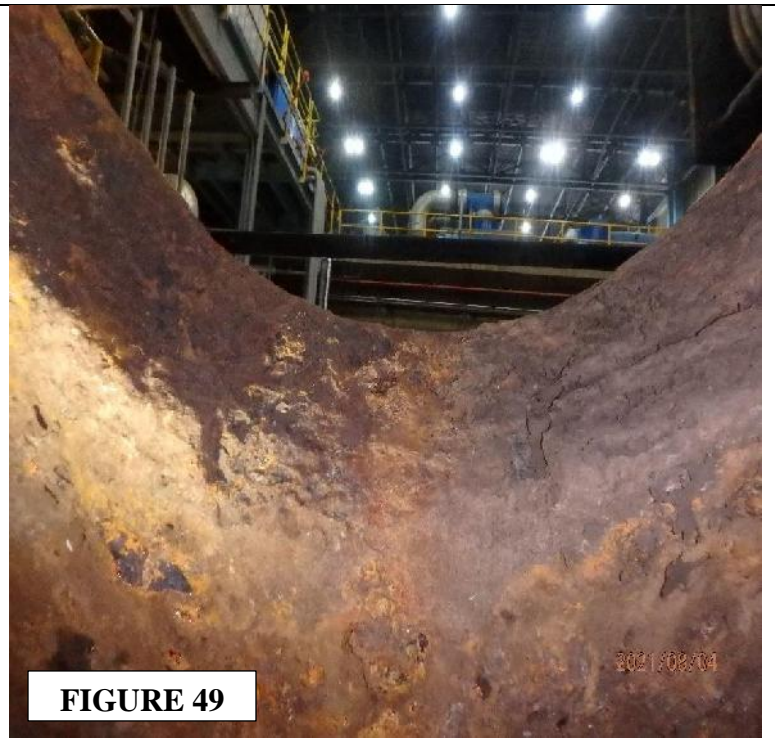
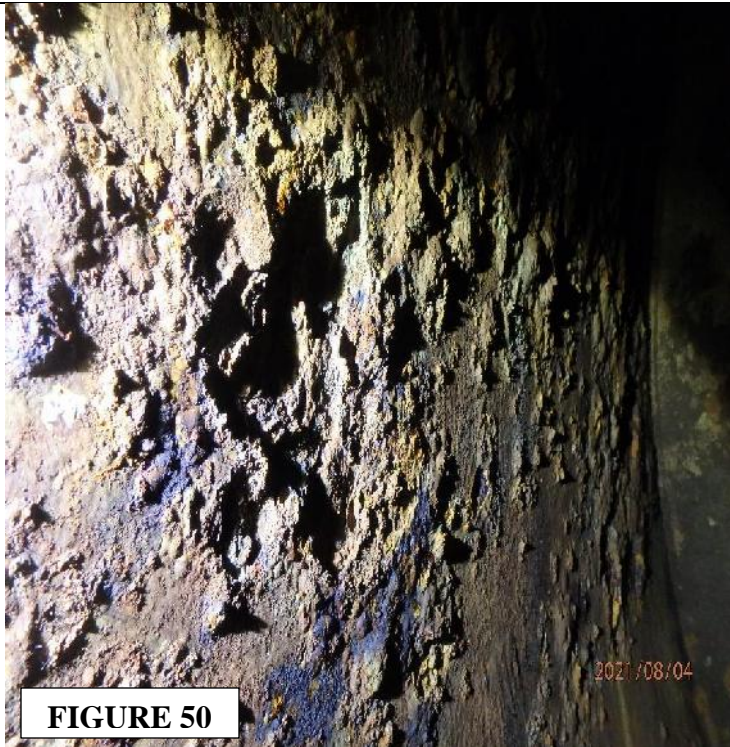
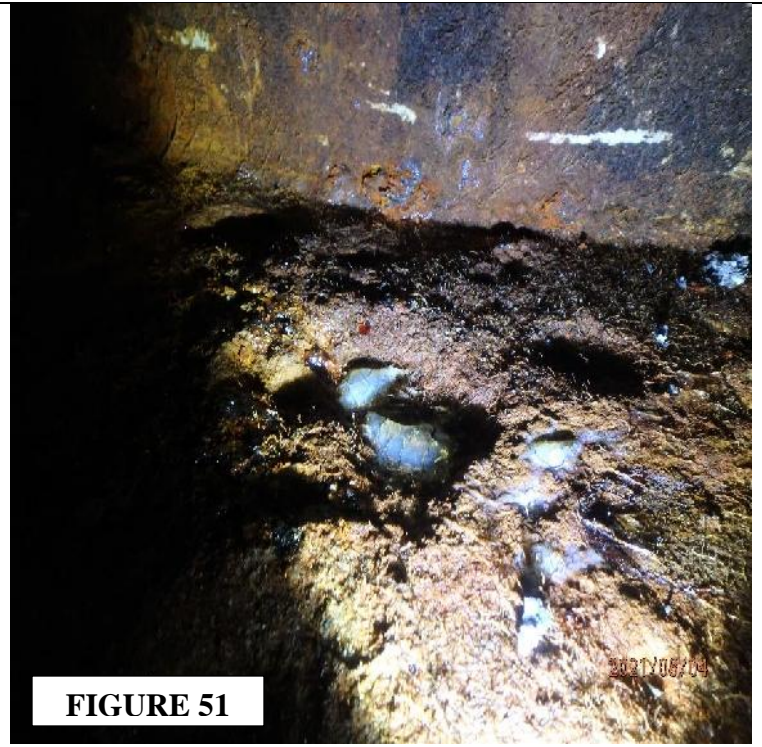
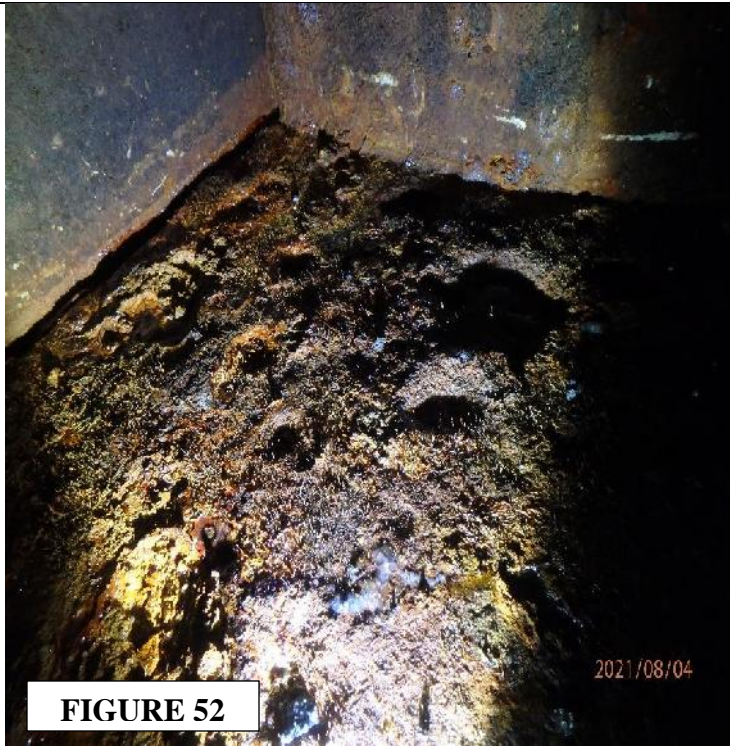
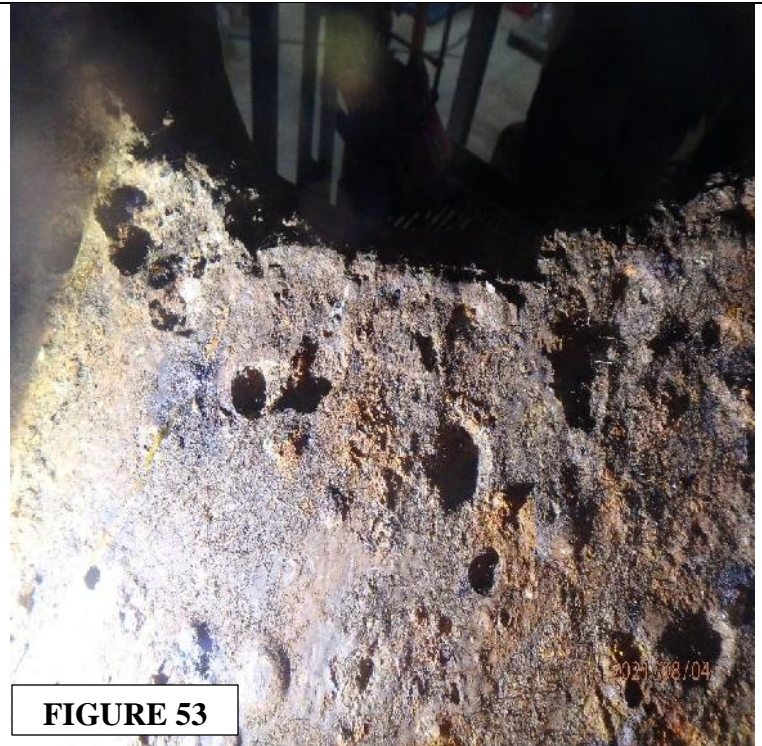
2.6 East Side – North Box

- The box was in poor condition with extensive coating breakdown and heavy corrosion throughout (**Figure 50-53**)
- Manways heavily corroded (**Figures 48-49**)
- Butterfly valve disc appeared to be in satisfactory condition
- Anodes in satisfactory condition
- No corrosion of tubesheet was observed
- Drain noted as being in good condition

- Continue with inspections and regular maintenance of the water boxes, i.e., tube cleaning, debris removal, replacement of anodes
- Coating repairs should be considered in the West water boxes and due to the excessive pitting noted in the East boxes, these should be further assessed and repaired as necessary

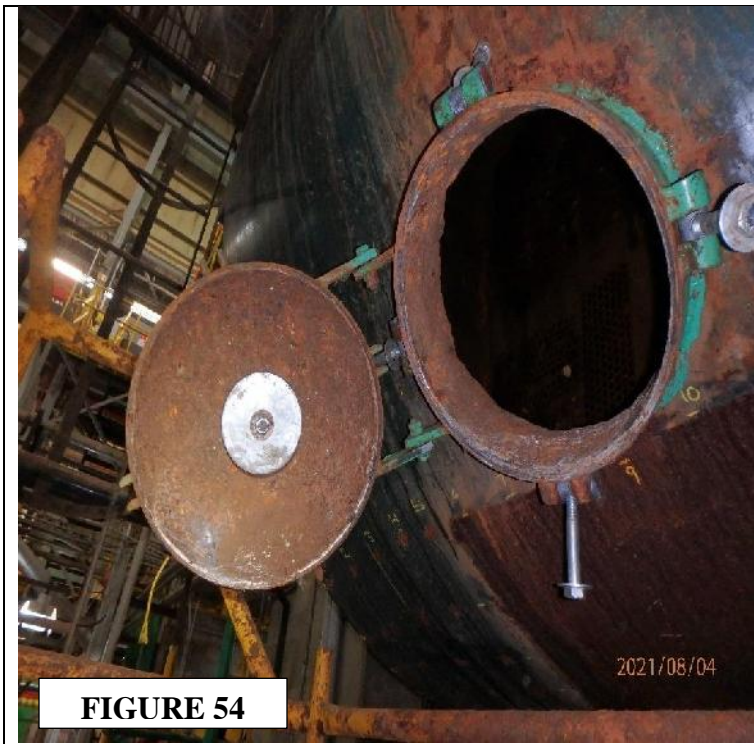
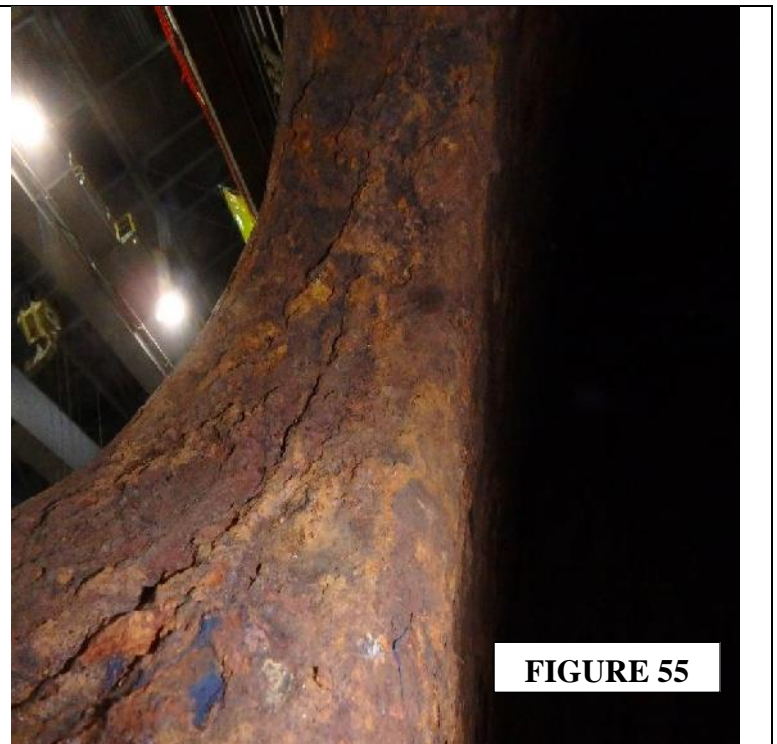
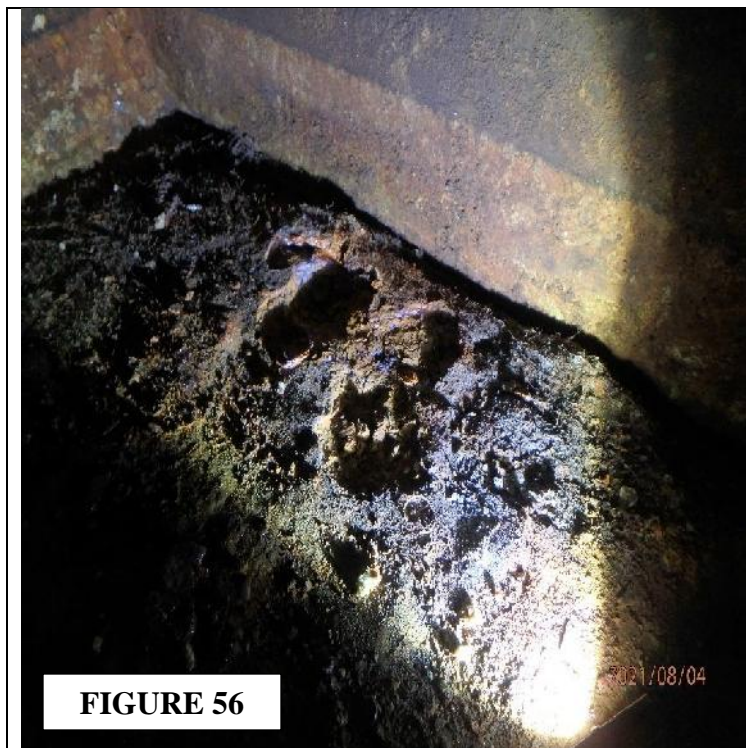
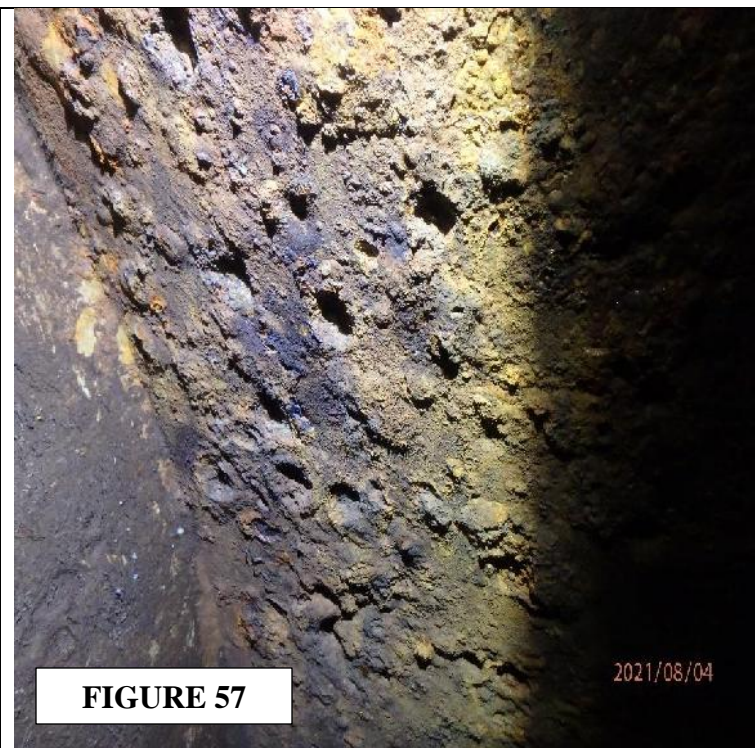
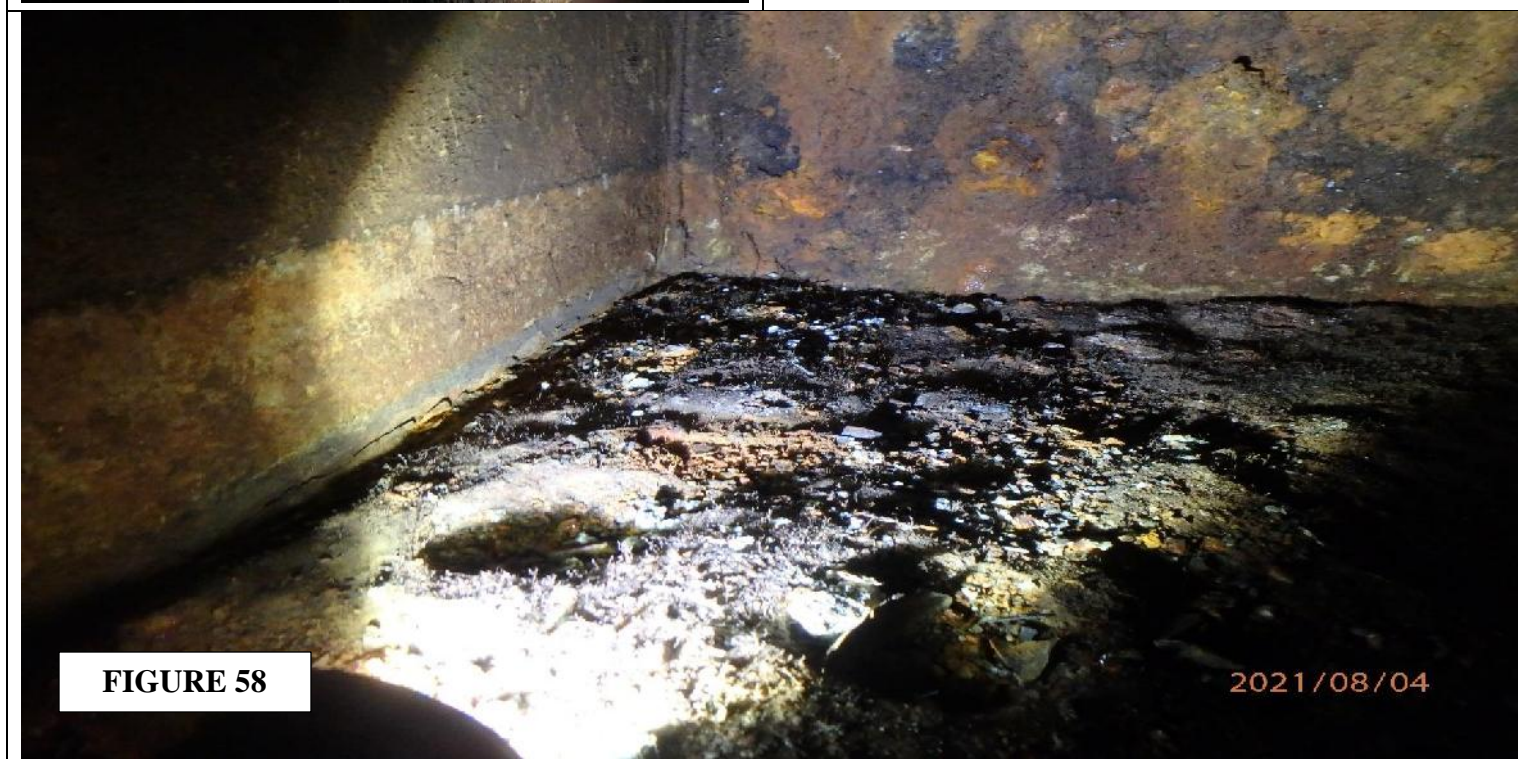
2.7 East Side – South Box

- The box was in poor condition with extensive coating breakdown and heavy corrosion throughout (**Figures 56-58**)
- Manways heavily corroded (**Figures 54, 55**)
- Butterfly valve appeared to be in satisfactory condition
- Anodes in satisfactory condition, 2 replaced (one inside and one on door)
- No corrosion of tubesheet was observed
- Drain noted as being in good condition
