Re: *Reliability and Resource Adequacy Study Review - Assessment to Determine the Potential Long-Term Viability of the Holyrood Thermal Generating Station*

Holyrood Thermal Generating Station Condition Assessment

**Newfoundland and Labrador Hydro
HTGS Condition Assessment and Life Extension Study
Executive Summary**

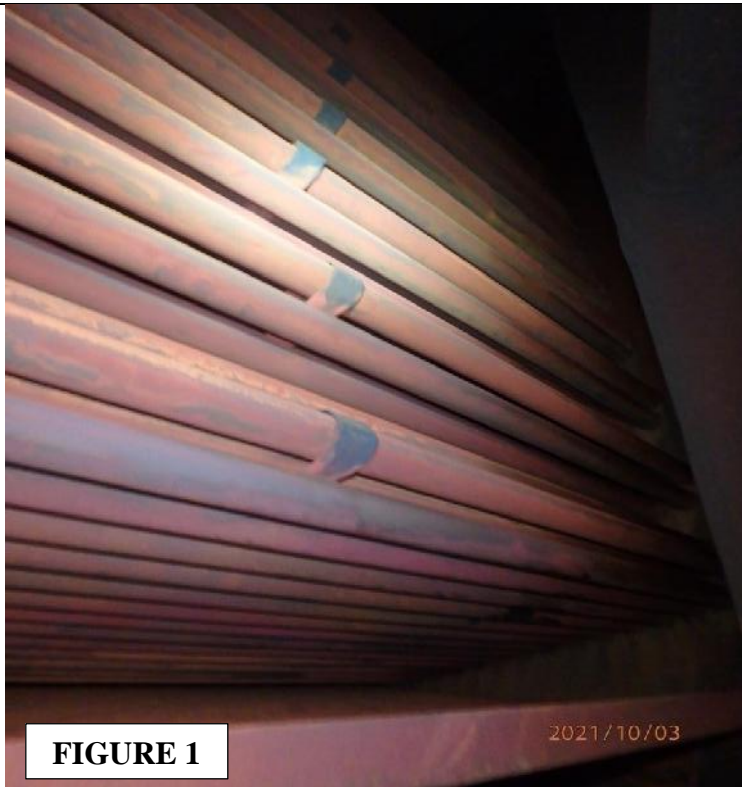
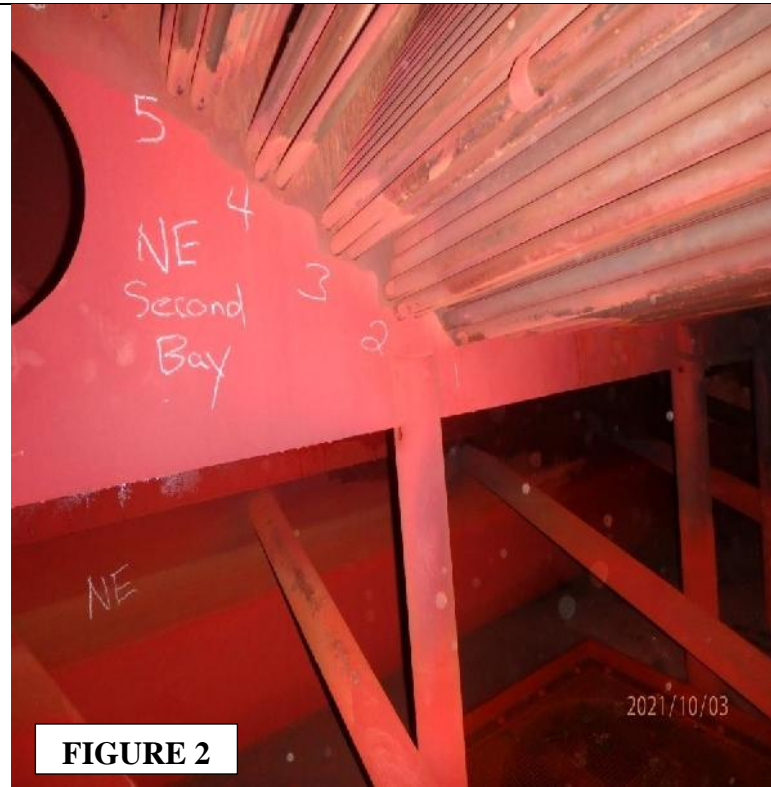
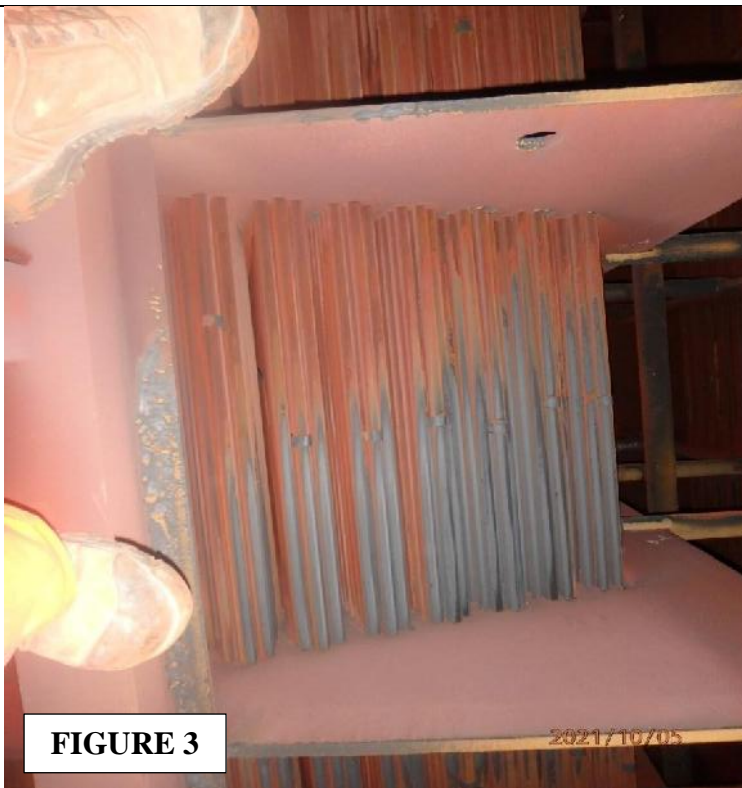
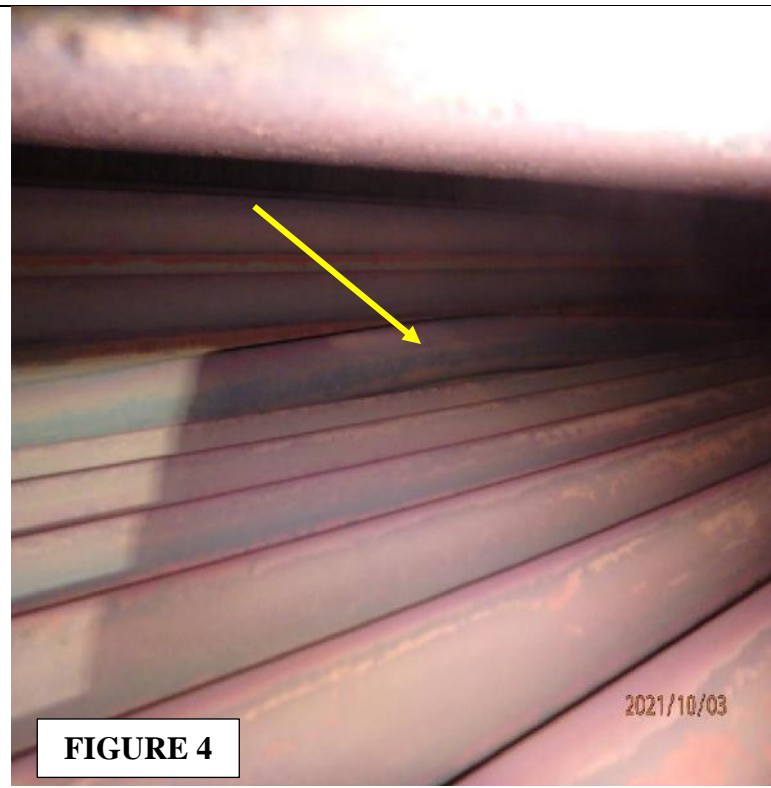
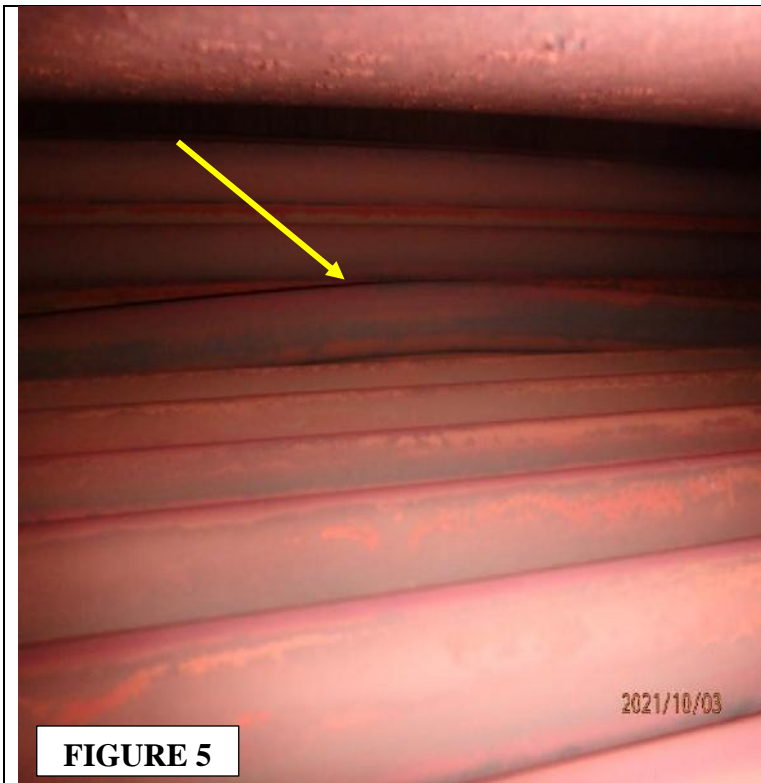
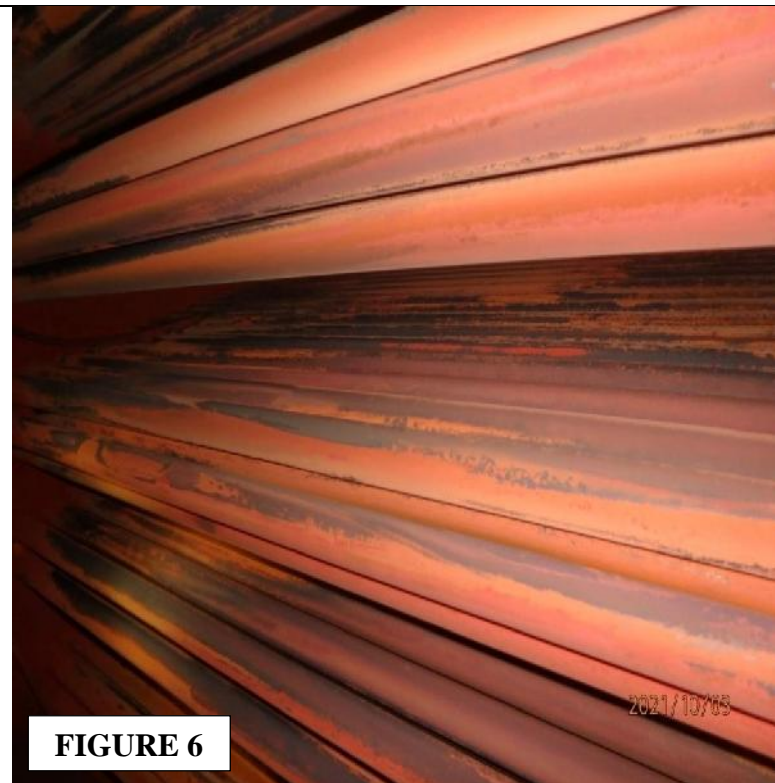
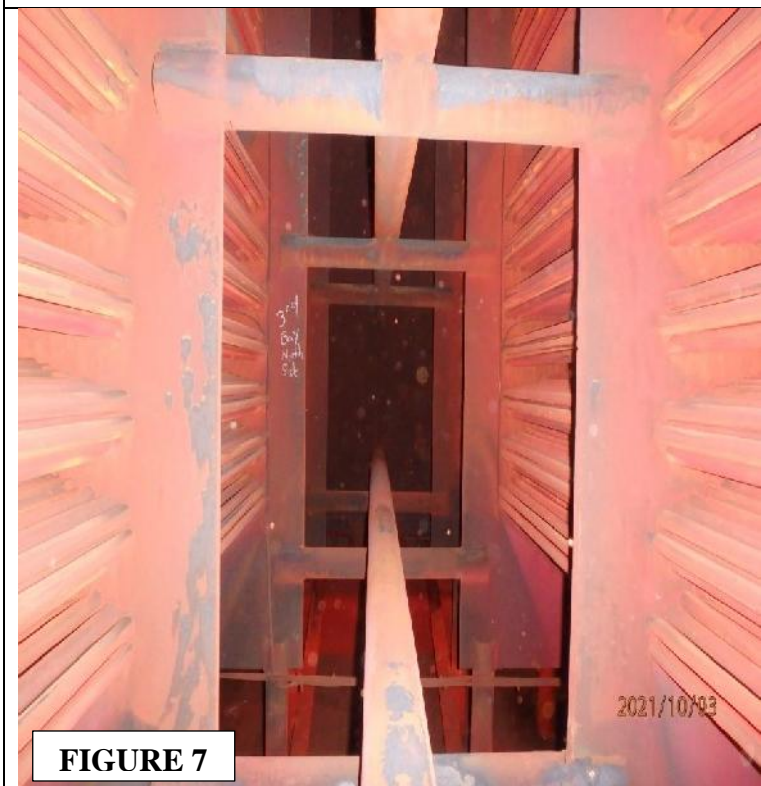
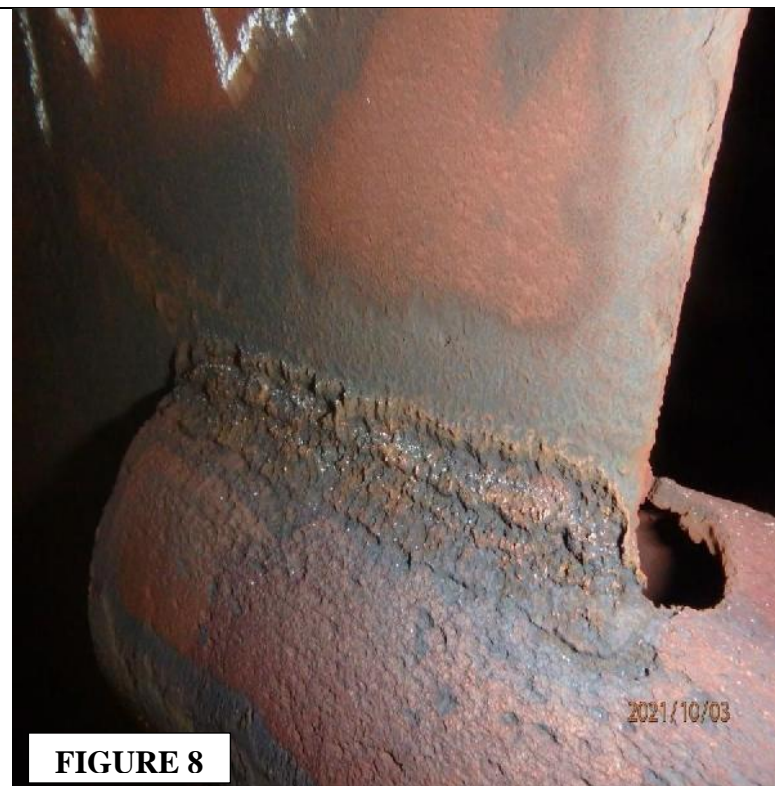
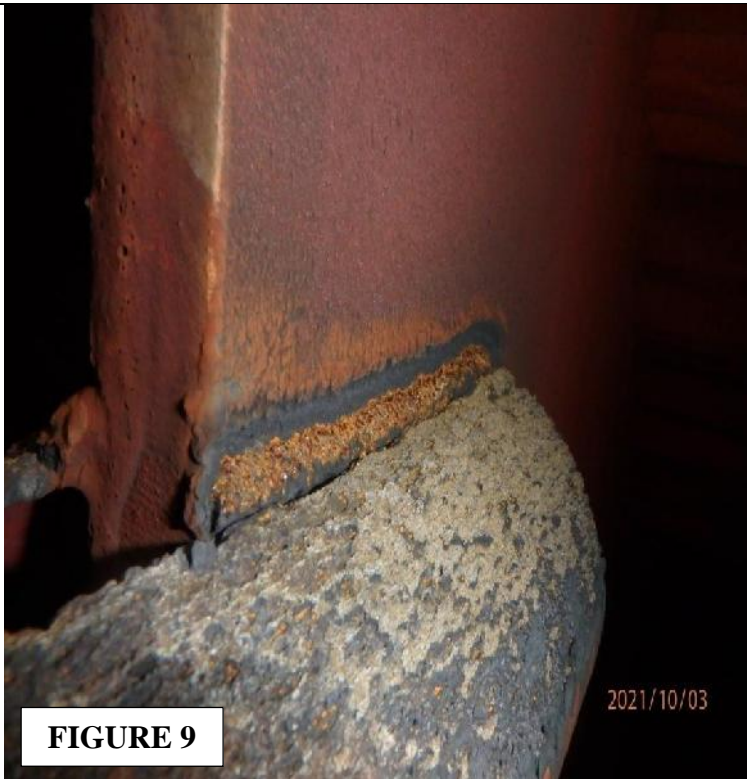
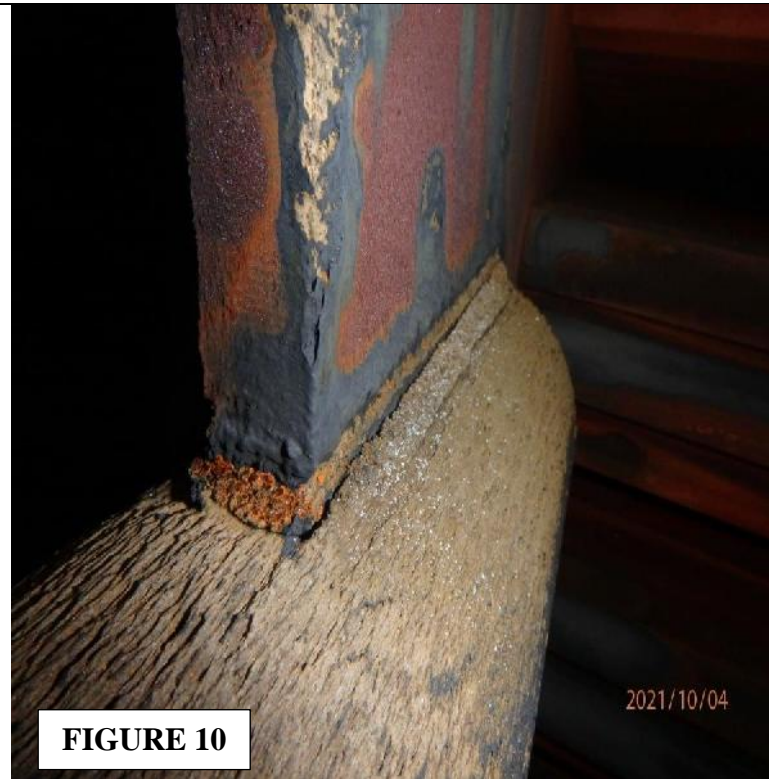
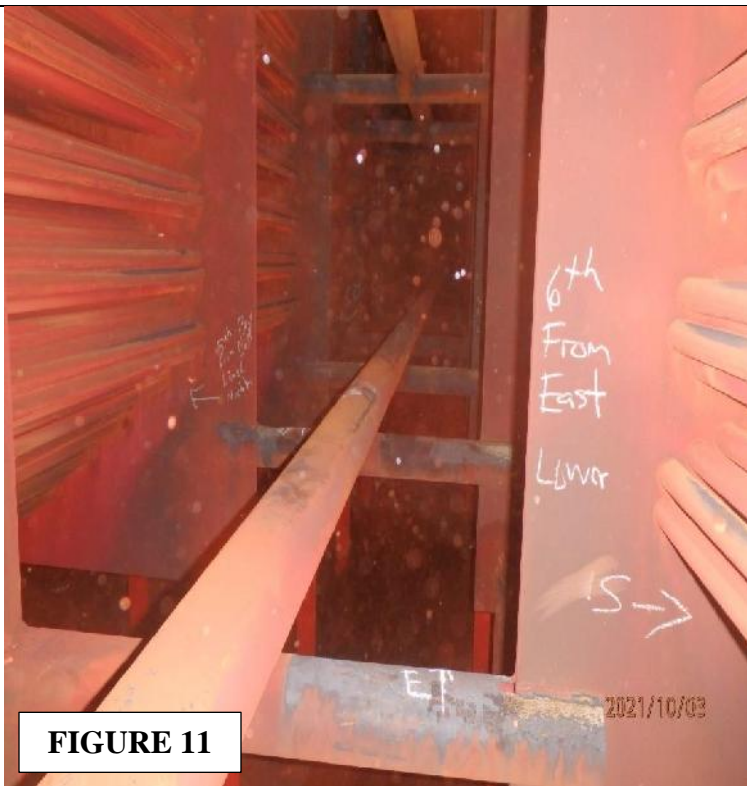
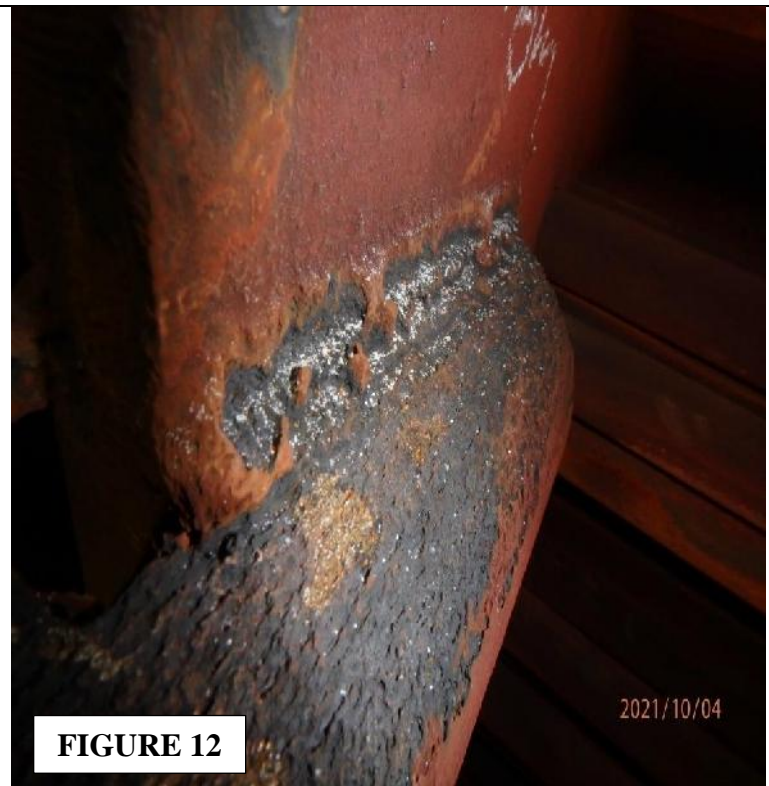
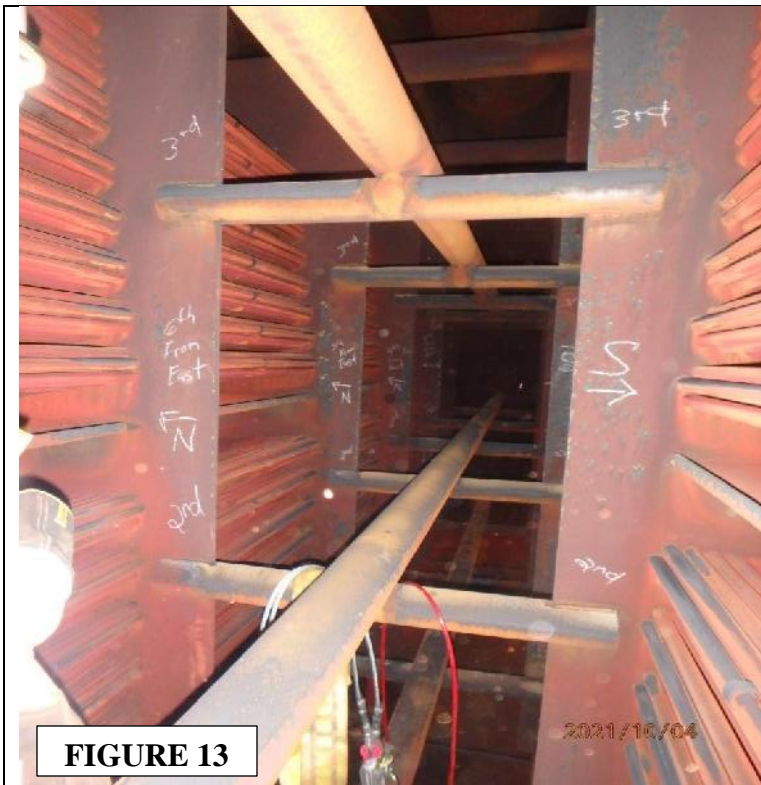
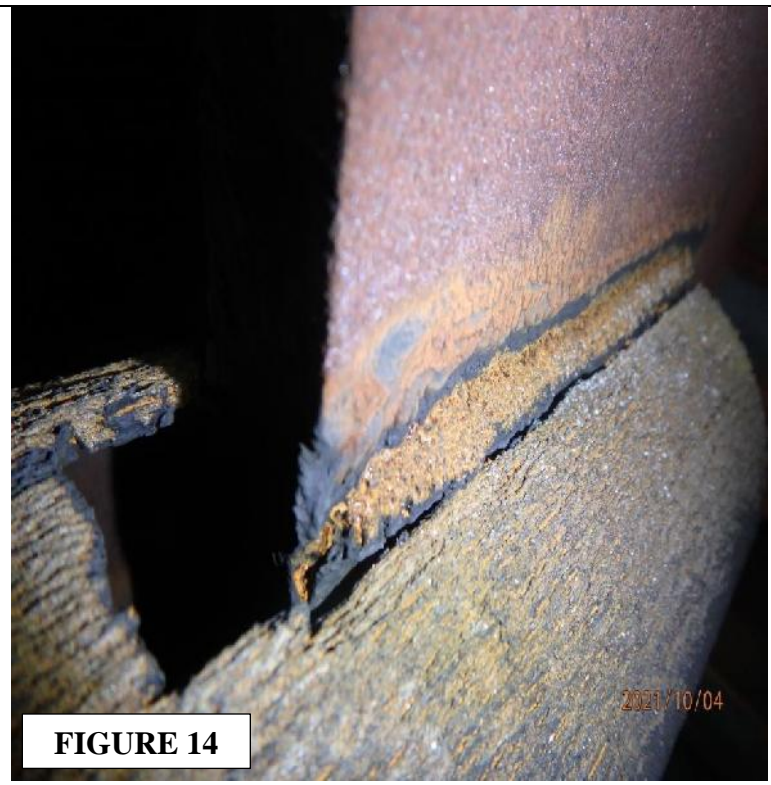
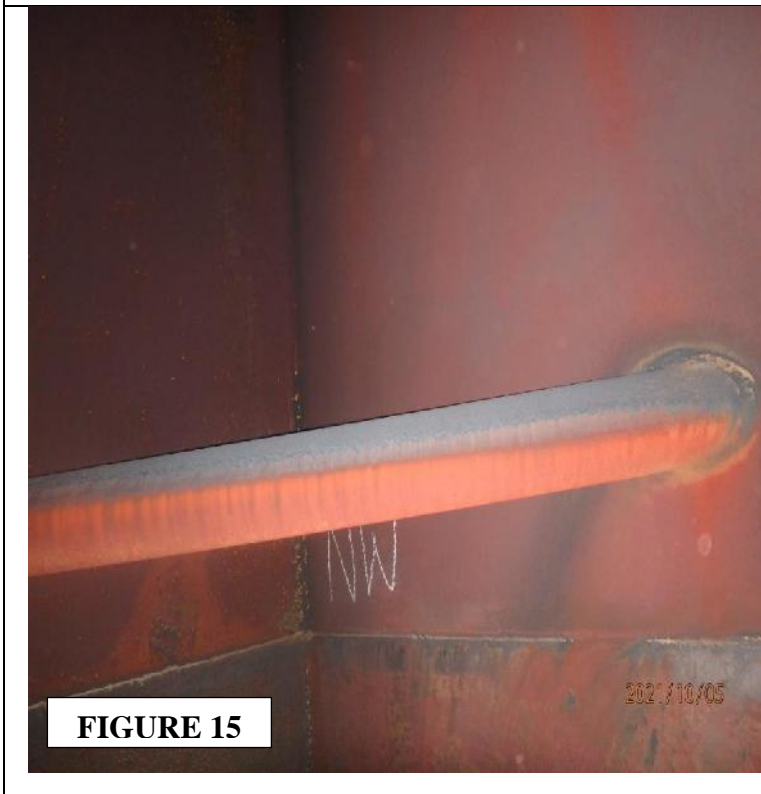
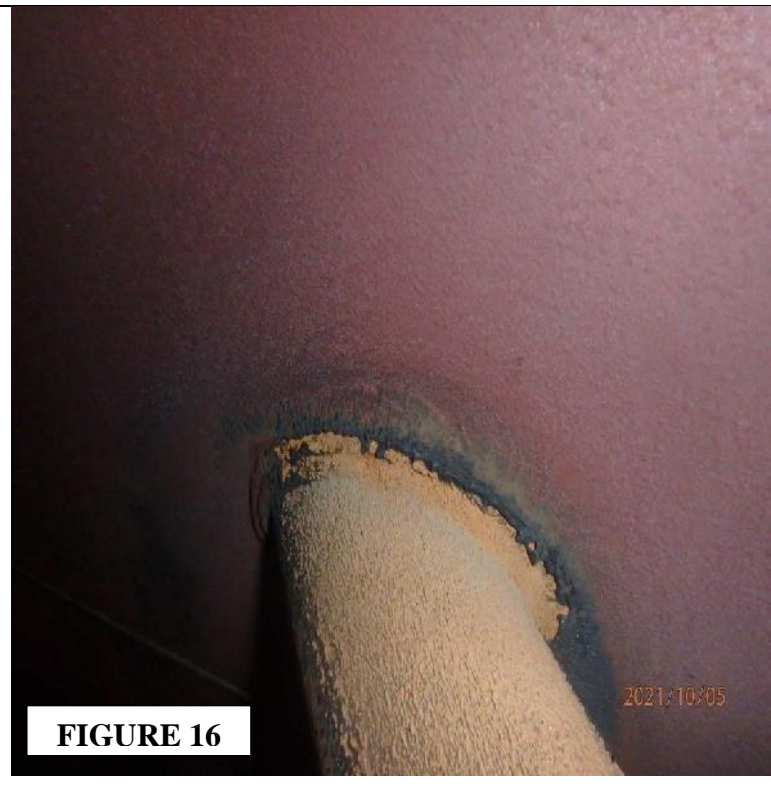
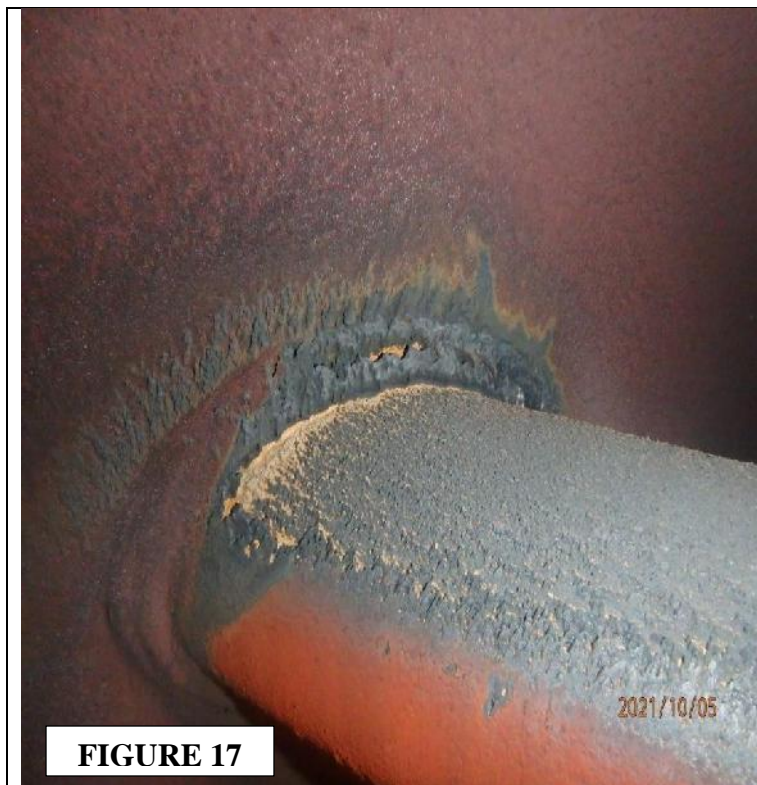
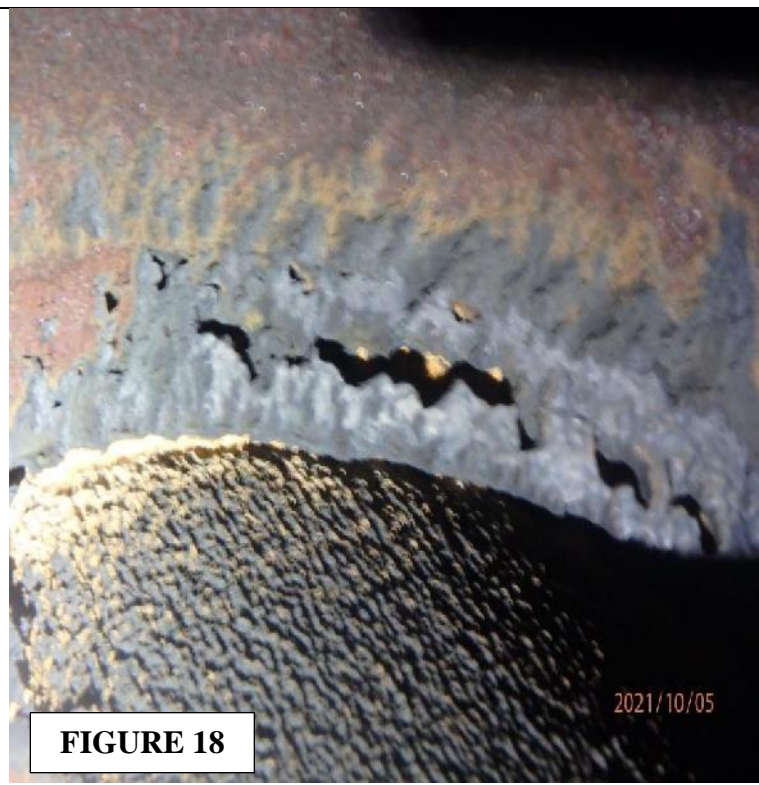
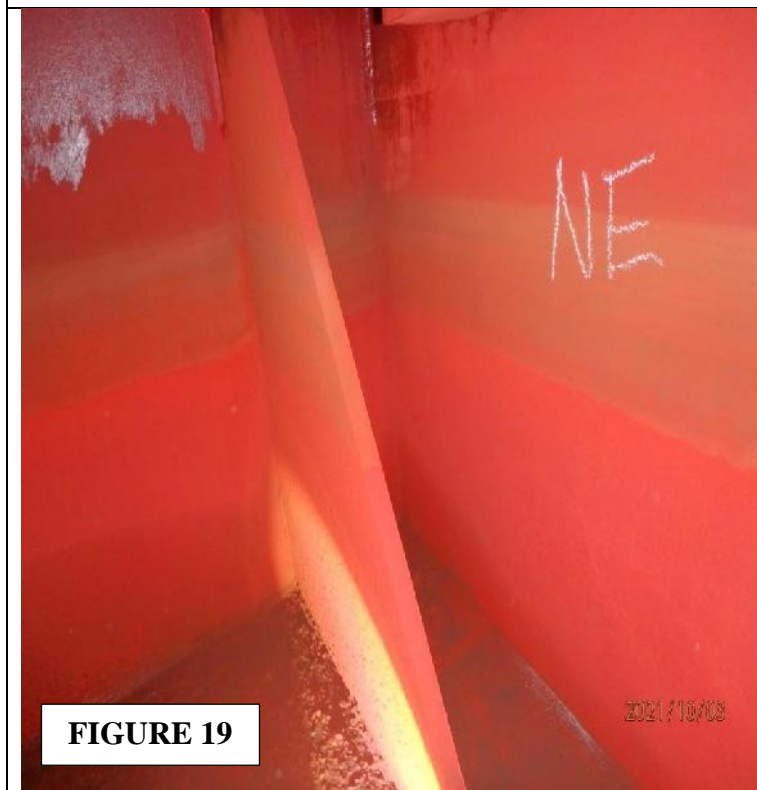
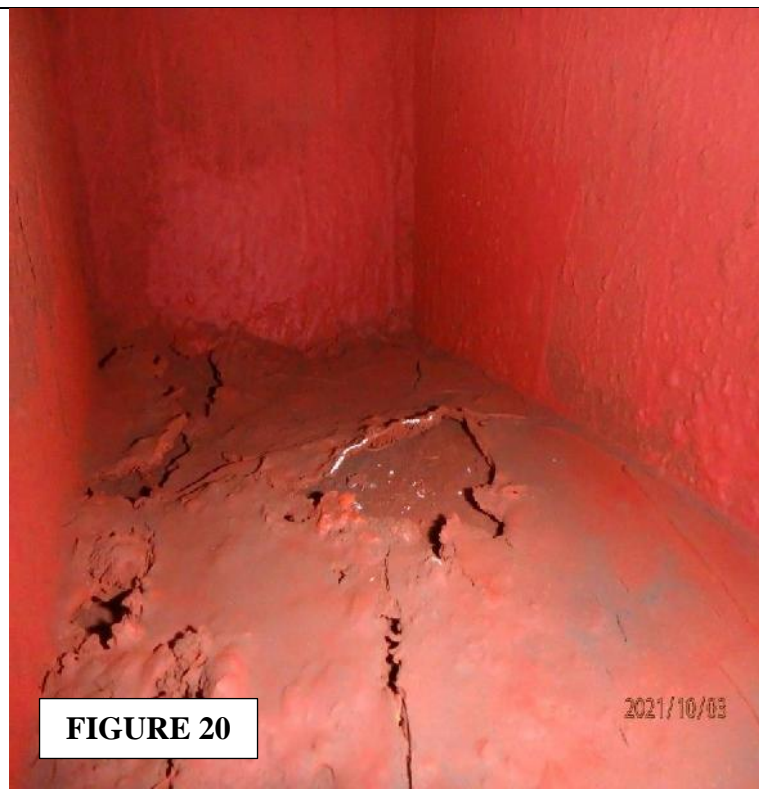
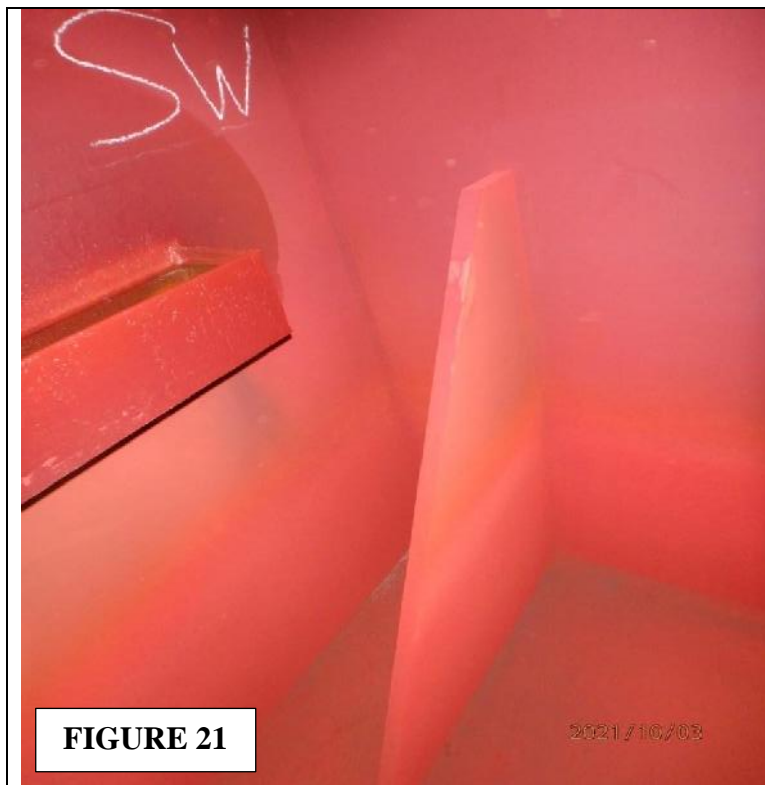
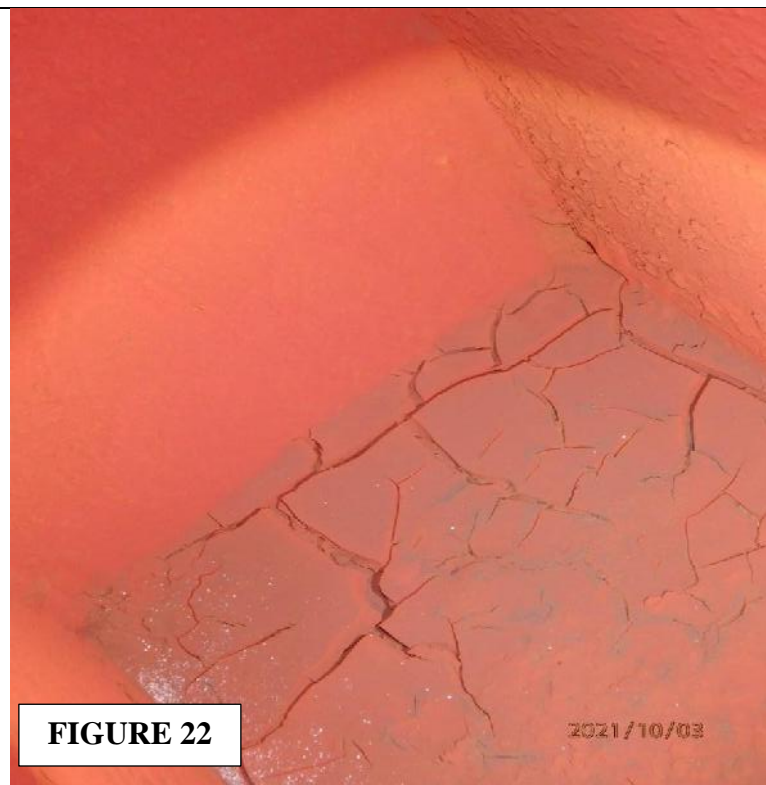
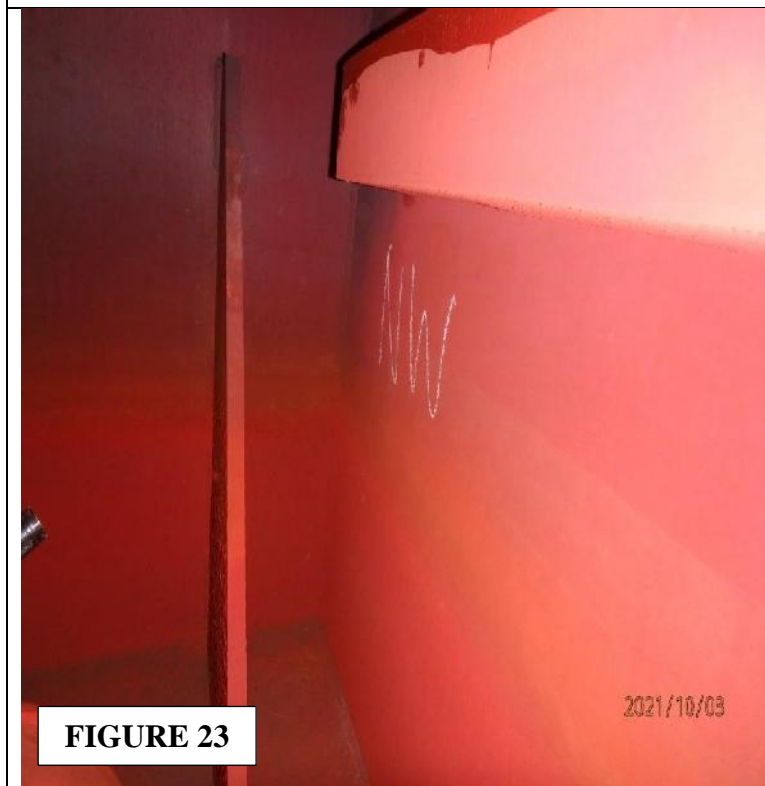
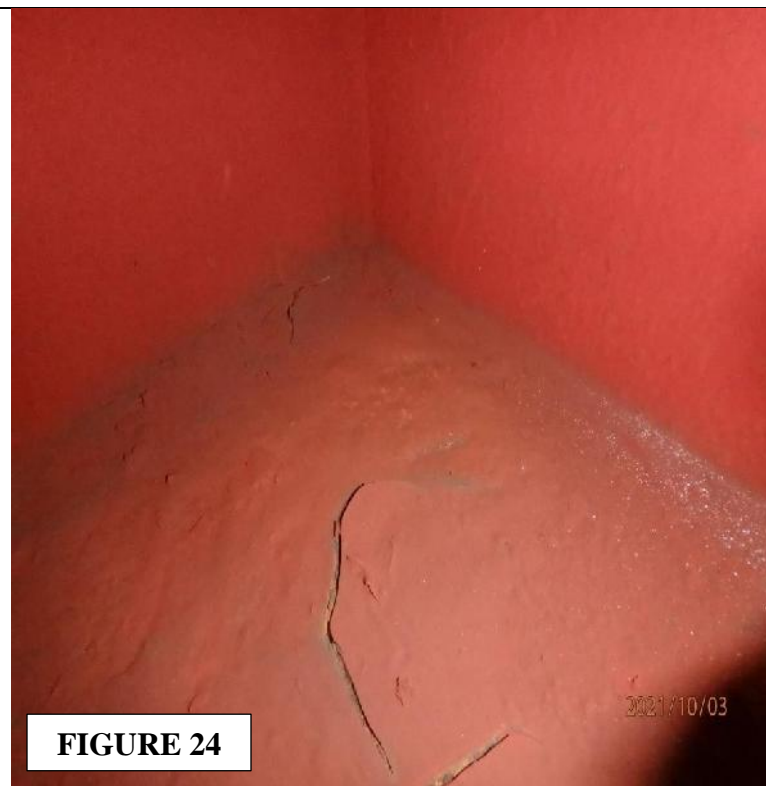
- Tube Bundles – Overall, the tube bundles appeared to be in good condition. Minor polishing and steam erosion was noted on the tubes, as well as, bowing of isolated tubes (**Figures 1–6**).

- Structural Supports – Broken/eroded welds were noted on the bundle supports on cross braces that extend horizontally between the tube support plates of the two bundles. These were noted in previous inspections as not being a significant finding since the braces are welded on both sides, as well as, top and bottom. The bottom welds were found to be satisfactory (**Figures 7–14**). Erosion was also observed on additional supports throughout the cavity (**Figures 15–18**).

- Hot Well Floor – Break down of floor coating was noted in Northeast, Northwest & Southwest corners (**Figures 19–24**).
- Expansion Joints
 - Extraction Piping – Erosion shields covering extraction piping bellows expansion joints appeared to be in satisfactory condition from point of assessment (**Figures 25–26**).

- Continue with regular inspections to monitor erosion of supports, especially the cross braces that extend horizontally between the tube support plate of the two tube bundles.
- Repair extraction piping expansion joint coverings. Monitor the corrosion of the shell expansion joint covering and erosion of the attachment welds.

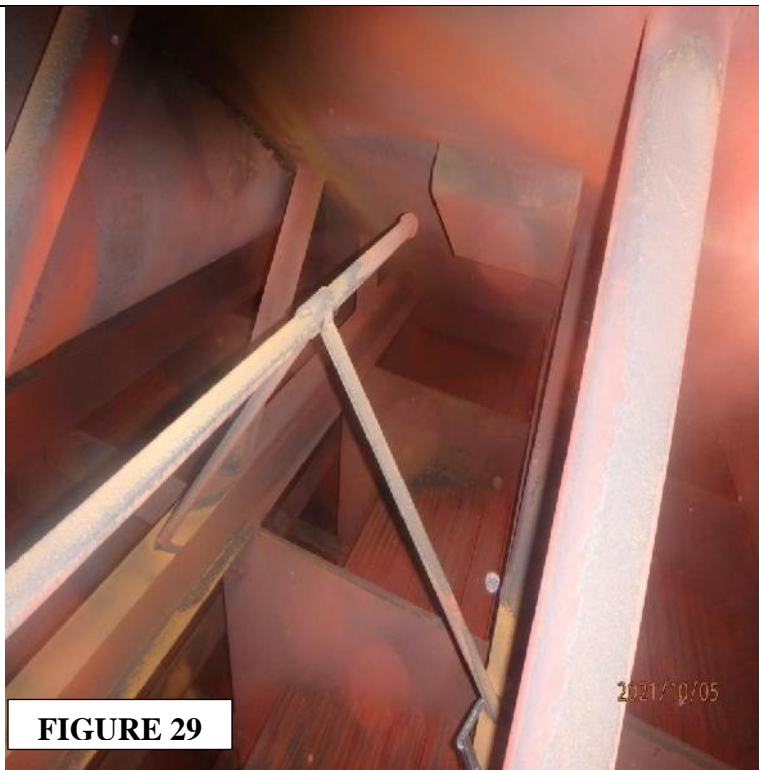
FIGURE 29

- The box was generally in good condition with minor coating breakdown and corrosion throughout, especially in corners, however, a few deep pits were observed (**Figures 28, 29, 31-33**)
- Corrosion noted in drain pipe (**Figure 30**)
- Anodes in satisfactory condition
- No corrosion of tubesheet was observed
- Inspection of inlet piping not obtainable as valve was in closed position

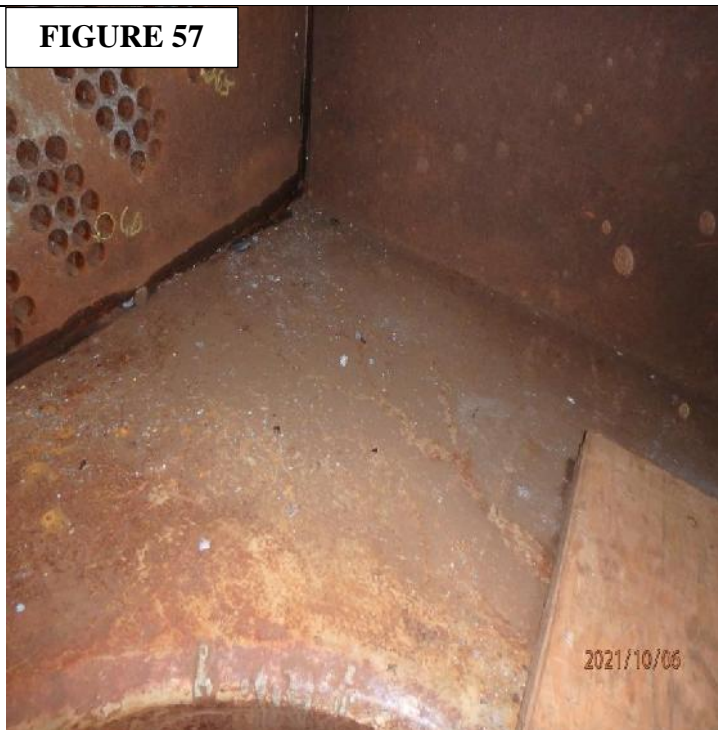
FIGURE 57

- The box was generally in good condition with minor coating breakdown and corrosion throughout (**Figures 52-59**)
- Corrosion noted in drain pipe (**Figure 60**)
- Door anode requires replacement, others in satisfactory condition (**Figure 51**)
- No corrosion of tubesheet was observed
- Inspection of inlet piping not obtainable as valve was in closed position

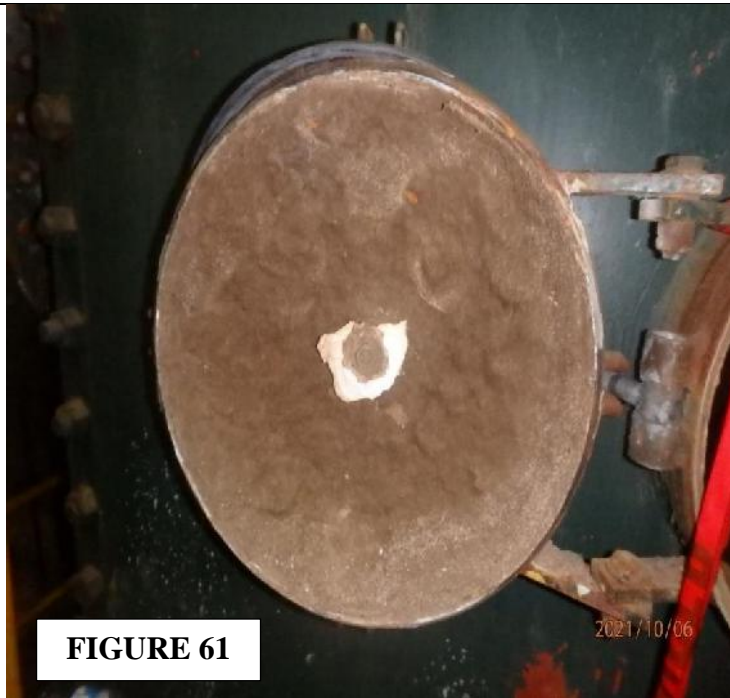
FIGURE 61

- The box was generally in good condition with minor coating breakdown and corrosion throughout, especially in corners, as seen in adjacent boxes. As well, a few larger pits were observed (**Figures 64, 66, 69, 70**)
- Manway door appeared to be heavily corroded, however would require additional cleaning for further assessment (**Figure 61**)
- Butterfly valve disc coating noted as being satisfactory (**Figure 67**)
- Door anode requires replacement, others in satisfactory condition (**Figure 61**)
- No corrosion of tubesheet was observed (**Figures 62, 68**)
- Minor corrosion noted in discharge piping (**Figures 63, 64**)
