Re: *Reliability and Resource Adequacy Study Review - Assessment to Determine the Potential Long-Term Viability of the Holyrood Thermal Generating Station*

Holyrood Thermal Generating Station Condition Assessment

**Newfoundland and Labrador Hydro
HTGS Condition Assessment and Life Extension Study
Executive Summary**

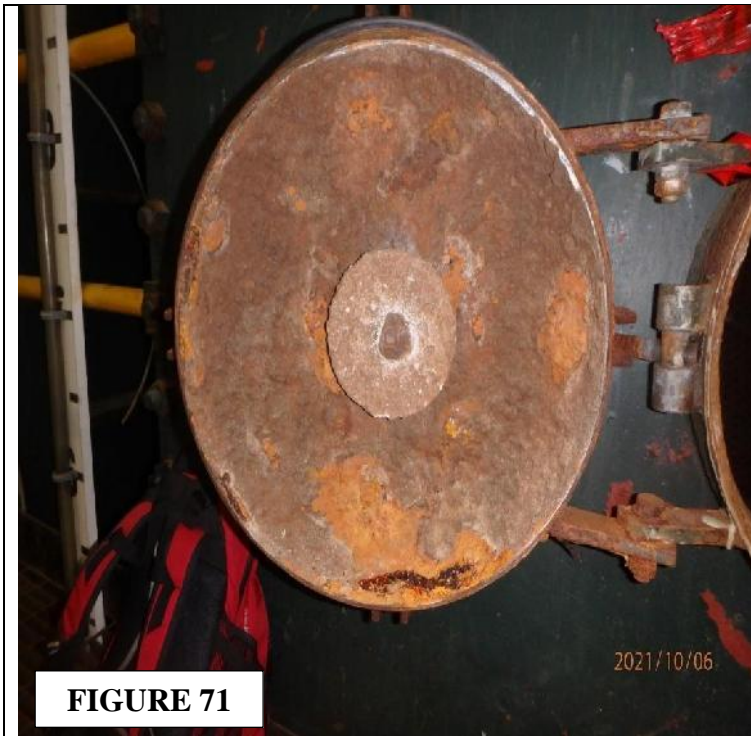
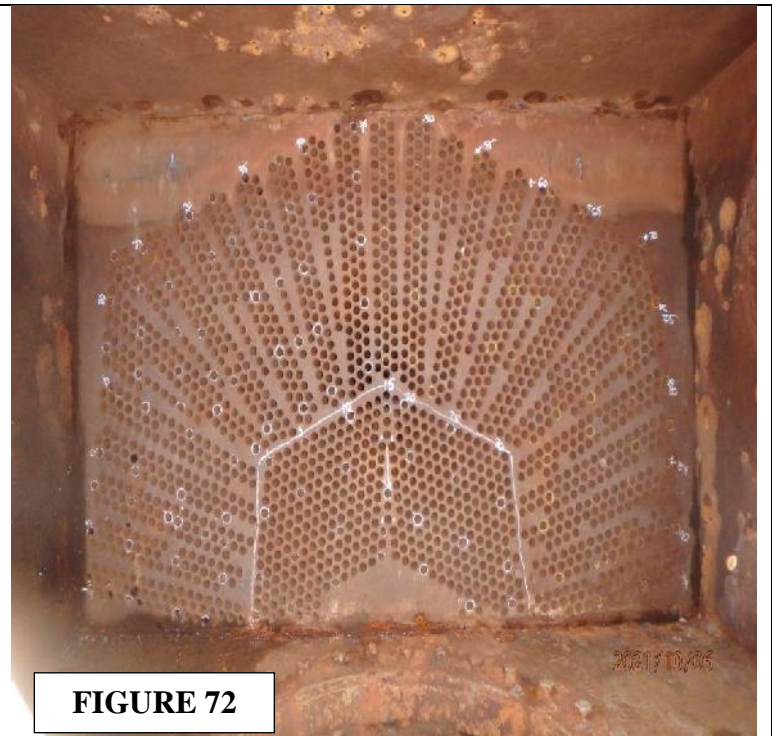
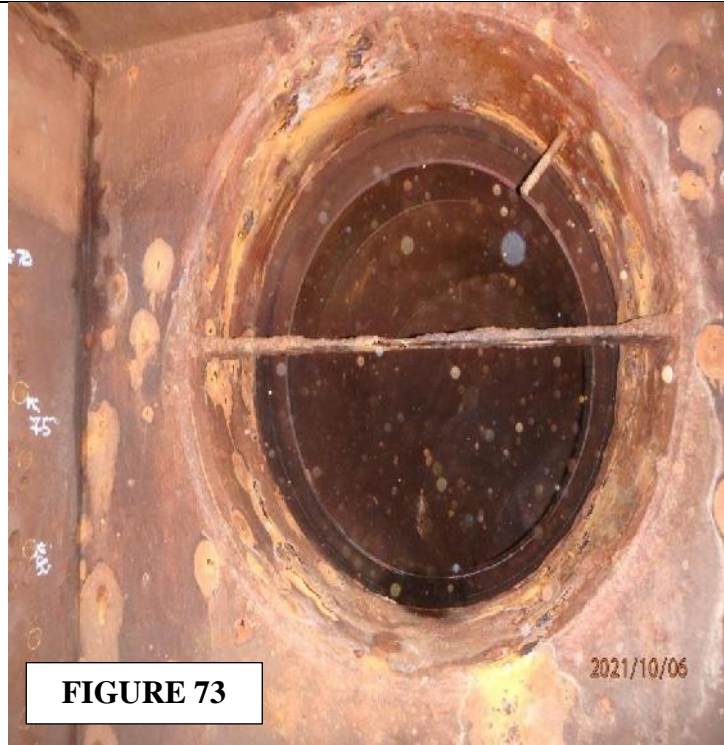
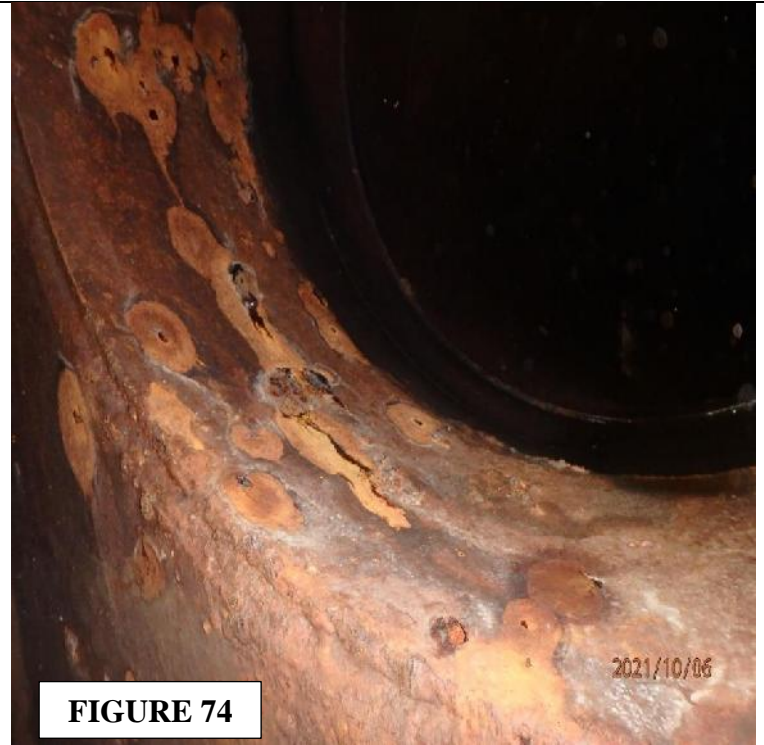
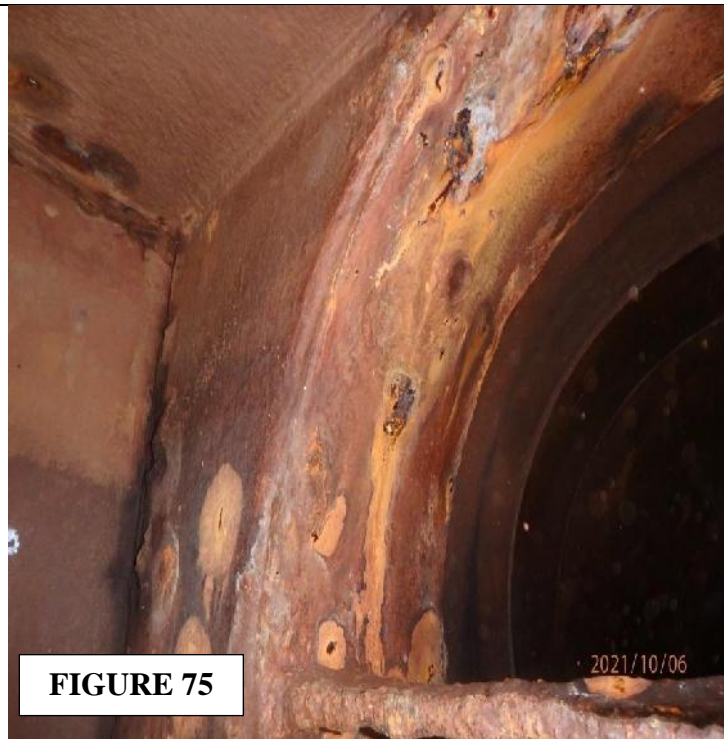
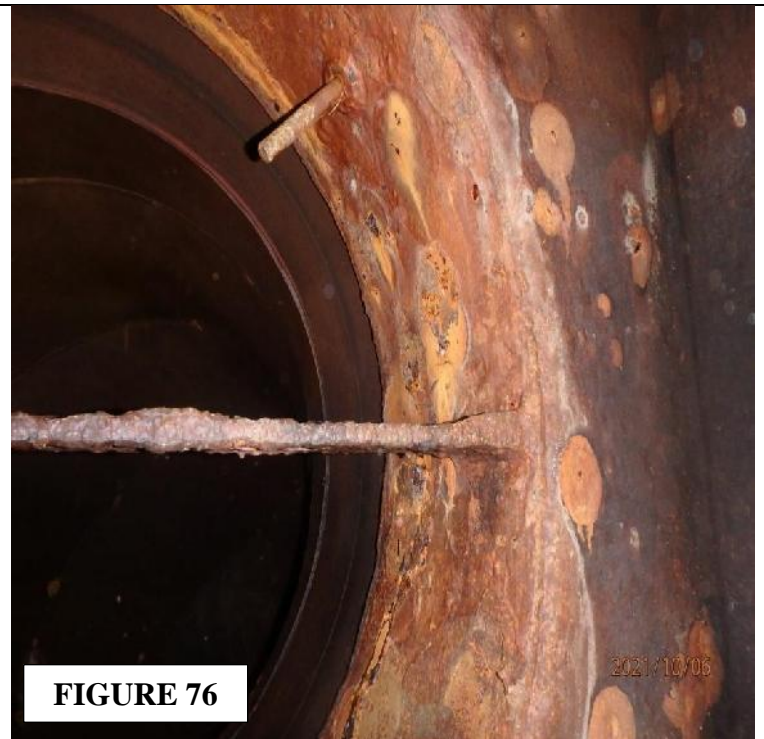
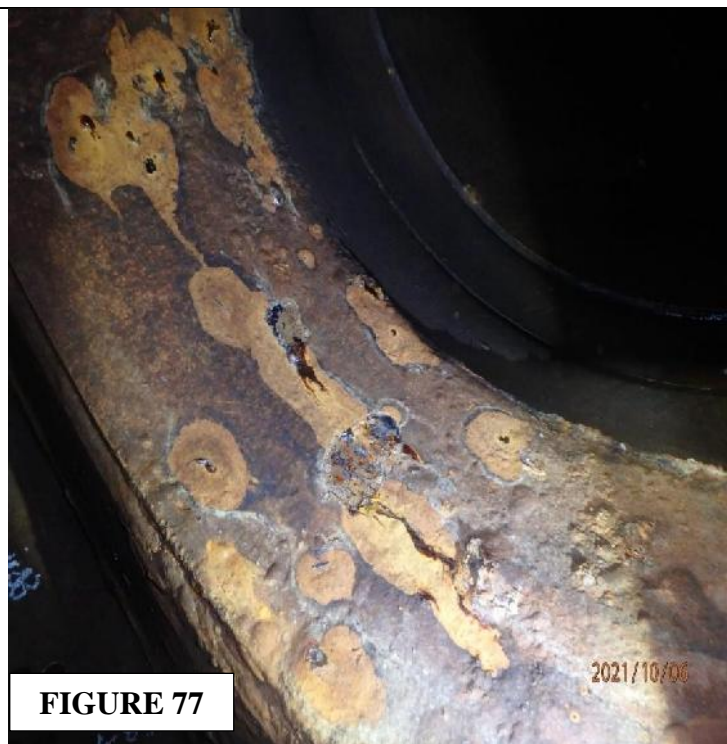
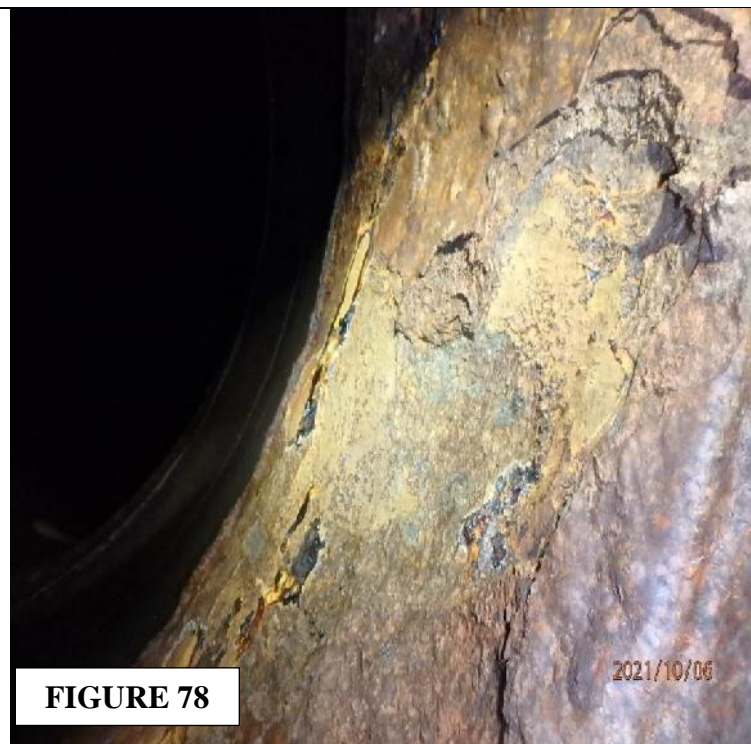
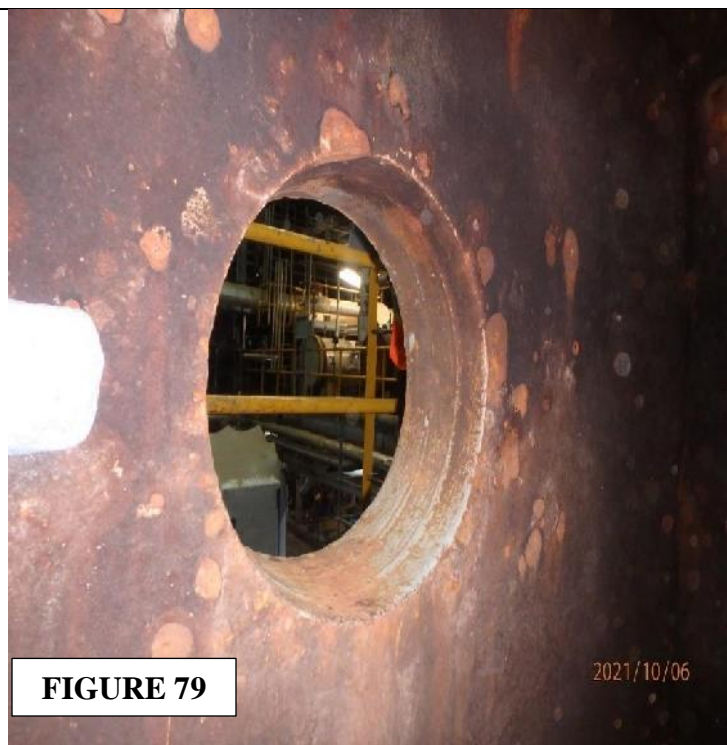
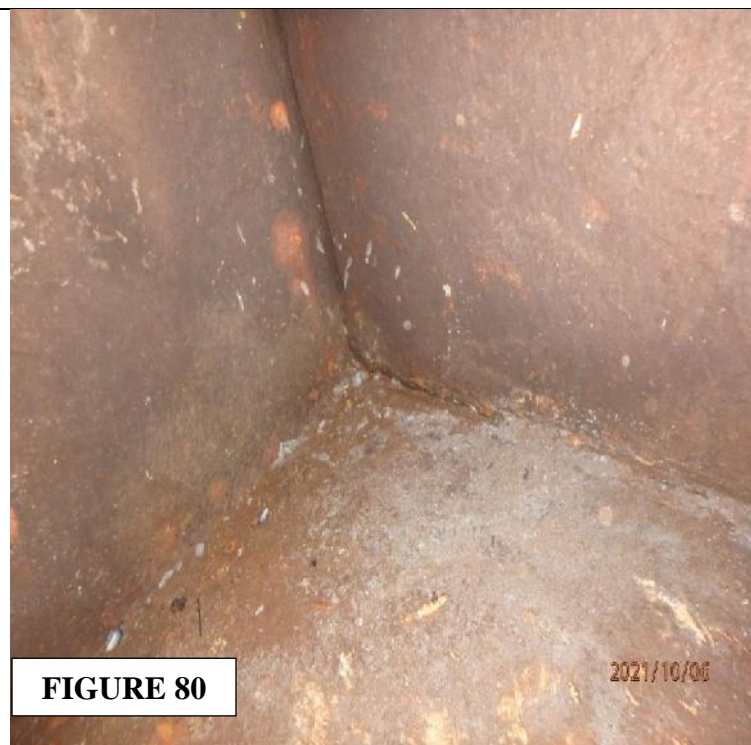
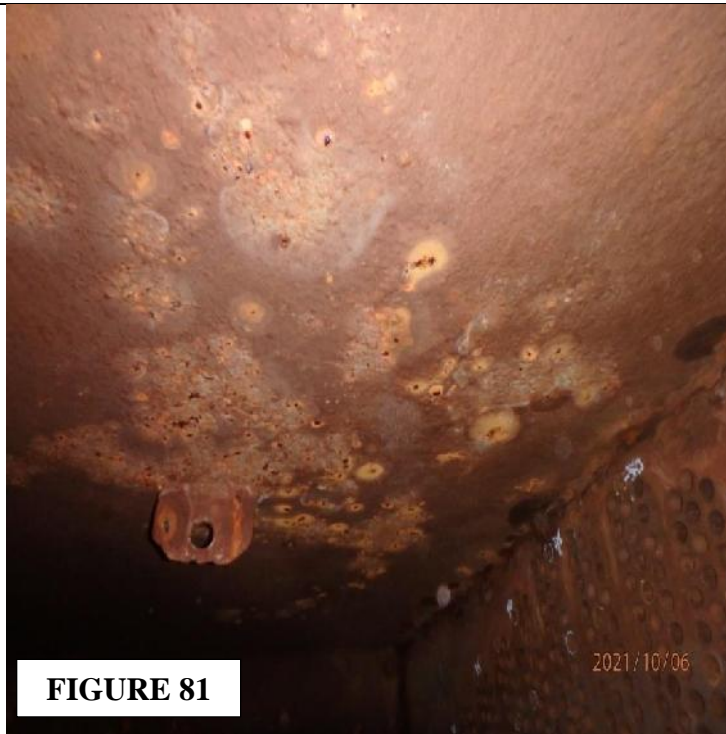
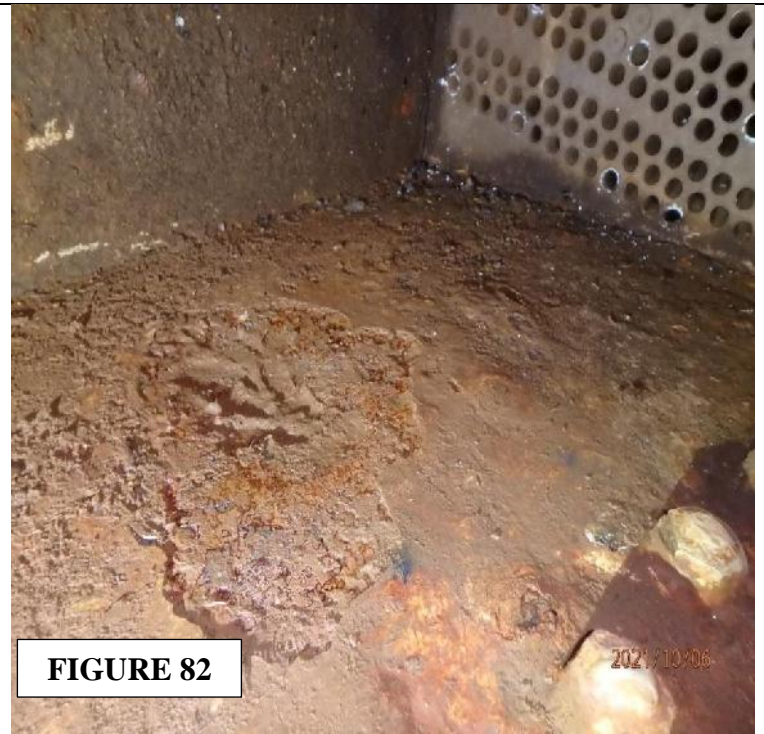
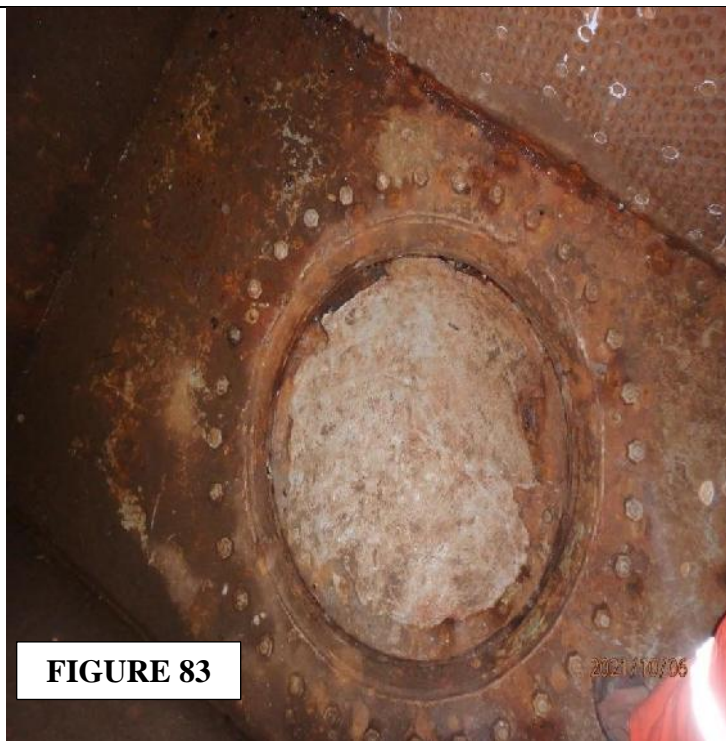
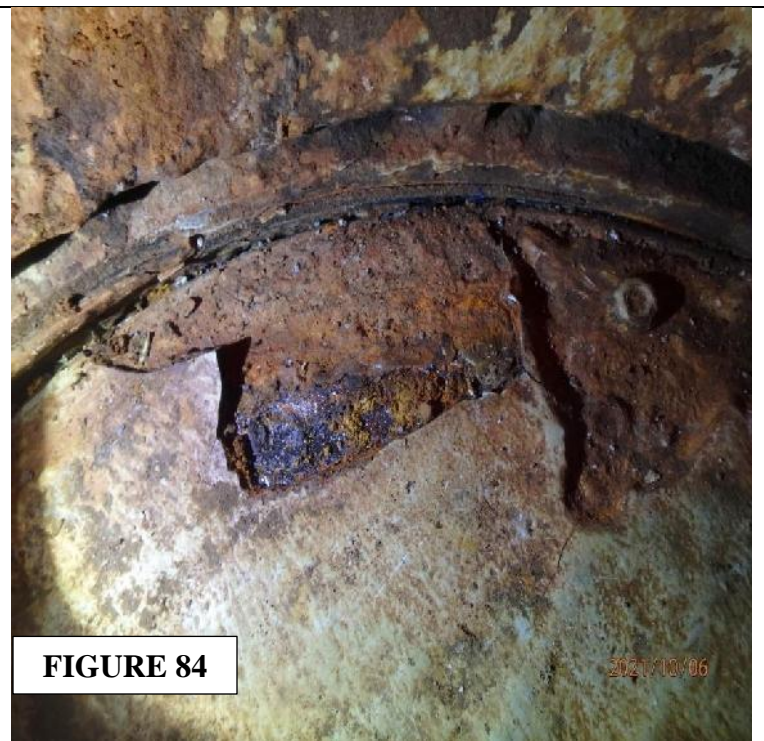
2.5 West Side – South Outlet Box

- The box was generally in good condition with minor coating breakdown and corrosion throughout, especially in corners, as seen in adjacent boxes. As well, a few larger pits were observed (**Figures 72, 79-82**)
- Manway door appeared to be heavily corroded, however would require additional cleaning for further assessment (**Figure 71**)
- Butterfly valve disc coating failure and corrosion noted (**Figures 83, 84**)
- Anodes – breakdown of door anode noted, internal anode found to be satisfactory (**Figure 71**)
- No corrosion of tubesheet was observed
- Corrosion and blistering noted at inlet to discharge piping (**Figures 73-78**)

- Continue with inspections and regular maintenance of the water boxes, i.e., tube cleaning, debris removal, replacement of anodes
- Coating, plate and drain repairs should be considered in the near future, where necessary

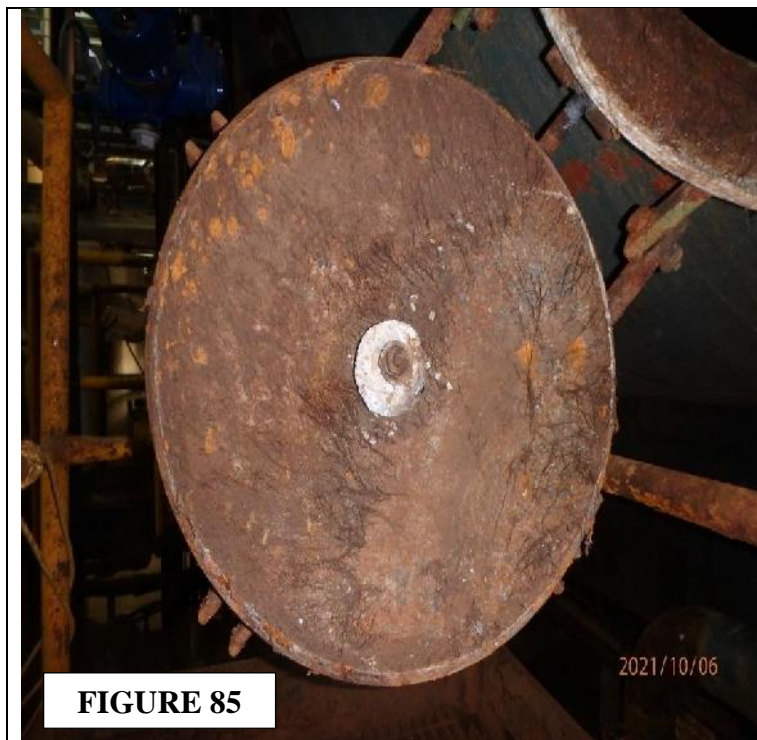
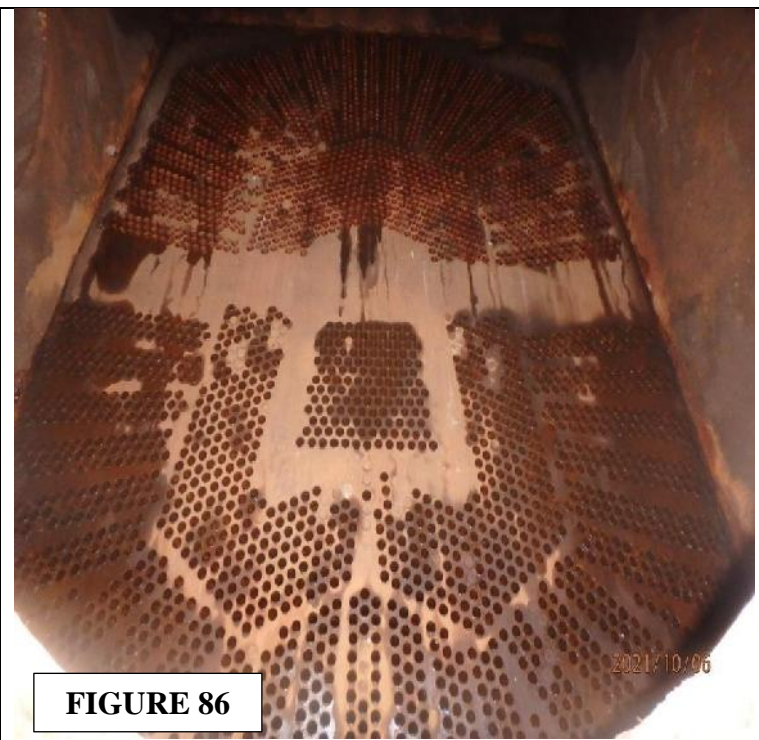
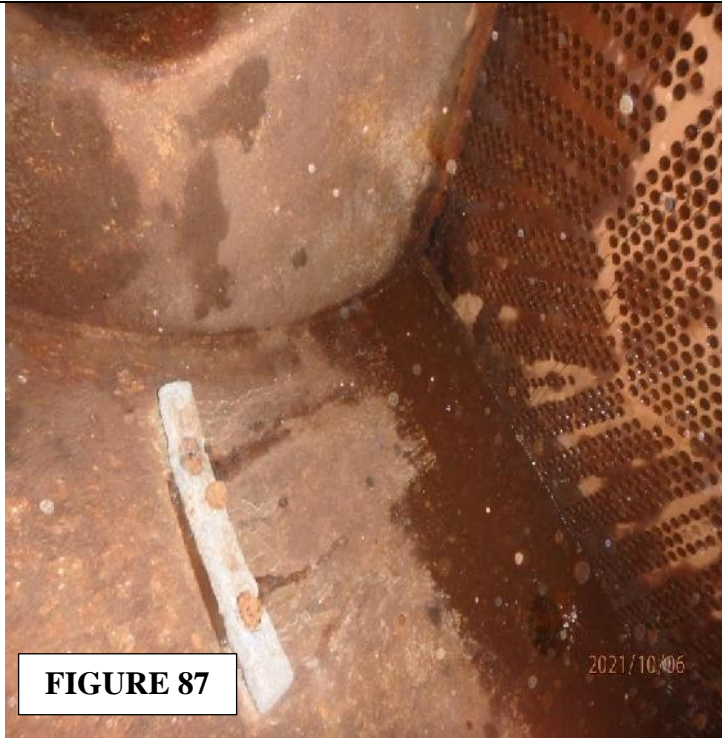
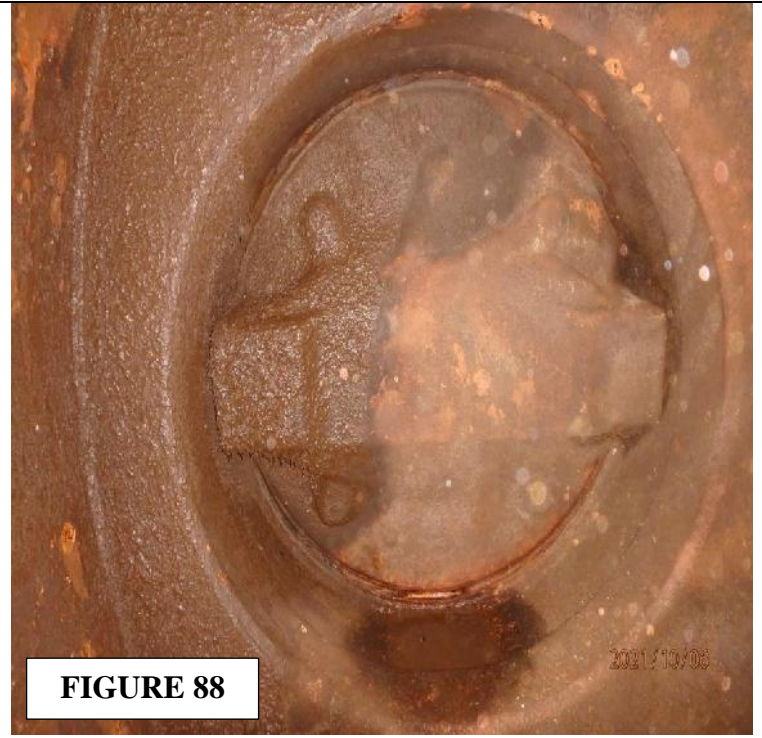
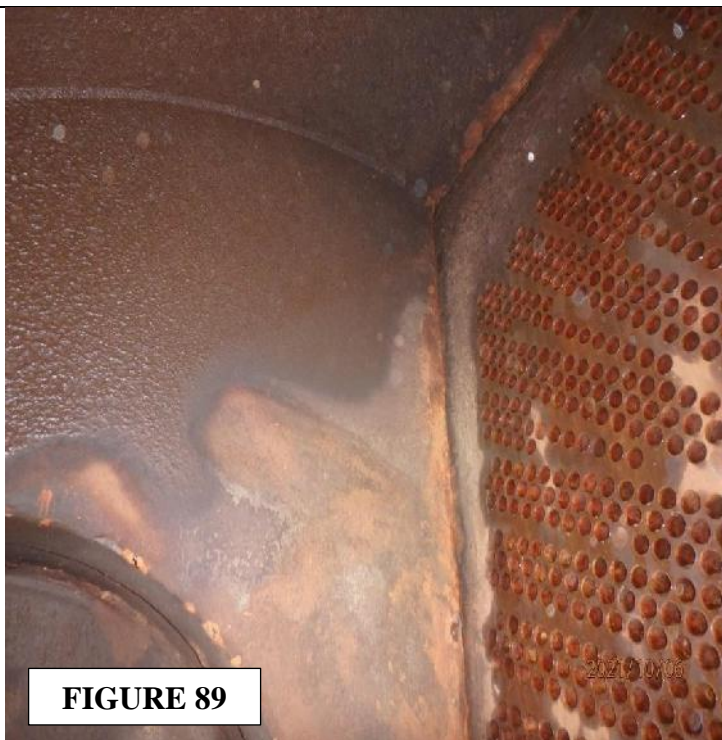
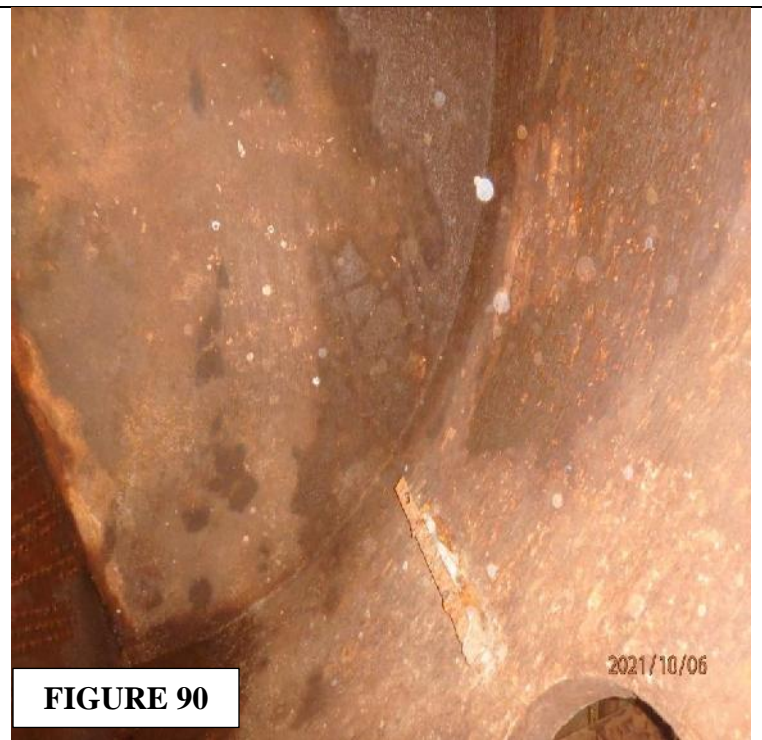
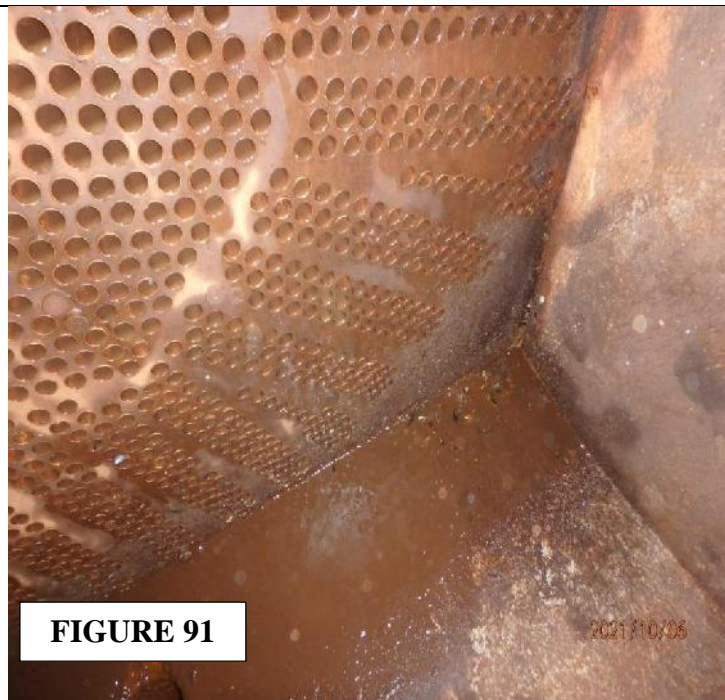
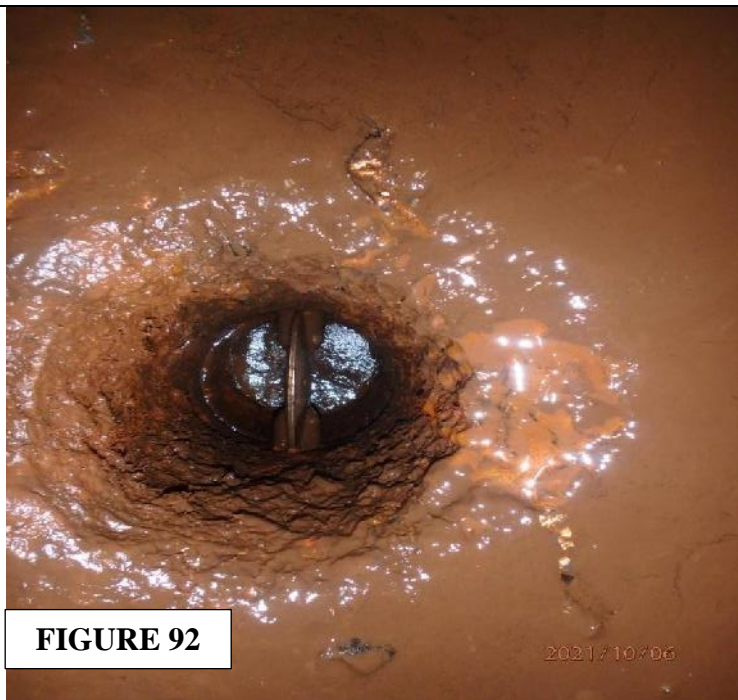
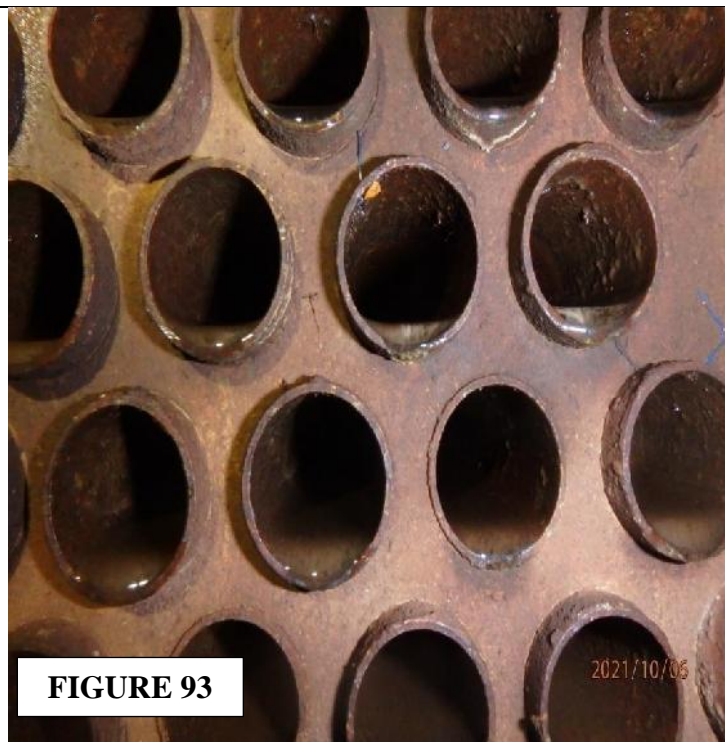
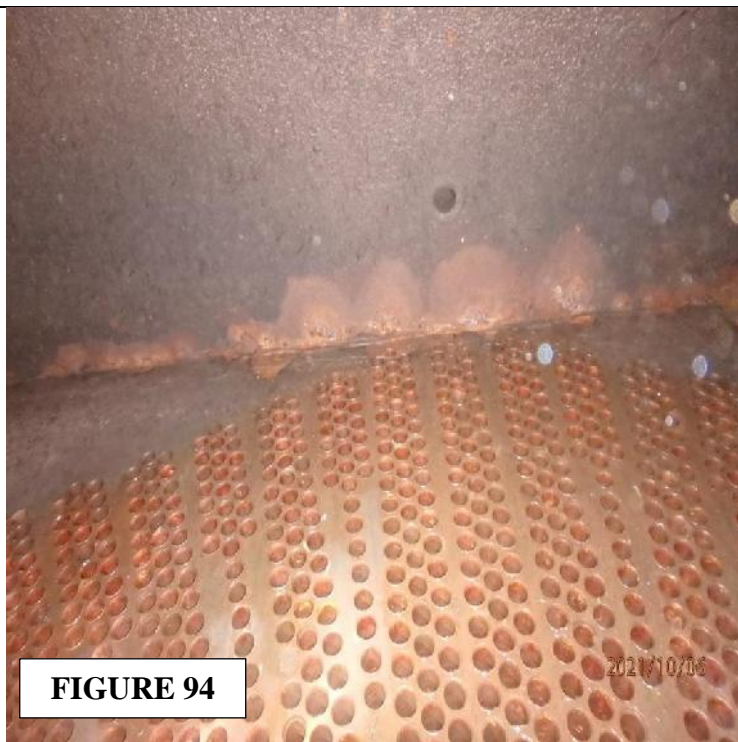
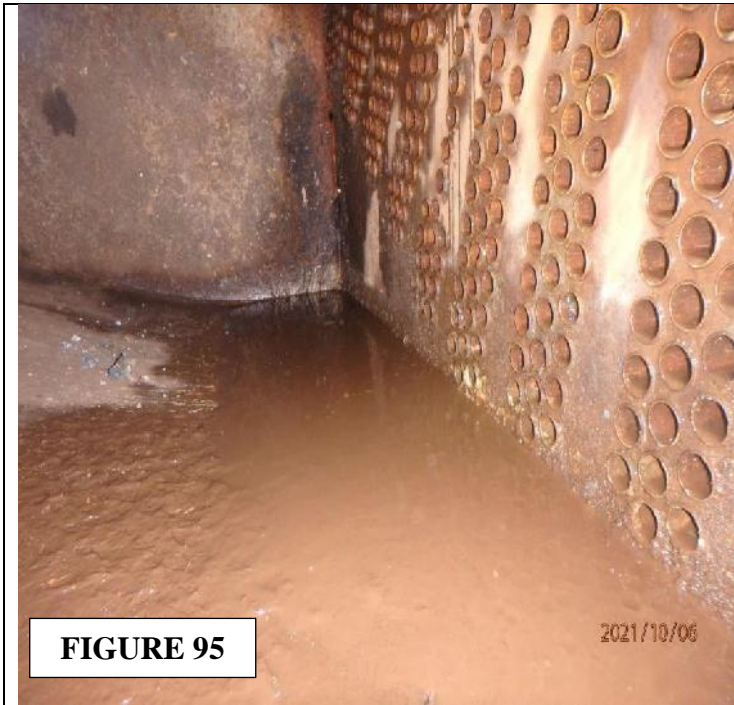
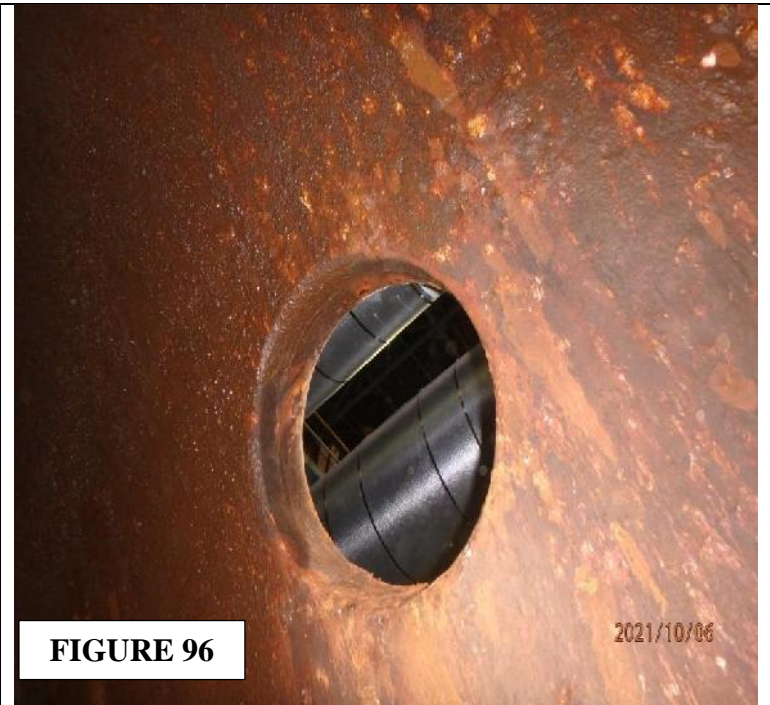
2.6 East Side – North Box

- Minor coating breakdown and corrosion noted throughout waterbox, difficult to assessment overall extent of corrosion and pitting due to lack of cleanliness **(Figures 86, 89, 91, 94-96)**
- Manway doors appeared to be heavily corroded, however would require additional cleaning for further assessment **(Figure 85)**
- Butterfly valve disc appeared to be in satisfactory condition **(Figure 88)**
- Anodes – breakdown of door and internal anode noted, one internal anode found to be satisfactory **(Figures 85, 87, 90)**
- No corrosion of tubesheet was observed **(Figure 93)**
- Drain - difficult to assess extent of corrosion due to lack of cleanliness **(Figure 92)**

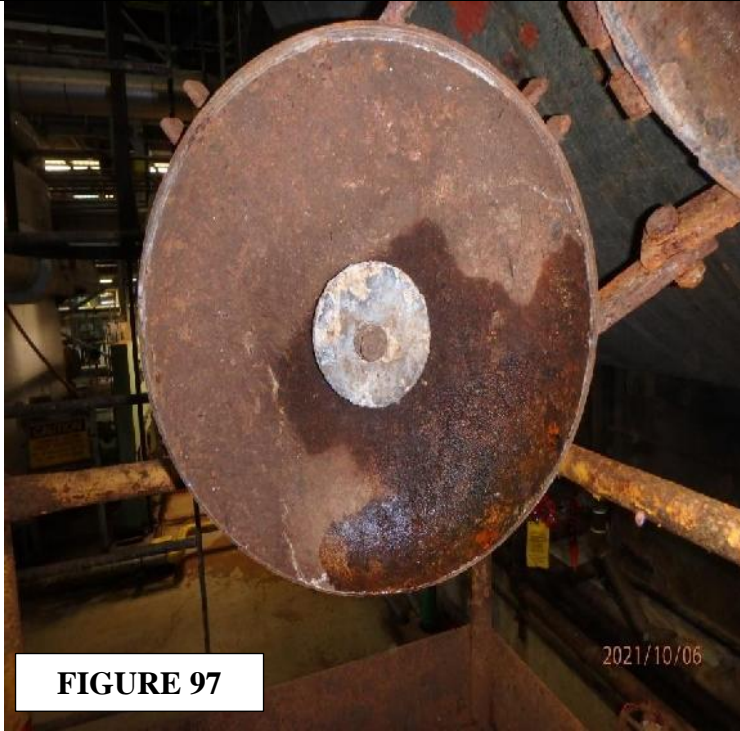
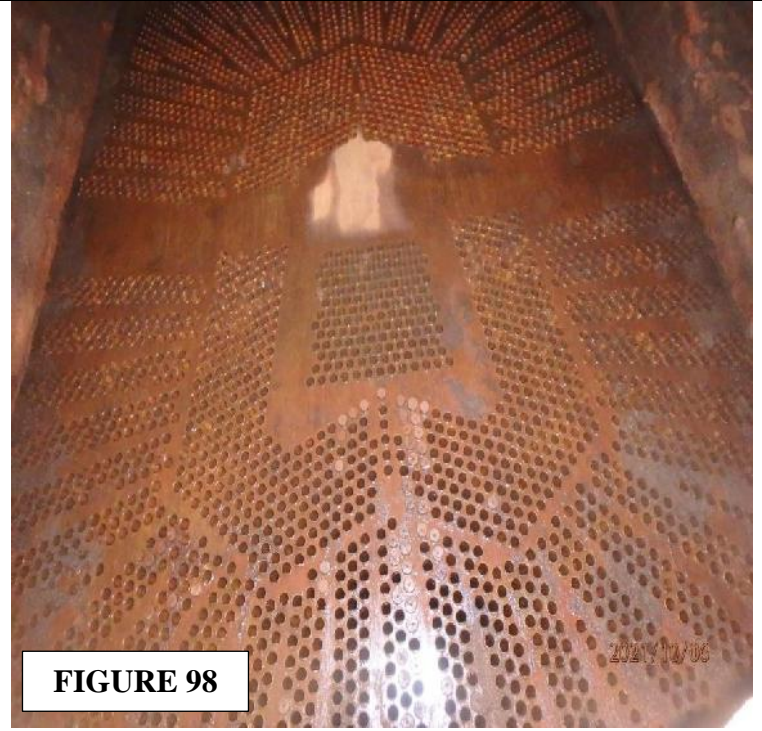
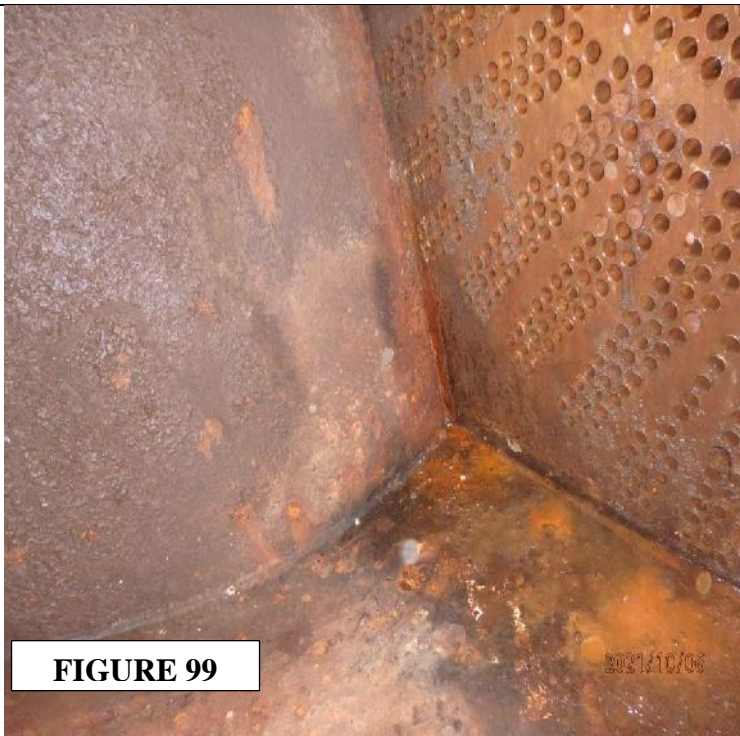
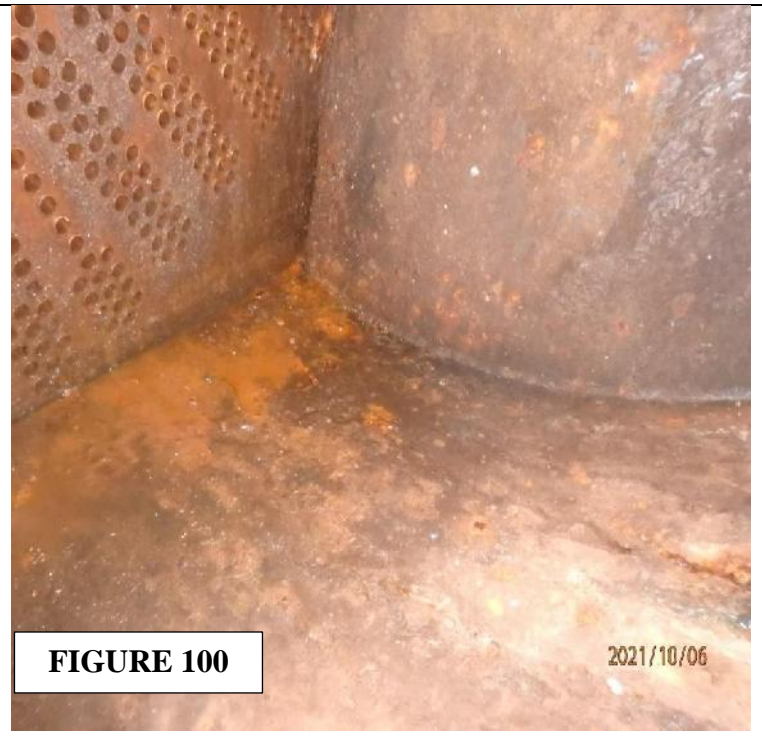
2.7 East Side – South Box

- The box was in poor condition with extensive coating breakdown and heavy corrosion throughout (**Figures 98-101, 105-109, 111, 112**)
- Manway doors appeared to be heavily corroded, however would require additional cleaning for further assessment (**Figure 97**)
- Butterfly valve appeared to be in satisfactory condition (**Figures 102-103**)
- Anodes found to be satisfactory (**Figures 97, 104, 111**)
- No corrosion of tubesheet was observed
- Drain - difficult to assess extent of corrosion due to lack of cleanliness (**Figure 110**)
- No corrosion of tubesheet was observed
