Re: *Reliability and Resource Adequacy Study Review - Assessment to Determine the Potential Long-Term Viability of the Holyrood Thermal Generating Station*

Holyrood Thermal Generating Station Condition Assessment

**Newfoundland and Labrador Hydro
HTGS Condition Assessment and Life Extension Study
Executive Summary**

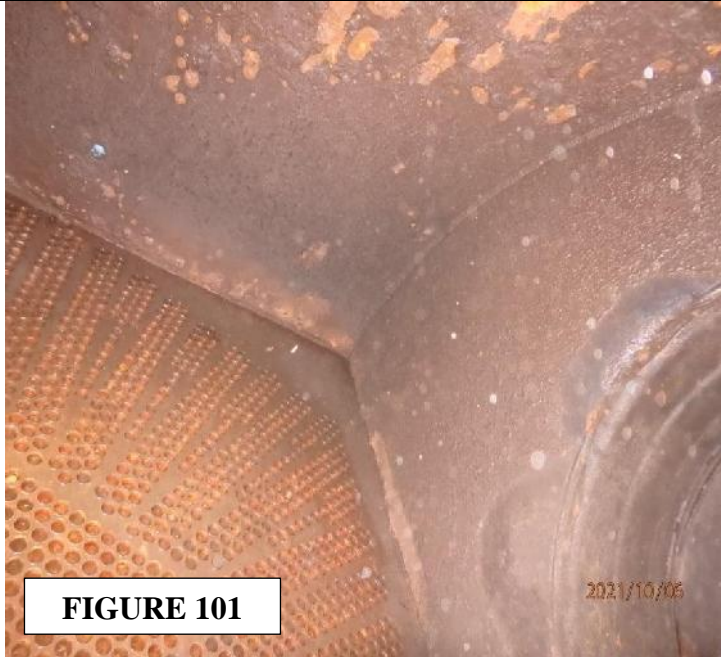
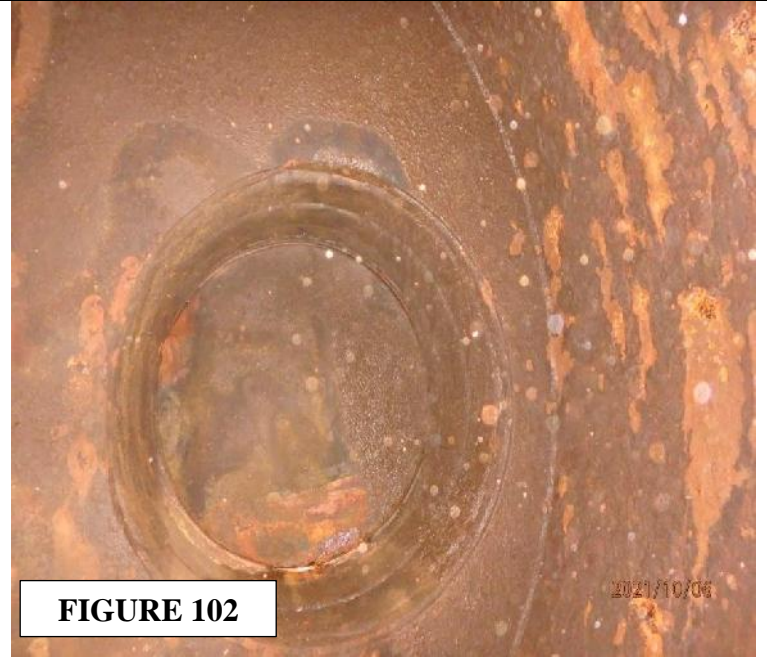
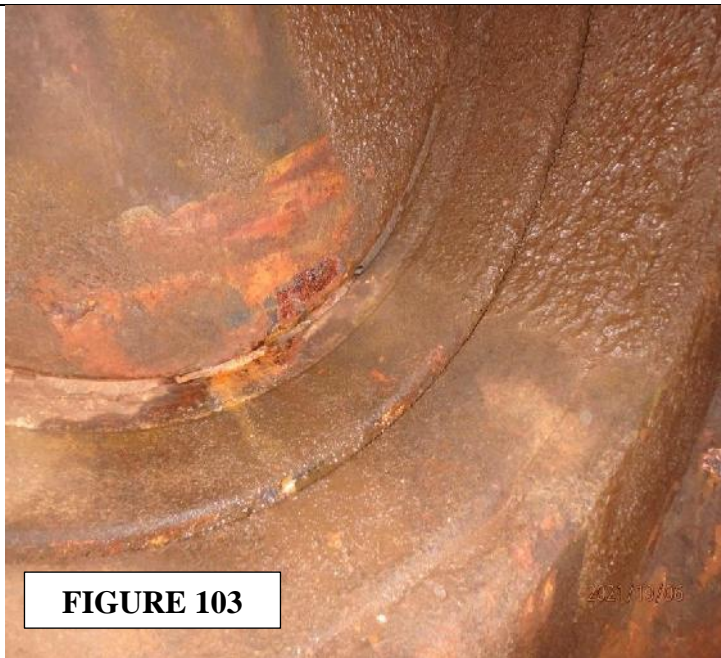
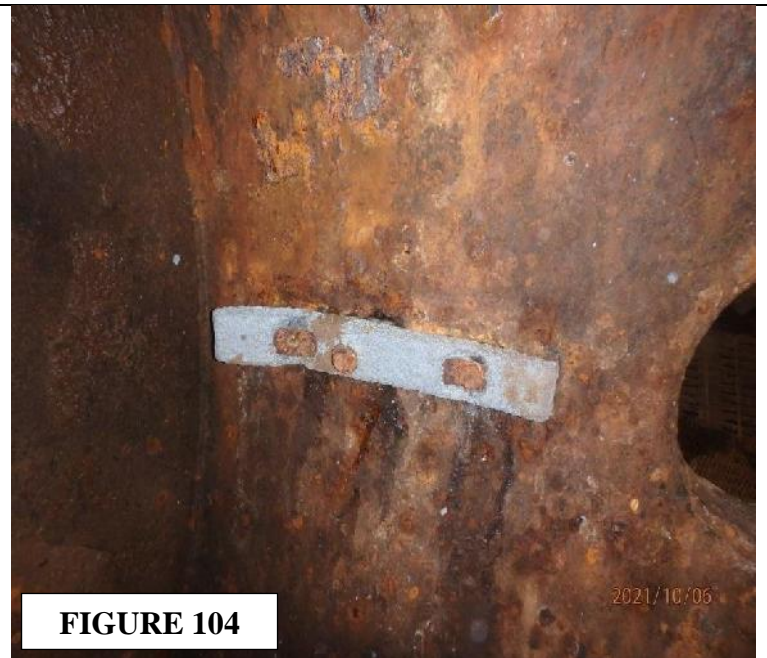
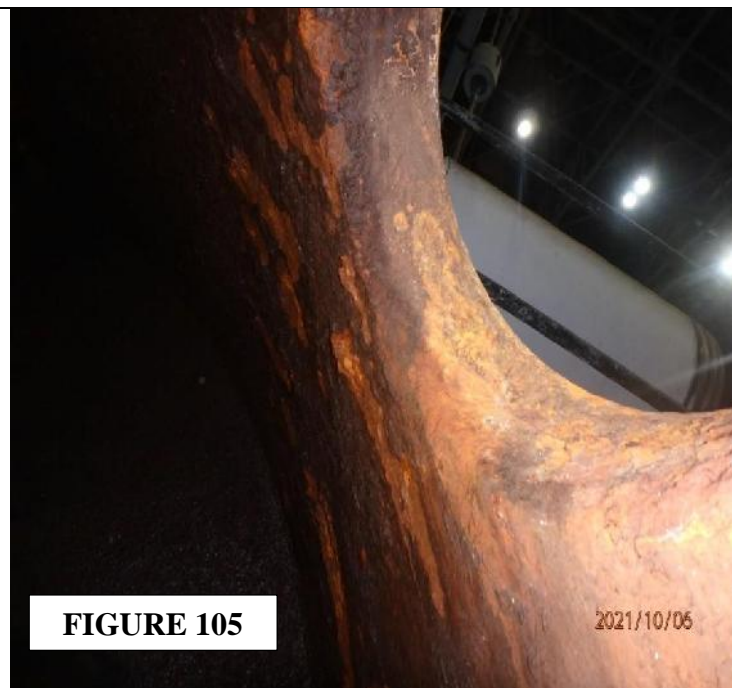
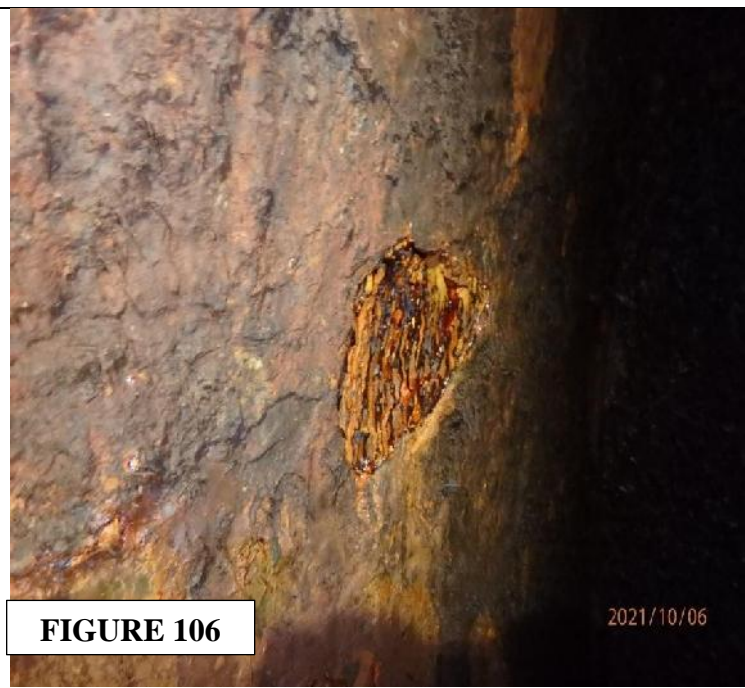
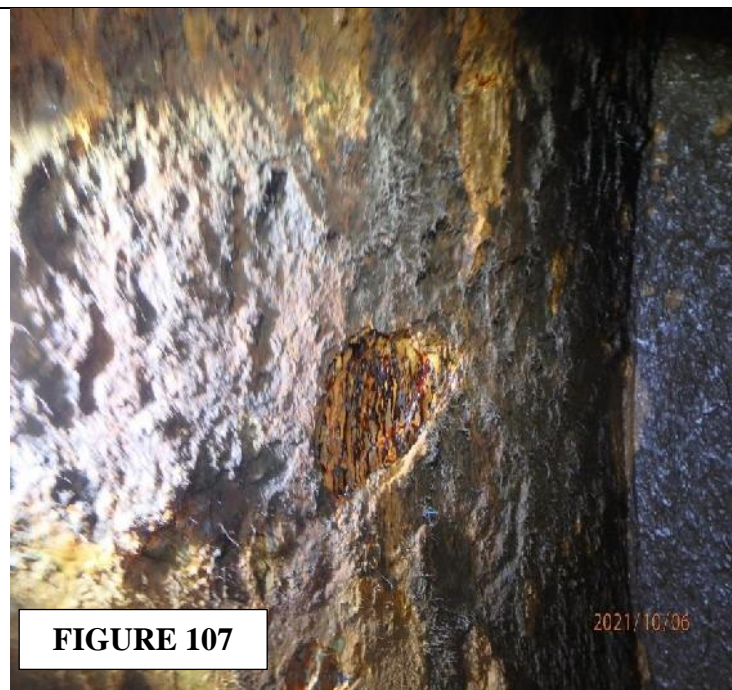
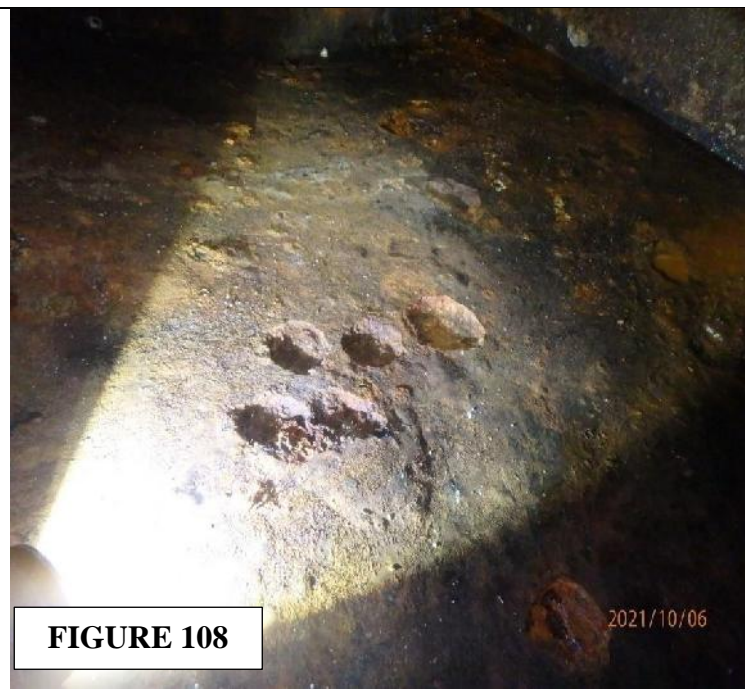
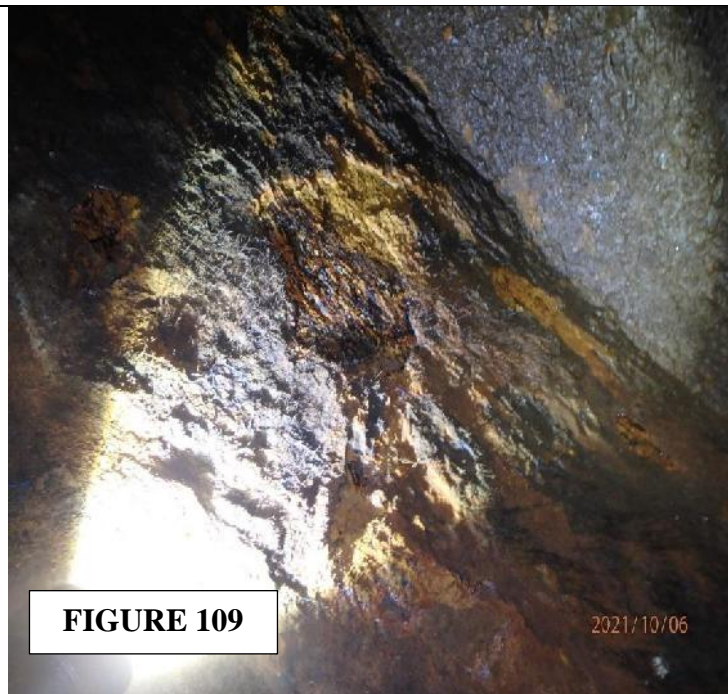
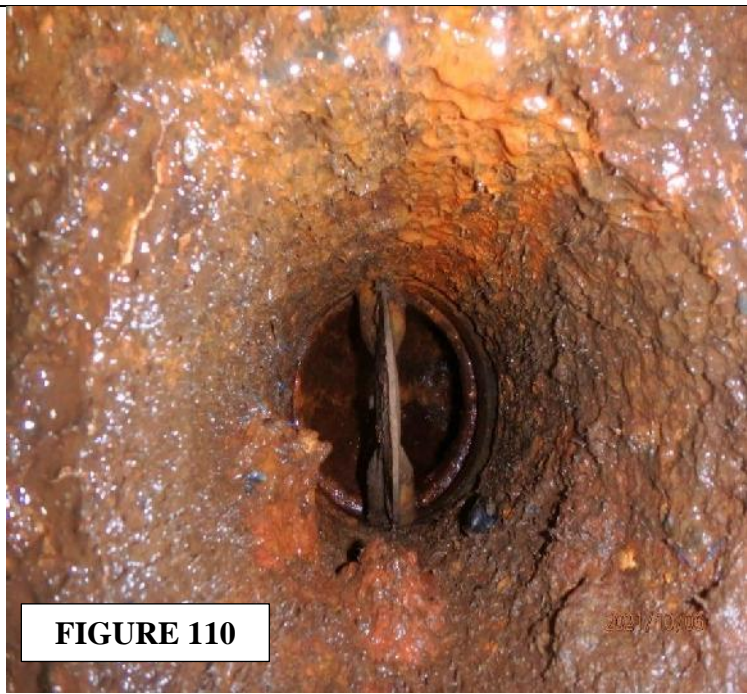
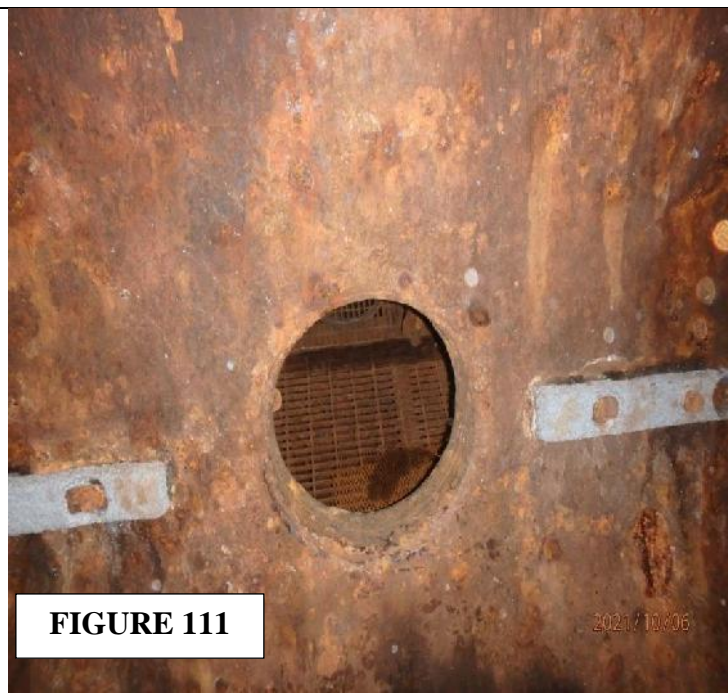
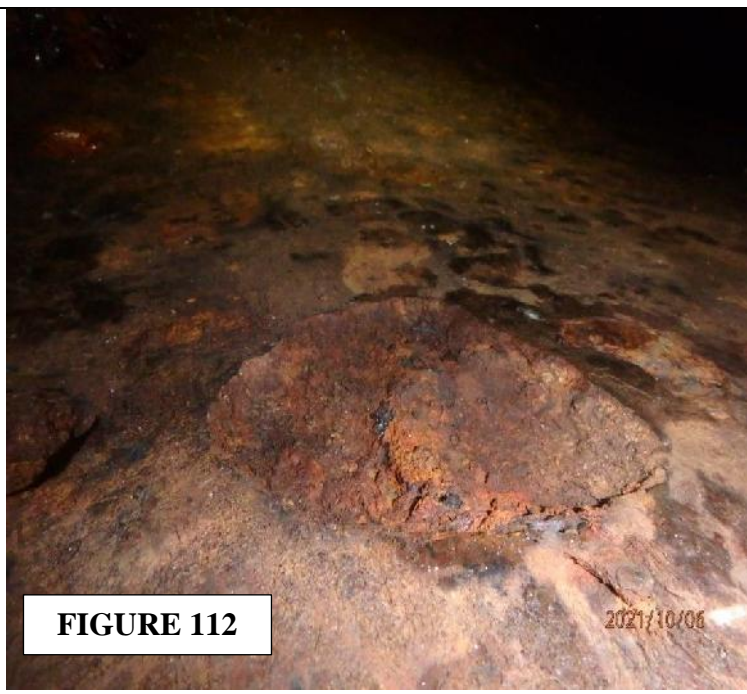
- The box was in poor condition with extensive coating breakdown and heavy corrosion throughout (**Figures 98-101, 105-109, 111, 112**)
- Manway doors appeared to be heavily corroded, however would require additional cleaning for further assessment (**Figure 97**)
- Butterfly valve appeared to be in satisfactory condition (**Figures 102-103**)
- Anodes found to be satisfactory (**Figures 97, 104, 111**)
- No corrosion of tubesheet was observed
- Drain - difficult to assess extent of corrosion due to lack of cleanliness (**Figure 110**)
- No corrosion of tubesheet was observed

- Continue with inspections and regular maintenance of the water boxes, i.e., tube cleaning, debris removal, replacement of anodes
- Coating, plate and drain repairs should be considered in the near future, where necessary

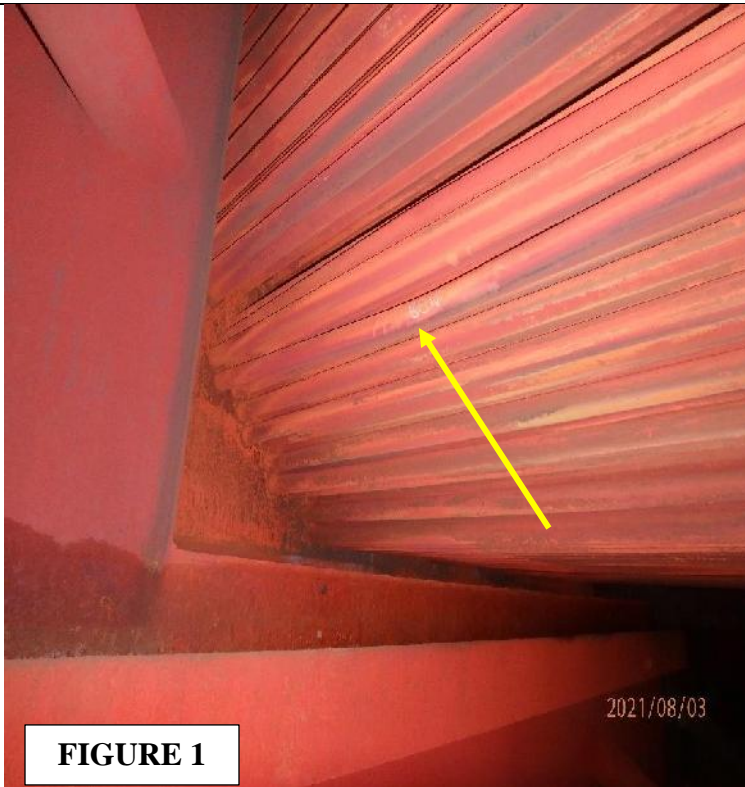
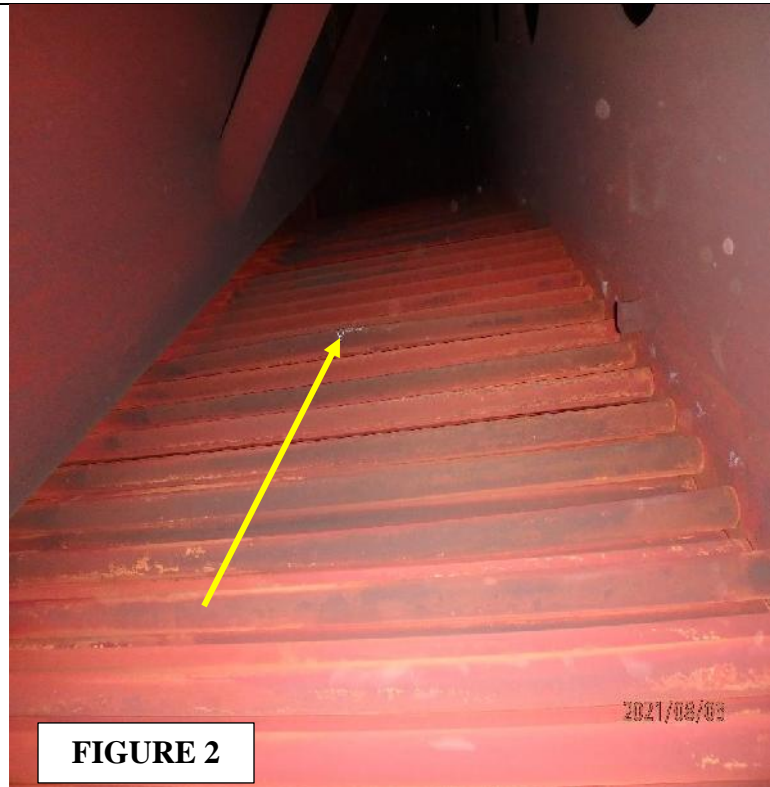
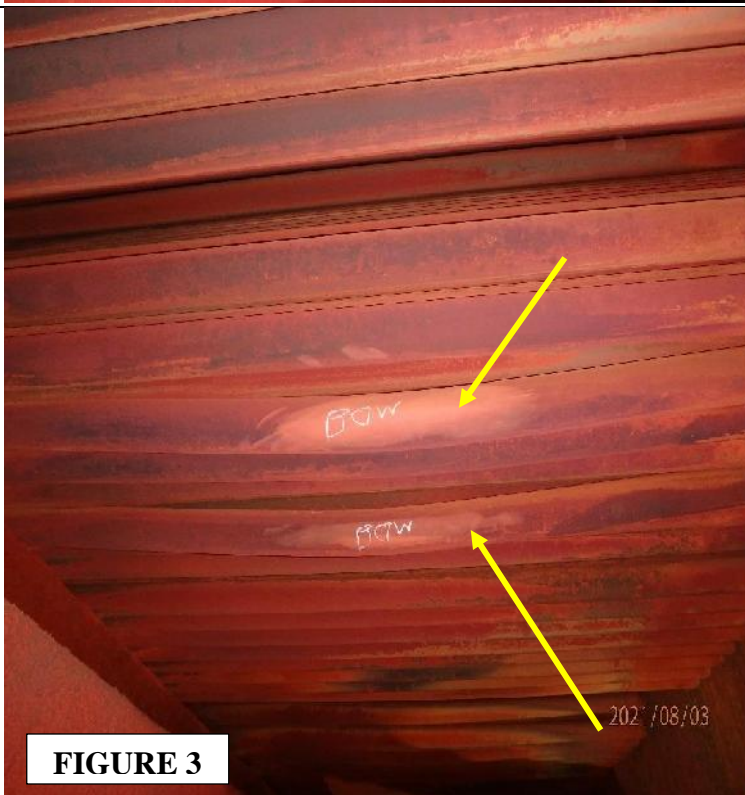
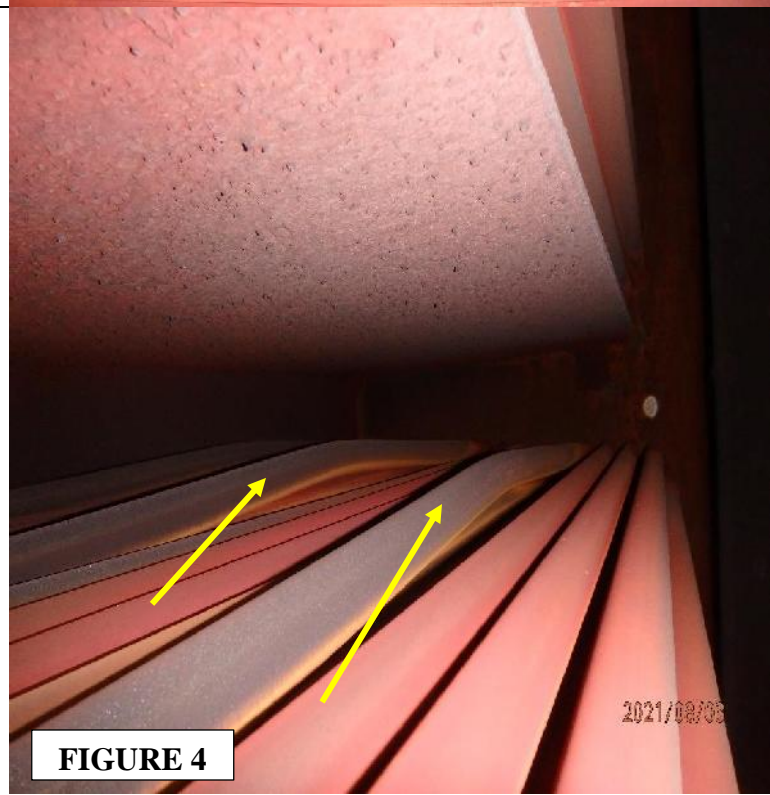
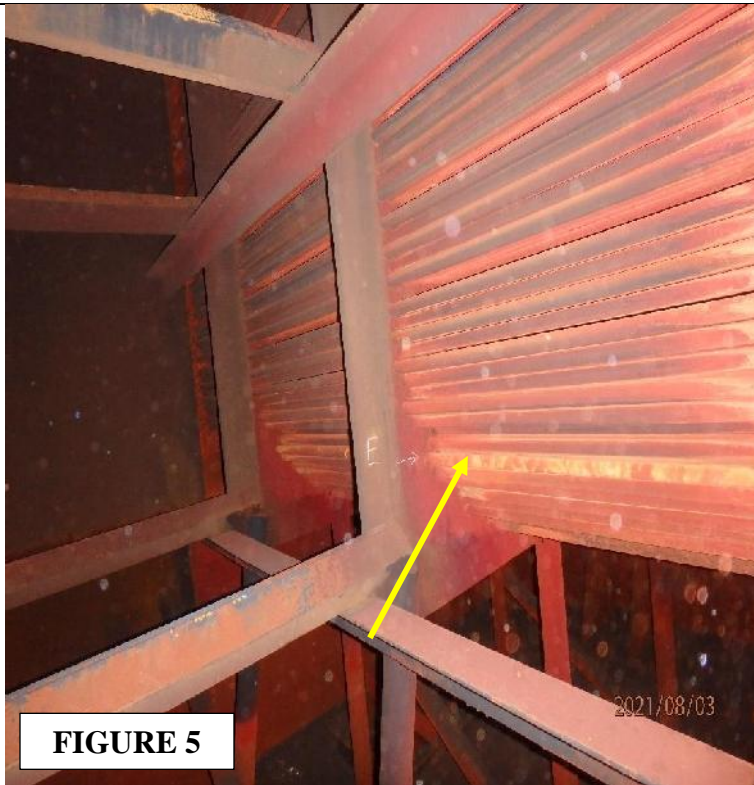
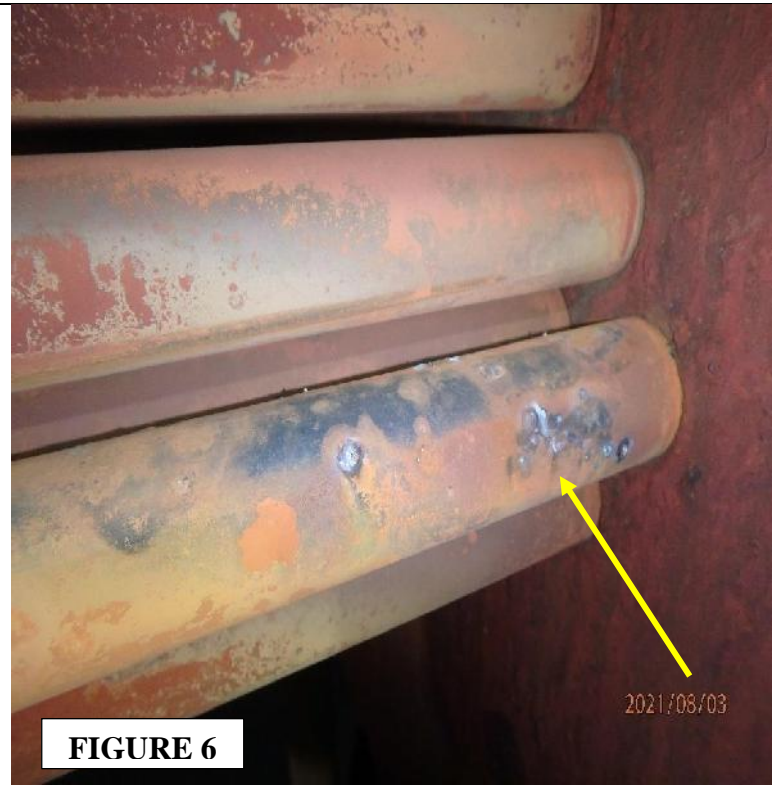
- Tube Bundles – Overall, the tube bundles appeared to be in good condition. Minor polishing and steam erosion was noted on the tubes, as well as, bowing of particular tubes. Mineral deposits observed during a previous inspection on the North side of the South LP outlet area on the 8th row from the bottom was also noted. **(Figures 1-6)**

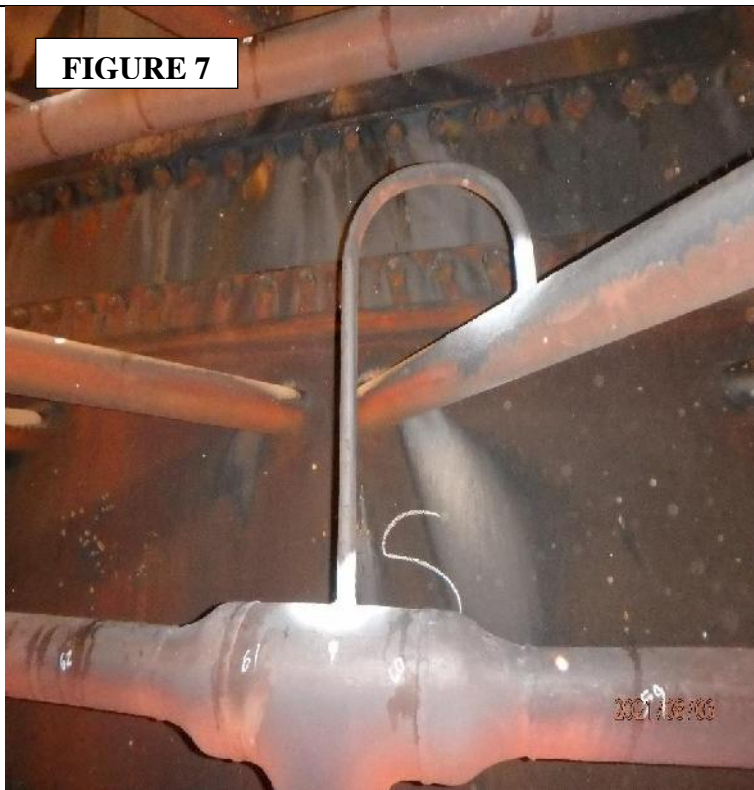
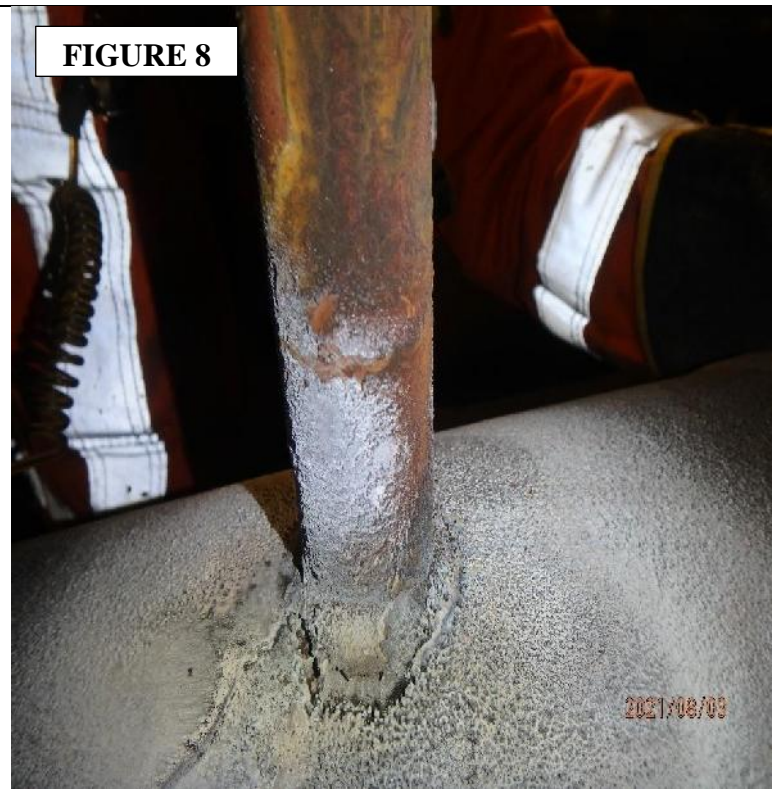
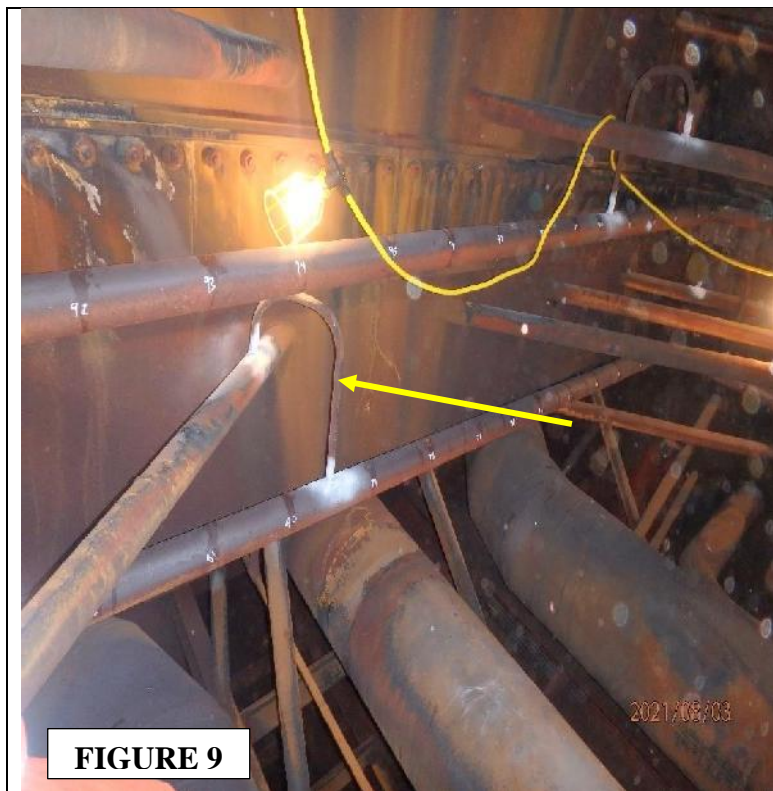
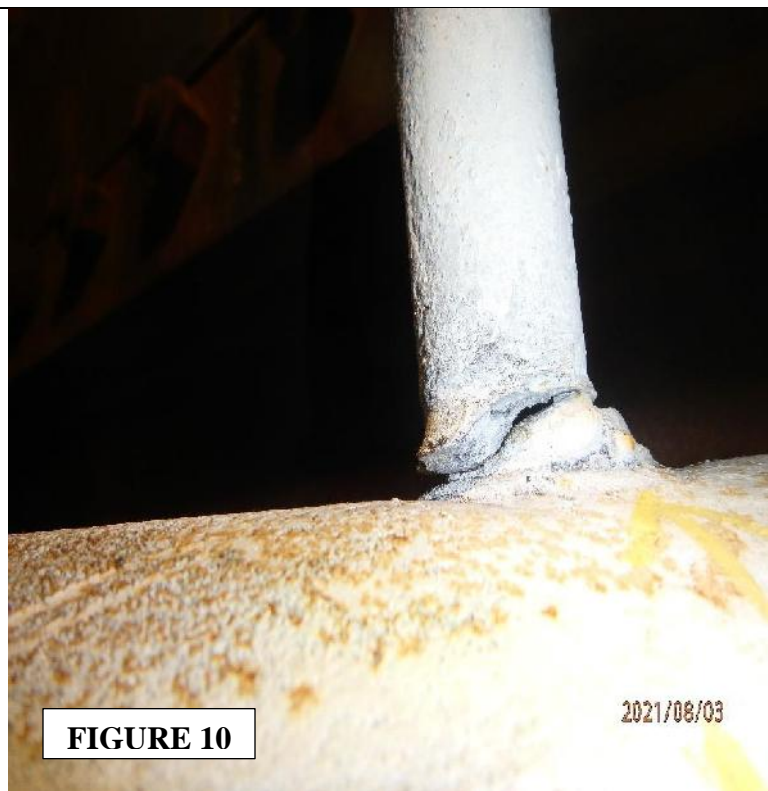
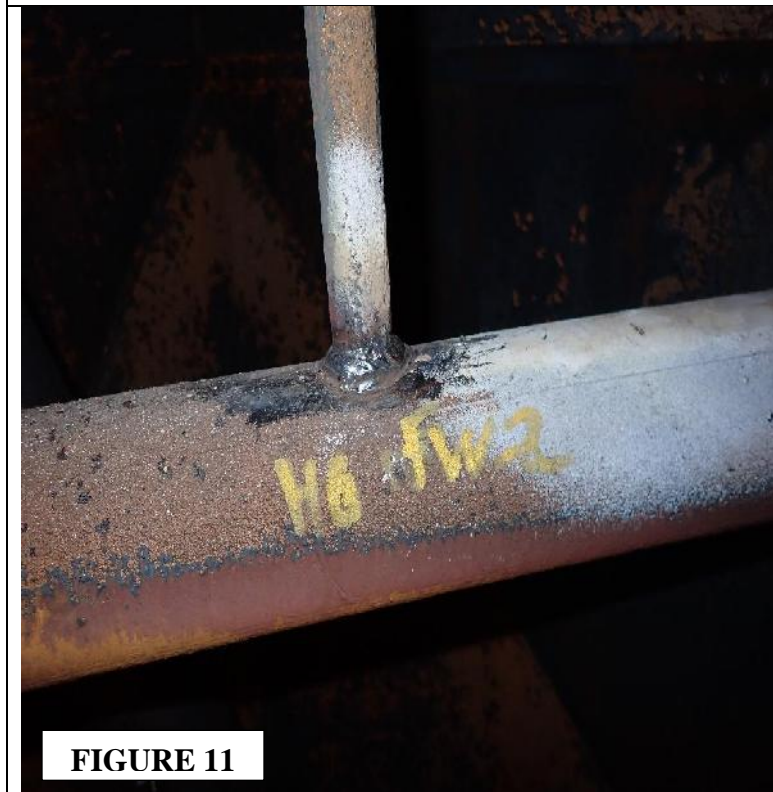
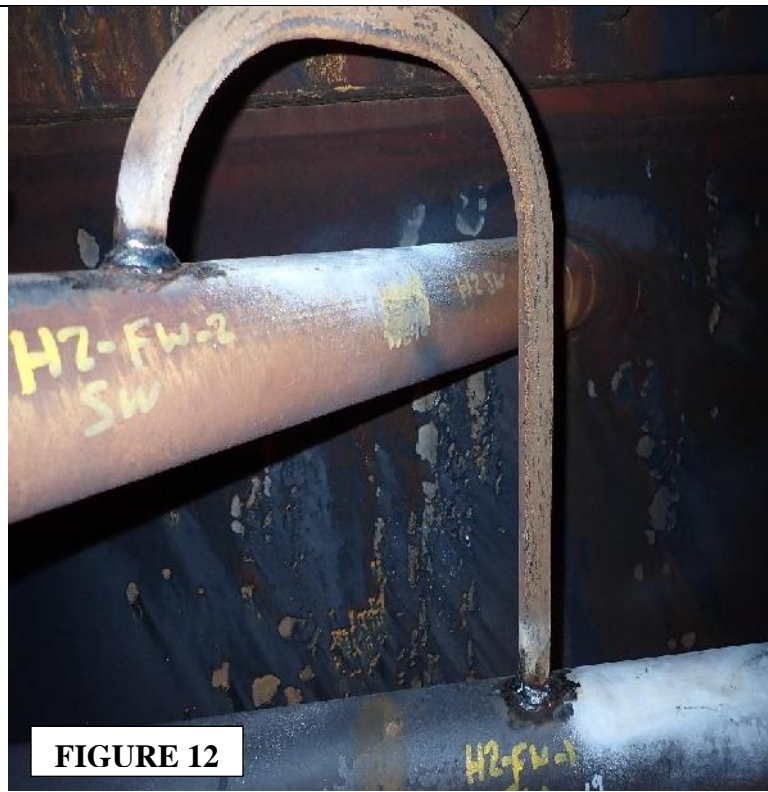
- Pipe Supports – Broken and eroded welds were noted on a total of 6 supports for the steam seal regulator piping. Upon discovery, these pipe supports were removed and repaired as necessary. **(Figures 7-12)**

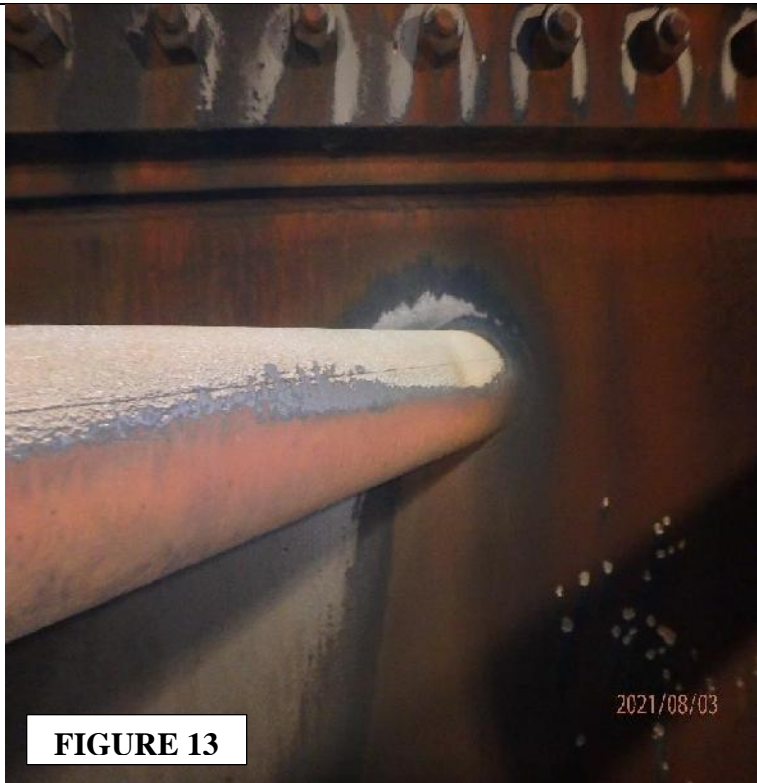
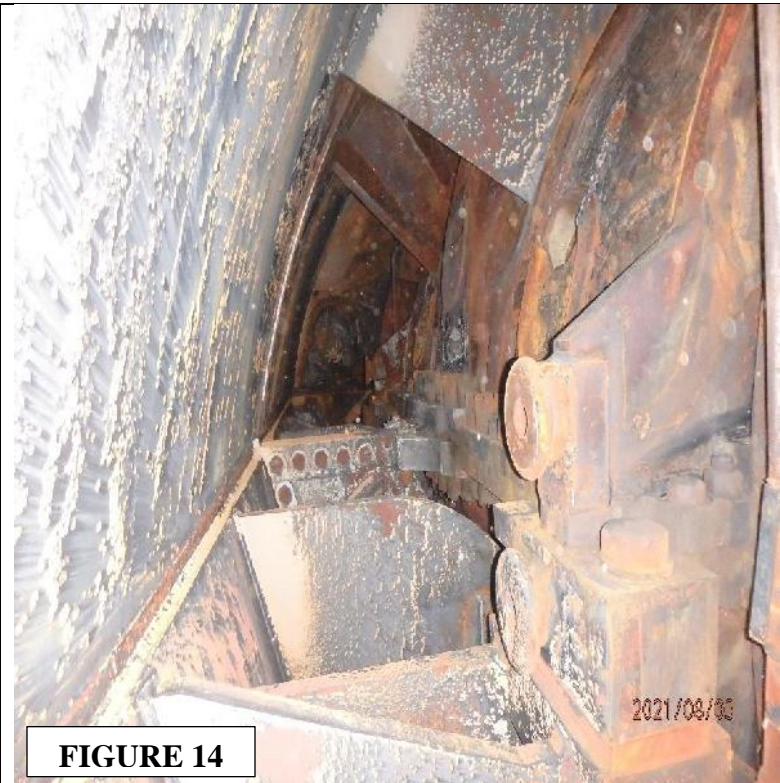
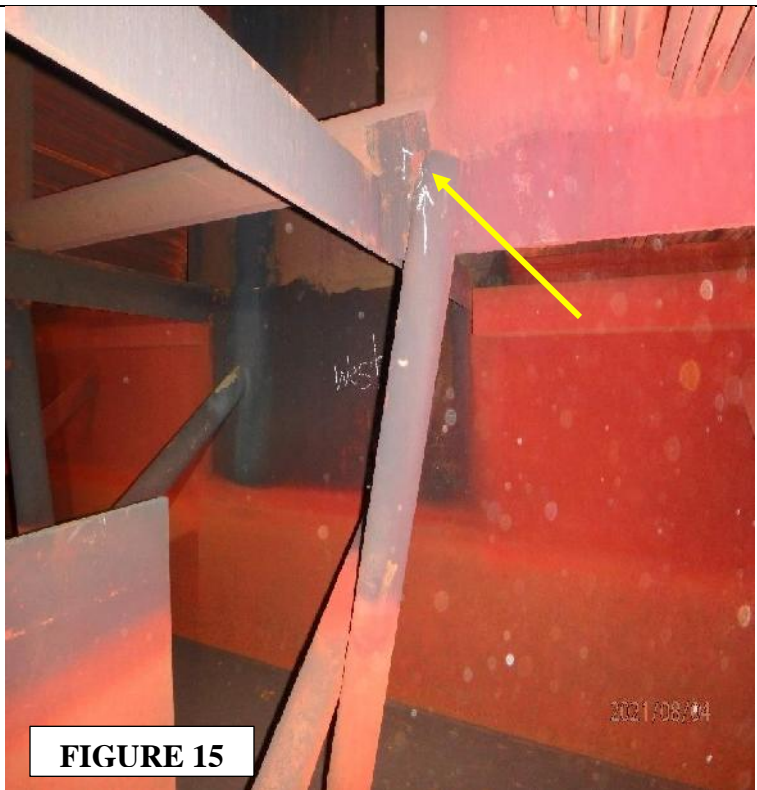
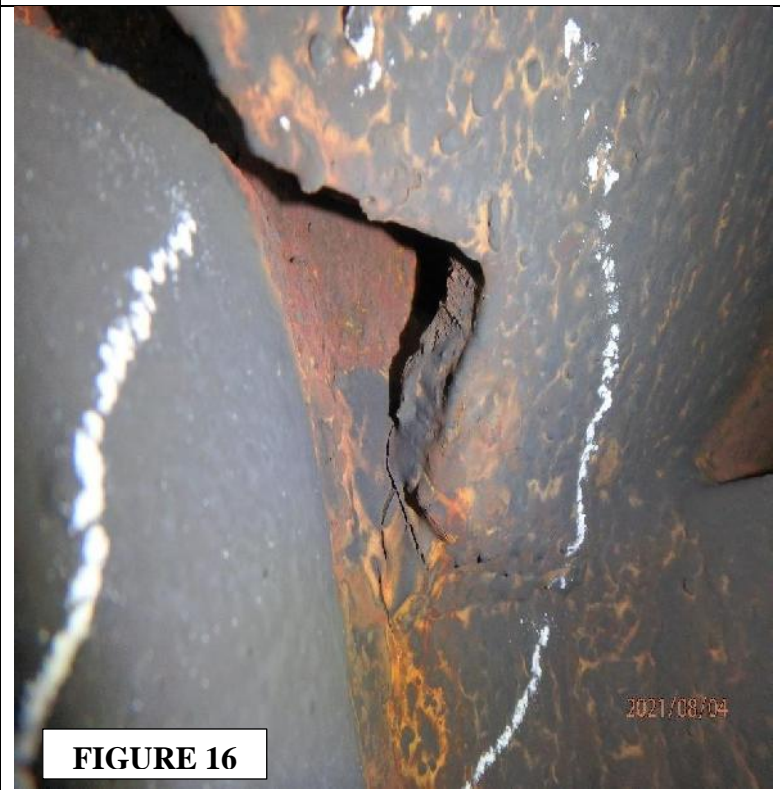
- Structural Supports – Erosion noted throughout. Also, broken welds were noted on various bundle supports on cross braces that extend horizontally between the tube support plates of the two bundles. The typical location of these broken welds is in the wrap of the fillet weld. Due to the amount of deposited weld metal, these are not deemed detrimental, however, should be monitored in future inspections. **(Figures 13-16)**

- Continue with regular inspections to monitor erosion of supports, especially the cross braces that extend horizontally between the tube support plate of the two tube bundles. Consider weld repairs in near future.
- Repair hole in extraction piping erosion shield
- Monitor the erosion of the shell expansion joint covering and attachment welds
- Consider replacement of vacuum measuring line and associated supports
- Continue monitoring stiffener erosion and shell attachment welds
- Repair floor coating in noted corners

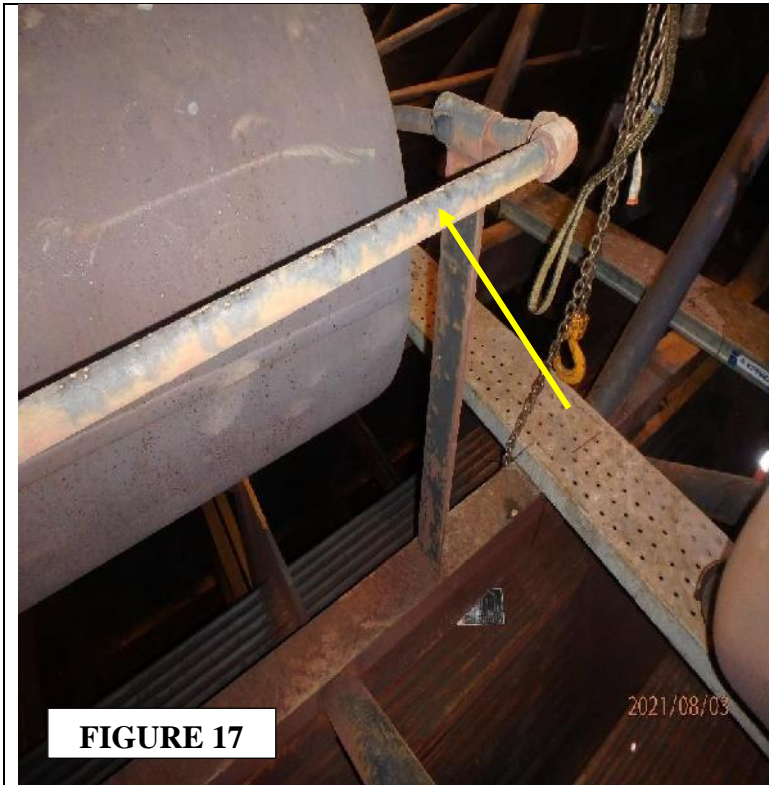
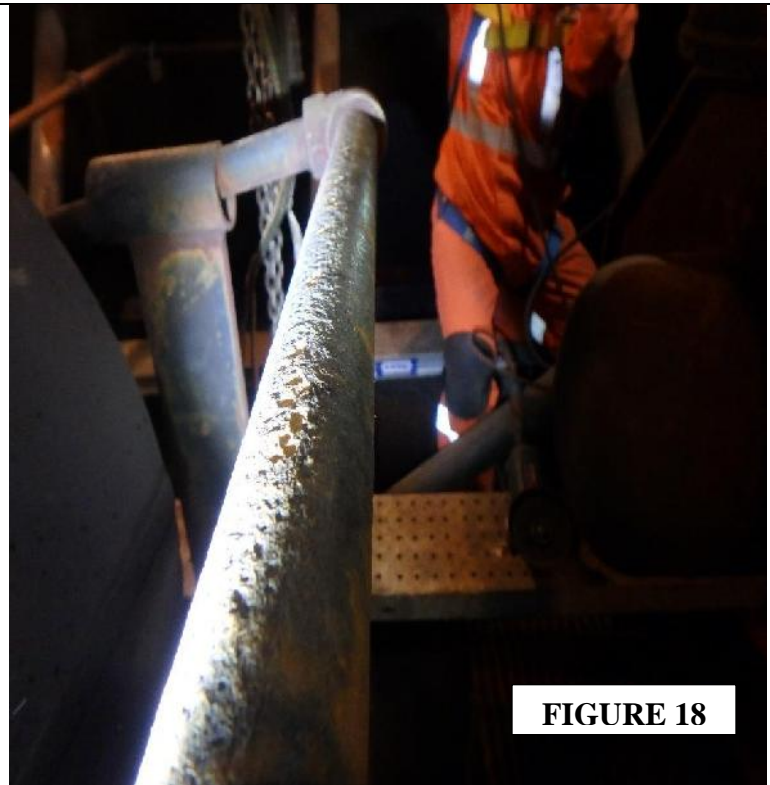
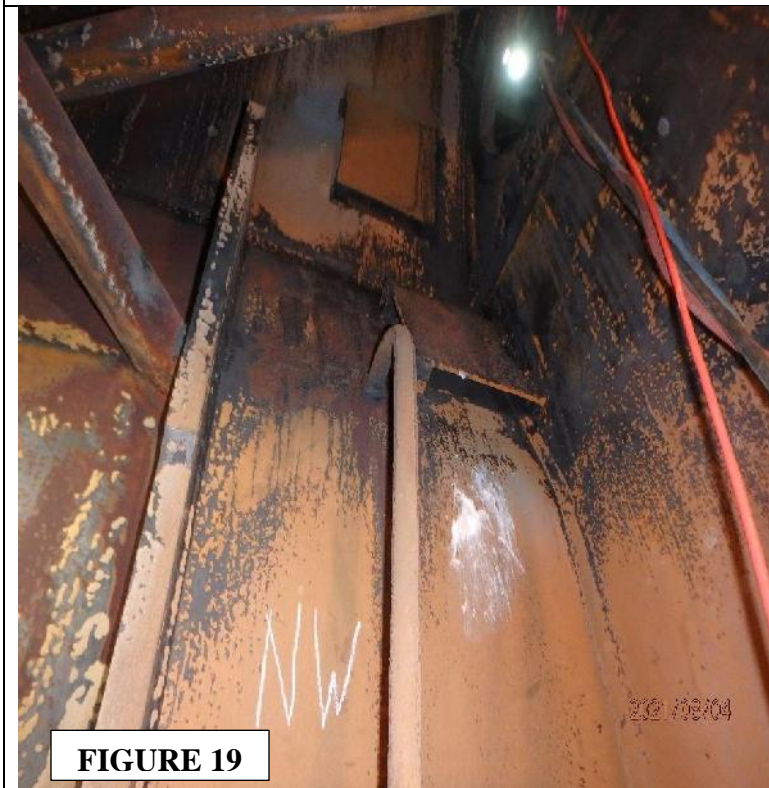
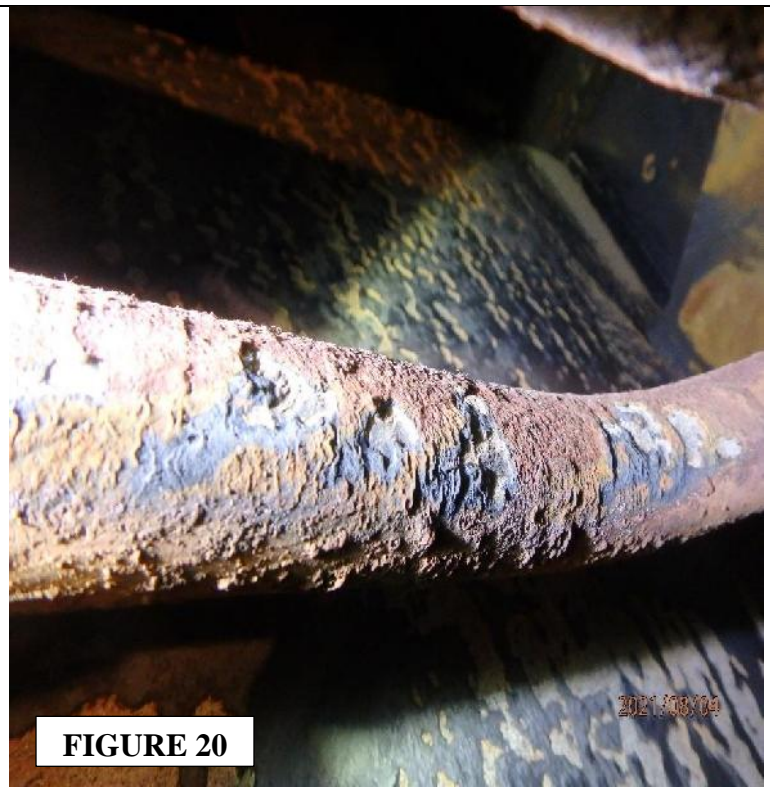
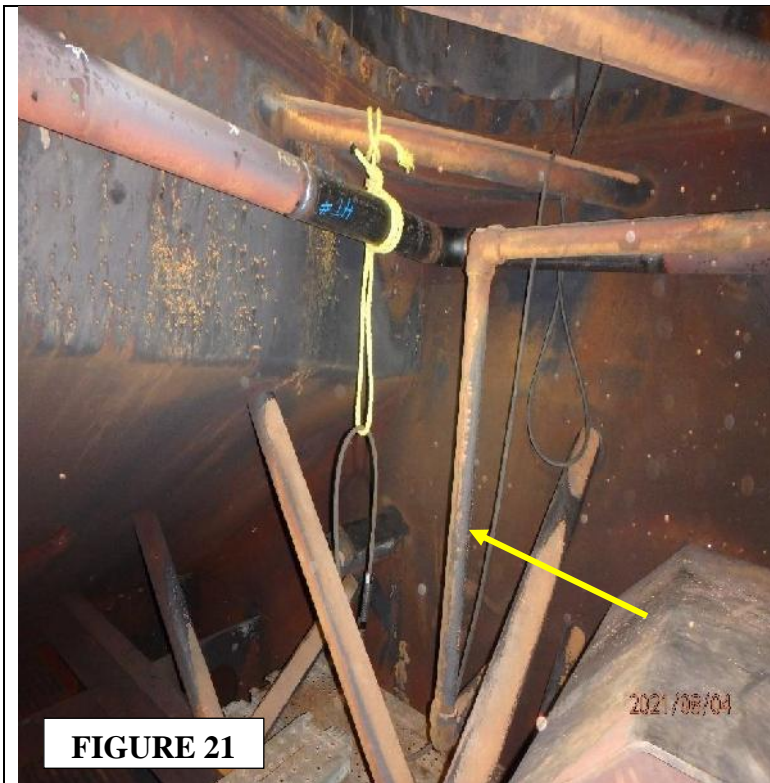
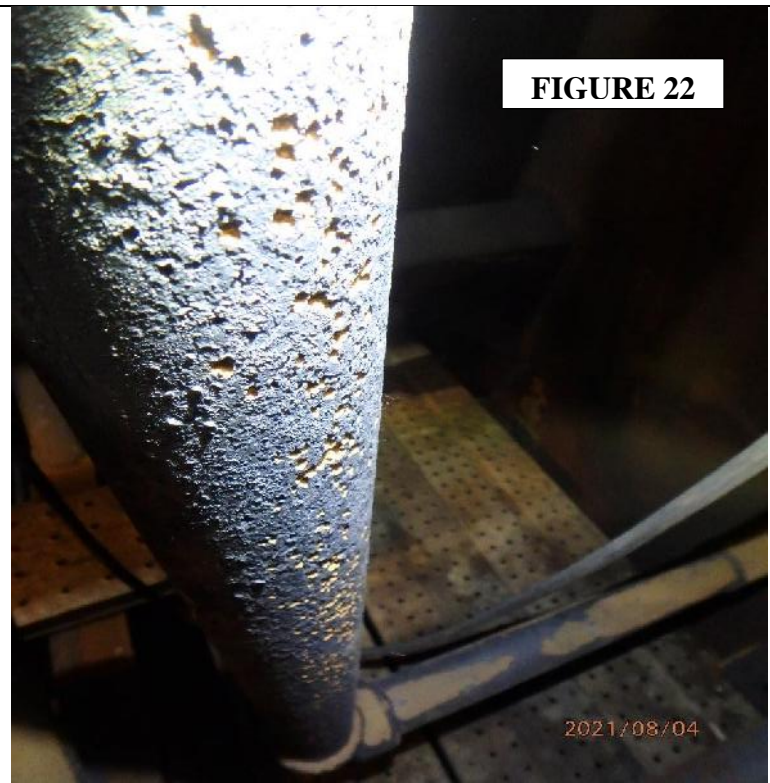
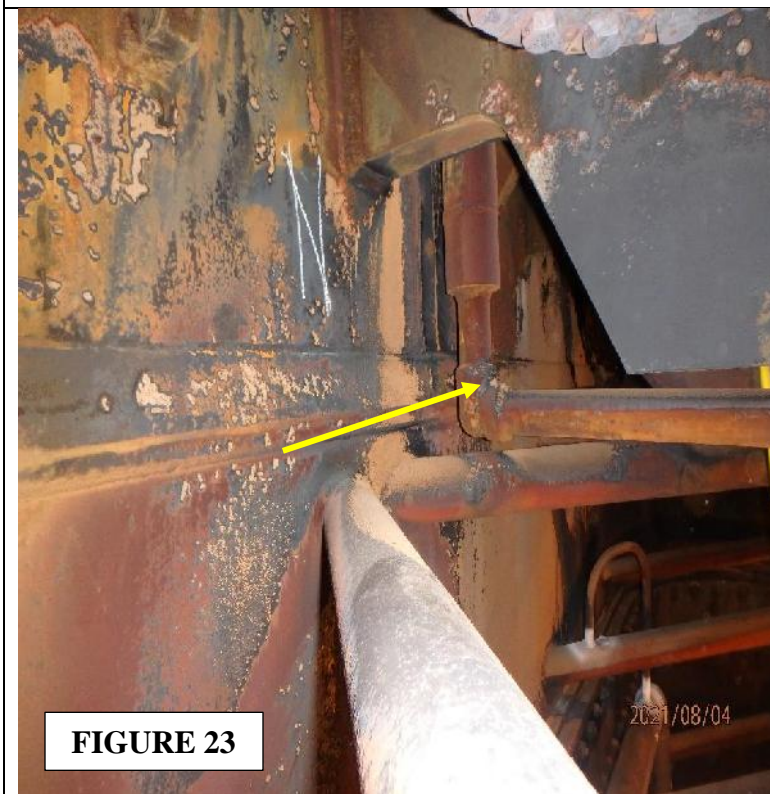
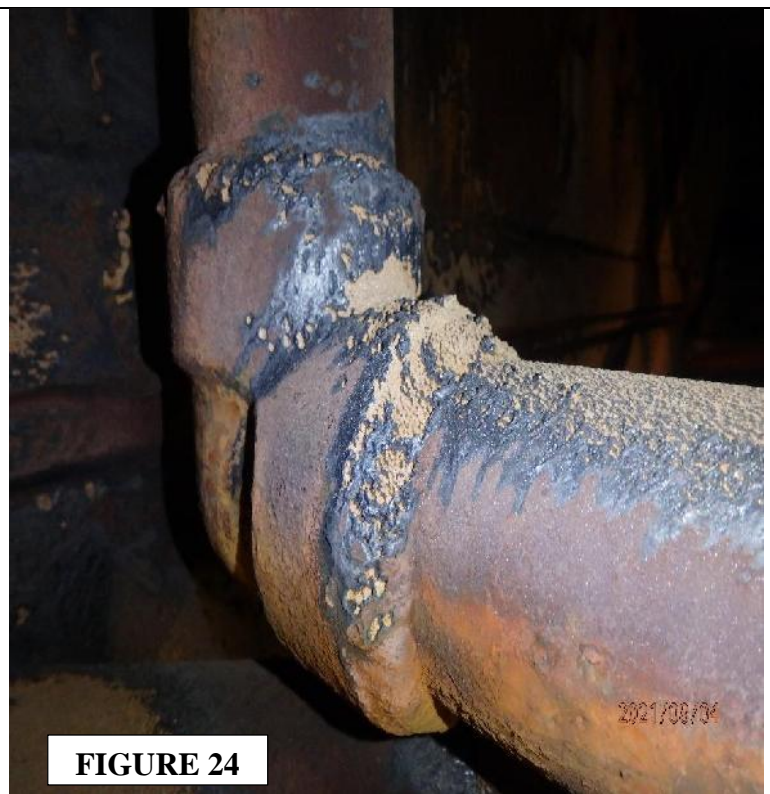
- Vacuum Measuring Reference Line – Extensive erosion/corrosion observed in various locations, no holes noted **(Figure 16-24)**

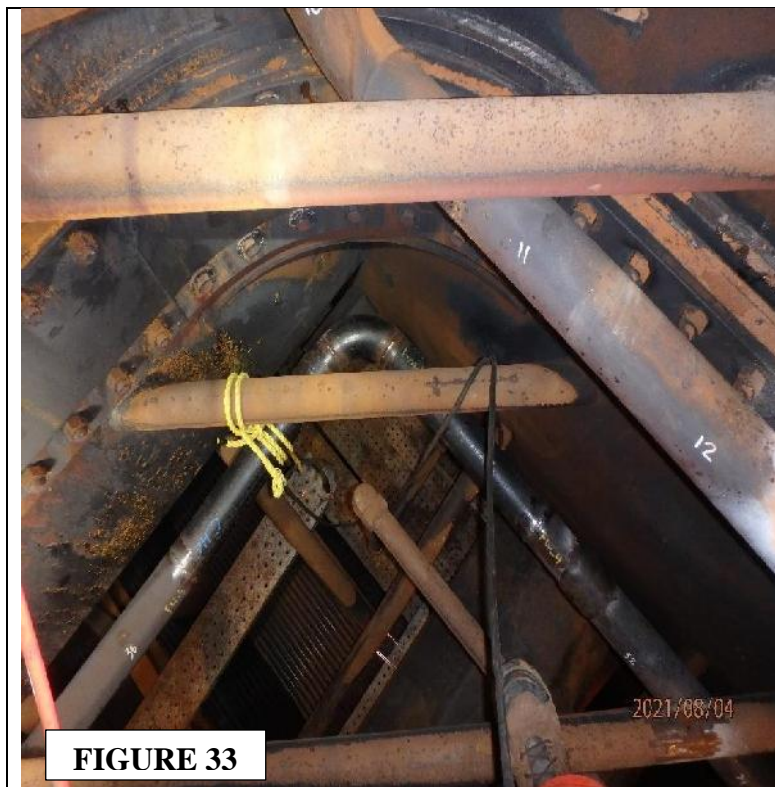
FIGURE 33

- Steam seal regulator piping – In the SW corner of the LP section of the condenser, a hole was noted in an elbow of the steam seal regulator piping. This elbow was removed and replaced as necessary; however, extensive erosion was noted on the I.D. of the piping. **(Figures 29-34)**

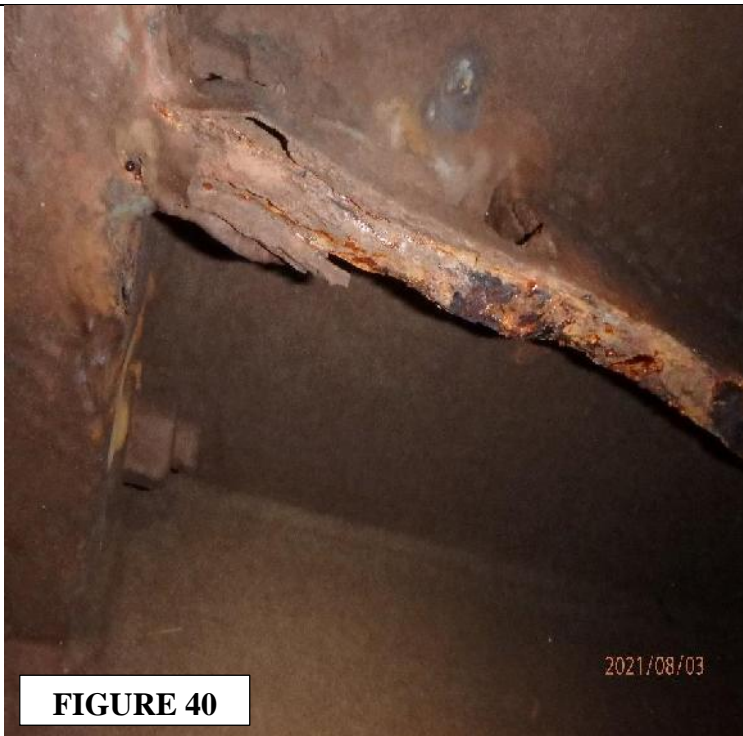
FIGURE 40

- The side walls of the box were generally in good condition with minor coating breakdown and corrosion noted, however, the floor and upper section coatings have failed more aggressively causing corrosion and erosion of structural components and casing (**Figure 37, 40-43**)
- Anodes in satisfactory condition
- Pitting of the tubesheet was observed (**Figure 38, 39**)
- Heavy corrosion and deep cavities were discovered around inside of manway due to coating breakdown (**Figures 35, 36**)
- Minor pitting noted in inlet piping
- Due to residual water, butterfly valve was not able to be inspected (**Figure 44**)
- Drain piping cover was intact and valve deemed satisfactory
