Re: *Reliability and Resource Adequacy Study Review - Assessment to Determine the Potential Long-Term Viability of the Holyrood Thermal Generating Station*

Holyrood Thermal Generating Station Condition Assessment

**Newfoundland and Labrador Hydro
HTGS Condition Assessment and Life Extension Study
Executive Summary**

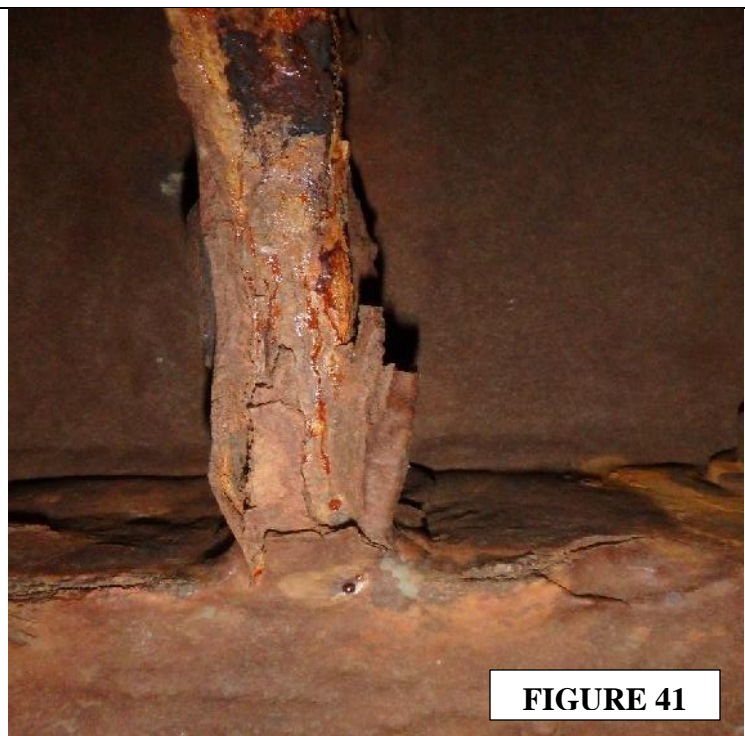
FIGURE 41

- The side walls of the box were generally in good condition with minor coating breakdown and corrosion noted, however, the floor and upper section coatings have failed more aggressively causing corrosion and erosion of structural components and casing (**Figure 37, 40-43**)
- Anodes in satisfactory condition
- Pitting of the tubesheet was observed (**Figure 38, 39**)
- Heavy corrosion and deep cavities were discovered around inside of manway due to coating breakdown (**Figures 35, 36**)
- Minor pitting noted in inlet piping
- Due to residual water, butterfly valve was not able to be inspected (**Figure 44**)
- Drain piping cover was intact and valve deemed satisfactory

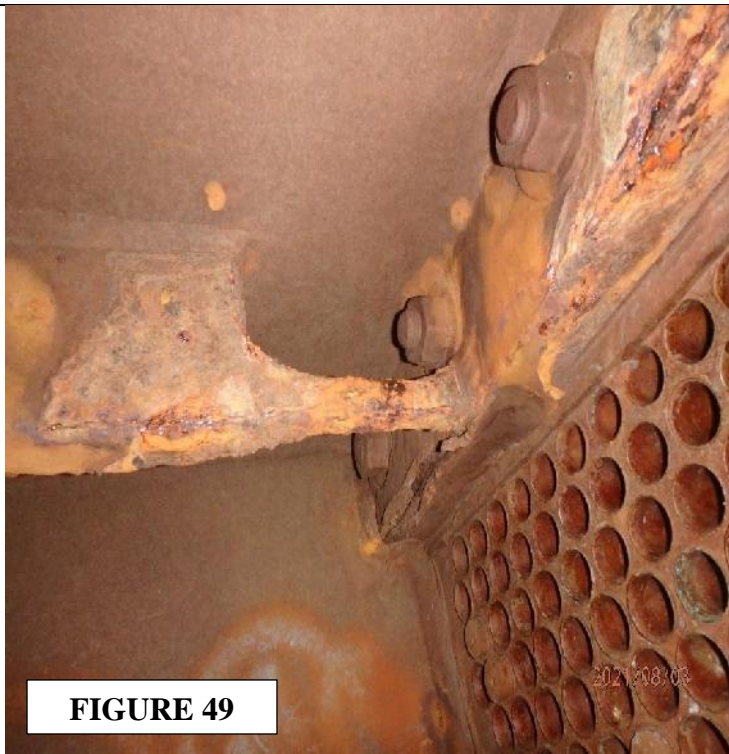
FIGURE 49

- The side walls of the box were generally in good condition with minor coating breakdown and corrosion noted, however, the floor and upper section coatings have failed more aggressively causing corrosion and pitting (**Figures 45, 48, 49**)
- Anodes in satisfactory condition
- No pitting of the tubesheet was observed
- Heavy corrosion and deep cavities were discovered around inside of manway due to coating breakdown (**Figure 50**)
- Minor pitting noted in inlet piping
- Due to residual water, inlet butterfly valve was not able to be inspected
- Drain found to be corroded with no cover installed. Valve noted as satisfactory (**Figure 46**)
- Outlet valve coating breakdown was observed causing corrosion (**Figure 47**)

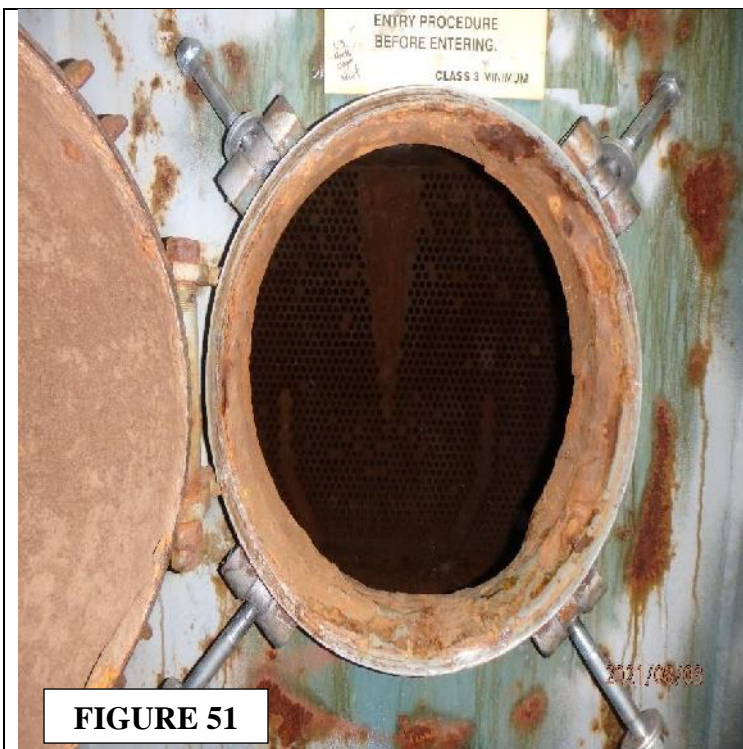
FIGURE 51

- The box was generally in poor condition with coating breakdown and corrosion throughout, especially of the floor and inlet to discharge piping (**Figures 54-58**)
- Manway heavily corroded (**Figure 51**)
- Butterfly valve disc coating failure and corrosion noted
- Anodes in satisfactory condition, one newly installed (**Figure 52, 53**)
- No corrosion of tubesheet was observed
- Minor corrosion noted in discharge piping

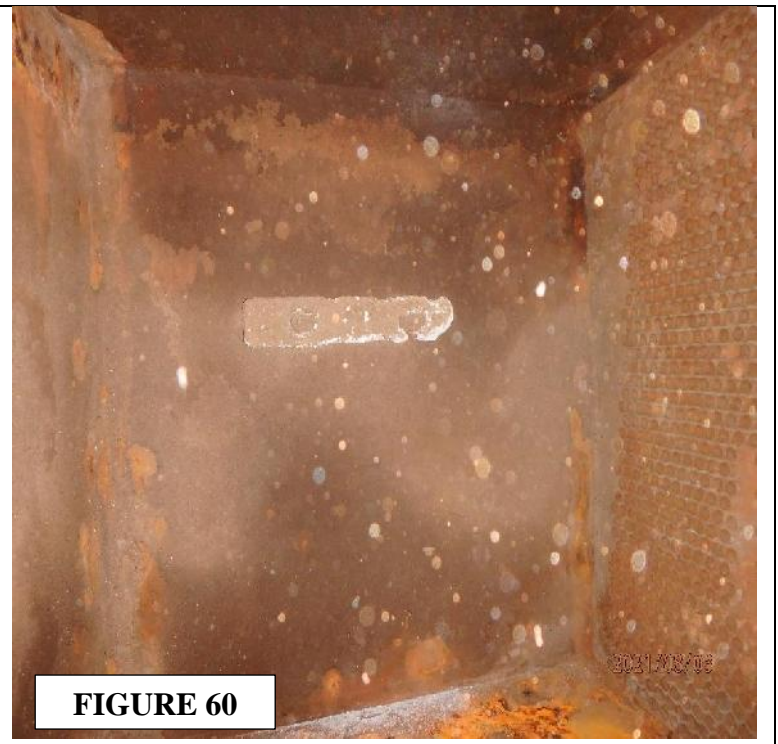
FIGURE 61

- The box was generally in poor condition with coating breakdown and corrosion throughout, especially of the floor and inlet to discharge piping (**Figures 61, 63-65**)
- Manway heavily corroded due to breakdown of coating
- Butterfly valve disc coating failure and corrosion noted (**Figure 66**)
- Minor breakdown of anodes, one newly installed (**Figure 59, 60**)
- No corrosion of tubesheet was observed
- Minor corrosion noted in discharge piping (**Figure 62**)

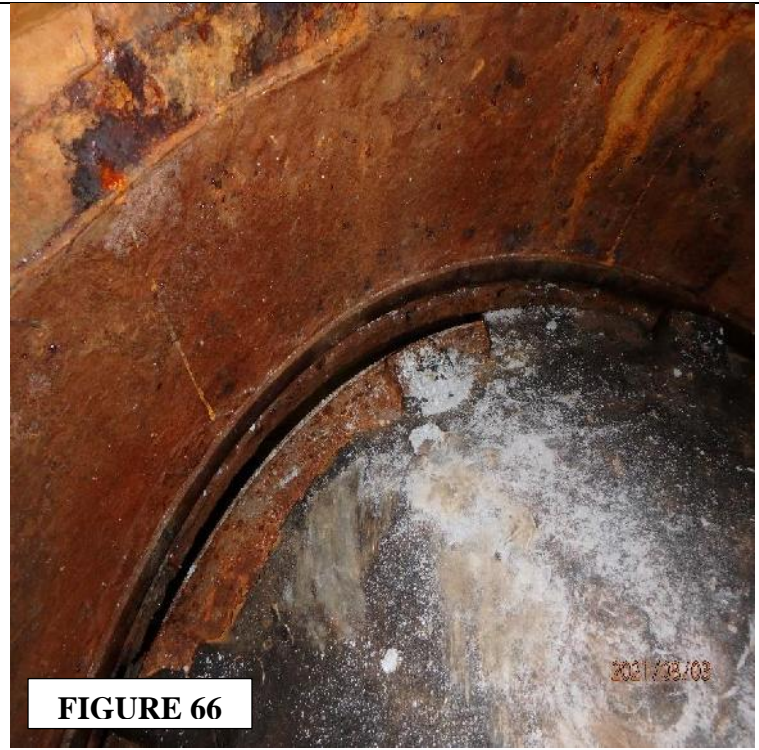
FIGURE 66

- The box was generally in good condition with minor coating breakdown and corrosion throughout, especially in corners, as seen in adjacent boxes. As well, a few larger pits were observed (**Figures 64, 66, 69, 70**)
- Manway door appeared to be heavily corroded, however would require additional cleaning for further assessment (**Figure 61**)
- Butterfly valve disc coating noted as being satisfactory (**Figure 67**)
- Door anode requires replacement, others in satisfactory condition (**Figure 61**)
- No corrosion of tubesheet was observed (**Figures 62, 68**)
- Minor corrosion noted in discharge piping (**Figures 63, 64**)

- Continue with inspections and regular maintenance of the water boxes, i.e., tube cleaning, debris removal, replacement of anodes
- Coating repairs should be considered due to the excessive breakdown and corrosion noted. These should be further assessed and repaired as necessary

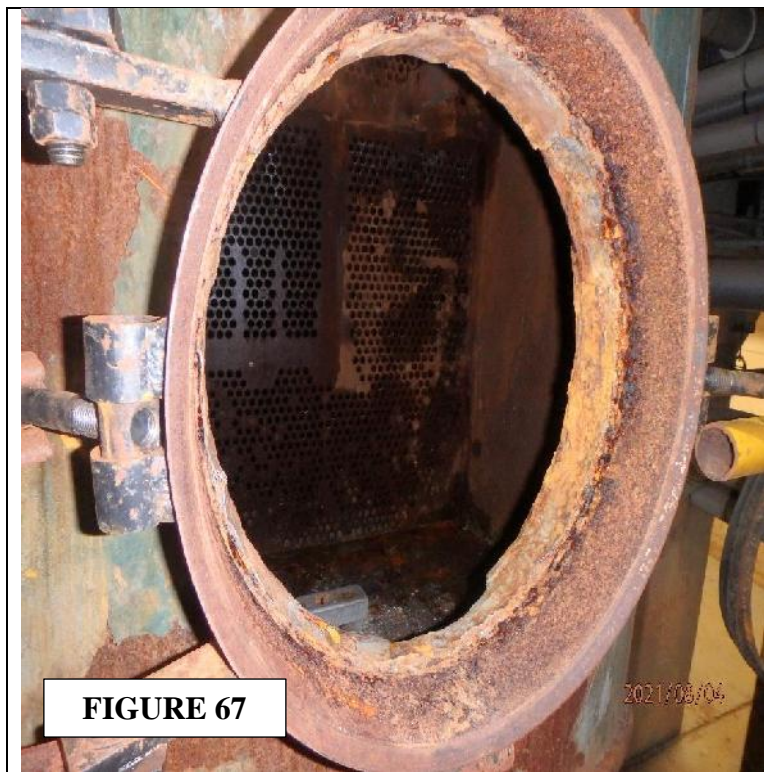
FIGURE 67

- The box was in poor condition with extensive coating breakdown and heavy corrosion throughout (**Figures 71-74**)
- Manways heavily corroded (**Figure 67**)
- Butterfly valve disc appeared to be in satisfactory condition
- One anode missing overhead, two newly installed, others deemed satisfactory (**Figure 68**)
- No corrosion of tubesheet was observed, with some debris noted in tubes
- Drain found to be corroded with no cover installed, valve satisfactory
- Debris from anode breakdown, as well, organic matter (**Figures 69, 70**)

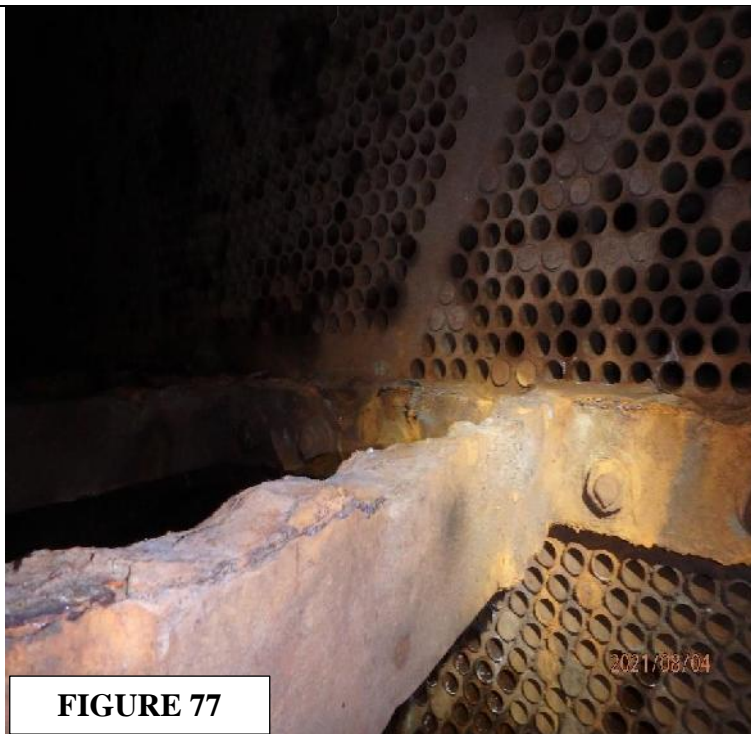
FIGURE 77

- The box was in poor condition with extensive coating breakdown and heavy corrosion throughout (**Figures 75, 76**)
- Manways heavily corroded (**Figure 82**)
- Butterfly valve disc appeared to be in satisfactory condition
- One anode missing overhead, two newly installed, others deemed satisfactory (**Figures 83, 84**)
- No corrosion of tubesheet was observed, however, some debris noted in tubes (**Figures 79, 81**)
- Drain found to be corroded with no cover installed, valve satisfactory (**Figure 80**)
- Debris from anode breakdown, as well, organic matter
- Extensive corrosion/erosion of supports (**Figures 77, 78**)

- Continue with regular inspections to monitor erosion of supports and the broken welds on the cross braces that extend horizontally between the two tube bundles, repair as necessary.
- Replace steam seal regulator piping next outage season due to the excessive erosion noted on the I.D. of the piping
- Replace corroded sections of vacuum reference line piping during next outage season to avoid failure
- During next outage season, repair discrepancy noted in the LP Heater extraction piping erosion shield

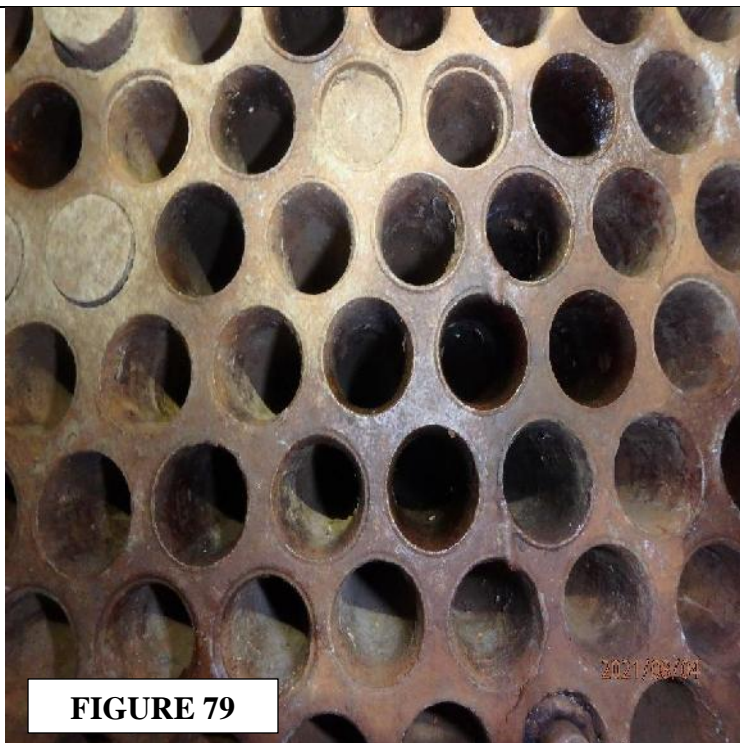
FIGURE 79

- The box was generally in good condition with minor coating breakdown and corrosion throughout, especially in corners, as seen in adjacent boxes. As well, a few larger pits were observed (**Figures 72, 79-82**)
- Manway door appeared to be heavily corroded, however would require additional cleaning for further assessment (**Figure 71**)
- Butterfly valve disc coating failure and corrosion noted (**Figures 83, 84**)
- Anodes – breakdown of door anode noted, internal anode found to be satisfactory (**Figure 71**)
- No corrosion of tubesheet was observed
- Corrosion and blistering noted at inlet to discharge piping (**Figures 73-78**)

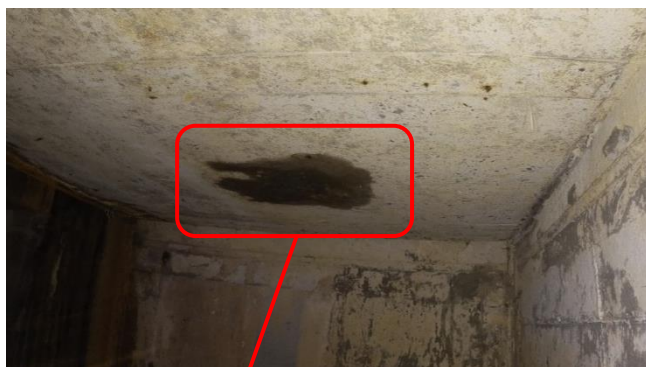
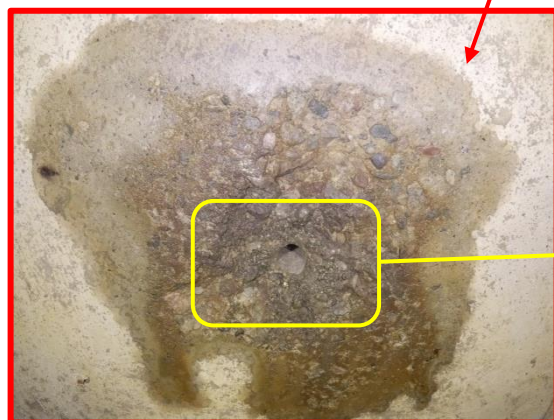
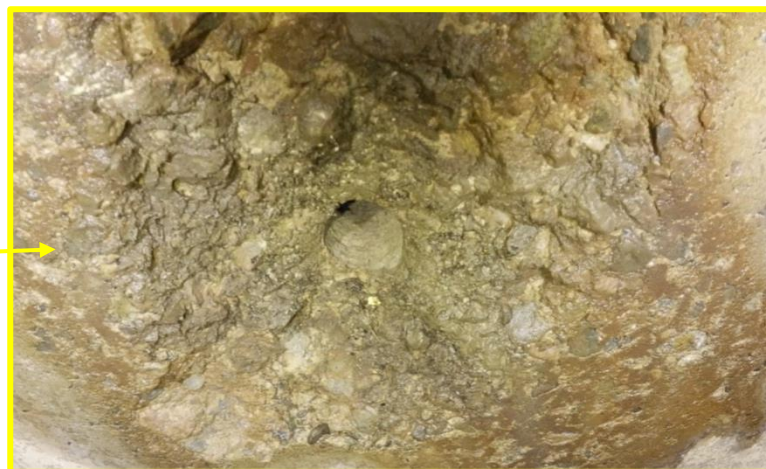
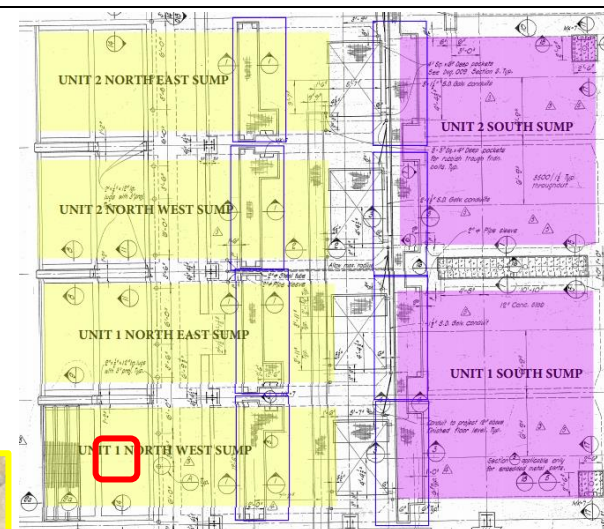
Anomaly (Y/N)	ID	Component	Component Tag	Type of Anomaly	Deg of Corrosion	Module	Level	Heat Map	Comments
Y	-	-	-	Deterioration	-	-	-	-	Hole in the center area as seen in highlighted close-up picture

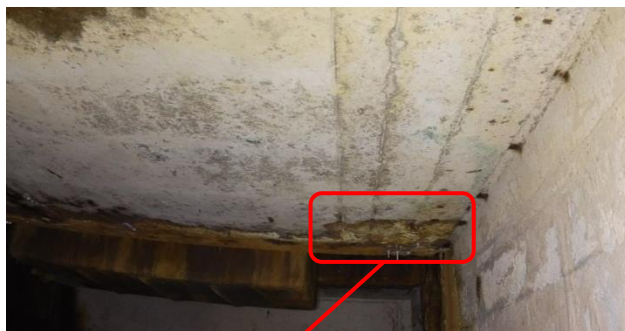
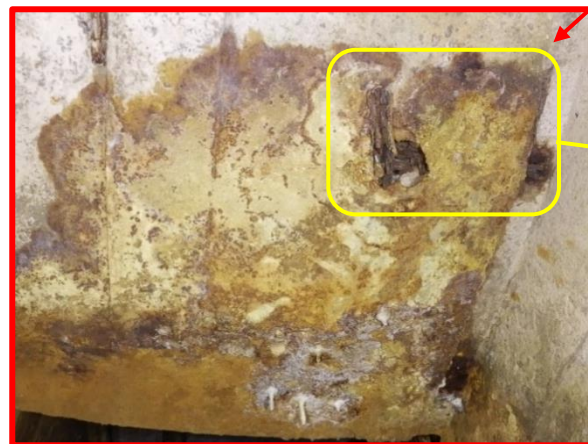
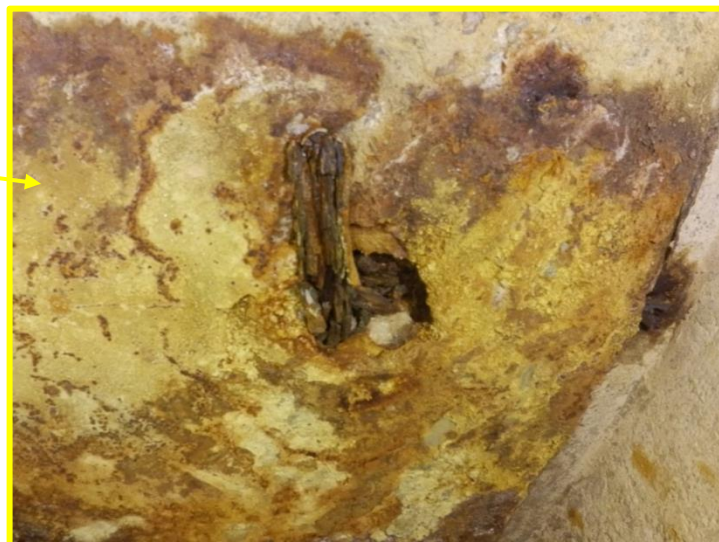
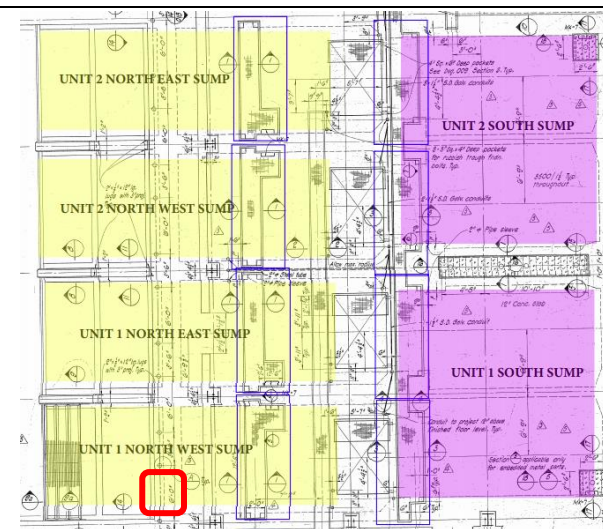
Anomaly (Y/N)	ID	Component	Component Tag	Type of Anomaly	Deg of Corrosion	Module	Level	Heat Map	Comments
Y	-	-	-	Deterioration of concrete	-	-	-	-	Hole forming as seen in highlighted picture rebar visible through the concrete.

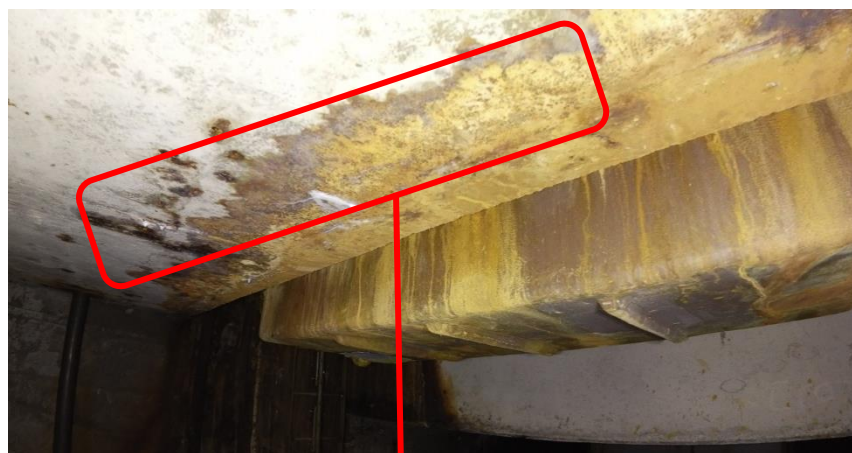
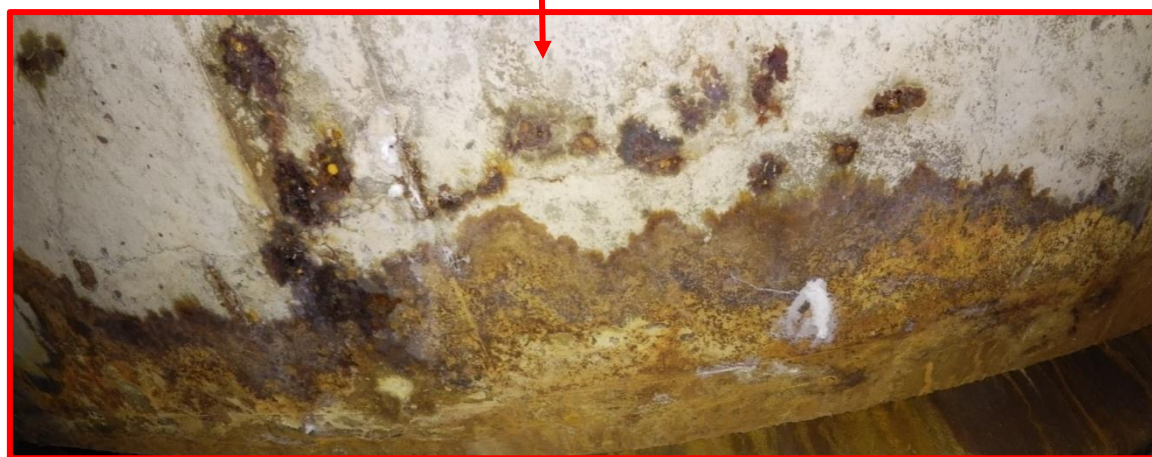
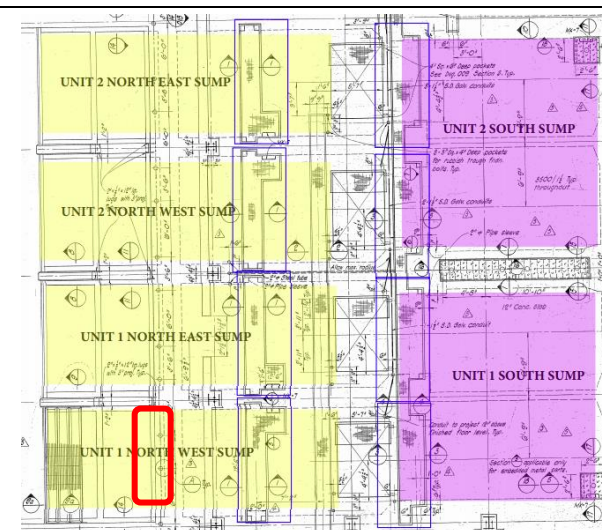
Anomaly (Y/N)	ID	Component	Component Tag	Type of Anomaly	Deg of Corrosion	Module	Level	Heat Map	Comments
Y	-	-	-	Deterioration of concrete	-	-	-	-	Typical of what is seen throughout

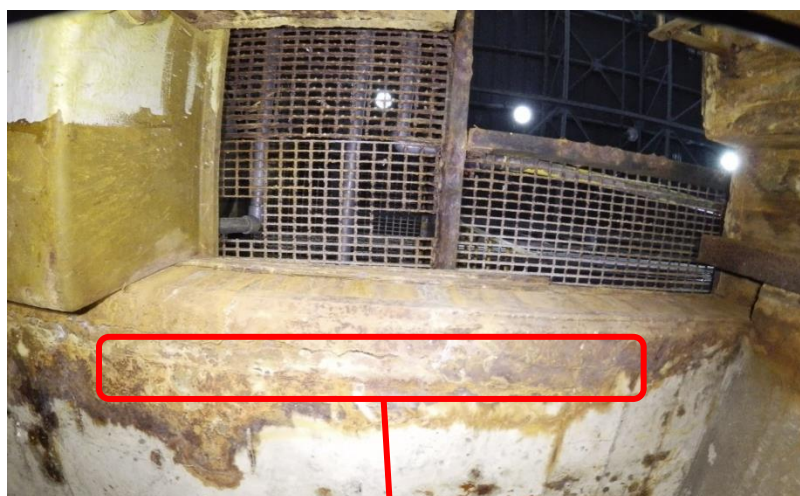
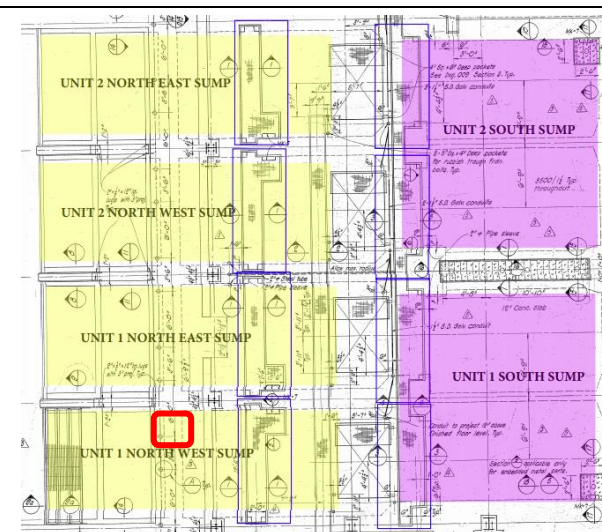
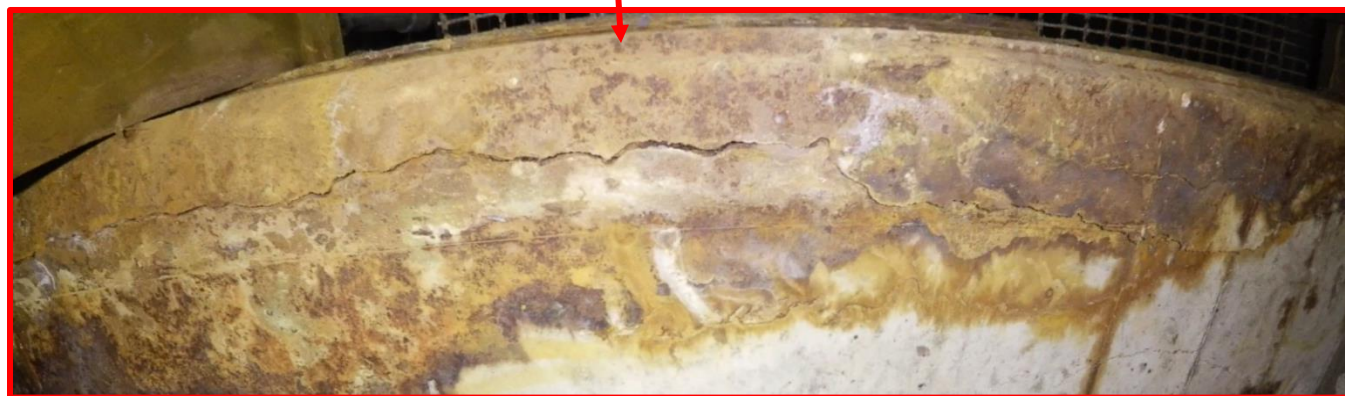
Anomaly (Y/N)	ID	Component	Component Tag	Type of Anomaly	Deg of Corrosion	Module	Level	Heat Map	Comments
Y	-	-	-	Crack	-	-	-	-	Crack formed near an entry access point

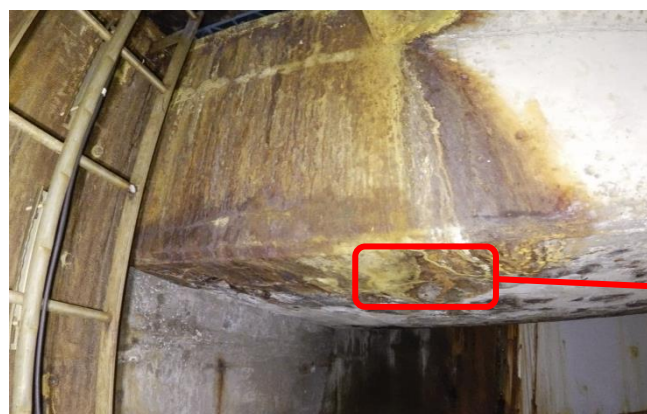
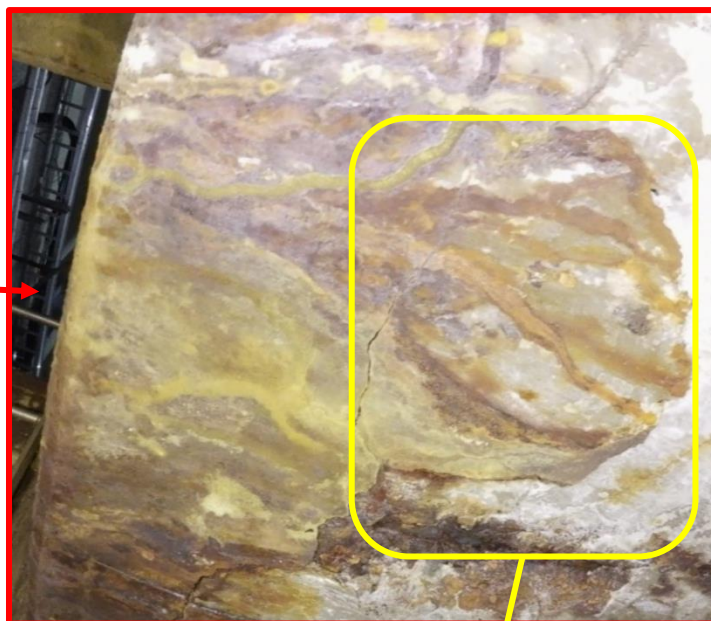
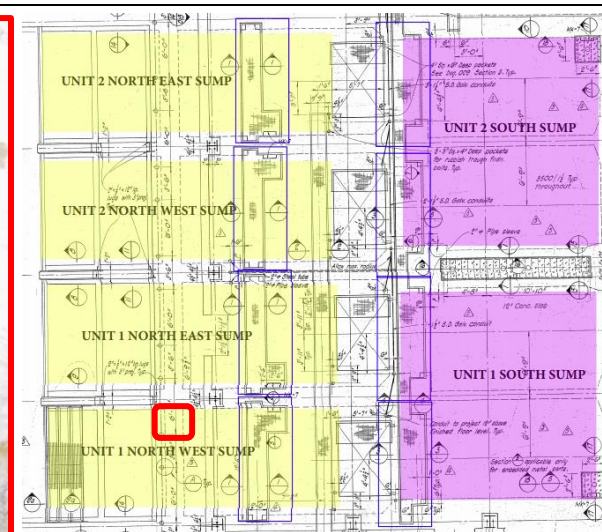
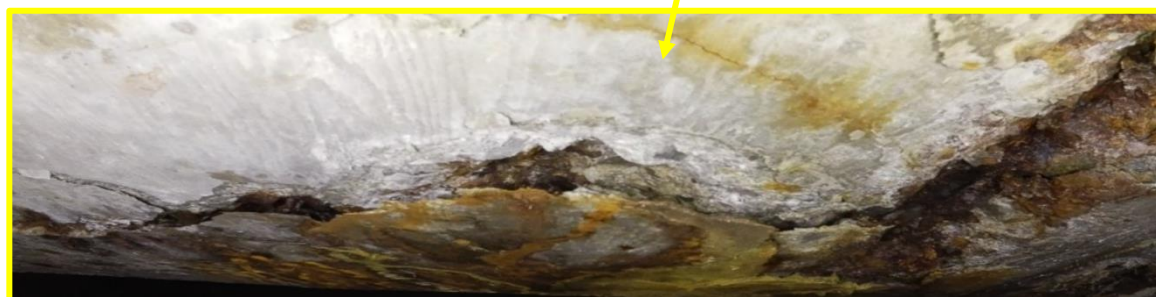
Anomaly (Y/N)	ID	Component	Component Tag	Type of Anomaly	Deg of Corrosion	Module	Level	Heat Map	Comments
Y	-	-	-	Deterioration of concrete	-	-	-	-	Delamination of concrete and corrosion of rebar

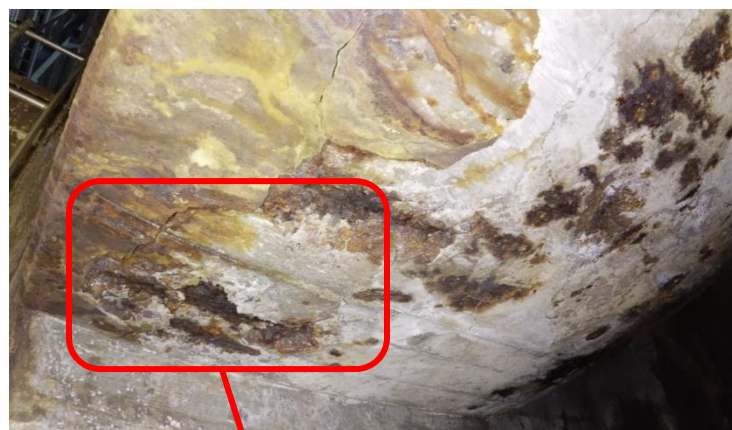
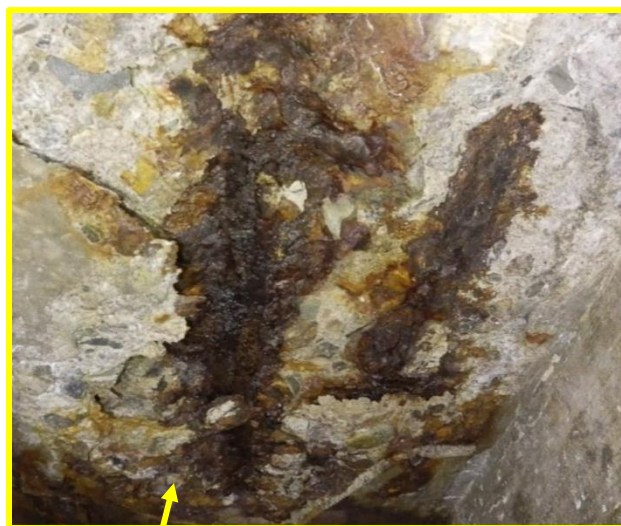
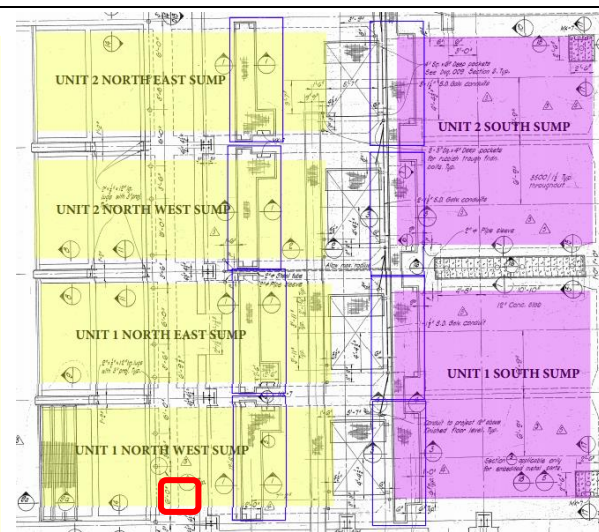
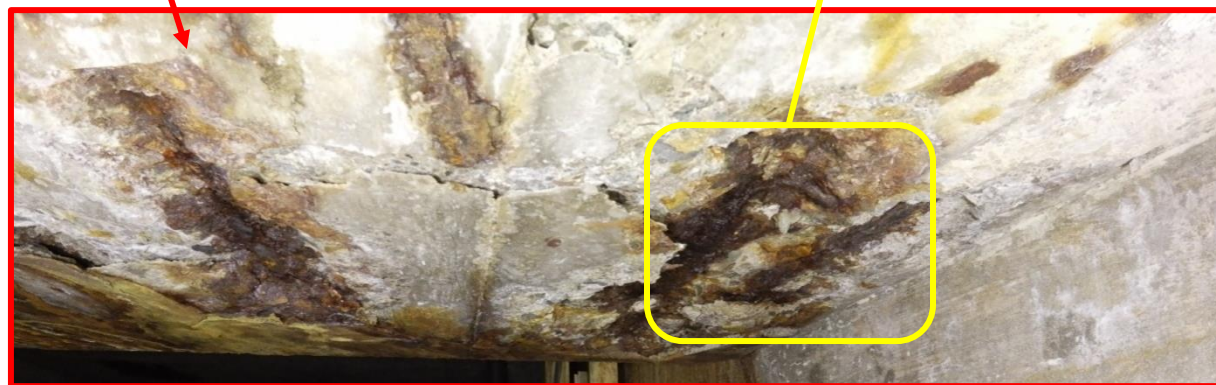
Anomaly (Y/N)	ID	Component	Component Tag	Type of Anomaly	Deg of Corrosion	Module	Level	Heat Map	Comments
Y	-	-	-	Deterioration of concrete	-	-	-	-	Concrete is deteriorating. Exposed rebar corrosion

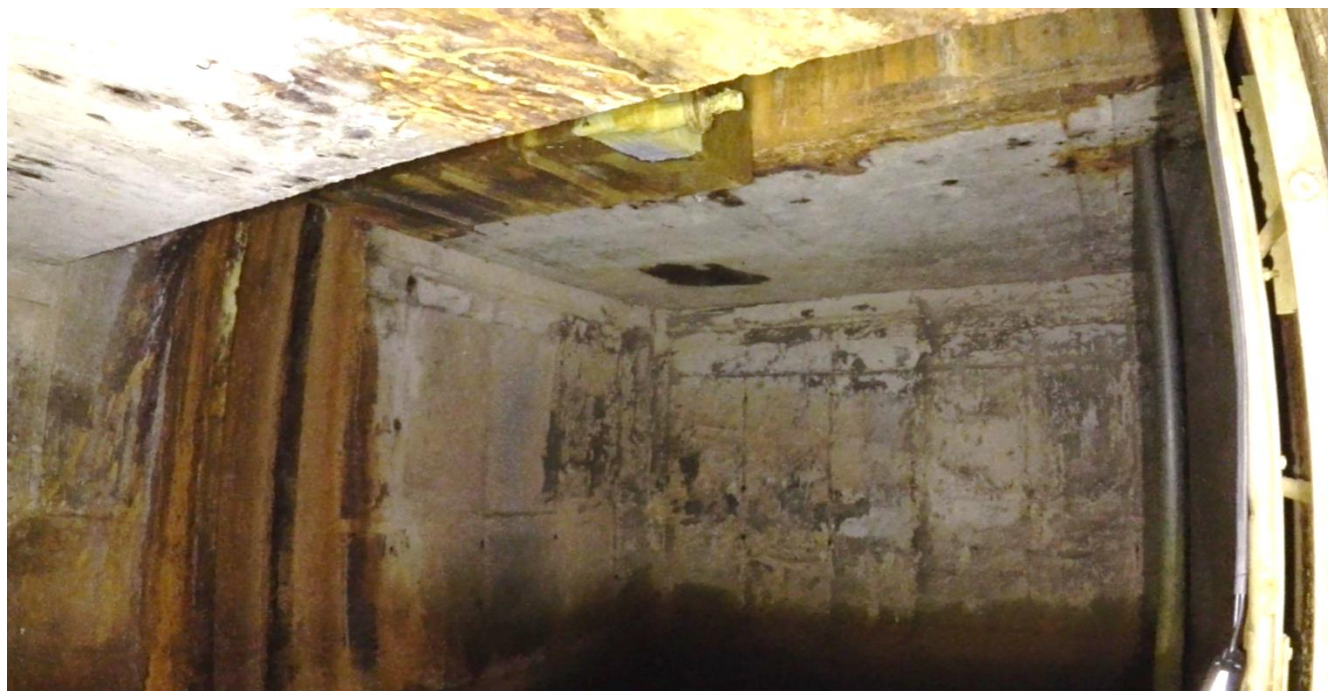
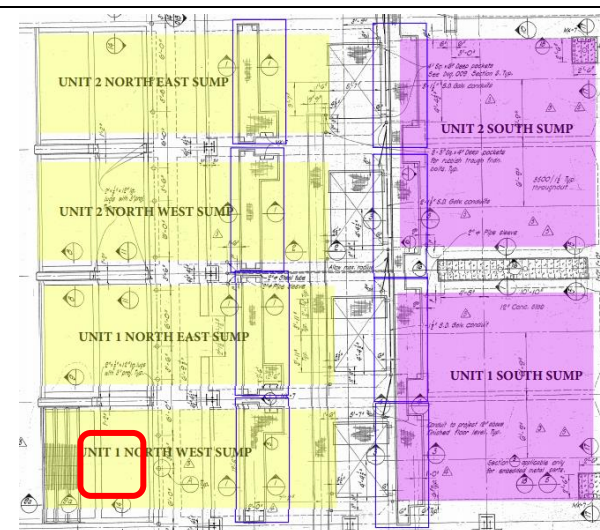
Anomaly (Y/N)	ID	Component	Component Tag	Type of Anomaly	Deg of Corrosion	Module	Level	Heat Map	Comments
N	-	-	-	-	-	-	-	-	Standoff of north end of the tank

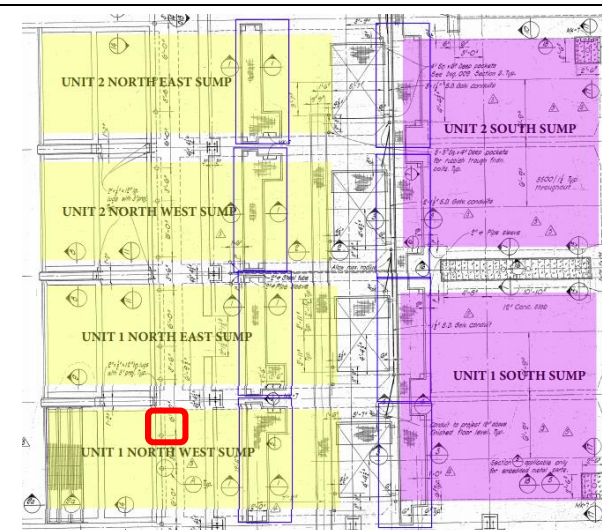
Anomaly (Y/N)	ID	Component	Component Tag	Type of Anomaly	Deg of Corrosion	Module	Level	Heat Map	Comments
Y	-	-	-	-	-	-	-	-	Standoff of entry access point. Deterioration of concrete present throughout

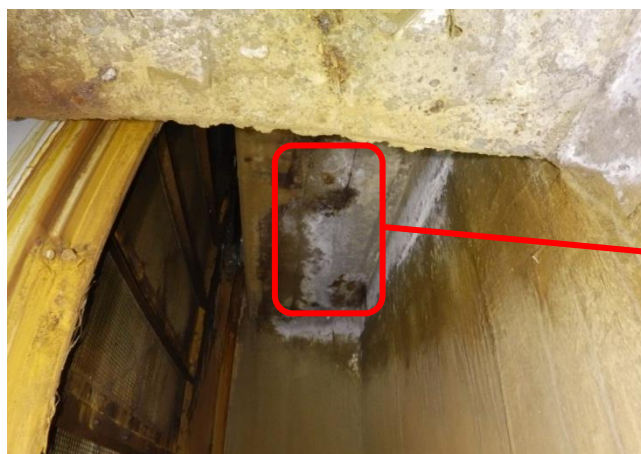
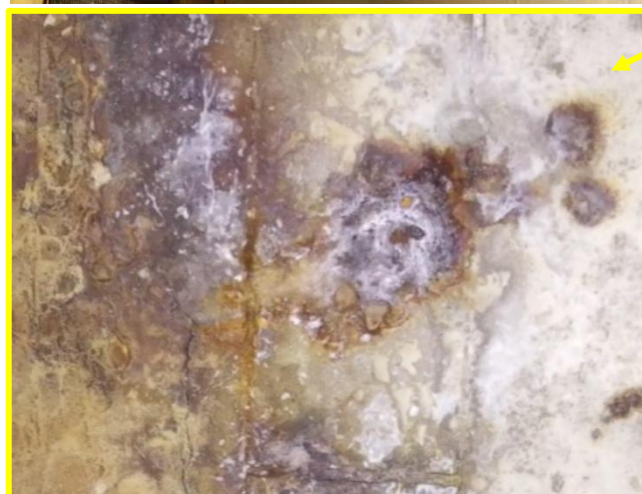
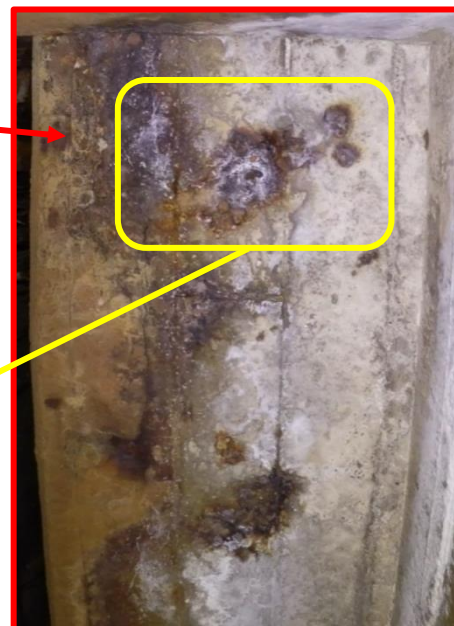
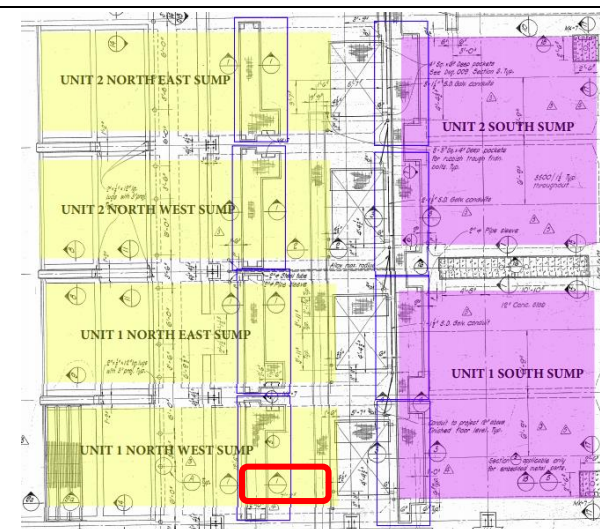
Anomaly (Y/N)	ID	Component	Component Tag	Type of Anomaly	Deg of Corrosion	Module	Level	Heat Map	Comments
Y	-	-	-	Deterioration of concrete	-	-	-	-	Concrete is deteriorating. Typical of what is seen throughout

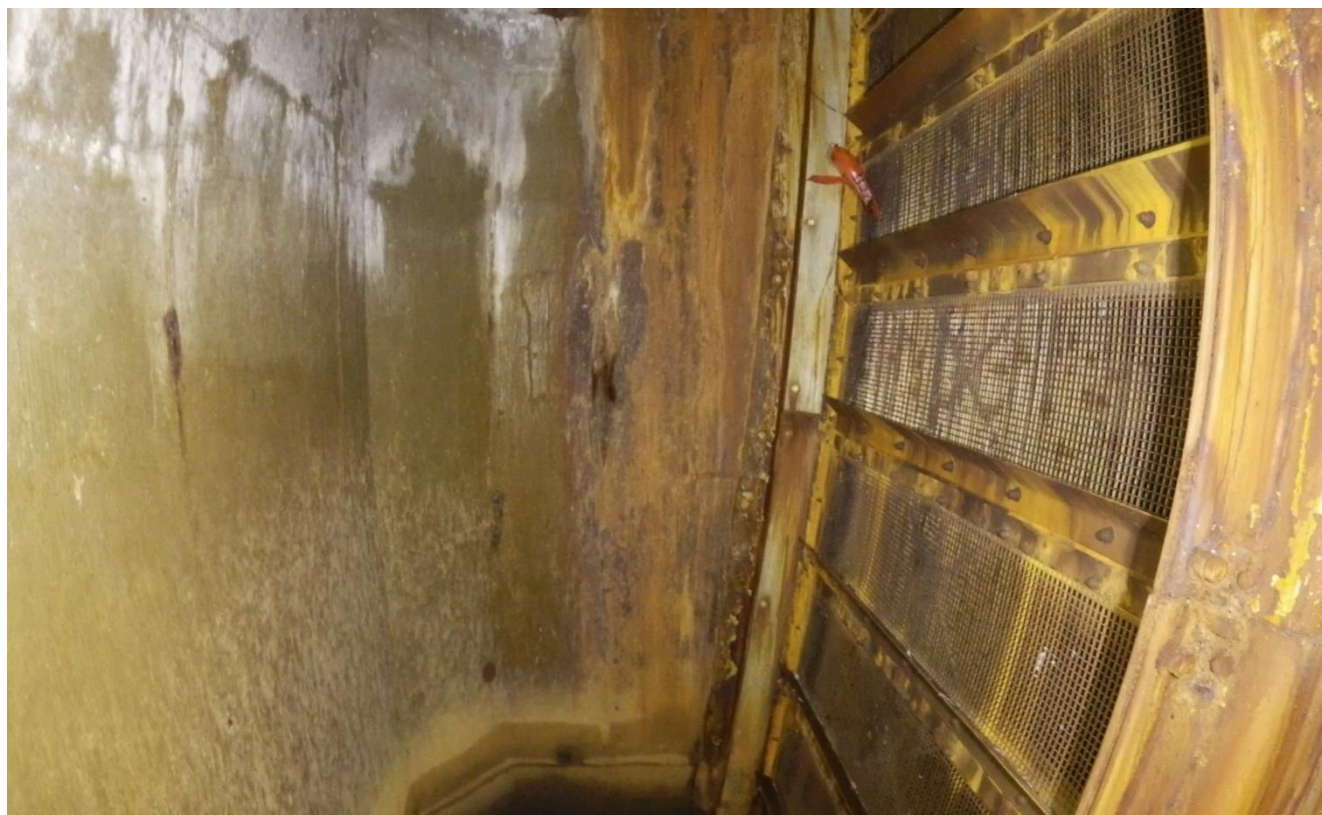
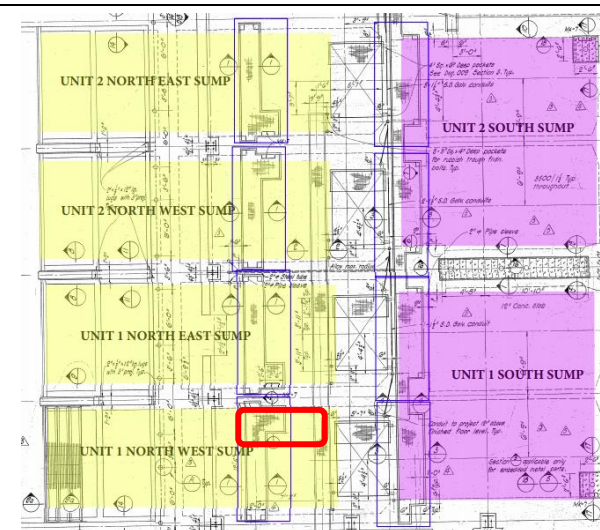
Anomaly (Y/N)	ID	Component	Component Tag	Type of Anomaly	Deg of Corrosion	Module	Level	Heat Map	Comments
N	-	-	-	-	-	-	-	-	Standoff of travelling screens. Deterioration of concrete present throughout

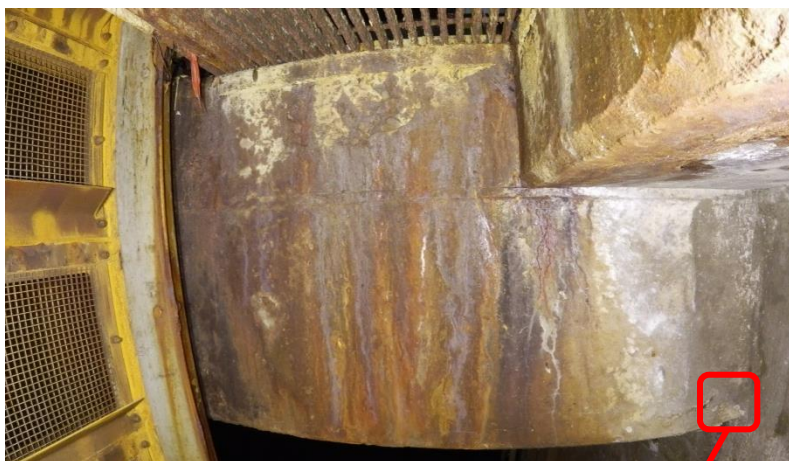
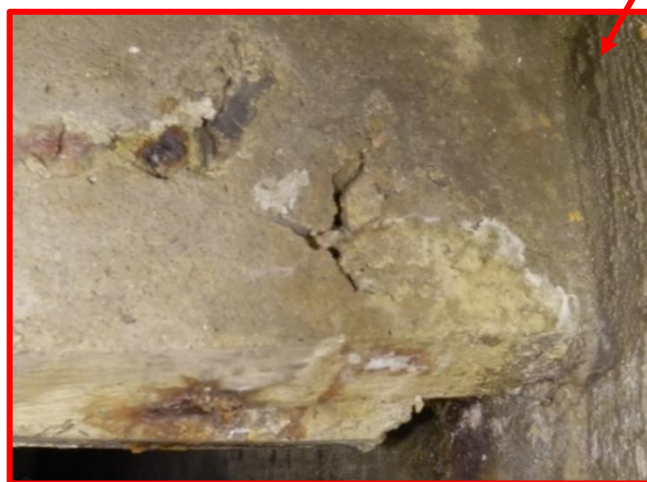
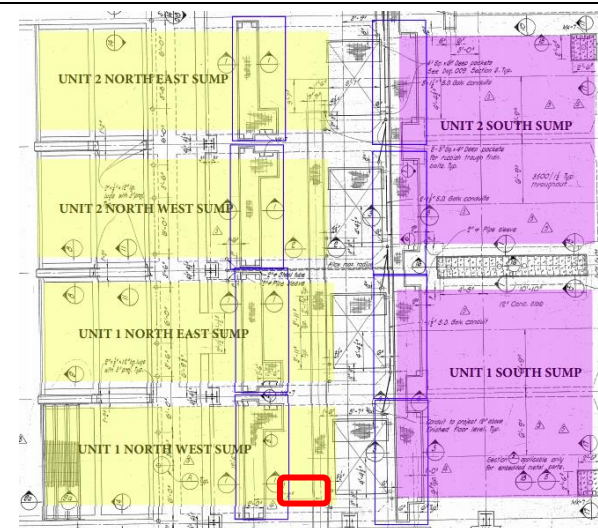
Anomaly (Y/N)	ID	Component	Component Tag	Type of Anomaly	Deg of Corrosion	Module	Level	Heat Map	Comments
Y	-	-	-	Crack	-	-	-	-	Crack formed in corner of cross beam

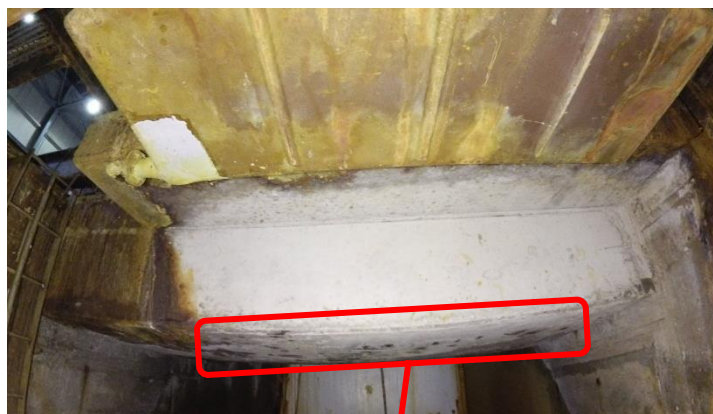
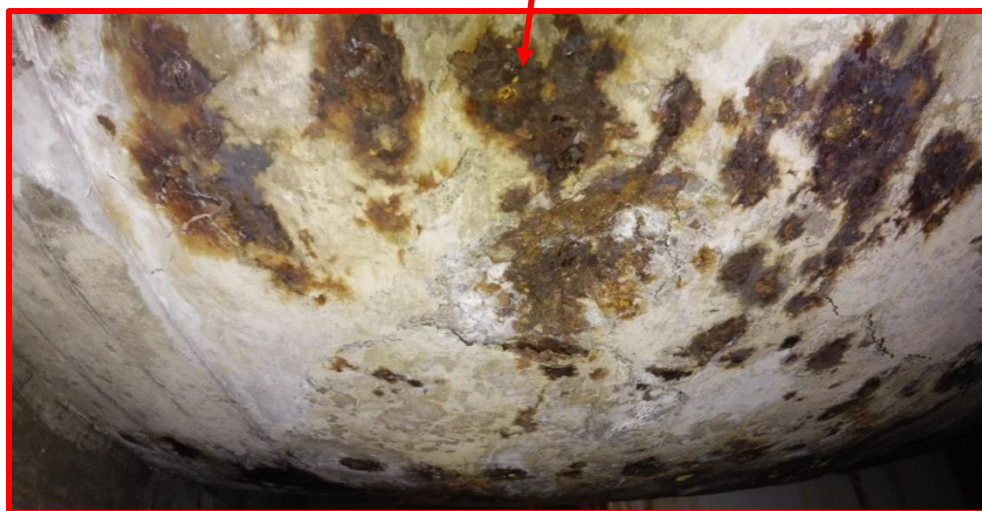
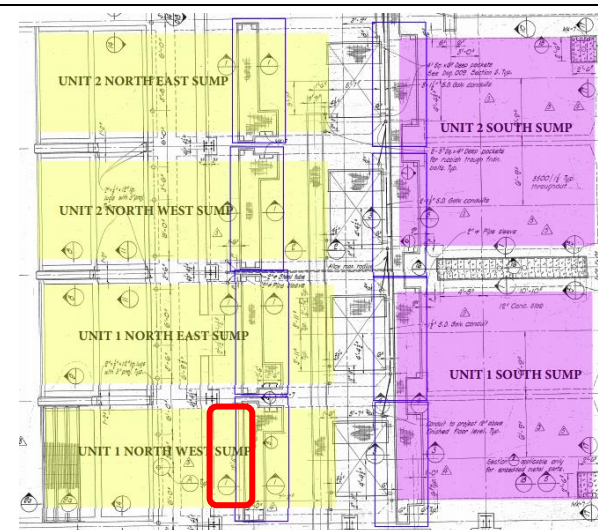
Anomaly (Y/N)	ID	Component	Component Tag	Type of Anomaly	Deg of Corrosion	Module	Level	Heat Map	Comments
Y	-	-	-	Deterioration of concrete	-	-	-	-	General overview of ceiling towards the south end Typical of what is seen throughout

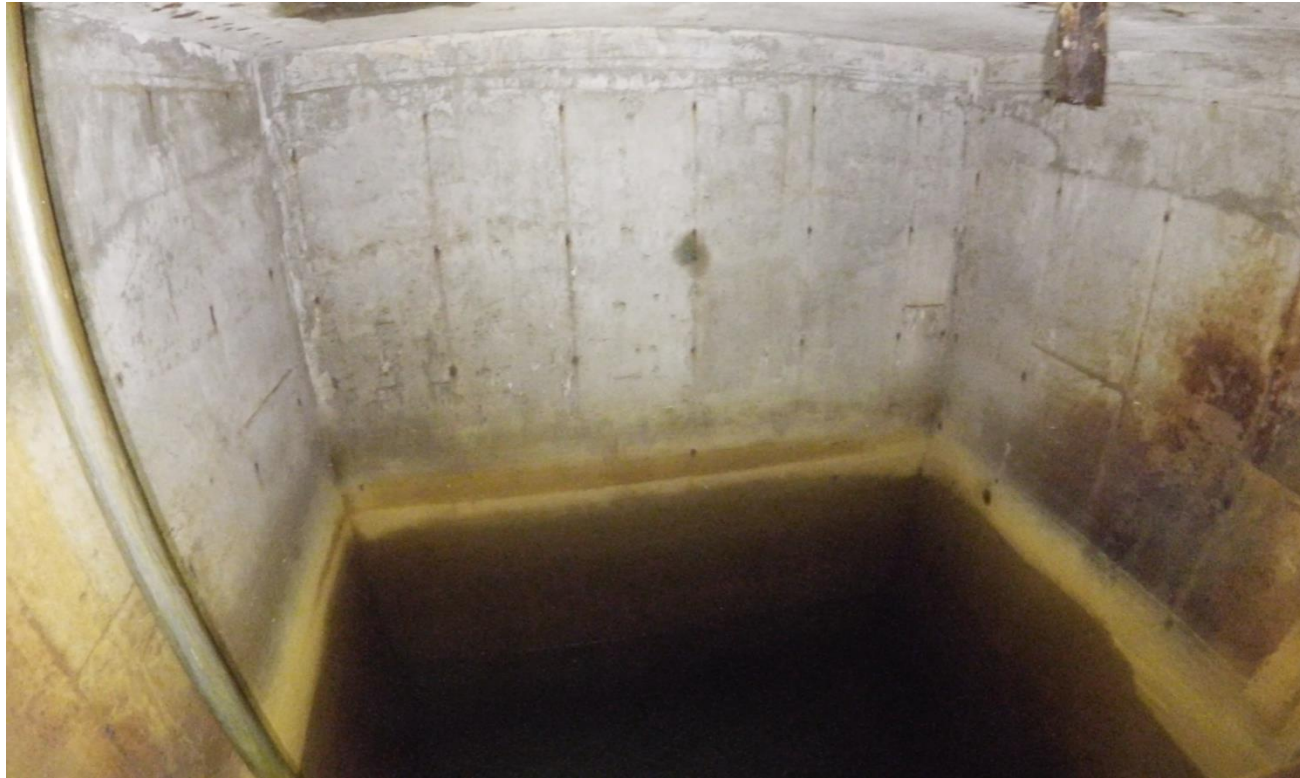
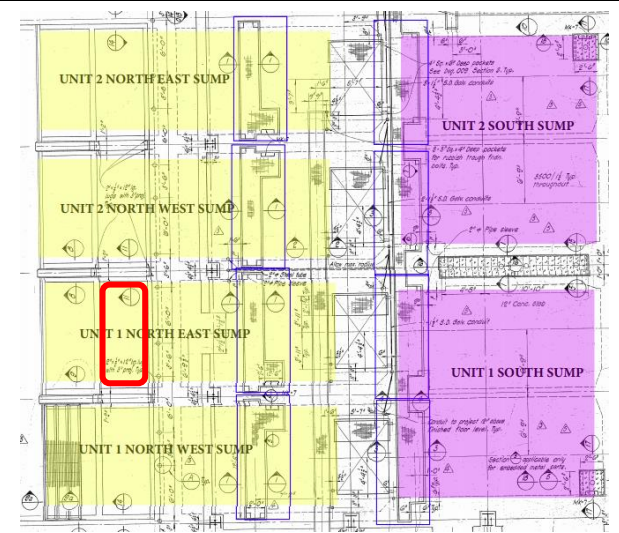
Anomaly (Y/N)	ID	Component	Component Tag	Type of Anomaly	Deg of Corrosion	Module	Level	Heat Map	Comments
N	-	-	-	-	-	-	-	-	Stand off of North End of sump
