Re: *Reliability and Resource Adequacy Study Review - Assessment to Determine the Potential Long-Term Viability of the Holyrood Thermal Generating Station*

Holyrood Thermal Generating Station Condition Assessment

**Newfoundland and Labrador Hydro
HTGS Condition Assessment and Life Extension Study
Executive Summary**

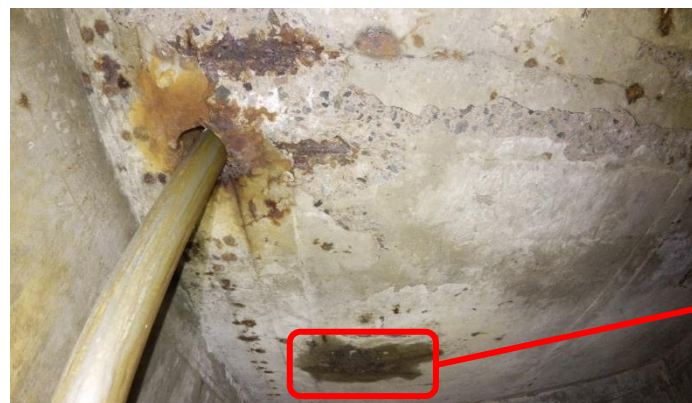
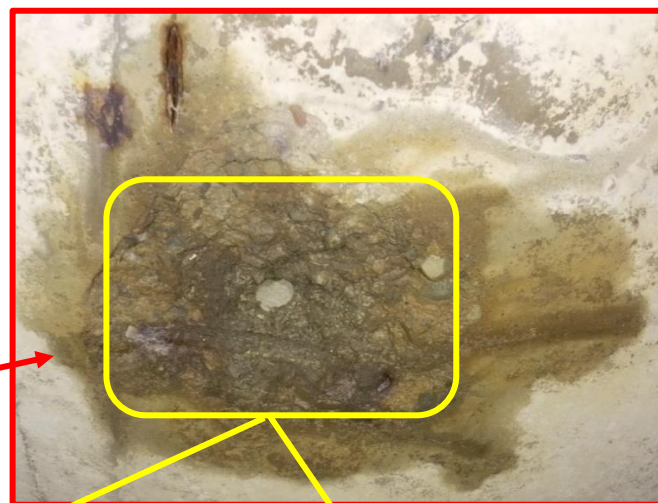
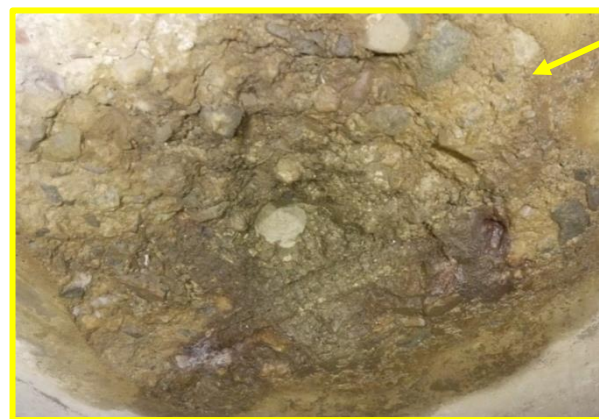
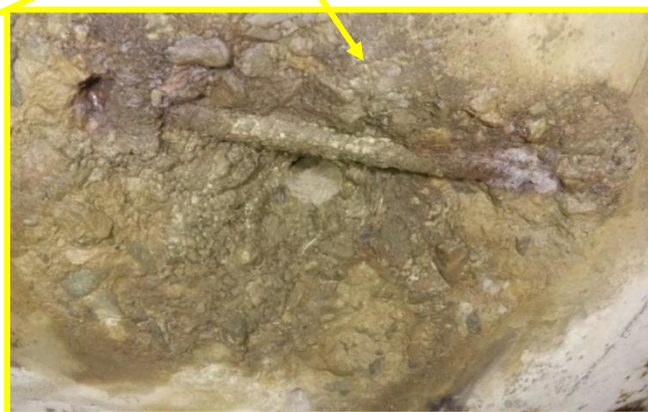
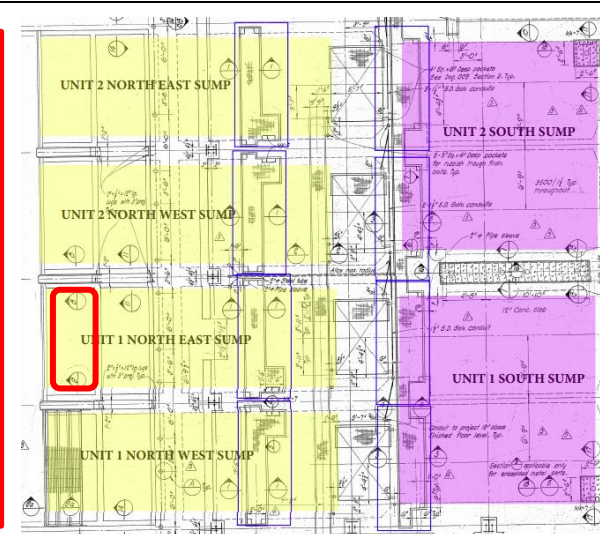
Anomaly (Y/N)	ID	Component	Component Tag	Type of Anomaly	Deg of Corrosion	Module	Level	Heat Map	Comments
Y	-	-	-	Deterioration of concrete	-	-	-	-	Heavy deterioration of concrete in the north end.

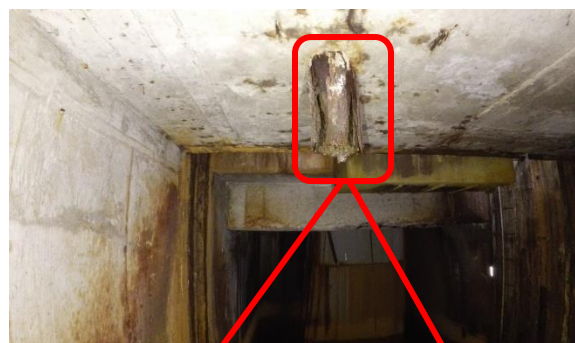
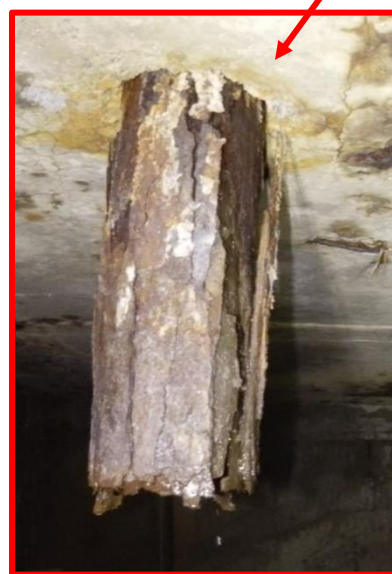
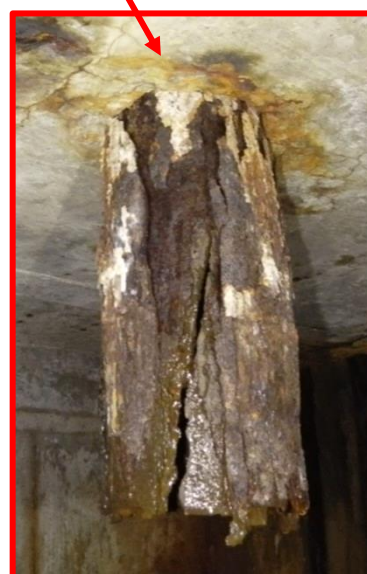
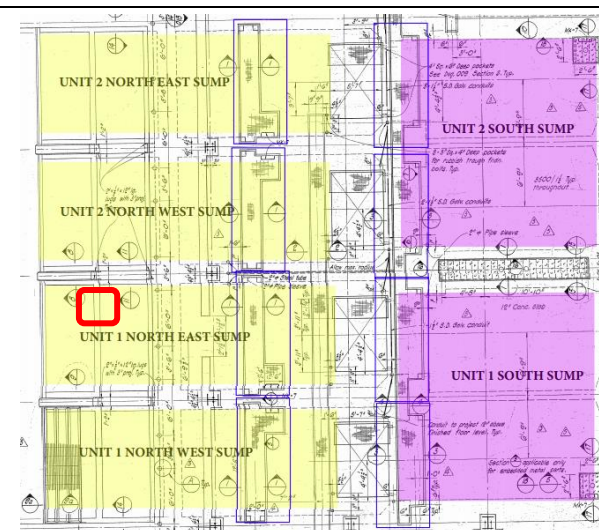
Anomaly (Y/N)	ID	Component	Component Tag	Type of Anomaly	Deg of Corrosion	Module	Level	Heat Map	Comments
Y	-	-	-	Corrosion	-	-	-	-	Severely corroded pipe

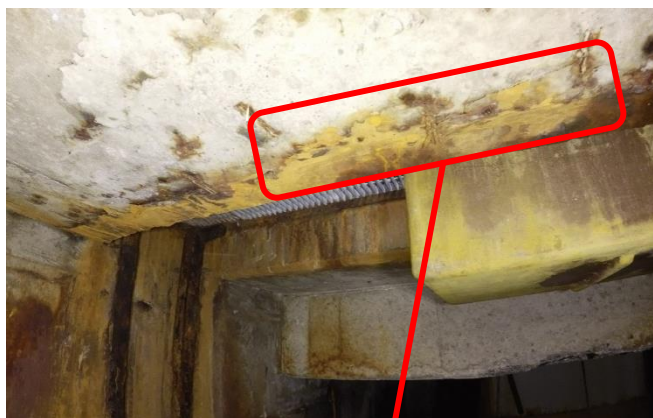
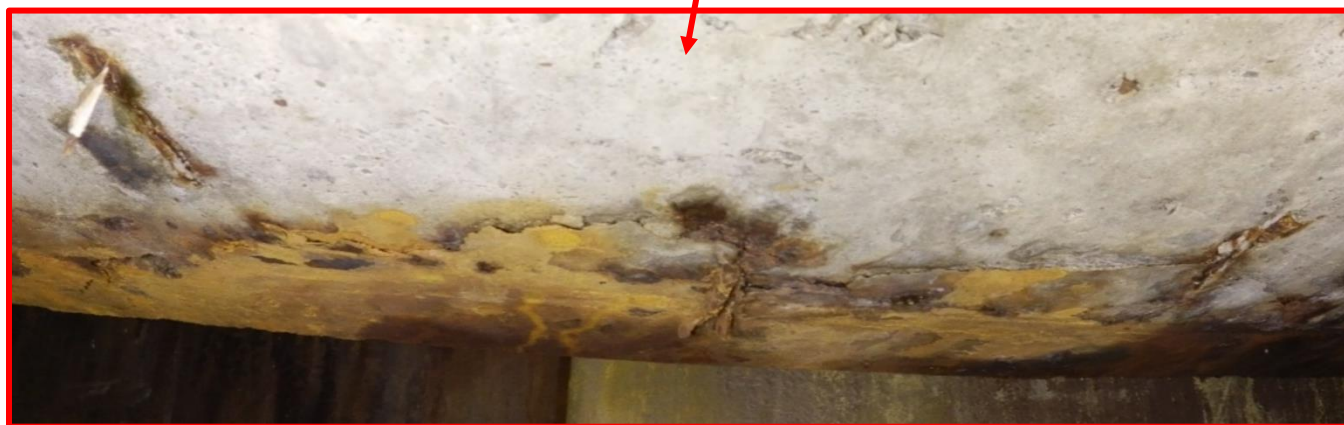
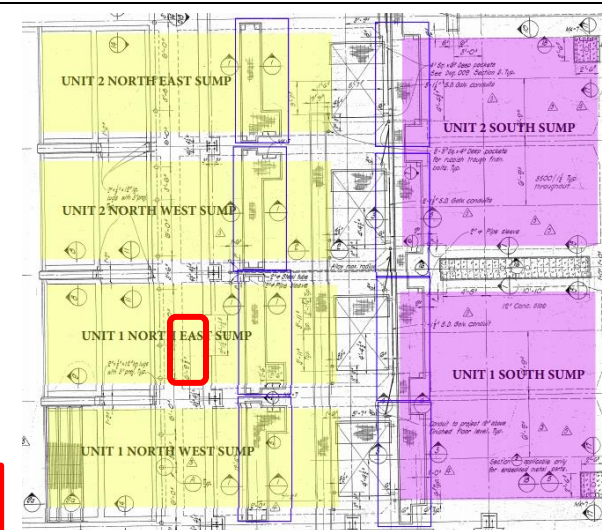
Anomaly (Y/N)	ID	Component	Component Tag	Type of Anomaly	Deg of Corrosion	Module	Level	Heat Map	Comments
Y	-	-	-	Deterioration of concrete	-	-	-	-	Delamination of concrete

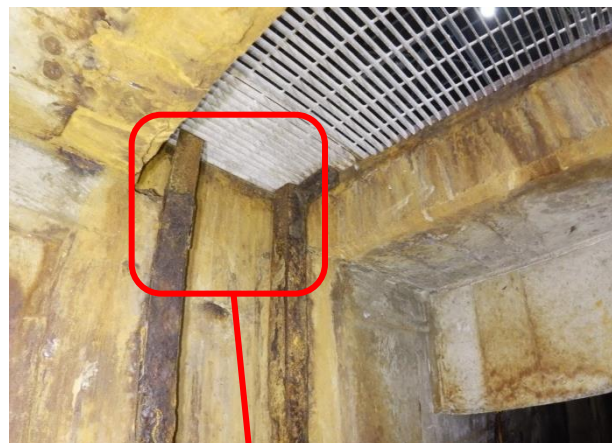
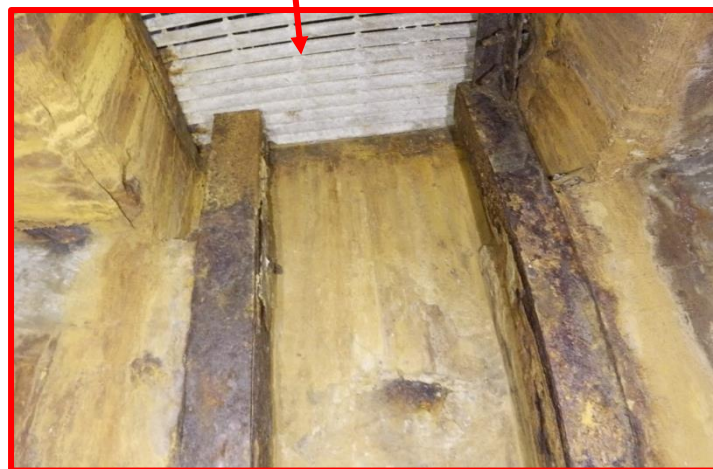
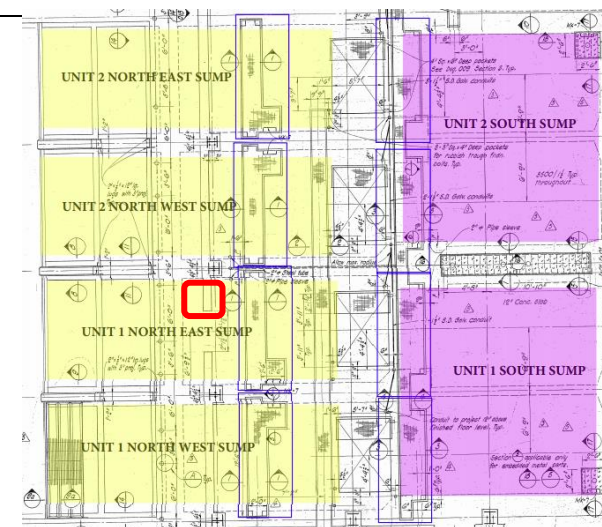
Anomaly (Y/N)	ID	Component	Component Tag	Type of Anomaly	Deg of Corrosion	Module	Level	Heat Map	Comments
Y	-	-	-	Corrosion	-	-	-	-	Corrosion of steel and deterioration of concrete at edge

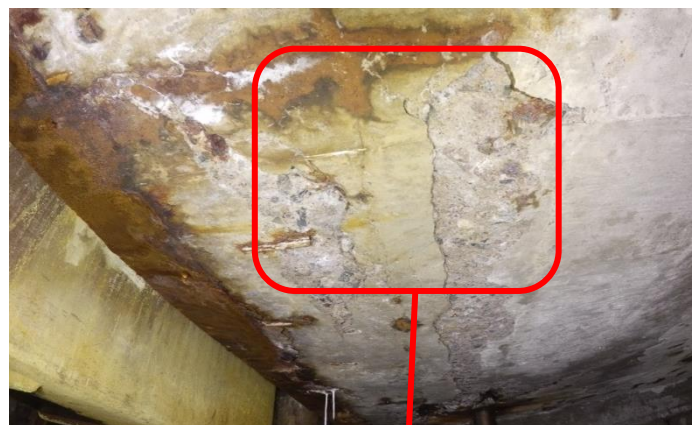
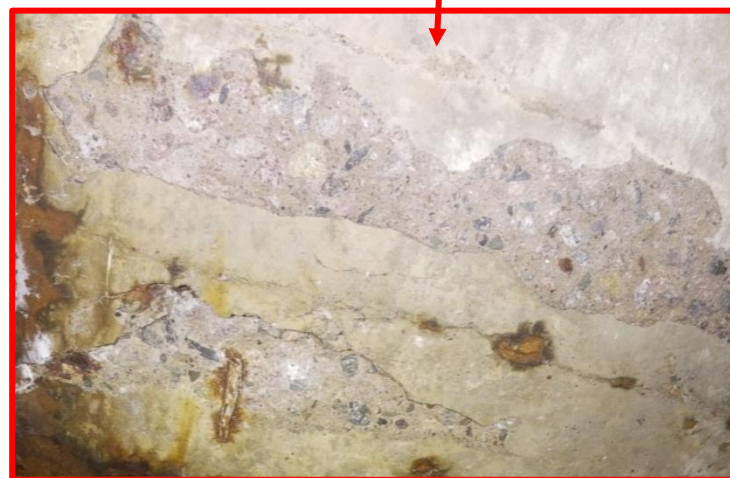
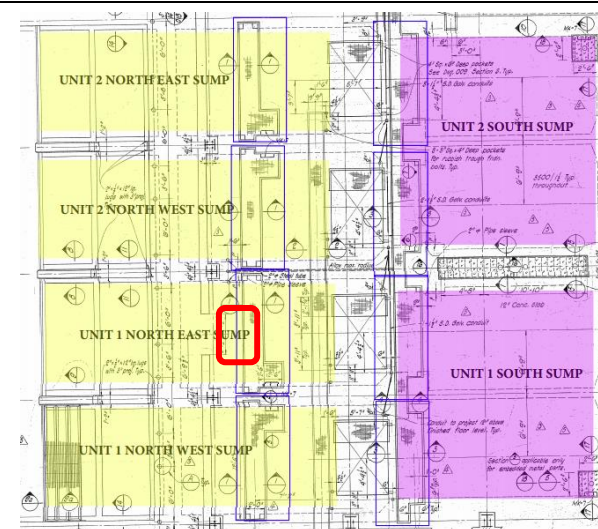
Anomaly (Y/N)	ID	Component	Component Tag	Type of Anomaly	Deg of Corrosion	Module	Level	Heat Map	Comments
Y	-	-	-	Deterioration of concrete	-	-	-	-	Spalling of concrete towards south of tank

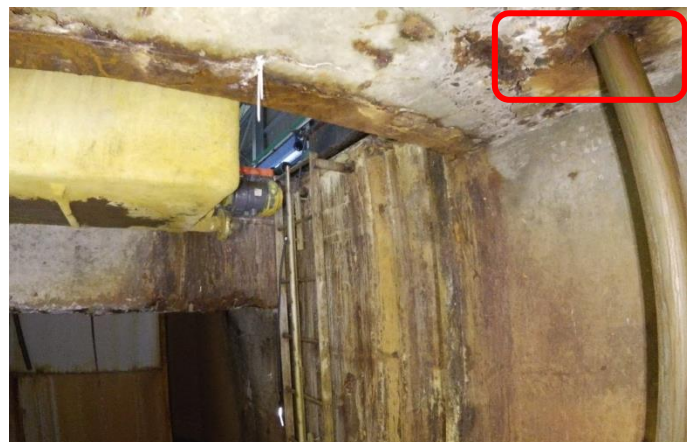
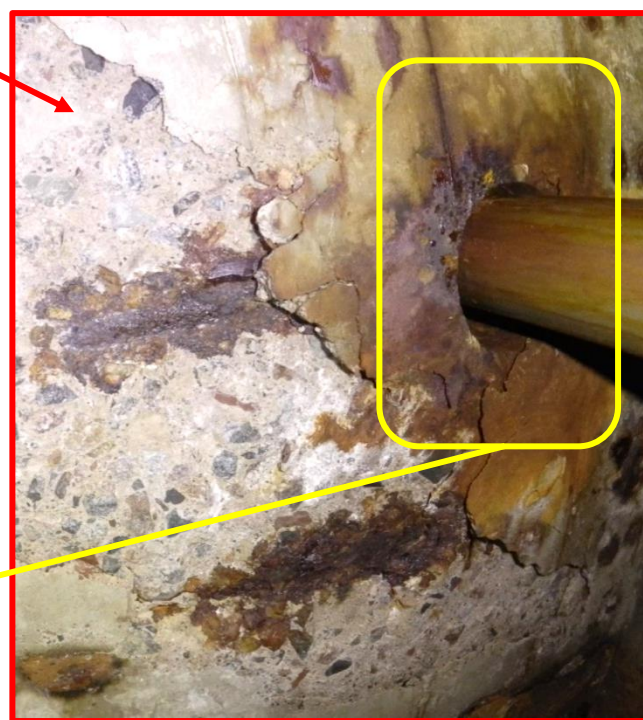
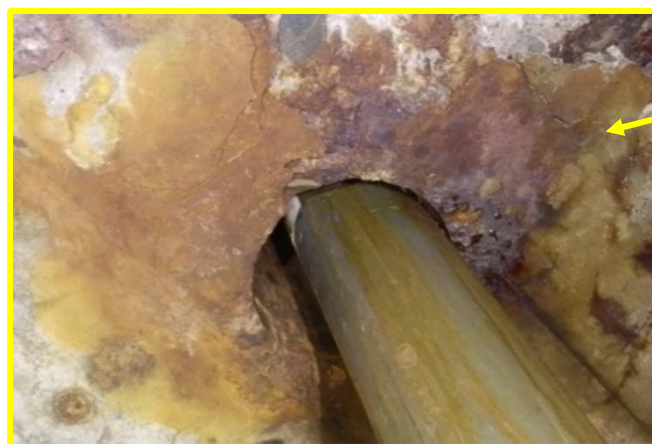
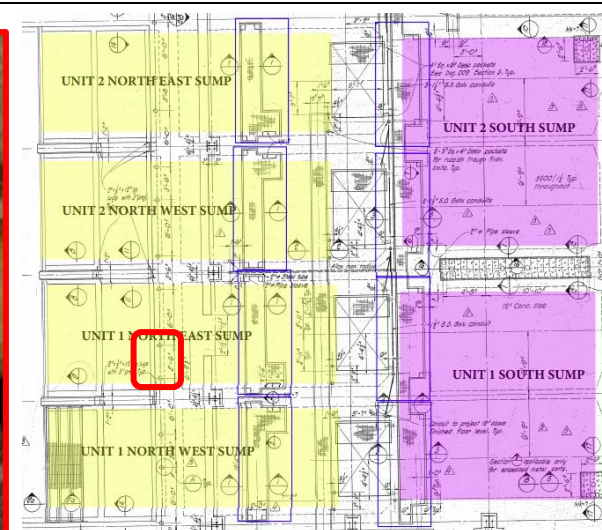
Anomaly (Y/N)	ID	Component	Component Tag	Type of Anomaly	Deg of Corrosion	Module	Level	Heat Map	Comments
Y	-	-	-	Deterioration of concrete	-	-	-	-	Spalling of concrete around penetration along with corrosion of exposed rebar.

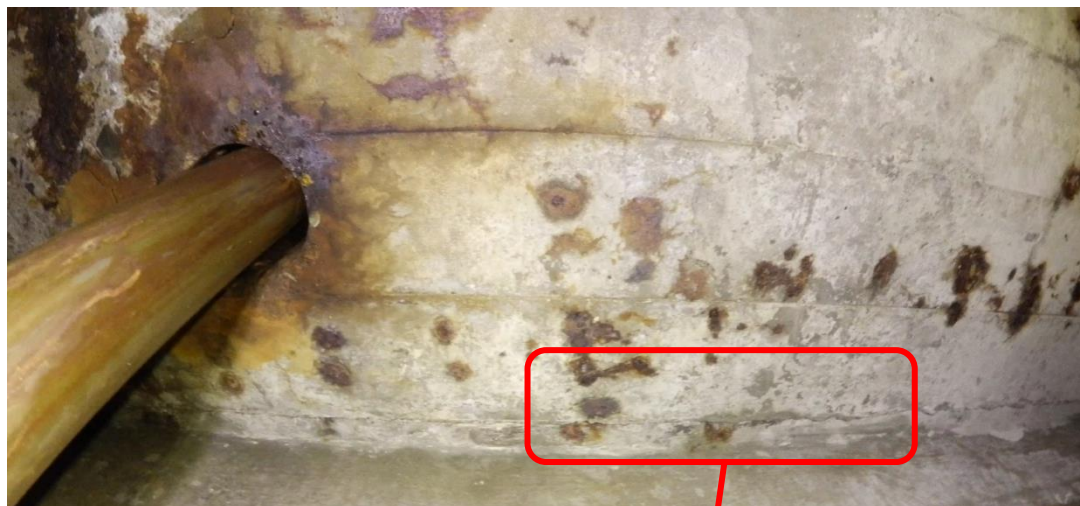
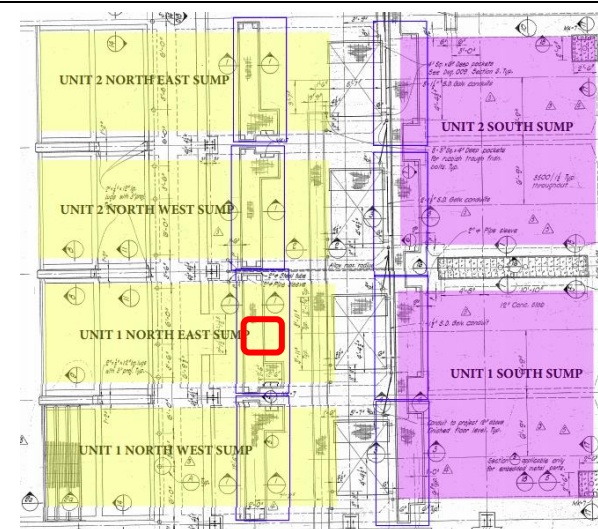
Anomaly (Y/N)	ID	Component	Component Tag	Type of Anomaly	Deg of Corrosion	Module	Level	Heat Map	Comments
Y	-	-	-	Crack	-	-	-	-	Cracking along west wall

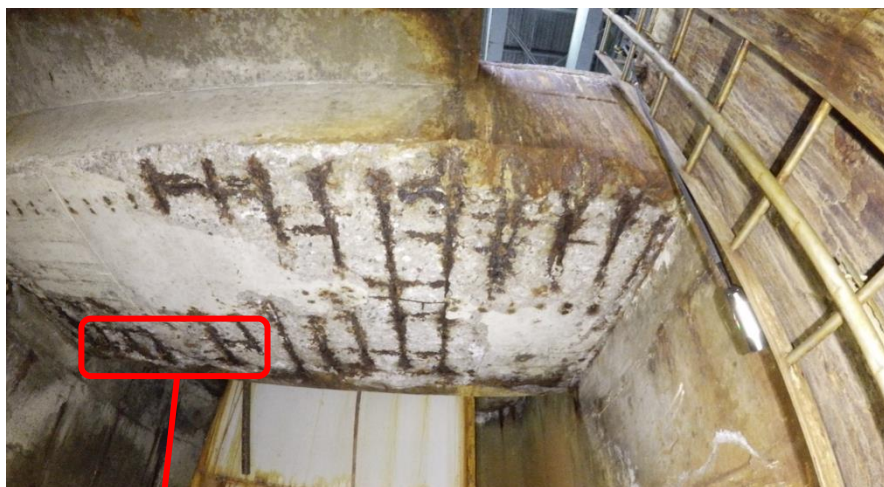
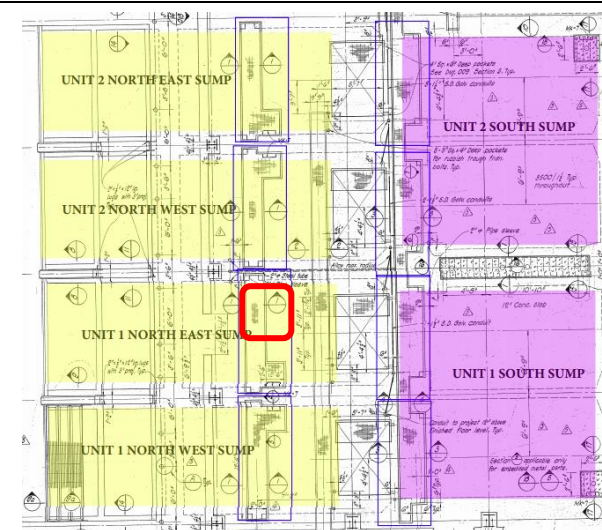
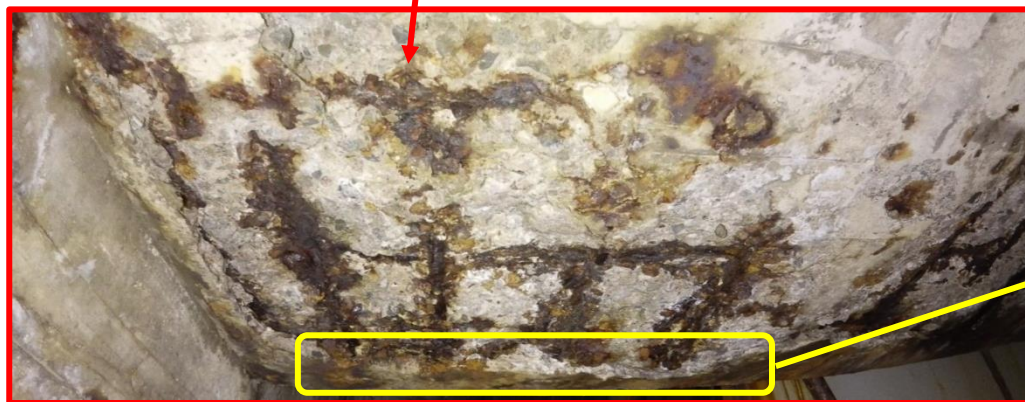
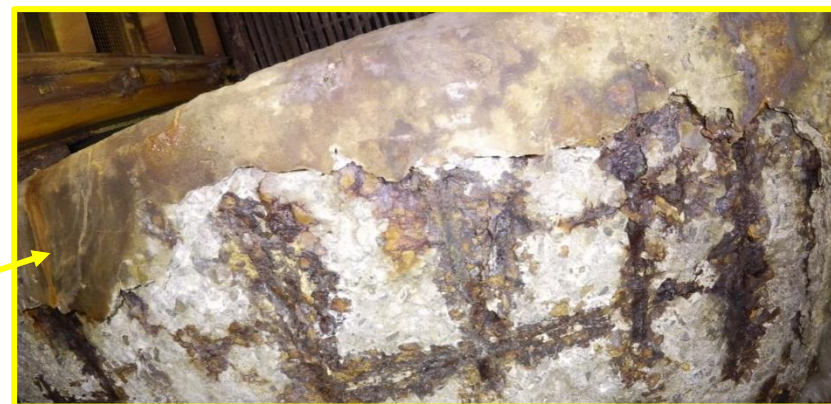
Anomaly (Y/N)	ID	Component	Component Tag	Type of Anomaly	Deg of Corrosion	Module	Level	Heat Map	Comments
Y	-	-	-	Deterioration of concrete	-	-	-	-	Spalling of concrete and corrosion of exposed rebar

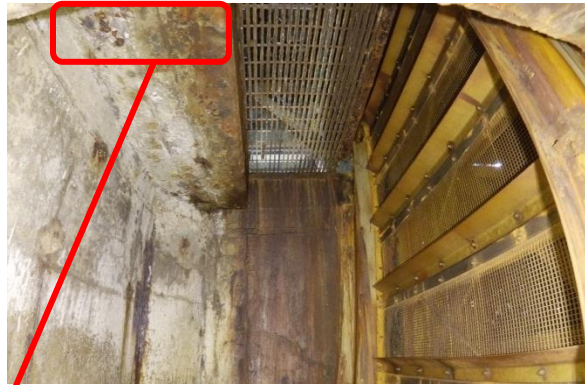
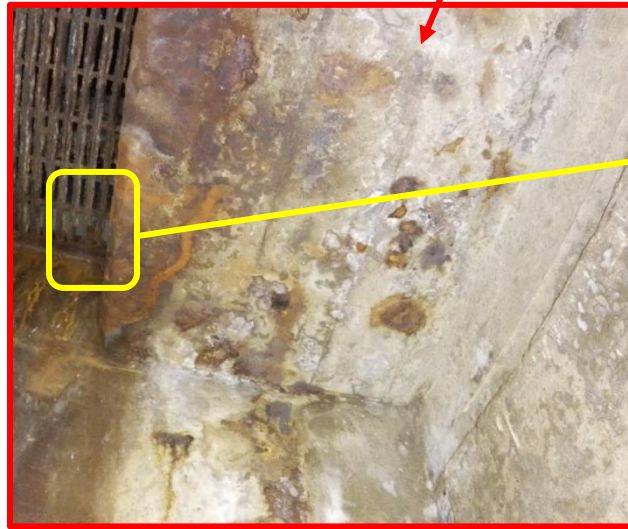
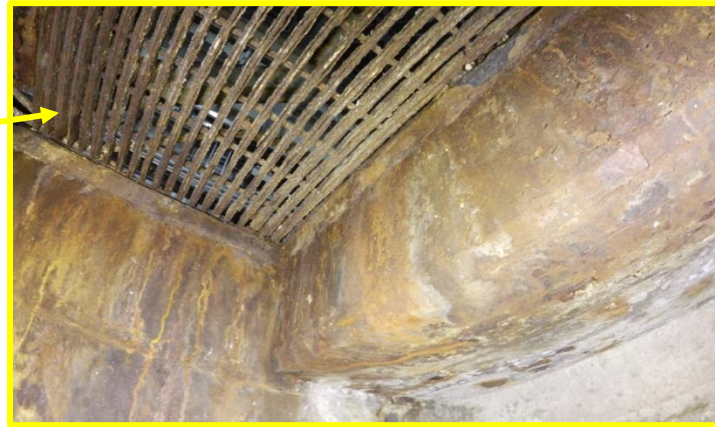
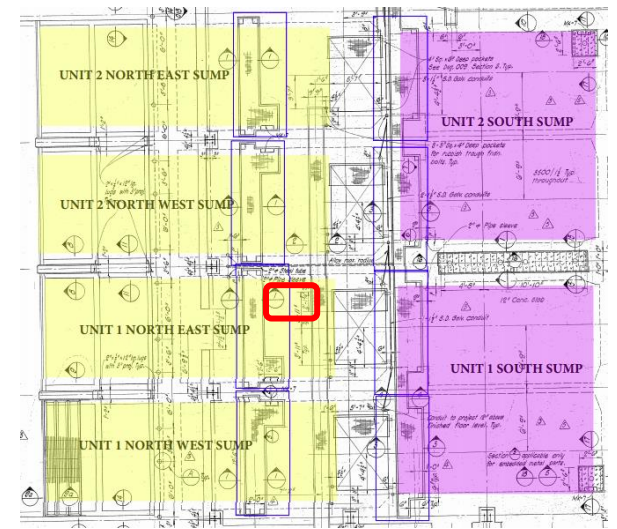
Anomaly (Y/N)	ID	Component	Component Tag	Type of Anomaly	Deg of Corrosion	Module	Level	Heat Map	Comments
Y	-	-	-	Deterioration of concrete	-	-	-	-	General poor condition.

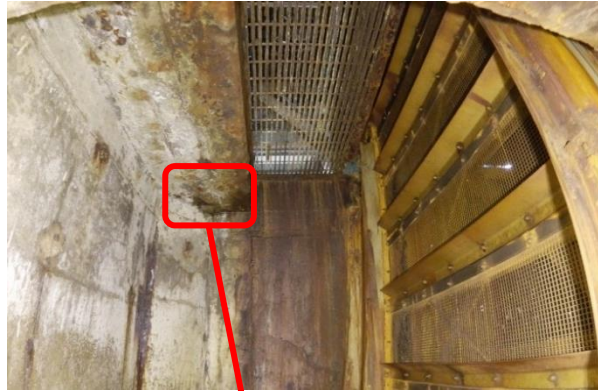
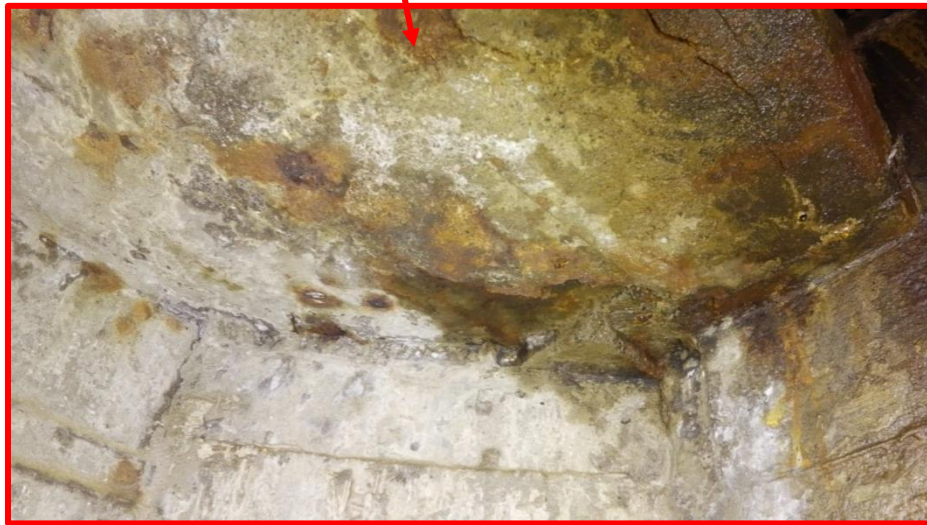
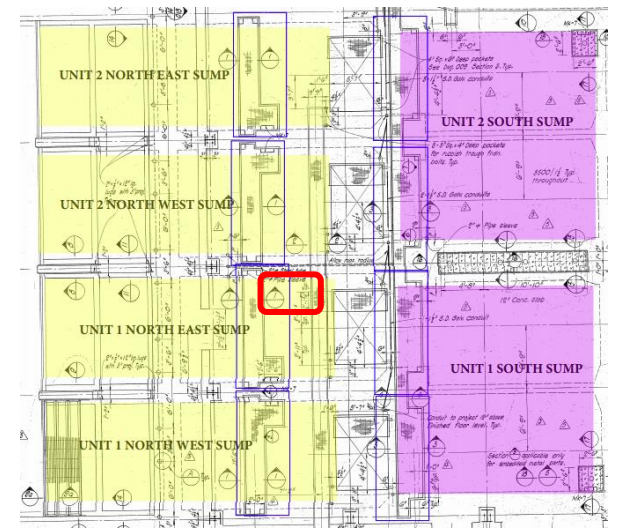
Anomaly (Y/N)	ID	Component	Component Tag	Type of Anomaly	Deg of Corrosion	Module	Level	Heat Map	Comments
Y	-	-	-	Deterioration of concrete	-	-	-	-	Deterioration of concrete typical of what was seen

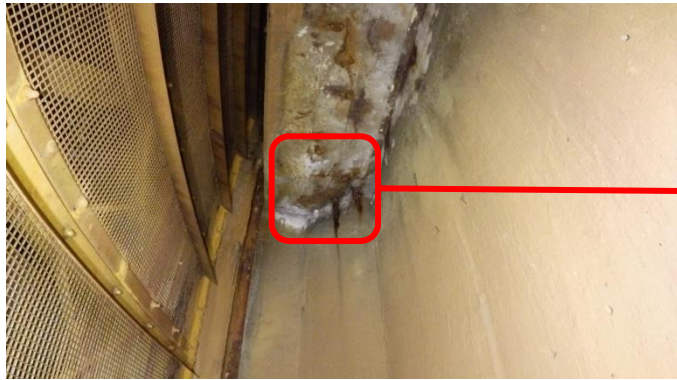
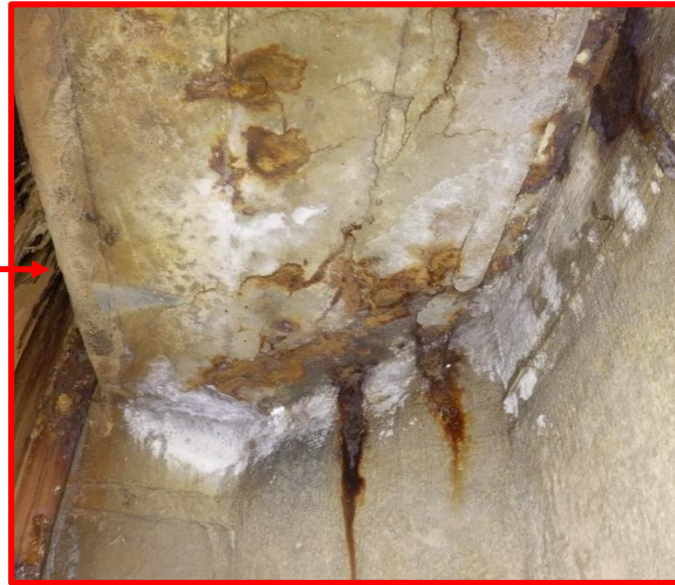
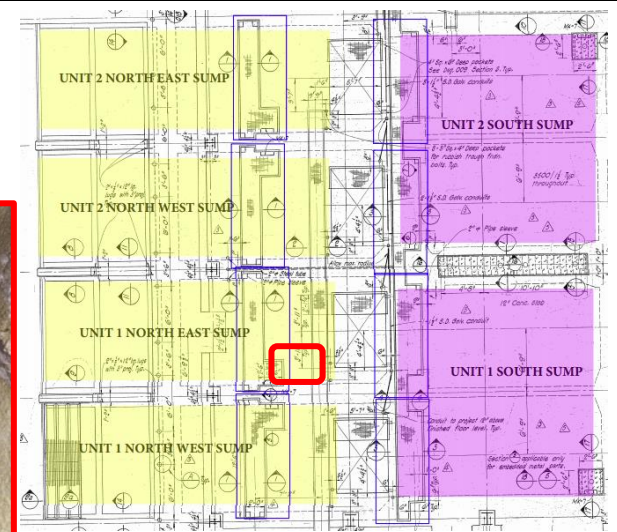
Anomaly (Y/N)	ID	Component	Component Tag	Type of Anomaly	Deg of Corrosion	Module	Level	Heat Map	Comments
Y	-	-	-	Deterioration of concrete	-	-	-	-	Deterioration of concrete typical of what was seen

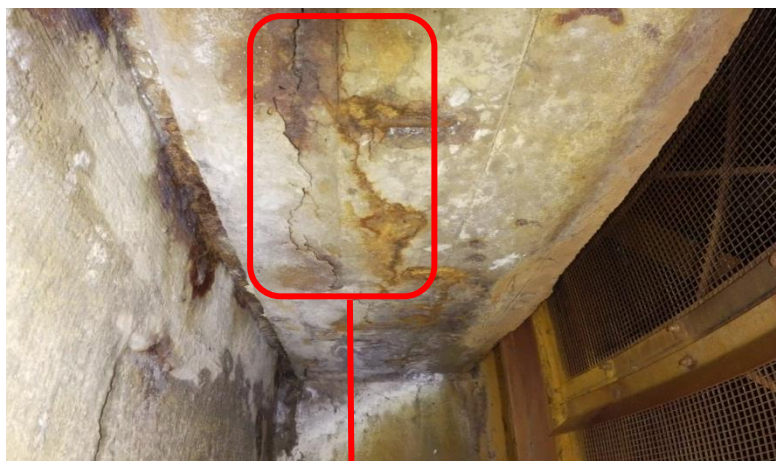
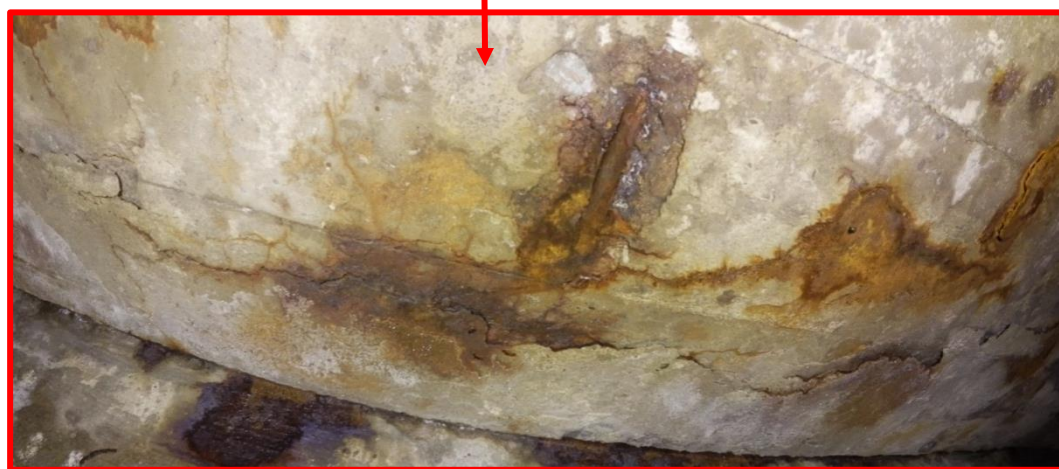
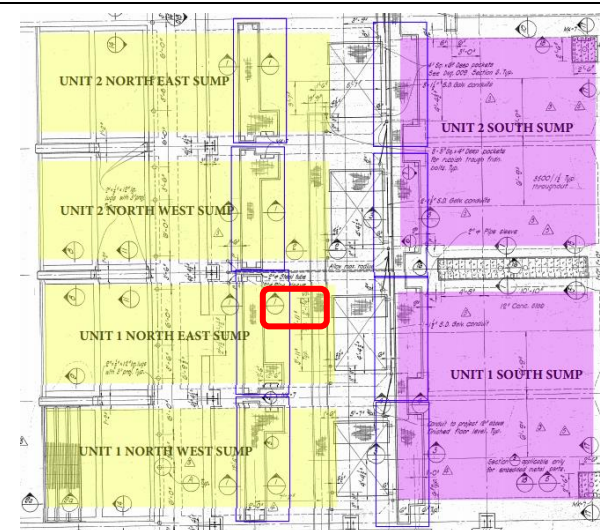
Anomaly (Y/N)	ID	Component	Component Tag	Type of Anomaly	Deg of Corrosion	Module	Level	Heat Map	Comments
Y	-	-	-	Deterioration of concrete	-	-	-	-	Spalling of concrete and corrosion of exposed rebar

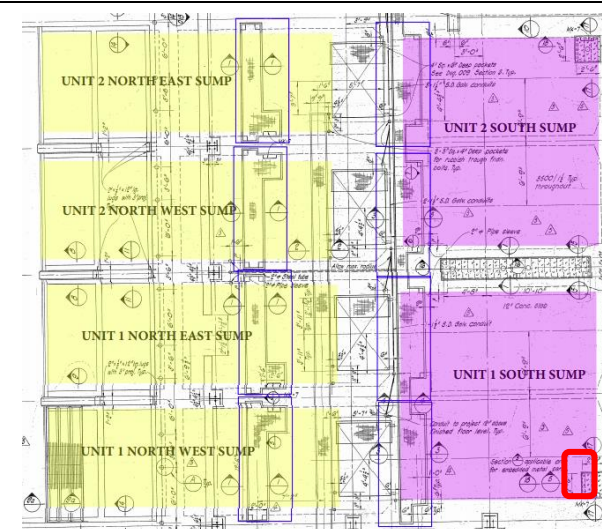
Anomaly (Y/N)	ID	Component	Component Tag	Type of Anomaly	Deg of Corrosion	Module	Level	Heat Map	Comments
Y	-	-	-	Crack	-	-	-	-	Large crack and deterioration of concrete at entry point

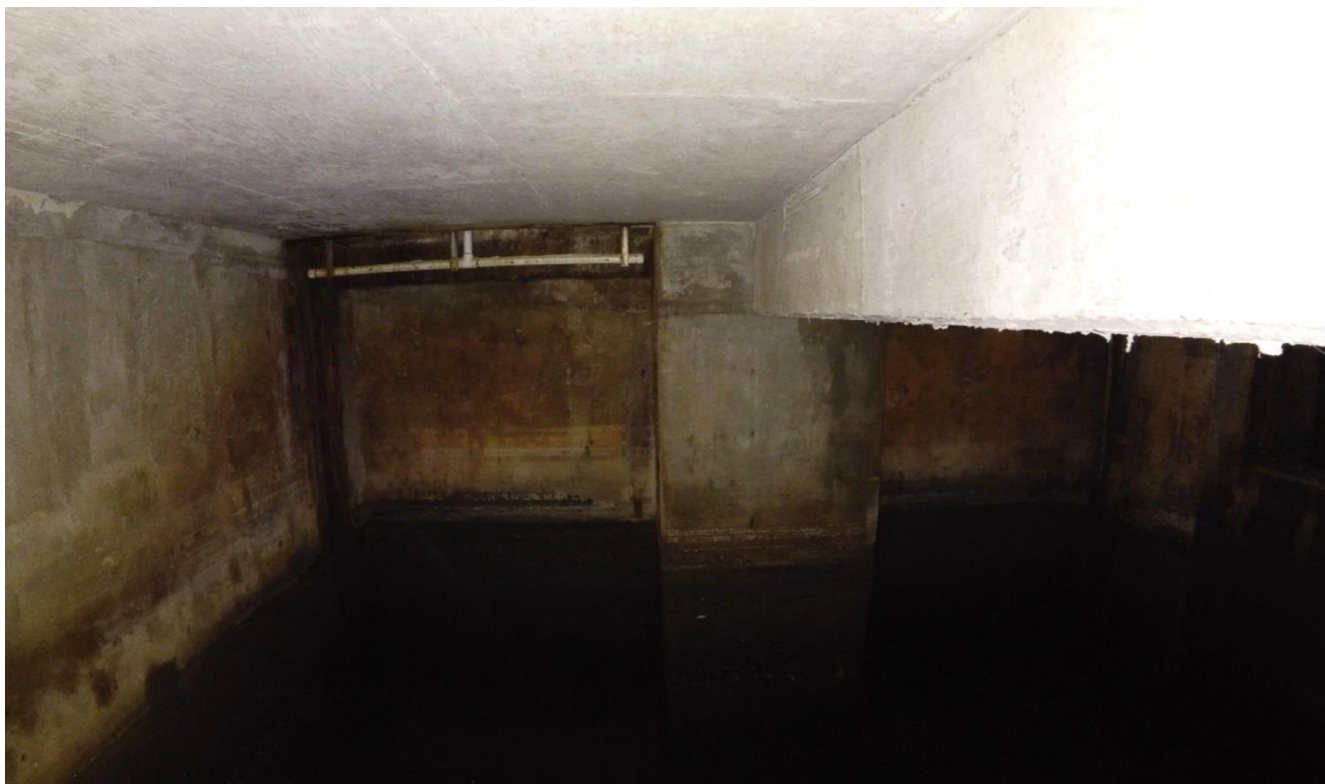
Anomaly (Y/N)	ID	Component	Component Tag	Type of Anomaly	Deg of Corrosion	Module	Level	Heat Map	Comments
N	-	-	-	-	-	-	-	-	Stand off North End

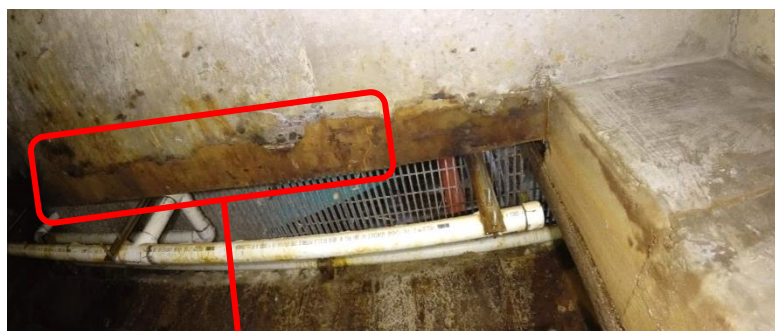
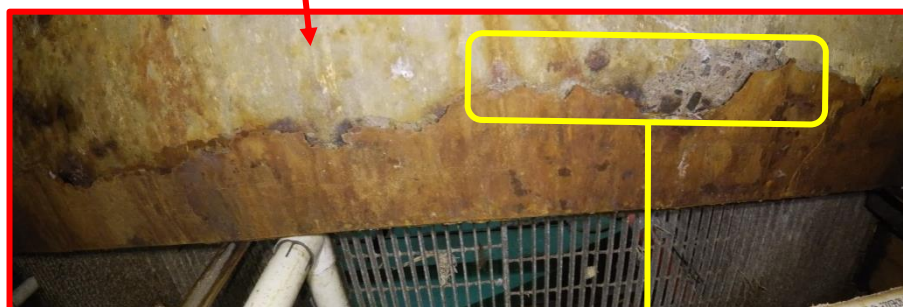
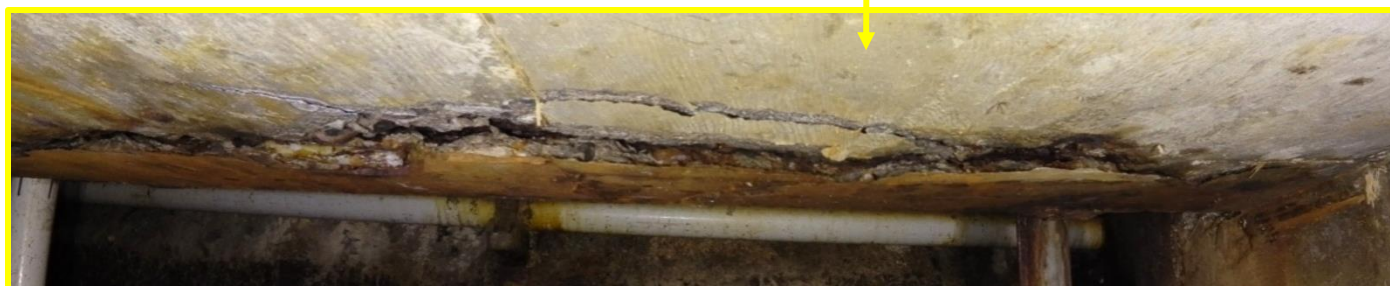
Anomaly (Y/N)	ID	Component	Component Tag	Type of Anomaly	Deg of Corrosion	Module	Level	Heat Map	Comments
Y	-	-	-	Deterioration of concrete	-	-	-	-	Concrete delamination

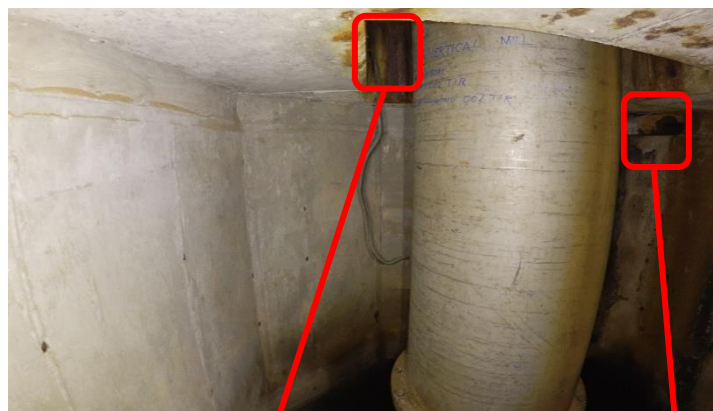
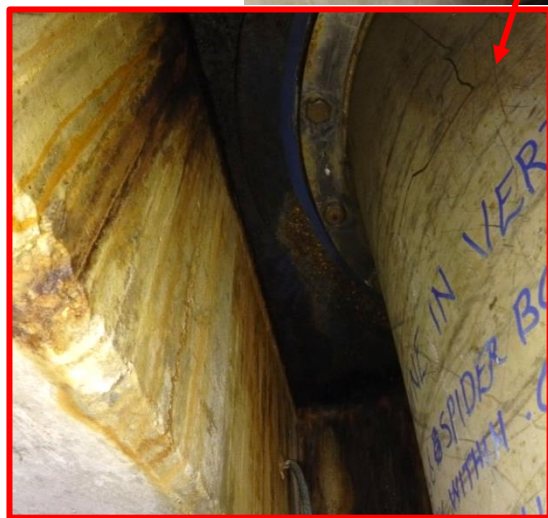
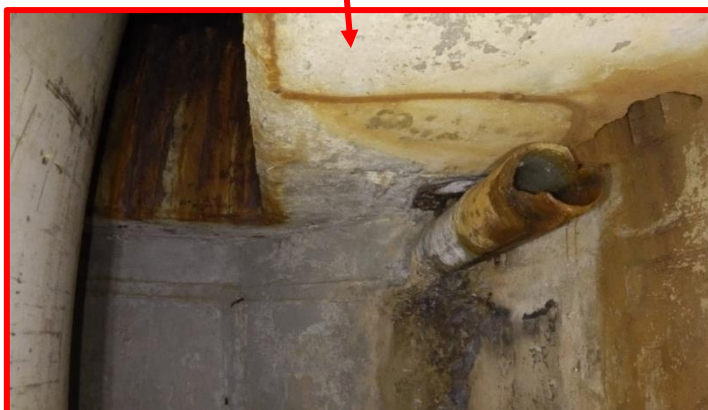
Anomaly (Y/N)	ID	Component	Component Tag	Type of Anomaly	Deg of Corrosion	Module	Level	Heat Map	Comments
N	-	-	-	-	-	-	-	-	General overview, Unit 1 intake area.

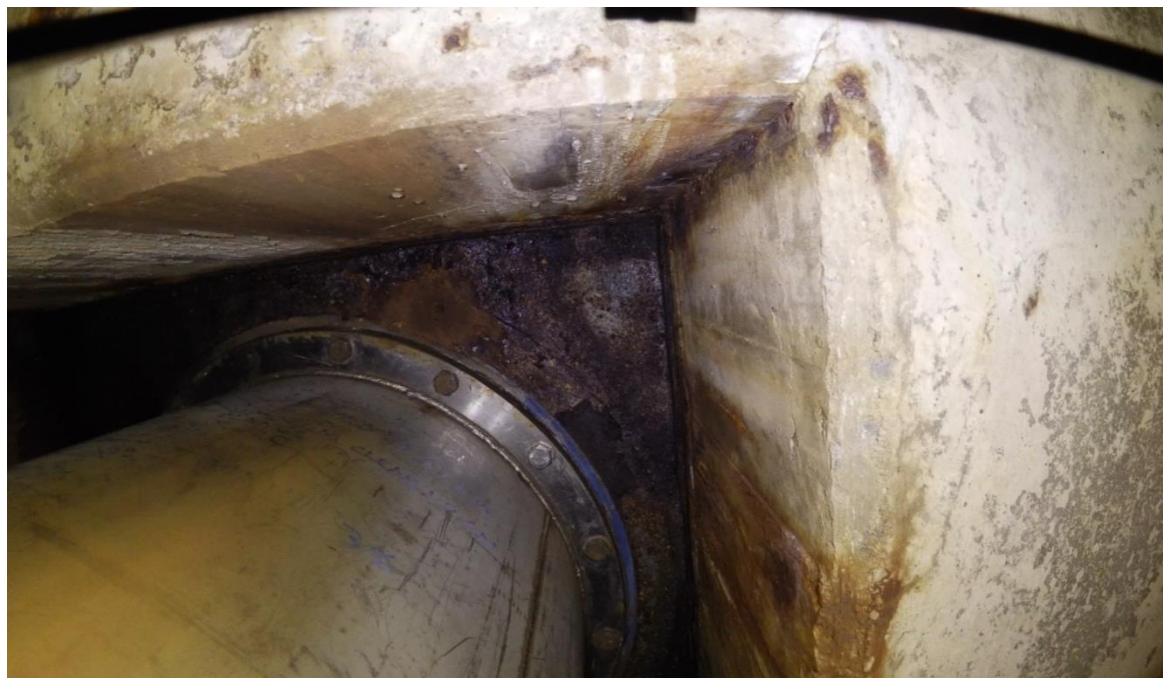
Anomaly (Y/N)	ID	Component	Component Tag	Type of Anomaly	Deg of Corrosion	Module	Level	Heat Map	Comments
N	-	-	-	-	-	-	-	-	General overview, Unit 1 Intake area.

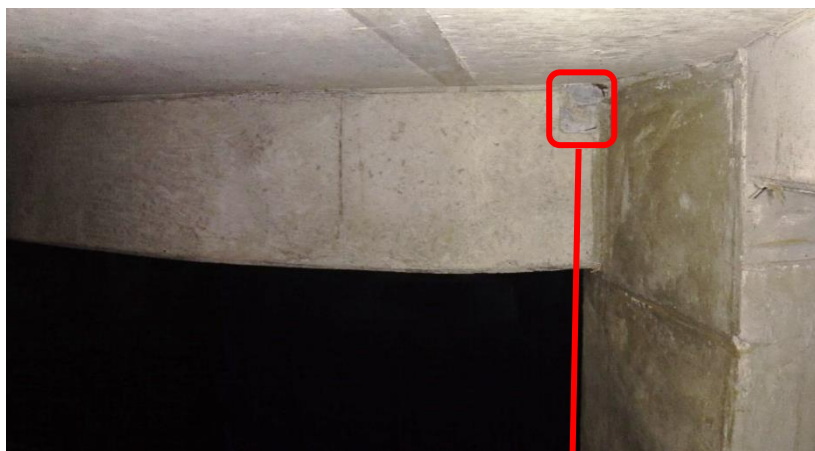
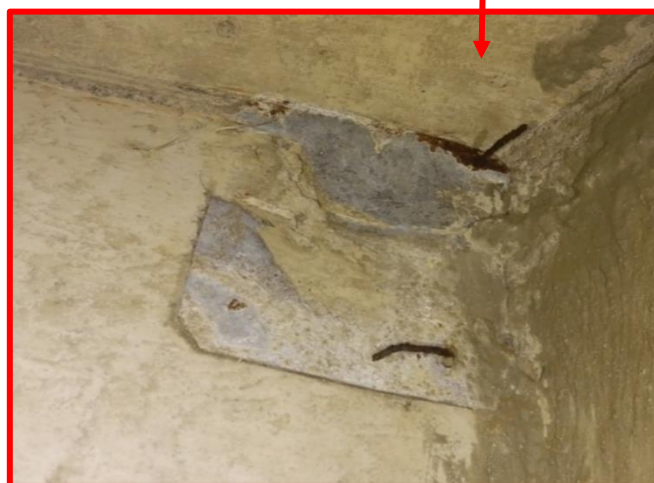
Anomaly (Y/N)	ID	Component	Component Tag	Type of Anomaly	Deg of Corrosion	Module	Level	Heat Map	Comments
N	-	-	-	-	-	-	-	-	Embedded plate left from repair or construction.

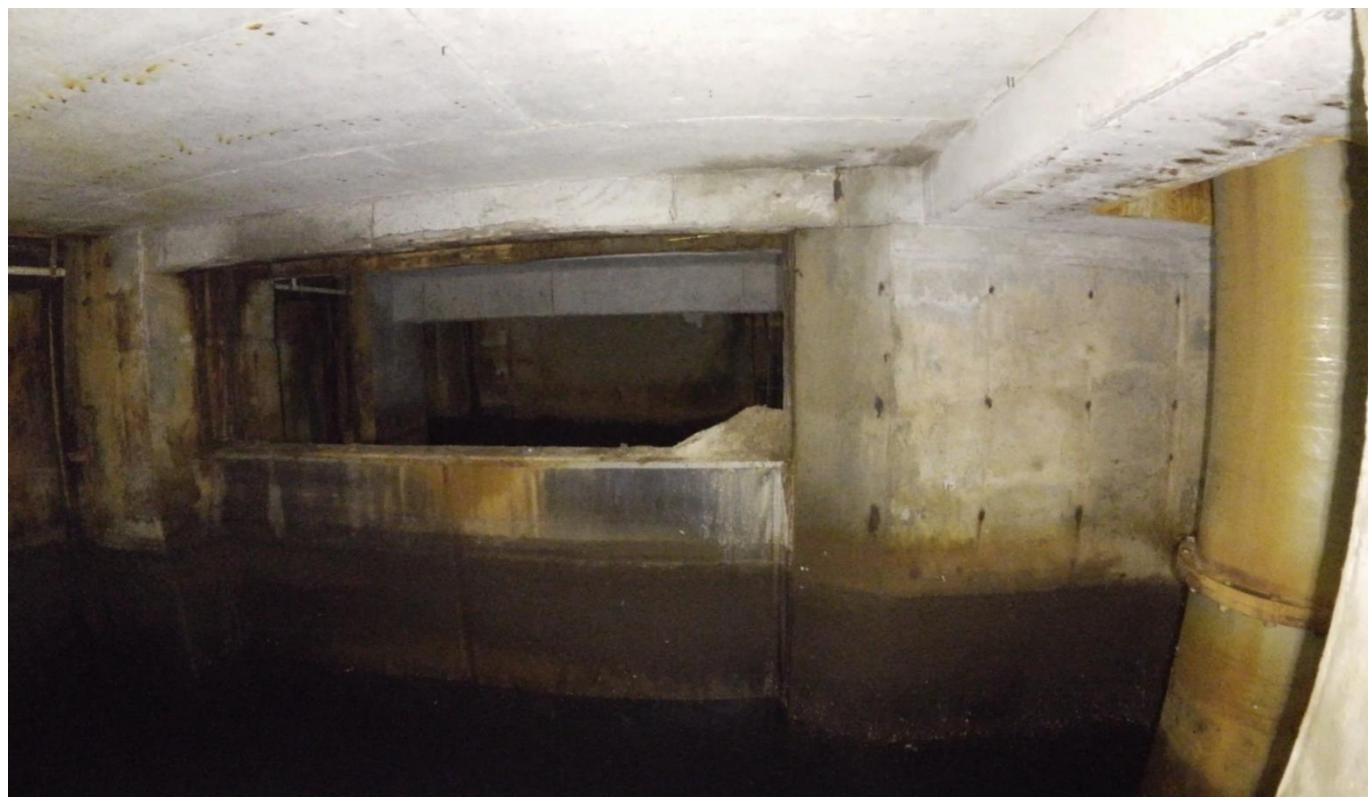
Anomaly (Y/N)	ID	Component	Component Tag	Type of Anomaly	Deg of Corrosion	Module	Level	Heat Map	Comments
N	-	-	-	-	-	-	-	-	Stand off looking east

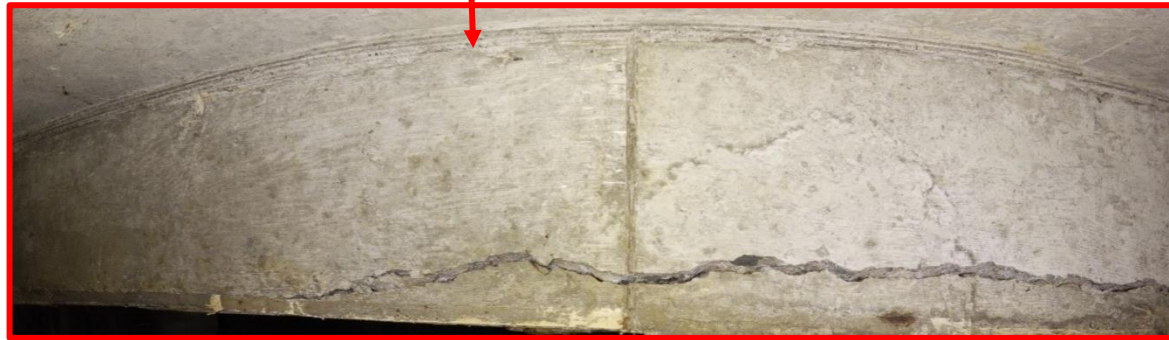
Anomaly (Y/N)	ID	Component	Component Tag	Type of Anomaly	Deg of Corrosion	Module	Level	Heat Map	Comments
Y	-	-	-	Crack	-	-	-	-	Cracking of concrete beam

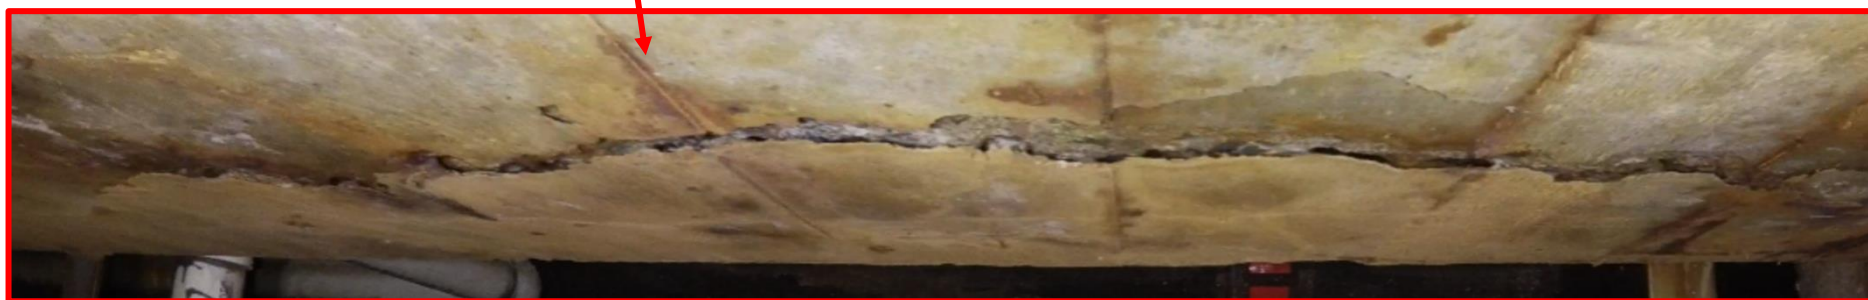
Anomaly (Y/N)	ID	Component	Component Tag	Type of Anomaly	Deg of Corrosion	Module	Level	Heat Map	Comments
Y	-	-	-	Deterioration of concrete	-	-	-	-	Concrete delamination

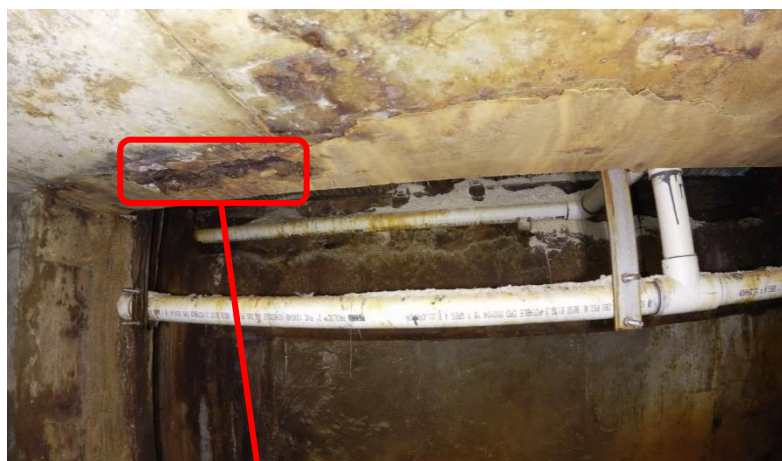
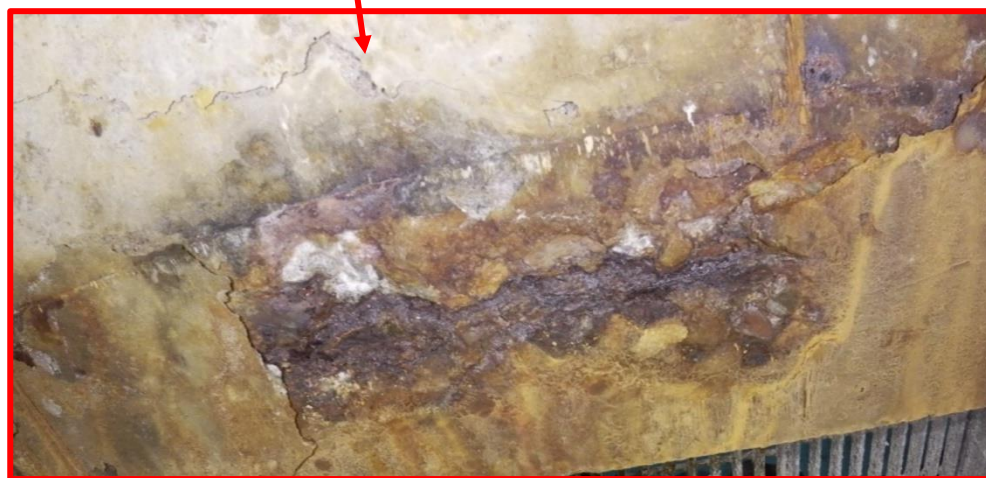
Anomaly (Y/N)	ID	Component	Component Tag	Type of Anomaly	Deg of Corrosion	Module	Level	Heat Map	Comments
Y	-	-	-	Deterioration of concrete	-	-	-	-	Concrete delamination

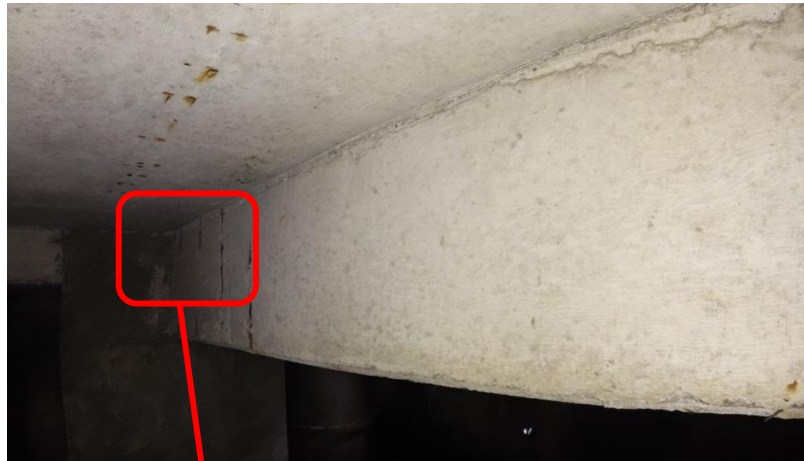
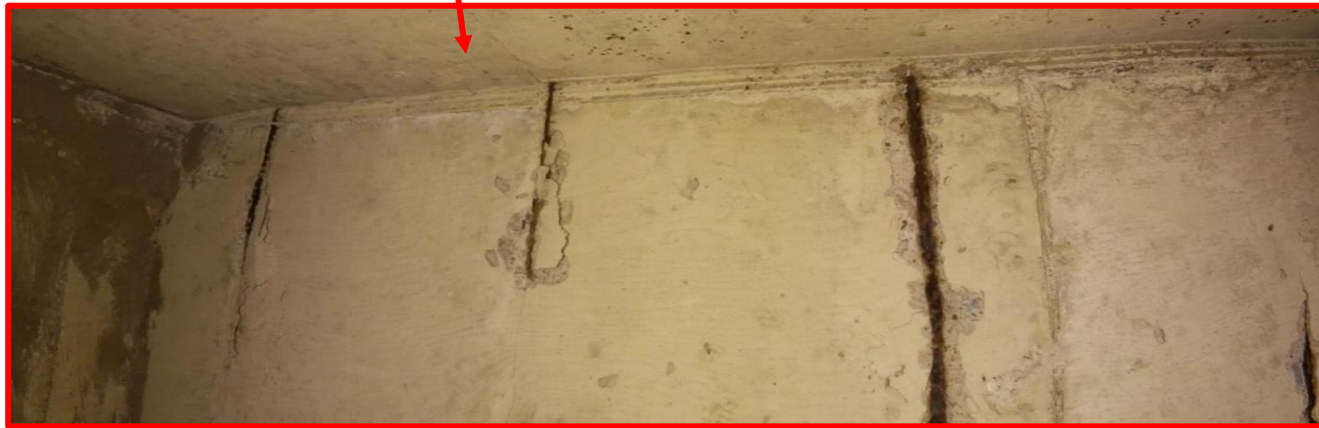
Anomaly (Y/N)	ID	Component	Component Tag	Type of Anomaly	Deg of Corrosion	Module	Level	Heat Map	Comments
Y	-	-	-	Corrosion	-	-	-	-	Spalling of concrete and corrosion of exposed rebar
