Re: *Reliability and Resource Adequacy Study Review - Assessment to Determine the Potential Long-Term Viability of the Holyrood Thermal Generating Station*

Holyrood Thermal Generating Station Condition Assessment

**Newfoundland and Labrador Hydro
HTGS Condition Assessment and Life Extension Study
Executive Summary**

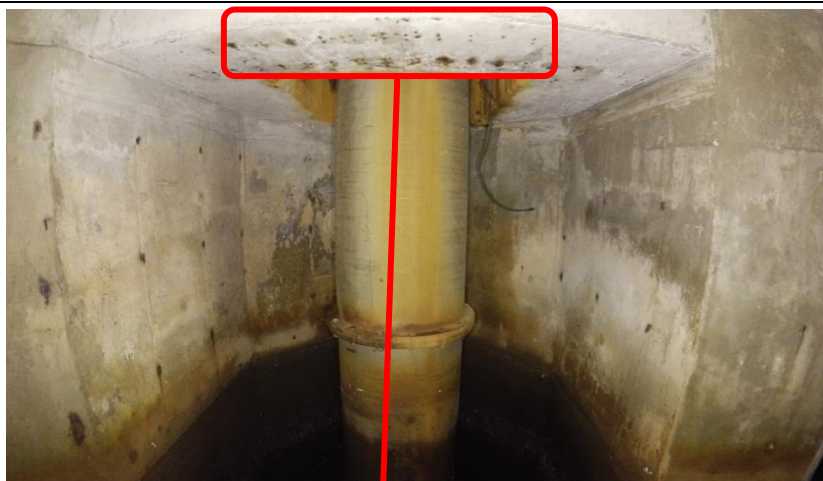
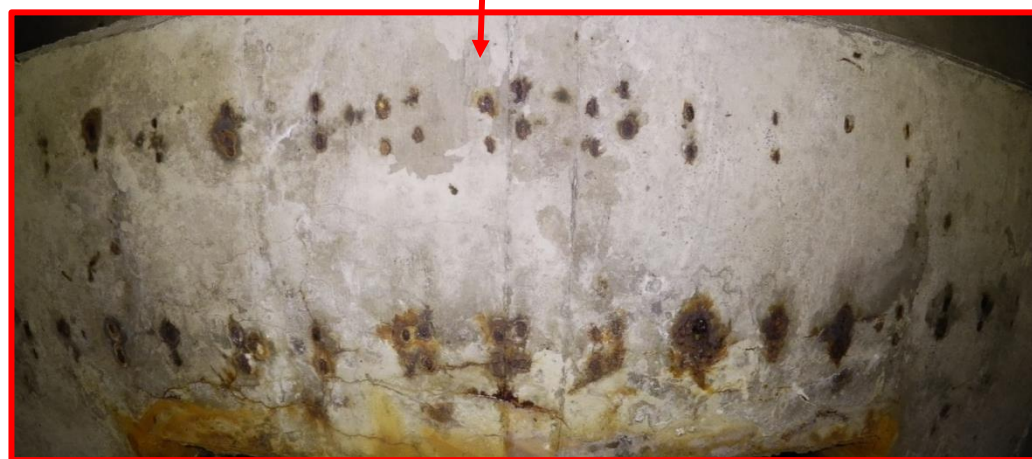
Anomaly (Y/N)	ID	Component	Component Tag	Type of Anomaly	Deg of Corrosion	Module	Level	Heat Map	Comments
Y	-	-	-	Deterioration of concrete	-	-	-	-	Deterioration of concrete and corrosion of exposed rebar.

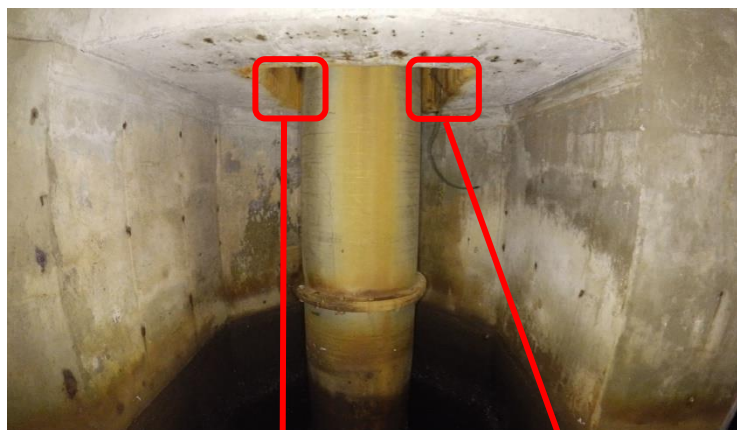
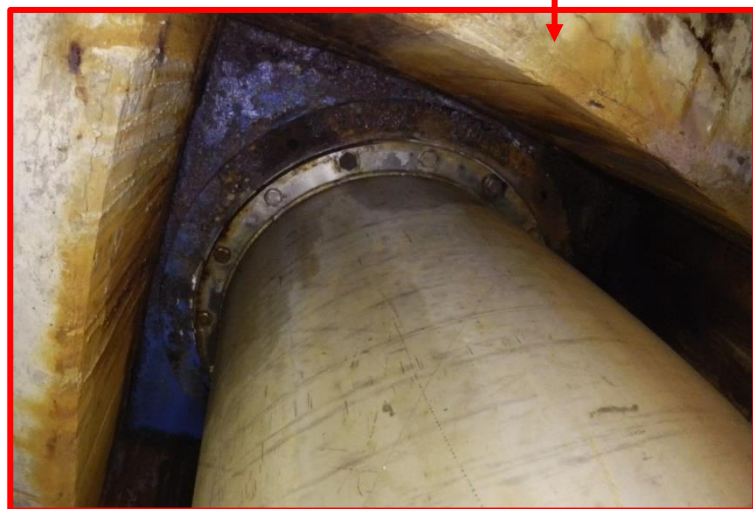
Anomaly (Y/N)	ID	Component	Component Tag	Type of Anomaly	Deg of Corrosion	Module	Level	Heat Map	Comments
N	-	-	-	-	-	-	-	-	General overview of intake area.

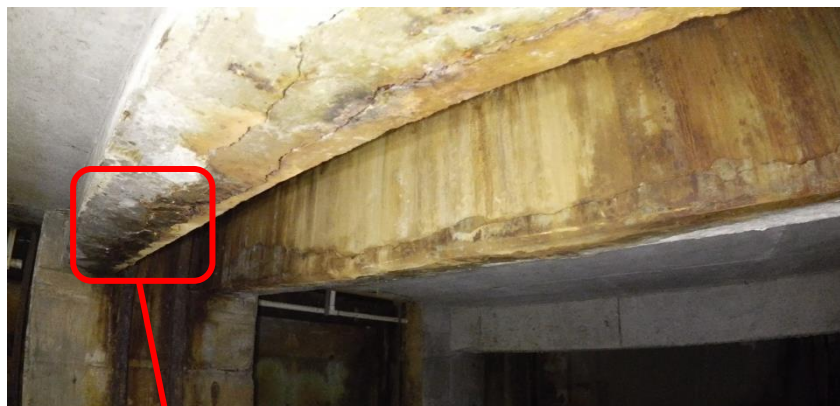
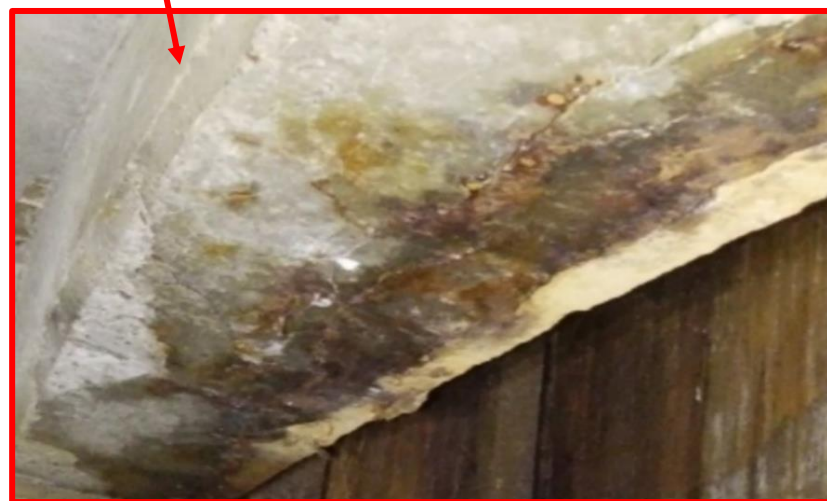
Anomaly (Y/N)	ID	Component	Component Tag	Type of Anomaly	Deg of Corrosion	Module	Level	Heat Map	Comments
Y	-	-	-	Deterioration of concrete	-	-	-	-	Spalling of underside of central beam

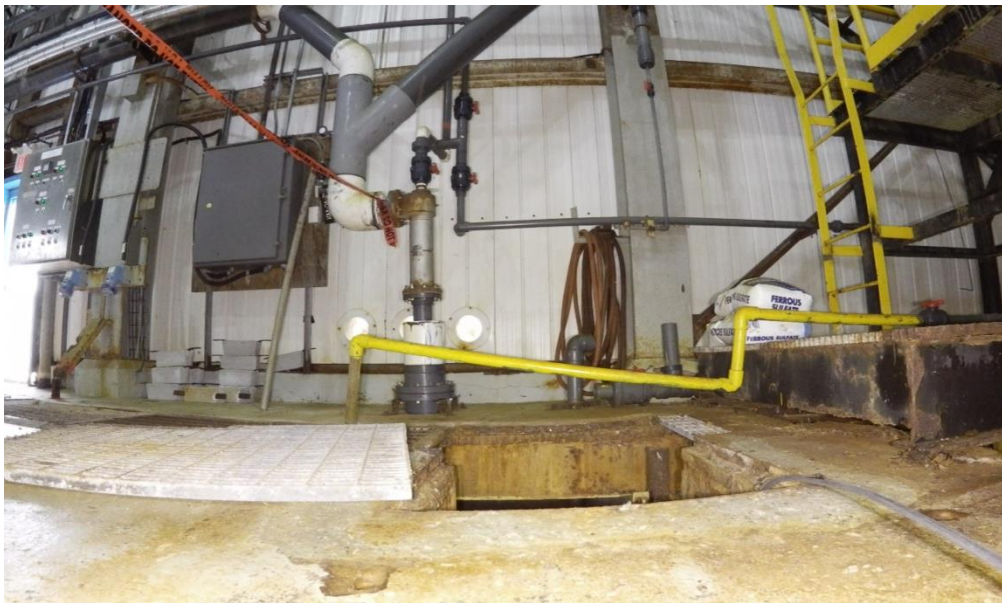
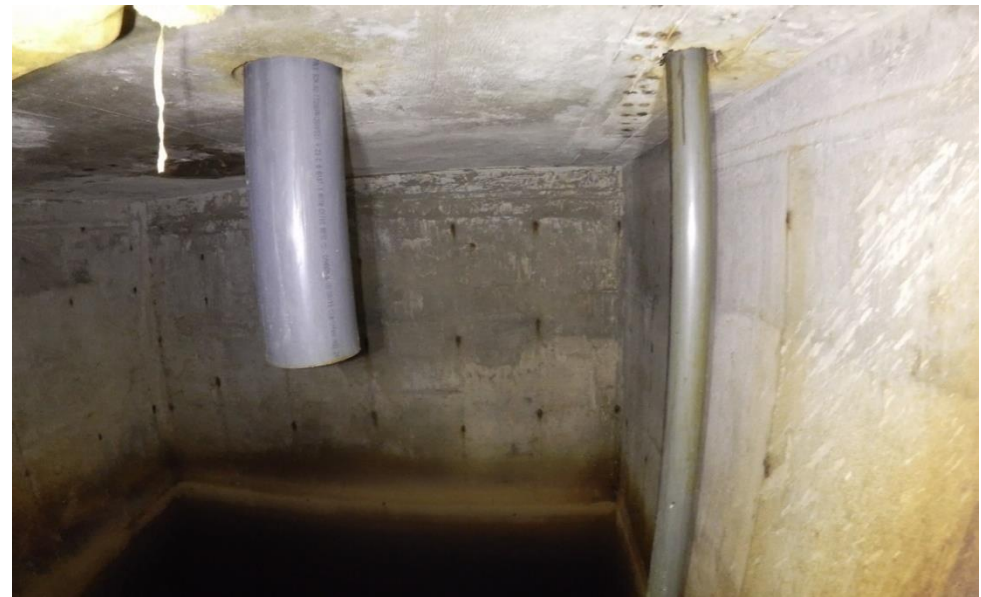
Anomaly (Y/N)	ID	Component	Component Tag	Type of Anomaly	Deg of Corrosion	Module	Level	Heat Map	Comments
Y	-	-	-	Deterioration of concrete	-	-	-	-	Deterioration of concrete and corrosion of exposed rebar

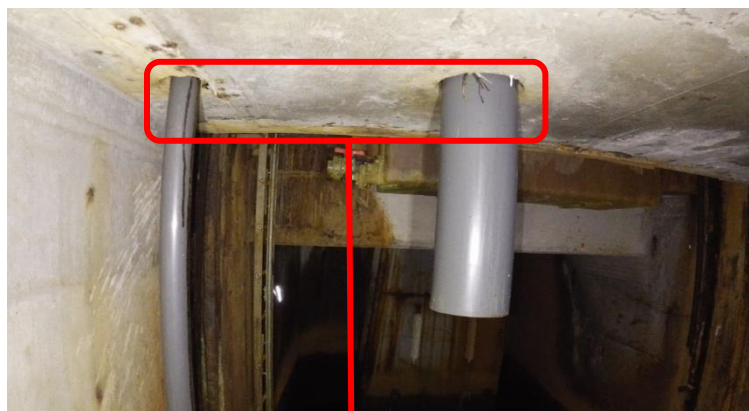
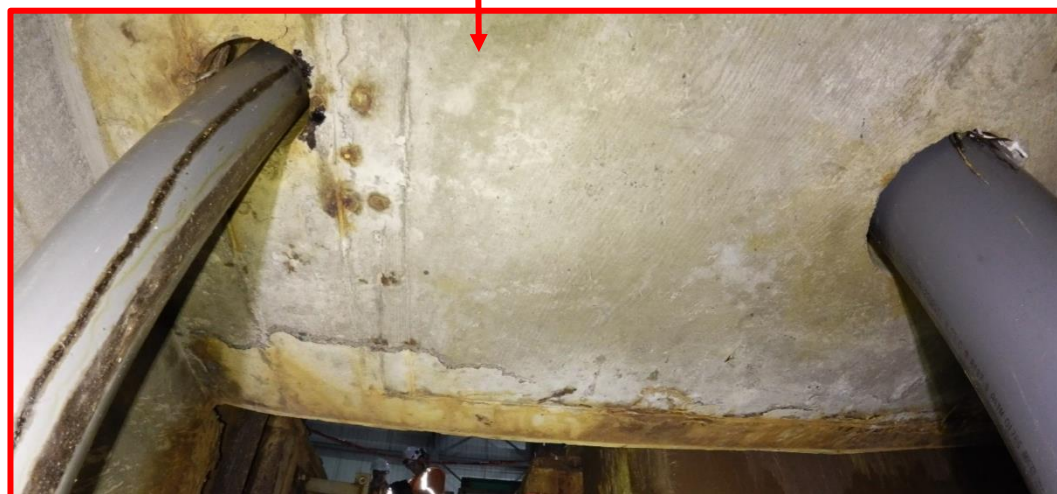
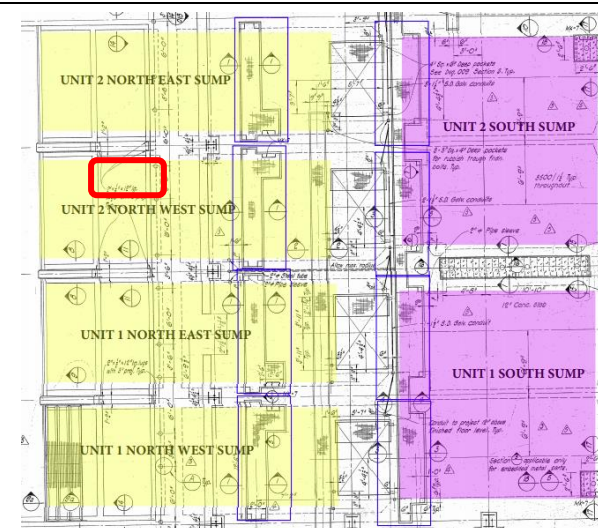
Anomaly (Y/N)	ID	Component	Component Tag	Type of Anomaly	Deg of Corrosion	Module	Level	Heat Map	Comments
Y	-	-	-	Deterioration of concrete	-	-	-	-	Delamination of concrete

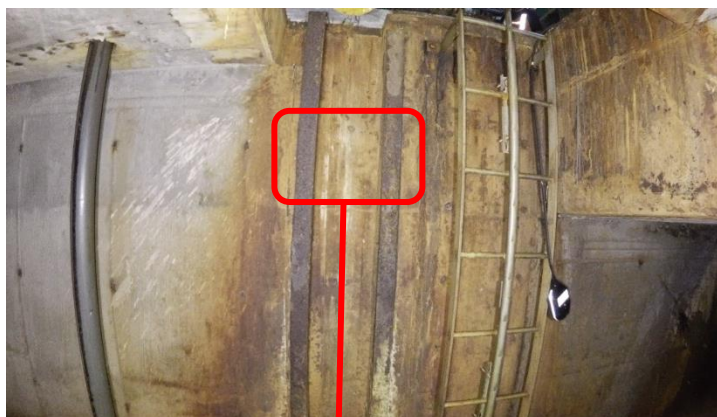
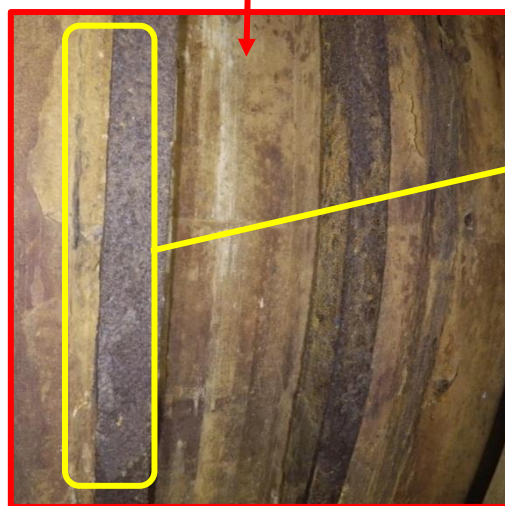
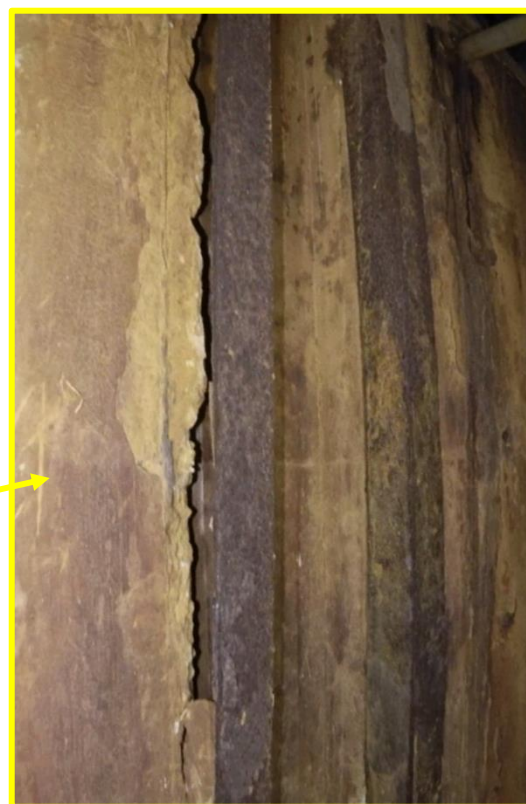
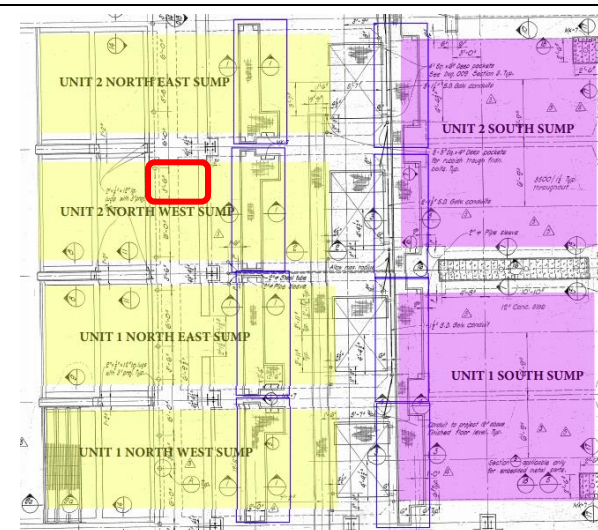
Anomaly (Y/N)	ID	Component	Component Tag	Type of Anomaly	Deg of Corrosion	Module	Level	Heat Map	Comments
Y	-	-	-	Deterioration of concrete	-	-	-	-	Minor deterioration of concrete edge

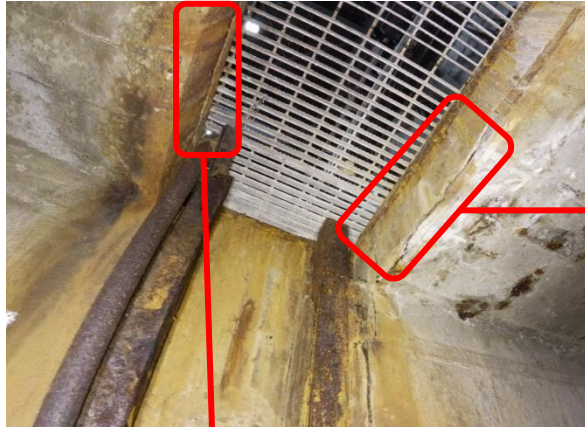
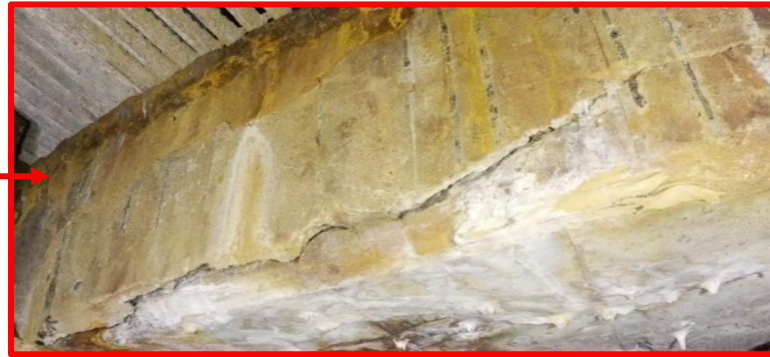
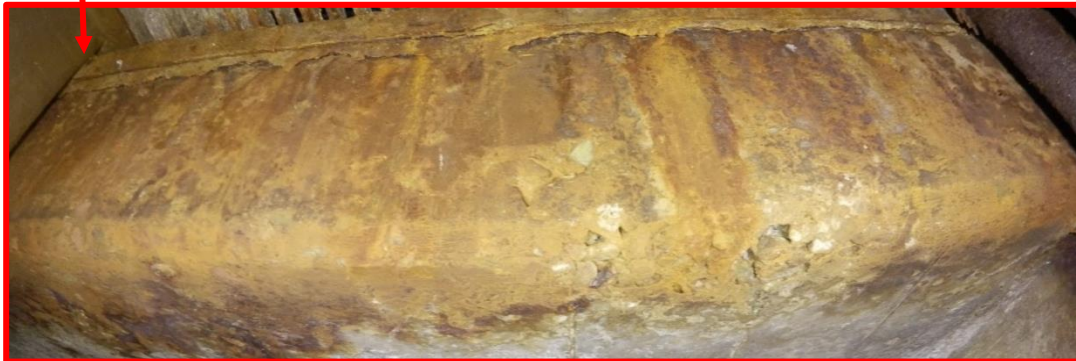
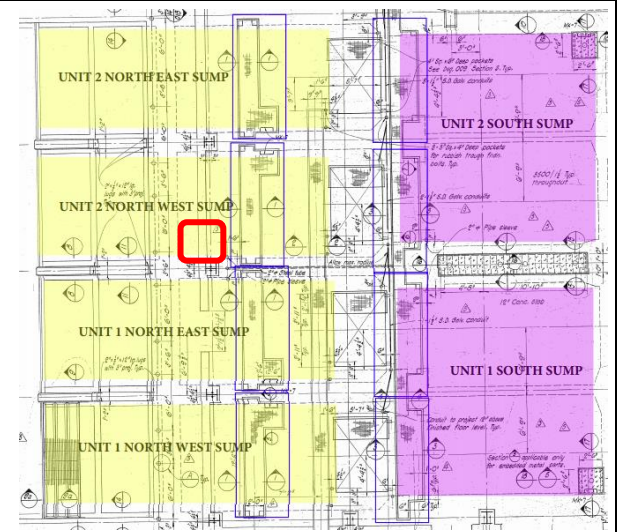
Anomaly (Y/N)	ID	Component	Component Tag	Type of Anomaly	Deg of Corrosion	Module	Level	Heat Map	Comments
Y	-	-	-	Deterioration of concrete	-	-	-	-	Deterioration of concrete near grating

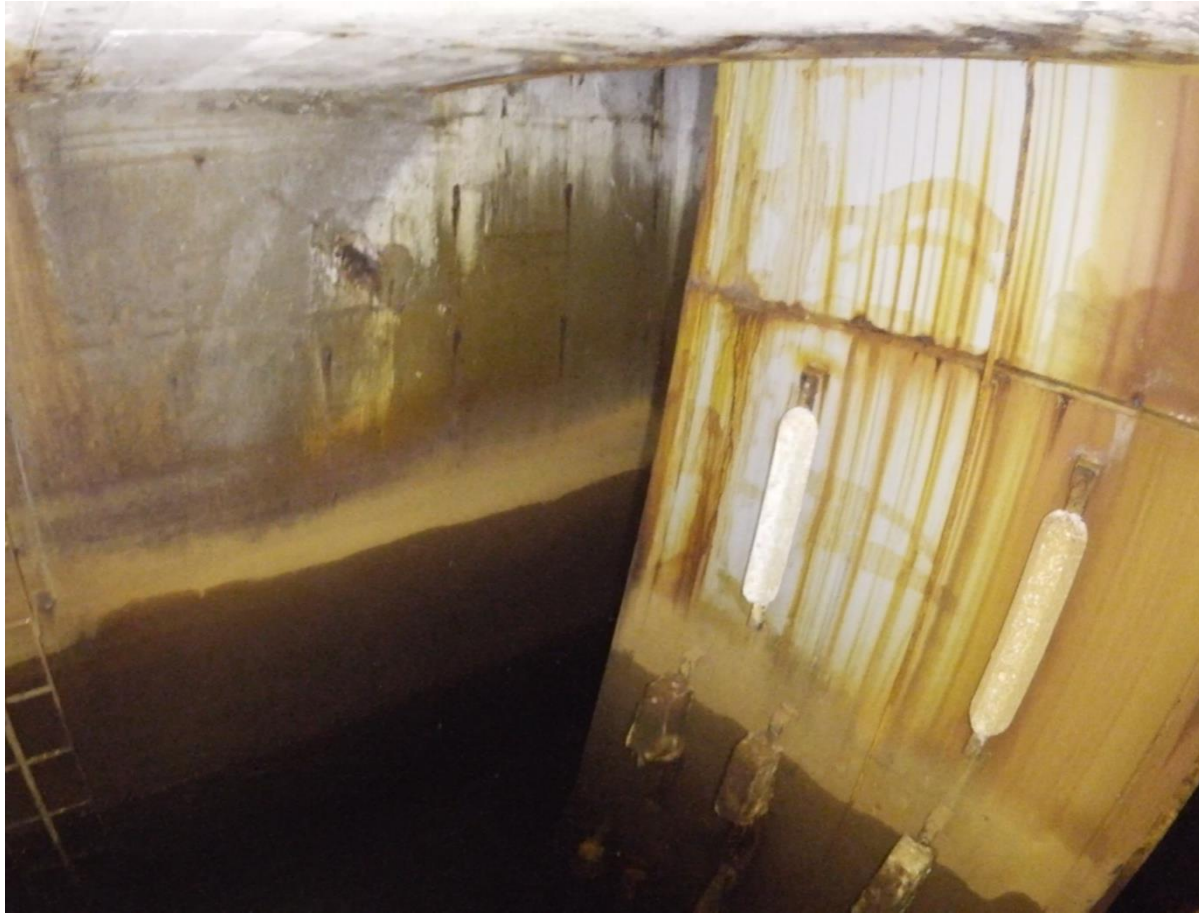
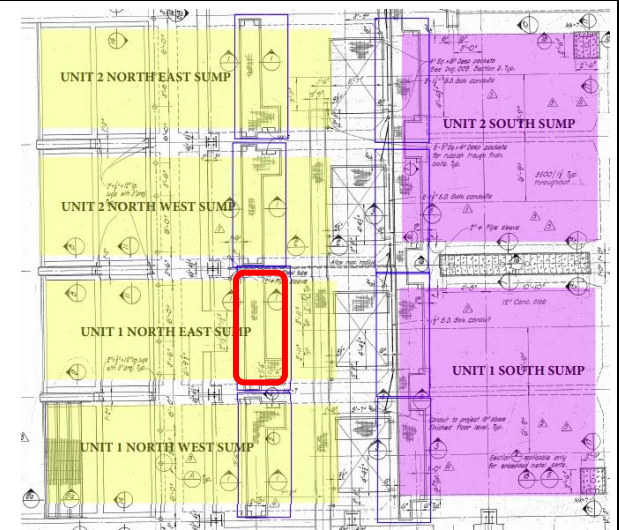
Anomaly (Y/N)	ID	Component	Component Tag	Type of Anomaly	Deg of Corrosion	Module	Level	Heat Map	Comments
N	-	-	-	-	-	-	-	-	Stand off south end, typical of what was seen

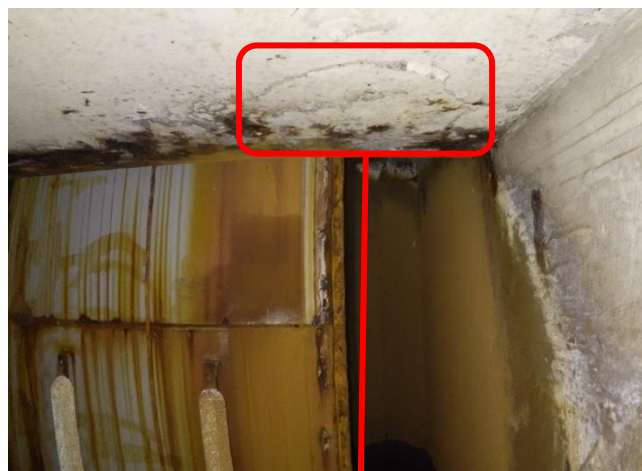
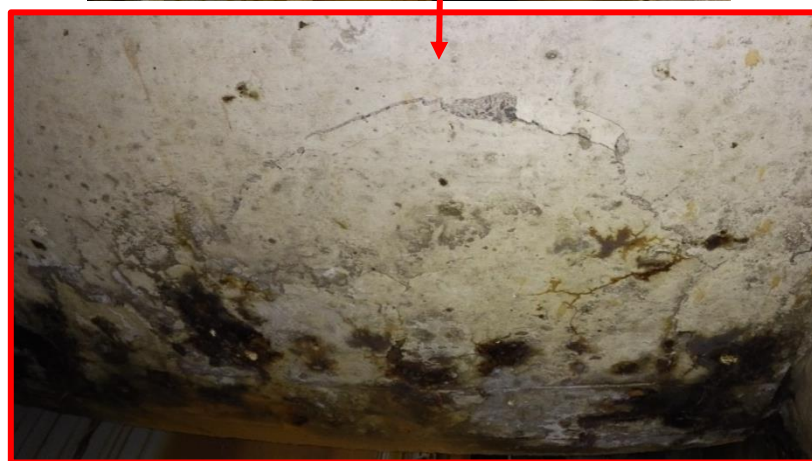
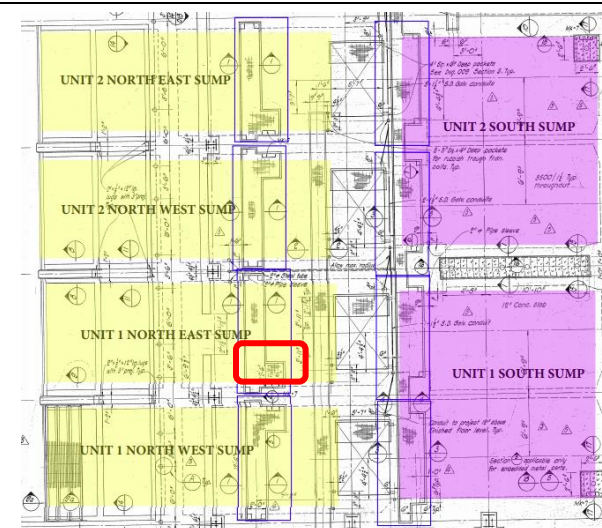
Anomaly (Y/N)	ID	Component	Component Tag	Type of Anomaly	Deg of Corrosion	Module	Level	Heat Map	Comments
Y	-	-	-	Deterioration of concrete	-	-	-	-	Spalling of concrete

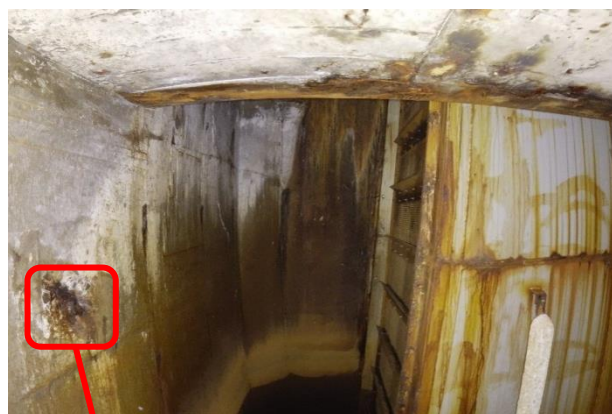
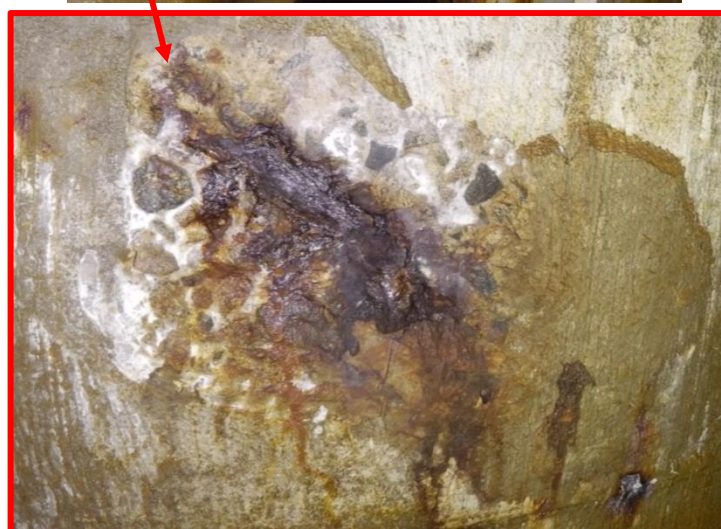
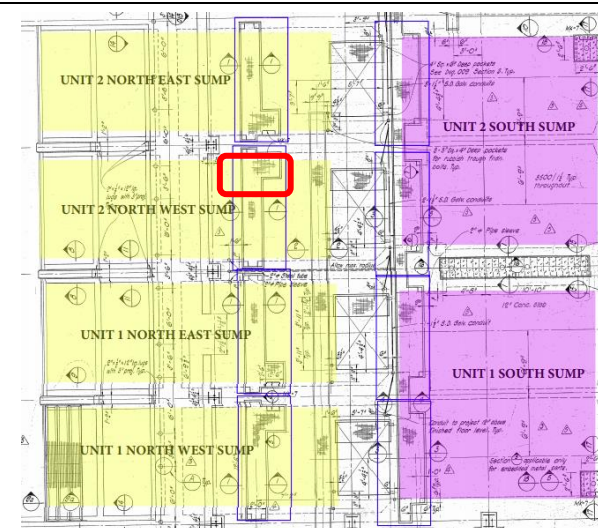
Anomaly (Y/N)	ID	Component	Component Tag	Type of Anomaly	Deg of Corrosion	Module	Level	Heat Map	Comments
Y	-	-	-	Deterioration of concrete	-	-	-	-	Deterioration of concrete and severe corrosion of exposed rebar

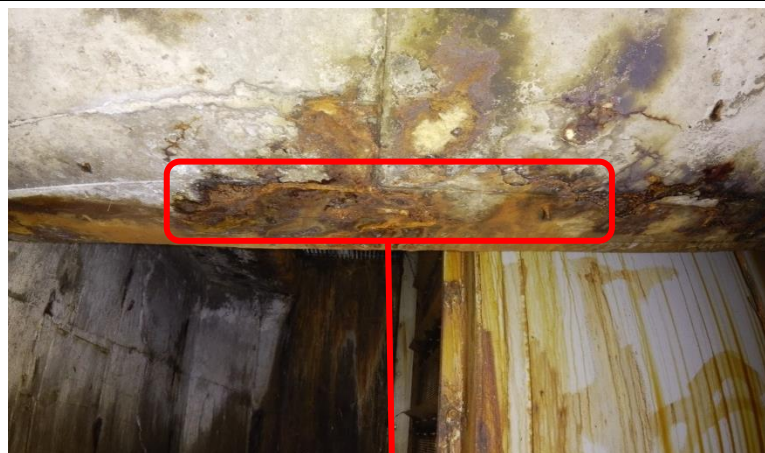
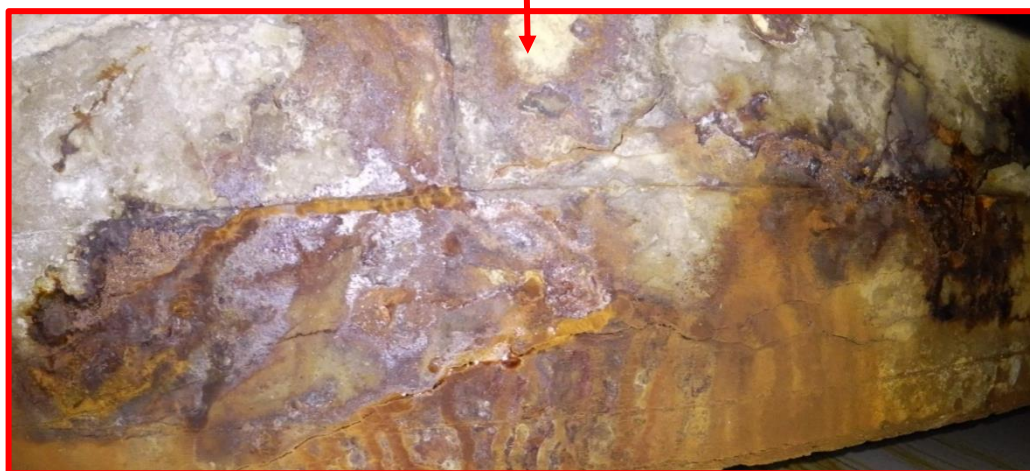
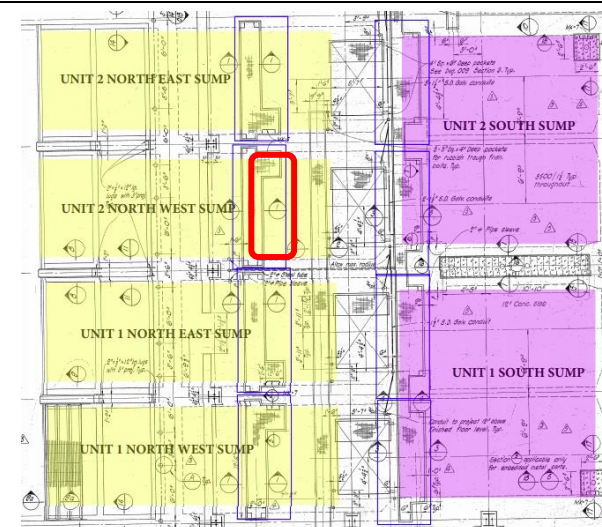
Anomaly (Y/N)	ID	Component	Component Tag	Type of Anomaly	Deg of Corrosion	Module	Level	Heat Map	Comments
Y	-	-	-	Deterioration of concrete	-	-	-	-	Deterioration of concrete, typical of what was seen

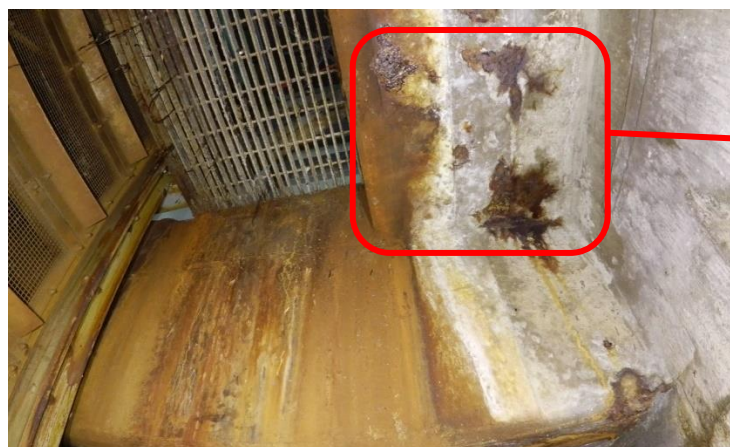
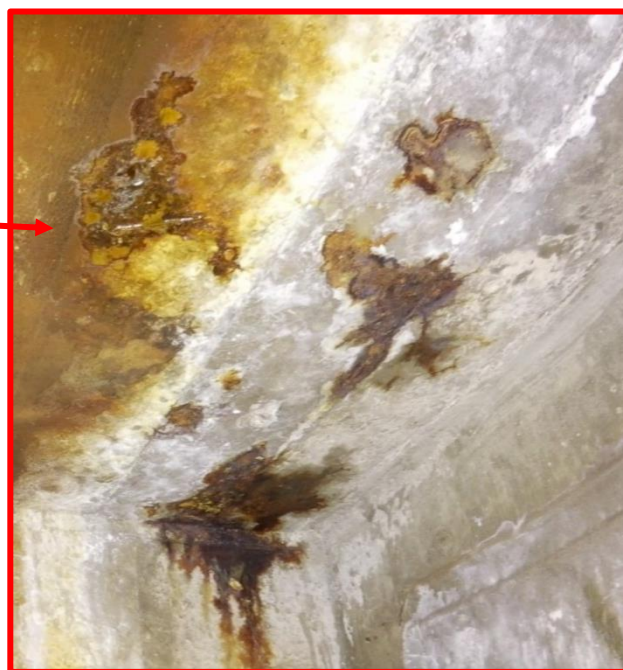
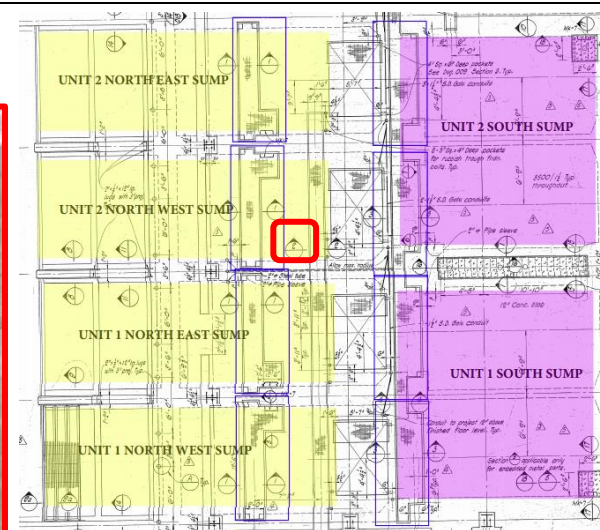
Anomaly (Y/N)	ID	Component	Component Tag	Type of Anomaly	Deg of Corrosion	Module	Level	Heat Map	Comments
Y	-	-	-	Deterioration of concrete	-	-	-	-	Deterioration of concrete and corrosion of rebar

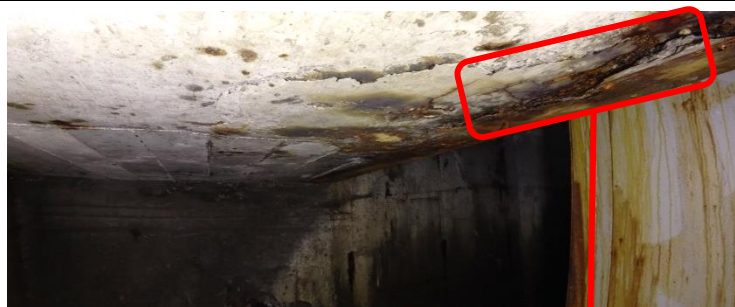
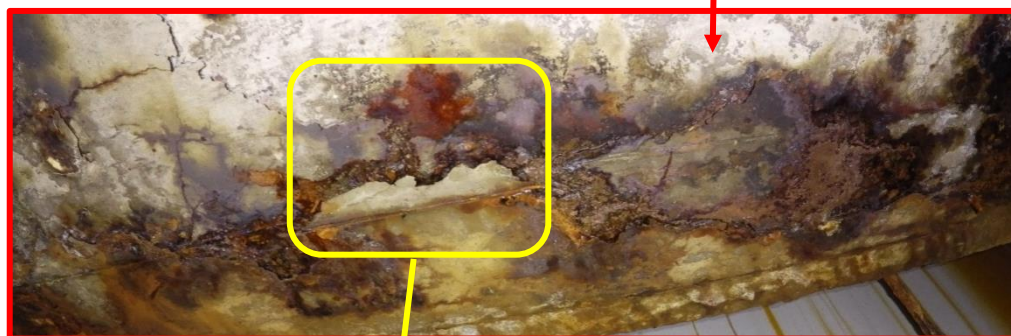
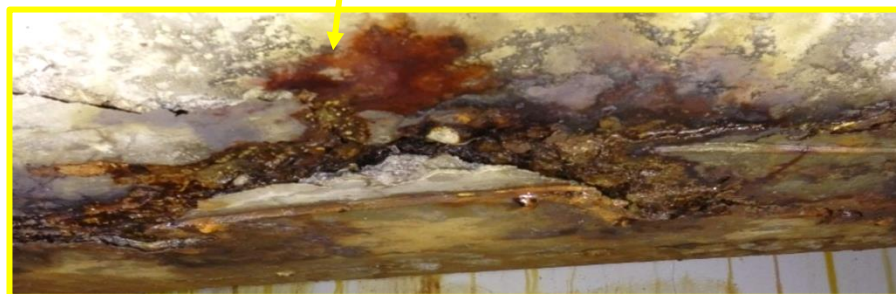
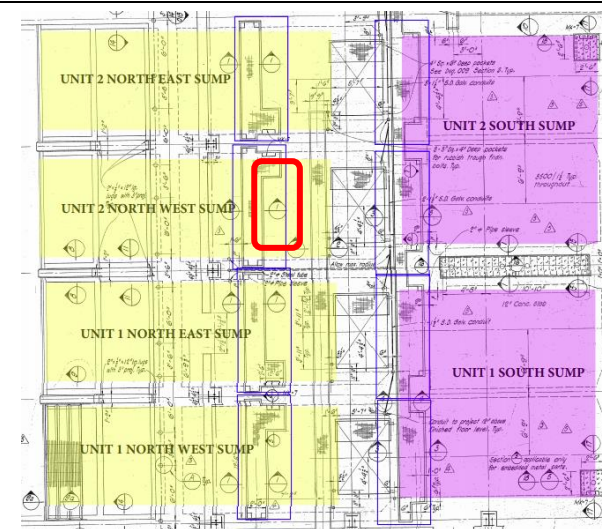
Anomaly (Y/N)	ID	Component	Component Tag	Type of Anomaly	Deg of Corrosion	Module	Level	Heat Map	Comments
Y	-	-	-	Deterioration of concrete	-	-	-	-	Delamination of concrete and corrosion of rebar

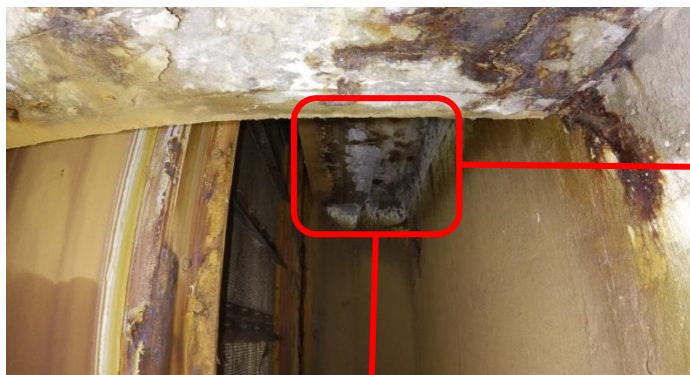
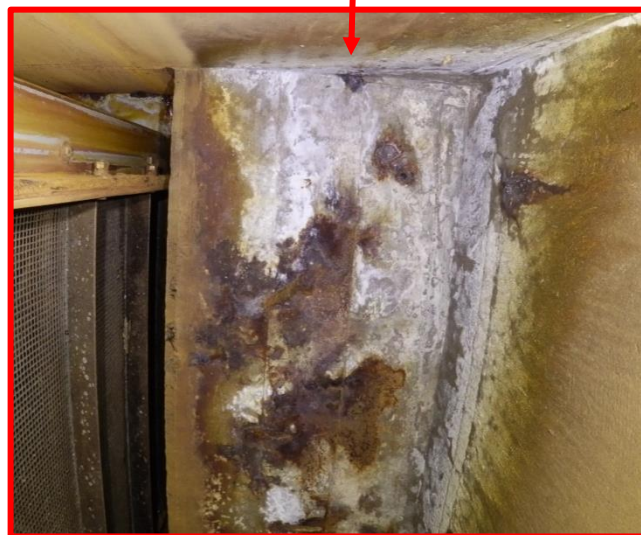
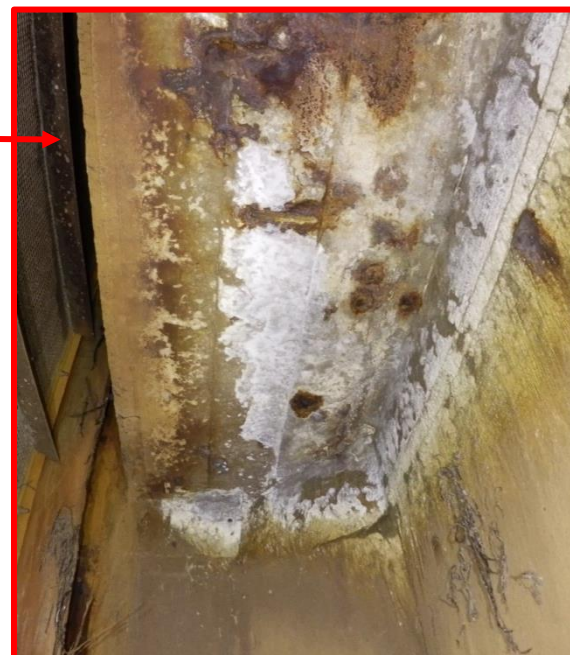
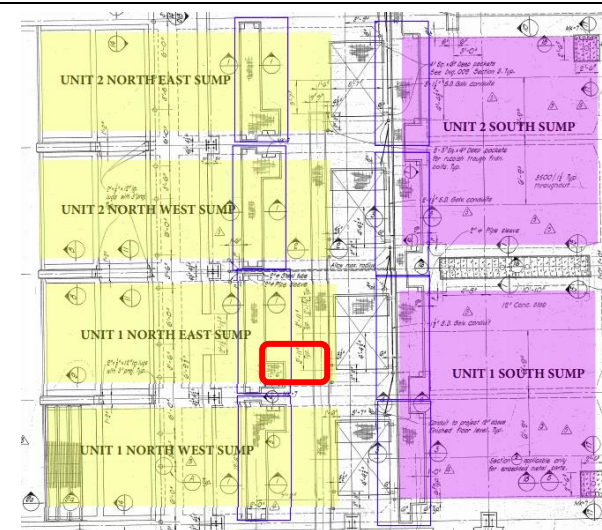
Anomaly (Y/N)	ID	Component	Component Tag	Type of Anomaly	Deg of Corrosion	Module	Level	Heat Map	Comments
Y	-	-	-	Deterioration of concrete	-	-	-	-	Deterioration of concrete and corrosion of rebar

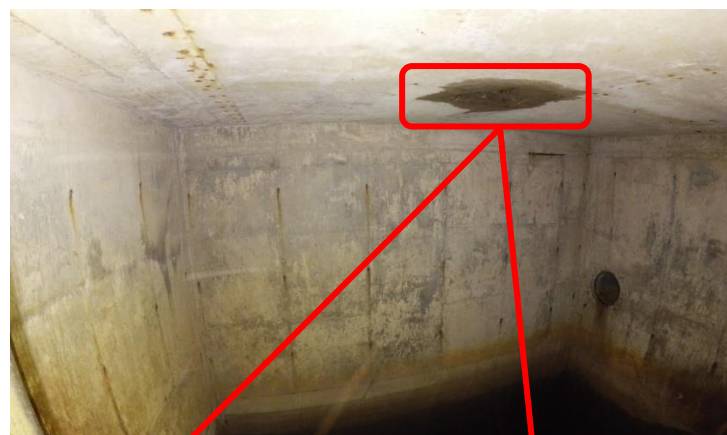
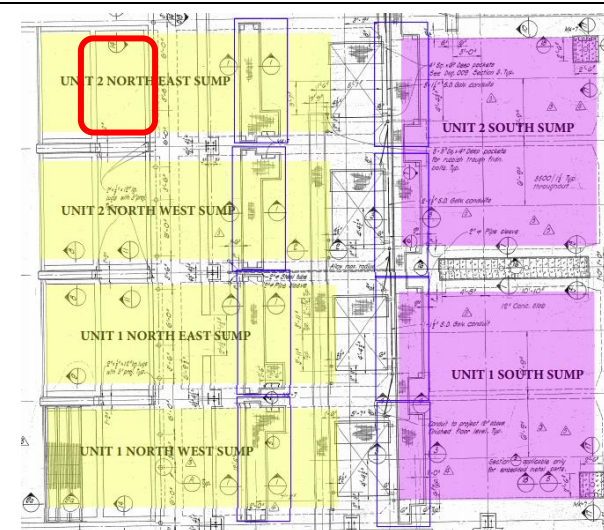
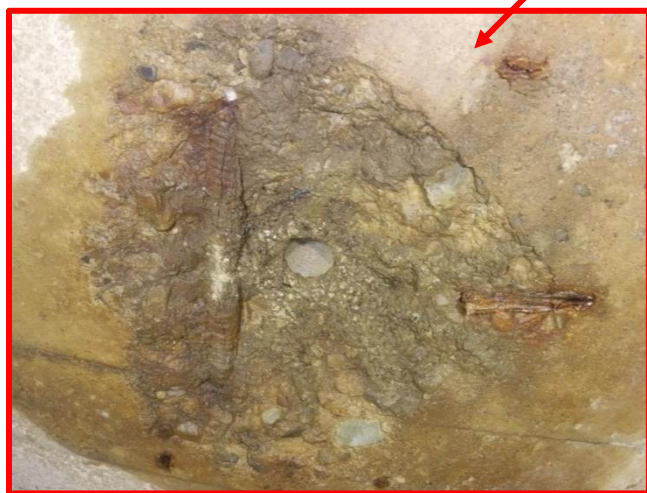
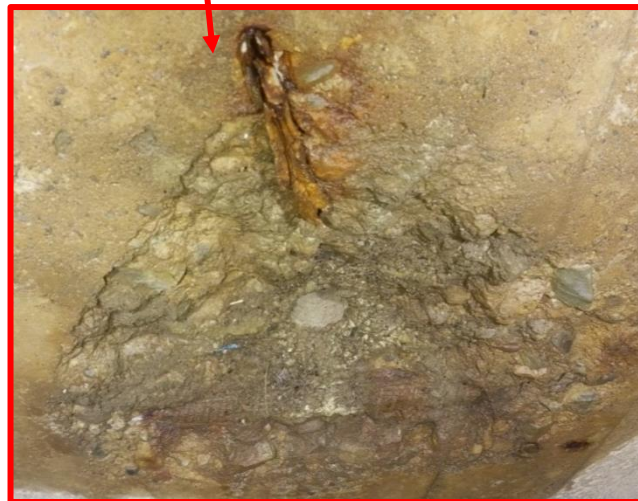
Anomaly (Y/N)	ID	Component	Component Tag	Type of Anomaly	Deg of Corrosion	Module	Level	Heat Map	Comments
Y	-	-	-	Deterioration of concrete	-	-	-	-	Deterioration of concrete and corrosion of exposed rebar

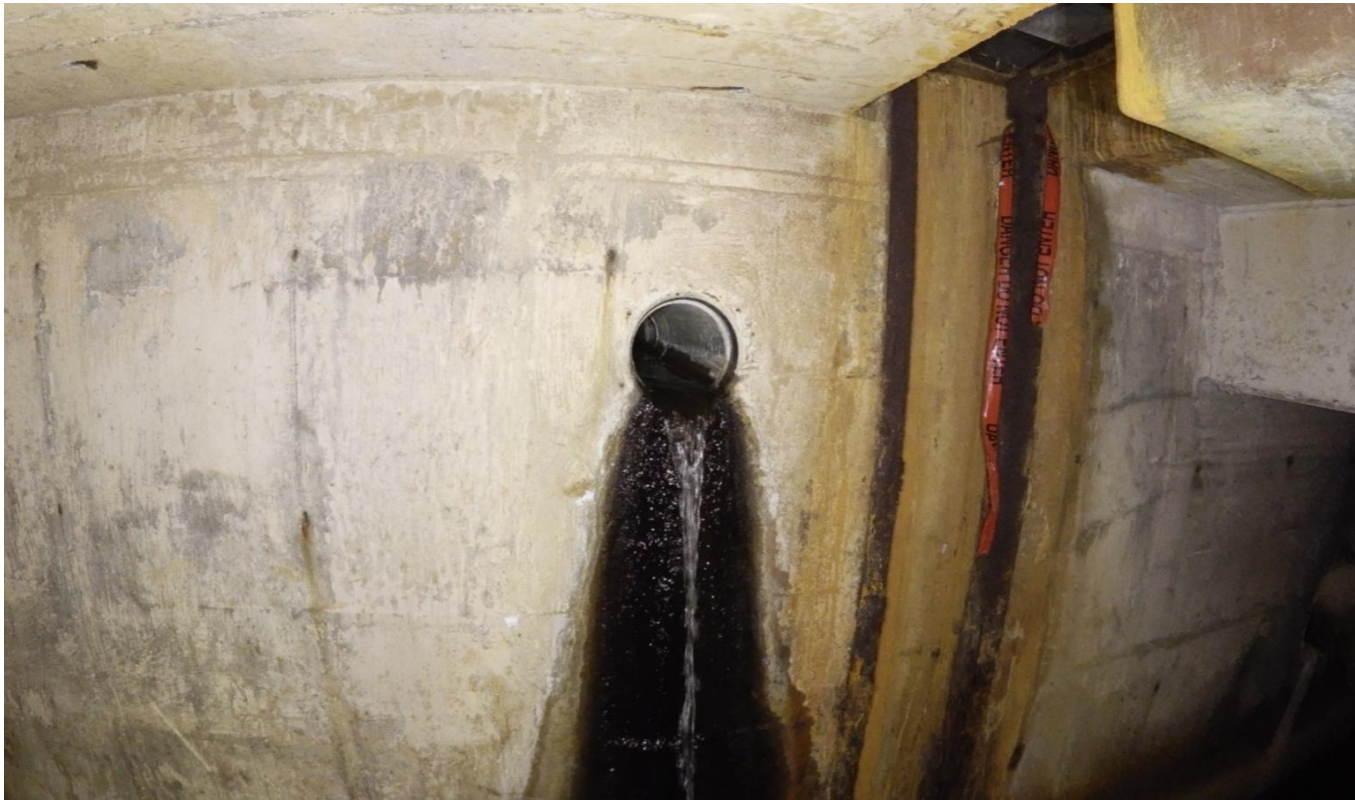
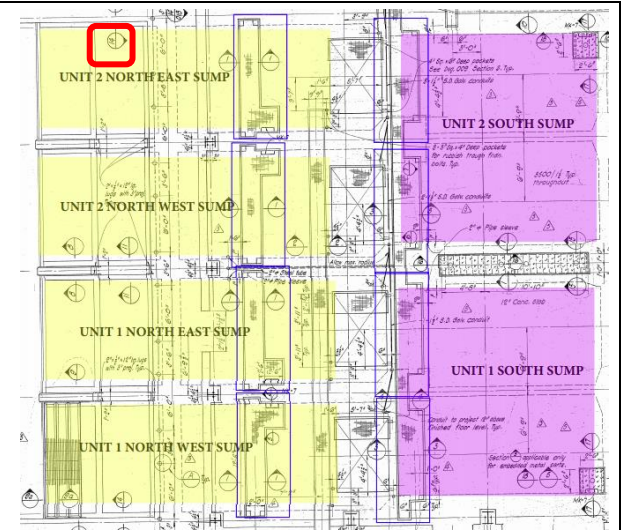
Anomaly (Y/N)	ID	Component	Component Tag	Type of Anomaly	Deg of Corrosion	Module	Level	Heat Map	Comments
N	-	-	-	-	-	-	-	-	Standoff of Northeast Sump inlet.

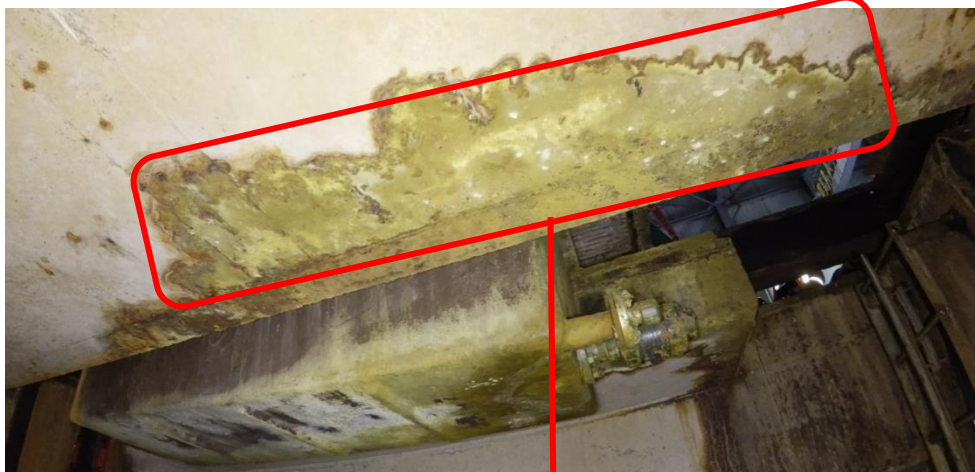
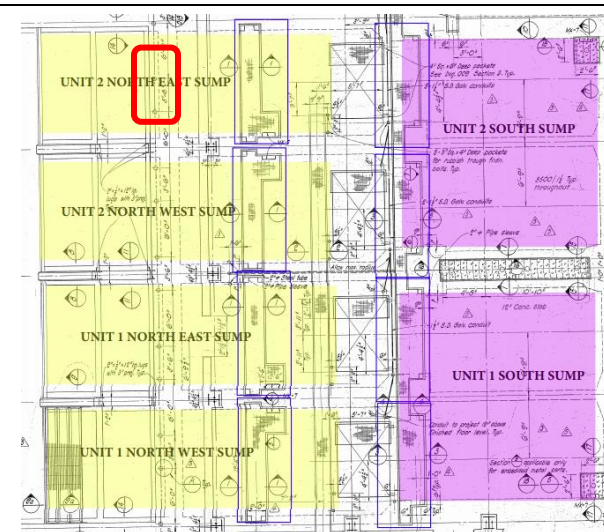
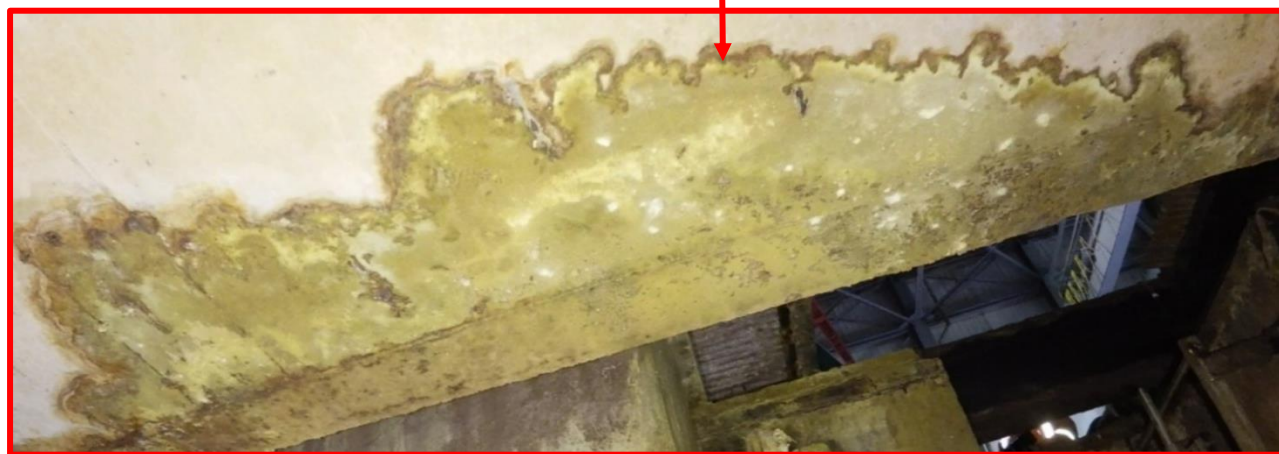
Anomaly (Y/N)	ID	Component	Component Tag	Type of Anomaly	Deg of Corrosion	Module	Level	Heat Map	Comments
Y	-	-	-	Delamination of concrete	-	-	-	-	Delamination of concrete, unit 2 NE Sump.

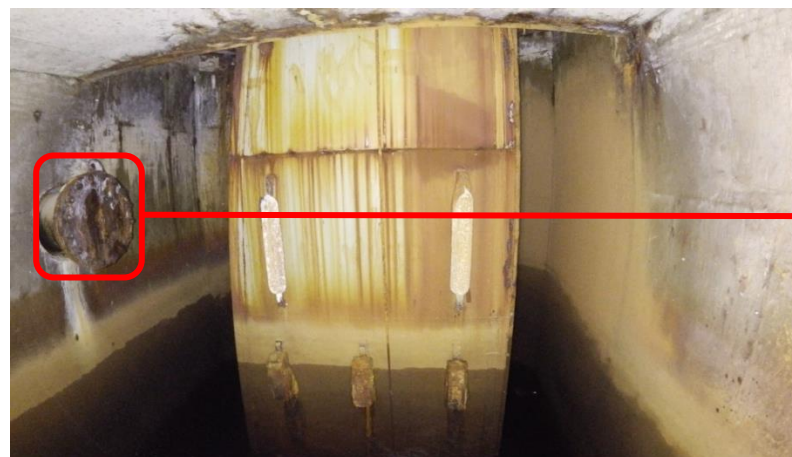
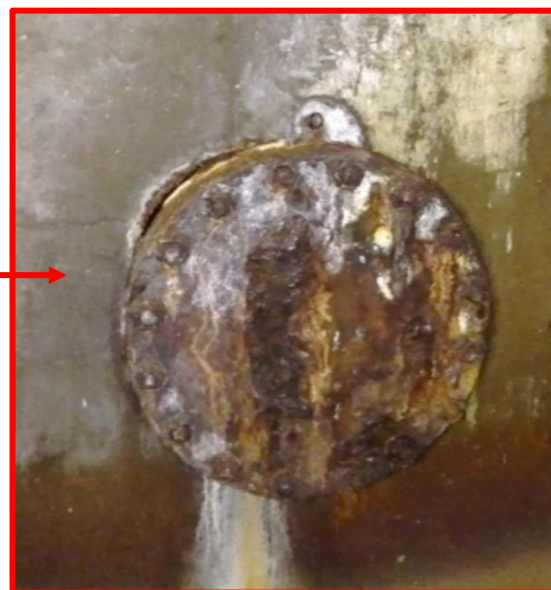
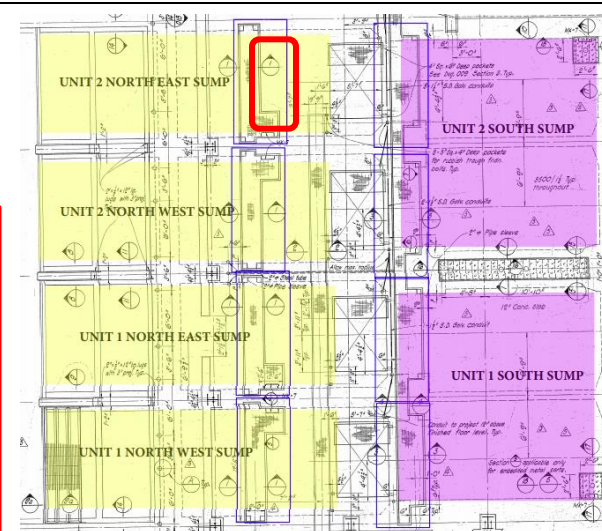
Anomaly (Y/N)	ID	Component	Component Tag	Type of Anomaly	Deg of Corrosion	Module	Level	Heat Map	Comments
Y	-	-	-	Corrosion	-	-	-	-	Substantial corrosion of blind

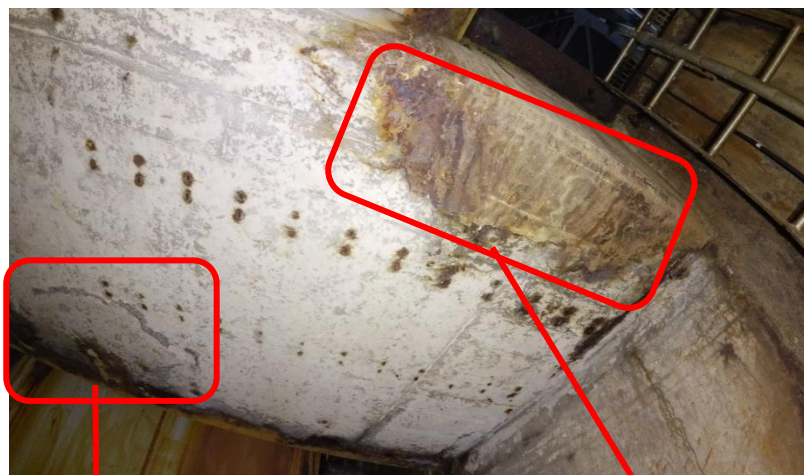
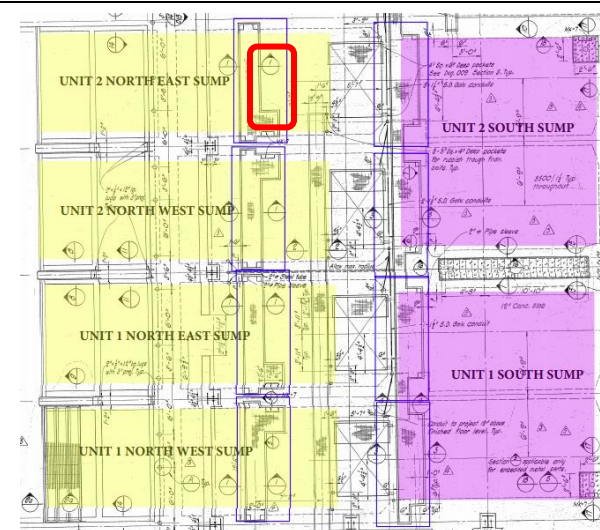
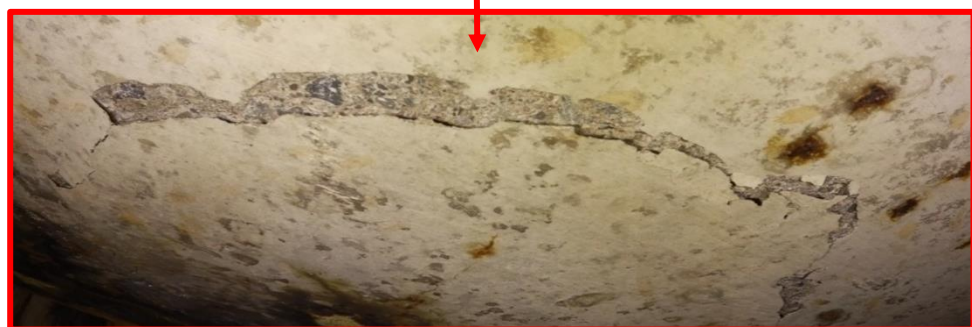
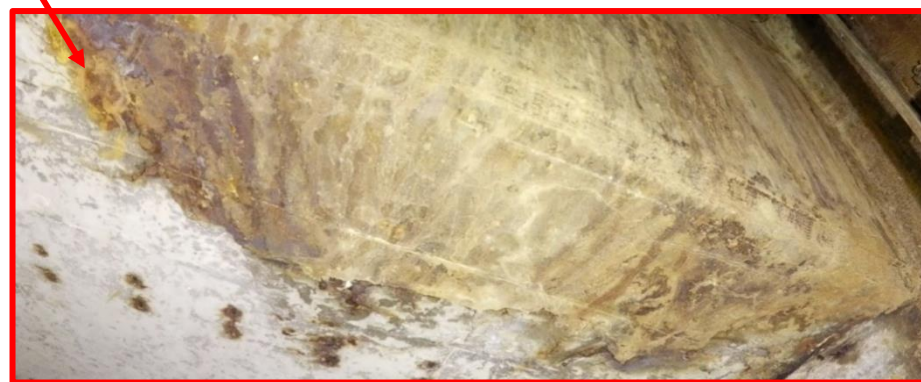
Anomaly (Y/N)	ID	Component	Component Tag	Type of Anomaly	Deg of Corrosion	Module	Level	Heat Map	Comments
Y	-	-	-	Deterioration of concrete	-	-	-	-	Delamination of concrete
