Re: *Reliability and Resource Adequacy Study Review - Assessment to Determine the Potential Long-Term Viability of the Holyrood Thermal Generating Station*

Holyrood Thermal Generating Station Condition Assessment

**Newfoundland and Labrador Hydro
HTGS Condition Assessment and Life Extension Study
Executive Summary**

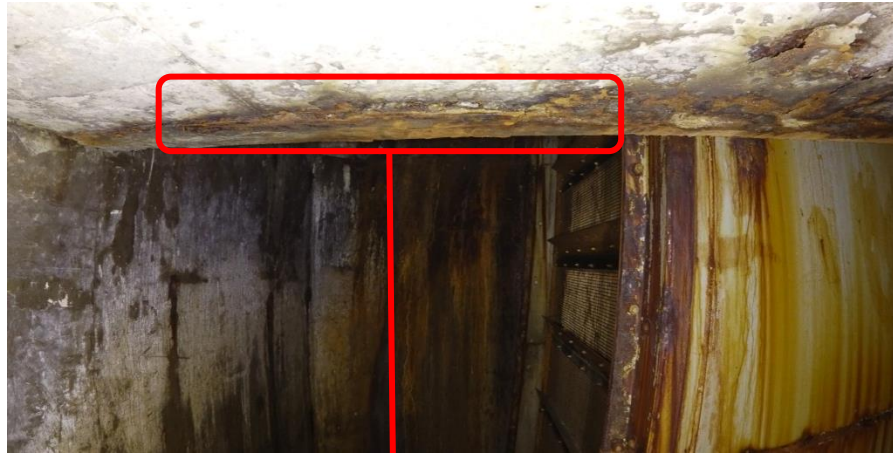
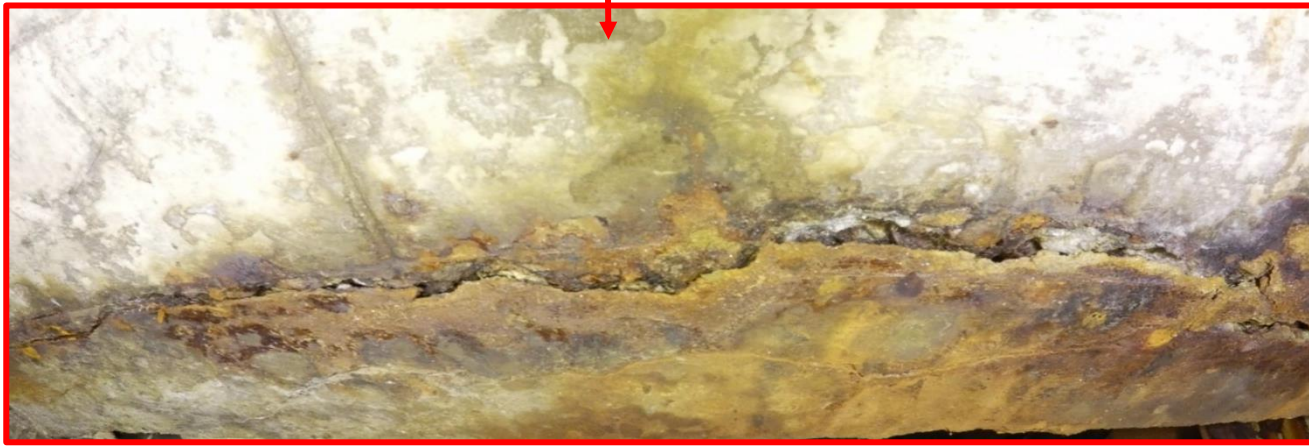
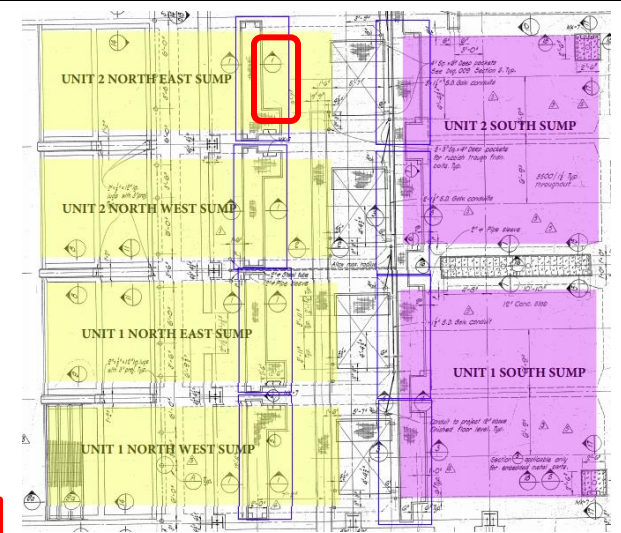
Anomaly (Y/N)	ID	Component	Component Tag	Type of Anomaly	Deg of Corrosion	Module	Level	Heat Map	Comments
Y	-	-	-	Deterioration of concrete	-	-	-	-	Delamination of concrete

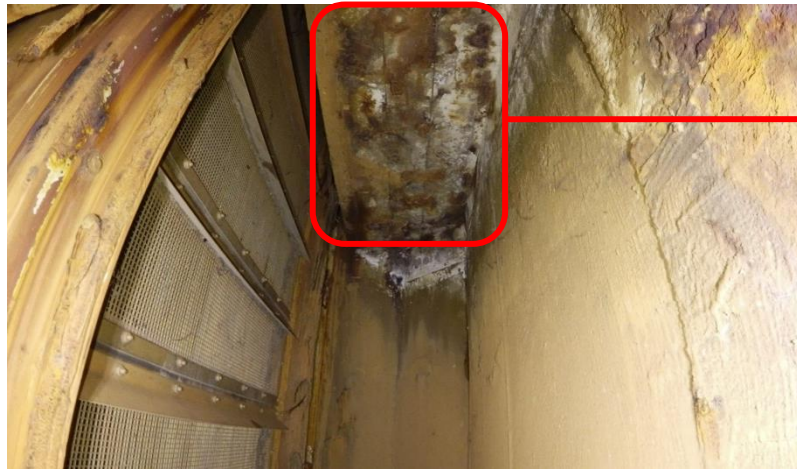
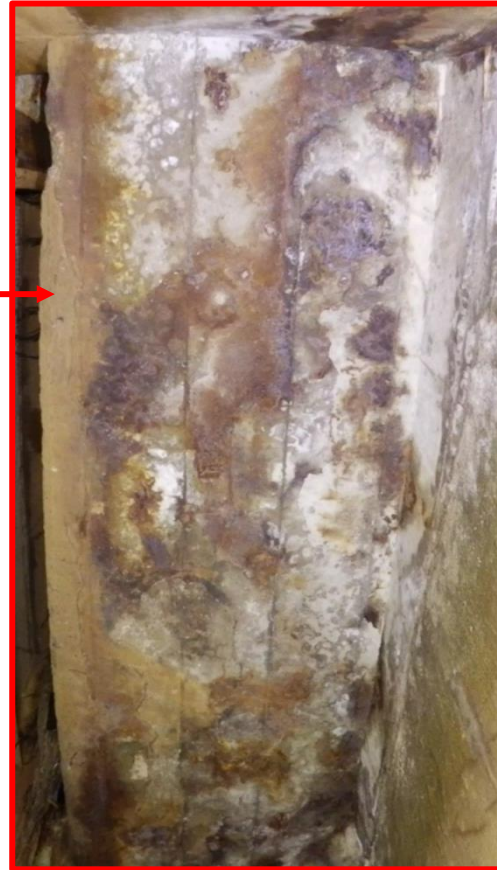
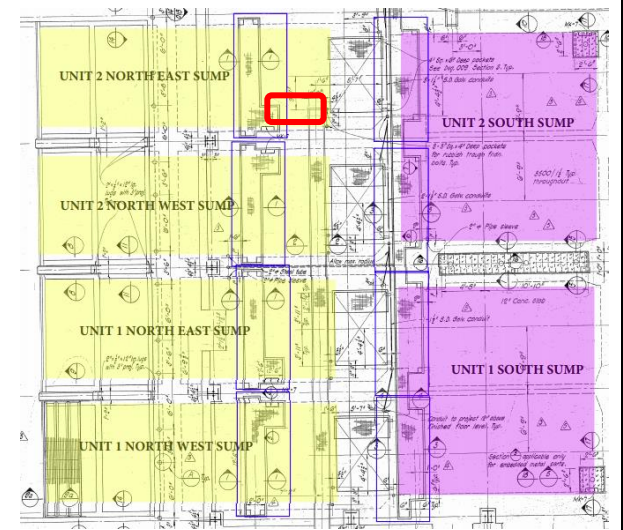
Anomaly (Y/N)	ID	Component	Component Tag	Type of Anomaly	Deg of Corrosion	Module	Level	Heat Map	Comments
Y	-	-	-	Deterioration of concrete	-	-	-	-	Deterioration of concrete

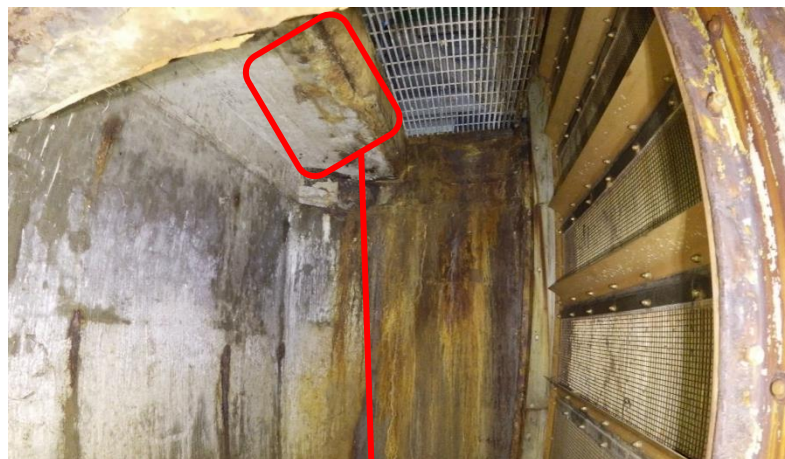
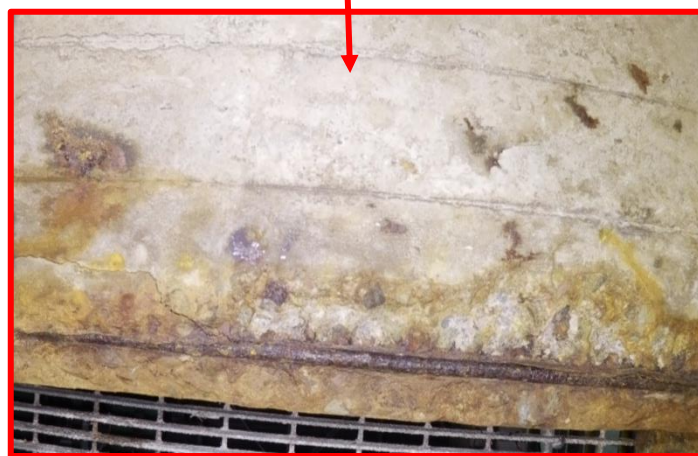
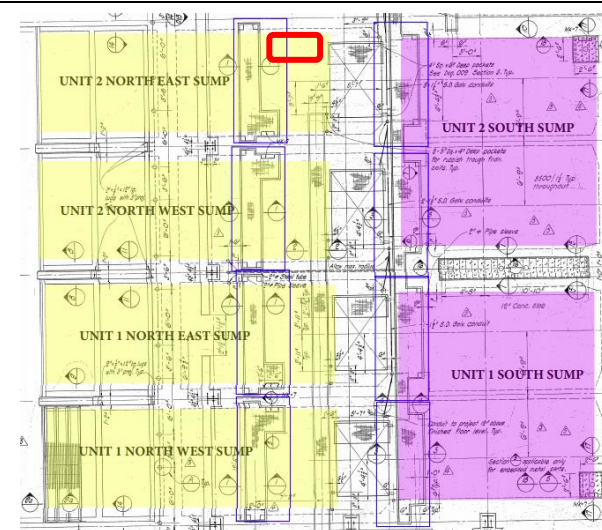
Anomaly (Y/N)	ID	Component	Component Tag	Type of Anomaly	Deg of Corrosion	Module	Level	Heat Map	Comments
Y	-	-	-	Deterioration of concrete	-	-	-	-	Deterioration of concrete and corrosion to exposed rebar

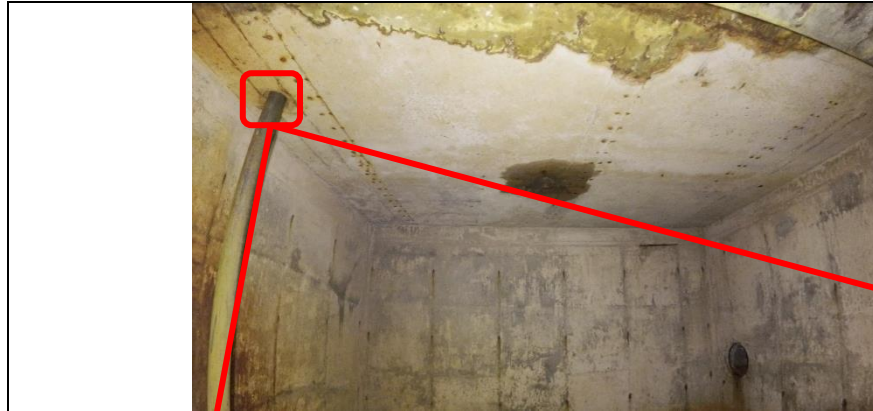
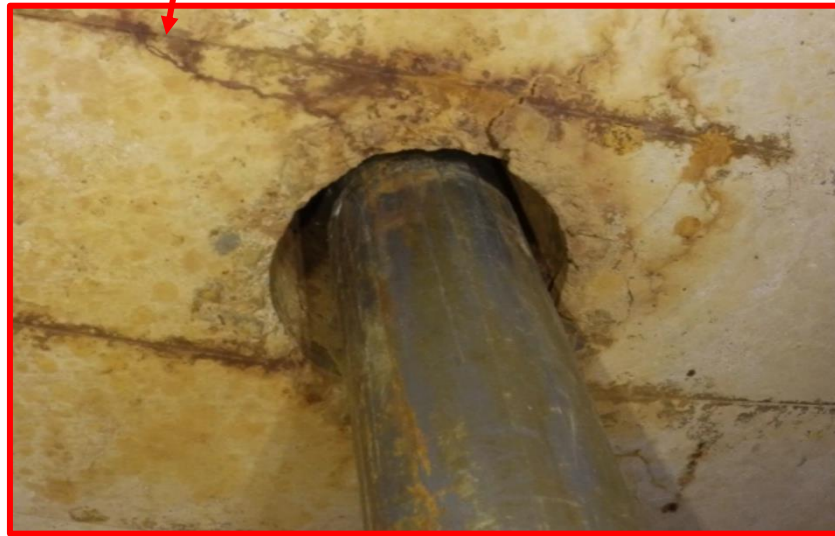
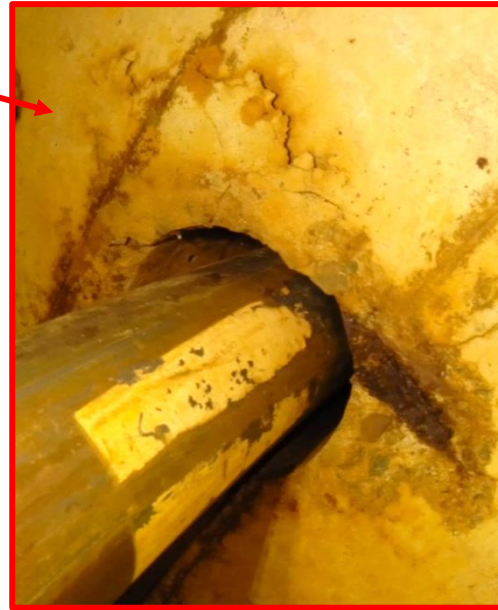
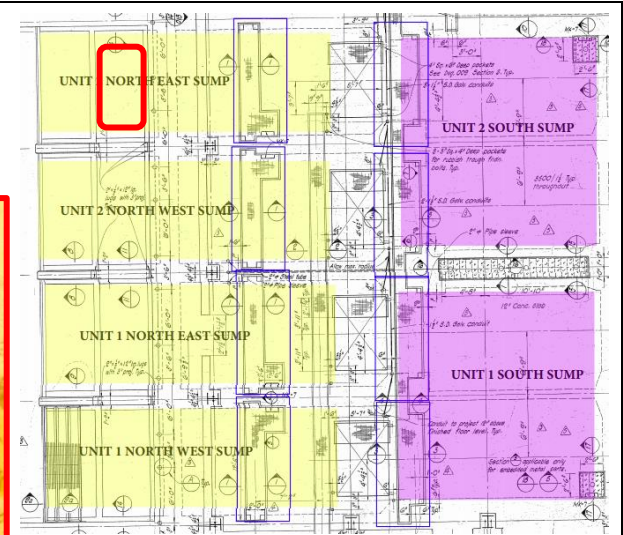
Anomaly (Y/N)	ID	Component	Component Tag	Type of Anomaly	Deg of Corrosion	Module	Level	Heat Map	Comments
Y	-	-	-	Deterioration of concrete	-	-	-	-	Spalling around piping penetration

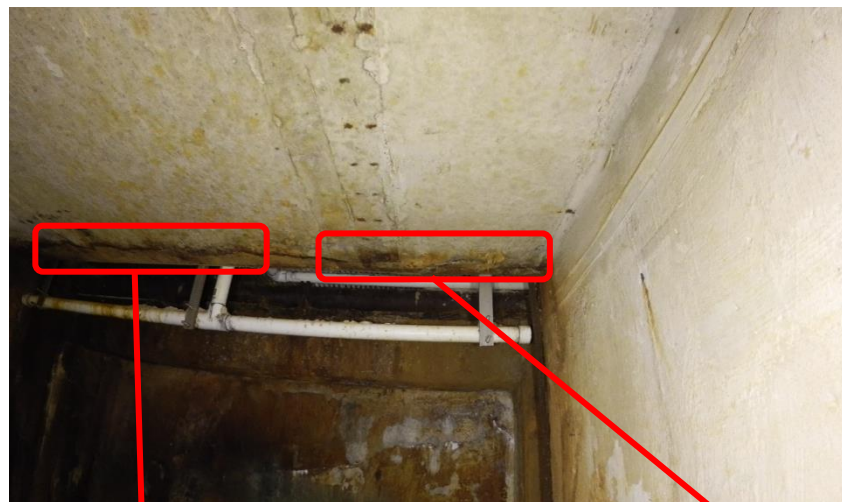
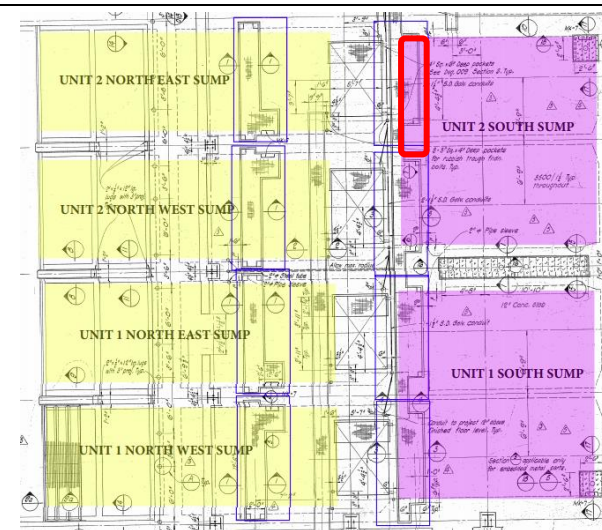
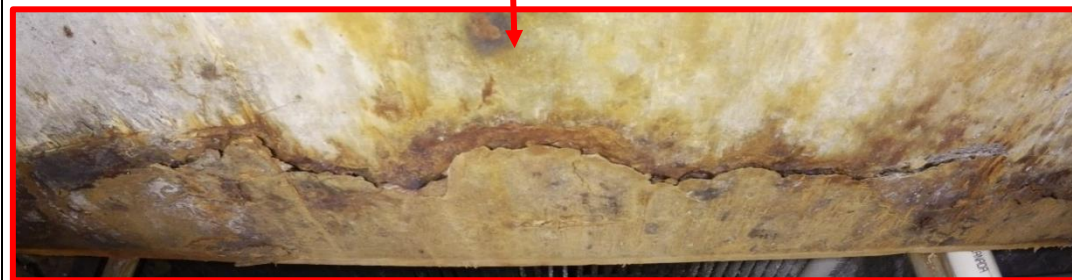
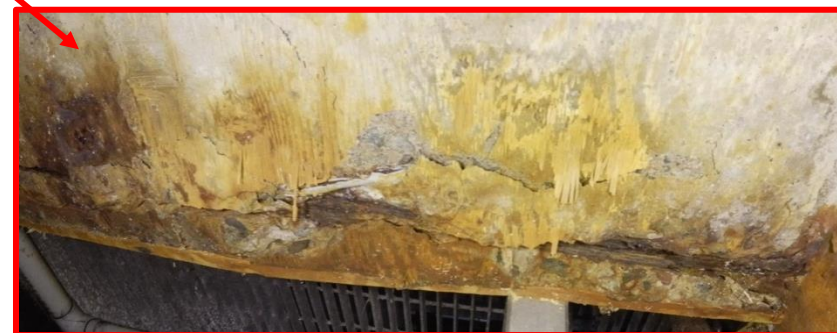
Anomaly (Y/N)	ID	Component	Component Tag	Type of Anomaly	Deg of Corrosion	Module	Level	Heat Map	Comments
Y	-	-	-	Deterioration of concrete	-	-	-	-	Delamination of concrete and corrosion of rebar

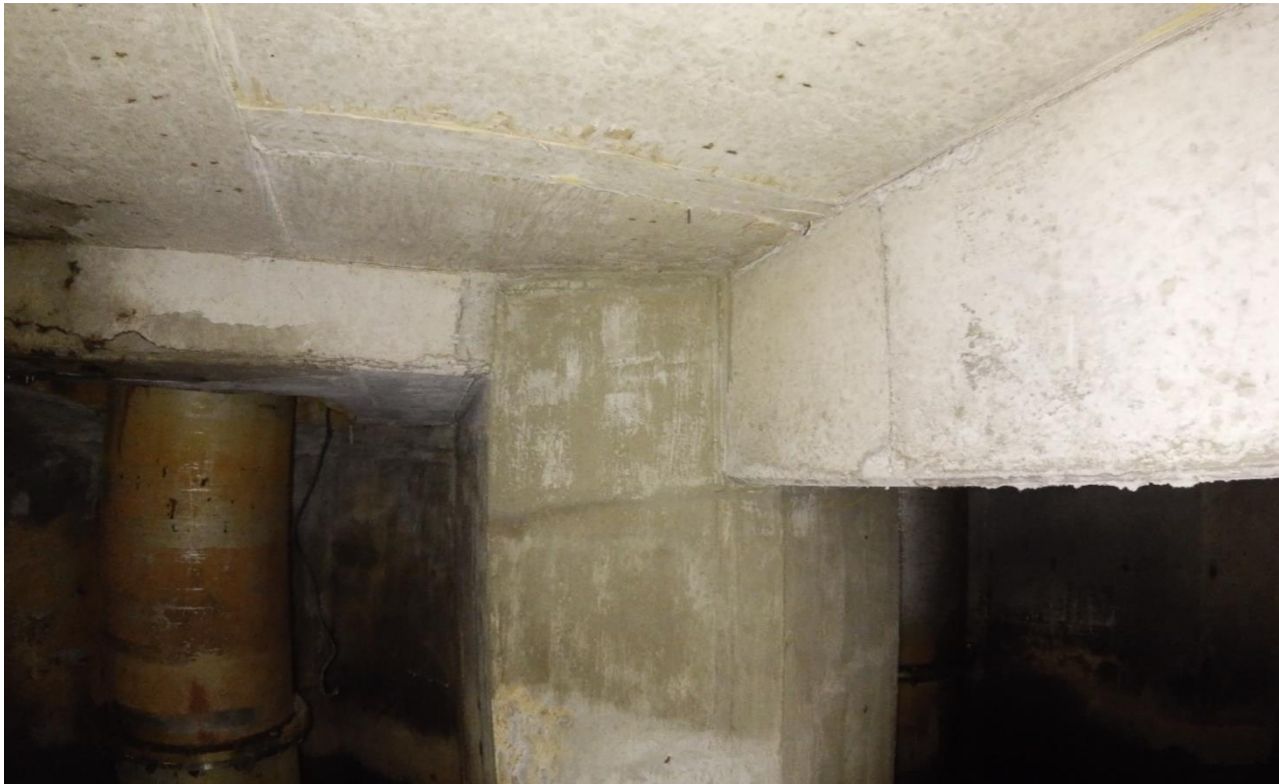
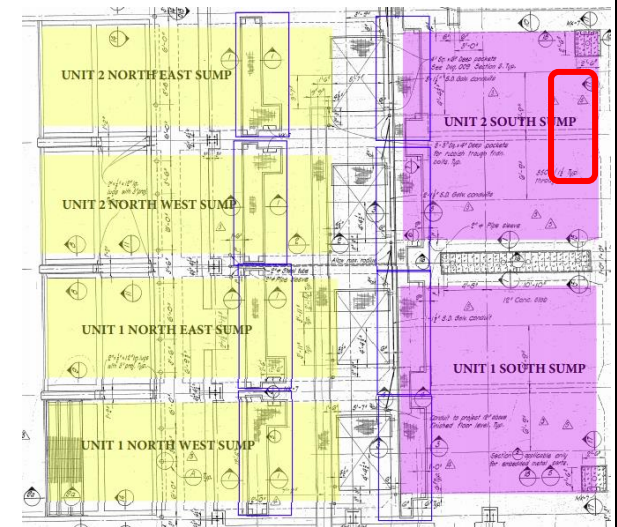
Anomaly (Y/N)	ID	Component	Component Tag	Type of Anomaly	Deg of Corrosion	Module	Level	Heat Map	Comments
N	-	-	-	-	-	-	-	-	Stand off unit 2 south.

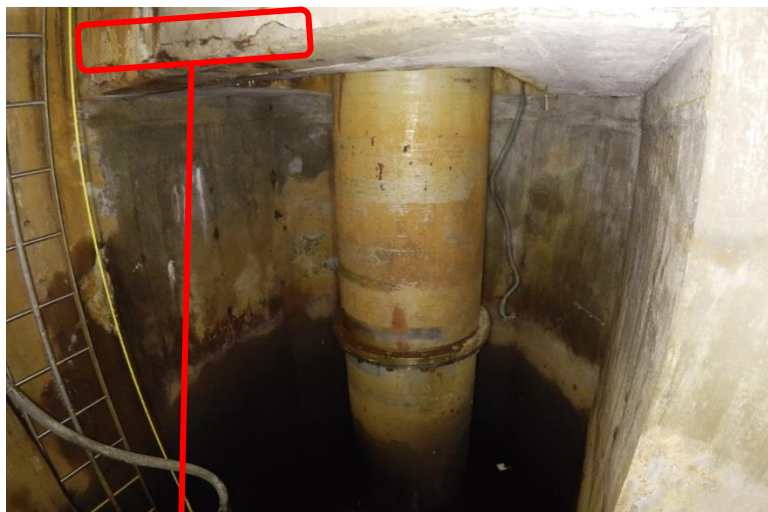
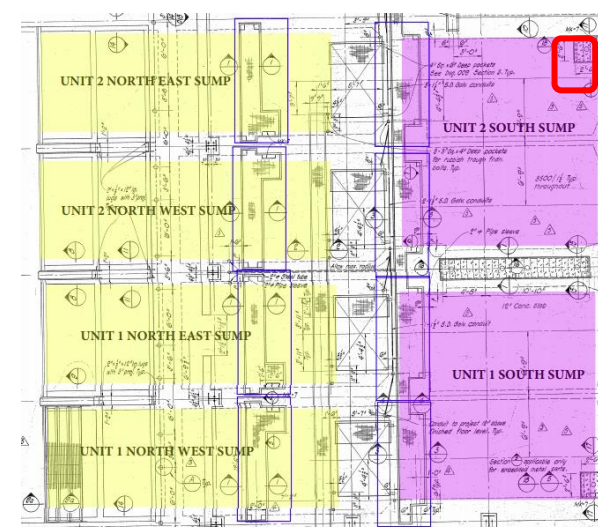
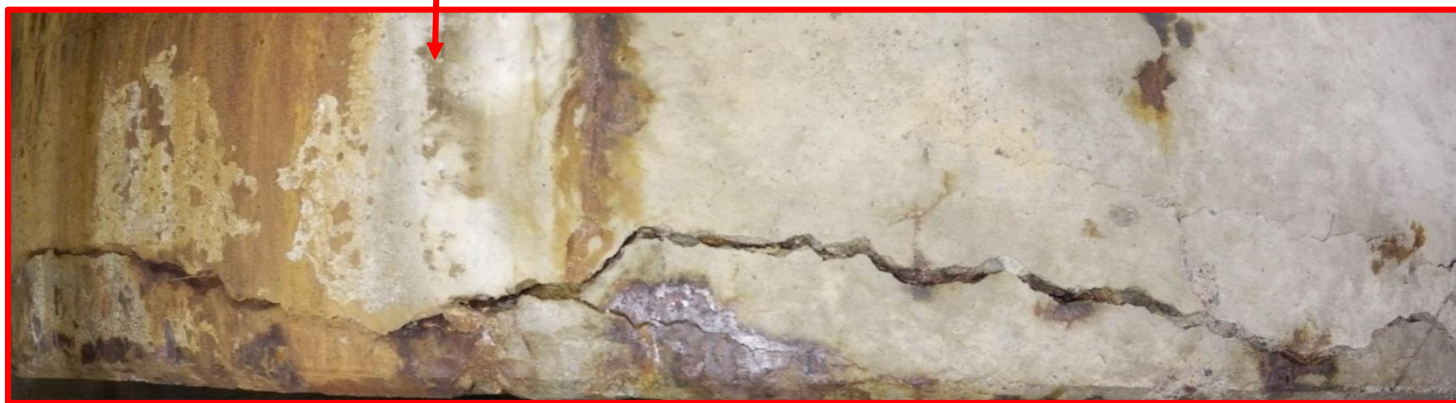
Anomaly (Y/N)	ID	Component	Component Tag	Type of Anomaly	Deg of Corrosion	Module	Level	Heat Map	Comments
Y	-	-	-	Crack	-	-	-	-	Substantial cracking near entry point/intake area.

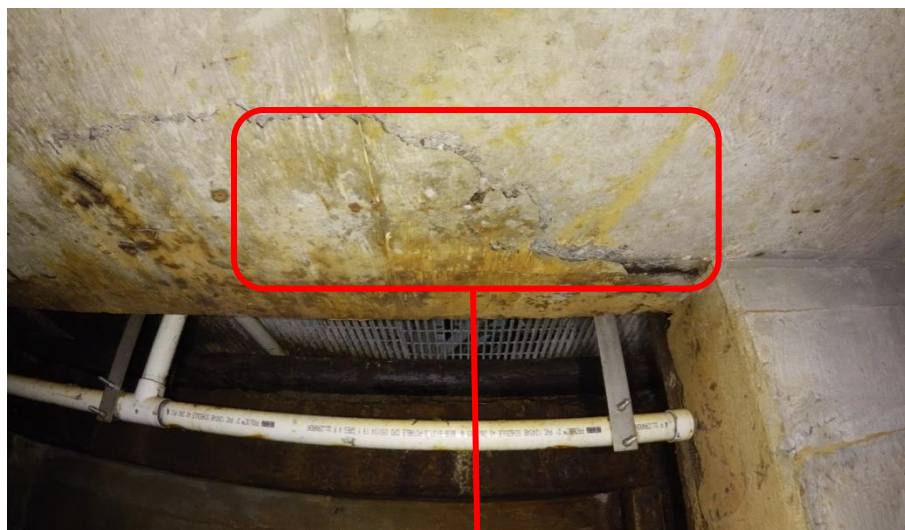
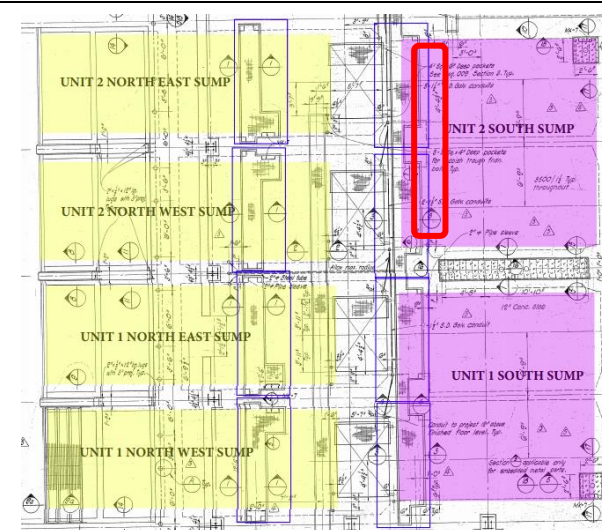
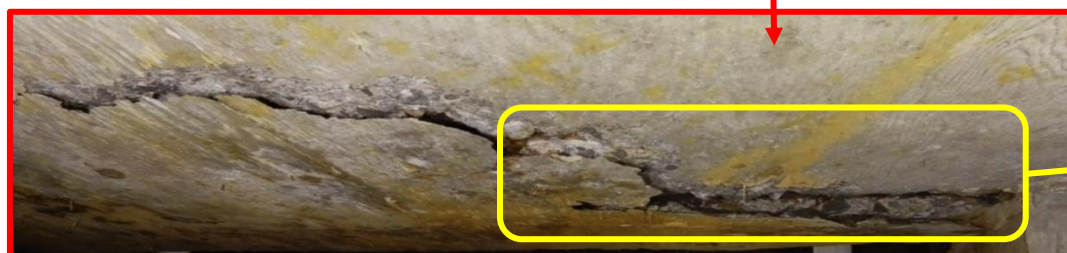
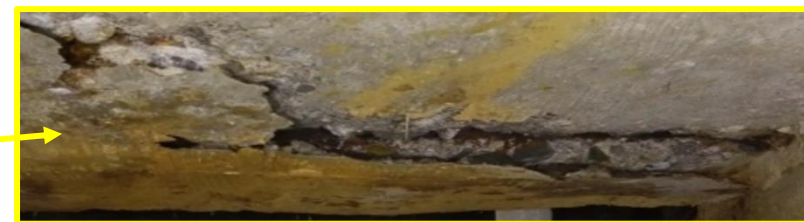
Anomaly (Y/N)	ID	Component	Component Tag	Type of Anomaly	Deg of Corrosion	Module	Level	Heat Map	Comments
Y	-	-	-	Deterioration of concrete	-	-	-	-	Delamination of concrete

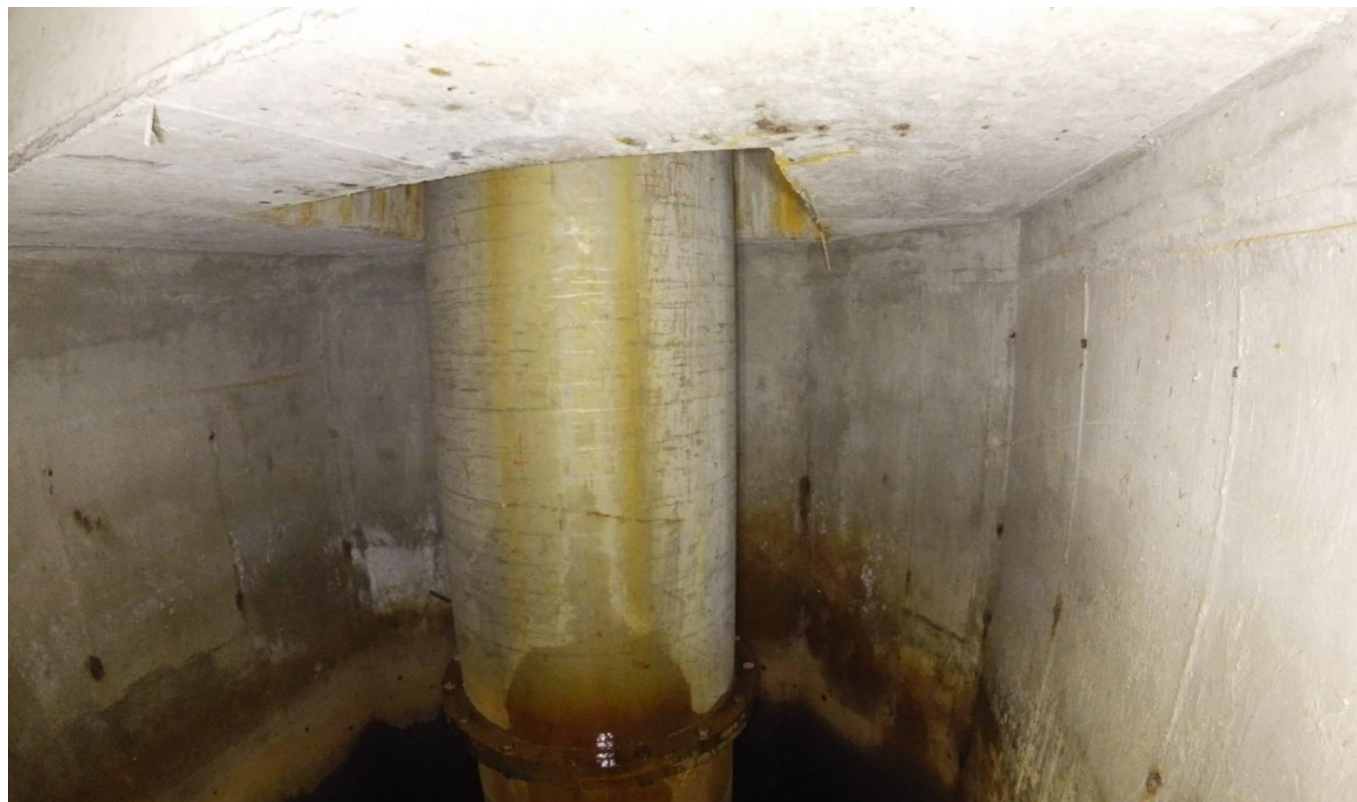
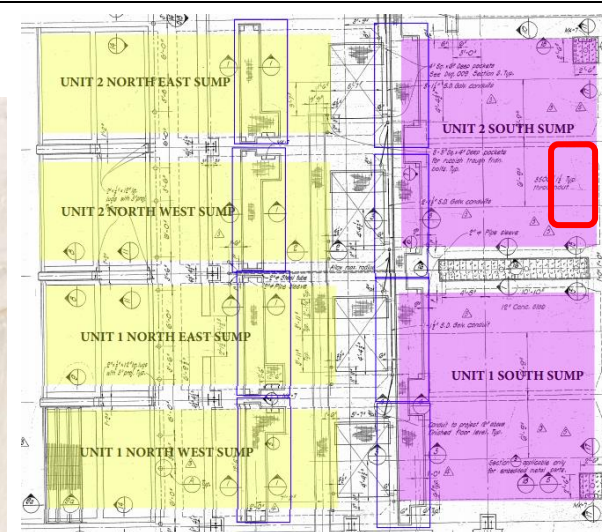
Anomaly (Y/N)	ID	Component	Component Tag	Type of Anomaly	Deg of Corrosion	Module	Level	Heat Map	Comments
N	-	-	-	-	-	-	-	-	Stand off south end intake area.

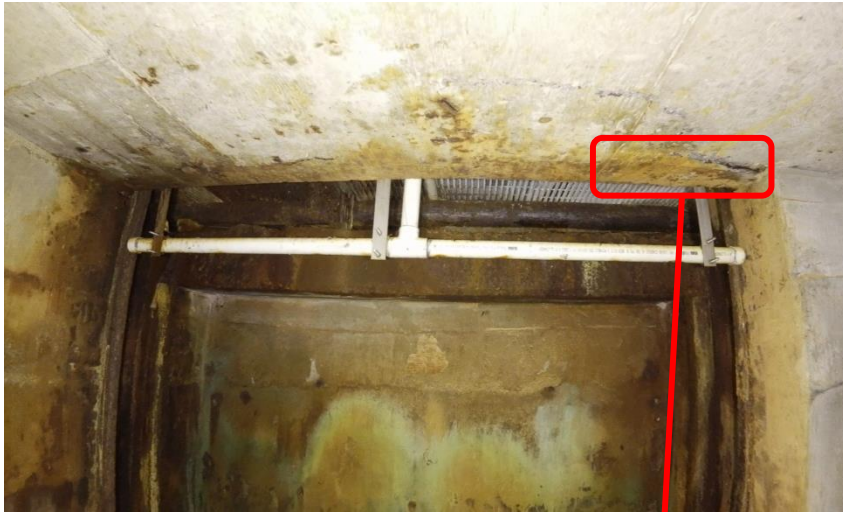
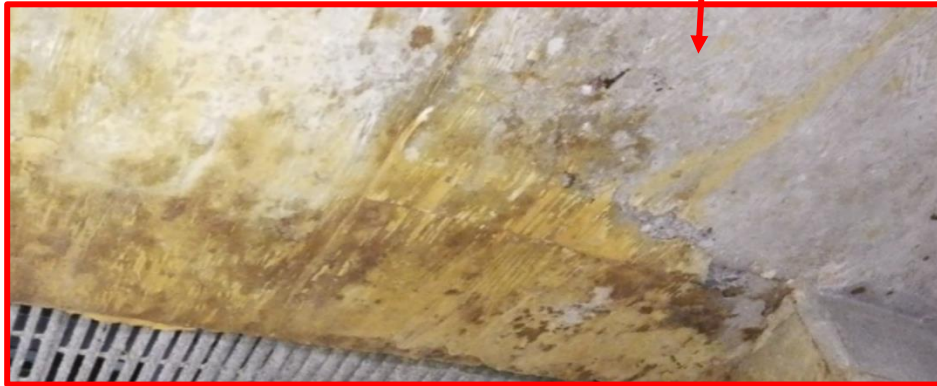
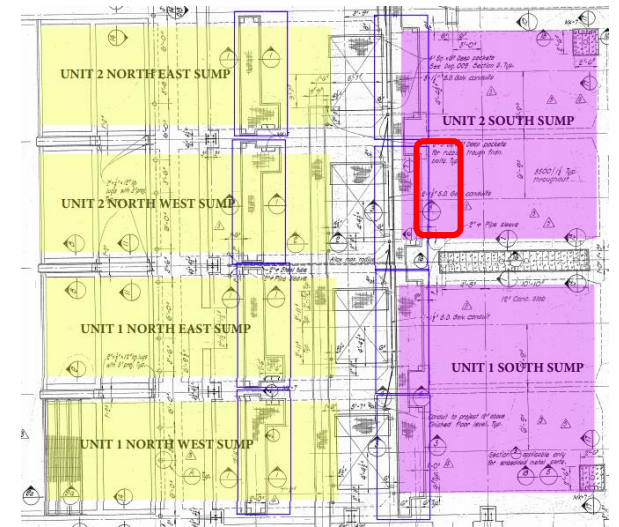
Anomaly (Y/N)	ID	Component	Component Tag	Type of Anomaly	Deg of Corrosion	Module	Level	Heat Map	Comments
Y	-	-	-	Deterioration of concrete	-	-	-	-	Delamination of concrete

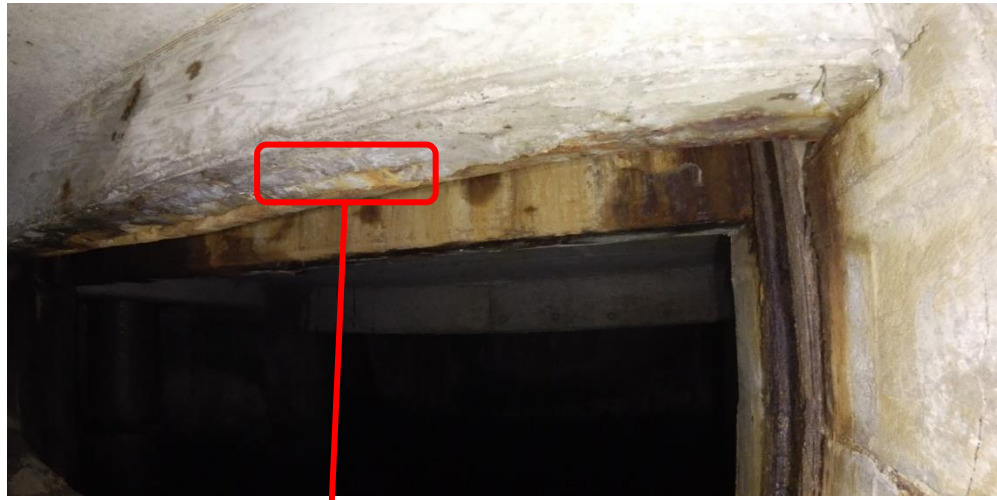
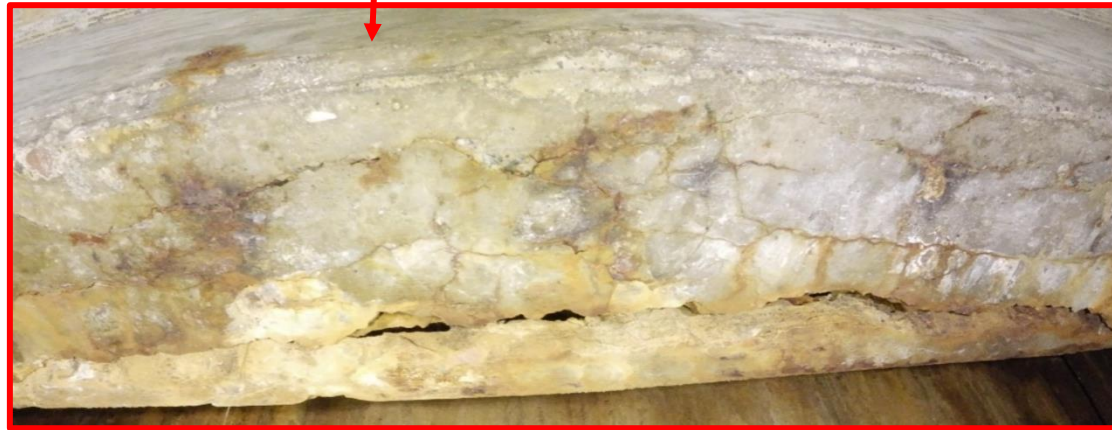
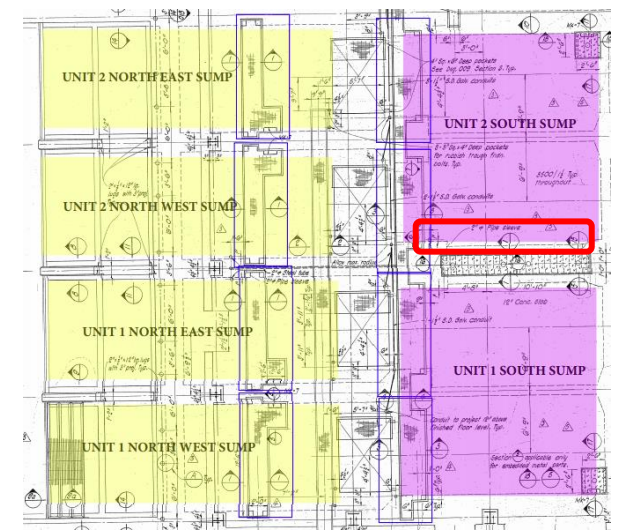
Anomaly (Y/N)	ID	Component	Component Tag	Type of Anomaly	Deg of Corrosion	Module	Level	Heat Map	Comments
Y	-	-	-	Deterioration of concrete	-	-	-	-	Cracking and corrosion

Recommendations from the inspection team would be to keeping monitoring the area at intervals identified in an asset integrity plan If one exists.

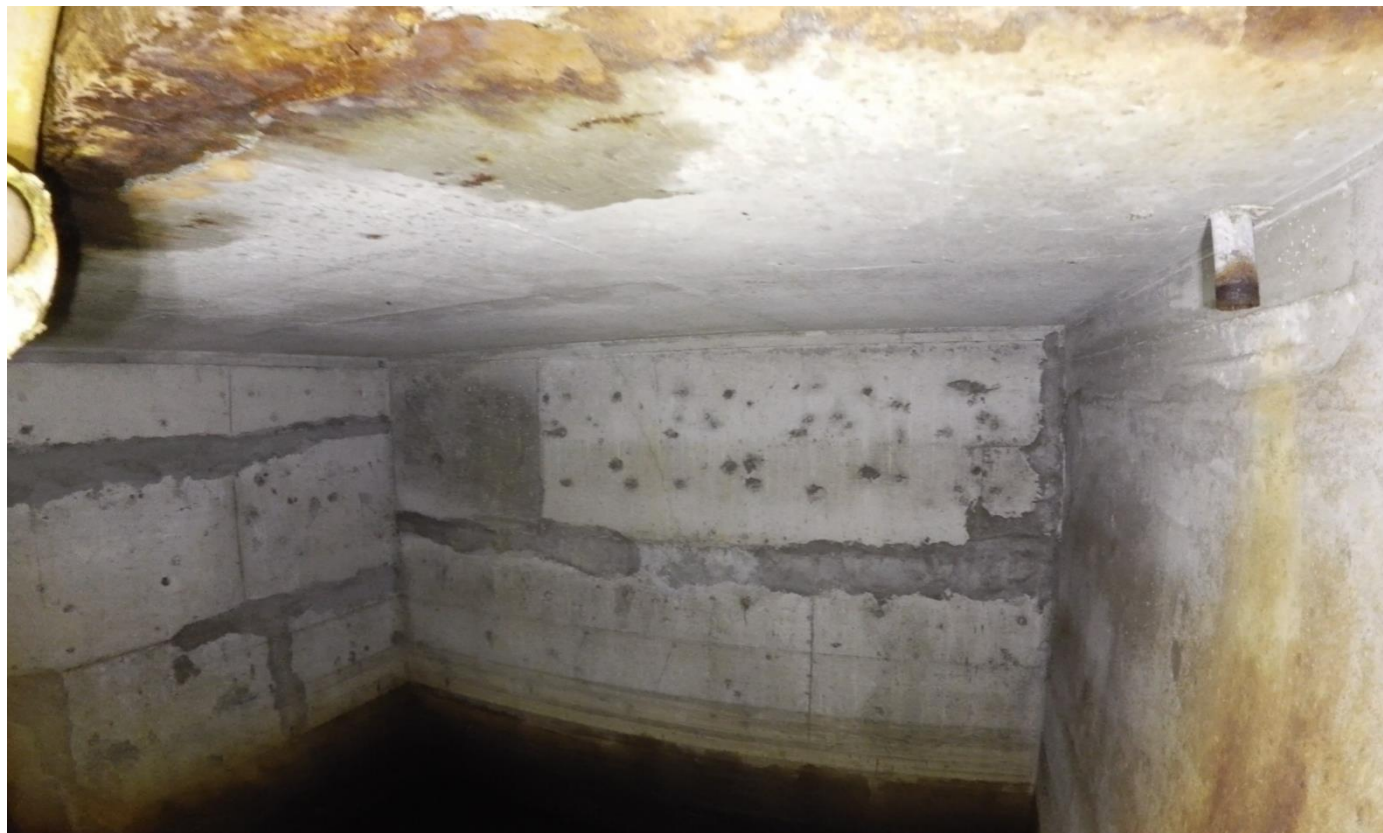
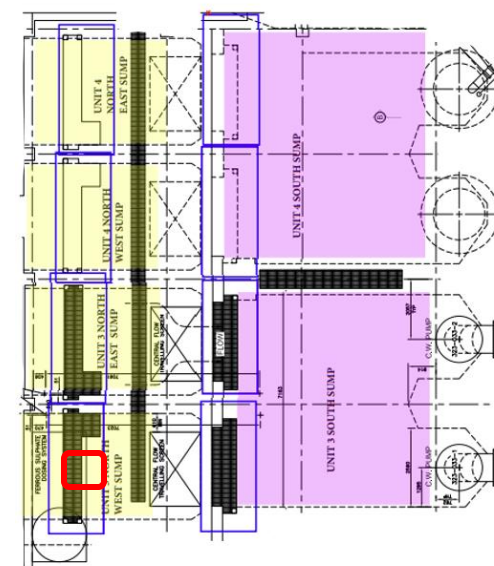
Anomaly (Y/N)	ID	Component	Component Tag	Type of Anomaly	Deg of Corrosion	Module	Level	Heat Map	Comments
N	-	-	-	-	-	-	-	-	Standoff of walls and top.

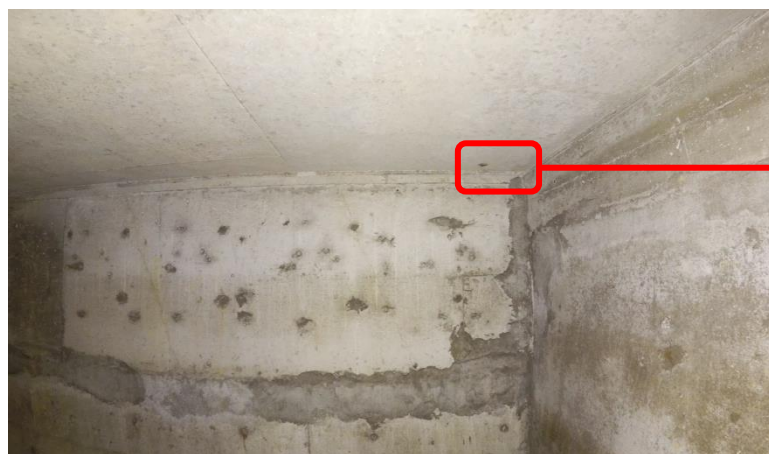
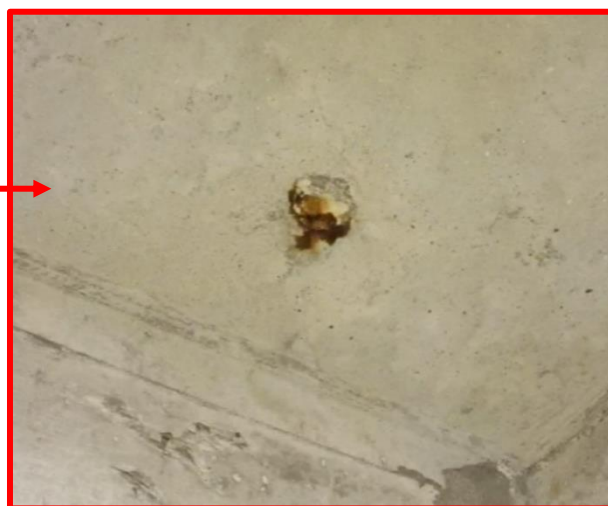
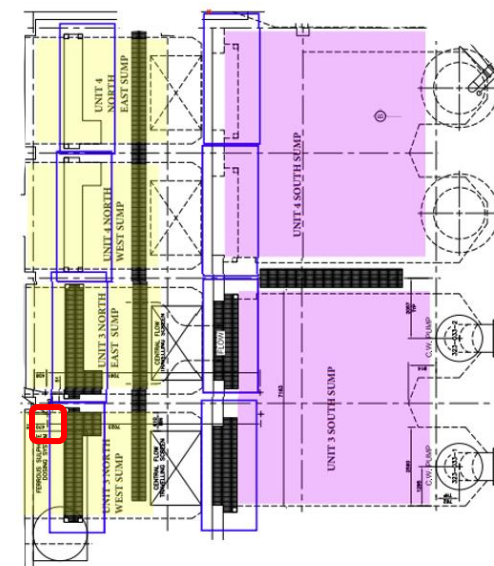
Anomaly (Y/N)	ID	Component	Component Tag	Type of Anomaly	Deg of Corrosion	Module	Level	Heat Map	Comments
Y	-	-	-	Deterioration of concrete	-	-	-	-	Deterioration of concrete.

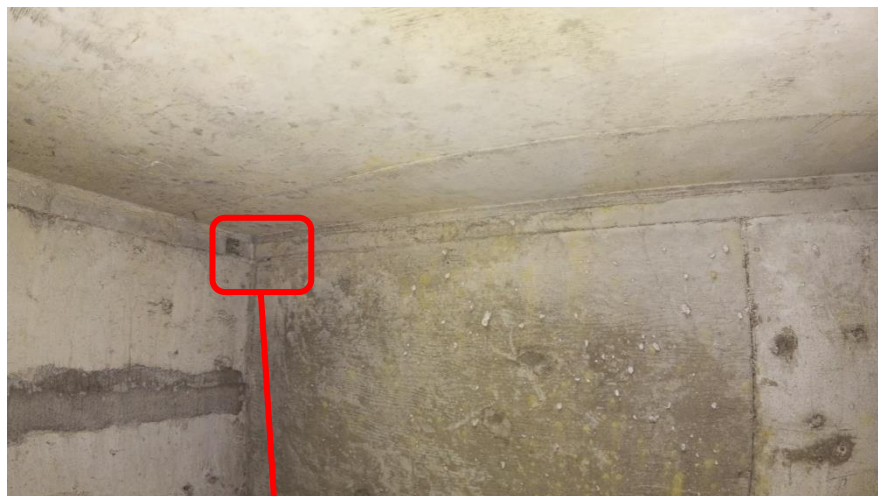
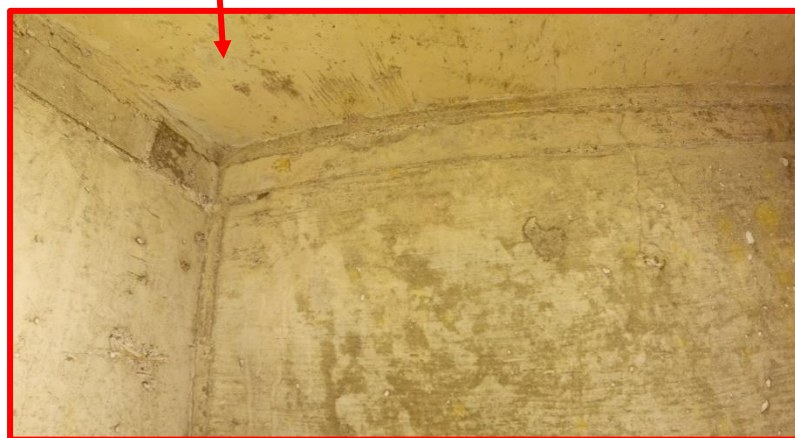
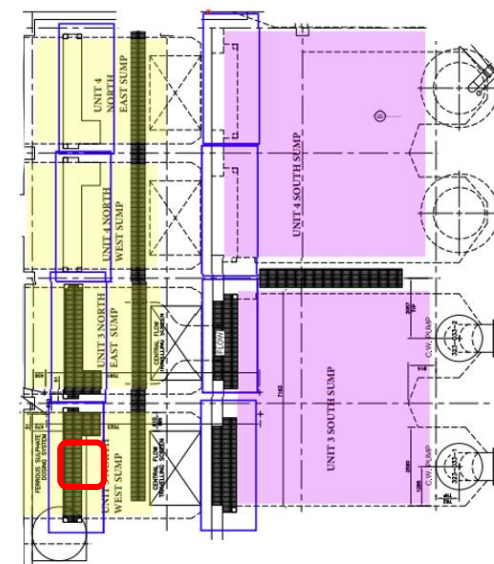
Anomaly (Y/N)	ID	Component	Component Tag	Type of Anomaly	Deg of Corrosion	Module	Level	Heat Map	Comments
N	-	-	-	-	-	-	-	-	General overview wall and ceiling and close up of corner seams.

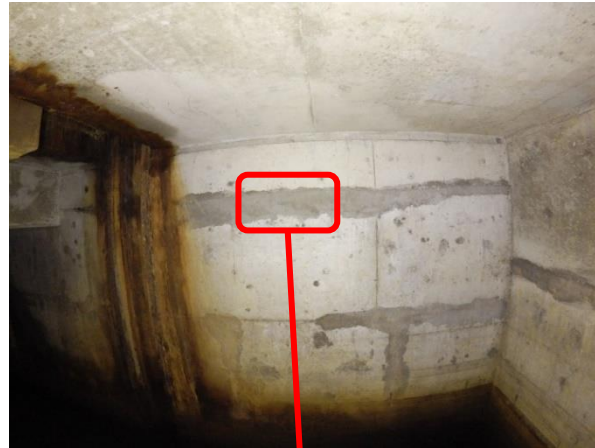
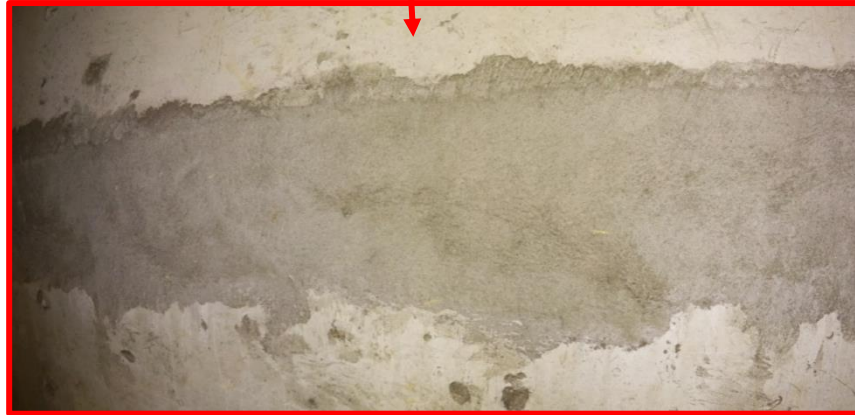
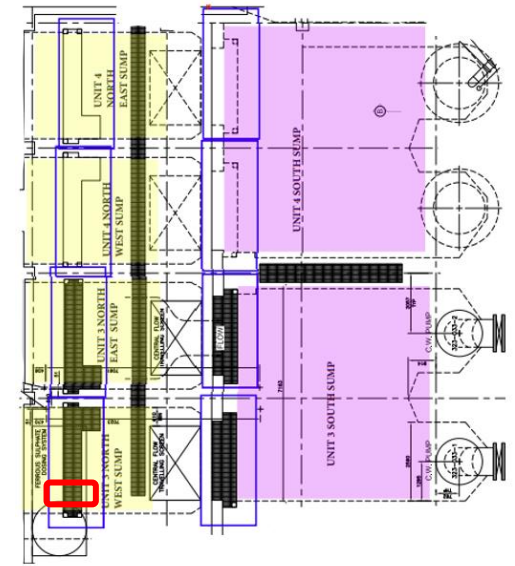
Anomaly (Y/N)	ID	Component	Component Tag	Type of Anomaly	Deg of Corrosion	Module	Level	Heat Map	Comments
Y	-	-	-	Repair	-	-	-	-	Repairs to concrete noted throughout.

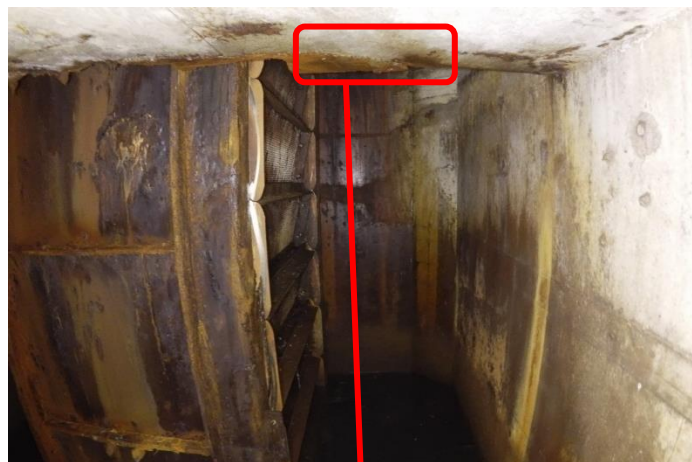
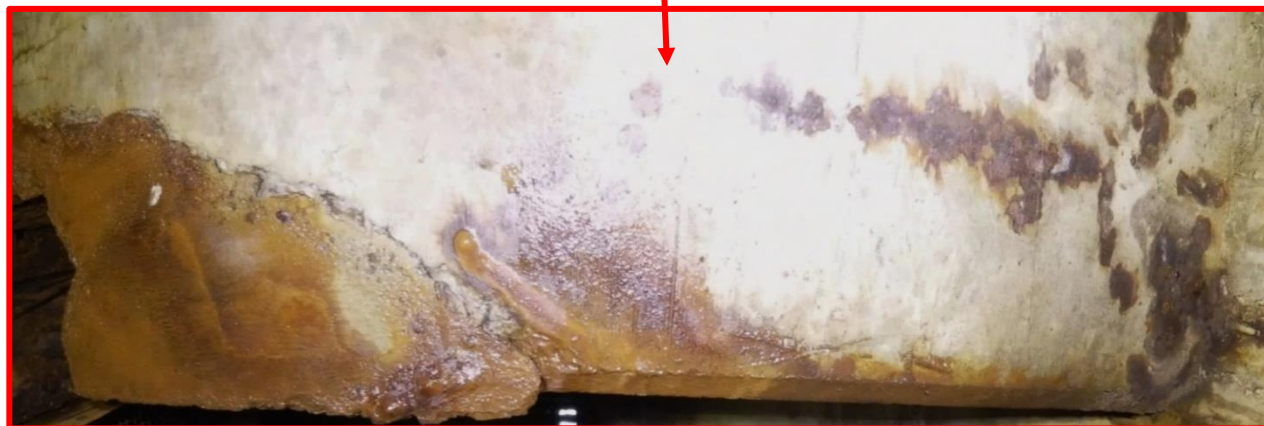
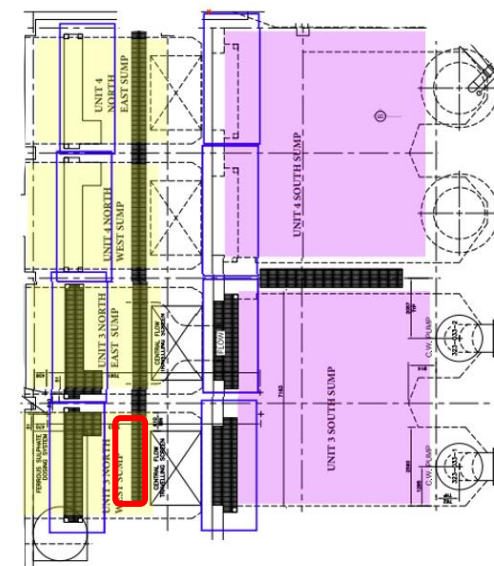
Anomaly (Y/N)	ID	Component	Component Tag	Type of Anomaly	Deg of Corrosion	Module	Level	Heat Map	Comments
Y	-	-	-	Deterioration of concrete	-	-	-	-	Concrete deterioration occurring on ceiling of sump/w corrosion of rebar.

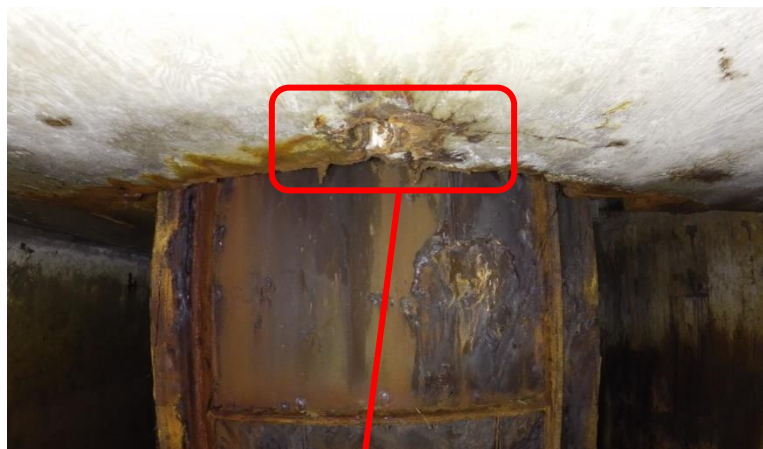
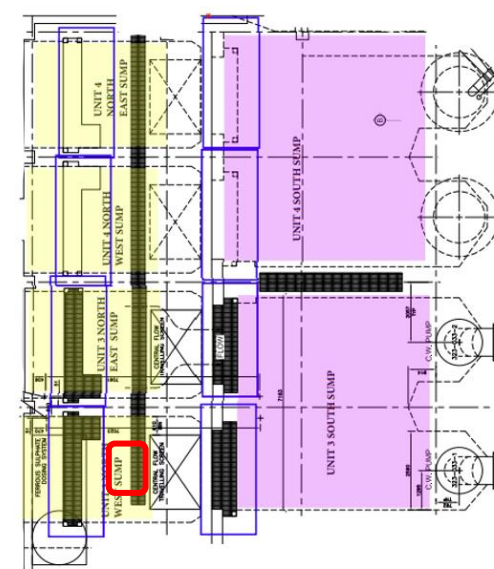
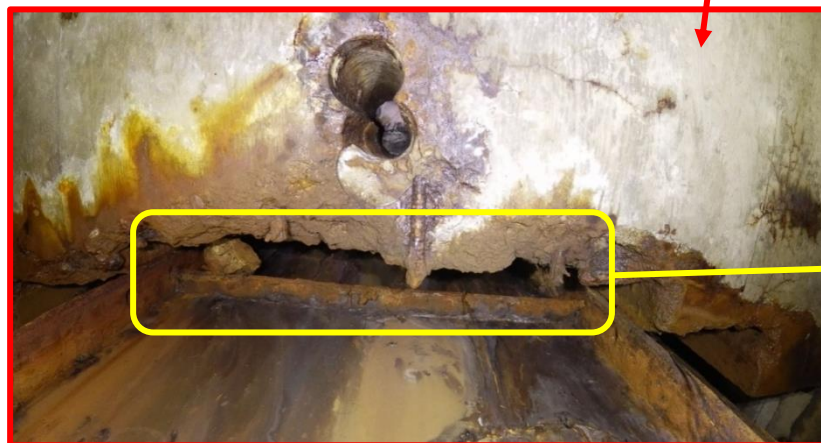
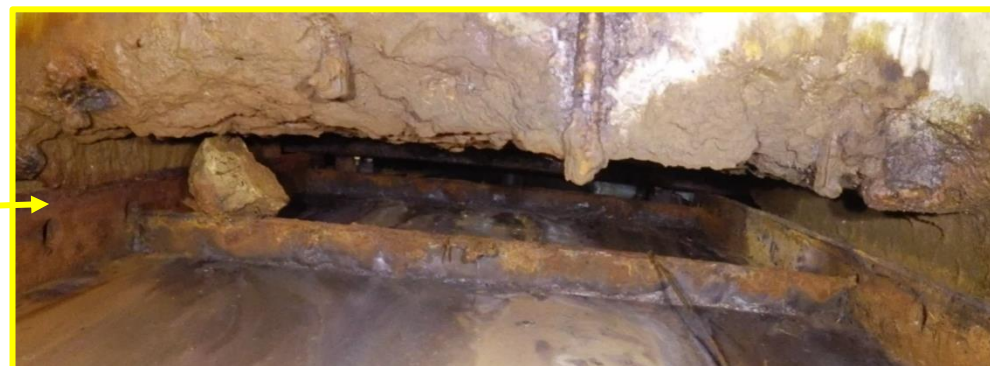
Anomaly (Y/N)	ID	Component	Component Tag	Type of Anomaly	Deg of Corrosion	Module	Level	Heat Map	Comments
Y	-	-	-	Deterioration of concrete	-	-	-	-	Concrete deteriorating and corrosion of rebar.

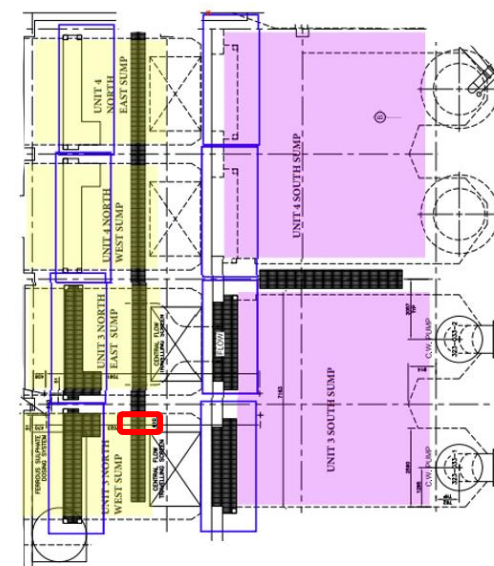
Anomaly (Y/N)	ID	Component	Component Tag	Type of Anomaly	Deg of Corrosion	Module	Level	Heat Map	Comments
Y	-	-	-	Deterioration of concrete	-	-	-	-	General overview of south end of sump, around the traveling screens. Noted throughout.
