Re: *Reliability and Resource Adequacy Study Review - Assessment to Determine the Potential Long-Term Viability of the Holyrood Thermal Generating Station*

Holyrood Thermal Generating Station Condition Assessment

**Newfoundland and Labrador Hydro
HTGS Condition Assessment and Life Extension Study
Executive Summary**

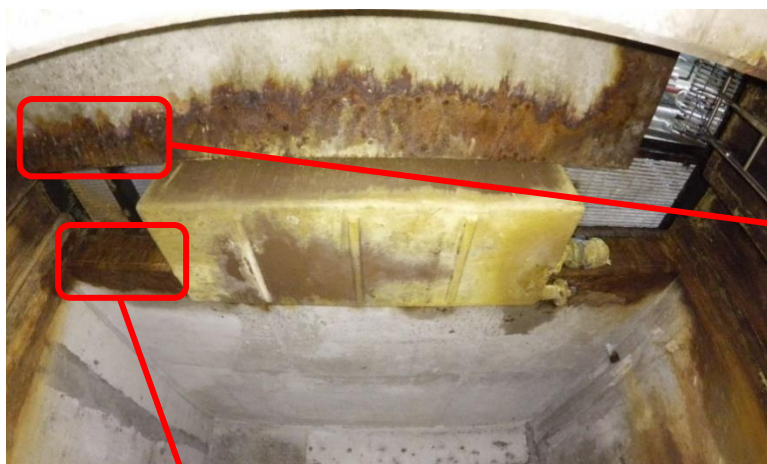
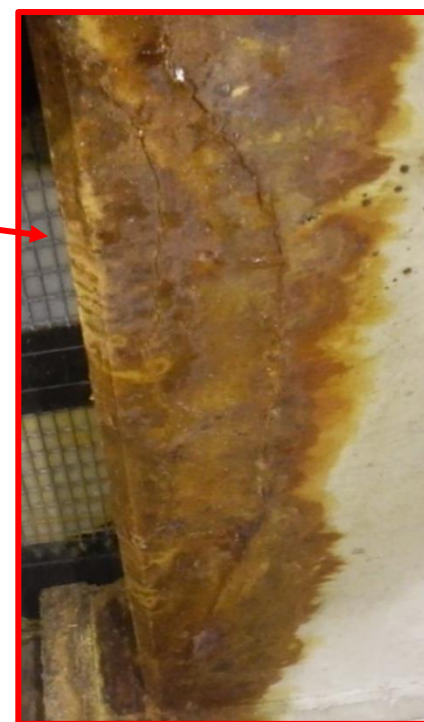
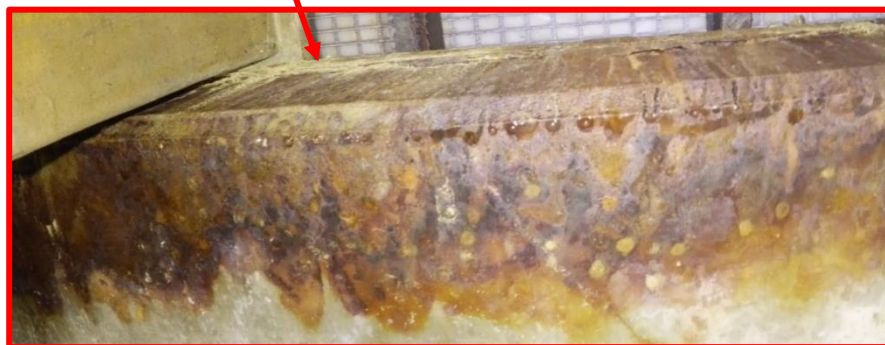
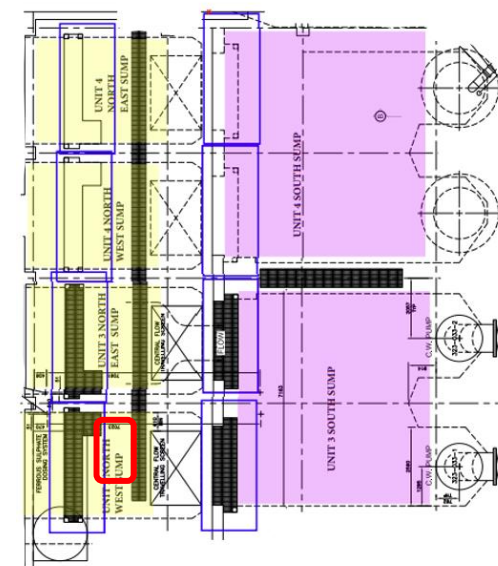
Anomaly (Y/N)	ID	Component	Component Tag	Type of Anomaly	Deg of Corrosion	Module	Level	Heat Map	Comments
Y	-	-	-	Deterioration of concrete	-	-	-	-	Concrete is deteriorating near the access points of the sump.

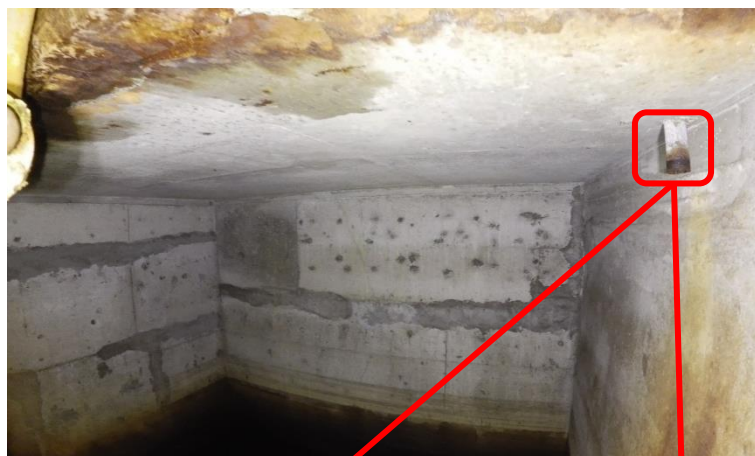
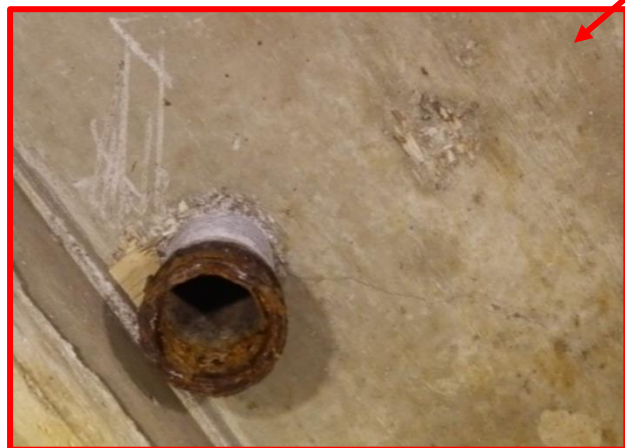
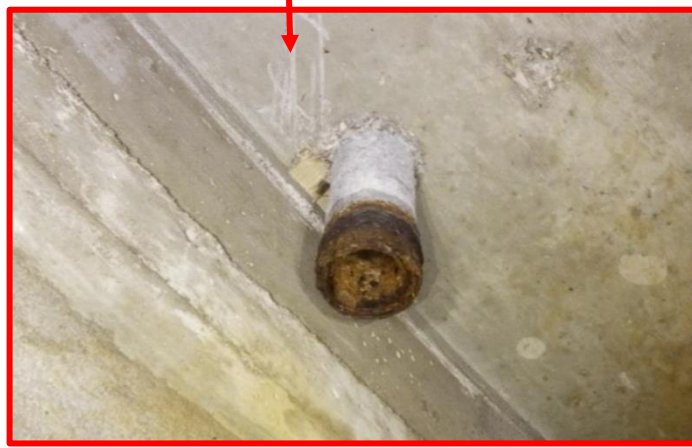
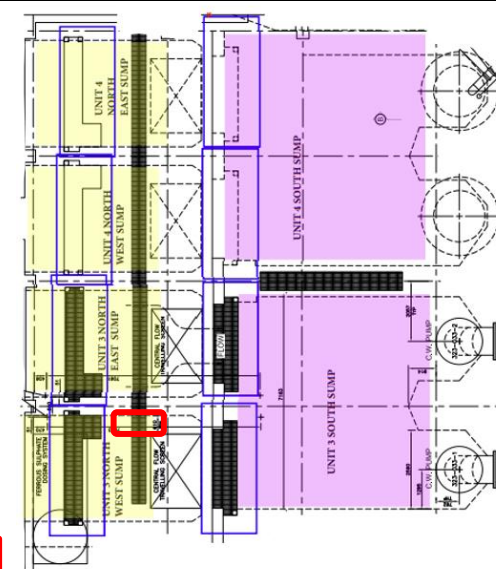
Anomaly (Y/N)	ID	Component	Component Tag	Type of Anomaly	Deg of Corrosion	Module	Level	Heat Map	Comments
Y	-	-	-	Corrosion	-	-	-	-	Corrosion on pipe located on ceiling of sump.

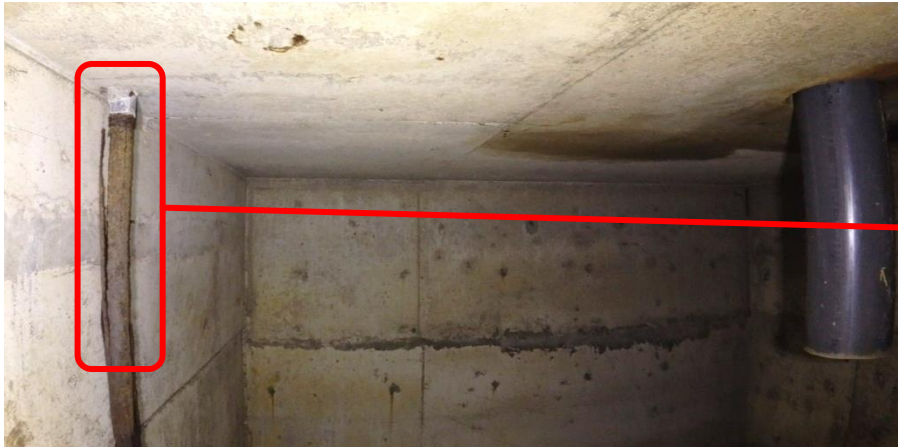
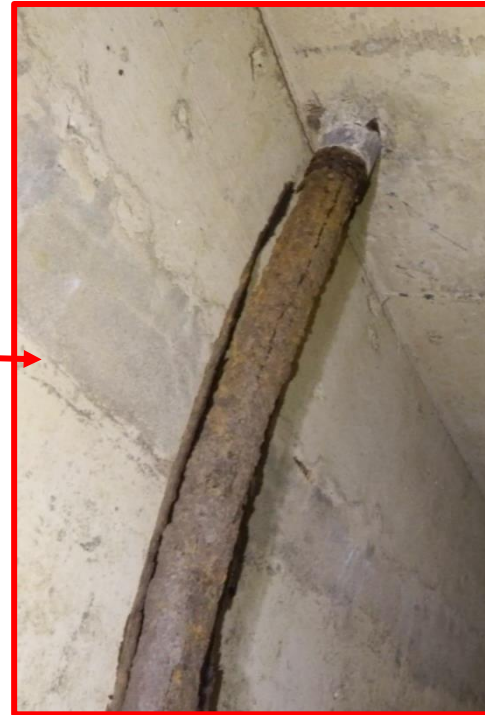
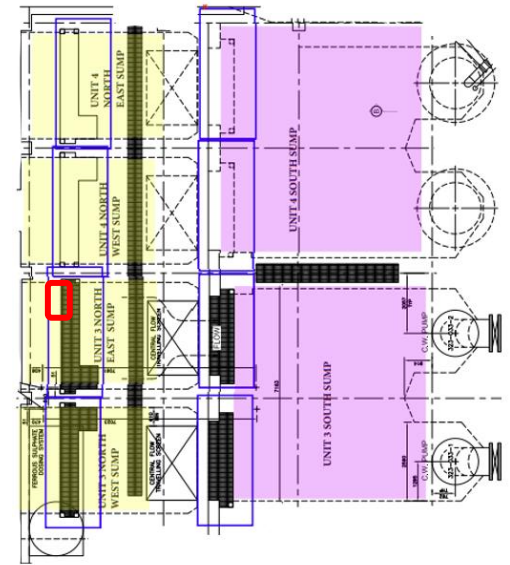
Anomaly (Y/N)	ID	Component	Component Tag	Type of Anomaly	Deg of Corrosion	Module	Level	Heat Map	Comments
Y	-	-	-	Corrosion	-	-	-	-	General overview of North end of sump Close up of pipe showing corrosion.

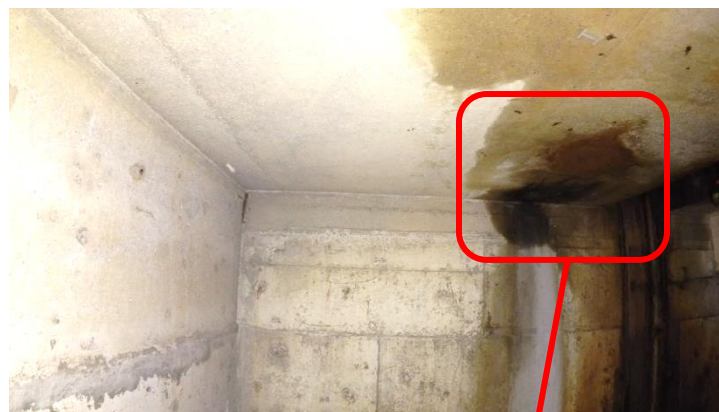
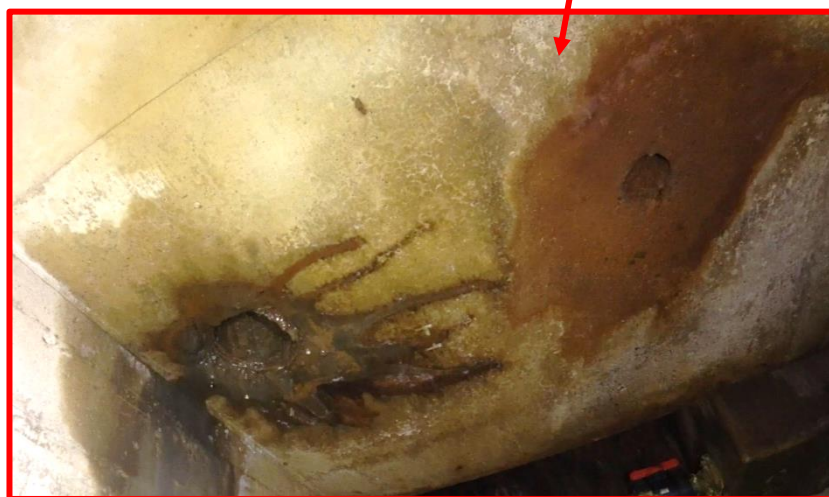
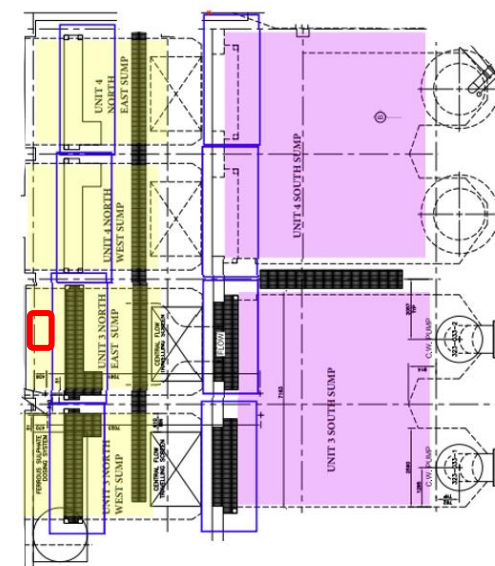
Anomaly (Y/N)	ID	Component	Component Tag	Type of Anomaly	Deg of Corrosion	Module	Level	Heat Map	Comments
Y	-	-	-	Deterioration of Concrete	-	-	-	-	Deterioration around drainage holes.

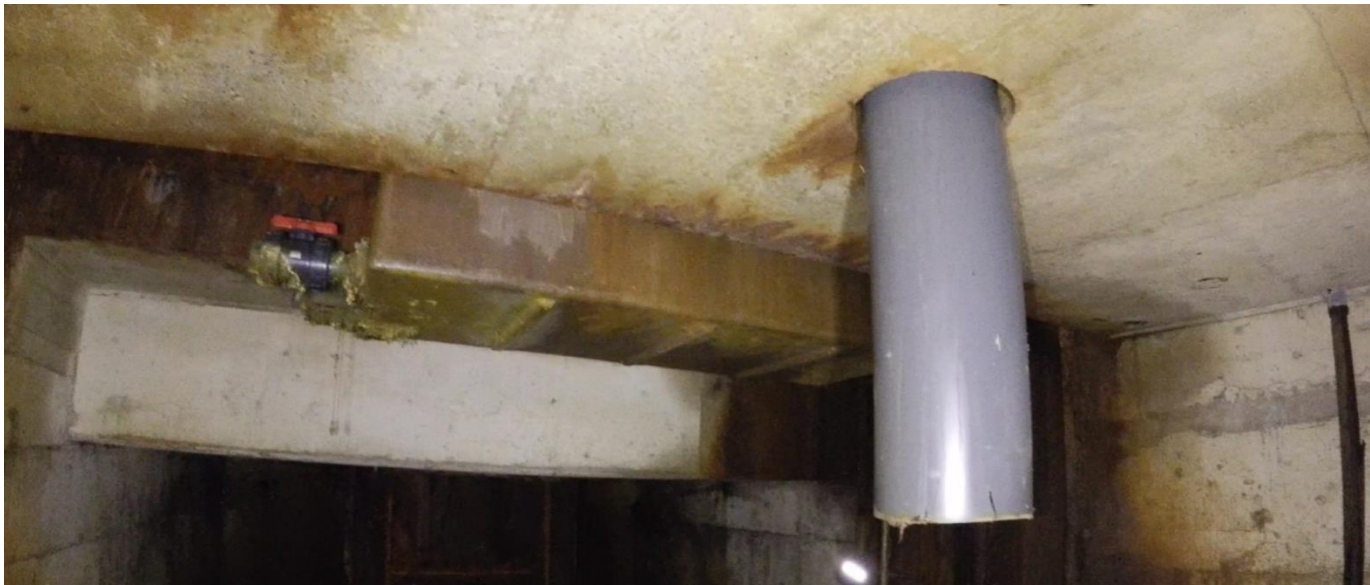
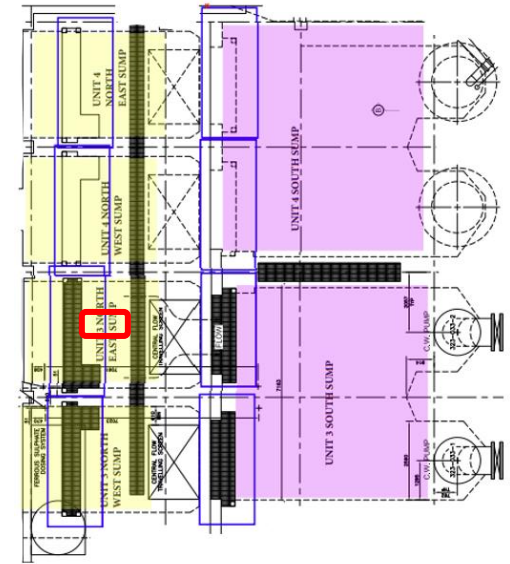
Anomaly (Y/N)	ID	Component	Component Tag	Type of Anomaly	Deg of Corrosion	Module	Level	Heat Map	Comments
N	-	-	-	-	-	-	-	-	General overview of pipe looking towards the south end of the sump.

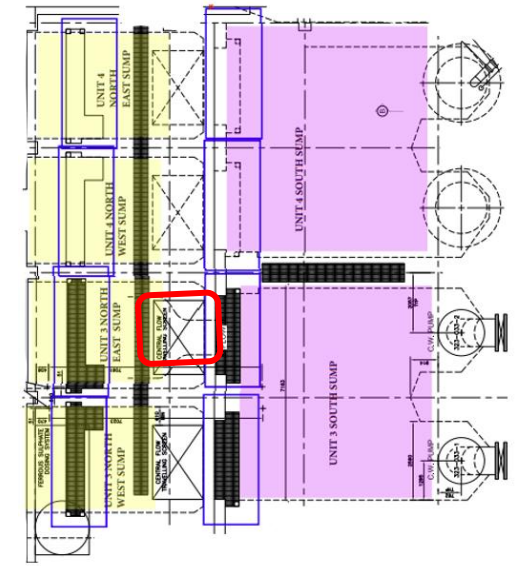
Anomaly (Y/N)	ID	Component	Component Tag	Type of Anomaly	Deg of Corrosion	Module	Level	Heat Map	Comments
Y	-	-	-	Deterioration of Concrete/corrosion	-	-	-	-	General overview of south end of sump Deterioration is present throughout and corrosion of steelwork, noted throughout.

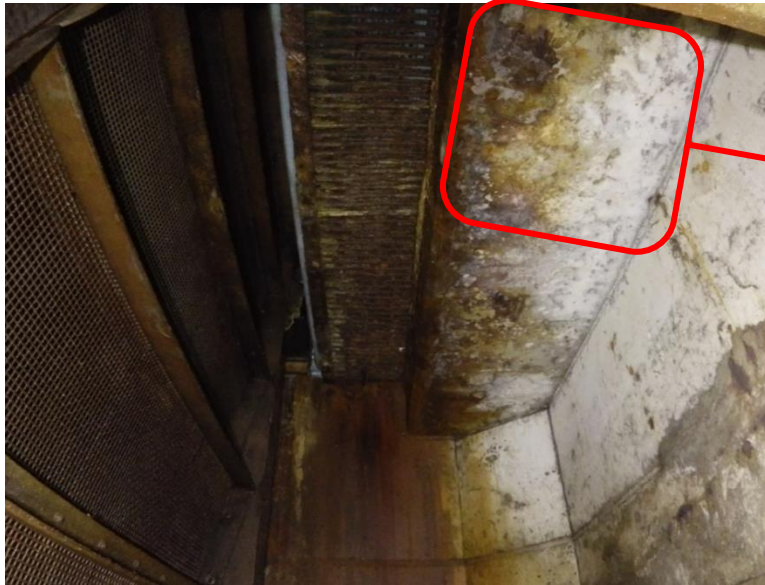
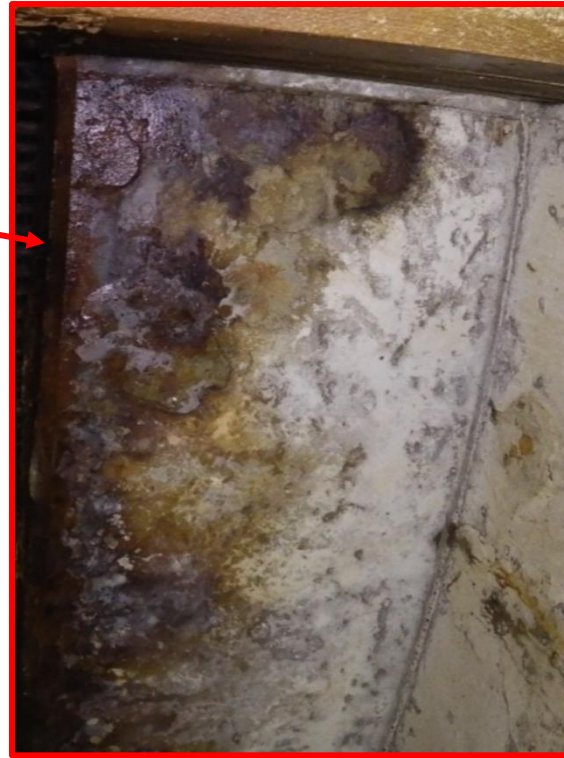
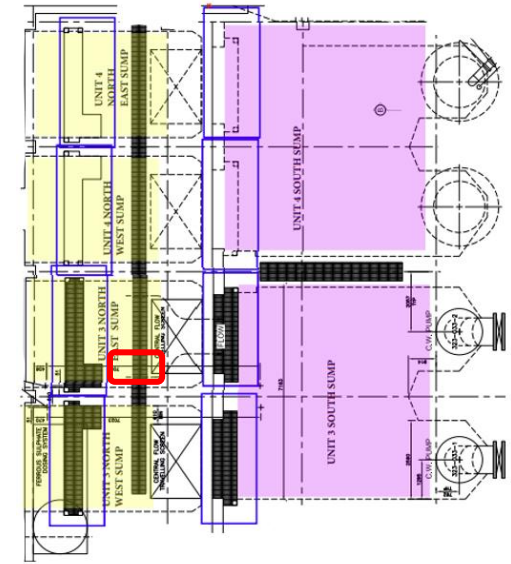
Anomaly (Y/N)	ID	Component	Component Tag	Type of Anomaly	Deg of Corrosion	Module	Level	Heat Map	Comments
Y	-	-	-	Deterioration of Concrete	-	-	-	-	Deterioration noted throughout.

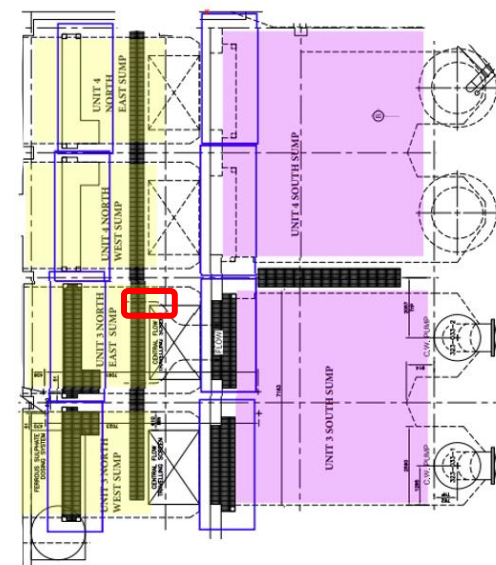
Anomaly (Y/N)	ID	Component	Component Tag	Type of Anomaly	Deg of Corrosion	Module	Level	Heat Map	Comments
Y	-	-	-	Deterioration / Corrosion	-	-	-	-	General overview of south end of sump Deterioration and corrosion noted around traveling screens.

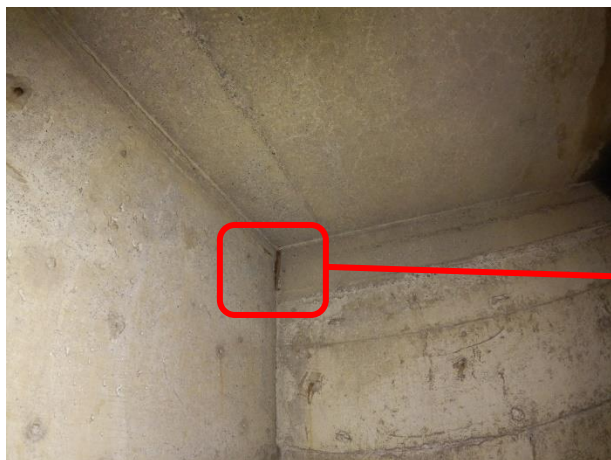
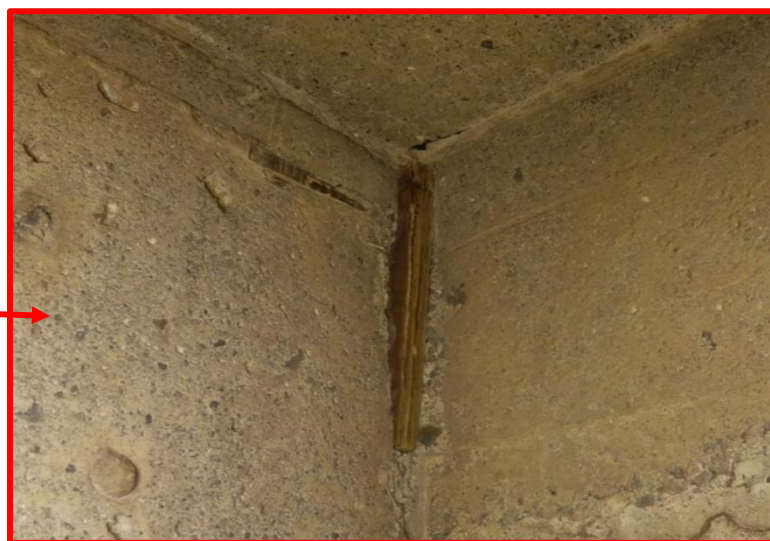
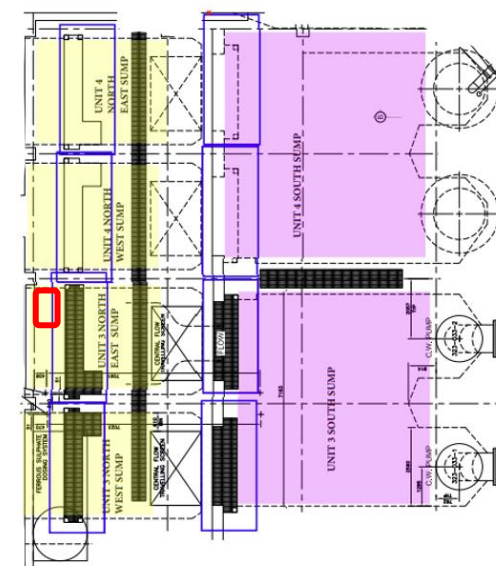
Anomaly (Y/N)	ID	Component	Component Tag	Type of Anomaly	Deg of Corrosion	Module	Level	Heat Map	Comments
Y	-	-	-	Embedded object	-	-	-	-	Embedded object.

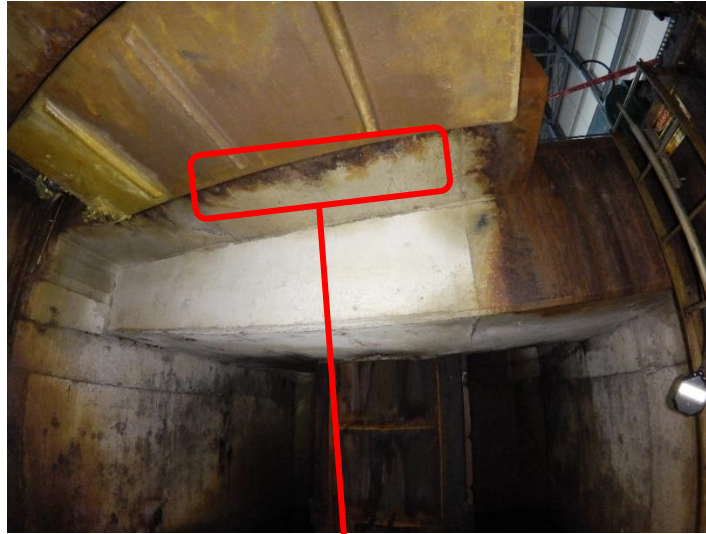
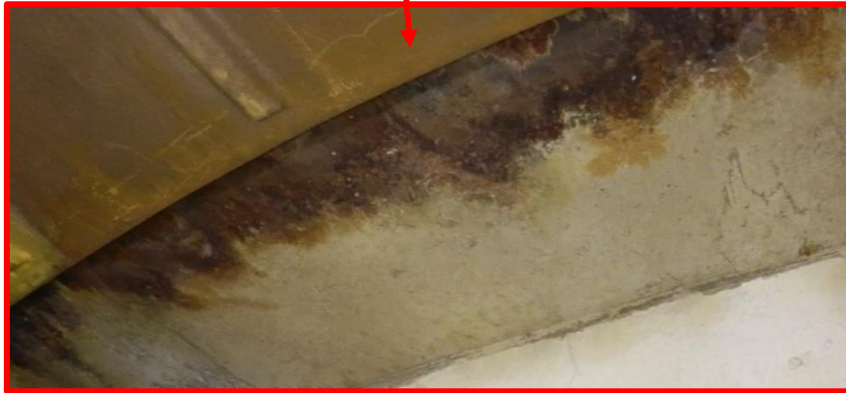
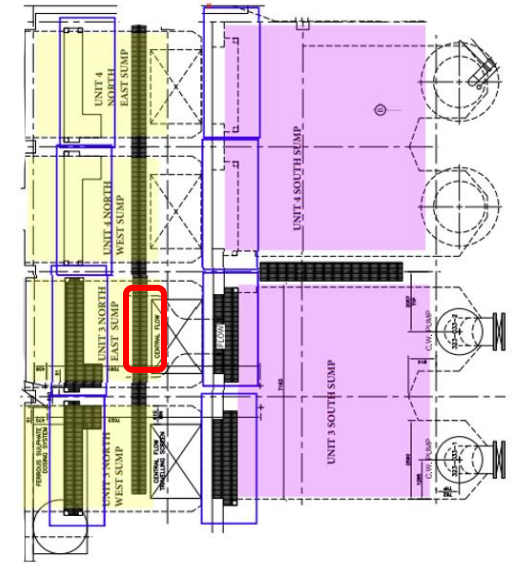
Anomaly (Y/N)	ID	Component	Component Tag	Type of Anomaly	Deg of Corrosion	Module	Level	Heat Map	Comments
Y	-	-	-	Deterioration of Concrete	-	-	-	-	Deterioration noted throughout.

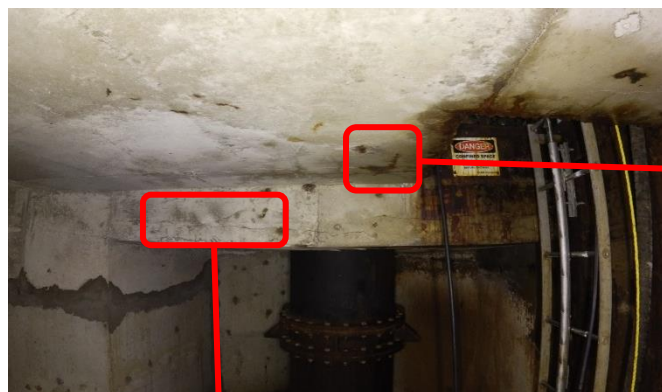
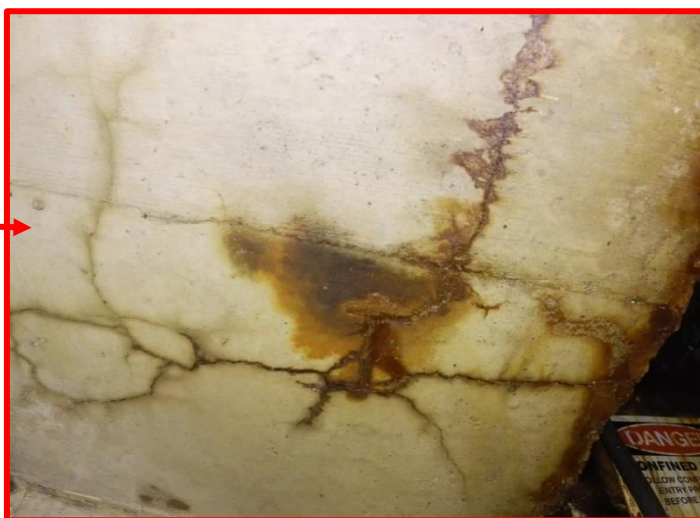
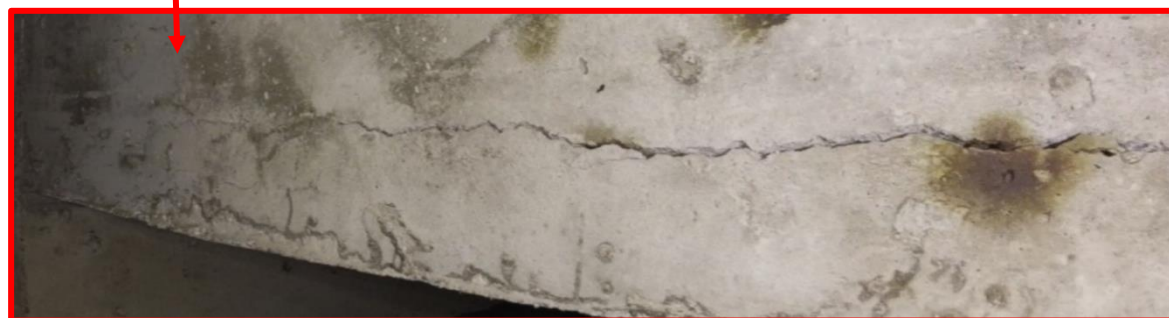
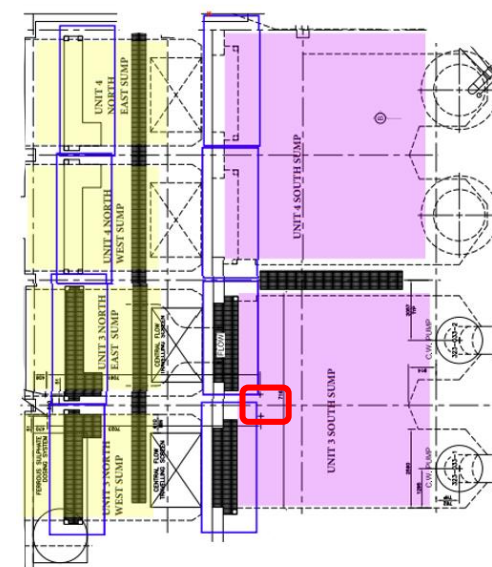
Anomaly (Y/N)	ID	Component	Component Tag	Type of Anomaly	Deg of Corrosion	Module	Level	Heat Map	Comments
Y	-	-	-	Crack	-	-	-	-	Cracking and deterioration of concrete near access point of sump.

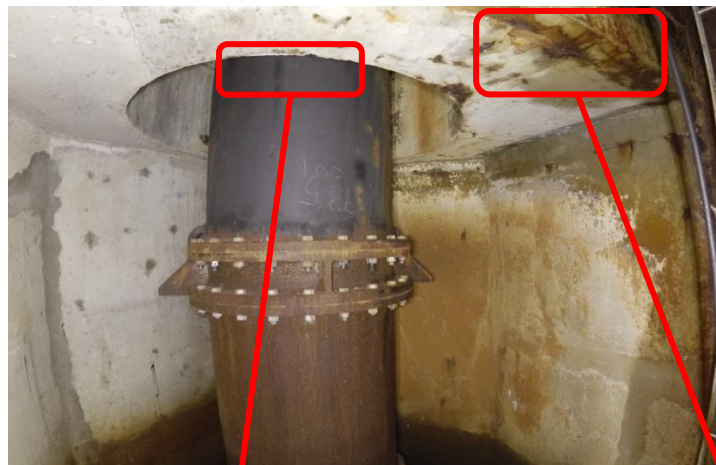
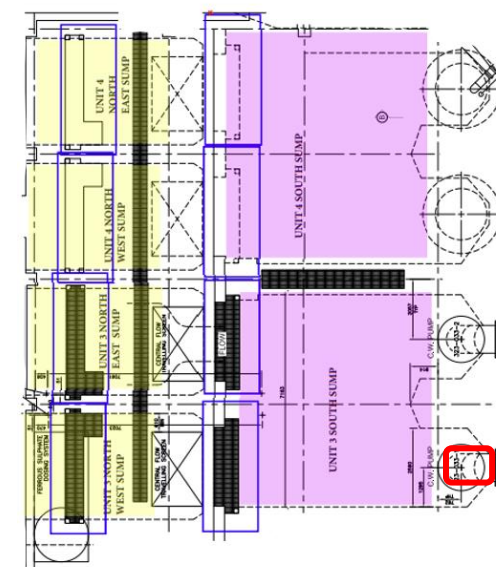
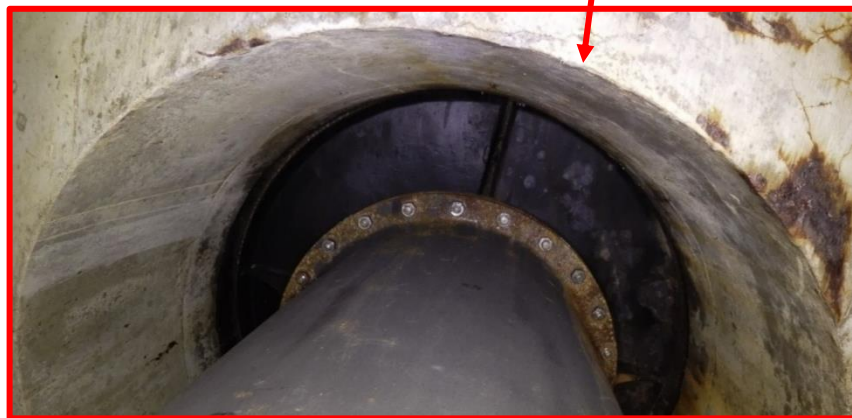
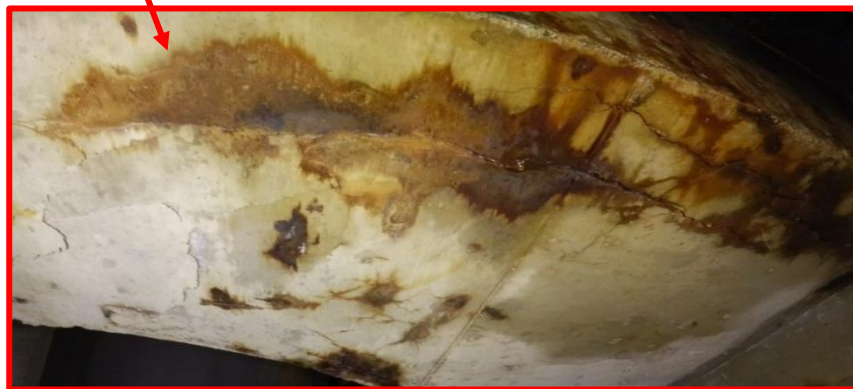
Anomaly (Y/N)	ID	Component	Component Tag	Type of Anomaly	Deg of Corrosion	Module	Level	Heat Map	Comments
Y	-	-	-	Deterioration of Concrete	-	-	-	-	Deterioration of concrete near pump.

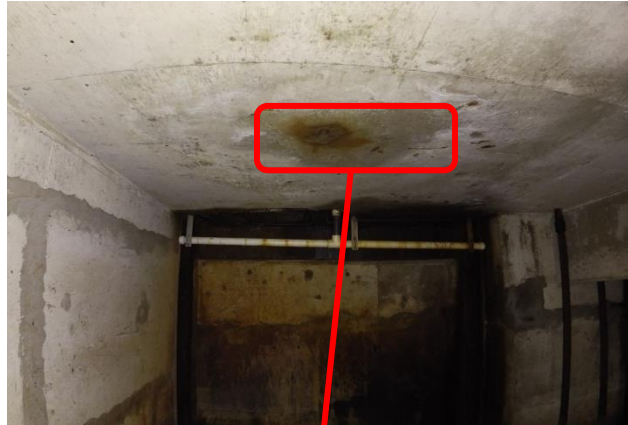
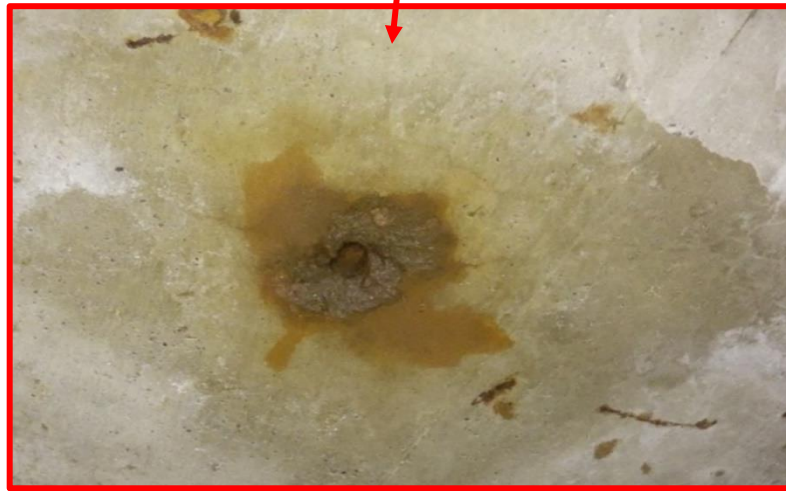
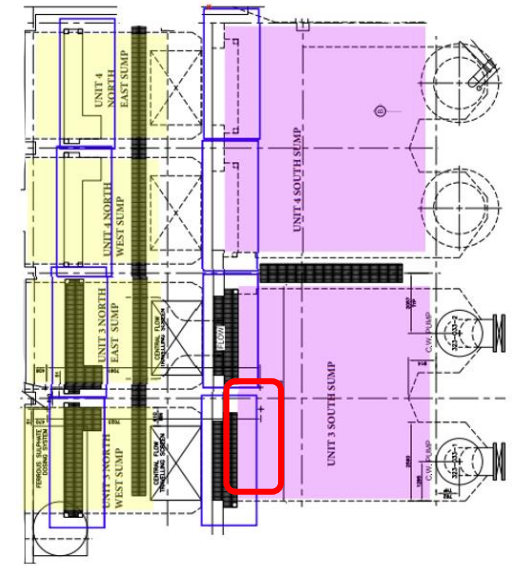
Anomaly (Y/N)	ID	Component	Component Tag	Type of Anomaly	Deg of Corrosion	Module	Level	Heat Map	Comments
Y	-	-	-	Deterioration of Concrete	-	-	-	-	Deterioration of concrete.

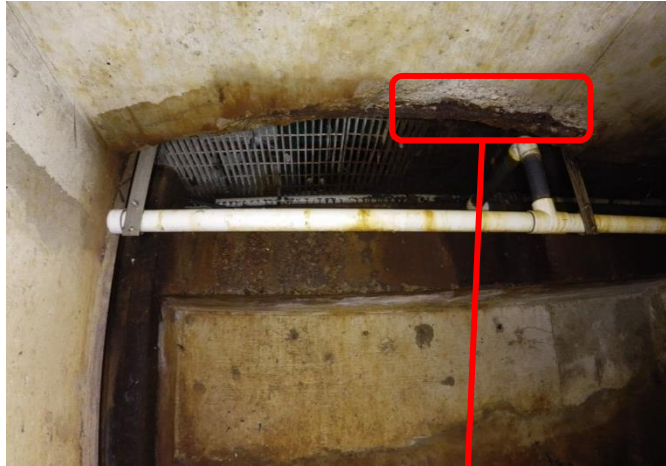
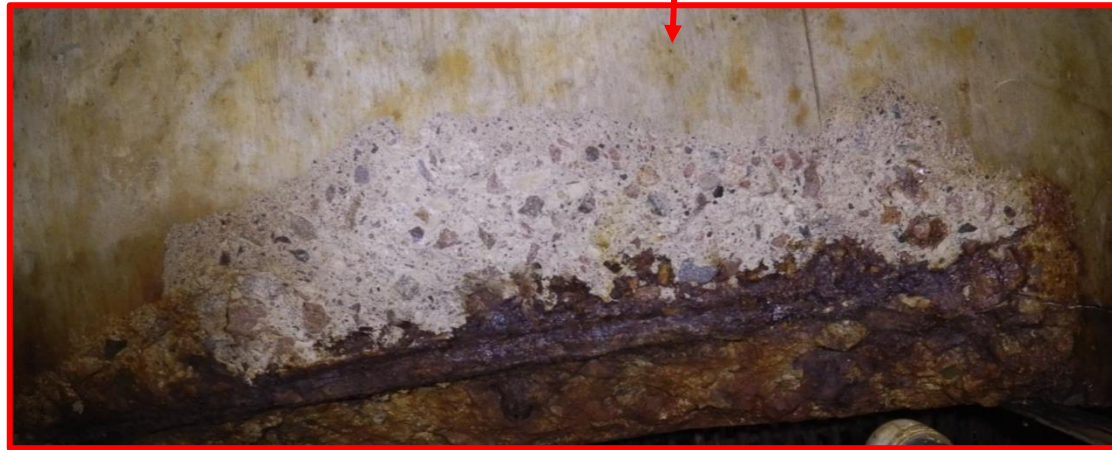
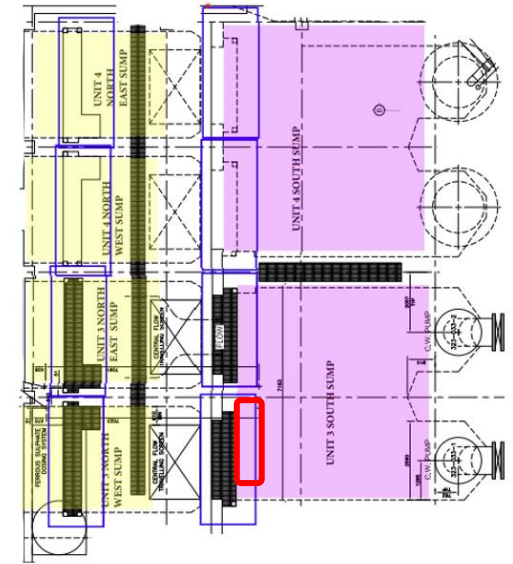
Anomaly (Y/N)	ID	Component	Component Tag	Type of Anomaly	Deg of Corrosion	Module	Level	Heat Map	Comments
Y	-	-	-	Deterioration / Corrosion	-	-	-	-	Deterioration of concrete Corrosion of rebar.

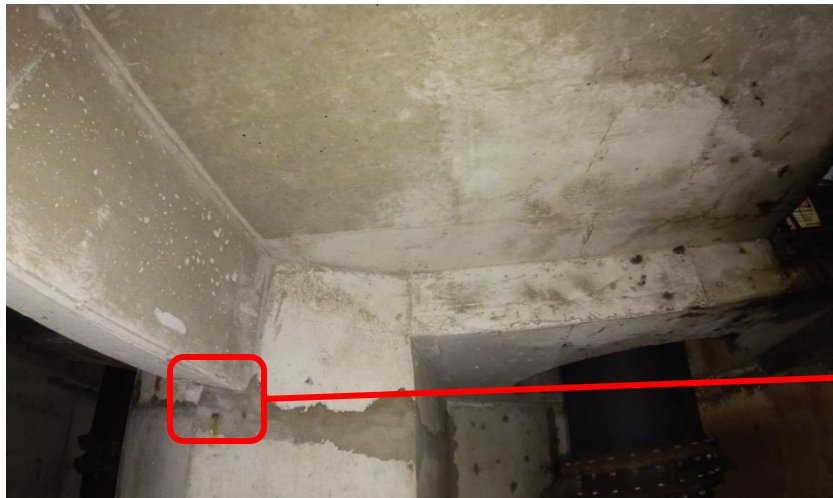
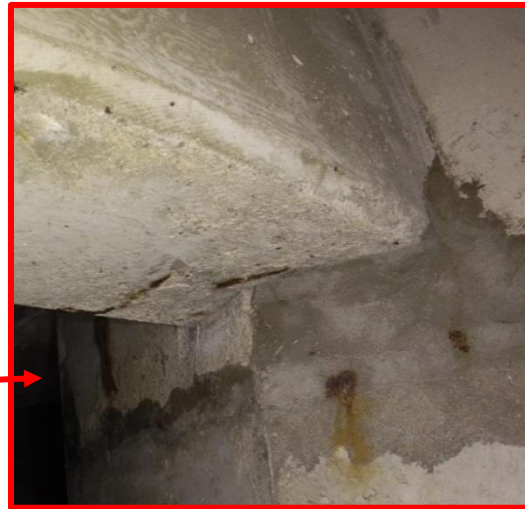
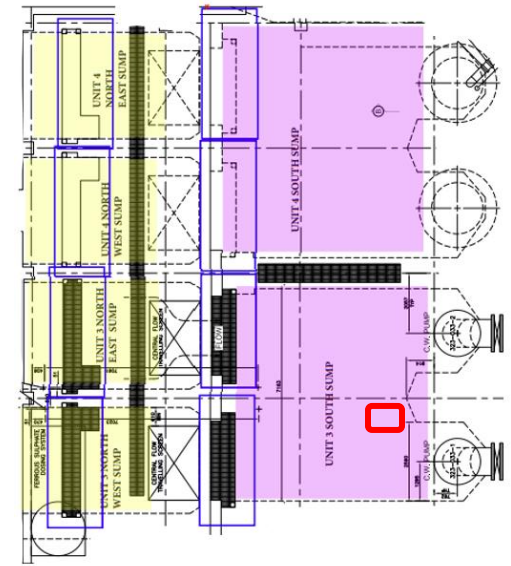
Anomaly (Y/N)	ID	Component	Component Tag	Type of Anomaly	Deg of Corrosion	Module	Level	Heat Map	Comments
Y	-	-	-	Spalling	-	-	-	-	Up close visual of spalling occurring near corner seams.

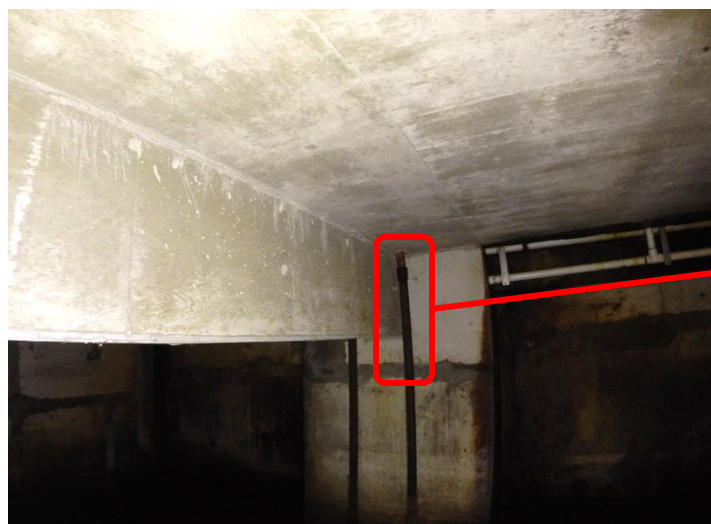
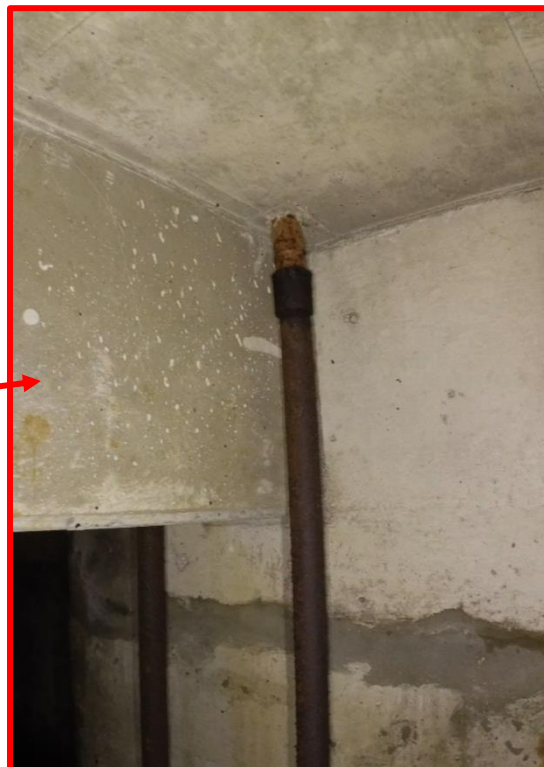
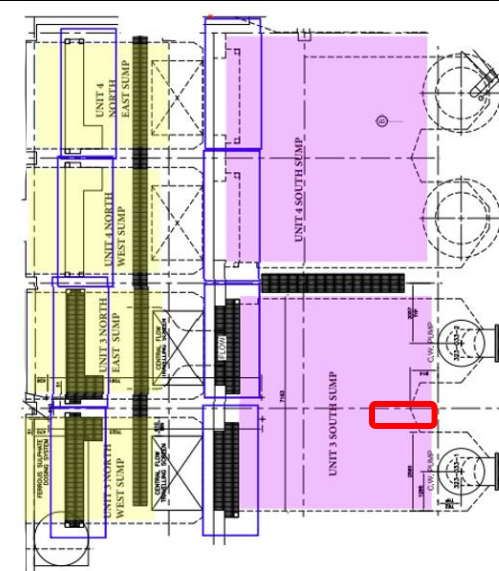
Anomaly (Y/N)	ID	Component	Component Tag	Type of Anomaly	Deg of Corrosion	Module	Level	Heat Map	Comments
Y	-	-	-	Corrosion	-	-	-	-	Corrosion of pipe.

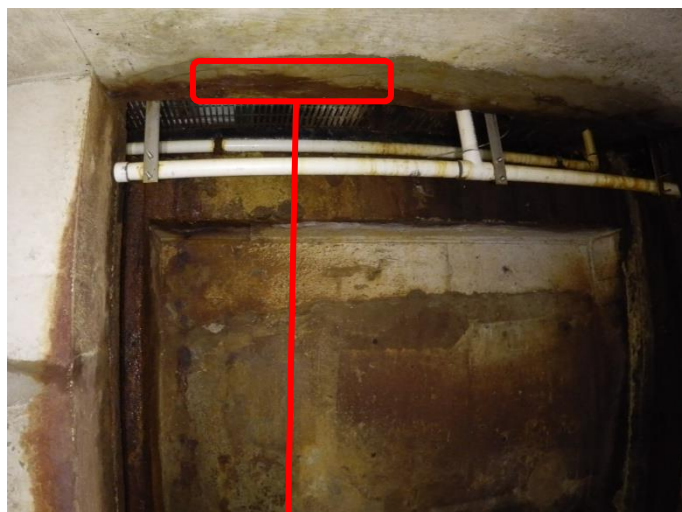
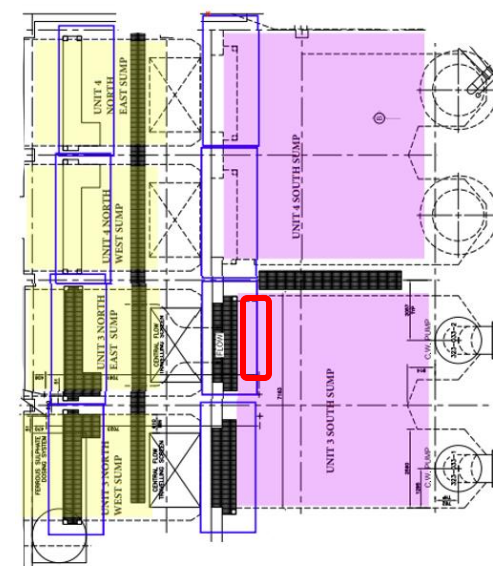
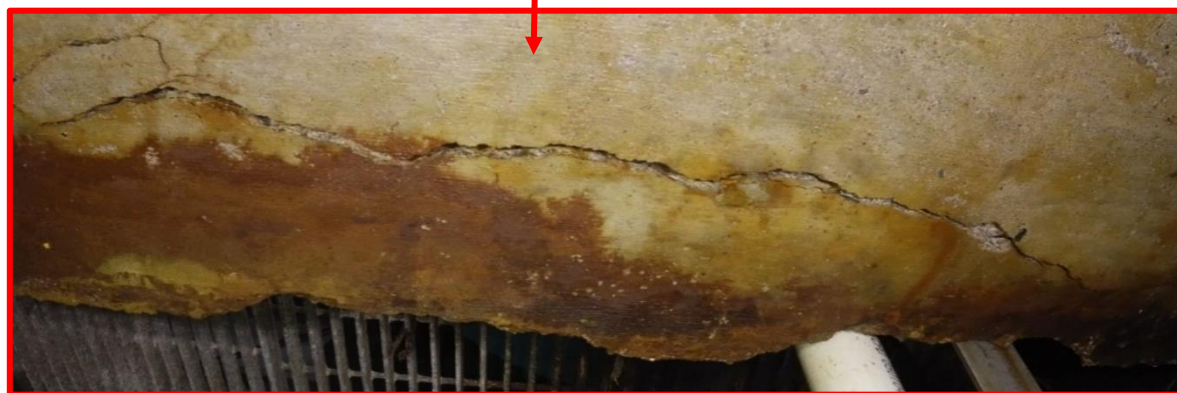
Anomaly (Y/N)	ID	Component	Component Tag	Type of Anomaly	Deg of Corrosion	Module	Level	Heat Map	Comments
Y	-	-	-	Cracking	-	-	-	-	Cracking of concrete near access points.

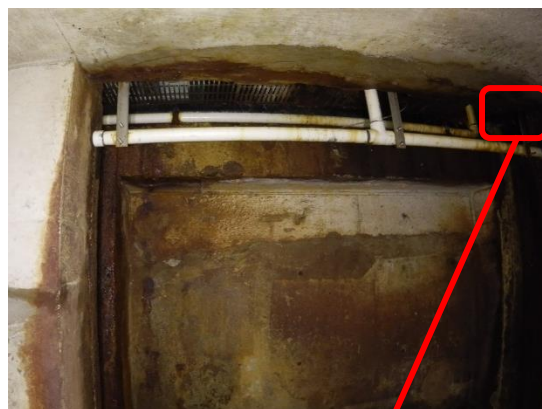
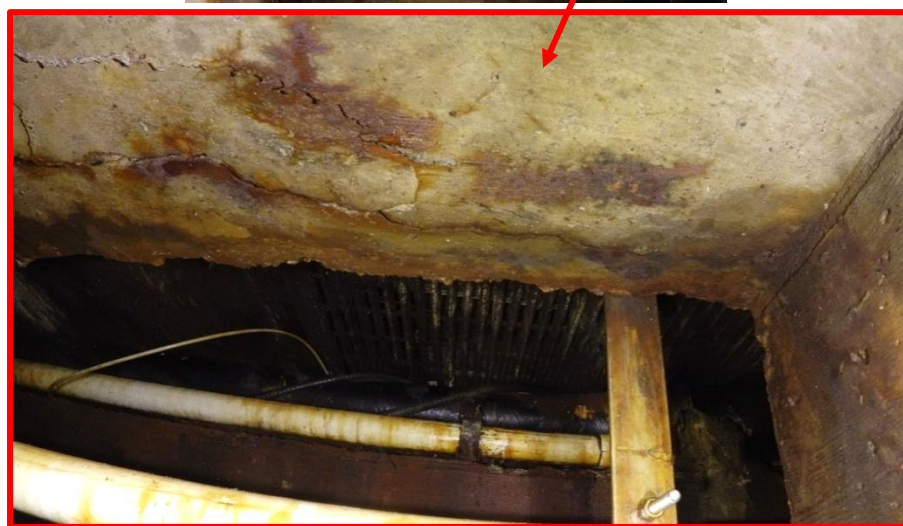
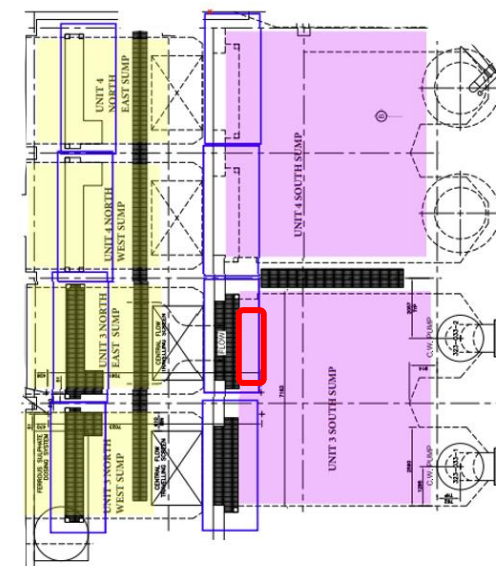
Anomaly (Y/N)	ID	Component	Component Tag	Type of Anomaly	Deg of Corrosion	Module	Level	Heat Map	Comments
Y	-	-	-	Deterioration of Concrete	-	-	-	-	Concrete is deteriorating and sheeting off/delamination.

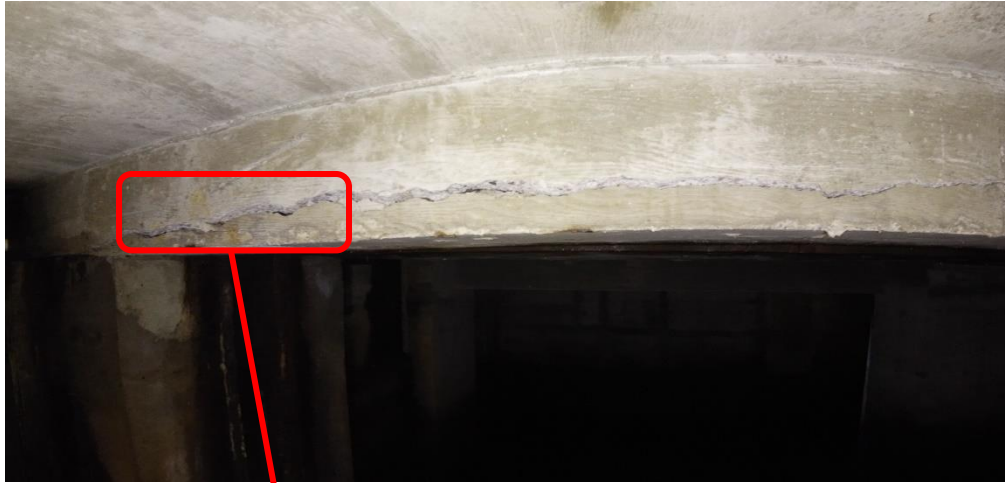
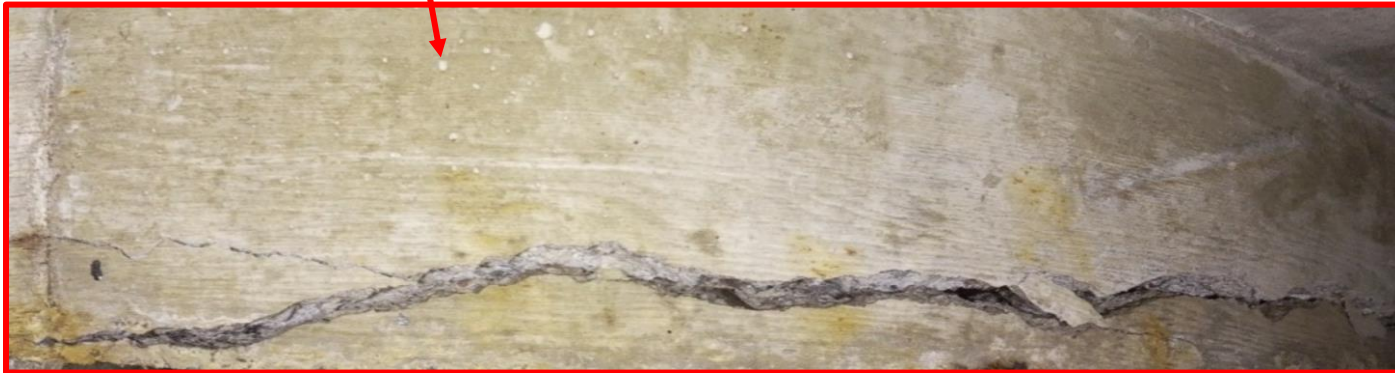
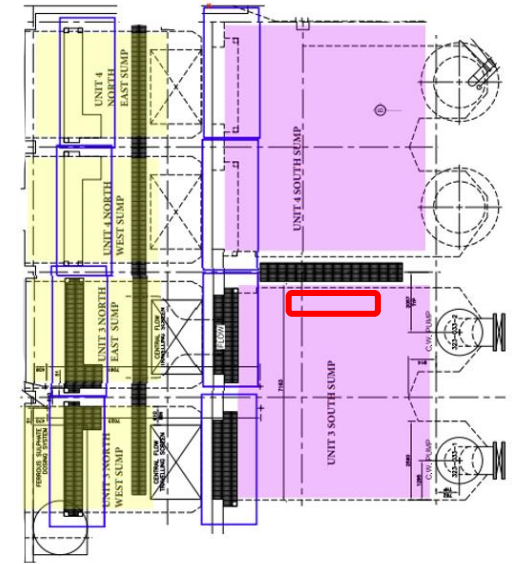
Anomaly (Y/N)	ID	Component	Component Tag	Type of Anomaly	Deg of Corrosion	Module	Level	Heat Map	Comments
Y	-	-	-	Crack	-	-	-	-	Substantial crack in concrete on center beam east side.

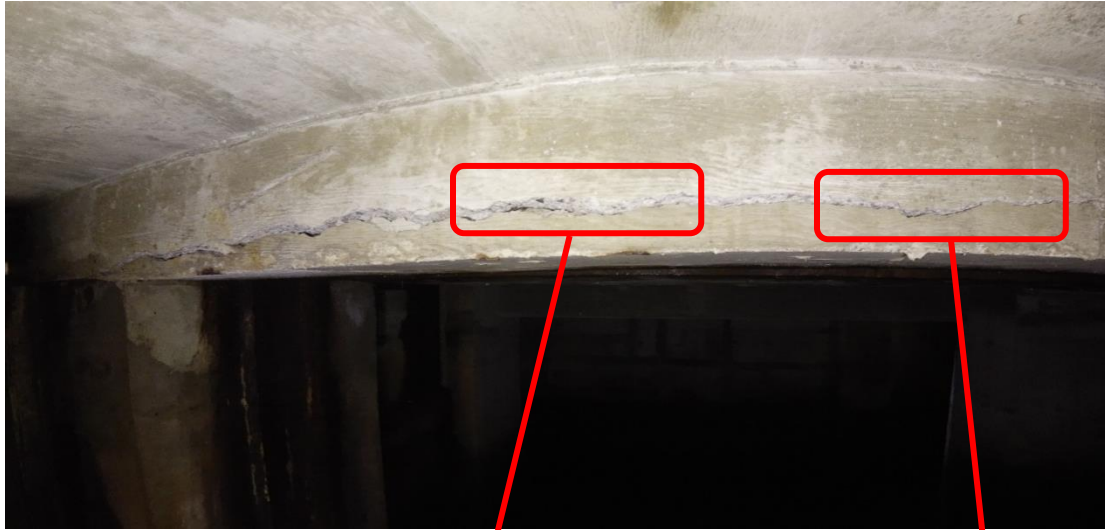
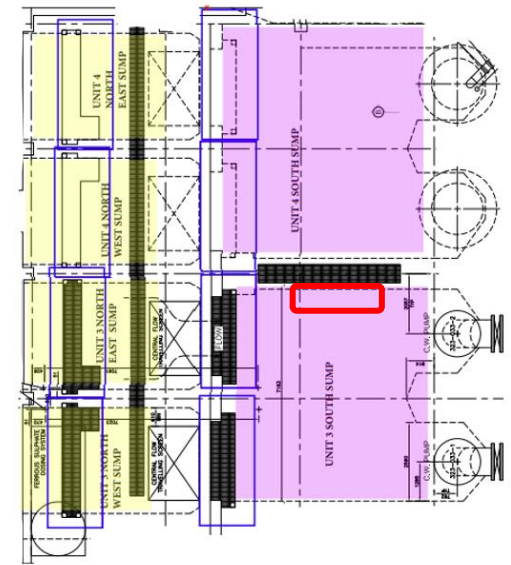
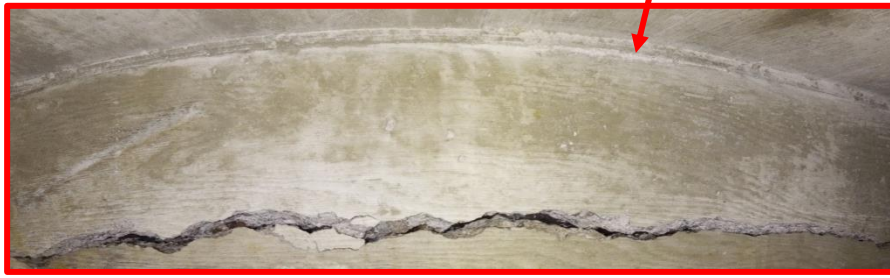
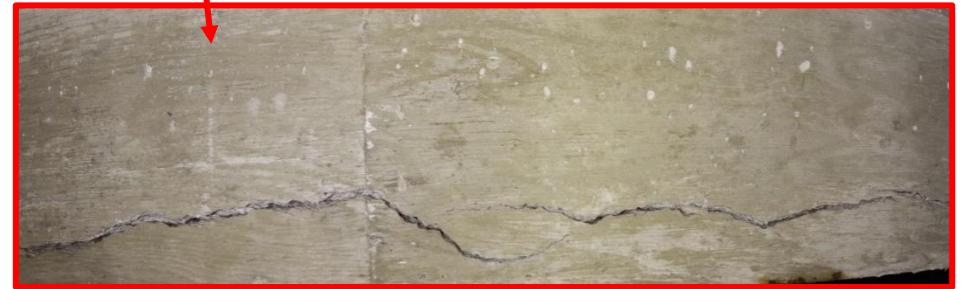
Anomaly (Y/N)	ID	Component	Component Tag	Type of Anomaly	Deg of Corrosion	Module	Level	Heat Map	Comments
Y	-	-	-	Crack	-	-	-	-	Substantial crack in concrete on center beam east side.
