Re: *Reliability and Resource Adequacy Study Review - Assessment to Determine the Potential Long-Term Viability of the Holyrood Thermal Generating Station*

Holyrood Thermal Generating Station Condition Assessment

**Newfoundland and Labrador Hydro
HTGS Condition Assessment and Life Extension Study
Executive Summary**

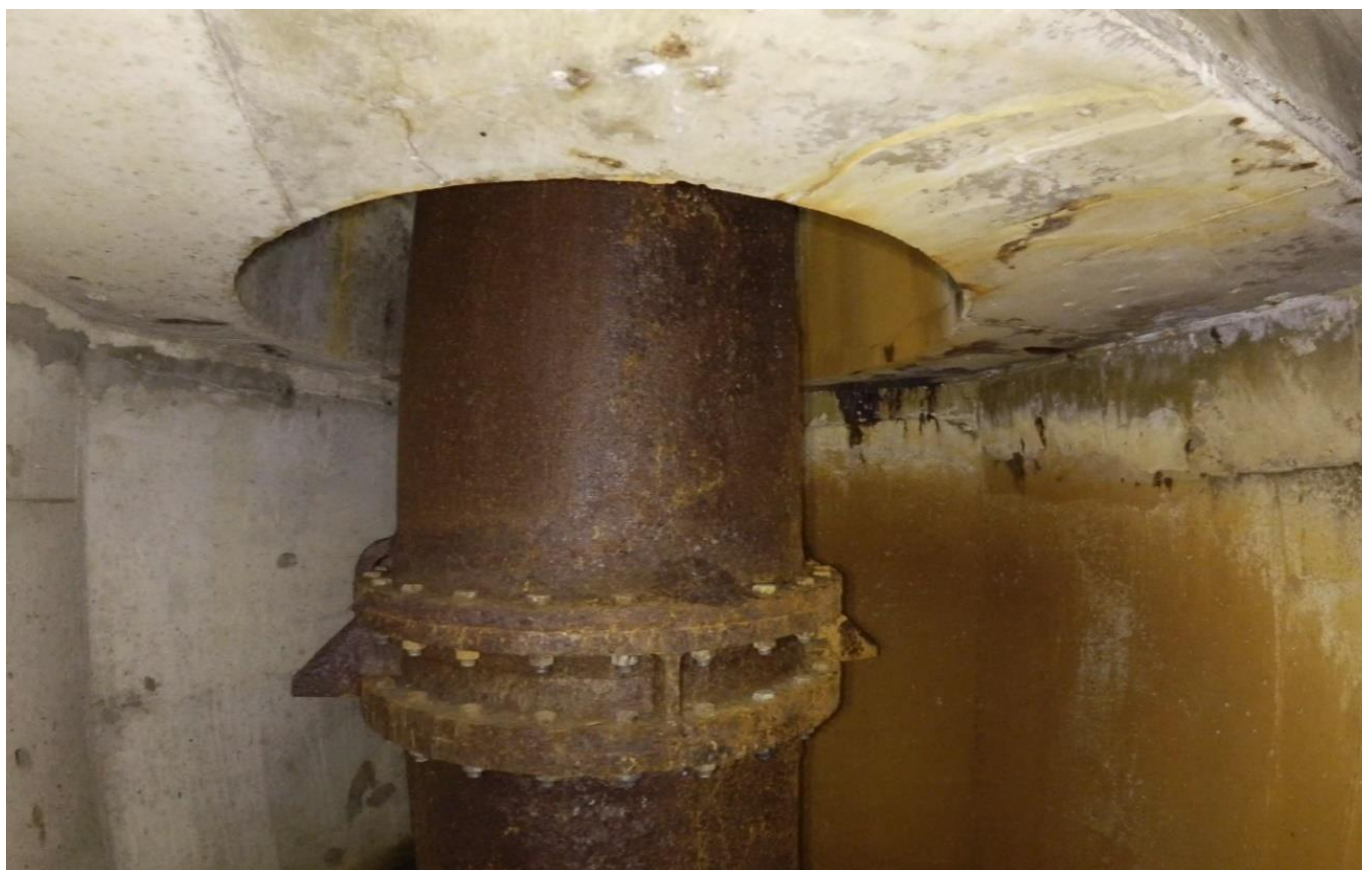
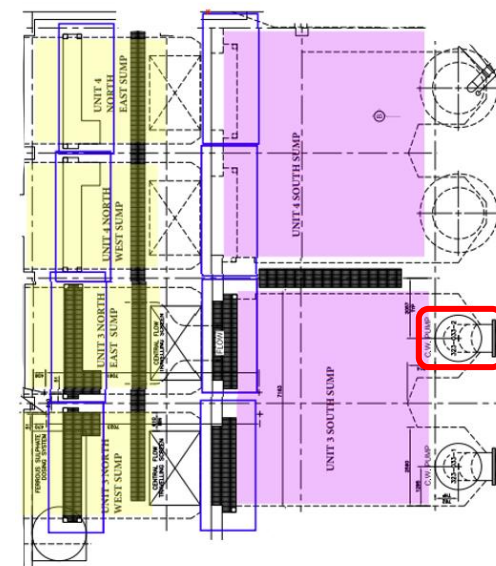
Anomaly (Y/N)	ID	Component	Component Tag	Type of Anomaly	Deg of Corrosion	Module	Level	Heat Map	Comments
N	-	-	-	-	-	-	-	-	General overview of pump intake area.

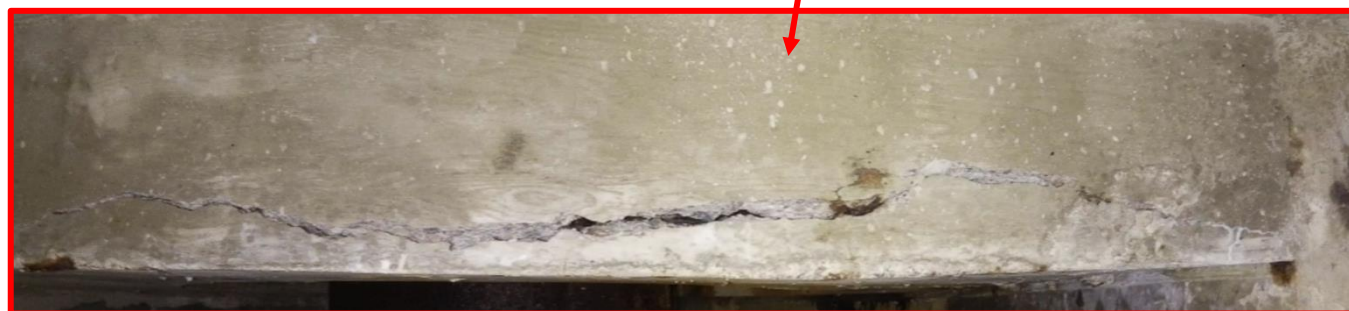
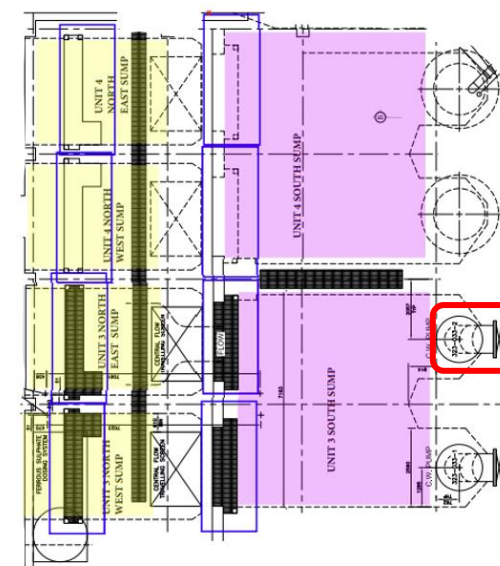
Anomaly (Y/N)	ID	Component	Component Tag	Type of Anomaly	Deg of Corrosion	Module	Level	Heat Map	Comments
Y	-	-	-	Crack	-	-	-	-	Substantial crack in concrete on the pump on the concrete cross member.

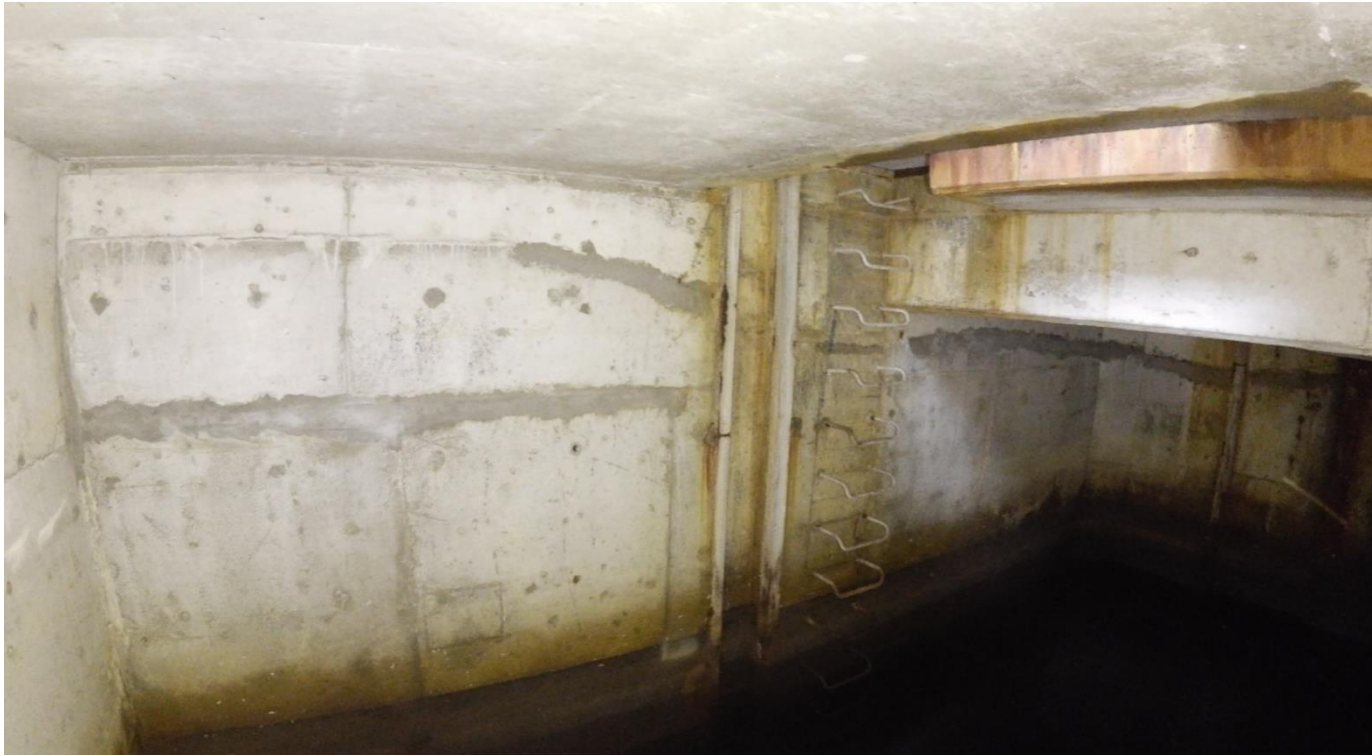
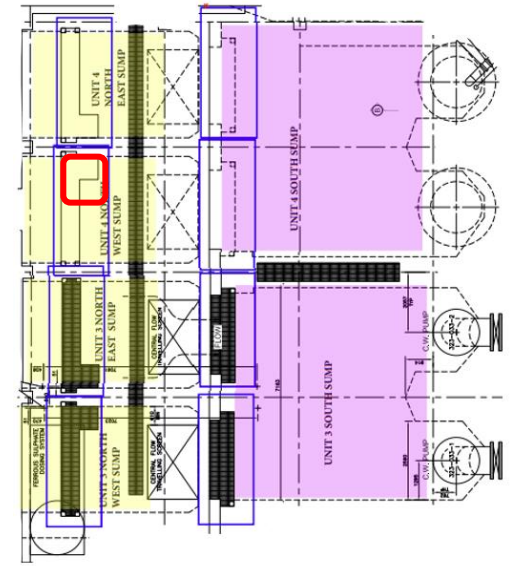
Anomaly (Y/N)	ID	Component	Component Tag	Type of Anomaly	Deg of Corrosion	Module	Level	Heat Map	Comments
N	-	-	-	-	-	-	-	-	General overview of ceiling and walls of sump.

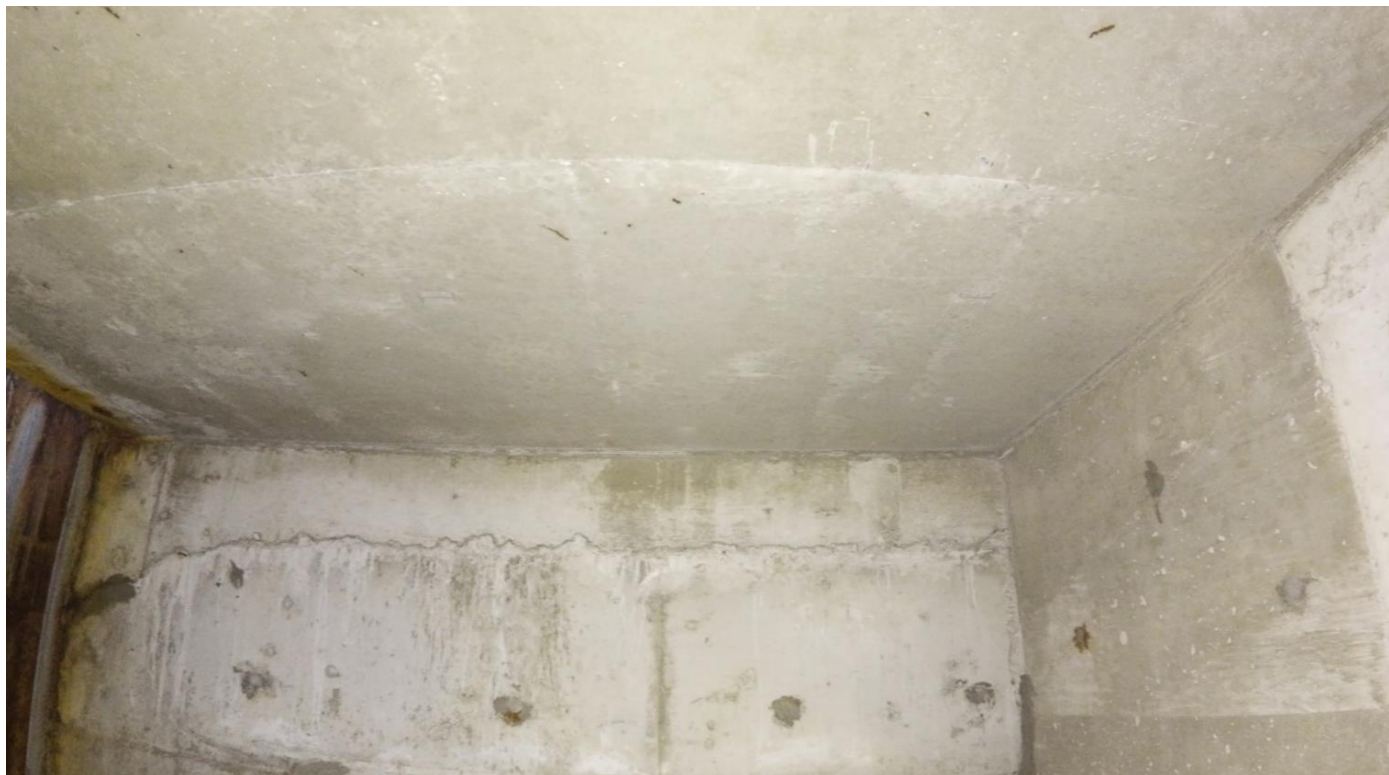
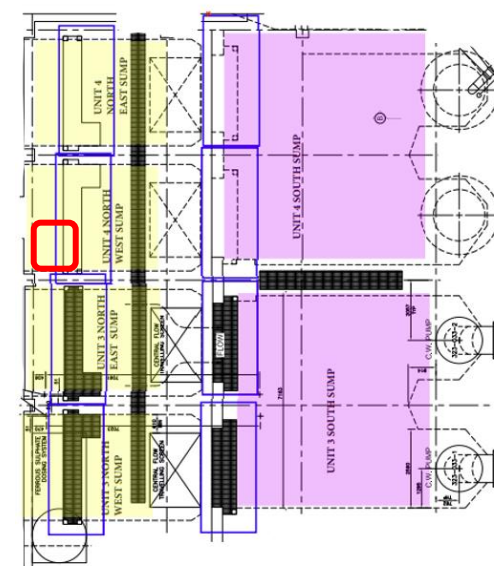
Anomaly (Y/N)	ID	Component	Component Tag	Type of Anomaly	Deg of Corrosion	Module	Level	Heat Map	Comments
N	-	-	-	-	-	-	-	-	General overview of ceiling and walls of sump.

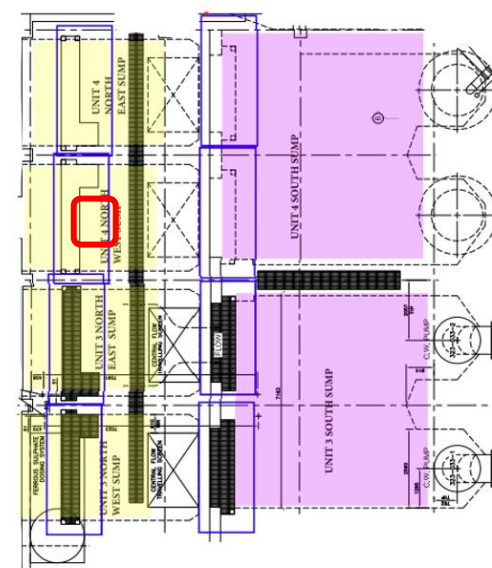
Anomaly (Y/N)	ID	Component	Component Tag	Type of Anomaly	Deg of Corrosion	Module	Level	Heat Map	Comments
Y	-	-	-	Deterioration of Concrete	-	-	-	-	Near entry point, deterioration noted around grating.

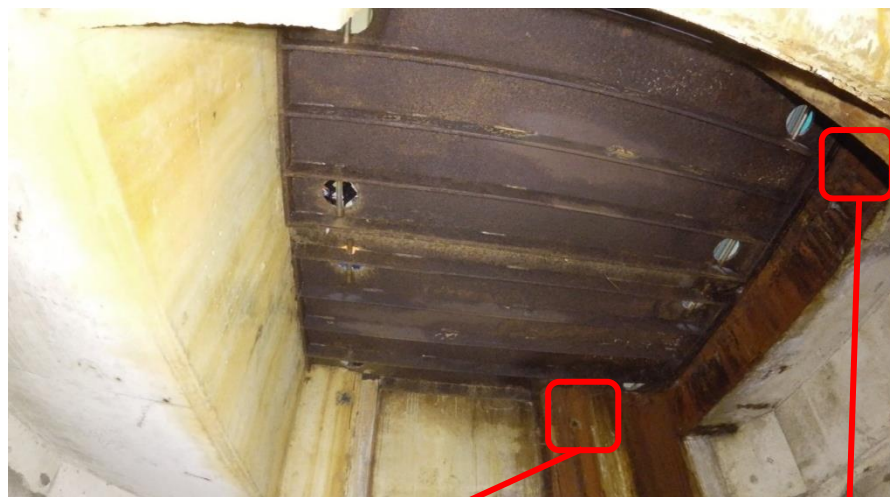
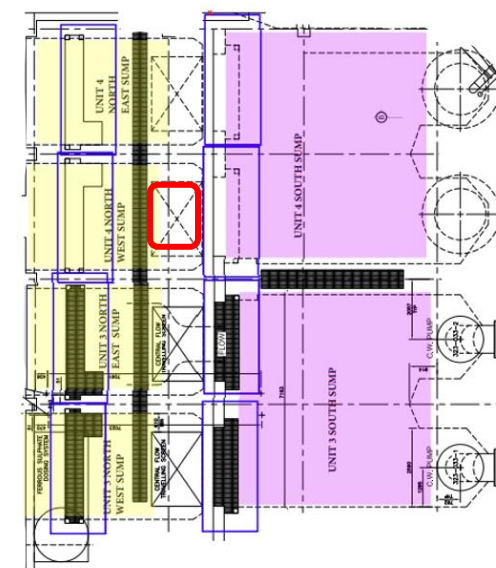
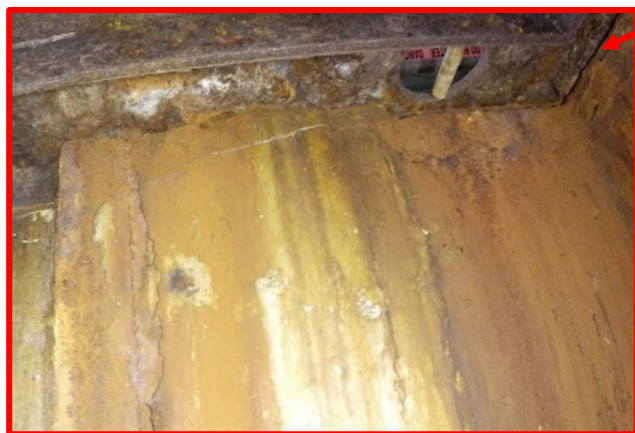
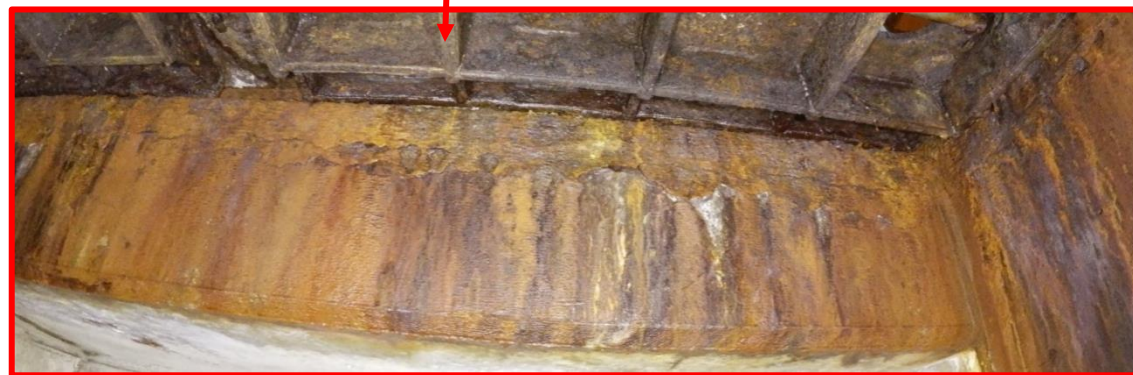
Anomaly (Y/N)	ID	Component	Component Tag	Type of Anomaly	Deg of Corrosion	Module	Level	Heat Map	Comments
Y	-	-	-	Deterioration / Corrosion	-	-	-	-	Deterioration of concrete around hatch, corrosion of hatch

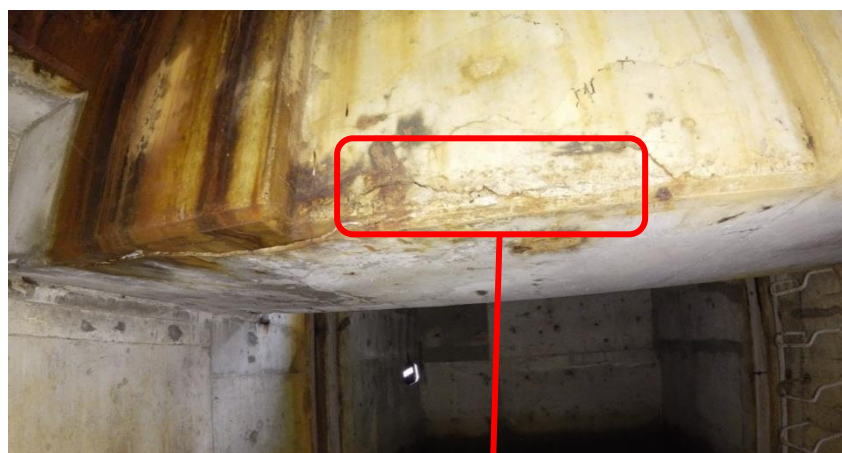
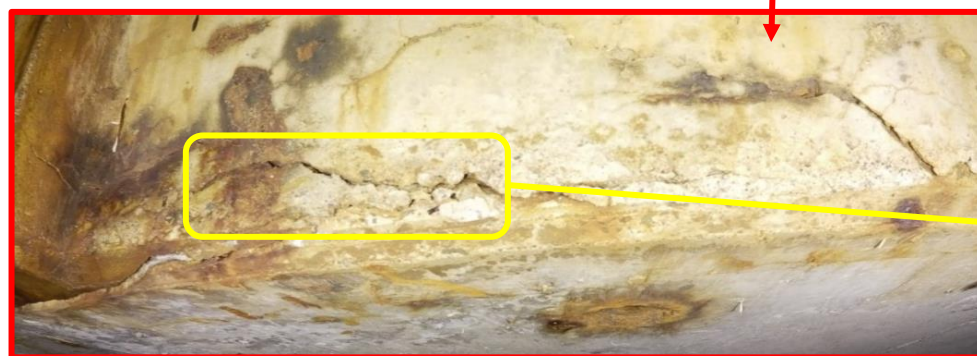
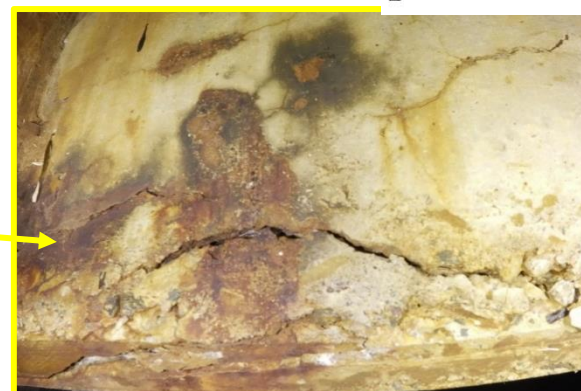
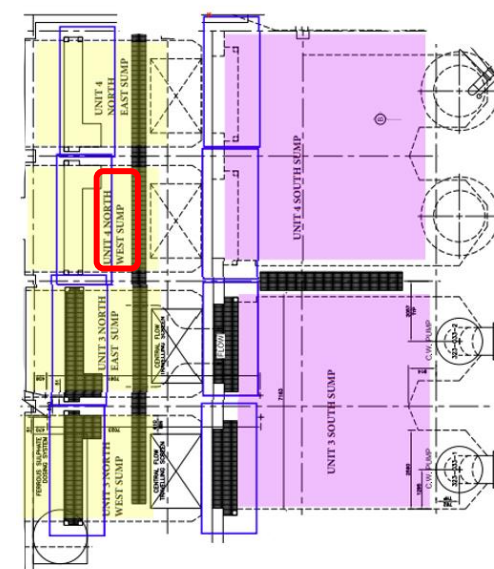
Anomaly (Y/N)	ID	Component	Component Tag	Type of Anomaly	Deg of Corrosion	Module	Level	Heat Map	Comments
Y	-	-	-	Crack	-	-	-	-	Crack located towards south end of tank on the concrete cross member.

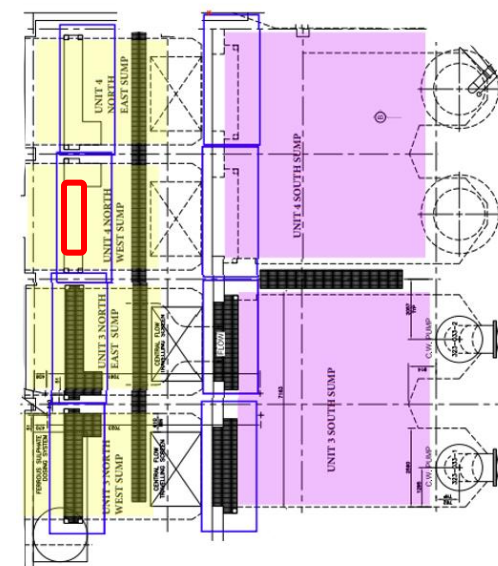
Anomaly (Y/N)	ID	Component	Component Tag	Type of Anomaly	Deg of Corrosion	Module	Level	Heat Map	Comments
Y	-	-	-	Deterioration / Crack	-	-	-	-	Deterioration of concrete around hatch, crack formed that can be seen highlighted

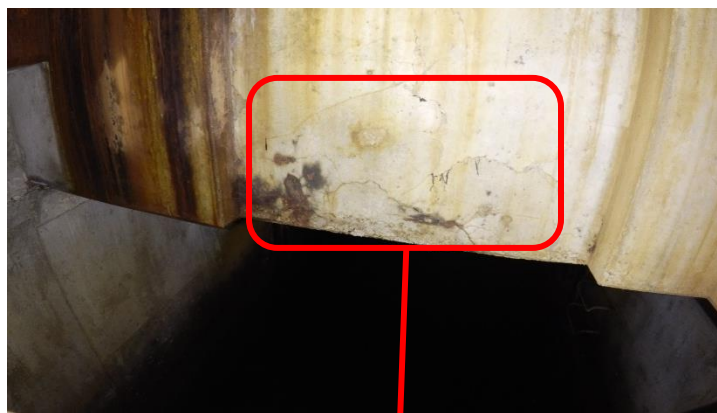
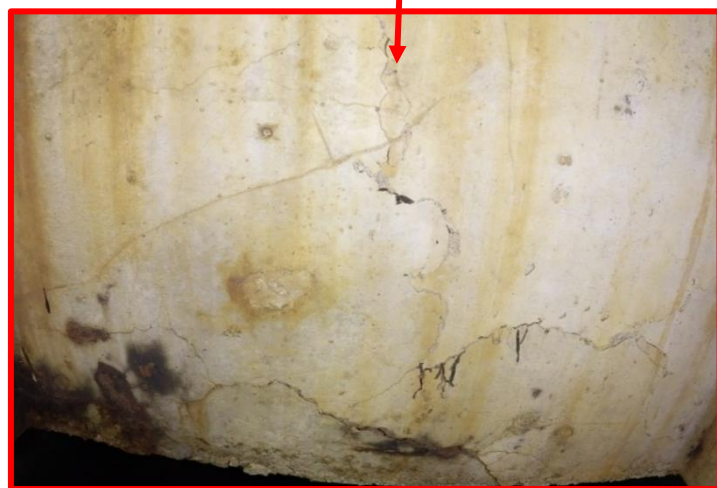
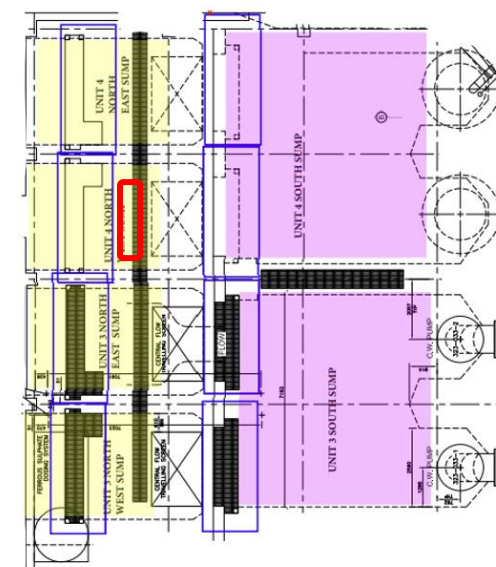
Anomaly (Y/N)	ID	Component	Component Tag	Type of Anomaly	Deg of Corrosion	Module	Level	Heat Map	Comments
Y	-	-	-	Crack	-	-	-	-	Cracking of concrete.

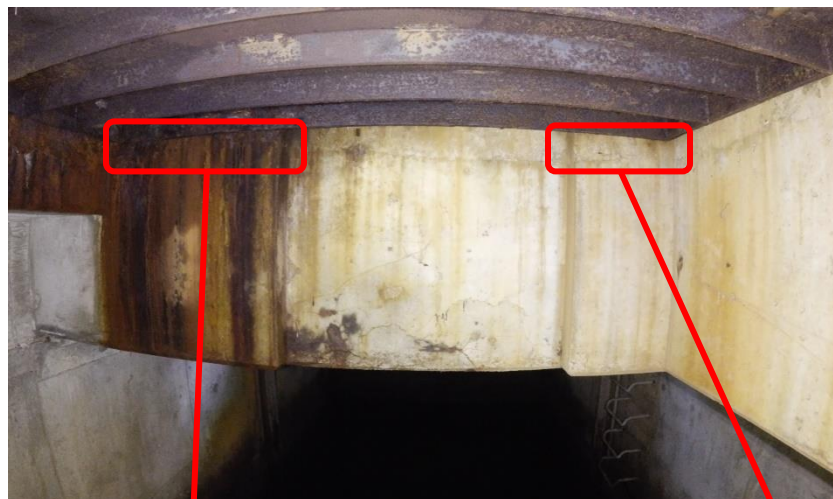
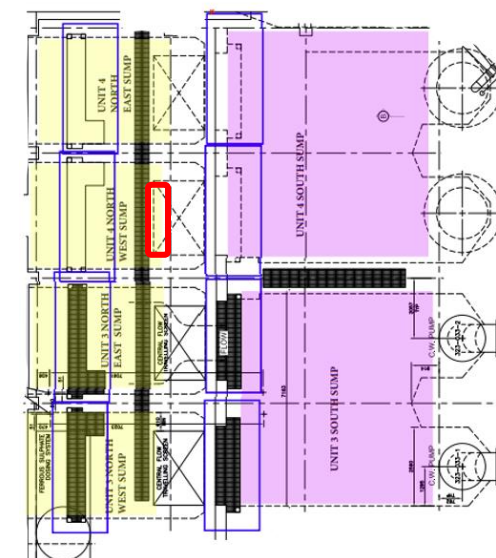
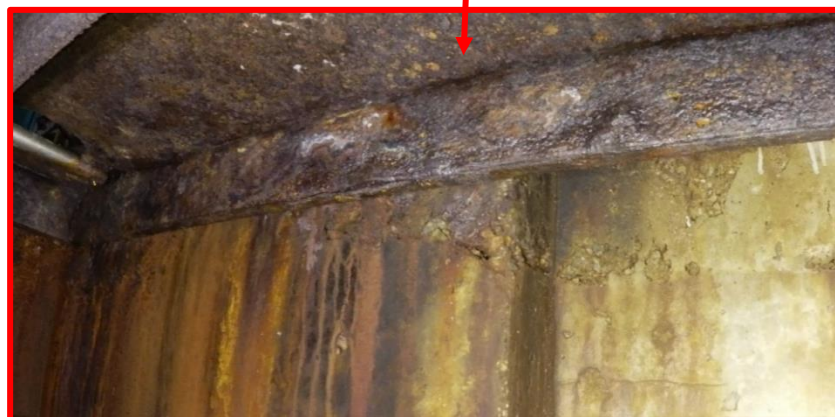
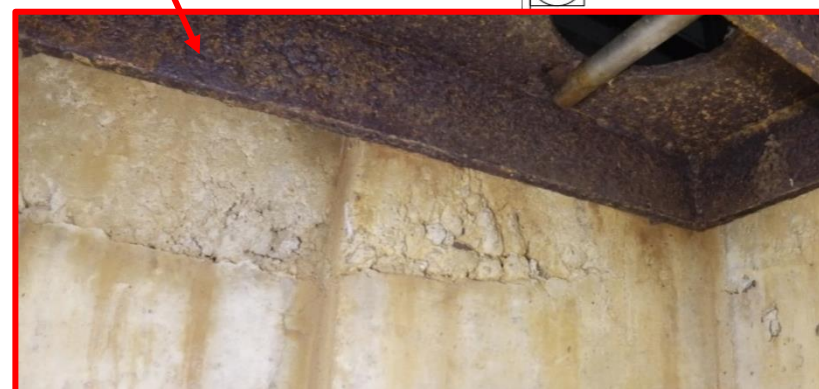
Anomaly (Y/N)	ID	Component	Component Tag	Type of Anomaly	Deg of Corrosion	Module	Level	Heat Map	Comments
Y	-	-	-	Deterioration / Corrosion	-	-	-	-	Deterioration of concrete near hatch Corrosion occurring on hatch and supports.

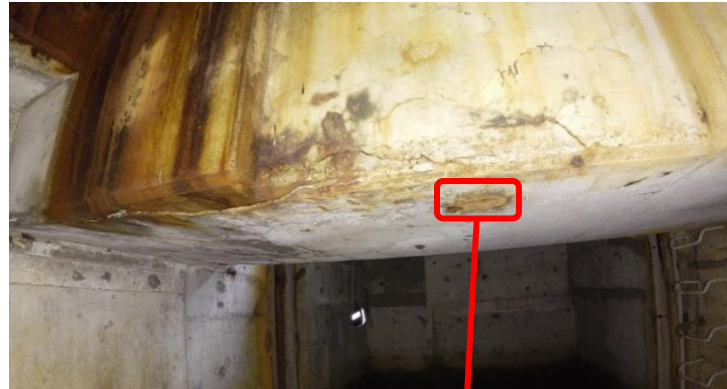
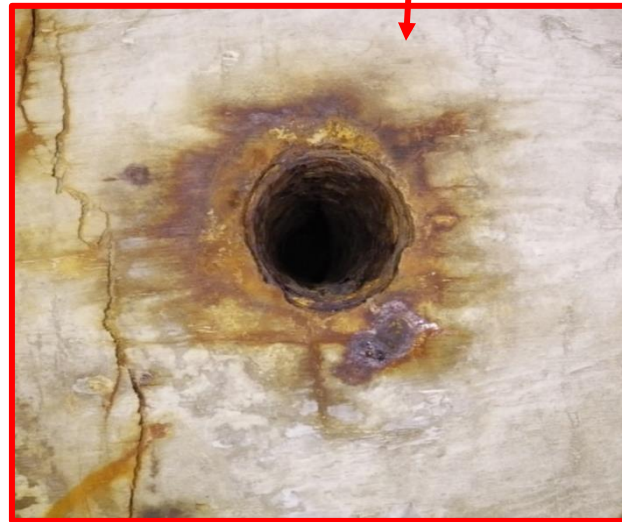
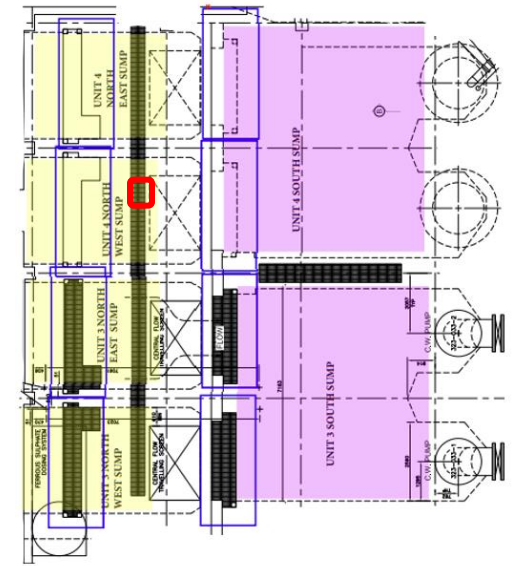
Anomaly (Y/N)	ID	Component	Component Tag	Type of Anomaly	Deg of Corrosion	Module	Level	Heat Map	Comments
Y	-	-	-	Deterioration of Concrete	-	-	-	-	Deterioration around opening/ piping.

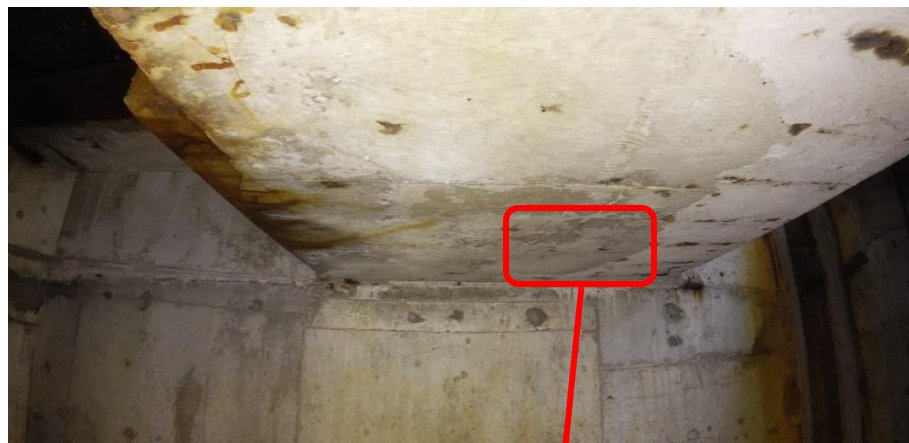
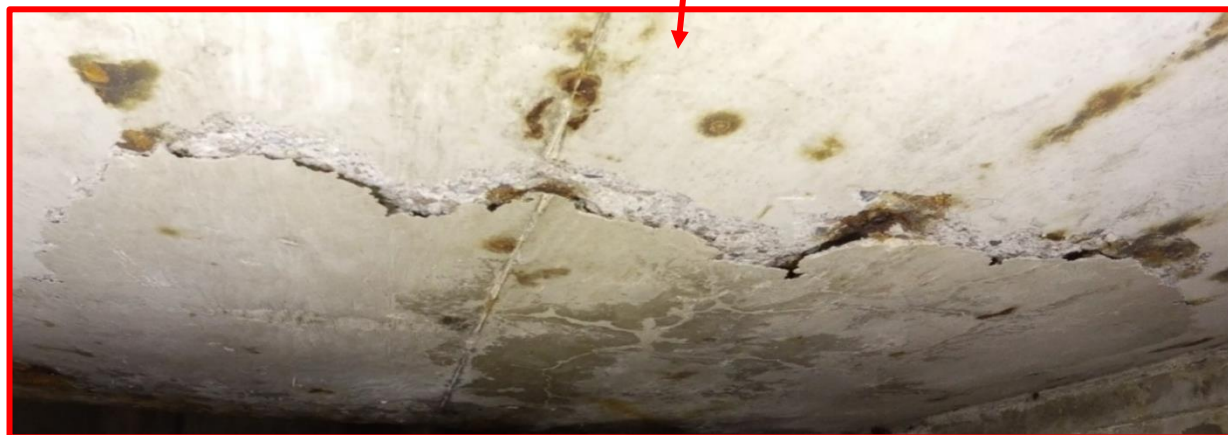
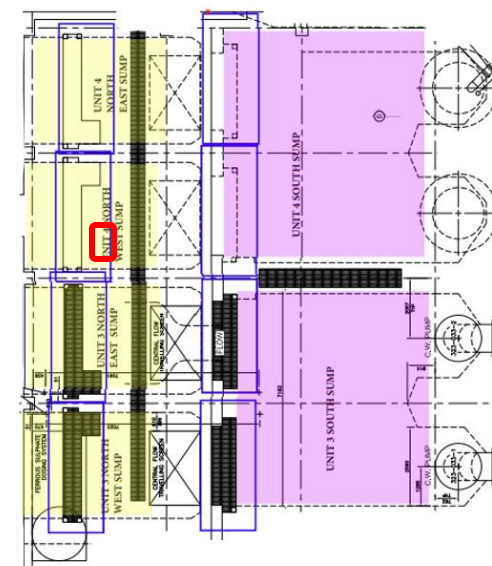
Anomaly (Y/N)	ID	Component	Component Tag	Type of Anomaly	Deg of Corrosion	Module	Level	Heat Map	Comments
Y	-	-	-	Crack	-	-	-	-	Crack formed and concrete is sheeting off.

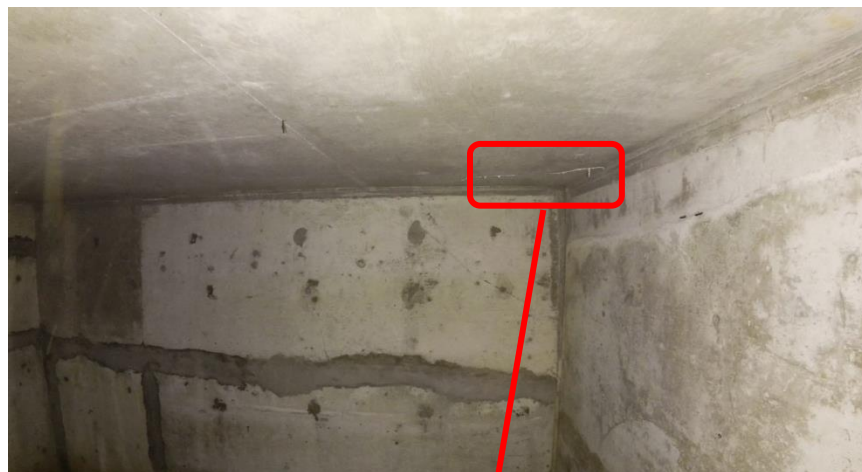
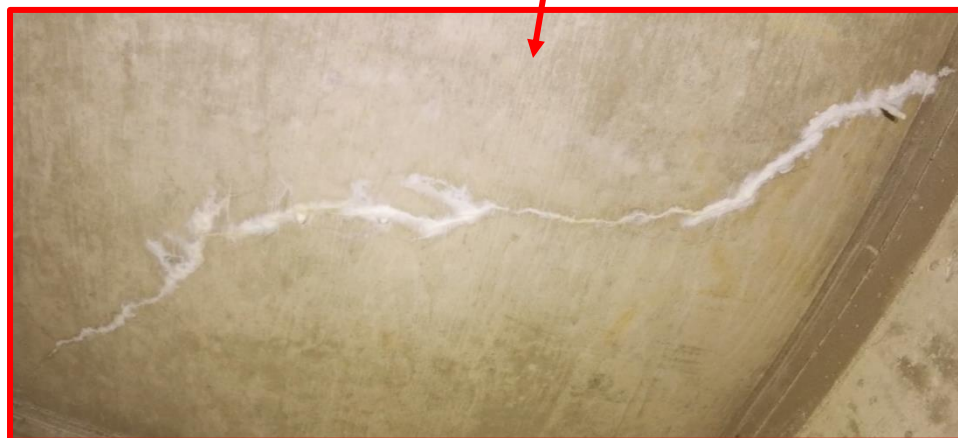
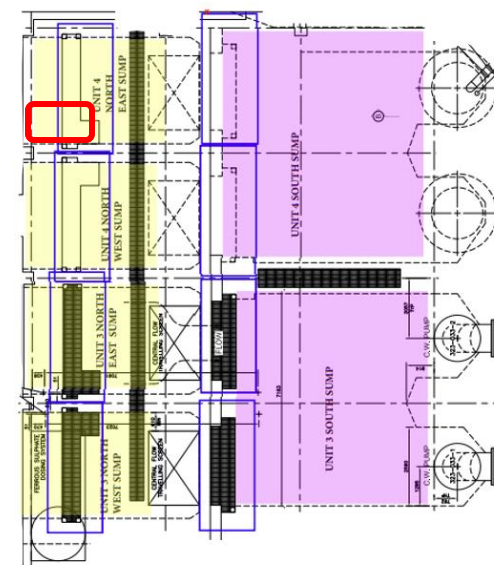
Anomaly (Y/N)	ID	Component	Component Tag	Type of Anomaly	Deg of Corrosion	Module	Level	Heat Map	Comments
Y	-	-	-	Crack	-	-	-	-	Crack on ceiling near North end of tank.

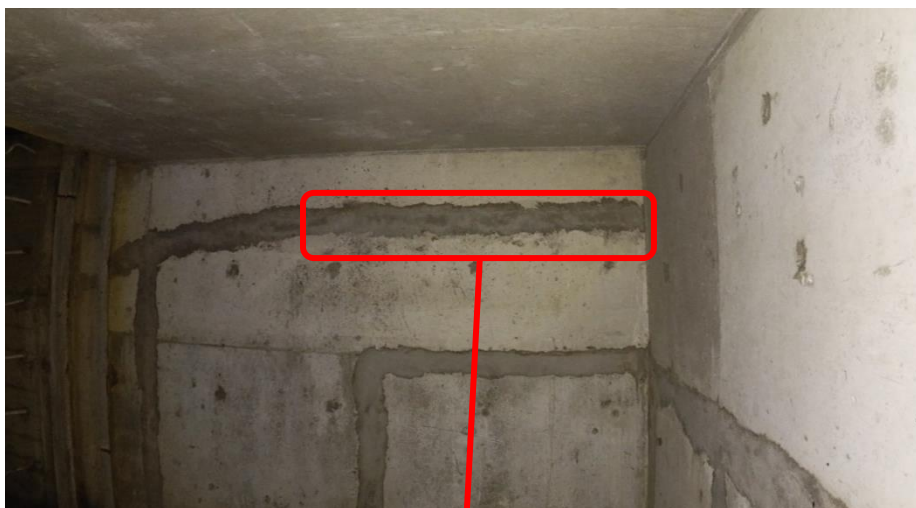
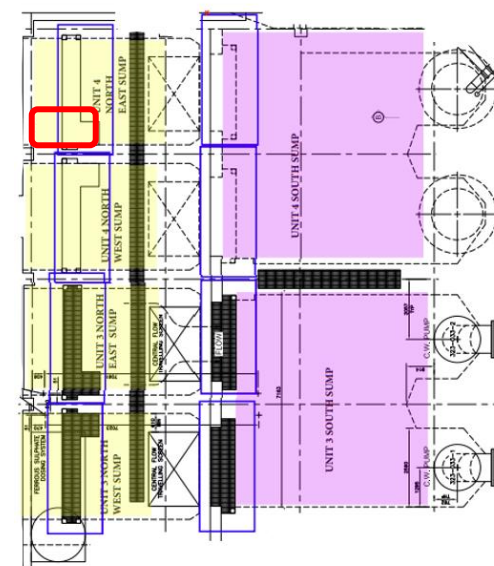
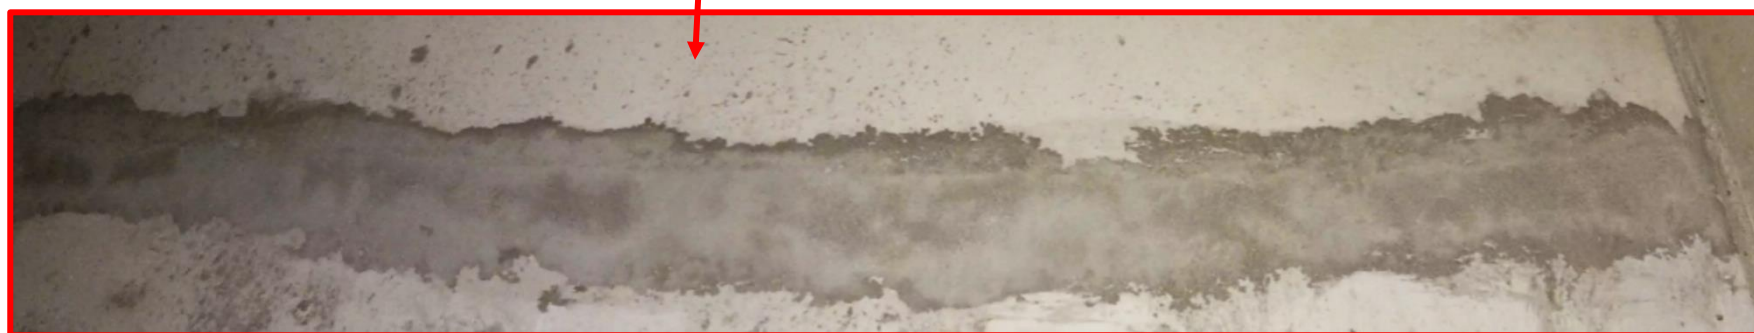
Anomaly (Y/N)	ID	Component	Component Tag	Type of Anomaly	Deg of Corrosion	Module	Level	Heat Map	Comments
Y	-	-	-	Repair	-	-	-	-	Appearance of repairs throughout the sump.

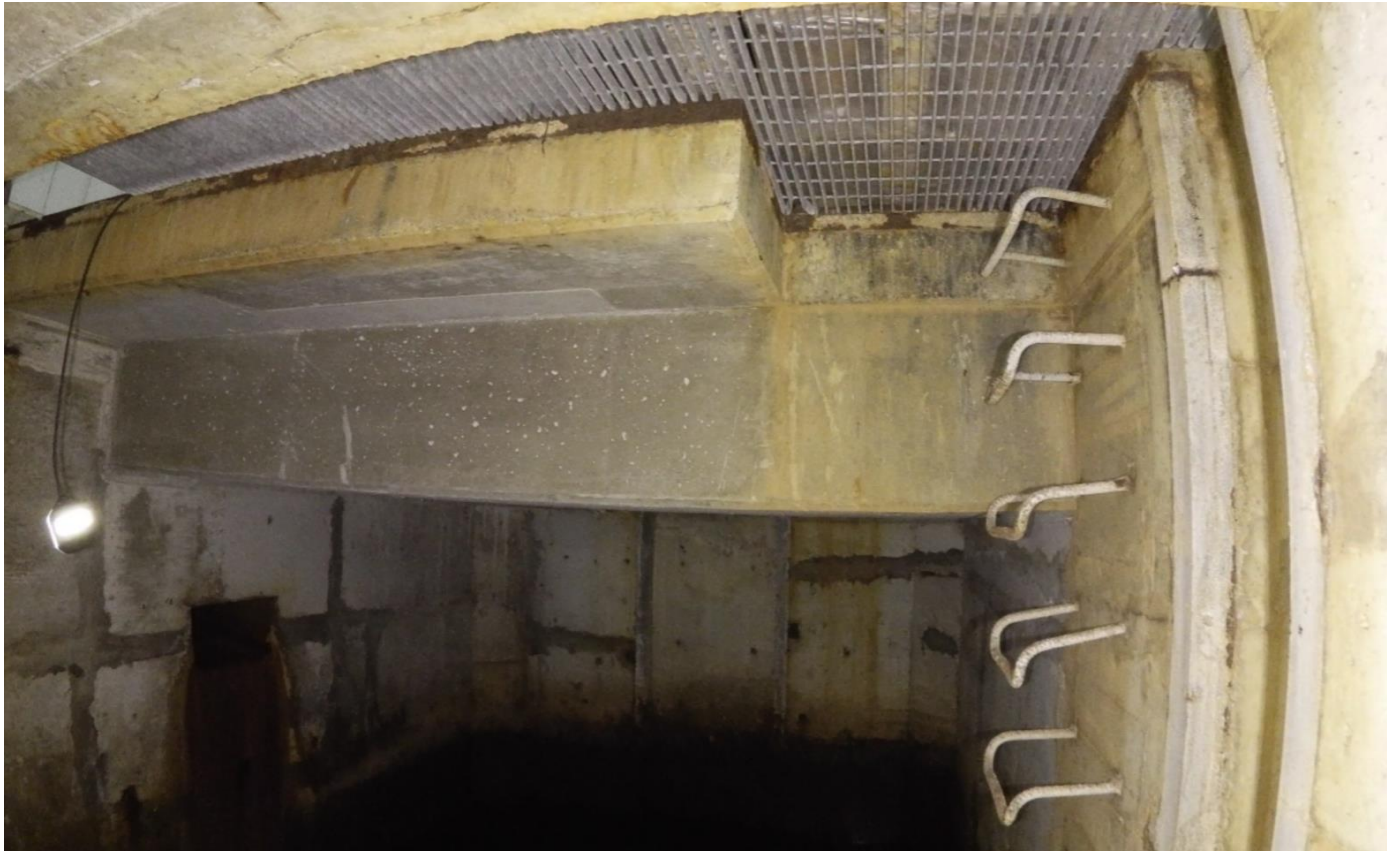
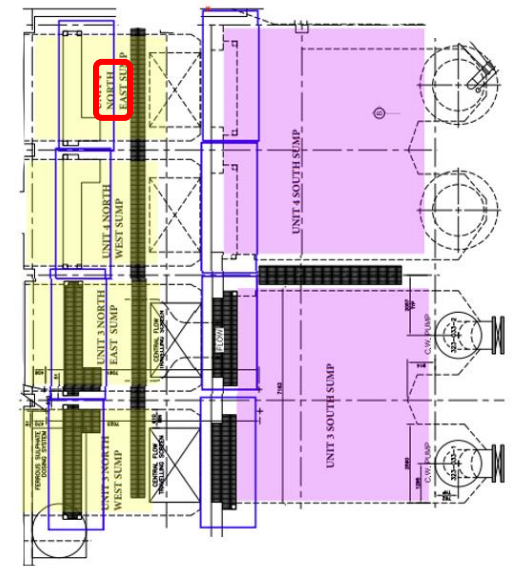
Anomaly (Y/N)	ID	Component	Component Tag	Type of Anomaly	Deg of Corrosion	Module	Level	Heat Map	Comments
N	-	-	-	-	-	-	-	-	Standoff looking north.

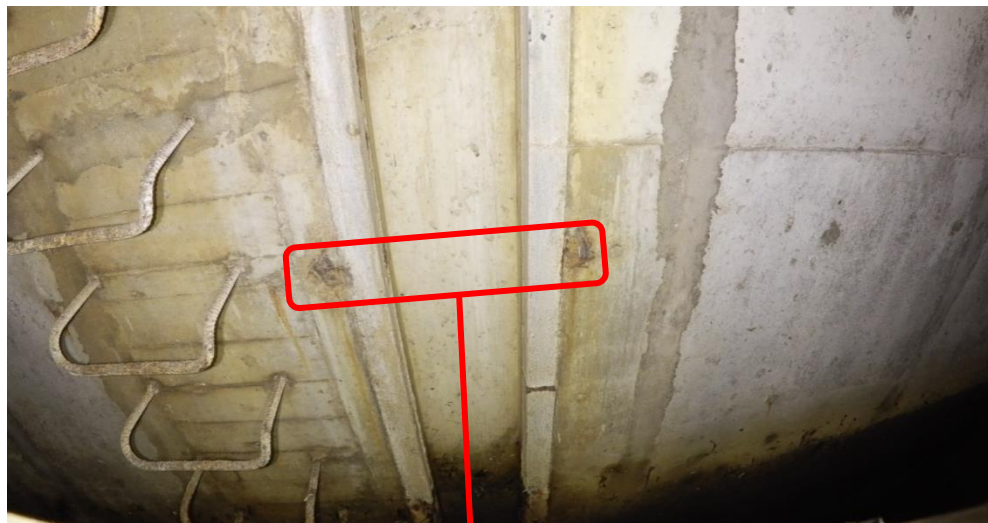
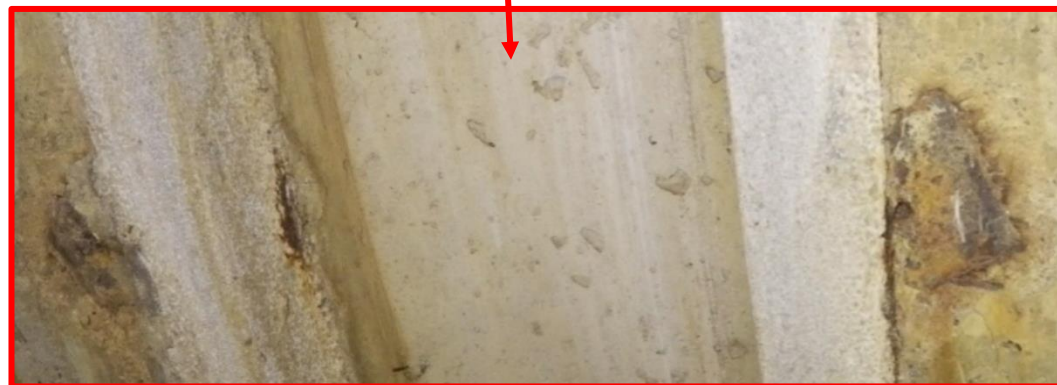
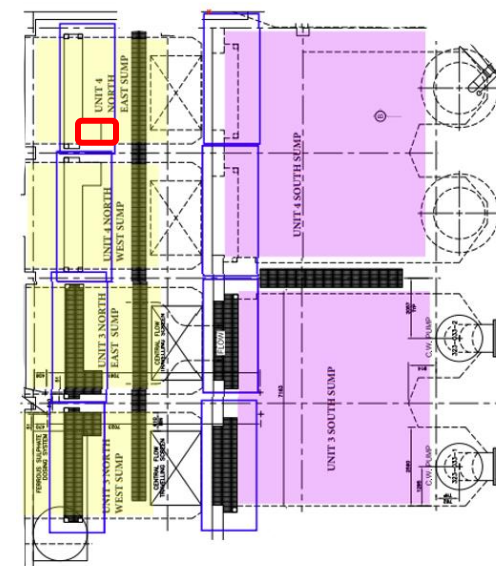
Anomaly (Y/N)	ID	Component	Component Tag	Type of Anomaly	Deg of Corrosion	Module	Level	Heat Map	Comments
Y	-	-	-	Deterioration of Concrete	-	-	-	-	Near ladder of entry point on stoplog slots.

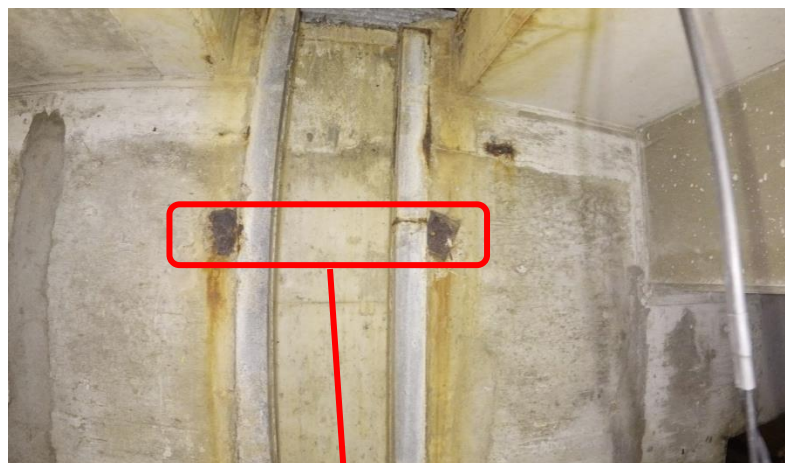
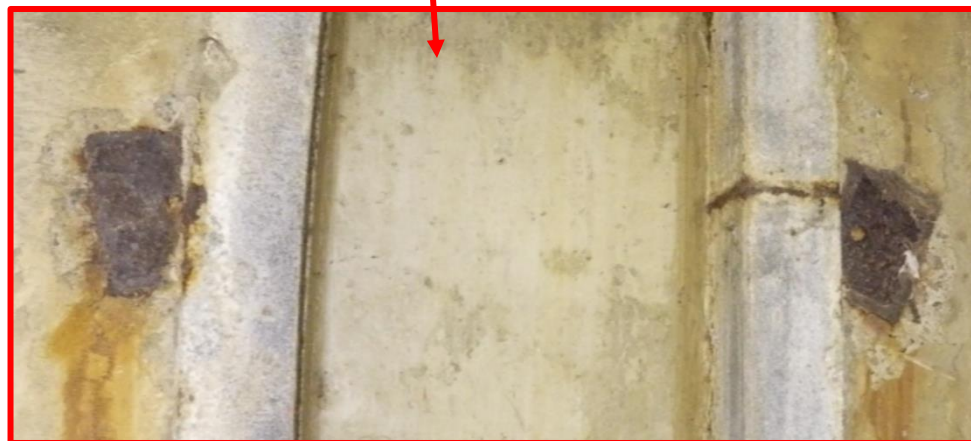
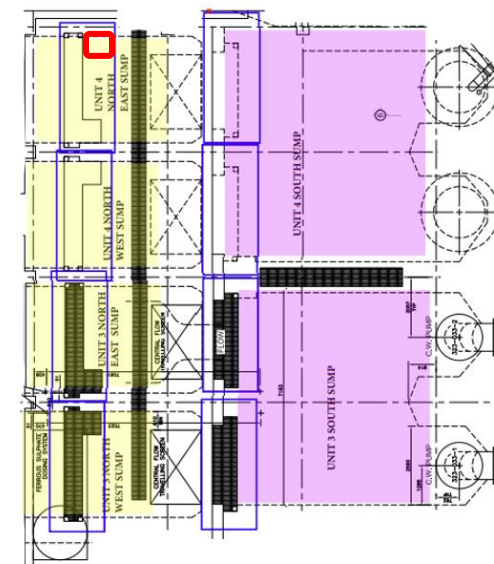
Anomaly (Y/N)	ID	Component	Component Tag	Type of Anomaly	Deg of Corrosion	Module	Level	Heat Map	Comments
Y	-	-	-	Deterioration of Concrete	-	-	-	-	Deterioration of spots Typical of what was seen throughout and along the stoplog slots.

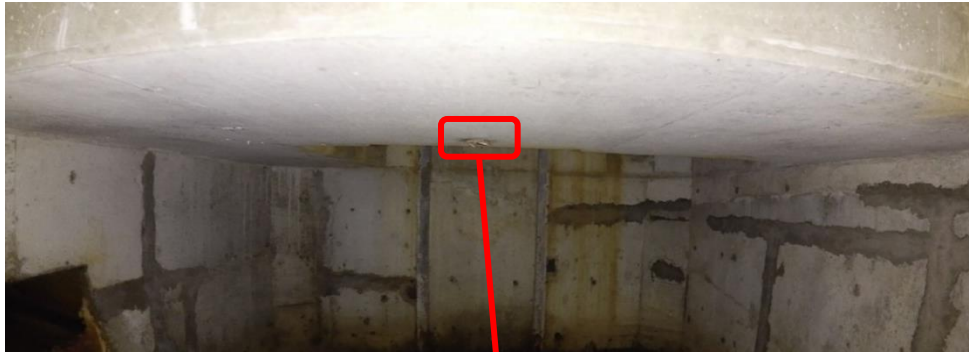
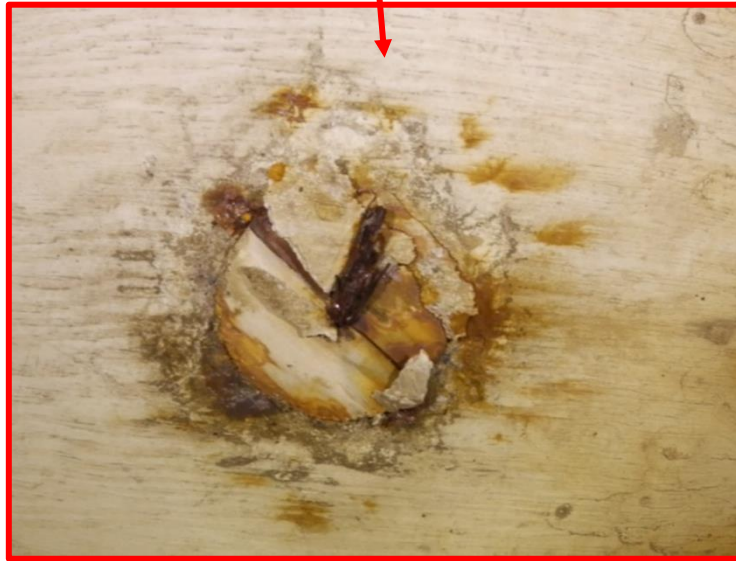
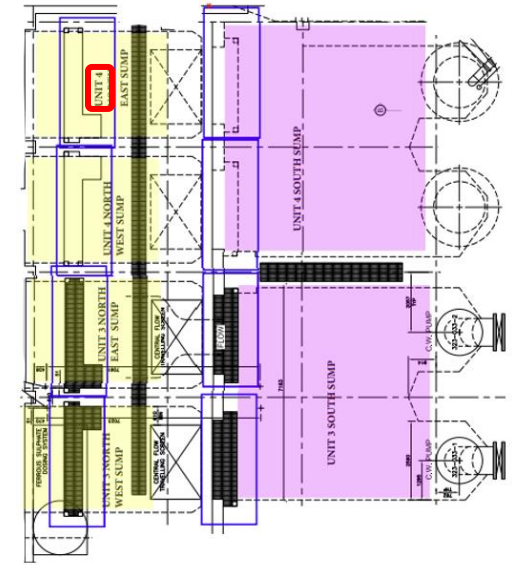
Anomaly (Y/N)	ID	Component	Component Tag	Type of Anomaly	Deg of Corrosion	Module	Level	Heat Map	Comments
Y	-	-	-	Deterioration / Corrosion	-	-	-	-	Corrosion of rebar and deterioration of concrete occurring around it.

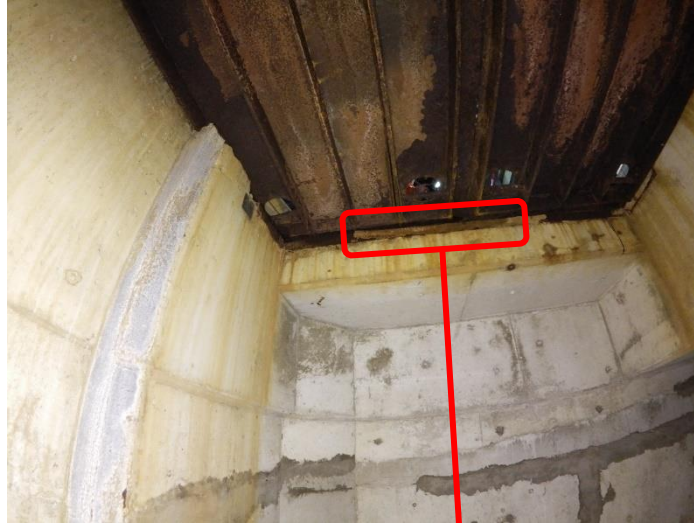
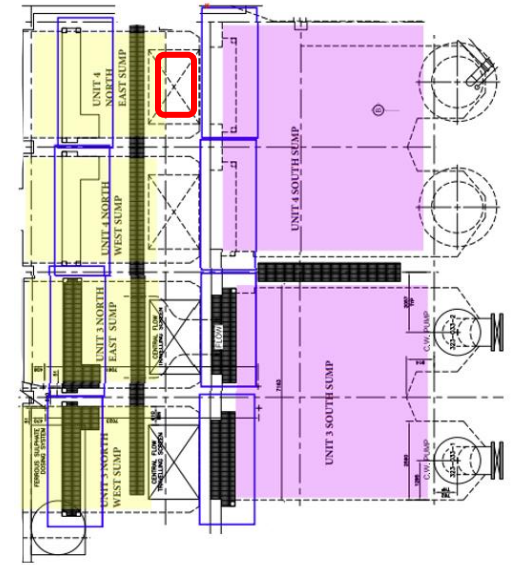
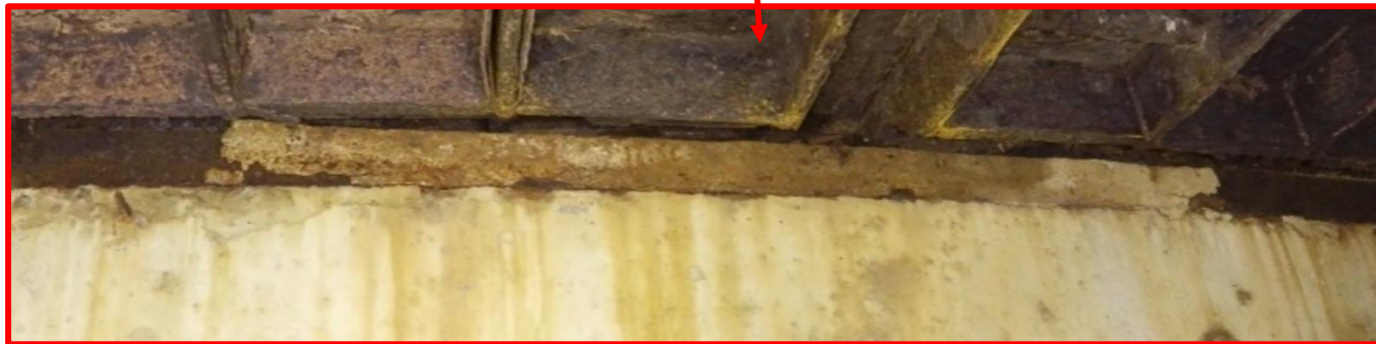
Anomaly (Y/N)	ID	Component	Component Tag	Type of Anomaly	Deg of Corrosion	Module	Level	Heat Map	Comments
Y	-	-	-	Deterioration of Concrete	-	-	-	-	Deterioration on and around the hatch.

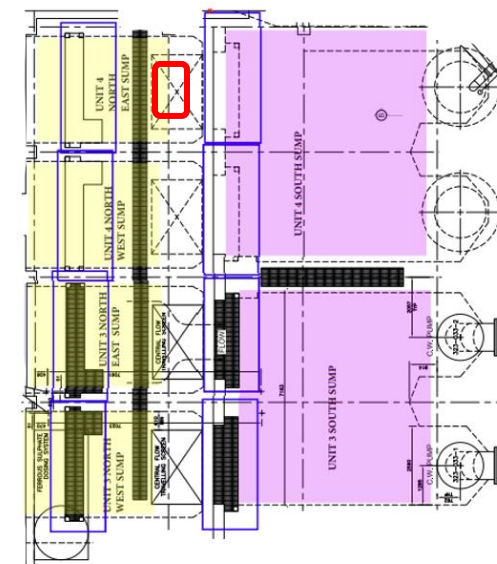
Anomaly (Y/N)	ID	Component	Component Tag	Type of Anomaly	Deg of Corrosion	Module	Level	Heat Map	Comments
Y	-	-	-	Minor spalling and deterioration	-	-	-	-	Minor spalling and deterioration occurring near south end looking north
