Re: *Reliability and Resource Adequacy Study Review - Assessment to Determine the Potential Long-Term Viability of the Holyrood Thermal Generating Station*

Holyrood Thermal Generating Station Condition Assessment

**Newfoundland and Labrador Hydro
HTGS Condition Assessment and Life Extension Study
Executive Summary**

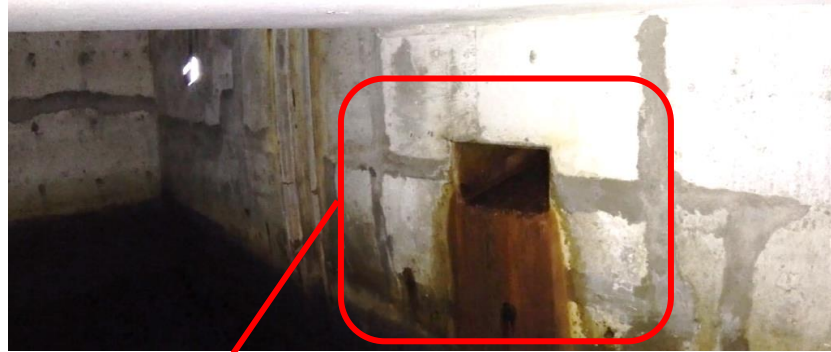
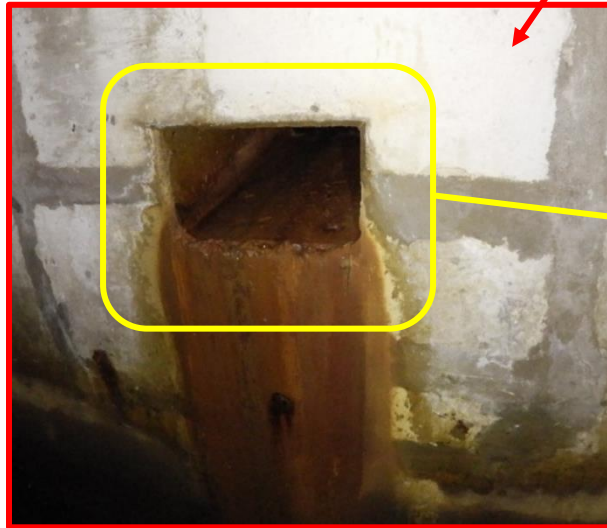
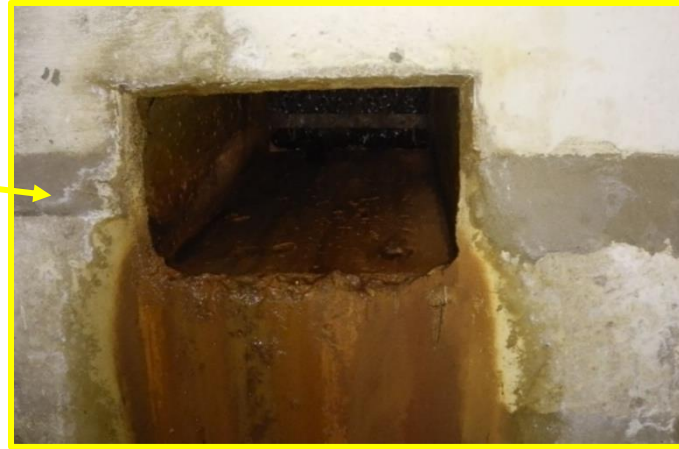
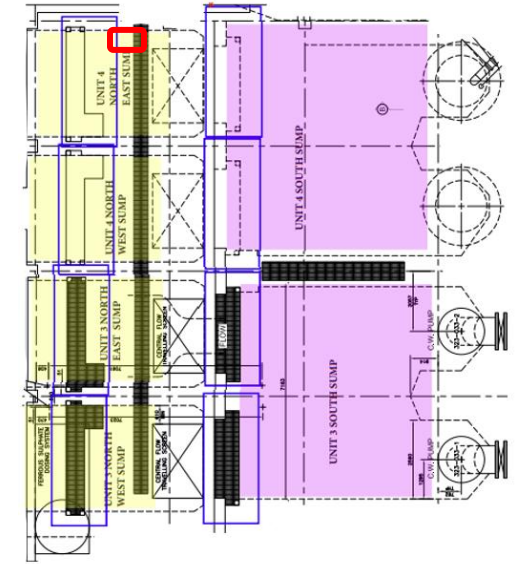
Anomaly (Y/N)	ID	Component	Component Tag	Type of Anomaly	Deg of Corrosion	Module	Level	Heat Map	Comments
Y	-	-	-	Deterioration of Concrete	-	-	-	-	Deterioration of concrete around opening.

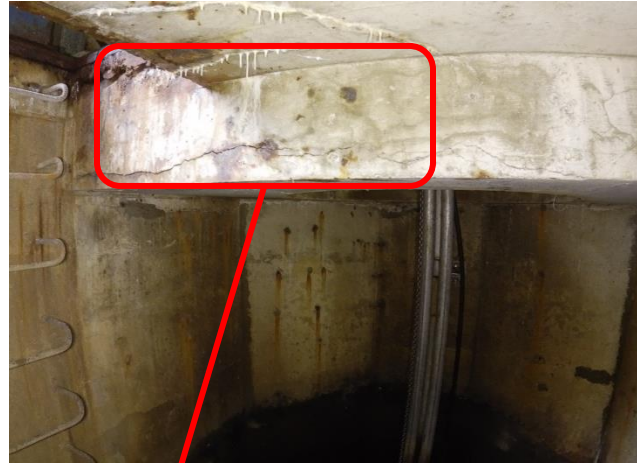
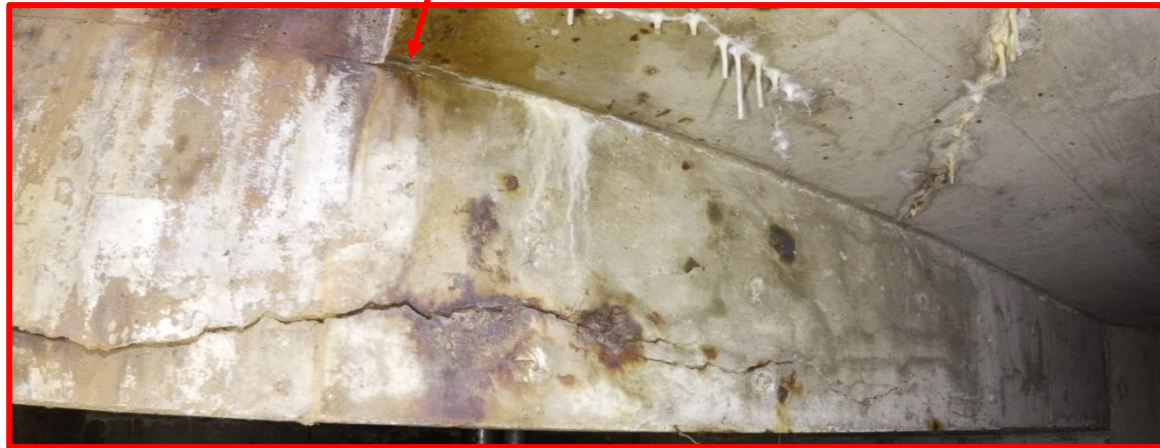
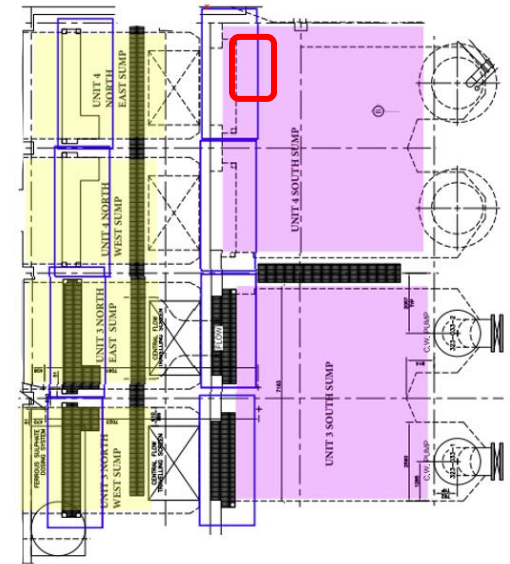
Anomaly (Y/N)	ID	Component	Component Tag	Type of Anomaly	Deg of Corrosion	Module	Level	Heat Map	Comments
Y	-	-	-	Crack / Deterioration	-	-	-	-	Substantial crack formed and deterioration of concrete around crack.

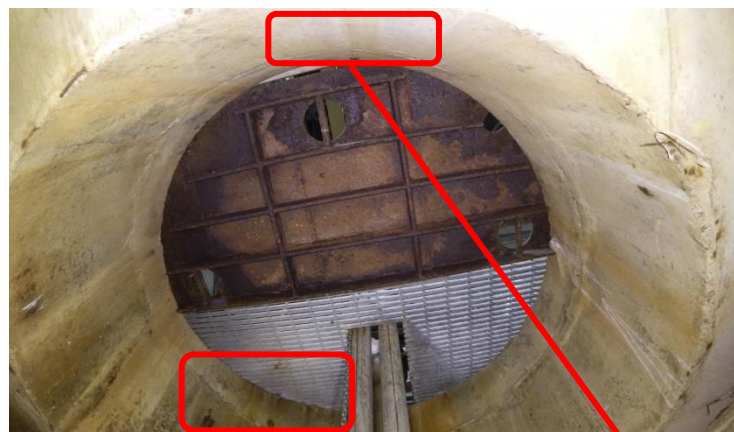
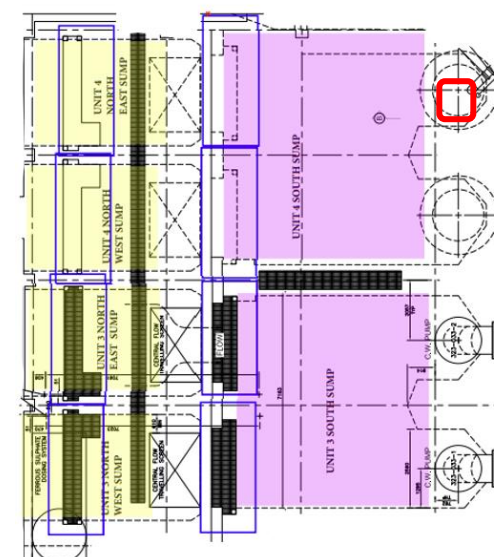
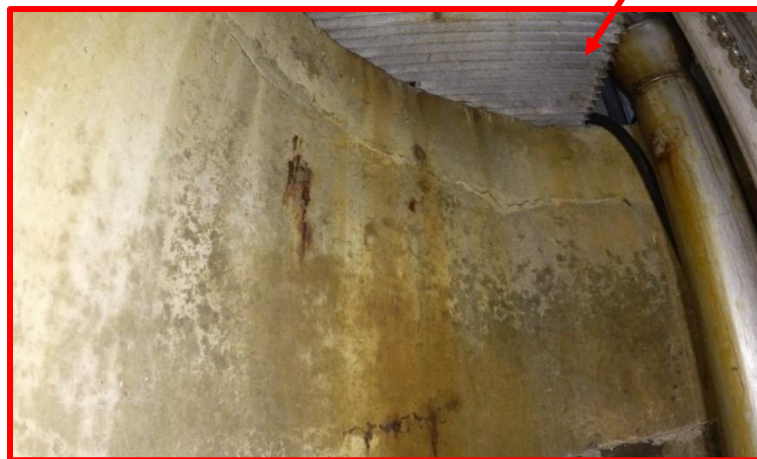
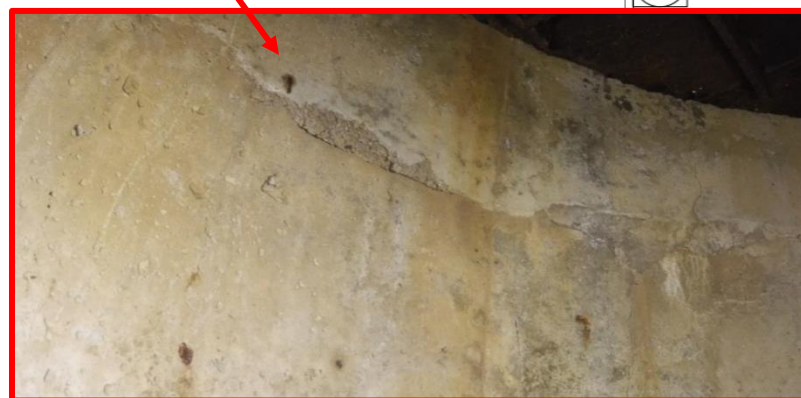
Anomaly (Y/N)	ID	Component	Component Tag	Type of Anomaly	Deg of Corrosion	Module	Level	Heat Map	Comments
Y	-	-	-	Deterioration / Minor Cracking	-	-	-	-	Some deterioration occurring and minor cracks forming.

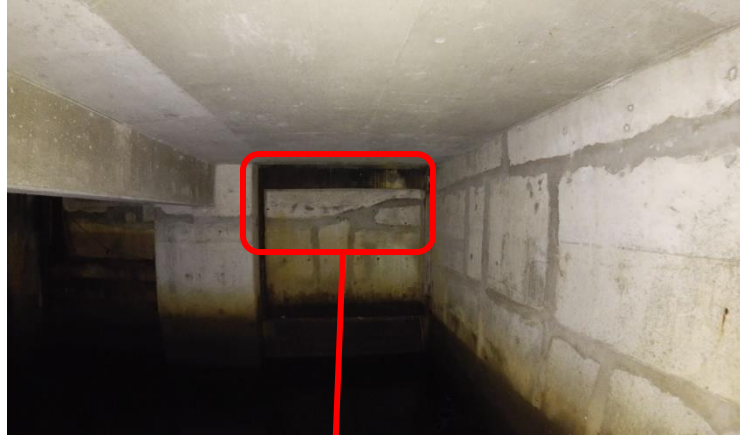
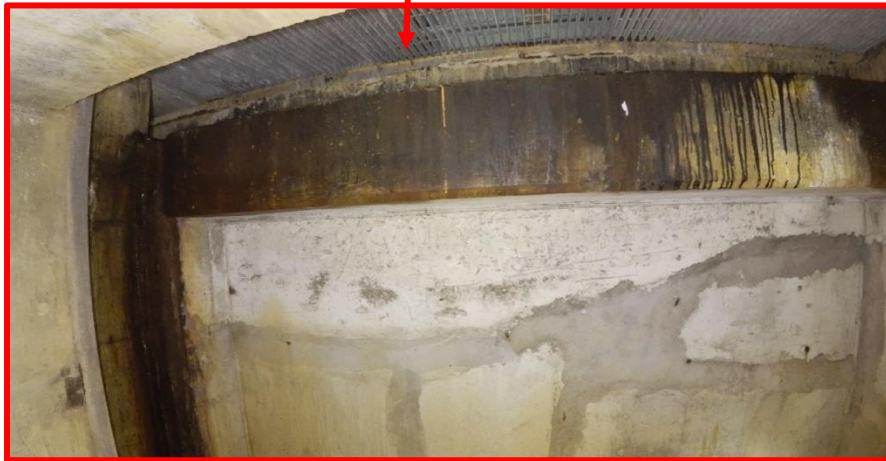
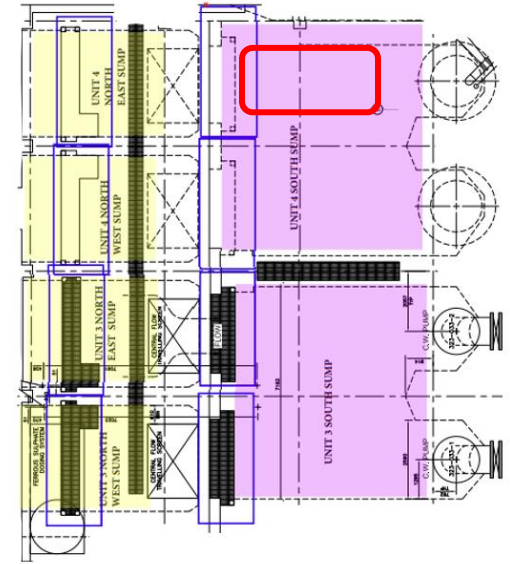
Anomaly (Y/N)	ID	Component	Component Tag	Type of Anomaly	Deg of Corrosion	Module	Level	Heat Map	Comments
Y	-	-	-	Deterioration	-	-	-	-	Standoff shot and noted deterioration near access points.

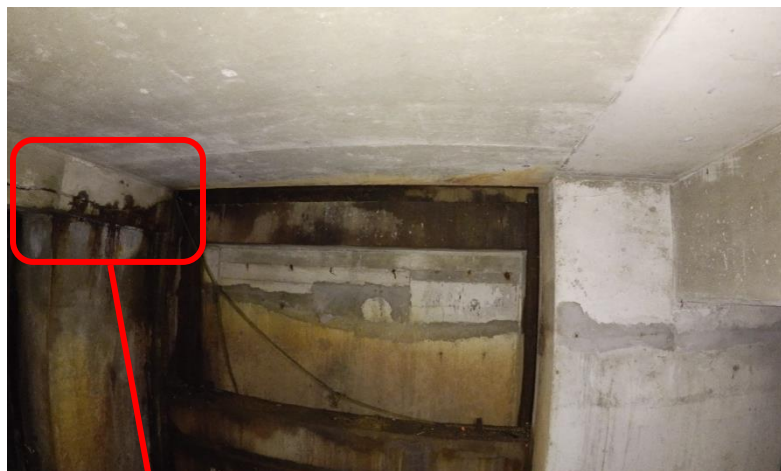
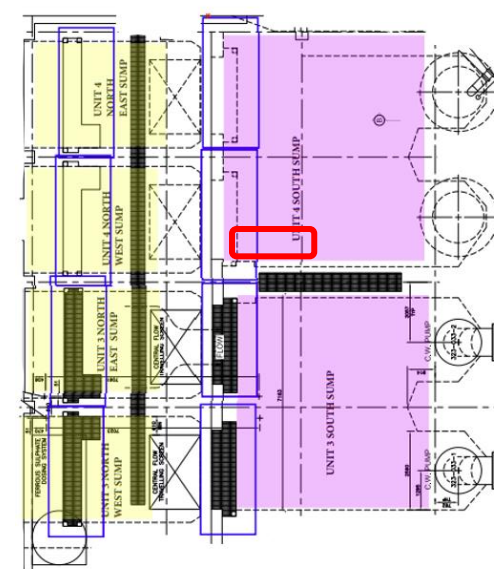
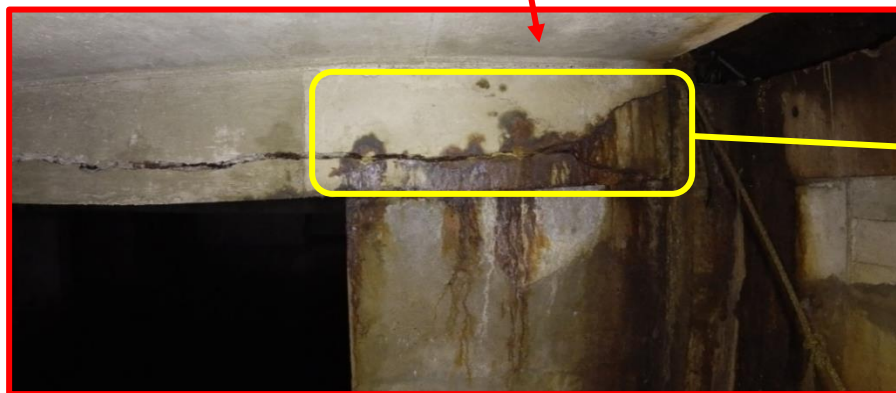
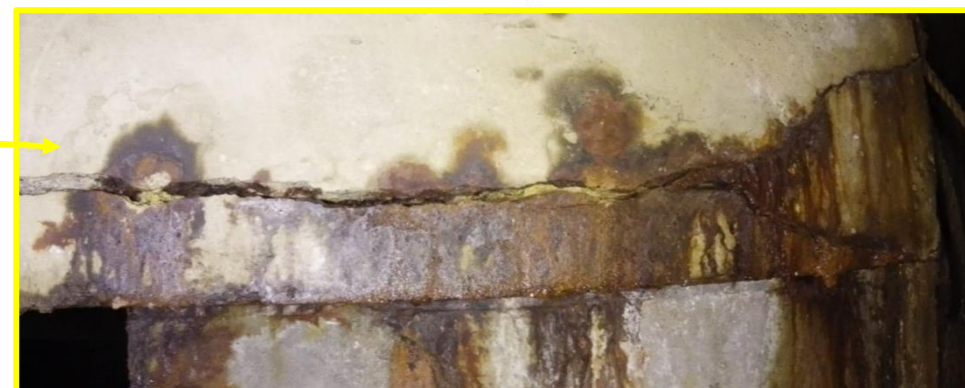
Anomaly (Y/N)	ID	Component	Component Tag	Type of Anomaly	Deg of Corrosion	Module	Level	Heat Map	Comments
Y	-	-	-	Crack	-	-	-	-	Substantial crack formed on the middle beam

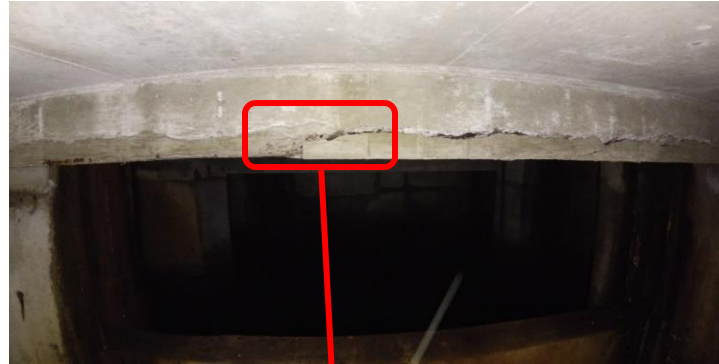
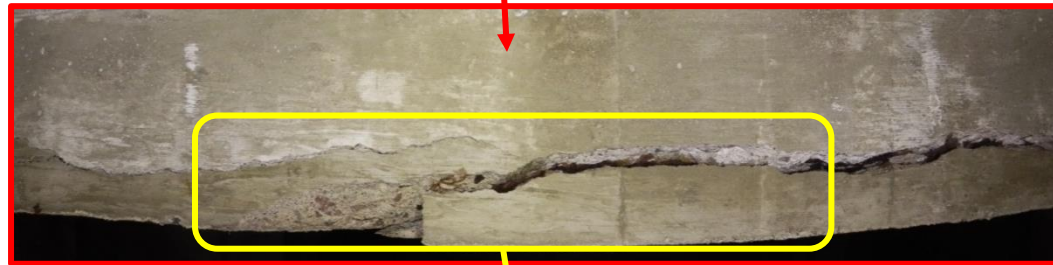
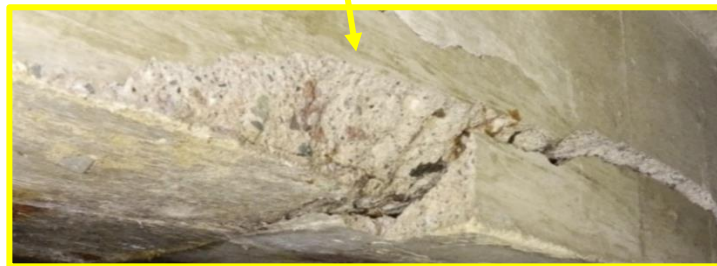
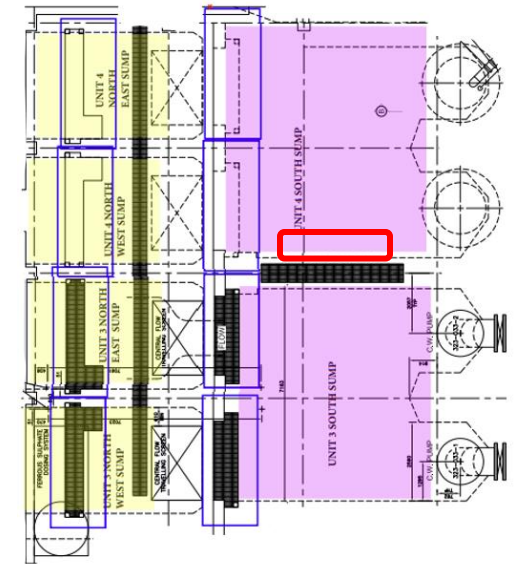
Anomaly (Y/N)	ID	Component	Component Tag	Type of Anomaly	Deg of Corrosion	Module	Level	Heat Map	Comments
Y	-	-	-	Crack	-	-	-	-	Substantial crack formed on the middle beam.

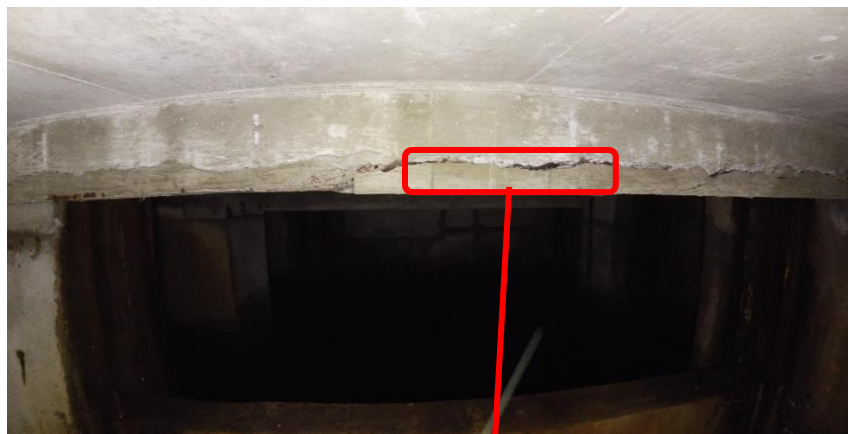
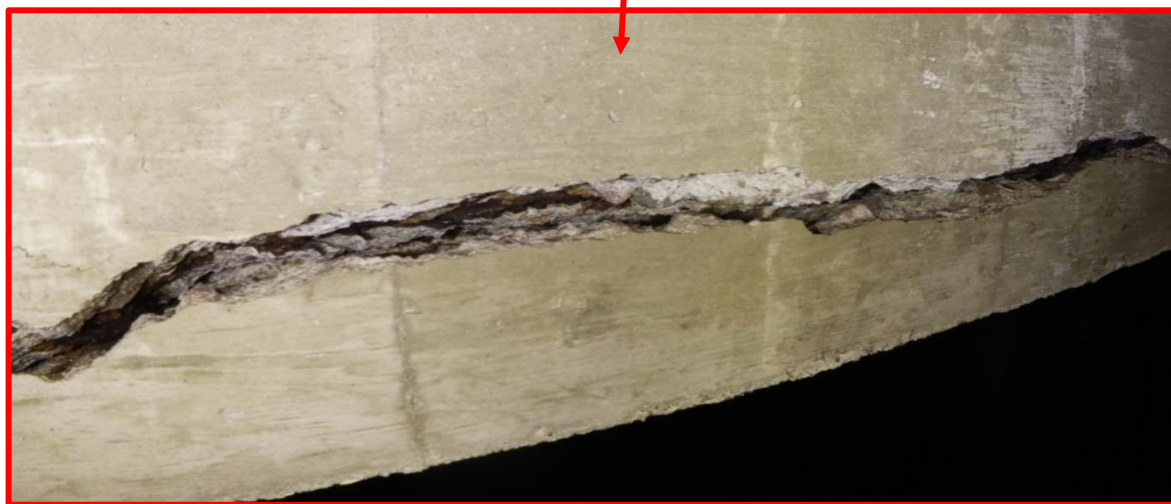
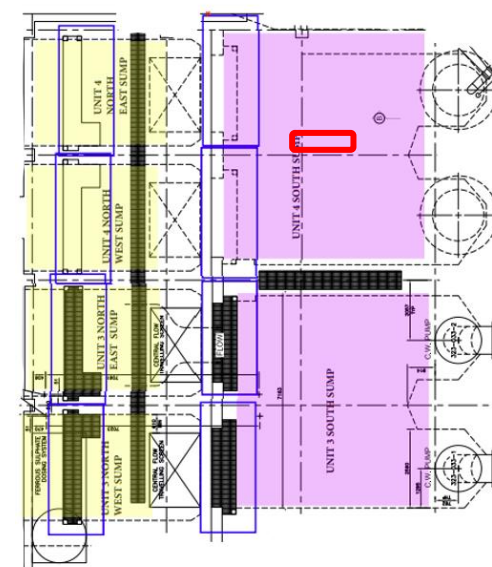
Anomaly (Y/N)	ID	Component	Component Tag	Type of Anomaly	Deg of Corrosion	Module	Level	Heat Map	Comments
Y	-	-	-	Crack	-	-	-	-	Substantial crack formed on the middle beam.

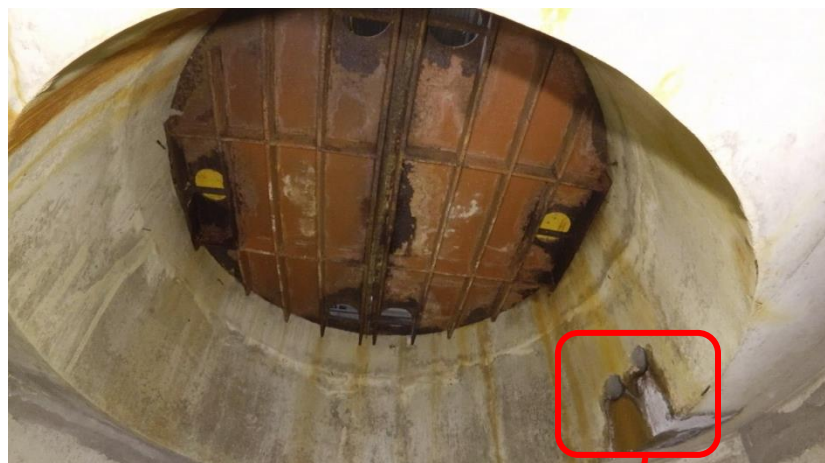
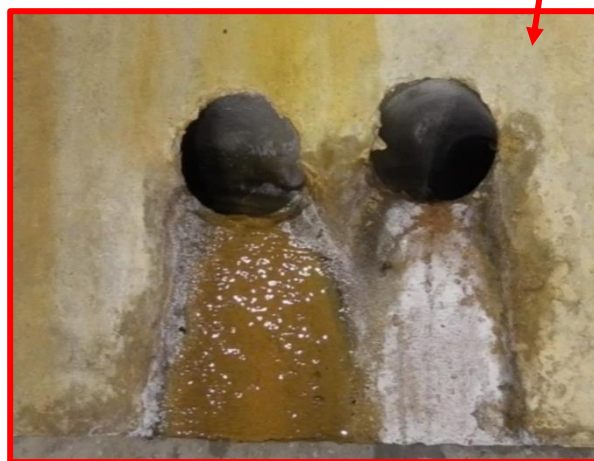
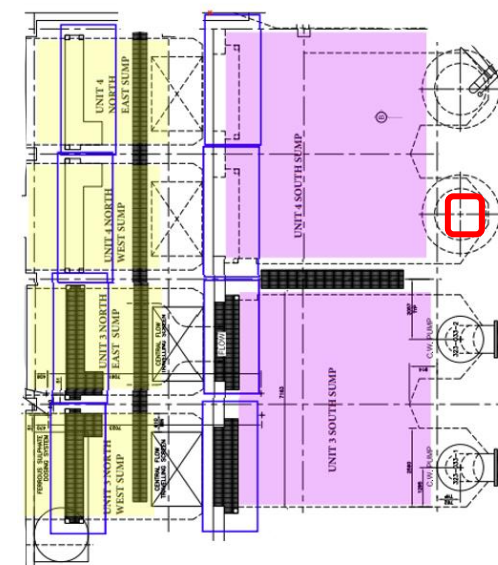
Anomaly (Y/N)	ID	Component	Component Tag	Type of Anomaly	Deg of Corrosion	Module	Level	Heat Map	Comments
Y	-	-	-	Deterioration	-	-	-	-	Deterioration around openings, Typical of what was seen throughout.

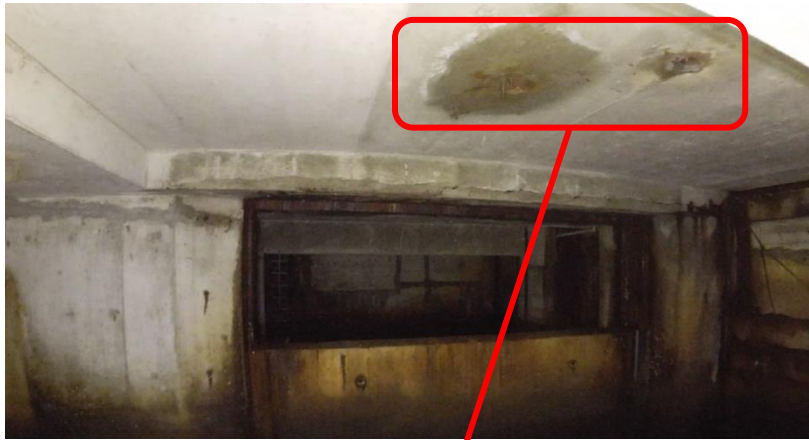
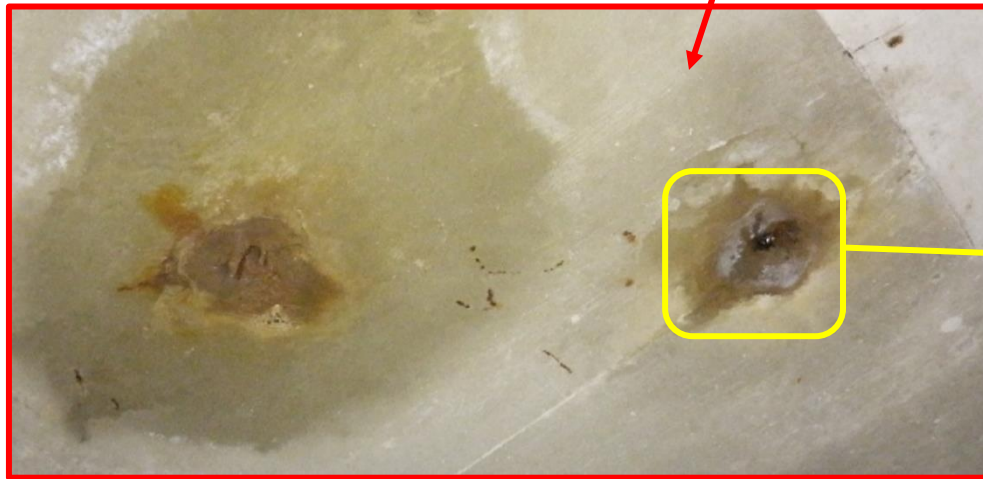
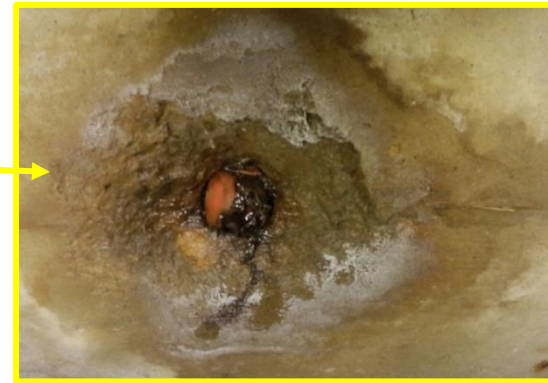
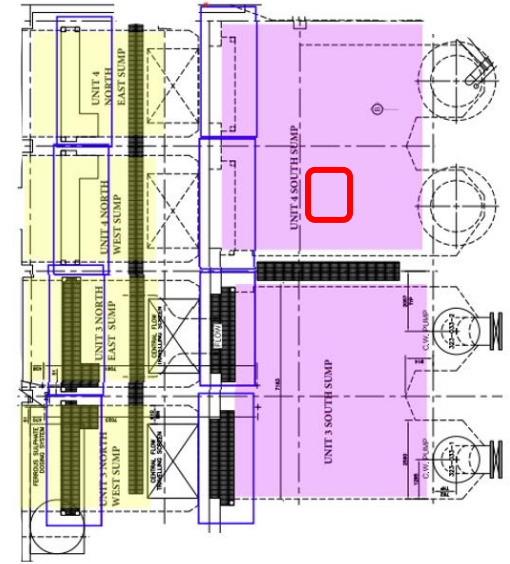
Anomaly (Y/N)	ID	Component	Component Tag	Type of Anomaly	Deg of Corrosion	Module	Level	Heat Map	Comments
Y	-	-	-	Deterioration of Concrete	-	-	-	-	Deterioration formed around drainage pipe.

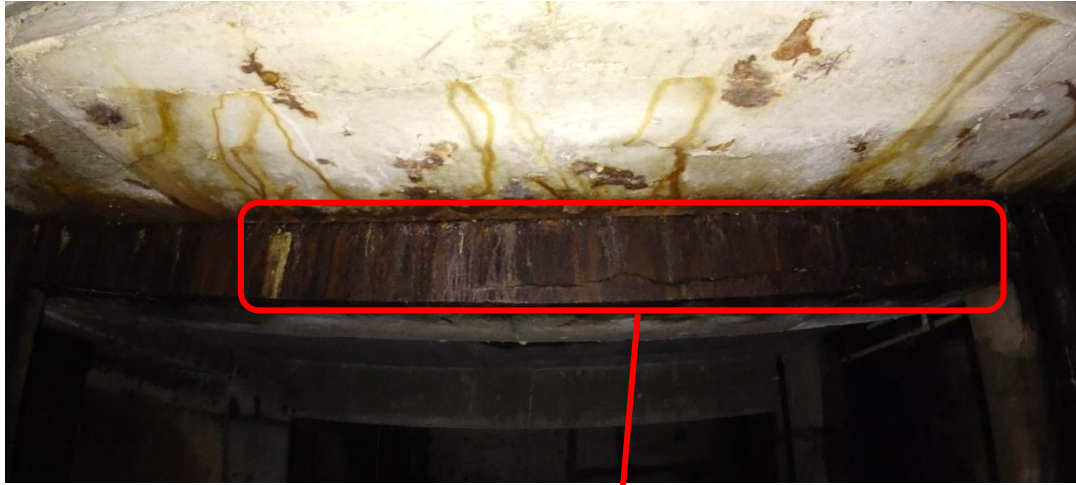
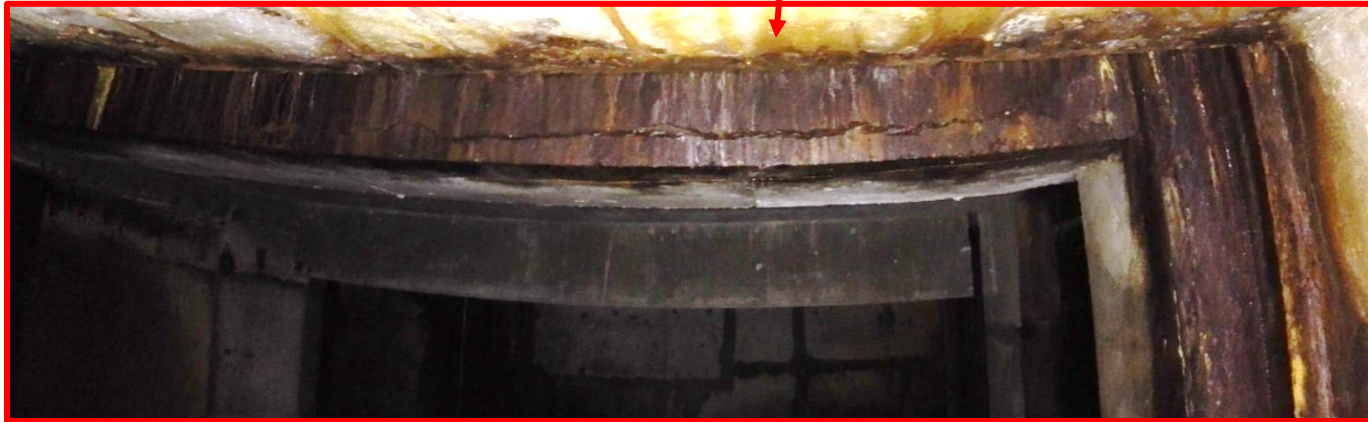
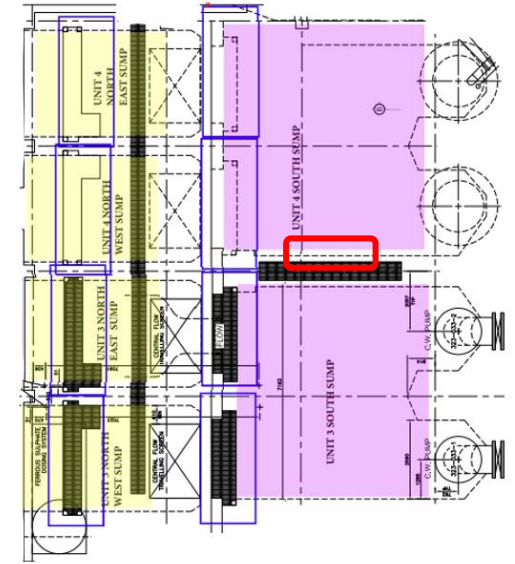
Anomaly (Y/N)	ID	Component	Component Tag	Type of Anomaly	Deg of Corrosion	Module	Level	Heat Map	Comments
Y	-	-	-	Crack / Deterioration	-	-	-	-	Looking towards Unit 3 South Sump Substantial crack formed along the length of the beam and deterioration of concrete.

Recommendations from the inspection team would be to keeping monitoring the area at intervals identified in the asset integrity plan if one exists.

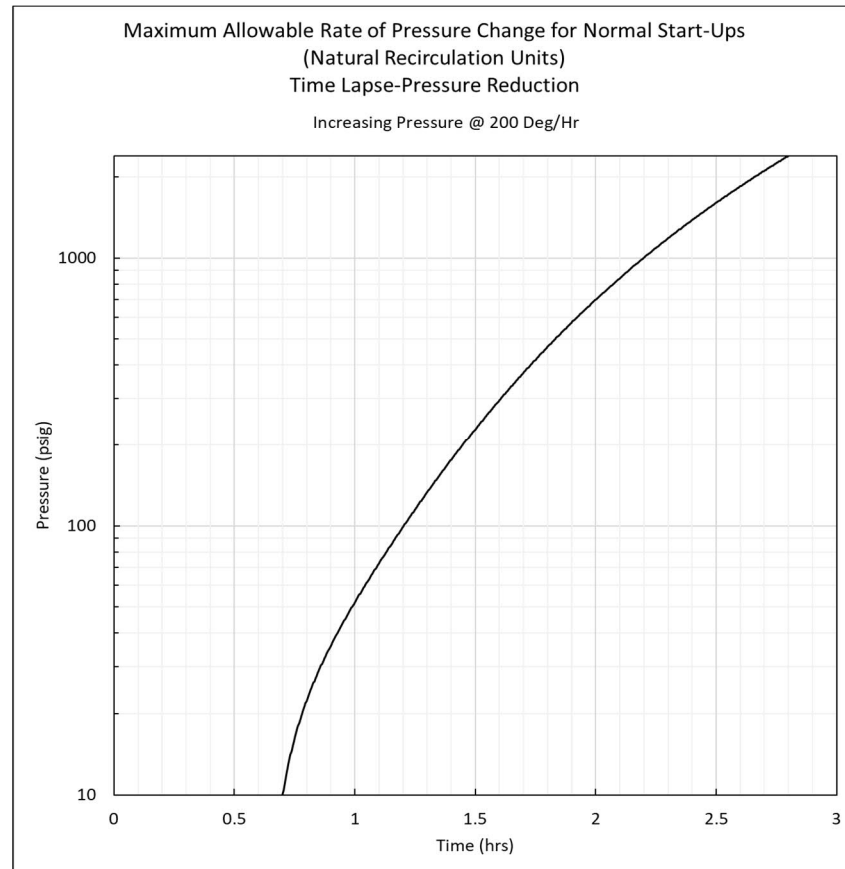
Figure 4-1: Maximum Allowable Rate of Pressure Change for Drum Boilers

The allowable boiler drum water heating rate and respective maximum rate of pressure change during start-up are shown in Figure 4-1, extracted from the boiler OEM manual. The time required for the boiler to reach a pressure of 700 psig, where the main boiler steam can be used for turbine pre-warming, is approximately 2 hours.

Note: The curve above is based on the OEM Manual

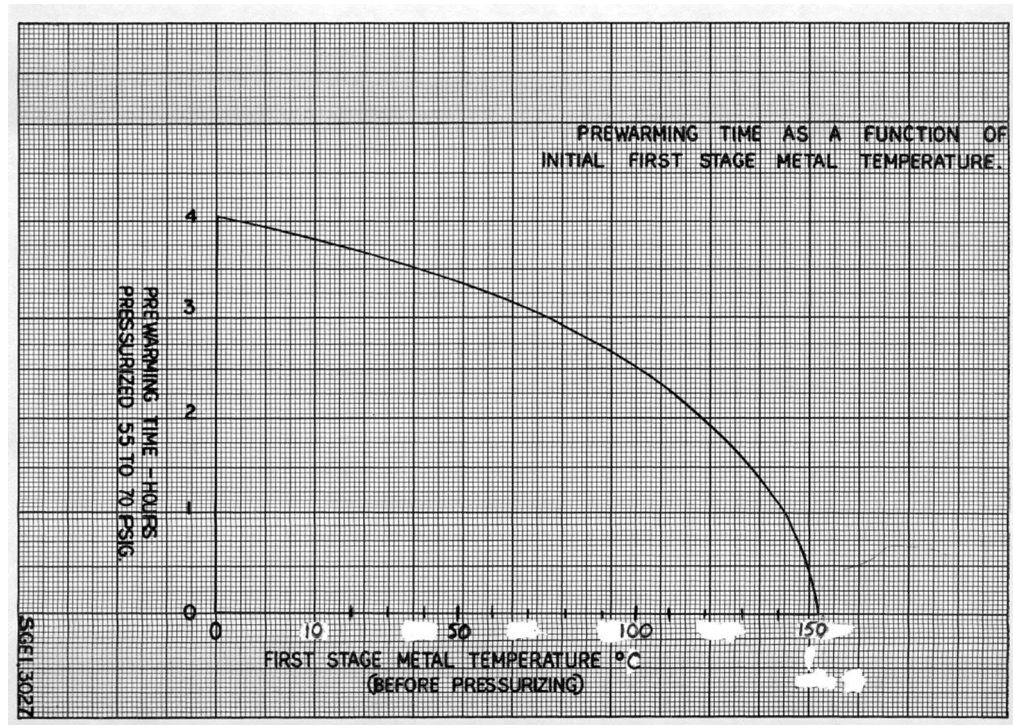
Figure 4-2: Pre-Warming Curve for Turbine Rotor

To avoid the thermal mismatch, the inner metal temperature should be within a reasonable limit before starting turbine rolling. More specifically, as per OEMs instructions for all three units, the inner metal temperature at the first stage of the turbine should be 150°C or more before turbine rolling. This pre-warming of the main steam valve and steam turbine chest is accomplished using steam from the auxiliary or main boiler and requires almost four hours to reach 150°C as shown in Figure 4-2.

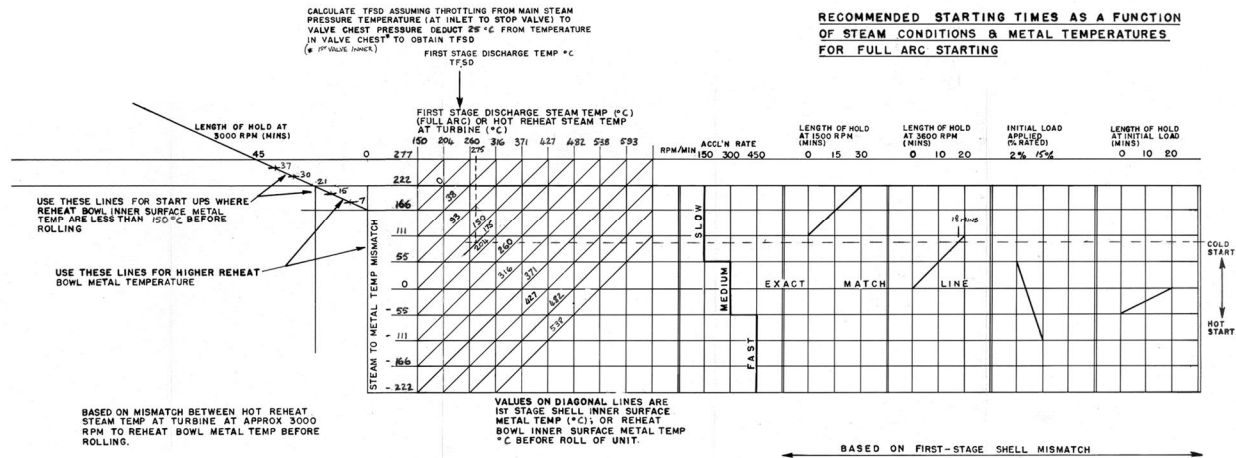
Figure 4-3: Turbine Start-up Curve

The manual gives Starting Times vs Steam Conditions for Full Arc admission shown in Figure 4-3. The figure indicates the following for a cold start based on a first stage steam temperature of 275°C:

- Pre-warming time of 4 hours for the turbine as show in Figure 4-2 above (Based on first stage metal temperature of 50°C).
- Acceleration rate 150 rpm/min.
- Length of hold at 3000 rpm of 45 minutes based on reheat metal temperature.
- Length of hold at 3600 rpm of 18 minutes.

This indicates a cumulative period of approximately 4 hours for pre-warming plus approximately 83 minutes for synchronizing and applying initial block load of about 2% of rated output.

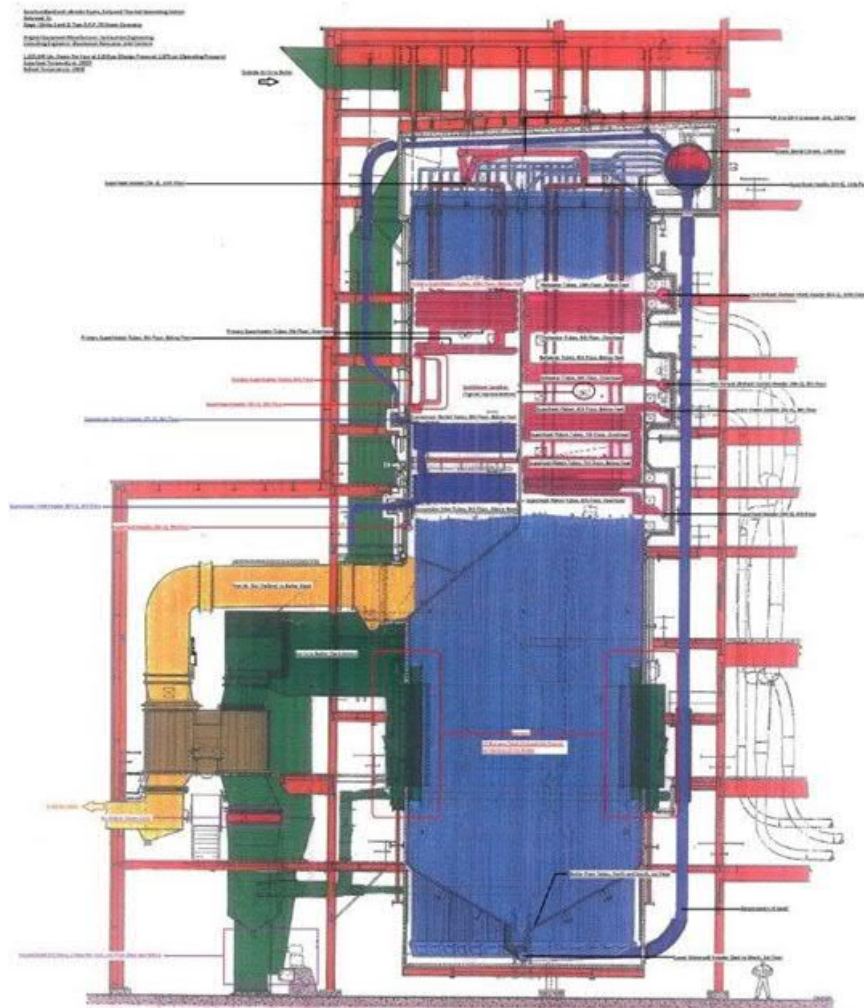
Figure 4-10: Drainable Boiler Superheaters at Units 1 and 2

As was common industry practice at the time, Units 1 and 2 boilers, Figure 4-10: Drainable Boiler Superheaters at Units 1 and 2, were designed with horizontal superheaters and reheaters to reduce the risk of freezing. This also facilitates long term wet layup while minimizing the boil-out time required for pendant type heating sections but, in the case of the reheaters, it increases the consumption of nitrogen. Where the risk of freezing is high, e.g., due to loss of the plant heating system for extended periods, nitrogen capping may be used in the drainable sections in place of buffered water.

For Scenarios 1, 2, and 3, the boiler will be under wet/dry lay-up conditions and for Scenario 4 the boiler will be maintained warm and under steam pressure. For each of the former scenarios, the boiler drum, economizer, and waterwalls will be filled to the maximum water level in the drum with nitrogen capping to maintain the balance of the steam circuit in an inert atmosphere. For Scenario 1, 24 to 30-hour recall time, the boiler superheaters may also be flooded up to the closed main steam stop valve. It is recommended that the reheaters be nitrogen capped.
