1 Q. Please provide a copy of equipment-related root cause or causal analyses reports
2 conducted over 2016-2018.

CRACK INVESTIGATION AND REPAIR REPORT

This report is intended to summarize the site inspection and repair recommendations of a crack that developed in Penstock No.1 at the Bat d'Espoir hydroelectric development owned and operated by Newfoundland and Labrador Hydro (NL Hydro).

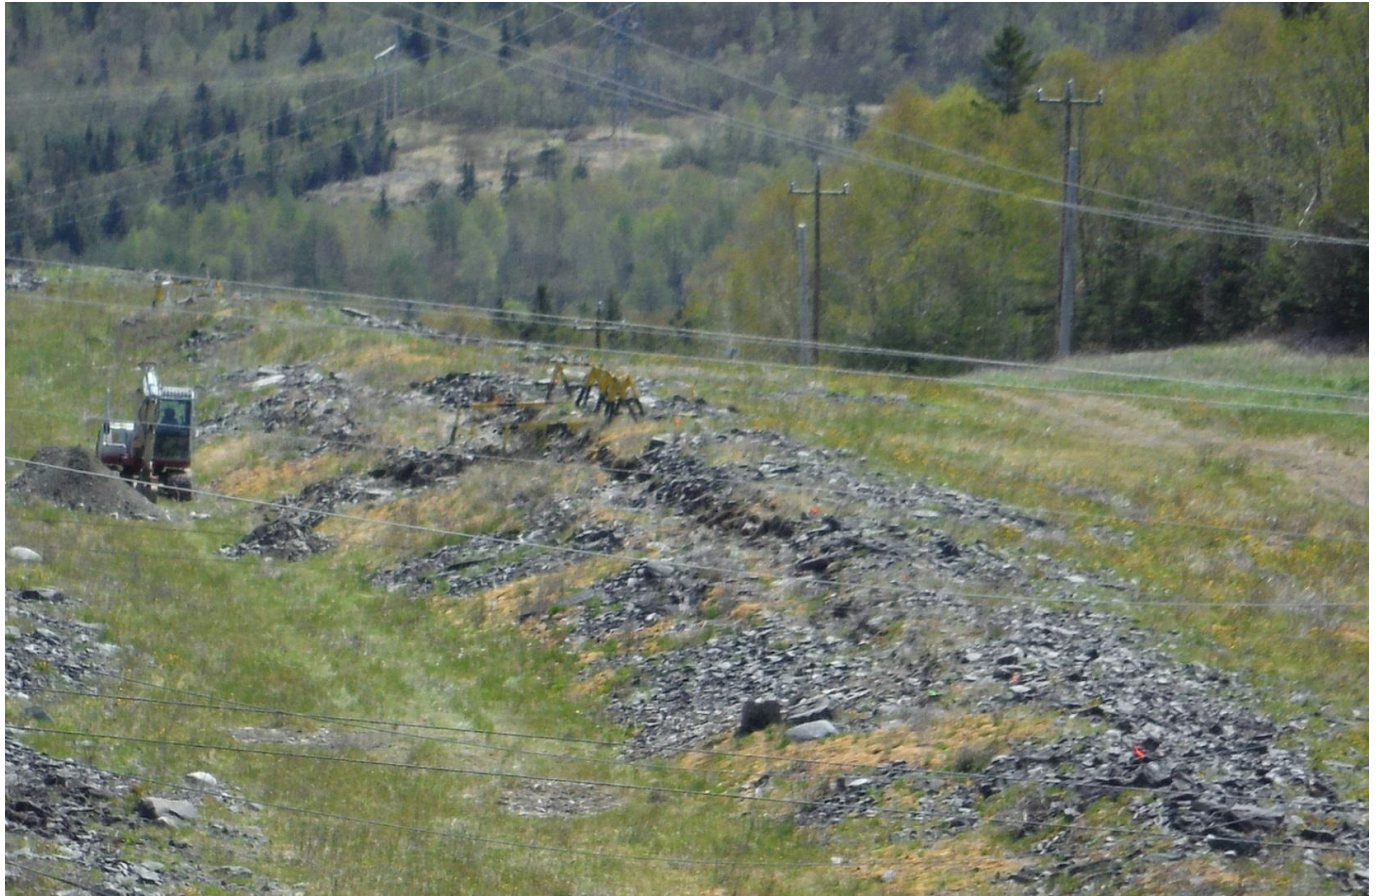
PHOTO 1 – LOOKING DOWNSTREAM FROM THE INTAKE AREA AT THE DAMAGED AREA OF PENSTOCK NO.1

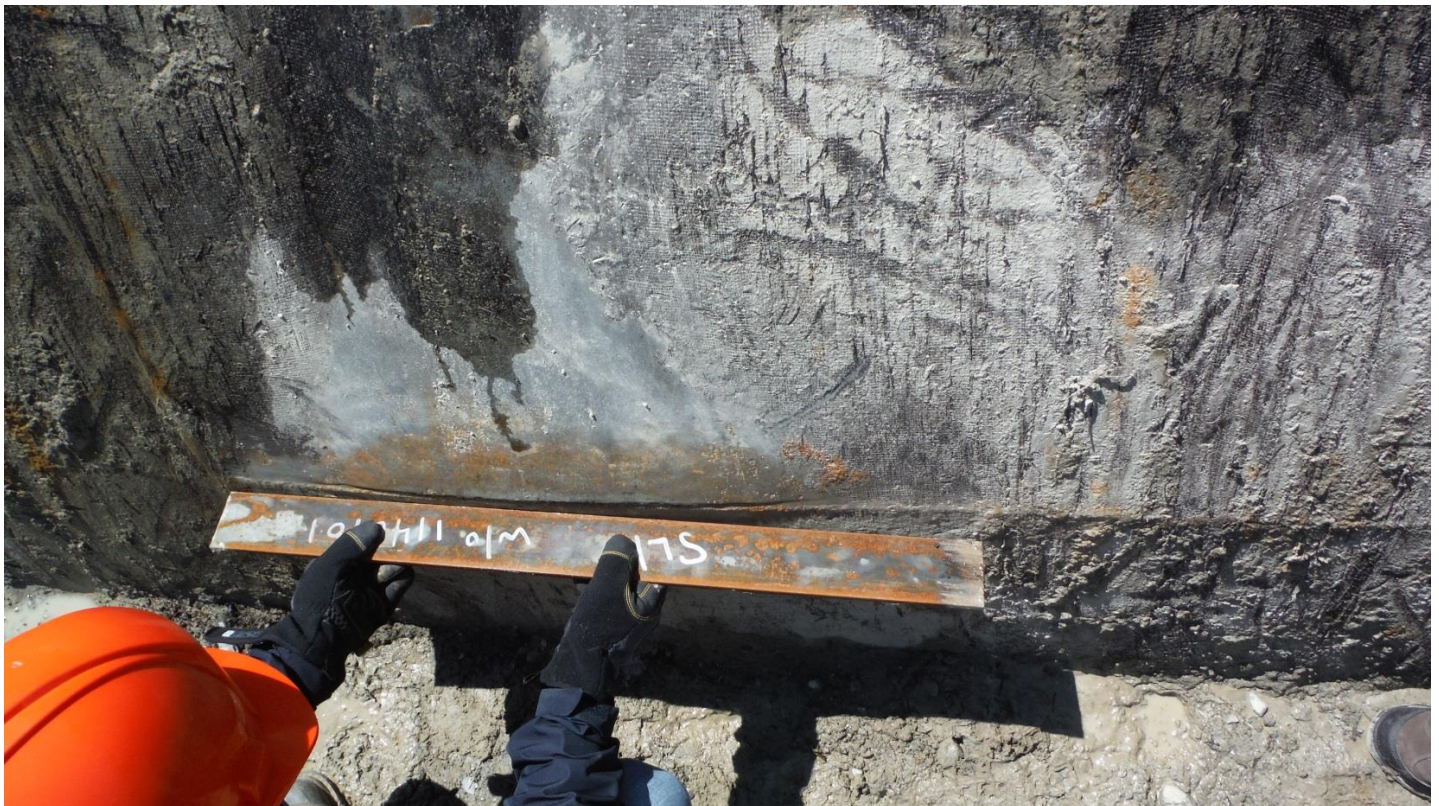
PHOTO 4 – USING STRAIGHT BAR TO HIGHLIGHT BULGE IN PENSTOCK PLATE

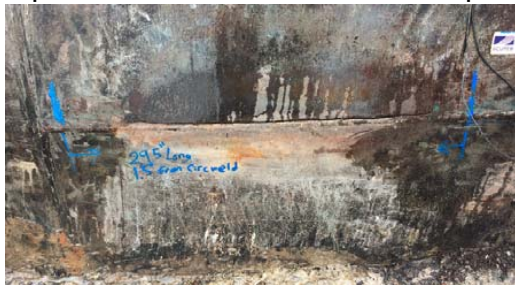
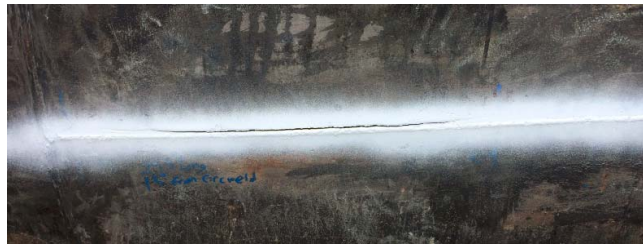
Shear wave ultrasound inspection was carried out on the areas either side of the crack found in penstock #1 to determine overall length. The crack was determined to have a length of 29.5" long and starts 1.5" from the closest downstream circ weld. The crack follows the toe of the weld and on either end turns up into the parent material of the penstock (as seen in picture) A Magnetic particle inspection was also carried out see attached MT report.

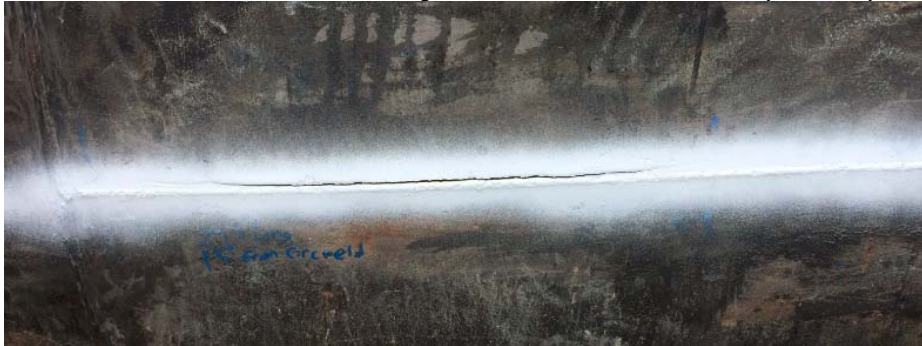
Magnetic particle inspection was carried out in the area on either side of the crack found in penstock #1 to ensure no surface cracks extended from either end. No difference in length was noted from the ultrasound inspection on previous report.

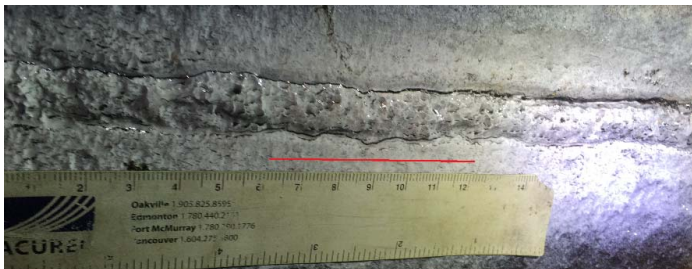
Magnetic particle inspection was carried out on the inside of the penstock after a scaffold was erected. The inspection was done on the bottom side of the weld that was inspected earlier today after one of the welders noticed a sharp edge on the toe of the weld opposite the crack. The sharp edge was caused by the parent material being eroded away leaving an edge of weld metal this continues on intermittently approx. 6" upstream from the crack on the other side of the weld from the crack.

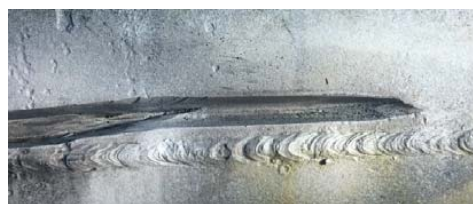
MT was performed on the excavated area on the crack in penstock #1. The ends of the crack were ground out until indication was fully removed.

Down Stream end of cracked area after MT Up Stream end of cracked area after MT

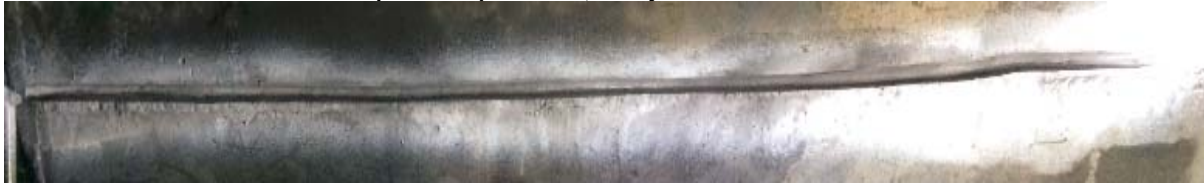
Root Area MT

After root was welded and cleaned up MT was performed, no rejectable indications were found.

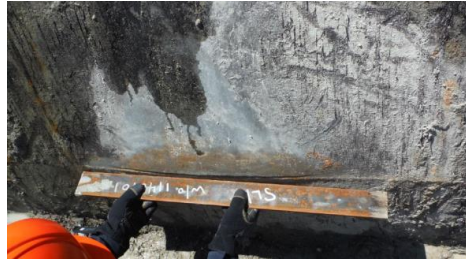
Difficulties with lining up the longitudinal seams at the time of construction in the 1960s are evident when examining the internals of the penstock and seeing evidence of extensive dogging¹ of the joints to bring the longitudinal seams together. The flat spots and induced stress from fitting the straight ends increase the residual stress at the joints. Below is an image of the longitudinal seam that failed in September. Large amounts of peaking were observed at the initial crack location, see Figure 3-2, and this would mean the weld was resisting significant residual stresses to maintain a round shape at the seam. The increased stress also makes the longitudinal joints more susceptible to material loss as they become sensitized to corrosion.

Figure 3-2: Longitudinal Weld Failure Showing Peaking

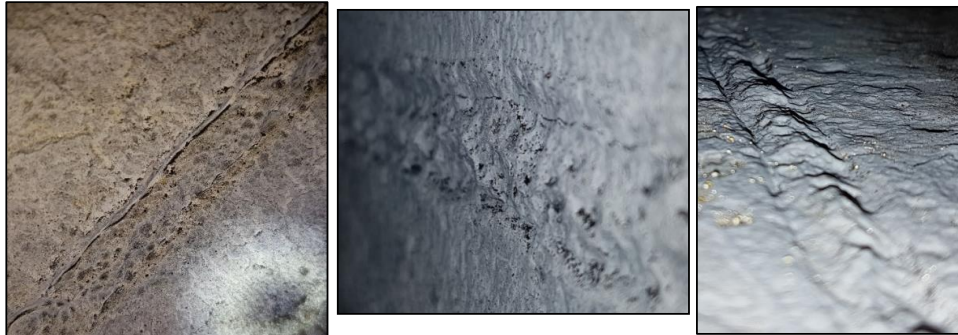
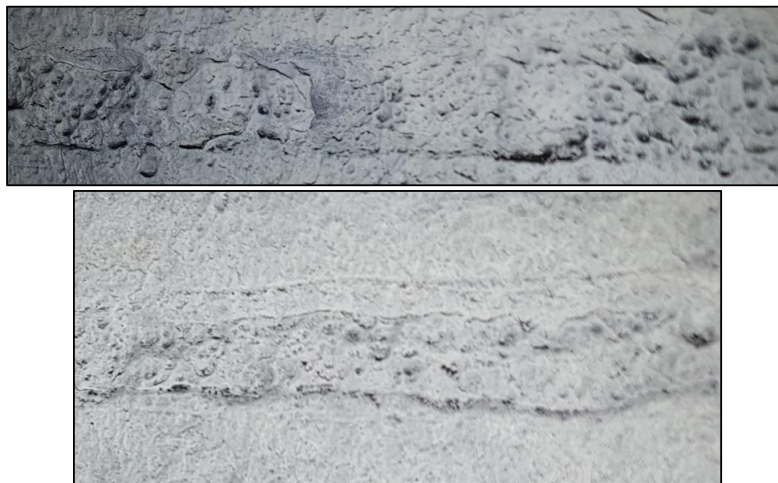
Throughout the upper section of the penstock it was noted that longitudinal seams were experiencing extensive pitting corrosion, material loss and well defined notches along the heat affected zone of the welds. This excess material loss and notching contributes to high stresses, crack initiation and propagation. Refer to Figure 3-3 and Figure 3-4 for images of the notching, excessive pitting corrosion, and material loss.

Figure 3-3: Longitudinal Seams in Penstock No.1 Section 16

Figure 3-4: Longitudinal Seams in Penstock No.1 Section 16

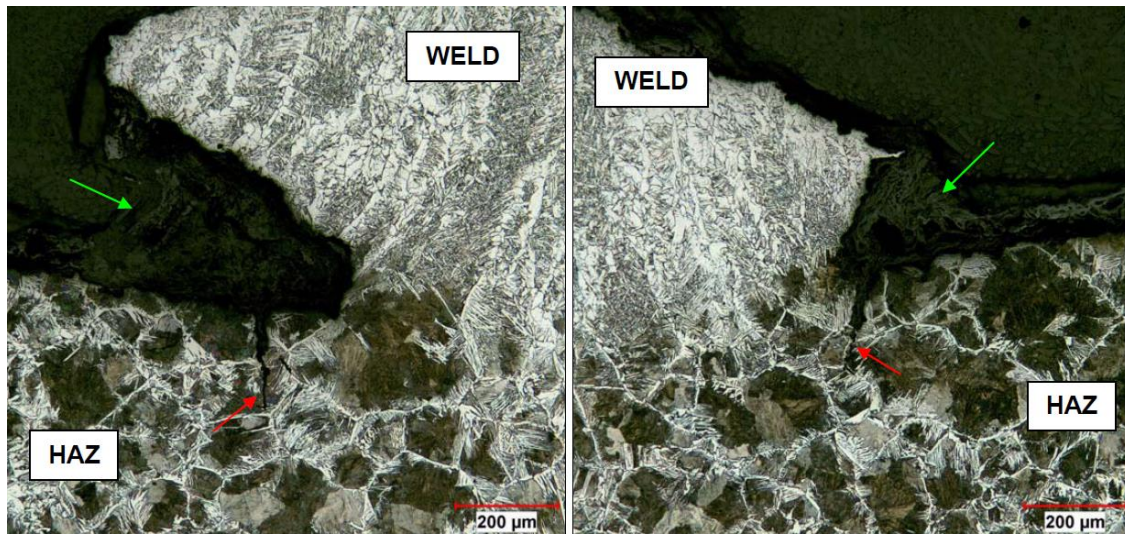
Figure 3-5: Coupon #1 Micro of Heat Affected Zone Transgranular Cracks

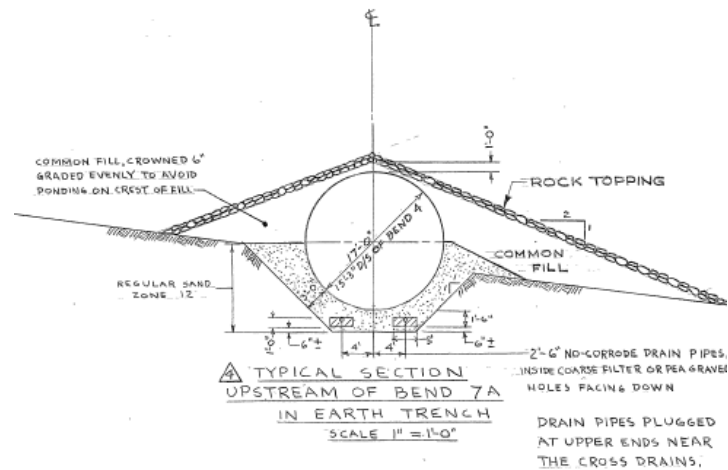
When reviewing the backfill requirements of Penstock No. 1 it was noted that there is a difference between the design specification and the “As Built” drawings. The specification states the penstocks were to be covered with soil to a minimum depth of 3 ft. The “As Built” drawing, Figure 3-8 is similar to the condition currently found in the field. The surrounding fill is part of the penstock construction, and serves to keep the penstock in shape when it is unwatered, to prevent collapse due to the pressure in the penstock falling below atmospheric, and by insulating to prevent excessive thermal stresses.

The "As Built" drawing shows a detail that has cover thicknesses in multiple locations below 1 ft.

Figure 3-8: Drawing Half Trench as per "As Built" Drawing

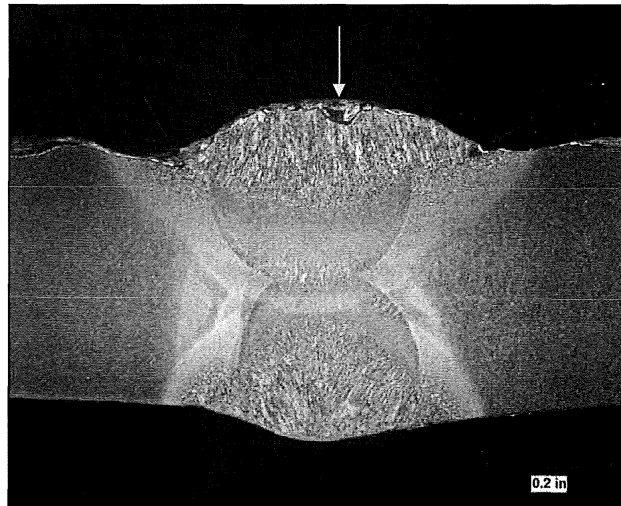
Figure 2: Photomacrograph of the Section 1, which had discontinuities at both toes (red arrows) and porosity (yellow arrow) on the face on one side of the weld.

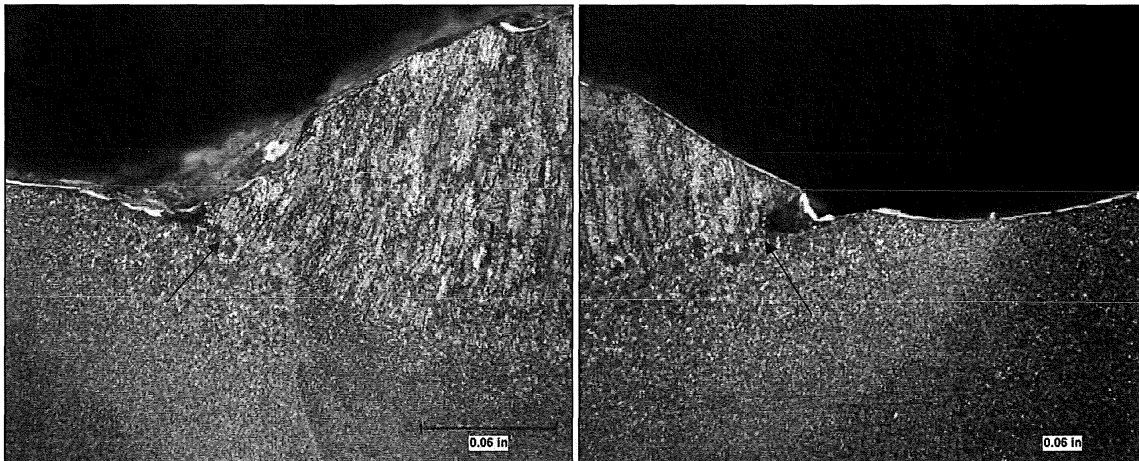
Figure 3: Photomicrographs of the Section 1. The discontinuities at the toes of the weld were revealed to be cracks propagating along the fusion line of the weld (red arrows).

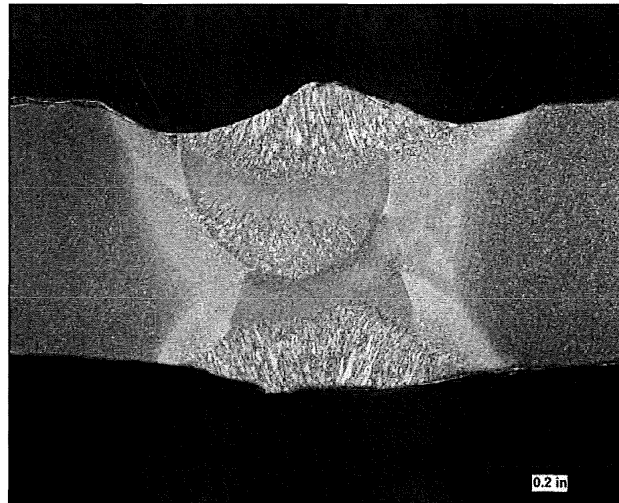
Figure 4: Photomacrograph of the Section 2, which had discontinuities at both toes (red arrows) on one side of the weld.

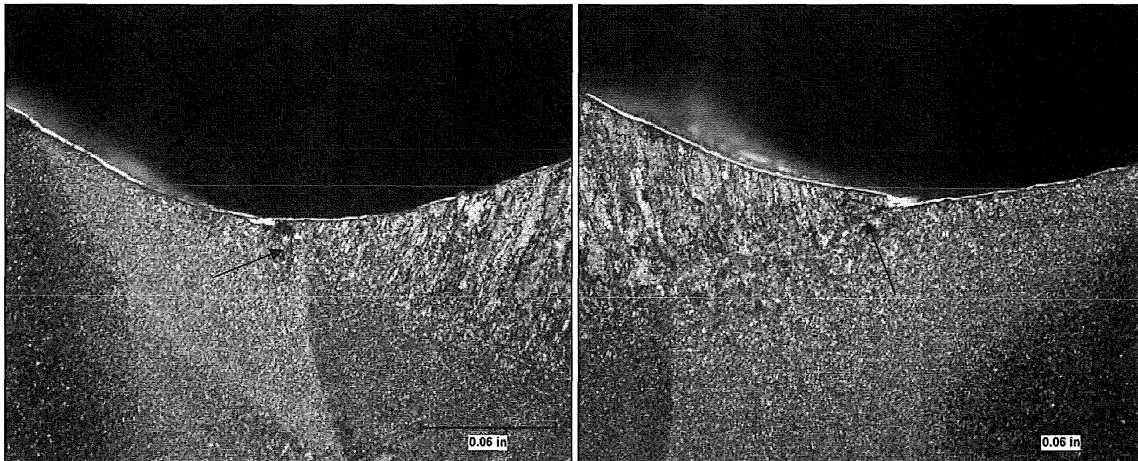
Figure 5: Photomacrographs of the Section 2. The discontinuities at the toes of the weld were revealed to be cracks propagating along the fusion line of the weld (red arrows).

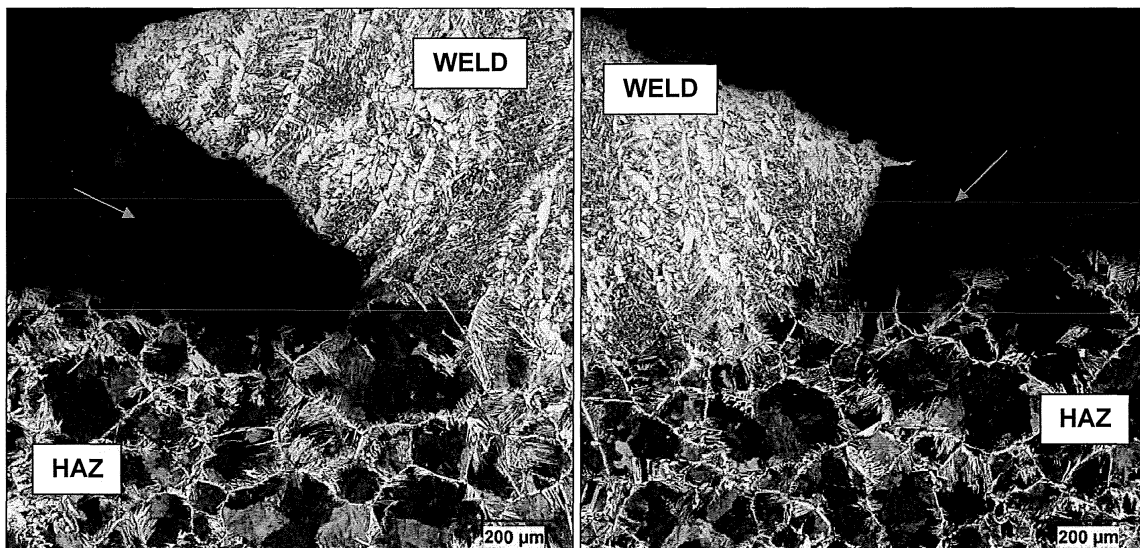
Figure 1: Photomicrographs of the Section 1 weld coupon at the "FL" locations. Transgranular cracks (red arrows) propagated through the HAZ of the weld from cavities located at the both toes on the face of the weld. Both cavities were filled with corrosion product (green arrows). The HAZ microstructure at the toe of the weld consisted of relatively coarse-grained pearlite with intergranular ferrite. The weld microstructure consisted of columnar ferrite and pearlite.

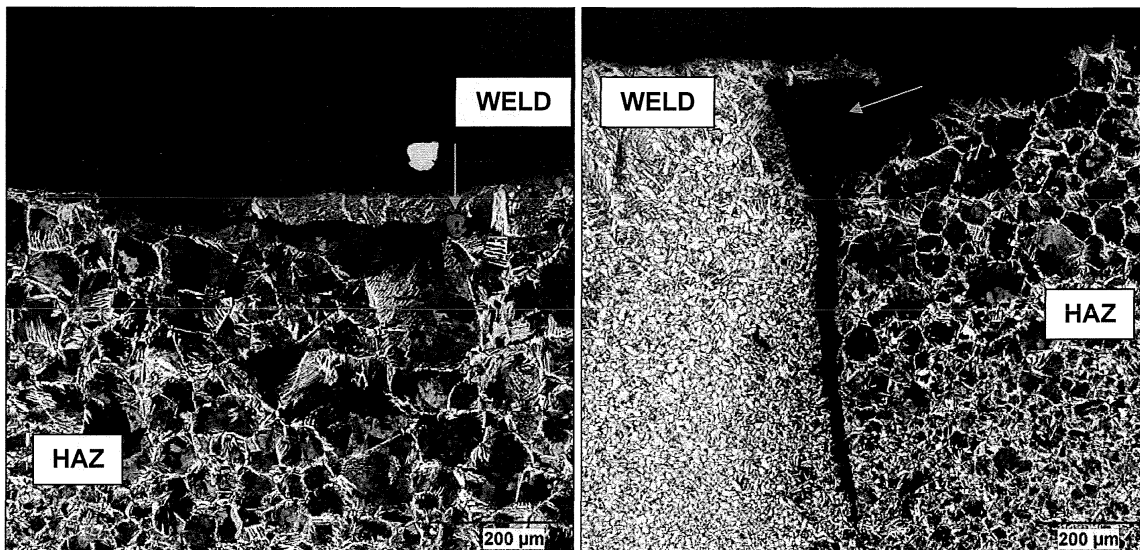
Figure 3: Photomicrographs of the Section 2 weld coupon at the "FL" locations. Transgranular cracks (red arrows) propagated through the HAZ of the weld from a cavity located at one toe on the face of the weld (right), and from an overlap at the other toe on the face of the weld (left). The cavity was filled with corrosion product (green arrow, right). An inclusion was observed within the overlap (green arrow, left). The HAZ microstructure at the toe of the weld consisted of relatively coarse-grained pearlite with intergranular ferrite. The weld microstructure consisted of columnar ferrite and pearlite.

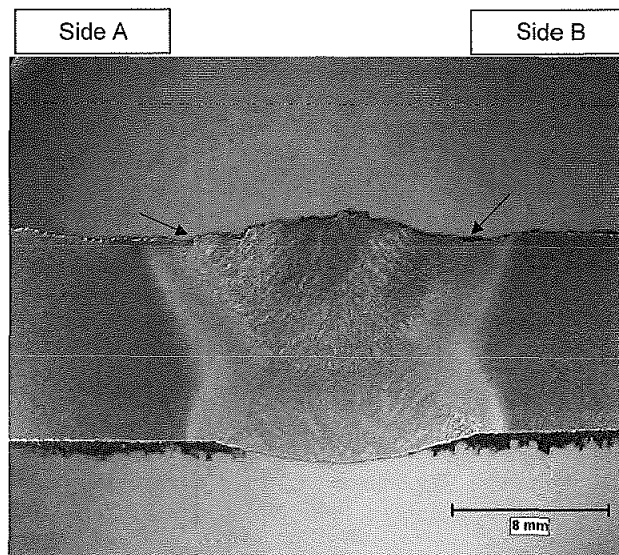
Figure 2: Photomicrograph of the Section 1, showing the pitting along the surface within the HAZ/at the weld toes along the inside diameter.

Section 1: Examination of the specimen showed that the weld had pitting along the surface within the HAZ (at the weld toes) (refer to Figure 2). The weld appeared to have no cracks or inclusions, and there was complete penetration and complete fusion observed throughout the weld.

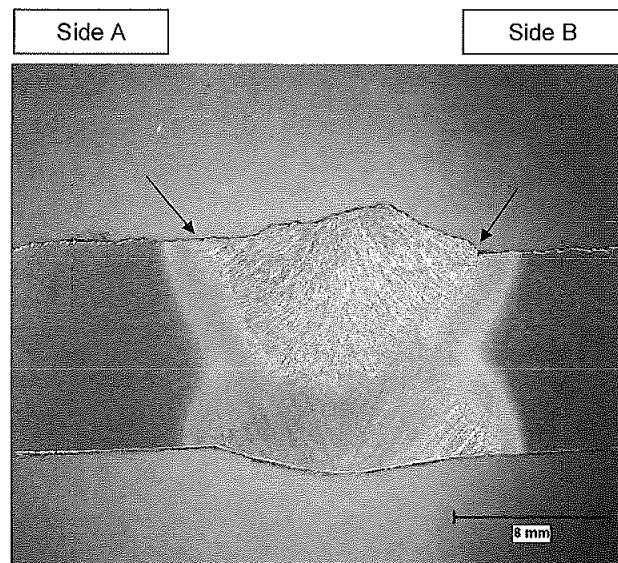
Figure 3: Photomacrograph of the Section 2, showing the pitting along the surface within the HAZ/at the weld toes along the inside diameter.

Section 2: Examination of the specimen showed that the weld had pitting along the surface within the HAZ (at the weld toes) (refer to Figure 3). The weld appeared to have no cracks or inclusions, and there was complete penetration and complete fusion observed throughout the weld.

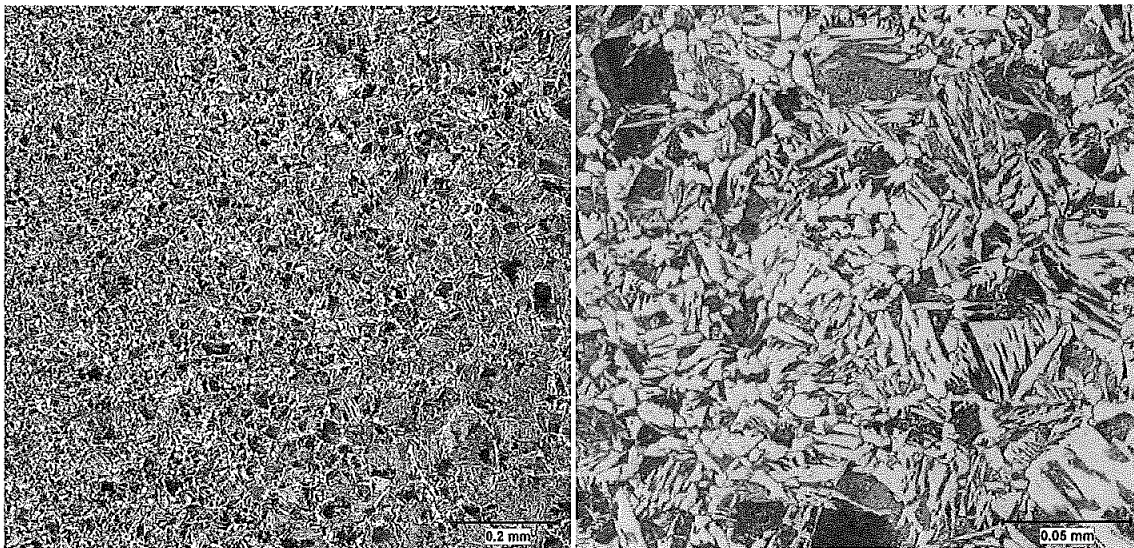
Figure 4: Photomicrographs of the Section 1 "Side A" weld coupon at the "FL" location, where a relatively coarse grain HAZ of ferrite and pearlite was observed.

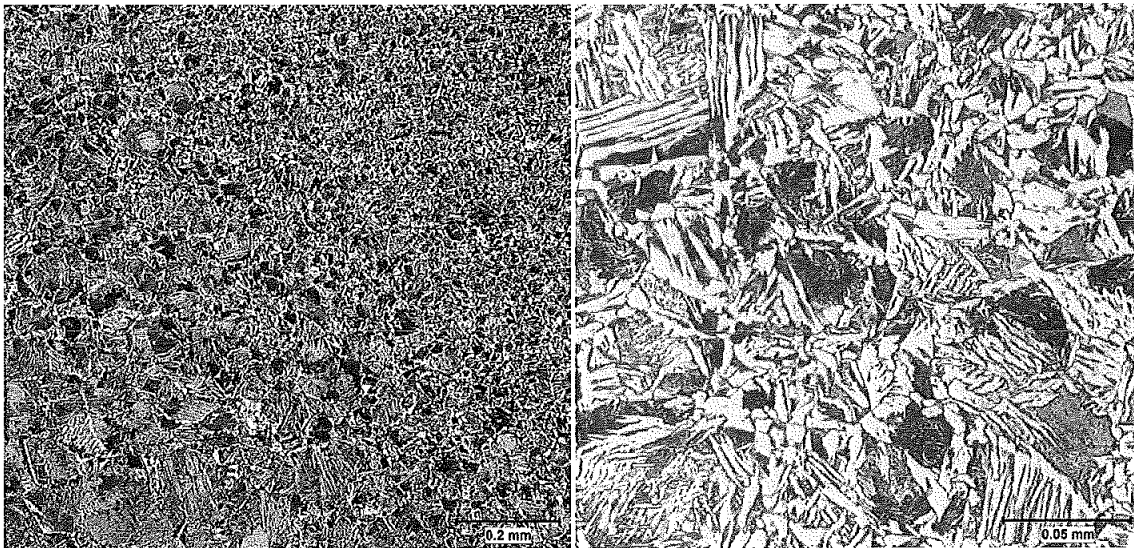
Figure 5: Photomicrographs of the Section 1 "Side B" weld coupon at the "FL" location, where a relatively coarse grain HAZ of ferrite and pearlite was observed.

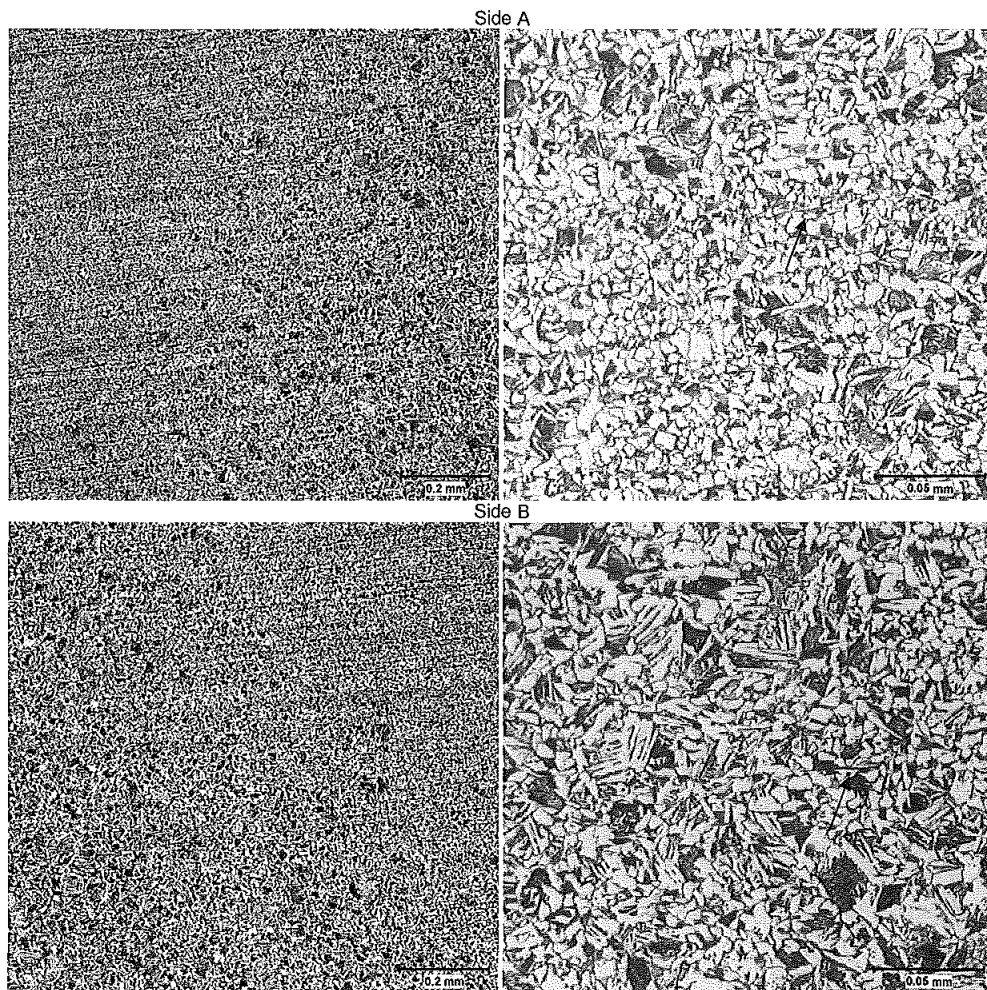
Figure 6: Photomicrographs of the Section 1 "Side A" and "Side B" weld coupon at the "FL +1" locations; where the HAZ microstructure showed a fairly uniform mixture of ferrite and pearlite, with a more refined grain size. At a higher magnification some sulphide inclusions were observed (refer to red arrows).

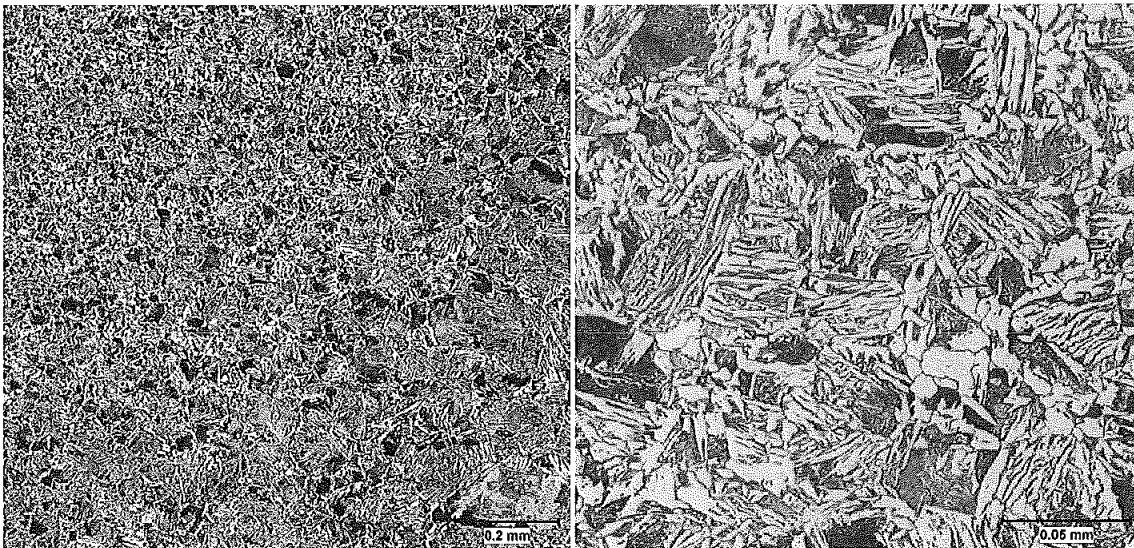
Figure 7: Photomicrographs of the Section 2 "Side A" weld coupon at the "FL" location, where a relatively coarse grain HAZ of ferrite and pearlite was observed.

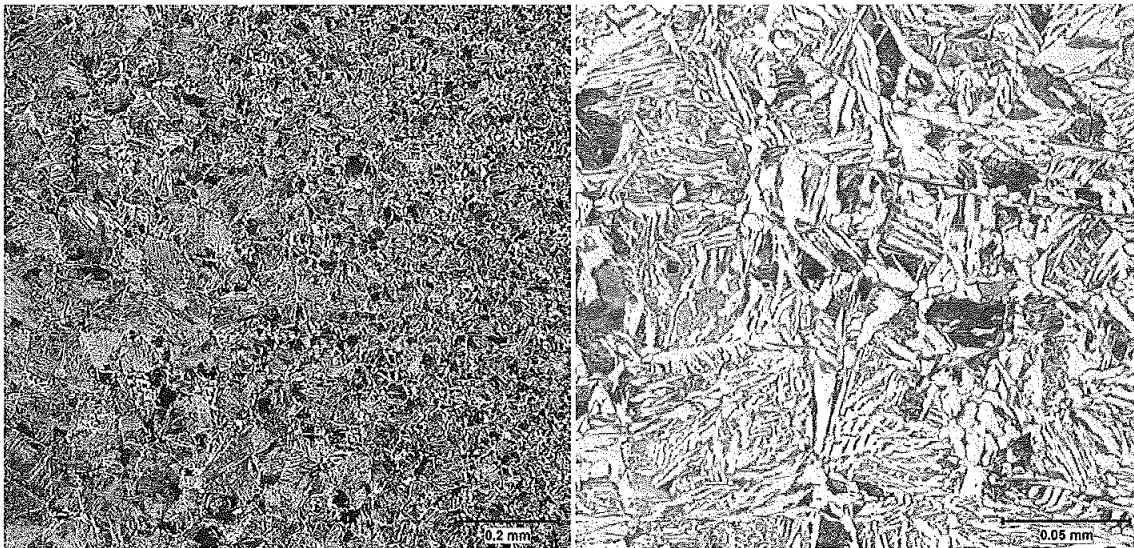
Figure 8: Photomicrographs of the Section 2 "Side B" weld coupon at the "FL" location, where a relatively coarse grain HAZ of ferrite and pearlite was observed.

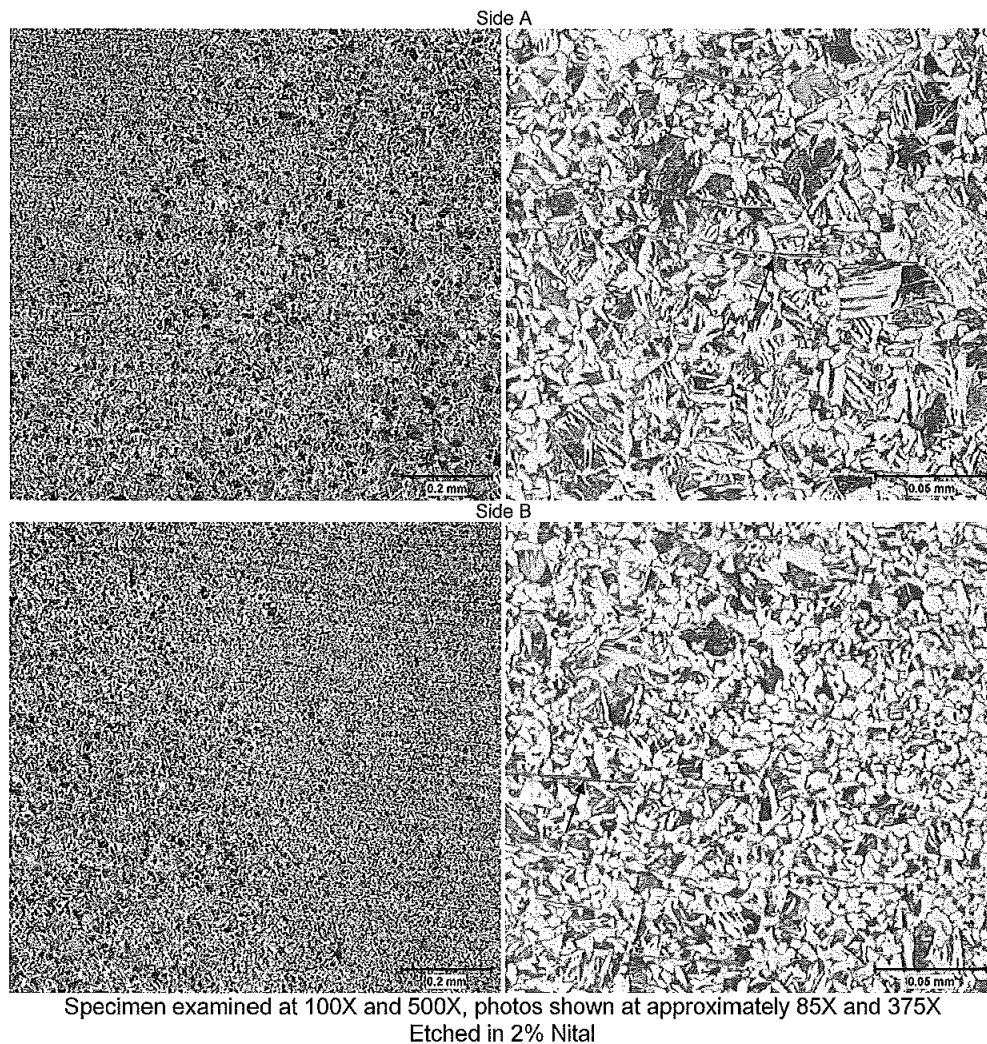
Figure 9: Photomicrographs of the Section 2 "Side A" and "Side B" weld coupon at the "FL +1" locations; where the HAZ microstructure showed a fairly uniform mixture of ferrite and pearlite, with a more refined grain size. At a higher magnification some sulphide inclusions were observed (refer to red arrows).

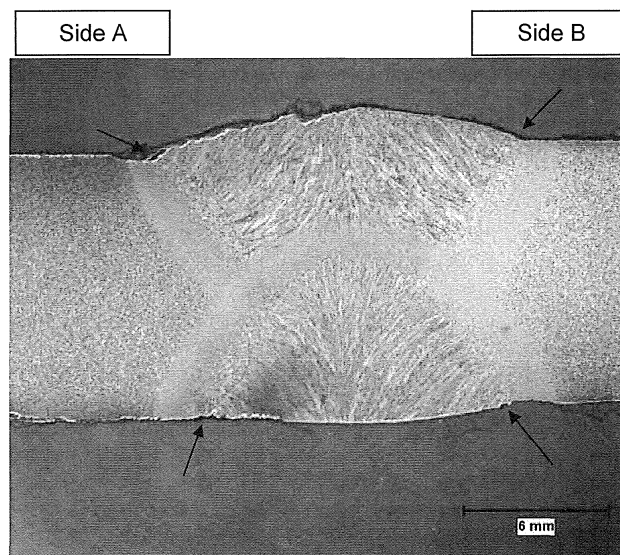
Figure 2: Photomacrograph of the Section 1, showing the pitting along the surface within the HAZ/at the weld toes.

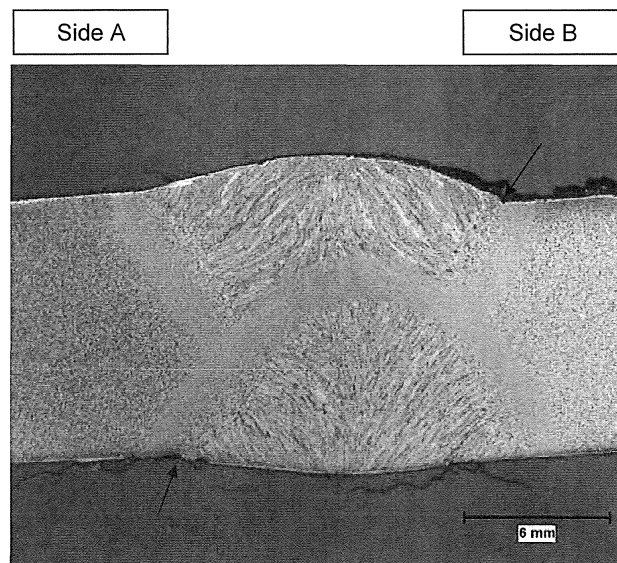
Figure 3: Photomicrograph of the Section 2, showing the pitting along the surface within the HAZ/at the weld toes.

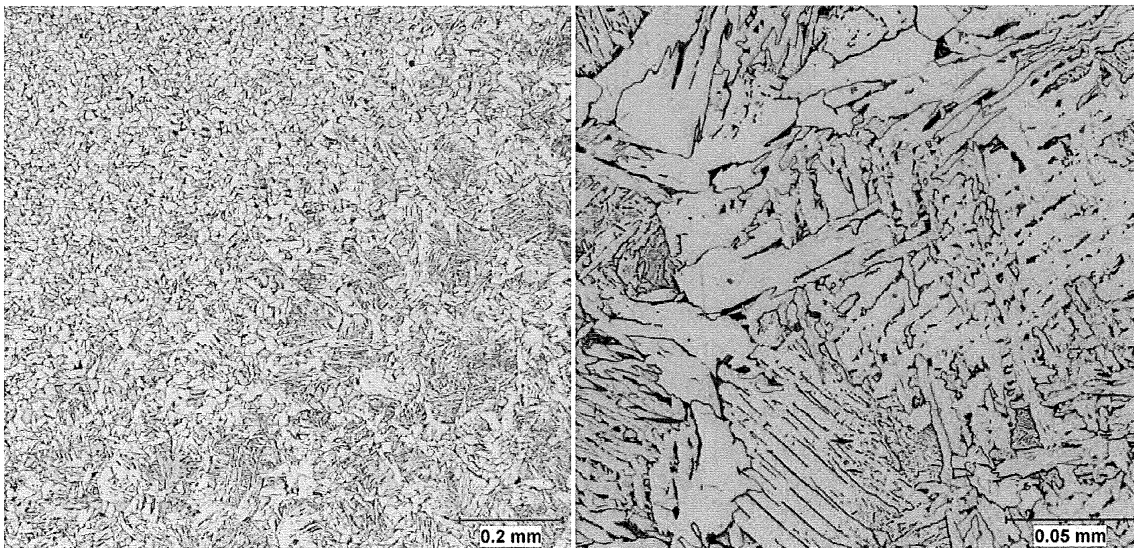
Figure 4: Photomicrographs of the Section 1 "Side A" weld coupon at the "FL" location, where a relatively coarse grain HAZ of ferrite and some pearlite was observed.

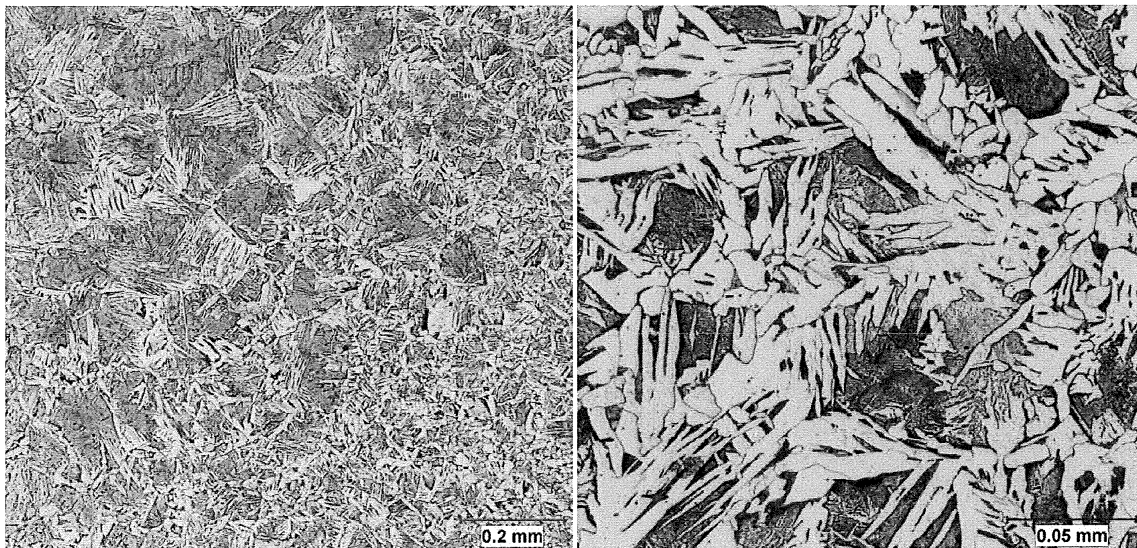
Figure 5: Photomicrographs of the Section 1 "Side B" weld coupon at the "FL" location, where a relatively coarse grain HAZ of ferrite and pearlite was observed.

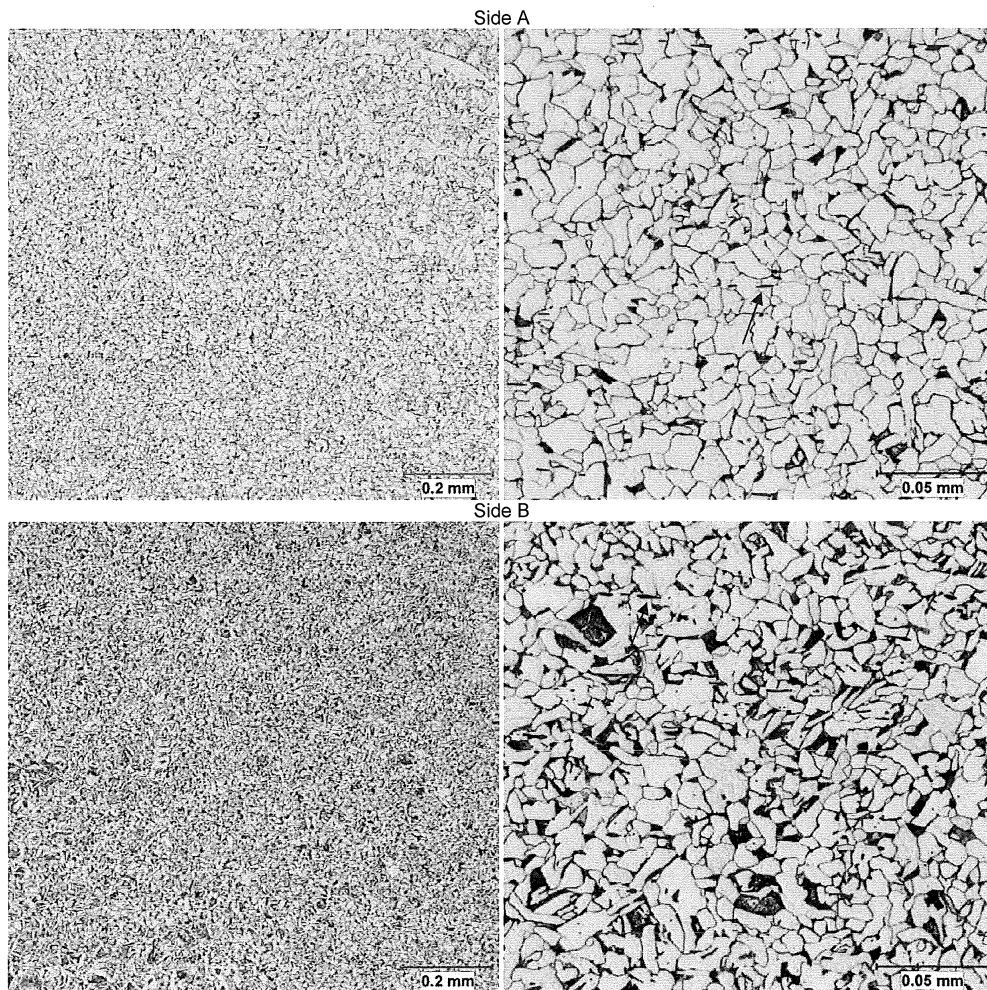
Figure 6: Photomicrographs of the Section 1 "Side A" and "Side B" weld coupon at the "FL +1" locations; where the HAZ microstructure showed a fairly uniform mixture of ferrite and pearlite, with a more refined grain size. At a higher magnification some sulphide inclusions were observed (refer to red arrows).

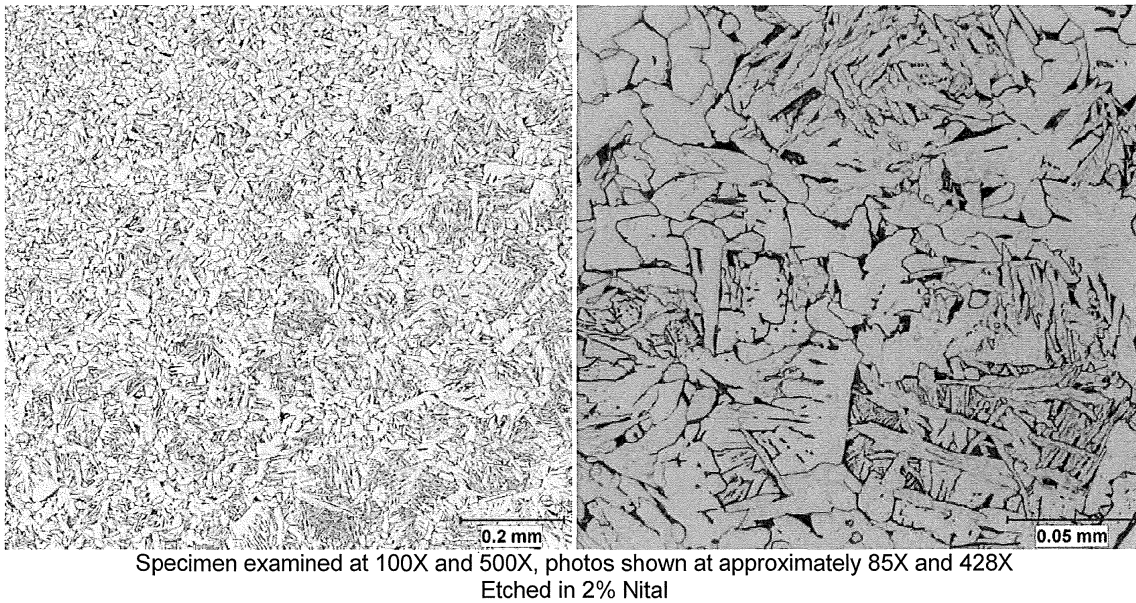
Figure 7: Photomicrographs of the Section 2 "Side A" weld coupon at the "FL" location, where a relatively coarse grain HAZ of ferrite and some pearlite was observed.

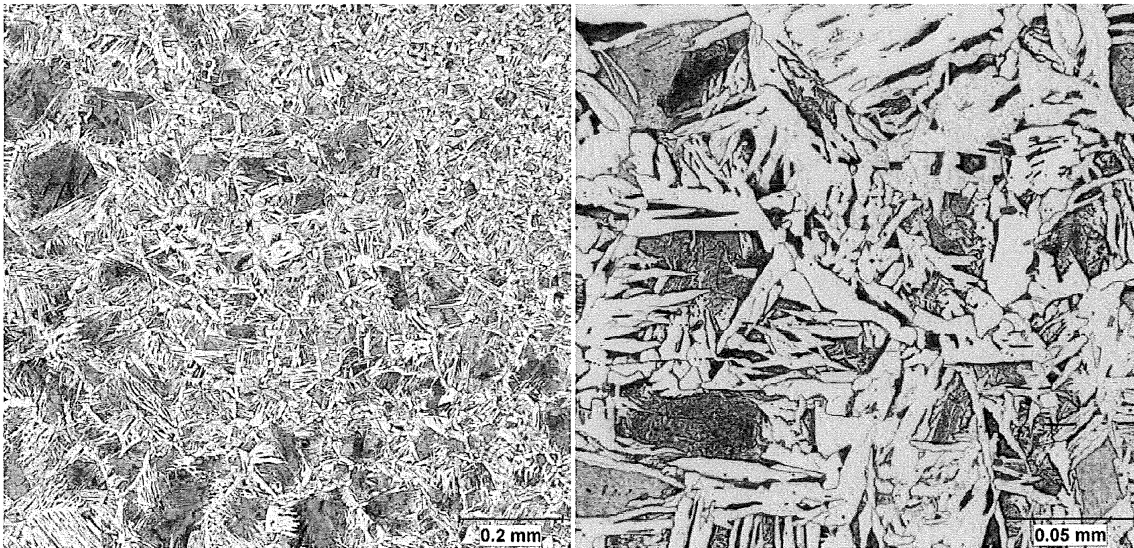
Figure 8: Photomicrographs of the Section 2 "Side B" weld coupon at the "FL" location, where a relatively coarse grain HAZ of ferrite and pearlite was observed.

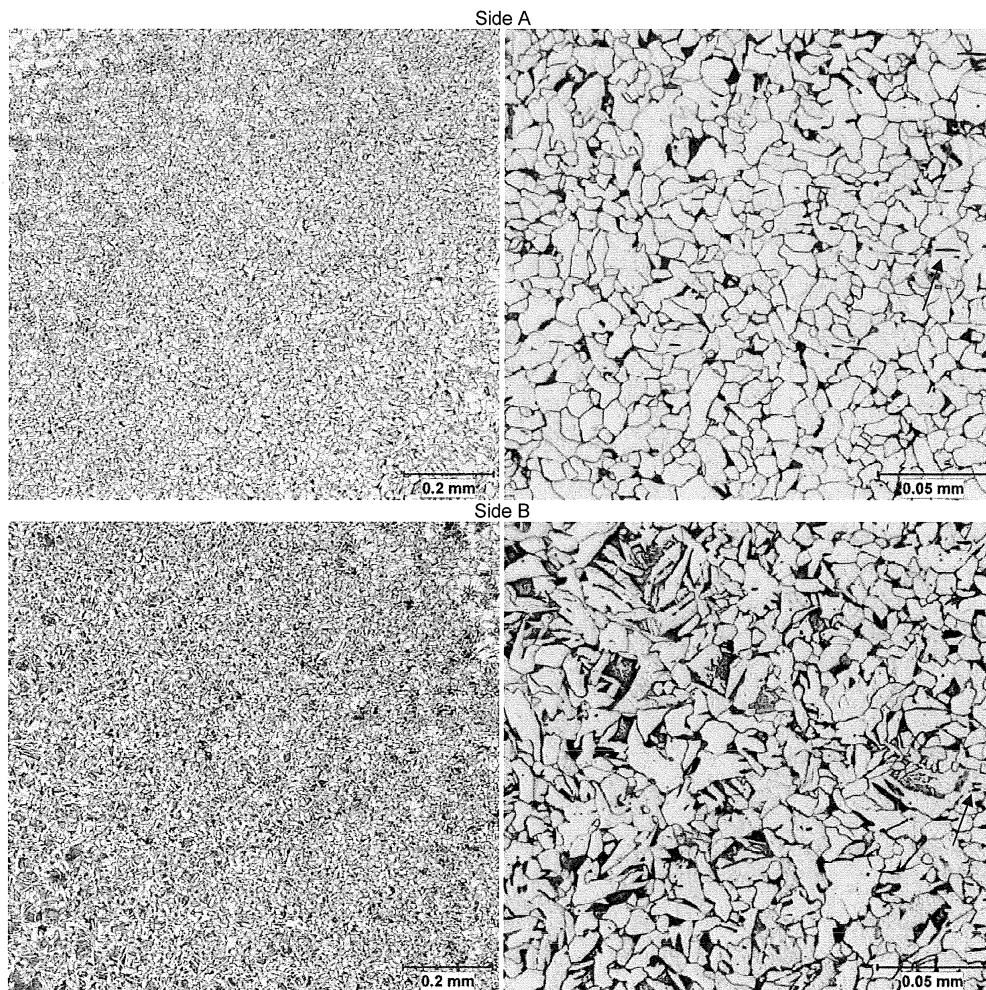
Figure 9: Photomicrographs of the Section 2 "Side A" and "Side B" weld coupon at the "FL +1" locations; where the HAZ microstructure showed a fairly uniform mixture of ferrite and pearlite, with a more refined grain size. At a higher magnification some sulphide inclusions were observed (refer to red arrows).

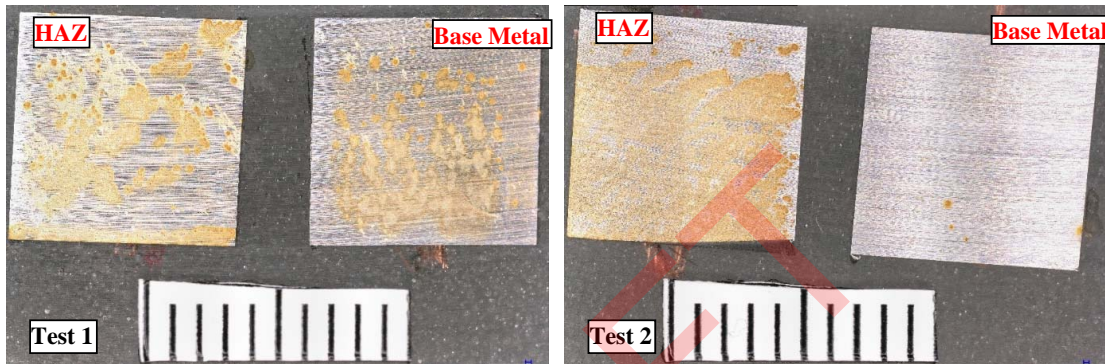
shown in Figure 4, HAZ was protected in both tests against the WELD. Based on the observations, it can be suggested that the weld has the least corrosion resistance in the galvanic setup and BM shows the best corrosion resistance.

Figure 2. Low magnification morphology of HAZ/BM couple Sample 1.

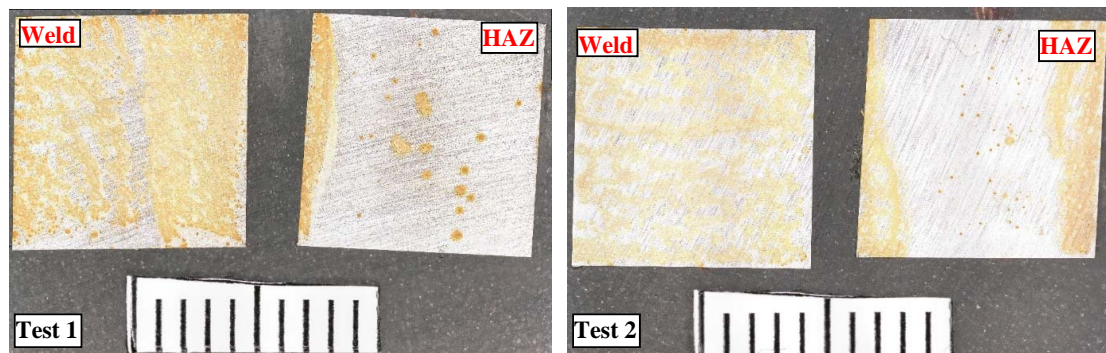
Figure 4. Low magnification morphology of WELD/HAZ couple Sample 1.

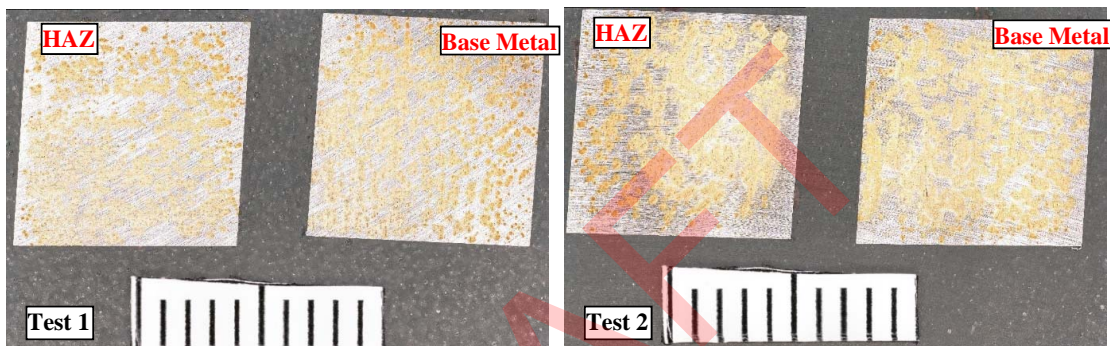
Figure 5 suggests that both HAZ and BM were corroded in both tests. For WELD/BM couple, both parts were corroded in both tests as shown in Figure 6. Figure 7 depicts that both WELD and HAZ regions were corroded in both tests. In total, it appears that none of the three regions is protected against one another, and pitting corrosion is a major feature on the surfaces of all samples.

Figure 5. Low magnification morphology of HAZ-Metal couple Sample 2.
