1 Q. Please provide a copy of equipment-related root cause or causal analyses reports
2 conducted over 2016-2018.

CRACK INVESTIGATION AND REPAIR REPORT

This report is intended to summarize the site inspection and repair recommendations of a crack that developed in Penstock No.1 at the Bat d'Espoir hydroelectric development owned and operated by Newfoundland and Labrador Hydro (NL Hydro).

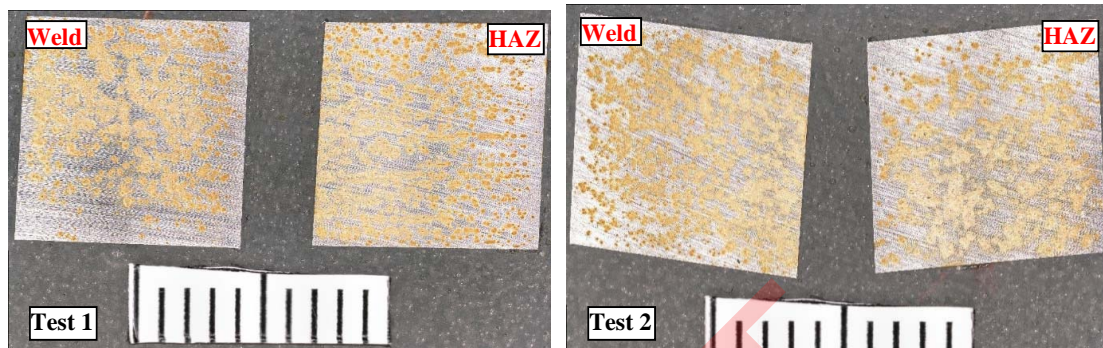
Figure 5 suggests that both HAZ and BM were corroded in both tests. For WELD/BM couple, both parts were corroded in both tests as shown in Figure 6. Figure 7 depicts that both WELD and HAZ regions were corroded in both tests. In total, it appears that none of the three regions is protected against one another, and pitting corrosion is a major feature on the surfaces of all samples.

Figure 7. Low magnification morphology of Weld-HAZ couple Sample 2.

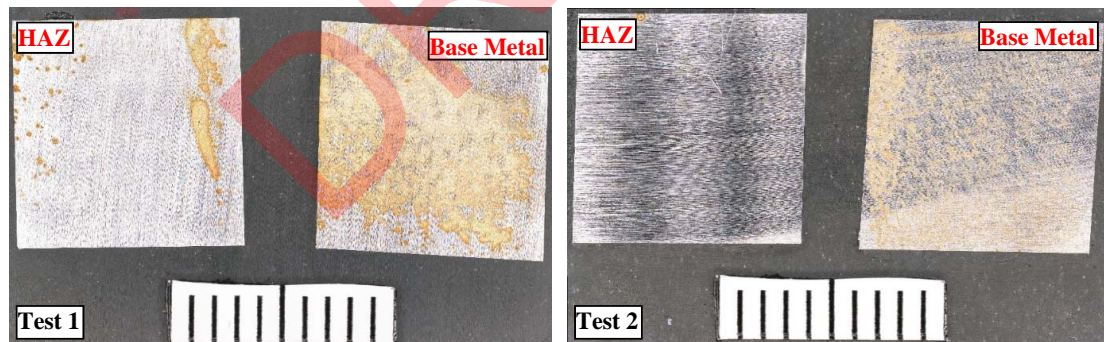
From Figure 8, it appears that HAZ was protected against BM in HAZ/BM galvanic couple. As for WELD/BM couple (Figure 9), both parts were corroded in test 1. In the second test, WELD is corroded, while BM is slightly corroded. As shown in Figure 10, in WELD/HAZ couple, the first test shows HAZ is corroded and WELD is protected, while in the second test, Weld is also corroded similar to HAZ.

Figure 8. Low magnification morphology of HAZ-Metal couple Sample 3.

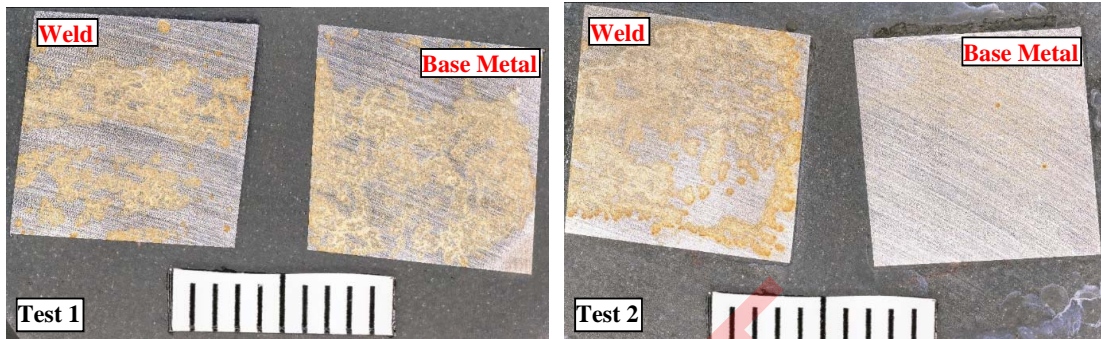
Figure 9. Low magnification morphology of Weld-Metal couple Sample 3.

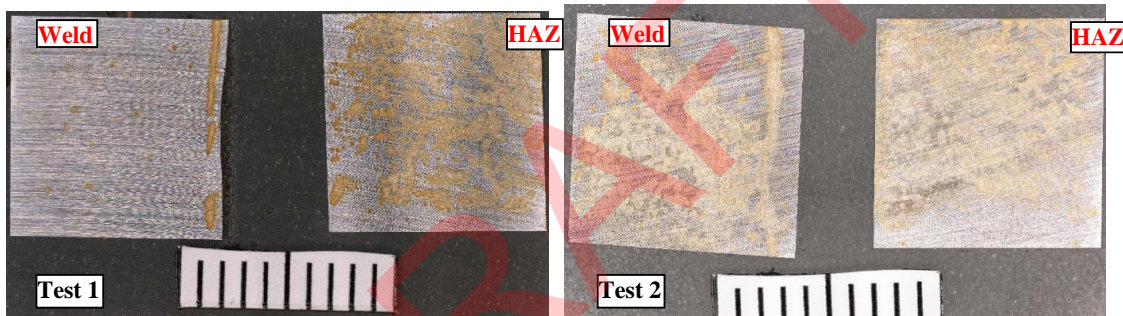
In General, it seems that apart from general corrosion of different parts of the weld joint, there is a possibility that HAZ could suffer from galvanic corrosion against WELD.

Figure 10. Low magnification morphology of Weld-HAZ couple Sample 3.

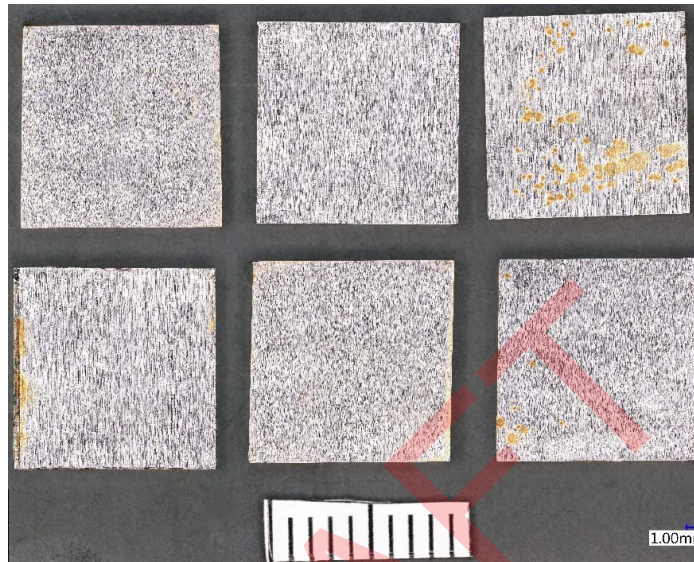
As it can be observed in Figure 11, samples show no significant corrosion after on hour of exposure to similar solution used for galvanic test. This indicates the severity of galvanic corrosion for this design.

Figure 11. Low magnification morphology of all reference samples after normal corrosion.

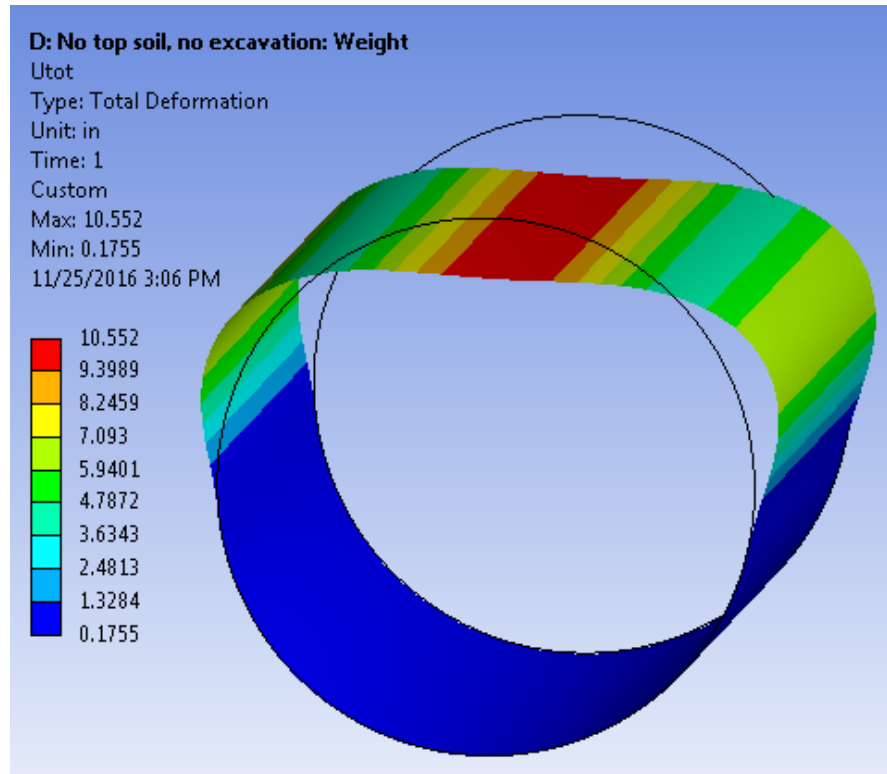
Figure 13: Deformation due LS1 without Internal Pressure.

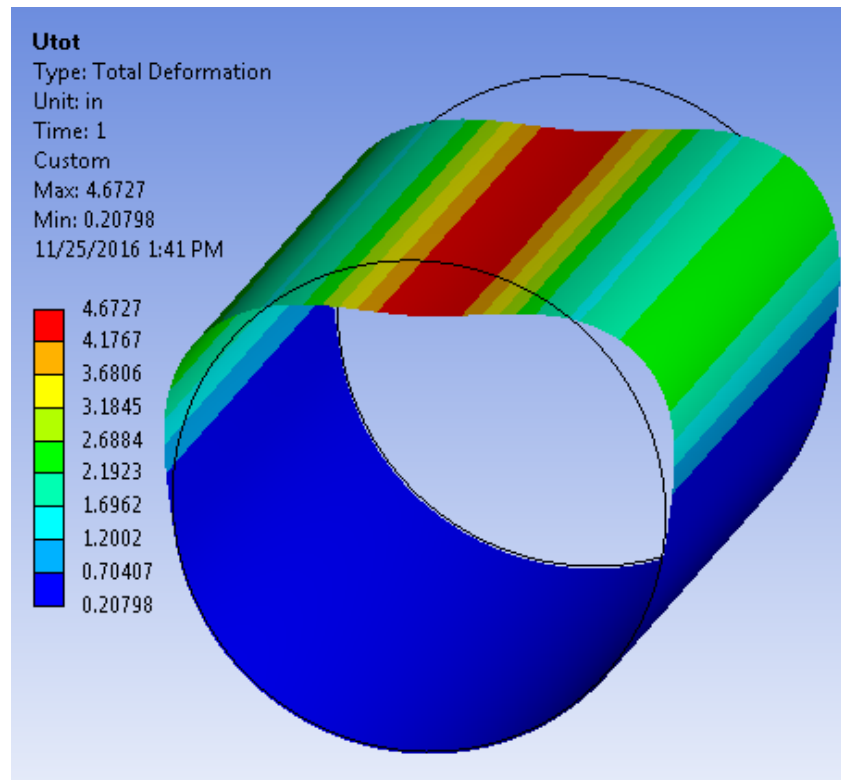
Figure 14: Deformation due LS2 without Internal Pressure.

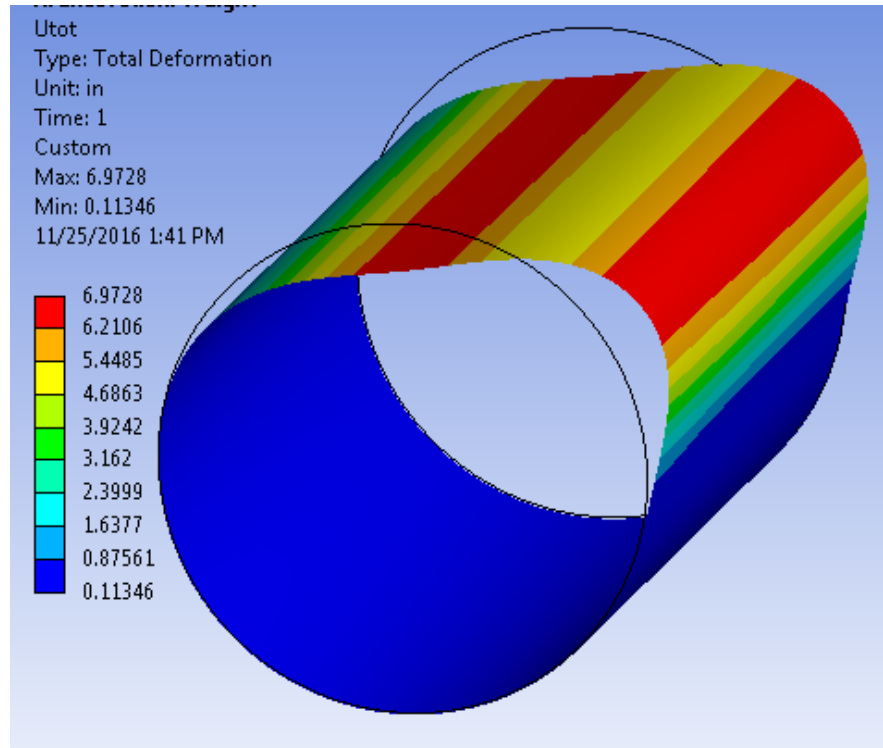
Figure 15: Deformation due LS3 without Internal Pressure.

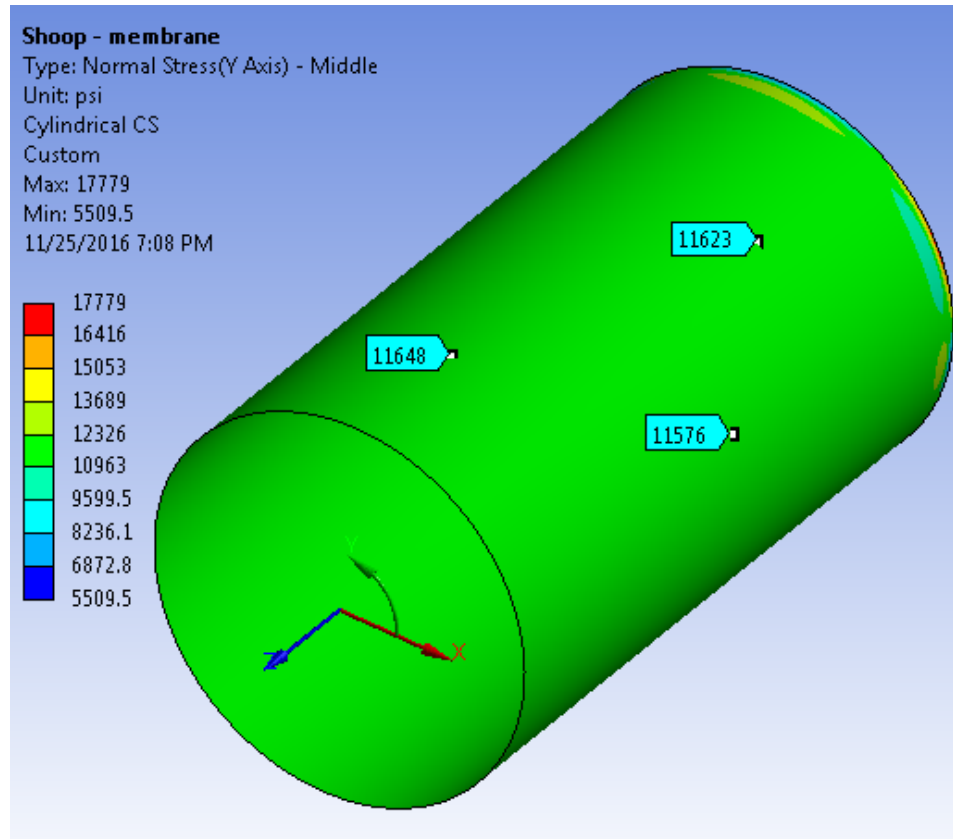
Figure 16: LS1 - Membrane hoop stress. Allowable for continuous plate $S_{pA285} = 20000 \cdot \text{psi}$. Ignore minor spikes at the boundary. No overstress.

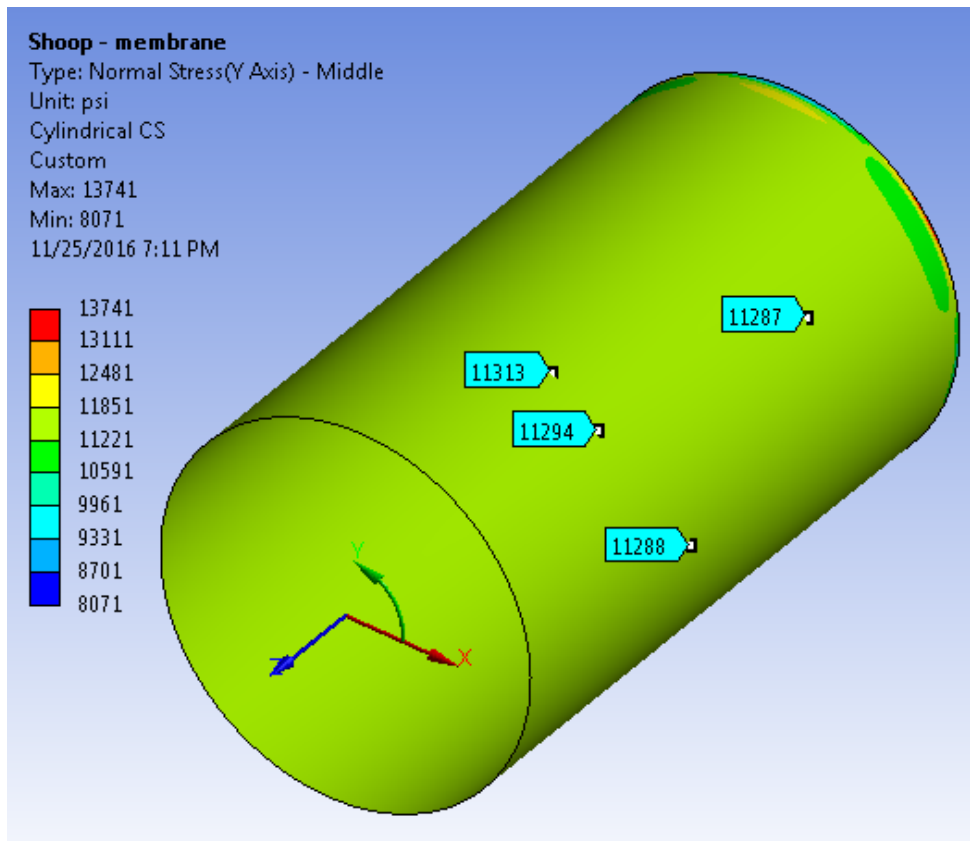
Figure 18: LS2 - Membrane hoop stress. Allowable for continuous plate $S_{pA285} = 20000 \cdot \text{psi}$. Ignore minor spikes at the boundary. No overstress.

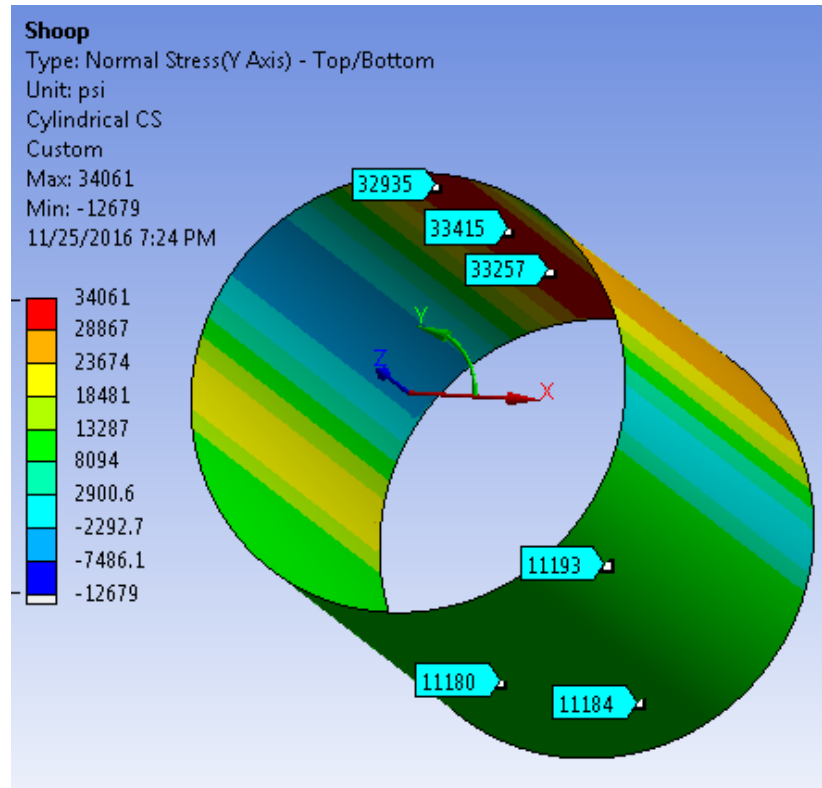
Figure 19: LS2 - Total hoop stress. Allowable for continuous plate $S_{A285} = 30000 \cdot \text{psi}$. 12 % overstress.

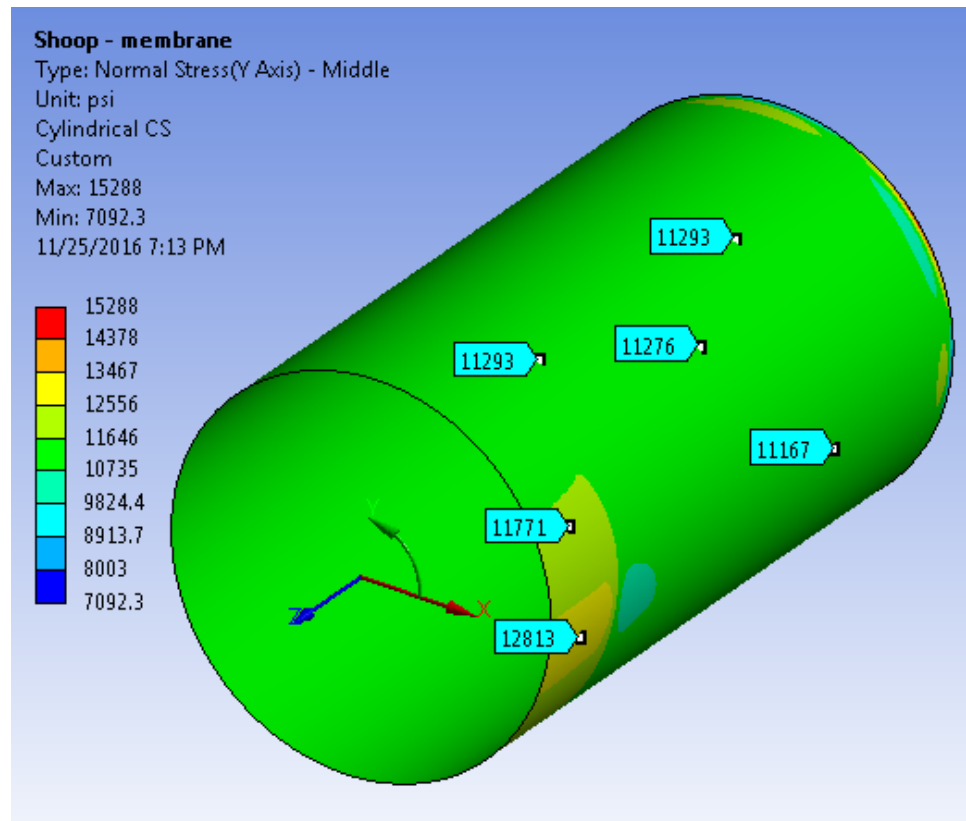
Figure 20: LS3 - Membrane hoop stress. Allowable for continuous plate $S_{pA285} = 20000$ ·psi. Ignore minor spikes at the boundary. No overstress.

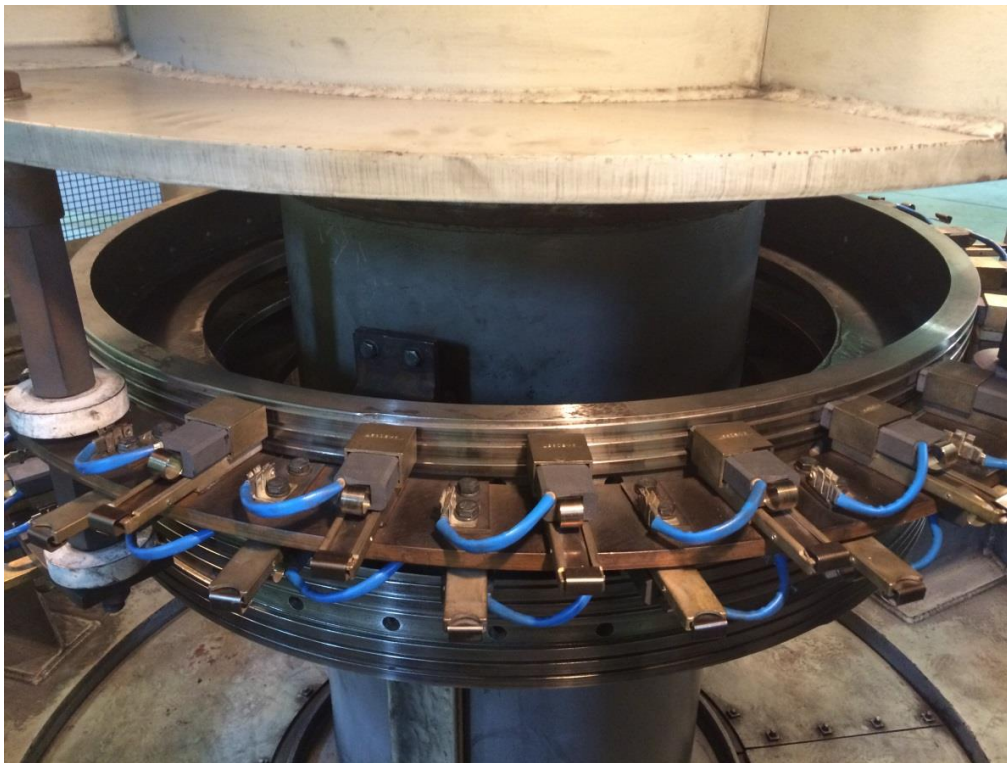
Picture 1: Cleaned slip ring with new brushes and brush holders

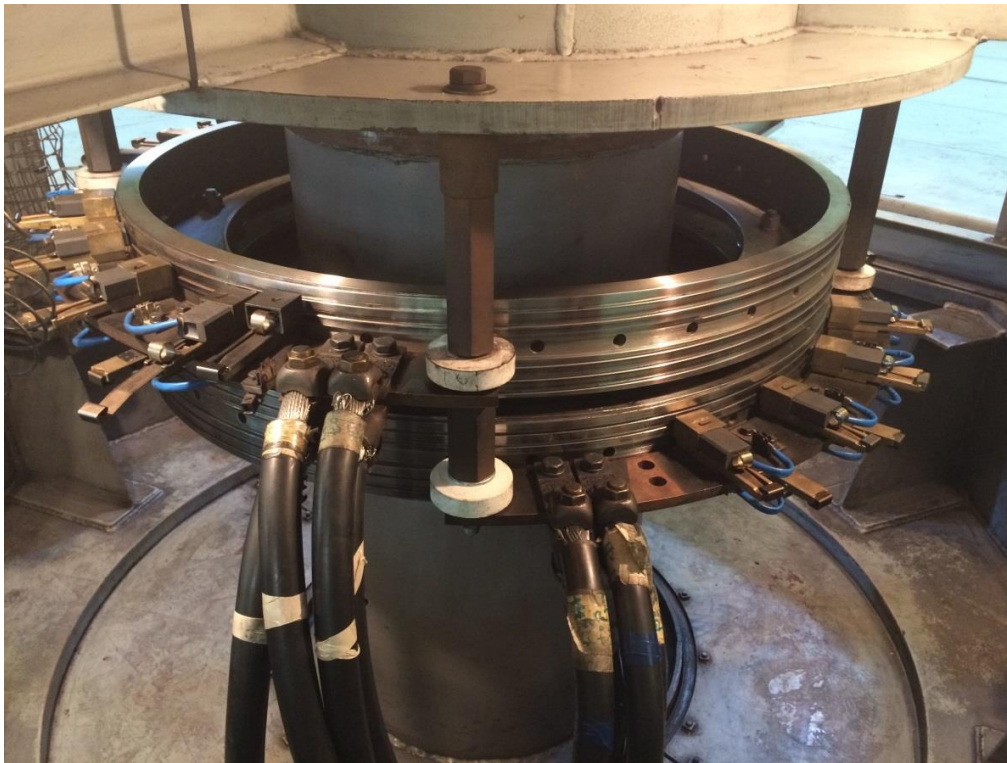
Picture 2: Different angle of complete slip ring brush installation

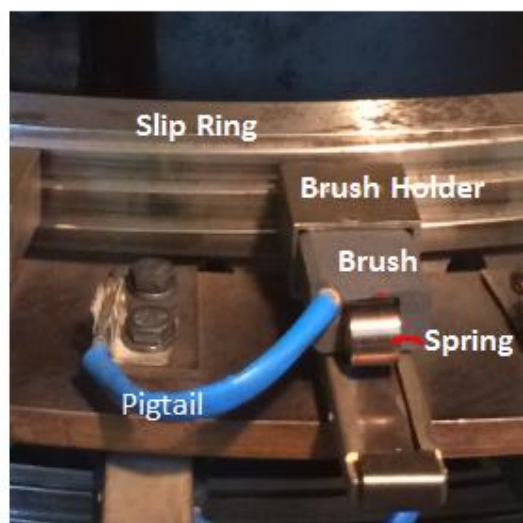
Picture 3 – Slip ring and brush gear assembly

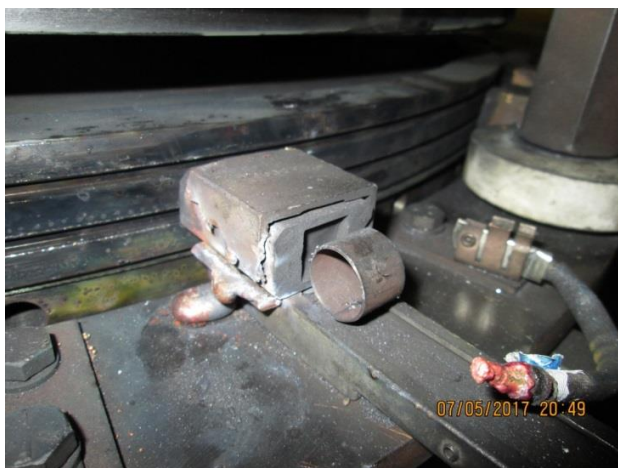
Picture 4 – Typical damage to brush

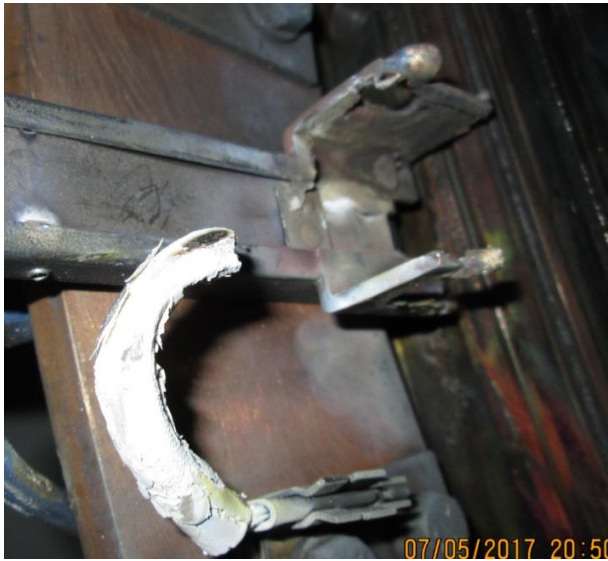
Missing Brush and melted brush holder with lead burnt off

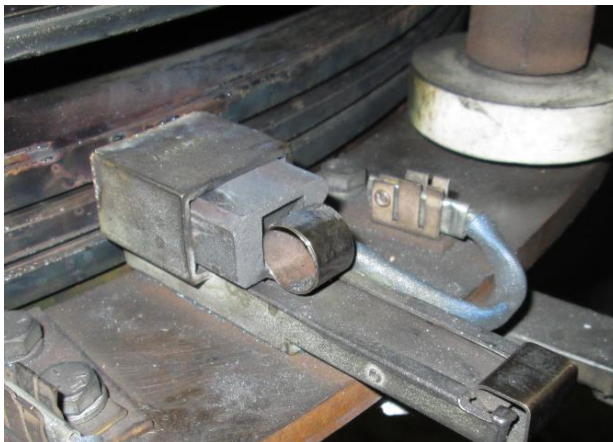
Acceptable brush with remaining wear

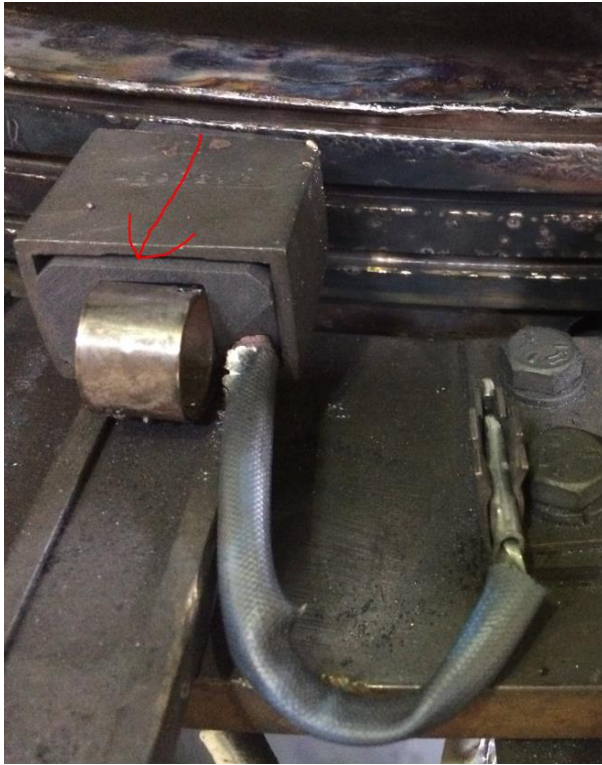
Not acceptable brush, less than acceptable wear remaining

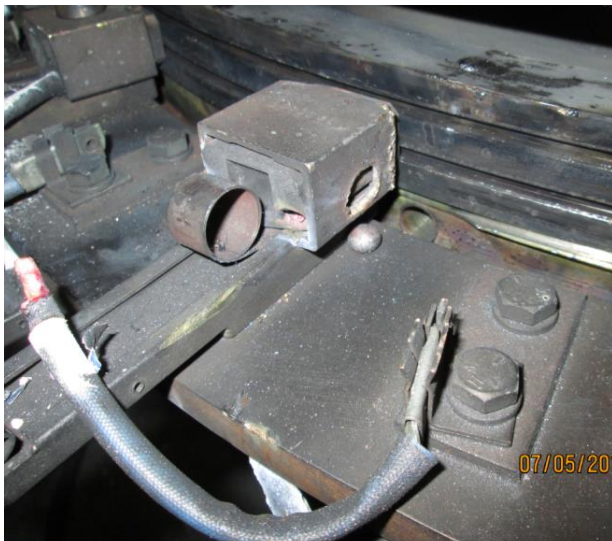
Lead burnt off and brush wear at zero remaining life

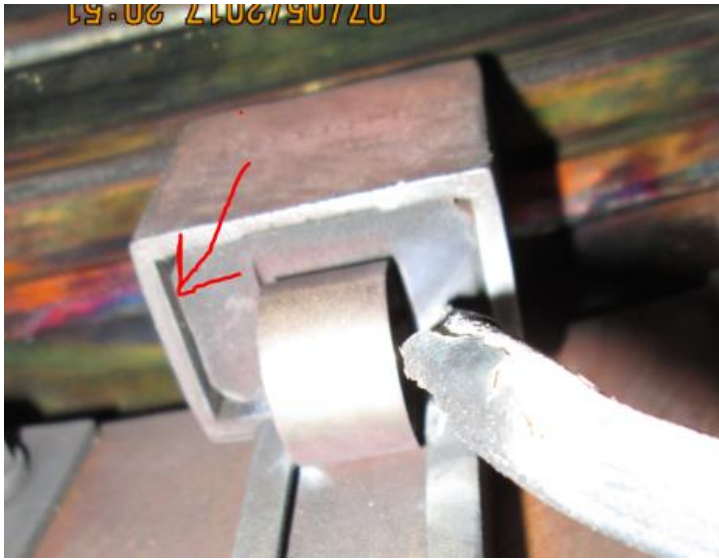
Brush with zero wear remaining

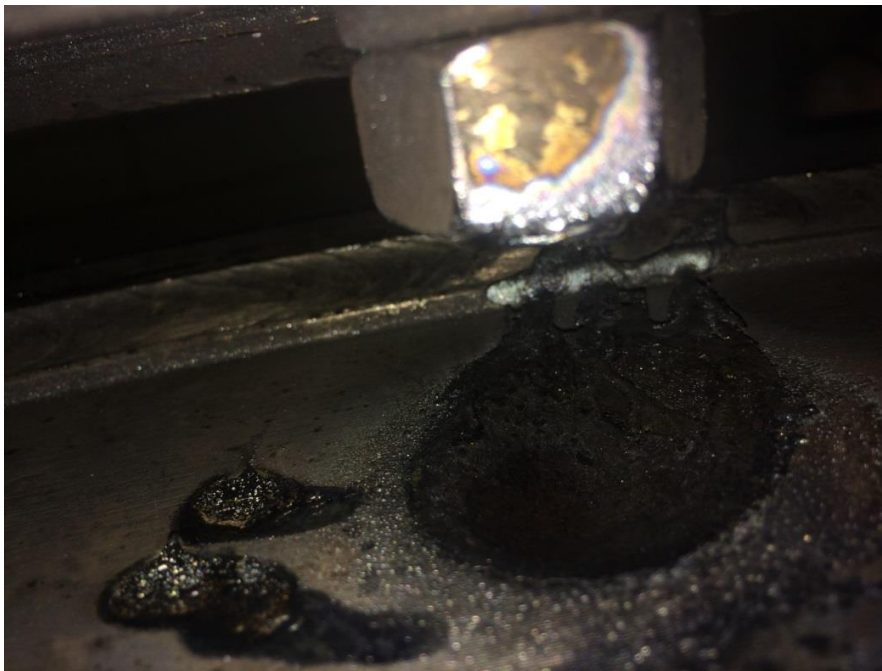
Close-up of a flashover point between the slip rings

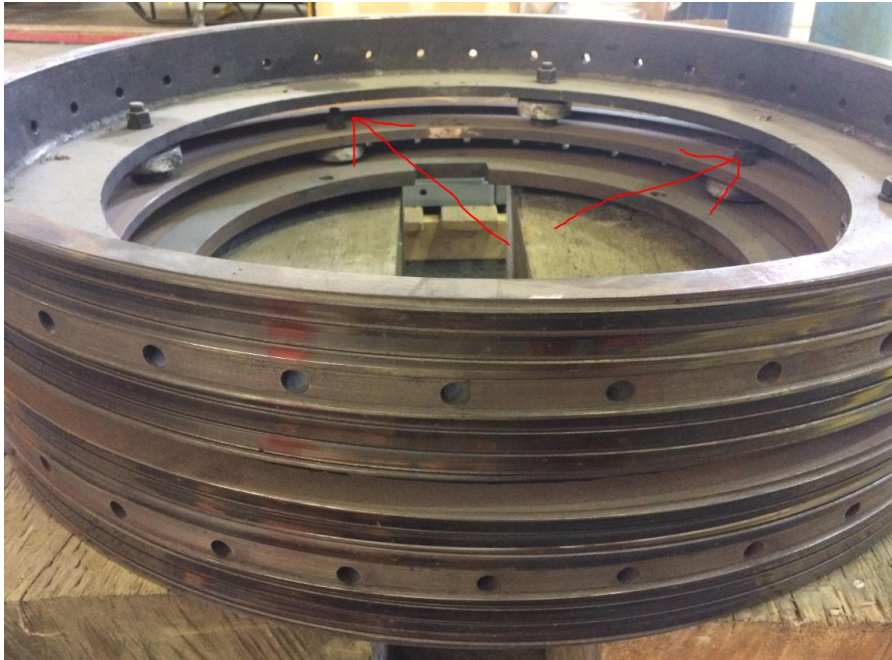
Picture of the slip ring, arrows indicated the flashover points (not all flashover points are indicated)

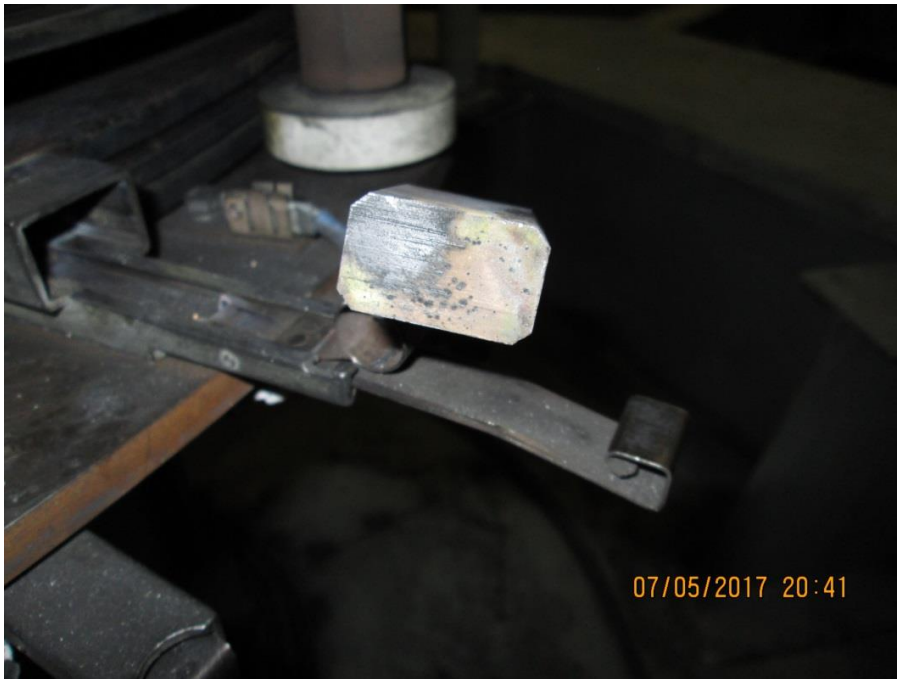
T2: The brush holder has some metal loss on the surface adjacent to the ring. The brush wear is a little below the threshold for replacement. The pigtail is melted off at the brush connection. (Picture 4)

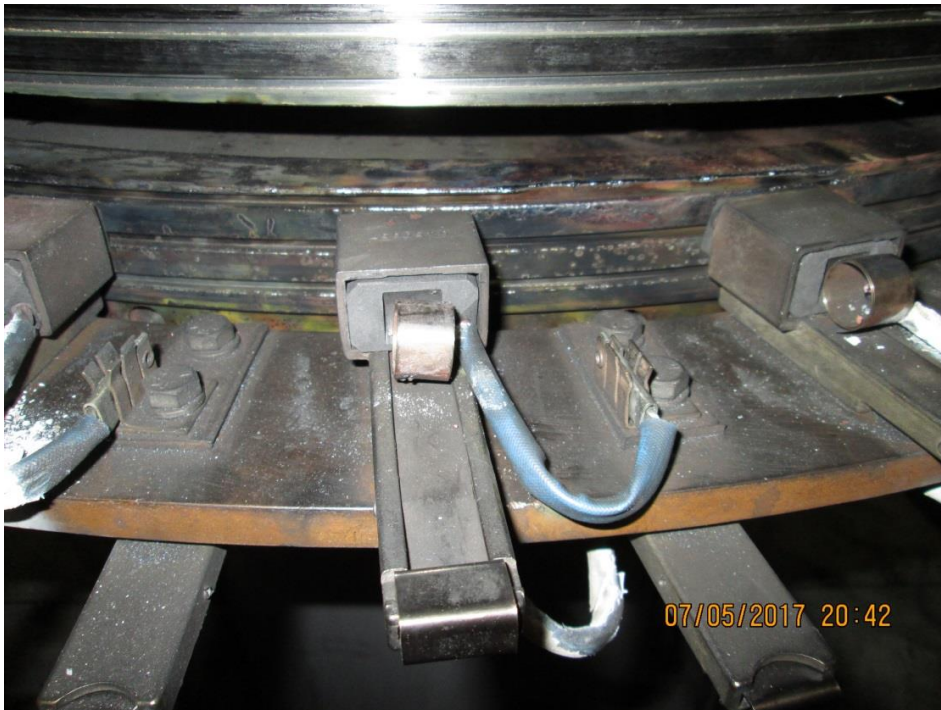
T4: There is minor damage to the brush holder. The brush wear is at the threshold for replacement. The pigtail is melted off in the middle (between the brush and the connector). (Picture 6)

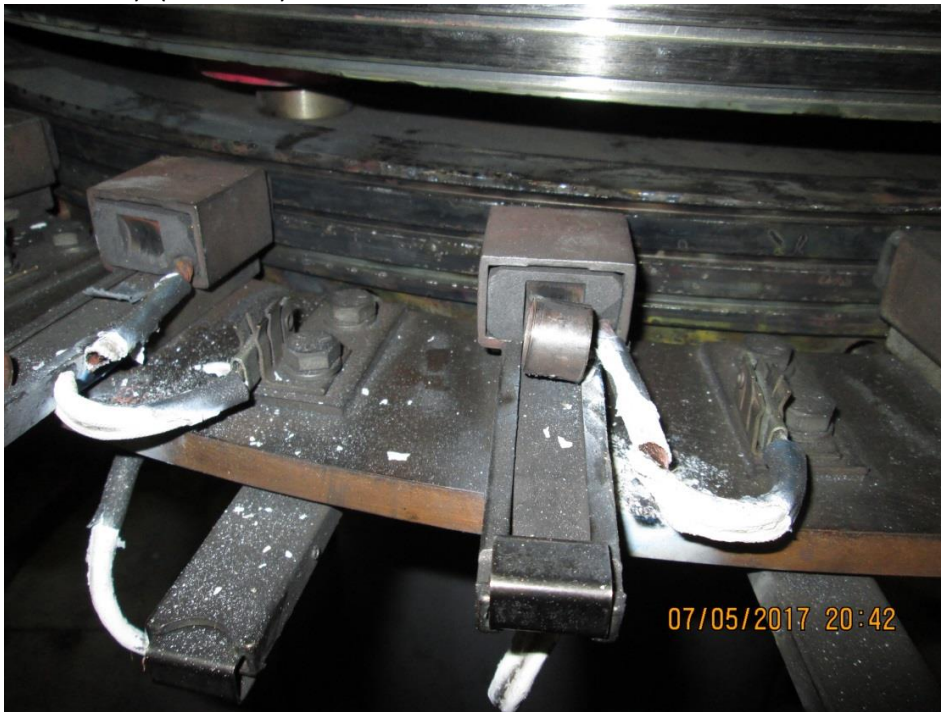
T5: There is arcing damage on one corner of the brush holder. The brush wear is at the threshold for replacement. The pigtail is melted off. The spring is broken. (Picture 7)

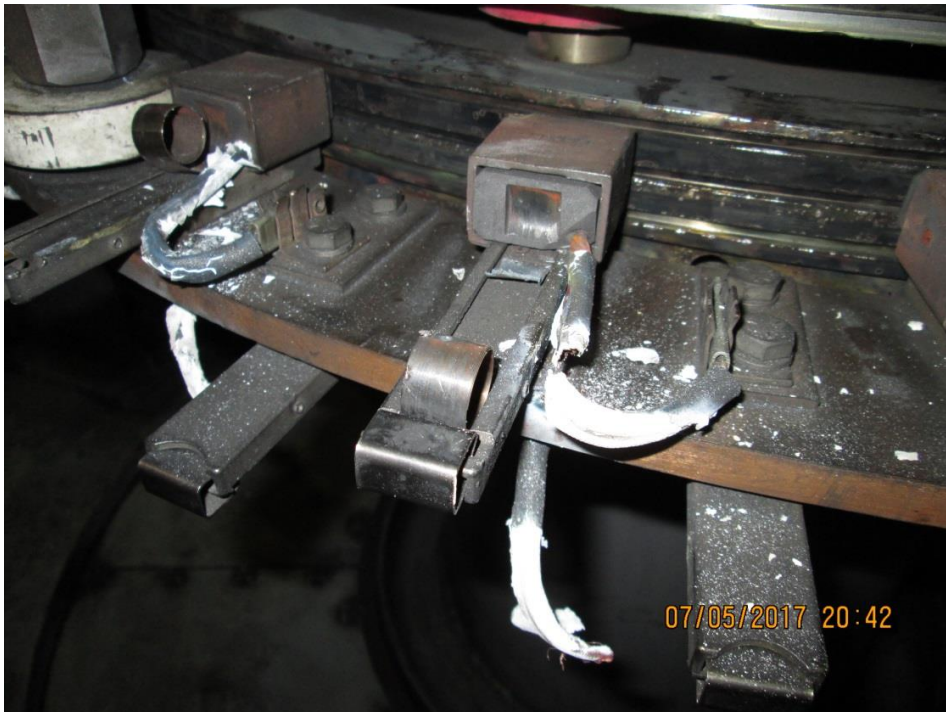
T6: The brush wear is at the threshold for replacement. The pigtail insulation is severely damaged, and the copper is intact. There is no spring tension. (Picture 1)

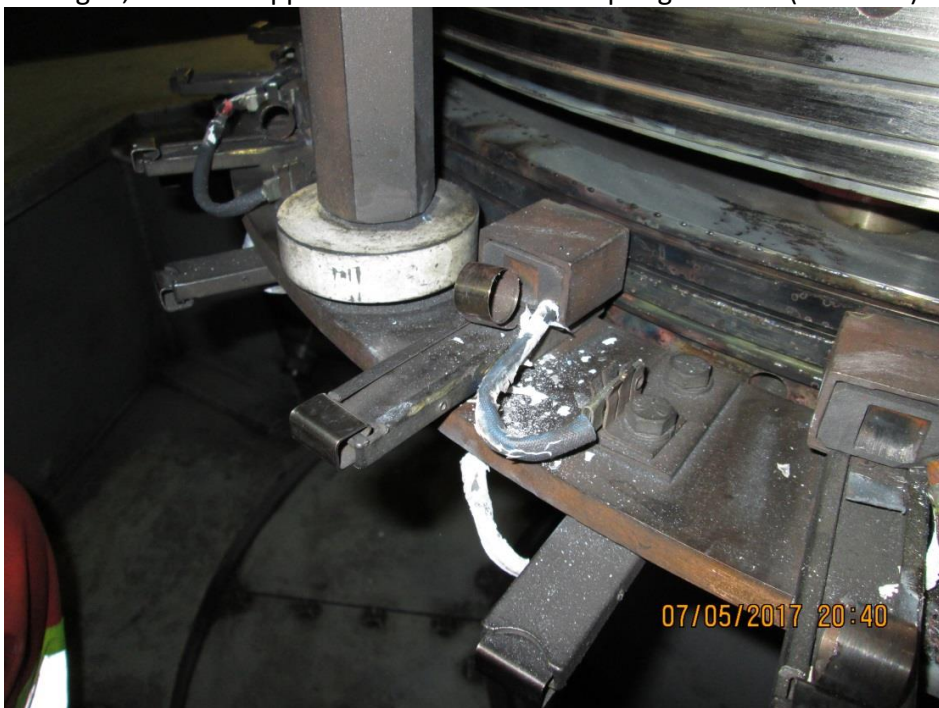
T7: The brush holder sides have holes melted in them, and some metal loss on the surface adjacent to the ring. The brush wear is at the threshold for replacement. The pigtail is melted off. (Pictures 8, 9 & 10)

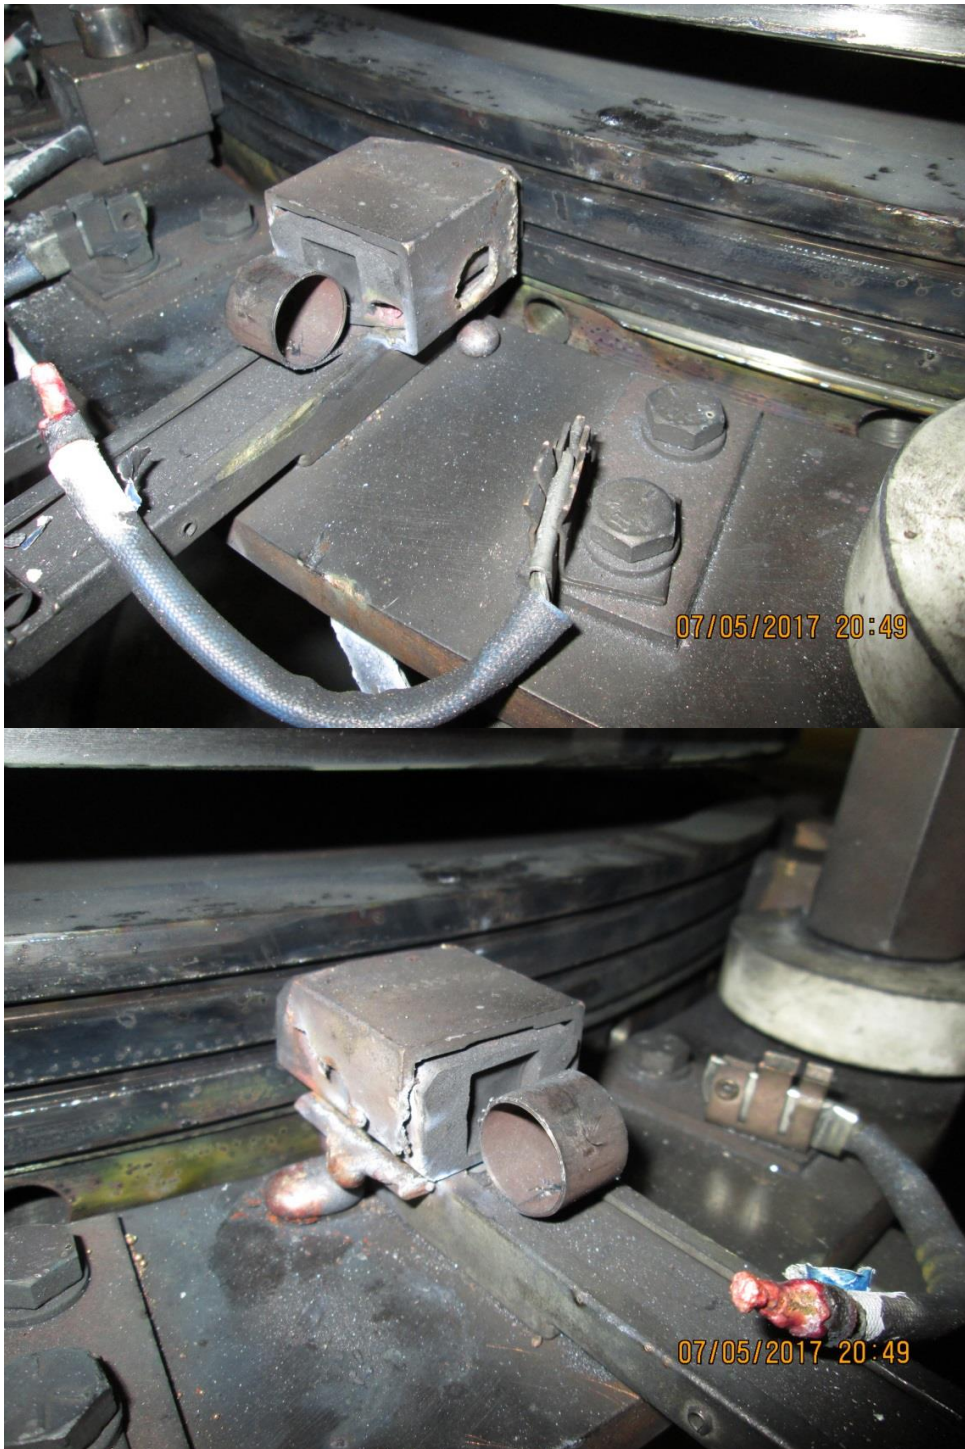
T8: The brush holder has pits / splatter on the top, and some metal loss on the surface adjacent to the ring. The brush wear is at the threshold for replacement. The pigtail is melted off in the middle (between the brush and the connector). The spring is broken. (Picture 11)

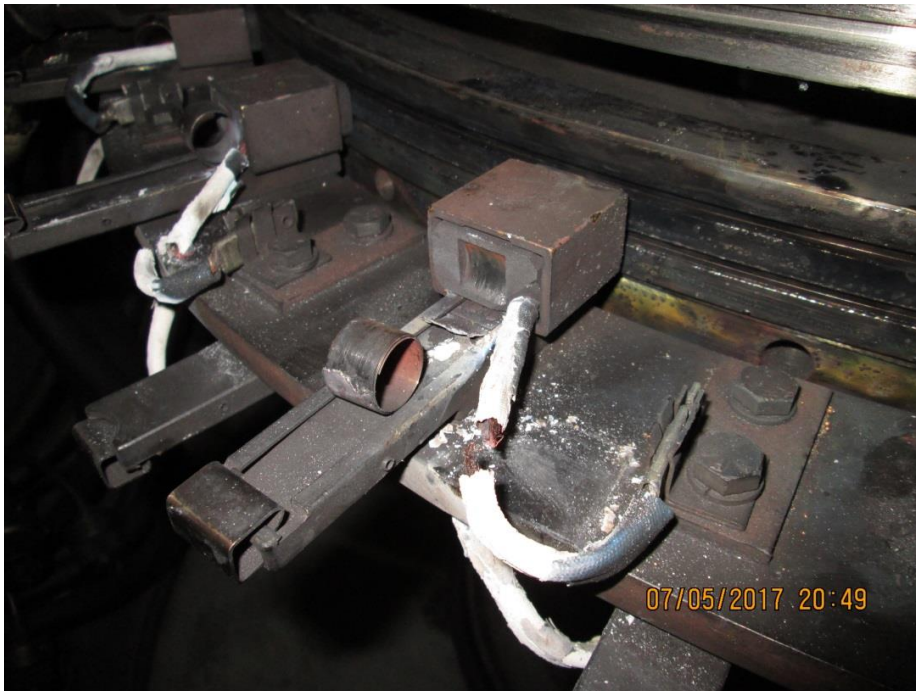
T9: The brush holder has pits / splatter on the top. The brush wear is at the threshold for replacement. The pigtail is melted off in the middle. There is full (poor) contact at the brush face. (Picture 12)

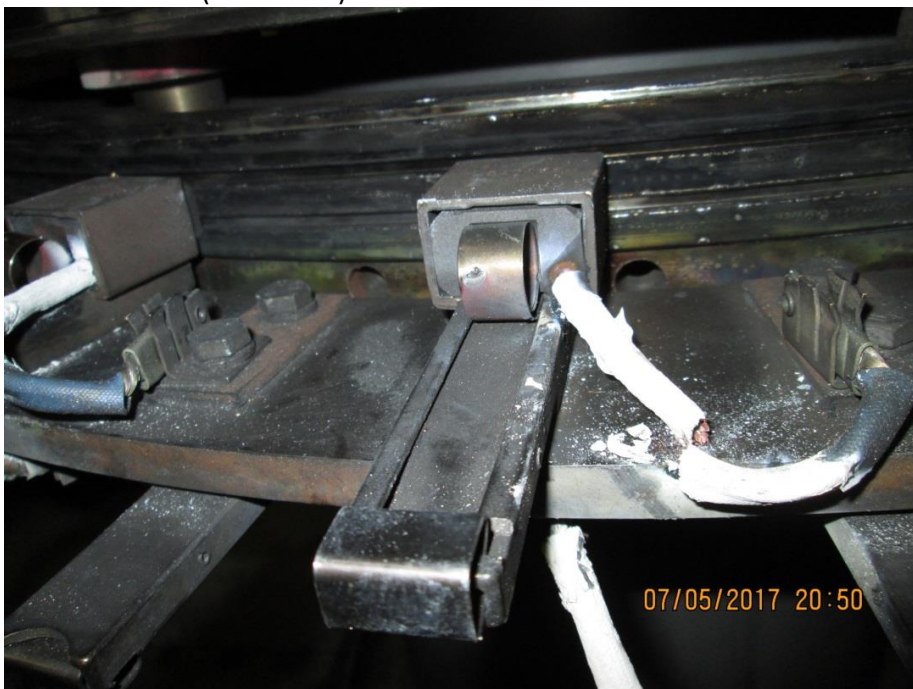
T10: The brush holder has a small melt area on one top corner. The brush wear is at the threshold for replacement. The pigtail insulation is melted through and copper is intact. (Picture 13)

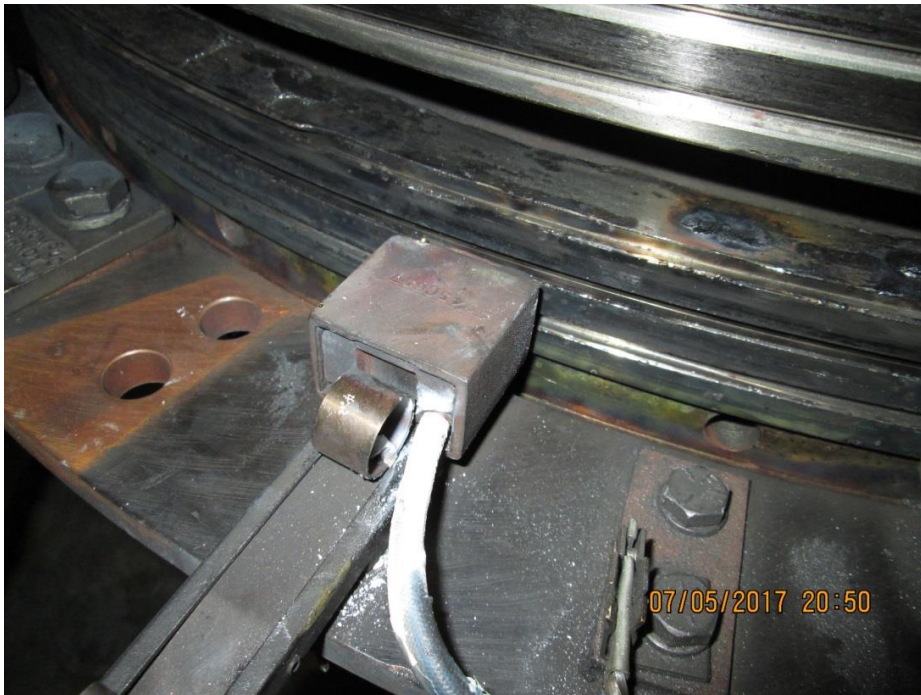
B1: Heavy heat damage to brush, pigtail and holder. The brush wear is less than the threshold for replacement. (Picture 14)

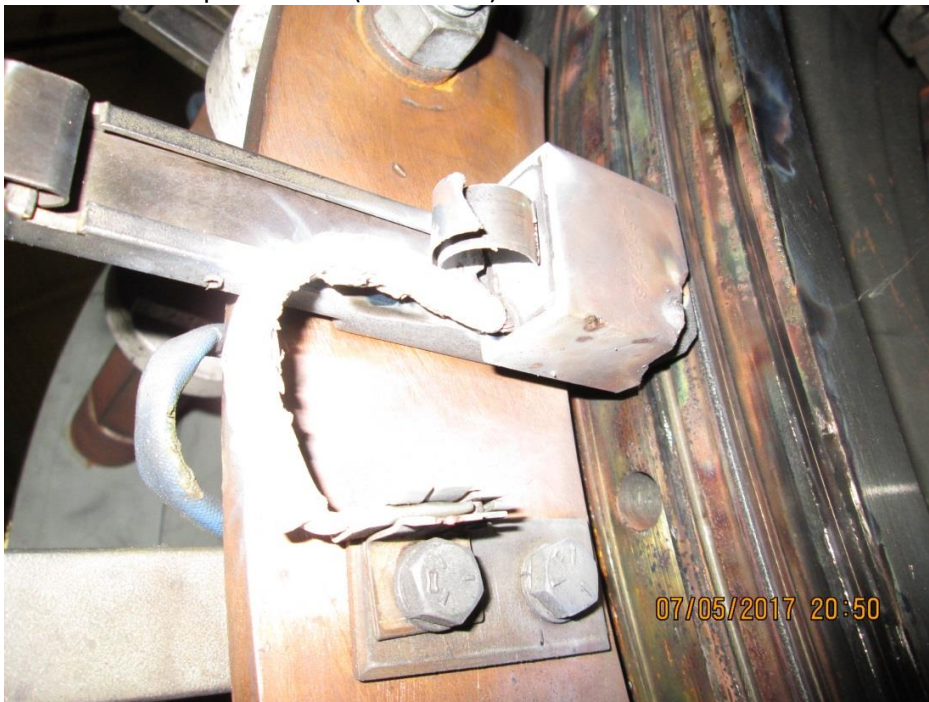
B2: The brush holder melted and the brush fell out. (Picture 15)

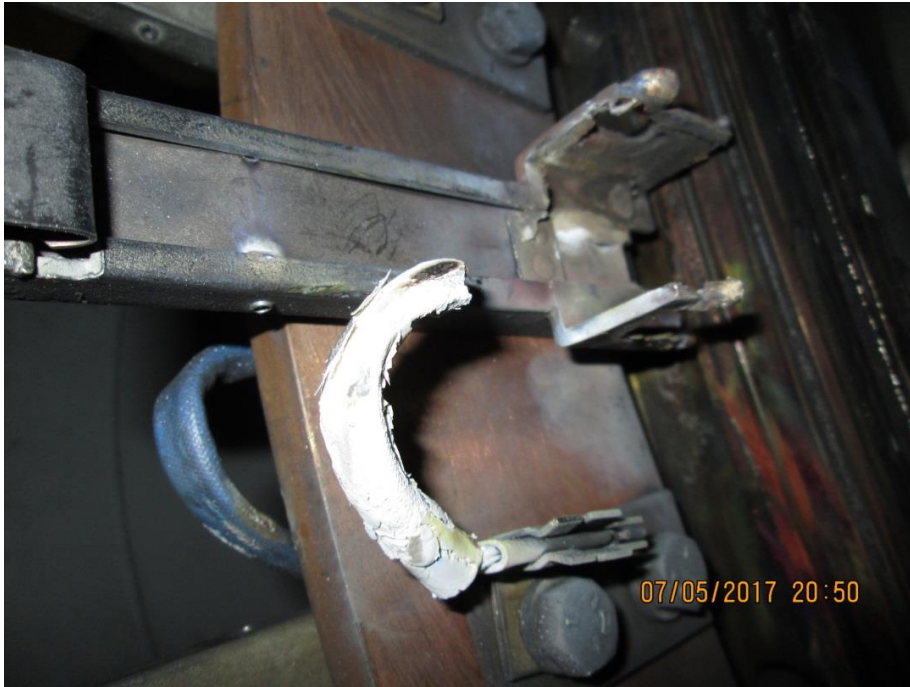
B3: Heavy heat damage to brush, pigtail and holder. The brush wear is less than the threshold for replacement. (Picture 16)

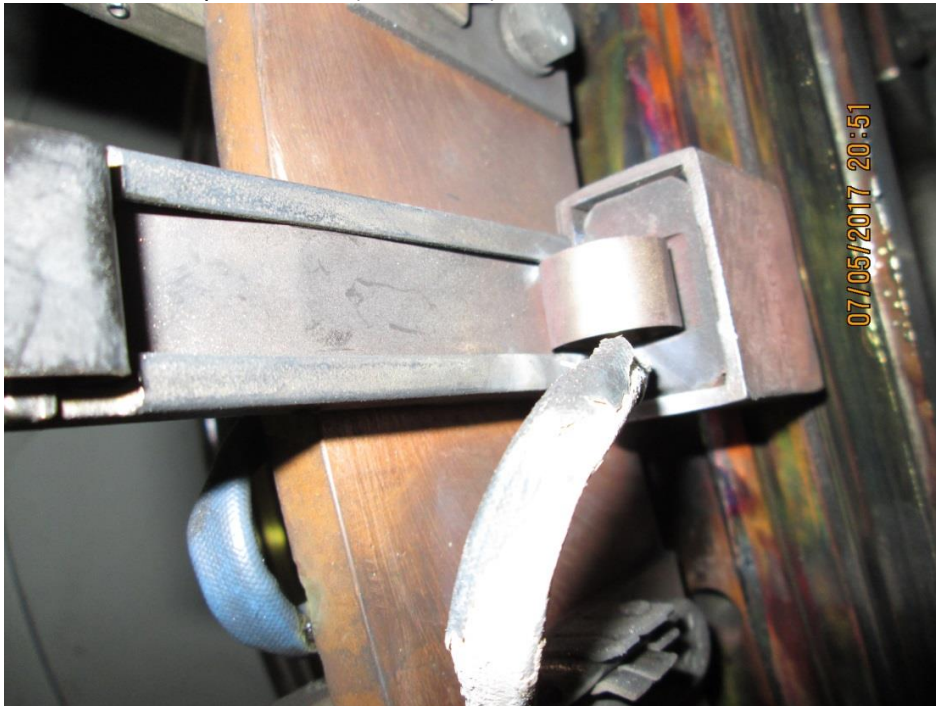
B4: The brush holder melted and the brush fell out. (Picture 17)

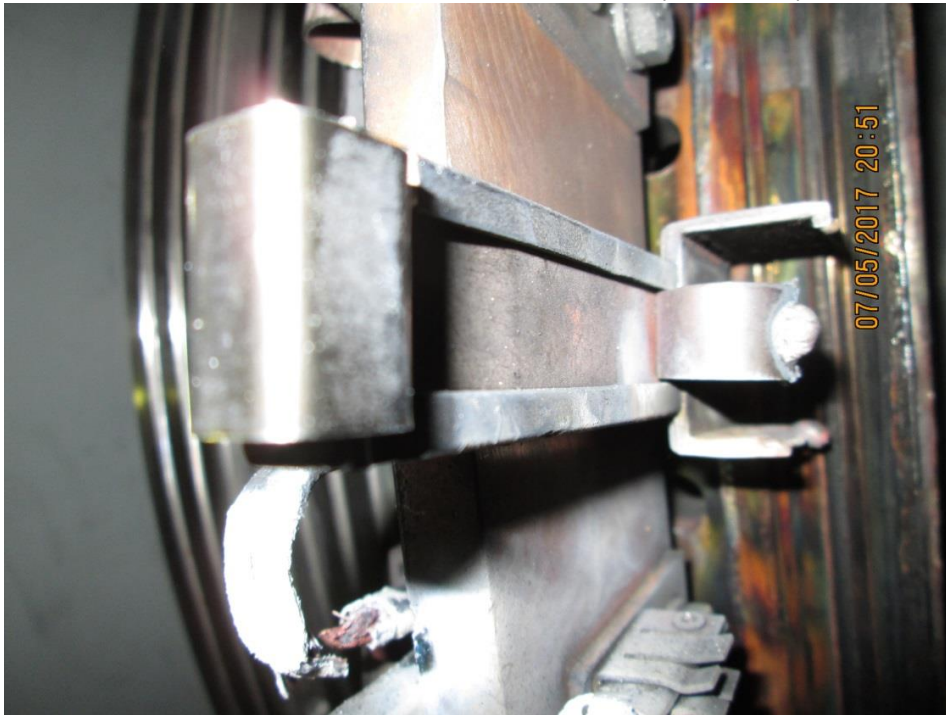
B5: Heavy heat damage to brush, pigtail and holder. The brush wear is less than the threshold for replacement. (Picture 18)
