1 Q. Please provide a copy of equipment-related root cause or causal analyses reports
2 conducted over 2016-2018.

CRACK INVESTIGATION AND REPAIR REPORT

This report is intended to summarize the site inspection and repair recommendations of a crack that developed in Penstock No.1 at the Bat d'Espoir hydroelectric development owned and operated by Newfoundland and Labrador Hydro (NL Hydro).

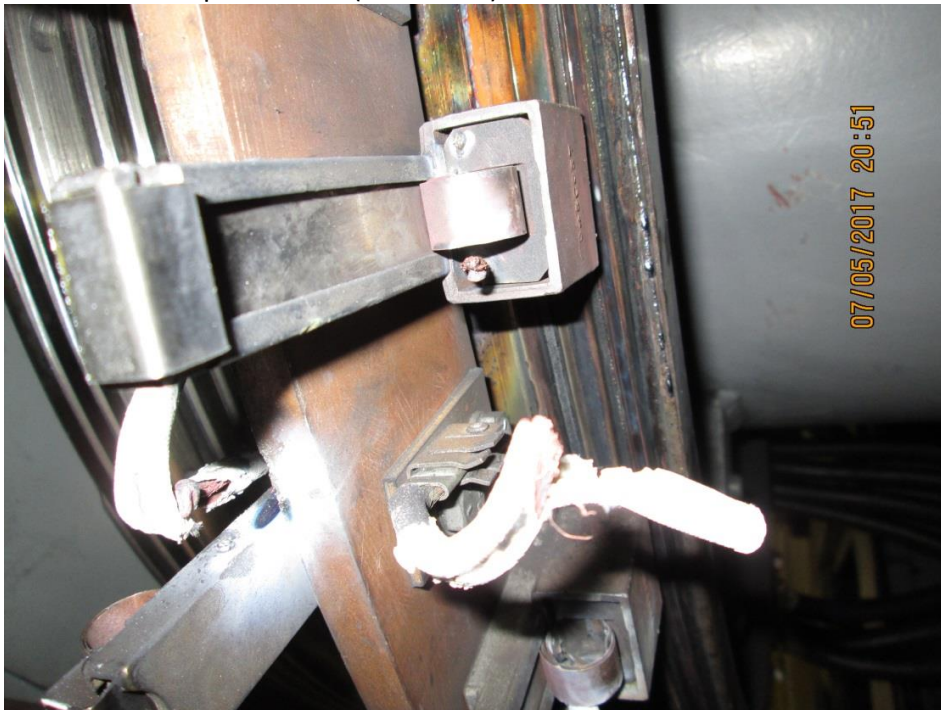
B6: Heavy heat damage to brush, pigtail and holder. The brush wear is less than the threshold for replacement. (Picture 19)

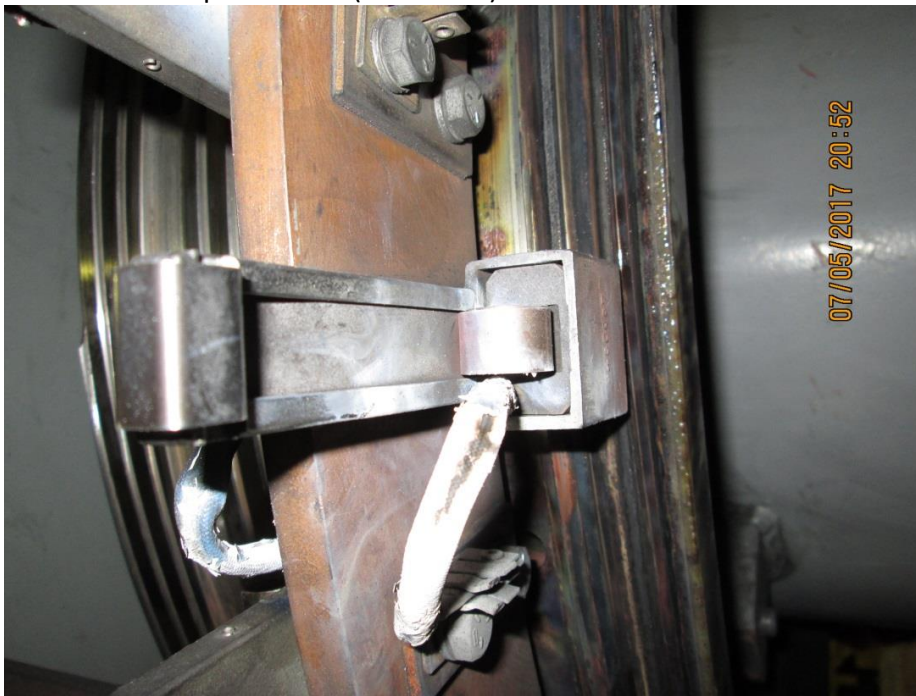
B7: Heavy heat damage to brush, pigtail and holder. The brush wear is less than the threshold for replacement. (Picture 20)

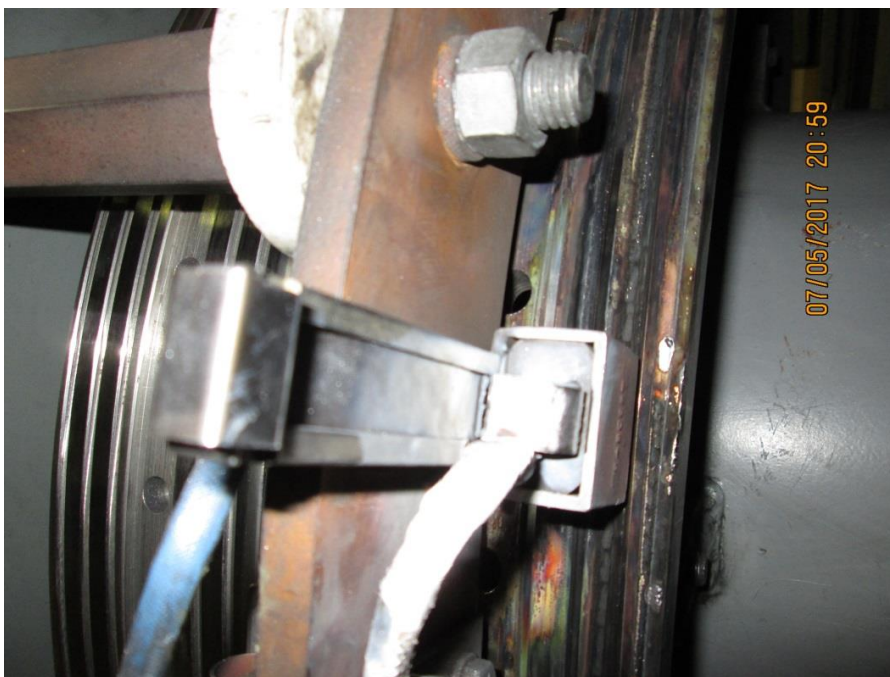
B8: The brush holder melted and the brush fell out. (Picture 21)

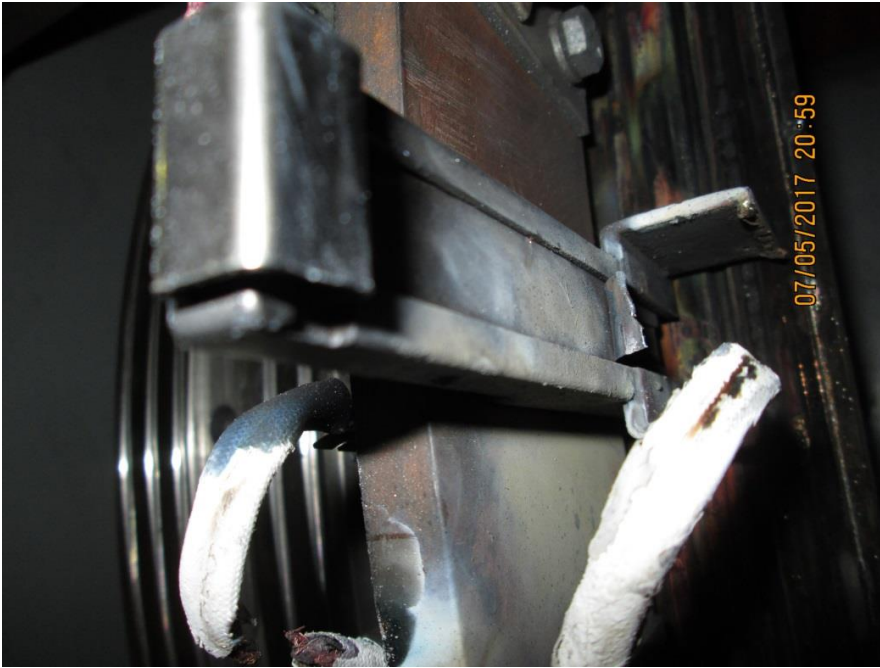
B9: The brush holder melted and the brush fell out. (Picture 22)

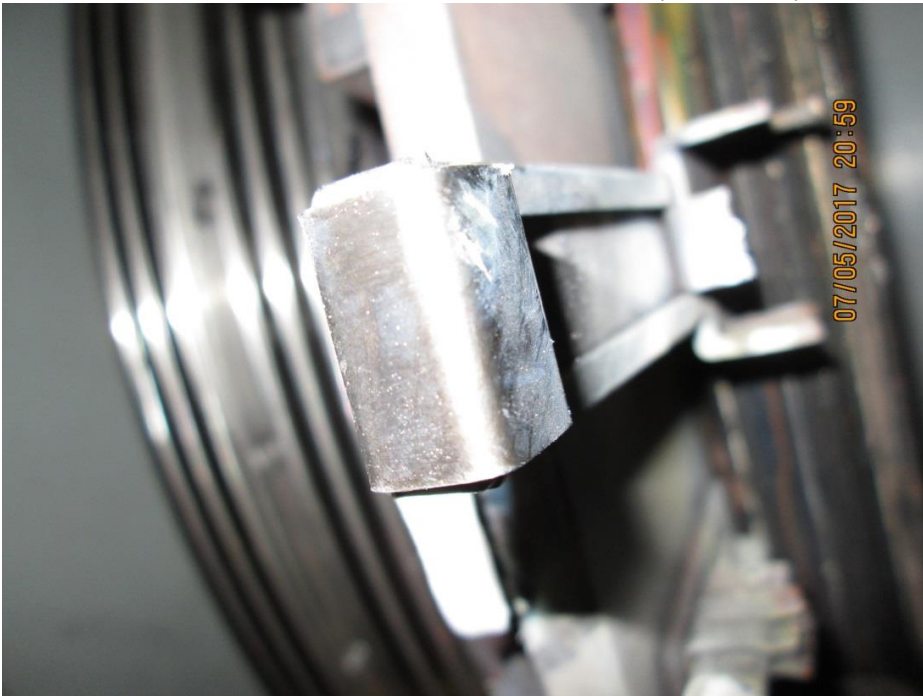
B10: The brush holder melted and the brush fell out. (Picture 23)

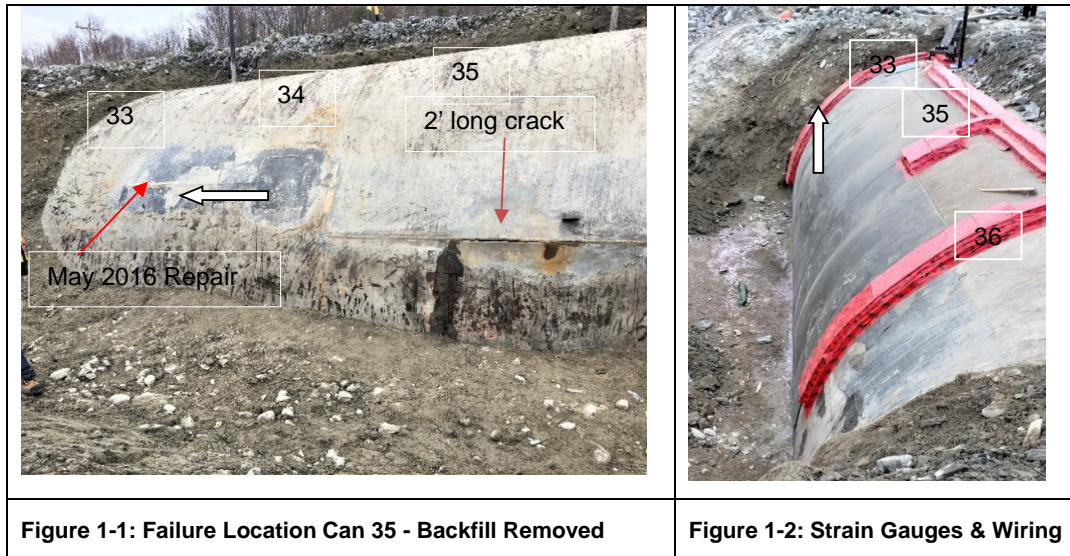
A third rupture of Penstock No. 1 at Bay d'Espoir (BDE) occurred on November 4, 2017. The rupture occurred in the form of a 2' long crack just below the crack that was repaired only 14 months earlier (September 2016) in Can 35.

Hatch mobilized a team to assist Newfoundland and Labrador Hydro (Hydro) in the repair and commissioning/testing of the penstock. The penstock was inspected visually and laser surveyed. Hatch designed a repair for the ruptured penstock which involved removal of a longitudinal strip of the penstock can with the crack in the middle and welding in place a 1/2" thick pre-rolled plate. Similarly, the repaired weld (May 2016) on Can 34 was removed as a precaution and a new pre-rolled plate welded in place. To reinforce the new repaired area and the one from May 2016, reinforcing plates (8' 6" radius, 1/2" thick) were welded on the exterior of Cans 33, 34 (ruptured in 2016), Can 35 (ruptured in 2016 and 2017) and Can 36. These plates were then welded to each other to operate as one large reinforcement over the entire area. Figure 1-1 and Figure 1-2 show the rupture area before and after repair, respectively.

The latest penstock rupture on November 4, 2017 was inspected visually (Figure 1-1). The entire length of the affected can around the crack was cut and shipped to a metallurgical laboratory for metallurgical analysis and material testing (Figure 4-1). The majority of longitudinal welds on the interior of the penstock from the intake to the surge tank (2272' or 690 m) were inspected visually, by magnetic particle, and using laser survey. Laser survey of the interior of the penstock was used to determine the interior shape of the penstock and confirm the level of peaking present. Cracks or defects were discovered on twenty-nine (29) longitudinal welds out of 430 seams inspected. Twenty-seven (27) of these were on 2016 repairs and two (2) were on original welds. Including the 2 longitudinal weld seams from the ruptured portion of the penstock makes the total 31 repaired seams. A detailed inspection chart is shown on the following page that shows 2016 repairs, 2017 repairs, cleared cans, cans that exhibited new indications, and cans that exhibited extensive cracking in 2016. The backfill and settlement monitoring posts over the same length of penstock were surveyed and the data is presented.

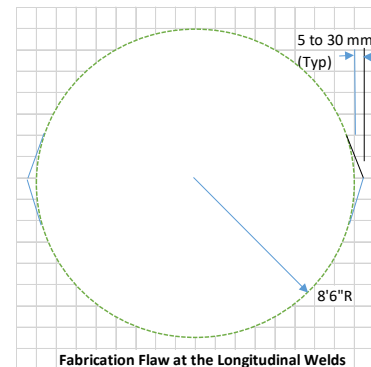
2. High localized bending stresses under internal pressure (measured and verified by FE modeling) due to the non-circular shell geometry at the longitudinal weld seam from original fabrication ("peaking"- due to insufficient plate rolling radius at start and end resulting in deviation of surface at the seam from a smooth arc; exaggerated illustration right).

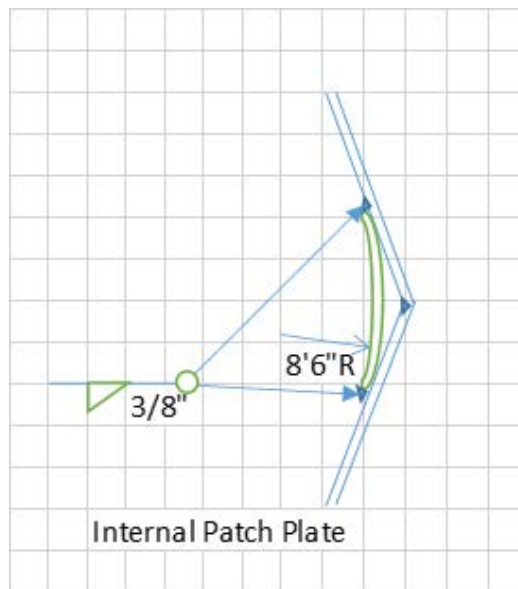
Figure 5-1: Weld Repair of Internal Longitudinal Seams

For the 29 longitudinal seams in other cans with defects or cracks, existing weld metal was removed from inside of the penstock and repair welded. Prior to the installation of the reinforcing plates, the excess weld reinforcement on the longitudinal welds was ground flush. To reduce the stress concentration at the welds and allowed the reinforcing plates to sit tighter to the existing plate surface. In each case a 22" wide 9' long rolled patch plate (8'6" radius, 1/2" thick) was welded in place on the inside of the repaired longitudinal welds, as shown schematically in Figure 5-1 below. Figure 5-1 also shows peaking at the weld.

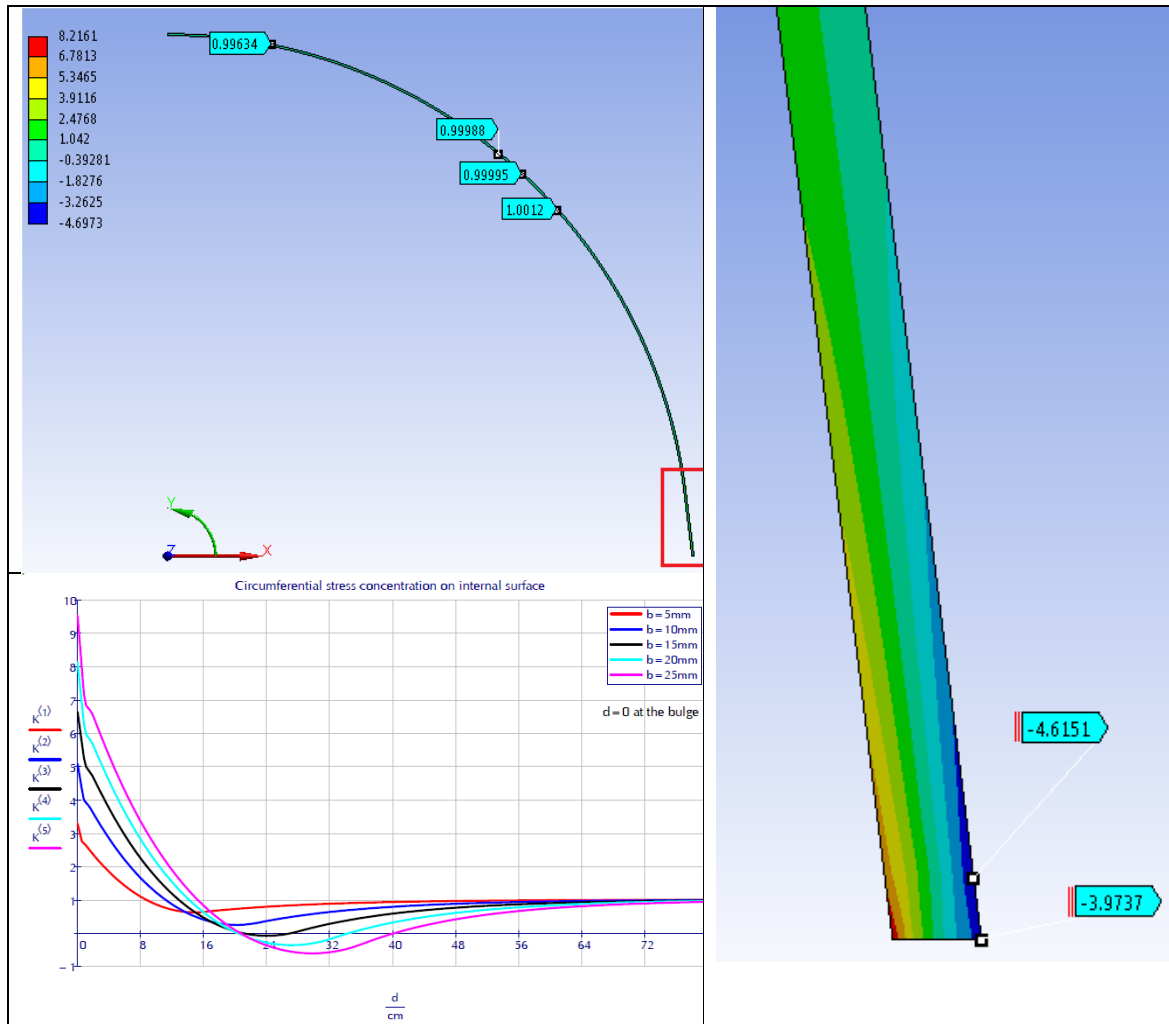
Figure 7-3: Influence of Non-Circular Geometry at Longitudinal Welds Under Pressure

Referring to Figure 7-3, a FE model was produced to determine the stress concentration or multiplication factor produced from the peaking/bulge. Using a conservative bulge distance, $b = 25$ mm, produces a multiplication factor of approximately 1.42 (distance from bulge center, $d = \sim 16$ mm, as the nearest strain gauge, T65_INT_P105, was approximately 5mm off of the toe of the weld).

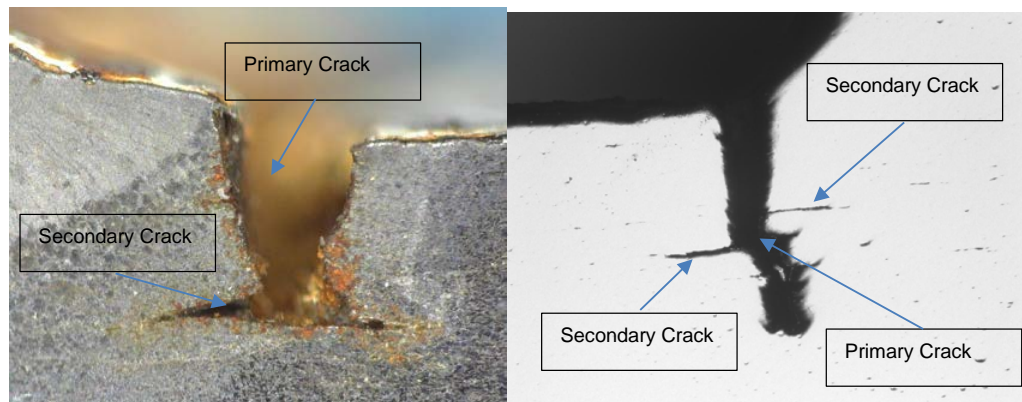
Figure 8-2: Primary Cracks (Vertical) and Secondary Cracks (Horizontal)

Two different types of cracks were discovered through macro examination and are shown in Figure 8-2. The primary cracks (through thickness) generally propagate from the toe of the weld through the heat affected zone (HAZ). All observed crack micro examinations had pearlitic structures which is a desirable trait and would indicate that the cracks were not caused by brittle structures. There is evidence of bending and high tensile loading when analyzing the micro photographs. Several of the samples had secondary cracking (interplanar) present. The secondary cracks appear to follow sulphide inclusions that are present within the base material and can likely be attributed to the presence of said inclusions. The sulphide inclusions are most likely caused by the higher than normal sulphur content found in the parent material. Additional testing is being considered to determine if this can be verified. It seems unlikely the secondary cracking is the primary cause of the rupture but could have accelerated the failure.

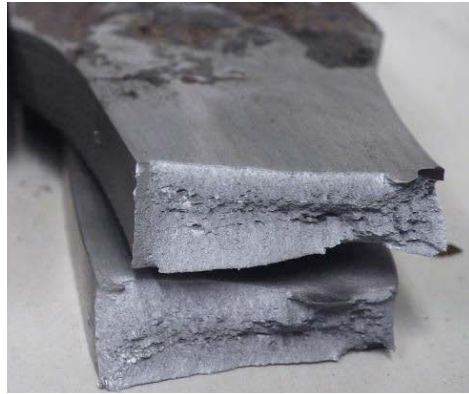
Figure 8-3: Ductile Failure Tensile Tests Penstock No. 1

Further to the visual, macro, micro and chemical analysis, a set of mechanical testing was completed. The testing consisted of tensile testing for the base metal and the weld metal. The tensile samples failed within the base metal and were also ductile in nature (similar to the results determined in the 2016 investigation). This is further evidence that brittle fracture was not involved and that the material and weld metal is ductile, which is preferred practice for design of steel structures. The tensile test in Figure 8-3 shows an extensive reduction in area and significant cupping which is typical of a ductile failure.

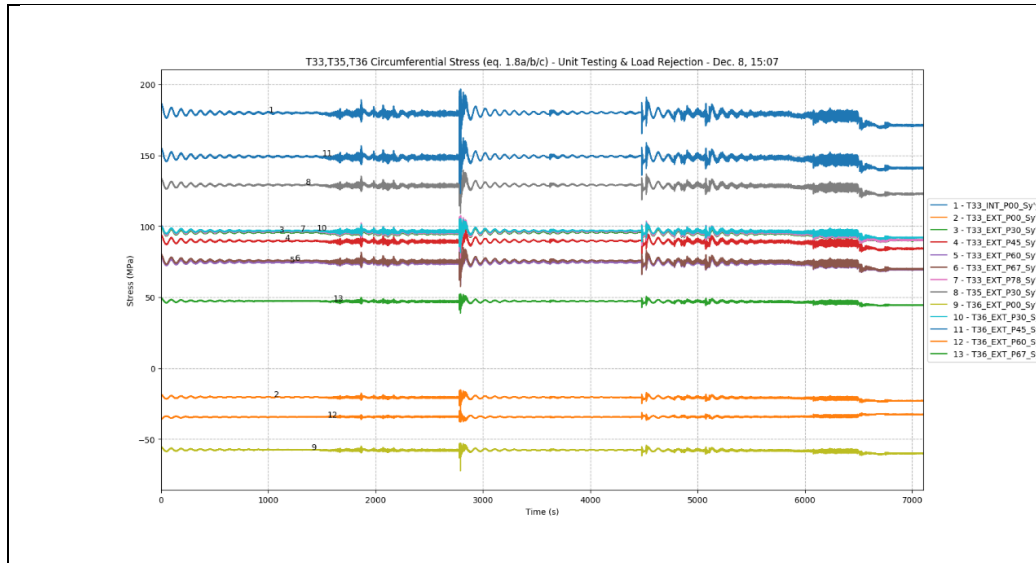
Figure 8-5: Circumferential Stresses in Penstock at Can 33 - Rough Zone & Load Rejection

- A load rejection results in pressure rise of 10% at the powerhouse (259 psi+26 psi). The corresponding pressure waves up the penstock cause fluctuations in pressure at T33 of the order of $\pm 17\%$ (± 6.8 psi) in the area where the rupture occurred (Figure 8-4). The corresponding fluctuation in the maximum stress is 280 ± 25 MPa during load rejection (Figure 8-5). Load rejection occurs between 1500 and 3500 seconds and the peak was at approximately 2700 seconds.

- The fluctuations in maximum stress during rough zone operation are of the order of ± 7 MPa (1.0 ksi) and ± 5 MPa (0.7 ksi) with two units and one unit in the rough zone, respectively (Figures 8-5 and 8-6). This is interesting as it was not anticipated that the rough zone operations would result in significant stress fluctuations in the penstock. Rough zone occurs from approximately 4500 seconds onward. Refer to Appendix D for additional detail.

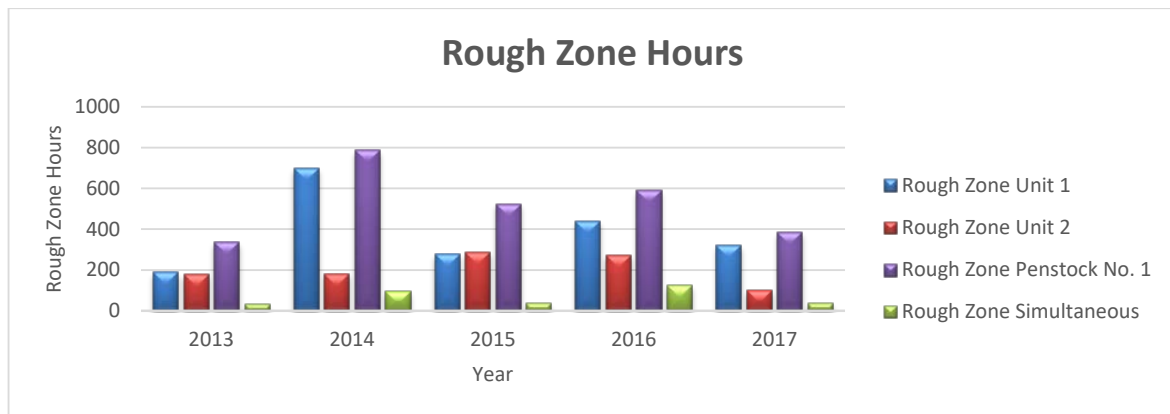
Figure 8-7: Rough Zone Trends

Hydro provided the last 5 years of operational data to Hatch to help determine if any operational changes contributed to the failures. The operational data shows high hourly operation in the rough zone for each unit and decreasing start/stop modulation. In general, eliminating unnecessary starts/stops is a common recommendation to increase the life of a system. However, transitioning from stop/start to modulation shows an increased amount of rough zone operation and it appears that the penstock may be spending substantially more time in the rough zone. Based on the measured test results the hydraulic rough zone occurs between 25 to 40 MW. Analyzing the data and approximating the total hydraulic rough zone time shows that recently Penstock No. 1 spends more than 400 hours in the hydraulic rough zone per year. Additionally, 2014 had the highest amount of rough zone operation to date at over 800 hours. The rough zone hours, Figure 8-7, and starts, Figure 8-8, are presented from 2013 to 2017. Additionally, it should be noted that 2016 and 2017 had significant down time for repairs and the duration of rough zone operation would be reduced.

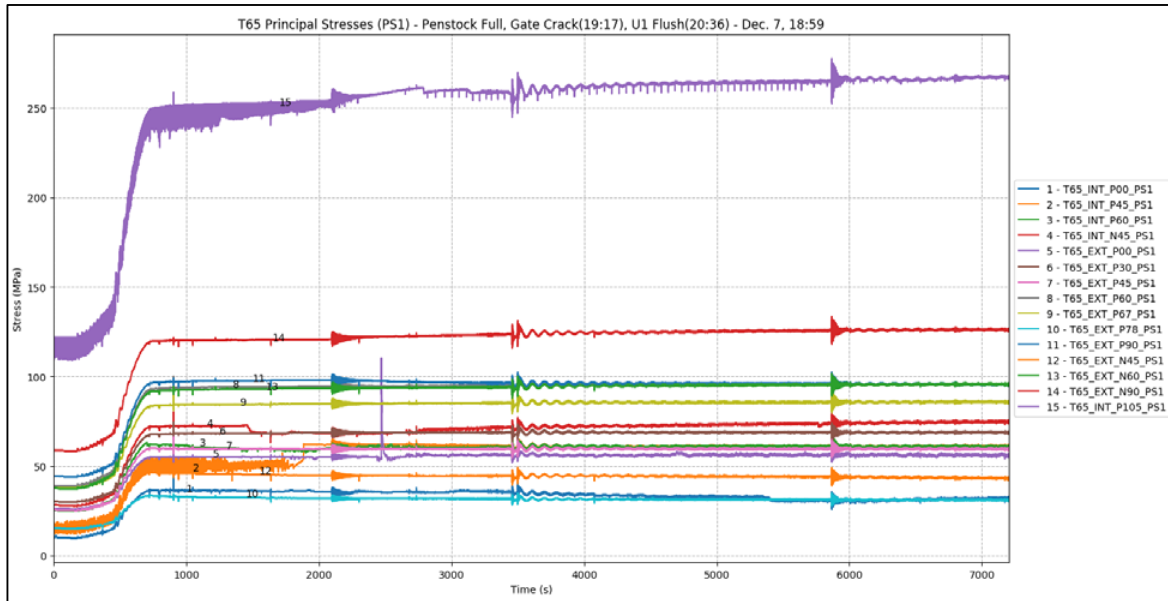
Figure A-9: T65 Principal Stress 1 (Circumferential) - Completion of Water Up to Full Penstock

With the penstock reaching a full state, stresses are noted to increase by a considerable magnitude upon pressurization, see Figure A-9. The location of the strain rosette indicating the point of highest circumferential stress is on can T65, adjacent to the longitudinal weld seam (T65_INT_P105). The rosette also shows this location to have the highest axial stress. Cans T33, T35, and T36 also show increases in circumferential and axial stresses but are not near the maximum values for the rosette located in T65 adjacent to the longitudinal weld seam.

It should be noted that the rosette hoop gauge T65_INT_P105_H started to have water intrusion and was compromised hours just after water up was completed. On the above graph, some noise is shown for T65_INT_P105_PS1 caused by water starting to infiltrate into the gauge. As only 1 of 3 gauges of the rosette was compromised and as this location has the highest stresses, one of the two remaining gauges, T65_INT_P105_C, was used with an extrapolation equation to plot the missing data for T65_INT_P105_H. Using the data from water up when all gauges of the T65_INT_P105 rosette were collecting data, a plot of T65_INT_P105_C vs. T65_INT_P105_H was produced. Using this plot, a linear best fit equation was produced and this equation was used to plot the T65_INT_P105_H values going forward. As the relation between the combined and hoop gauge is linear, the best fit produced an R^2 value of 0.998 for the plot.

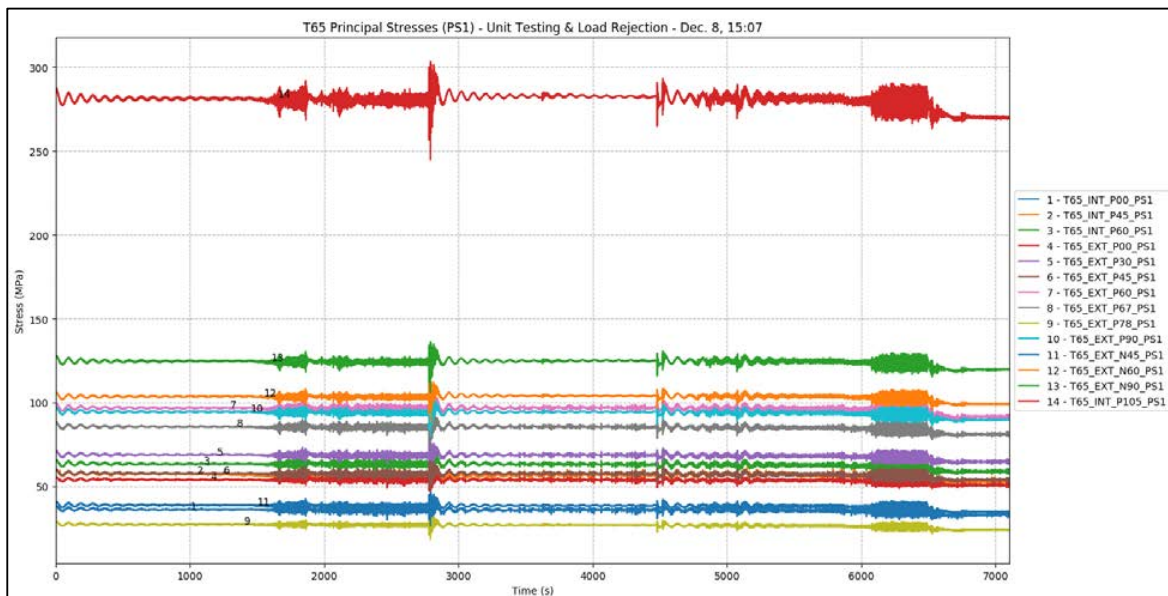
Figure A-11: T65 Principal Stress 1 (Circumferential) – Unit Testing and Load Rejection

Stresses for the unit testing range from approximately -50 MPa (PS2 Axial at the T36_EXT_P00 gauge) to a maximum of approximately 303 MPa (PS1 at T65_INT_P105) during load rejection. The average for T65_INT_P105 (PS1 – circumferential) during the unit testing was approximately 280 MPa, this gauge had the highest stress as it was ~5mm above one of the longitudinal weld seams of can T65.

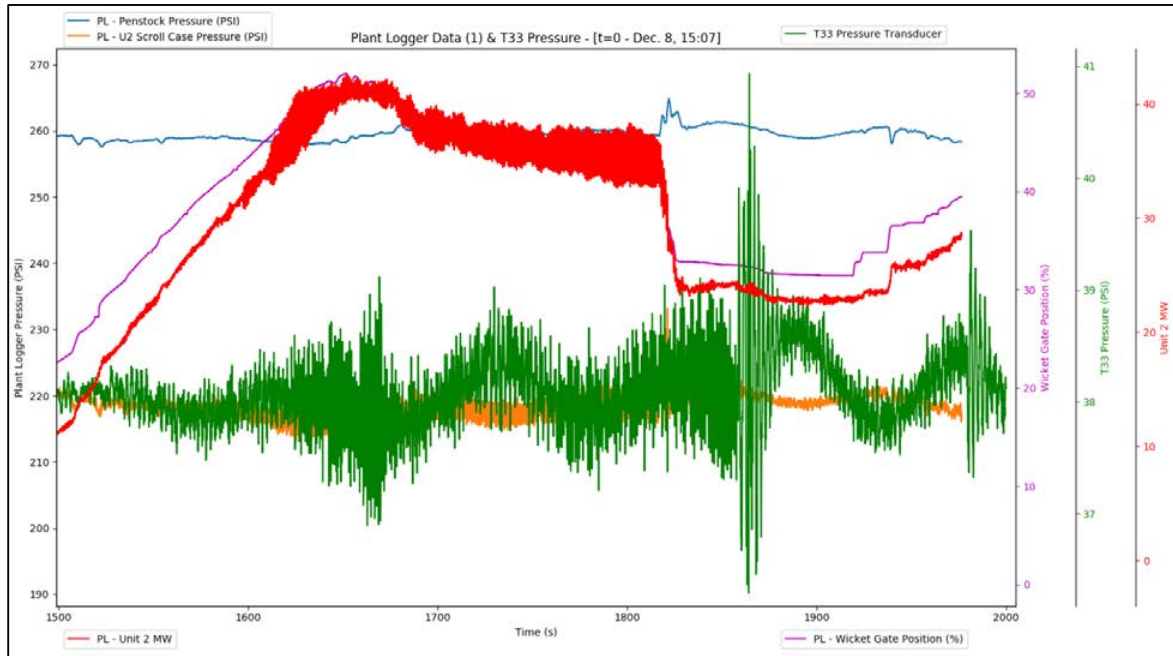
Figure A-16: Unit 2 Rough Zone

From a Fourier analysis of 40s of rough zone operation (T33 Pressure), multiple frequencies are notable. The frequency showing the highest spectral amplitude is approximately 1 Hz. Other notable frequencies are approximately 0.025, 0.4, 0.9, 1.8, 2.05, and 3.1 Hz. The ~1 Hz frequency is caused by the turbulent “draft tube rope” vorticity and vortex shedding that occurs as the fluid passes through the runner and travels downstream through the draft tube.

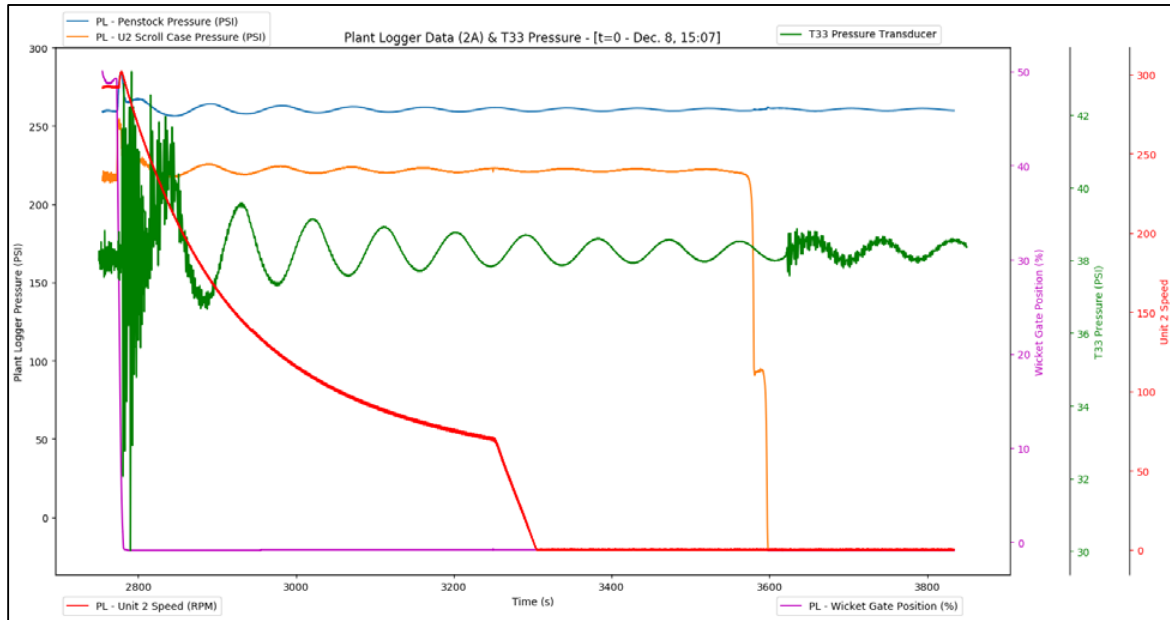
Figure A-20: Unit 2 Load Rejection

The Unit 2 Load rejection occurred at approximately 15:53 on Dec. 8th. A notable spike in pressure of approximately 35.98 psi occurred in the powerhouse (Unit 2 Scroll Case Pressure). The pressure transducer at T33 showed an immediate increase of approximately 3.81 psi followed by an increasing oscillation that reached a maximum transducer reading of 43.19 psi and a minimum reading of 30.02 psi, the oscillation then started decaying.

The highest location of stress T65_INT_P105 showed a principal stress 1 (circumferential) increase of approximately 18.66 MPa followed by the increasing oscillation with a maximum reading of 303.33 MPa, and a minimum of 244.62 MPa before decaying. The highest stress location on T33, T35, and T36 is T33_INT_P00 which had a maximum principal stress 1 of 163.67 MPa and a minimum PS1 value of 126.67 MPa.

Another unique area to note on Figure A-20 is ~3622-3850s, this is the time after the closure of the Unit 2 Spherical Valve, as noted by the loss of pressure from the Unit 2 Scroll Case Pressure Transducer. As the spherical valve closes, a small pulsation is sent through the penstock as shown by the T33 Pressure Transducer. The pulsation frequencies are as shown in Table A-6. The spectral amplitude caused by the pulsation is almost negligible.

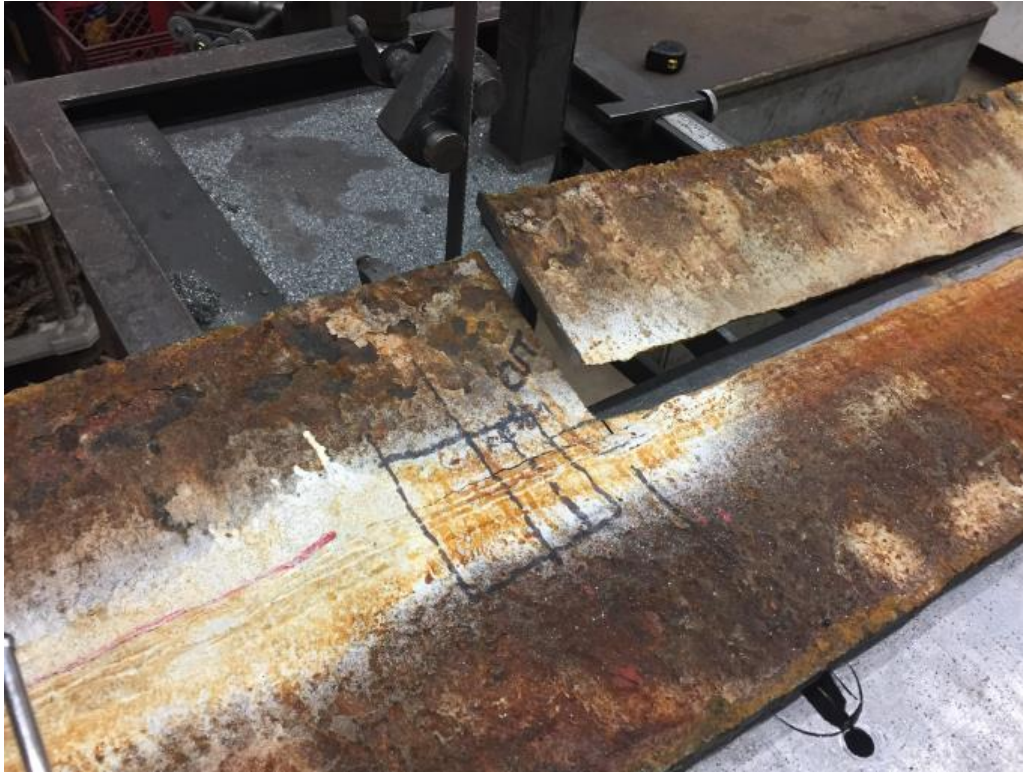
The plate was sectioned to allow for cleaning and examination of the fracture surfaces. The plate appeared to have significant residual stresses present, as one section of the plate displaced away from the main body of the plate when it was cut. The final displacement of the cut section is shown in Figure 12. After sectioning the plate was cleaned of soil and loose debris using water, detergent and a soft brush. The corrosion product was then removed using a rust removal product (Evaporust) that does not attack the underlying metal.

Figure 12 Photograph of the plate as it was being sectioned showing deformation due to residual stresses

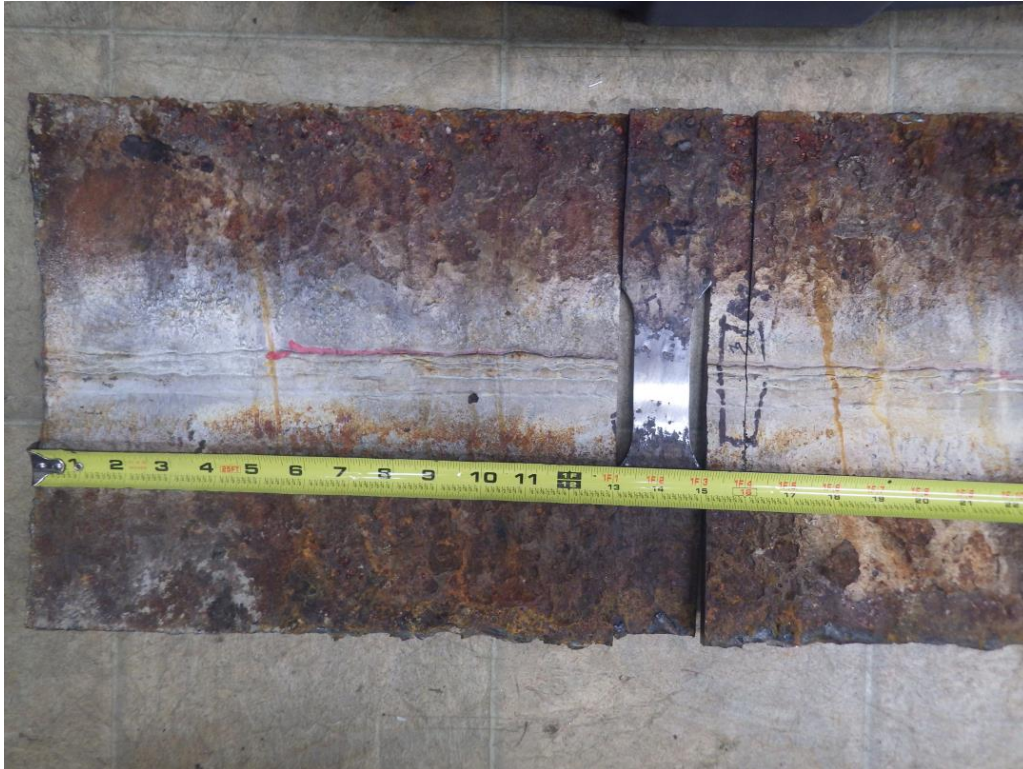
Figure 14 Photograph showing the location of Tensile 1 (T1) and macro 1 (M1) between the 13 & 16 in. marks

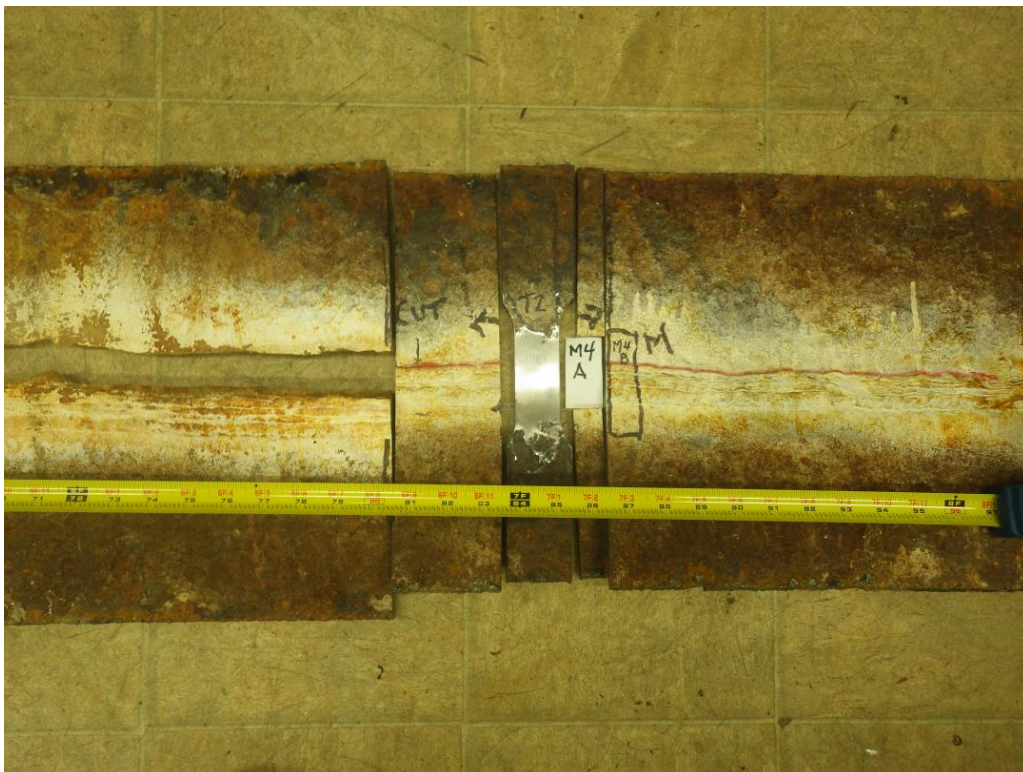
Figure 15 shows the polished section of macro M1 from near the 15 inch location on the plate. Although visually there did not appear to be any cracking, it is evident that there was a crack created in service. The as-polished section shows that a crack had propagated along the toe of the weld for a distance of approximately 0.75 mm into the plate. An unusual feature was that an

Figure 15 Photograph showing the location of Tensile 2, Macros M4A & M4B between the 72 & 75 in. marks

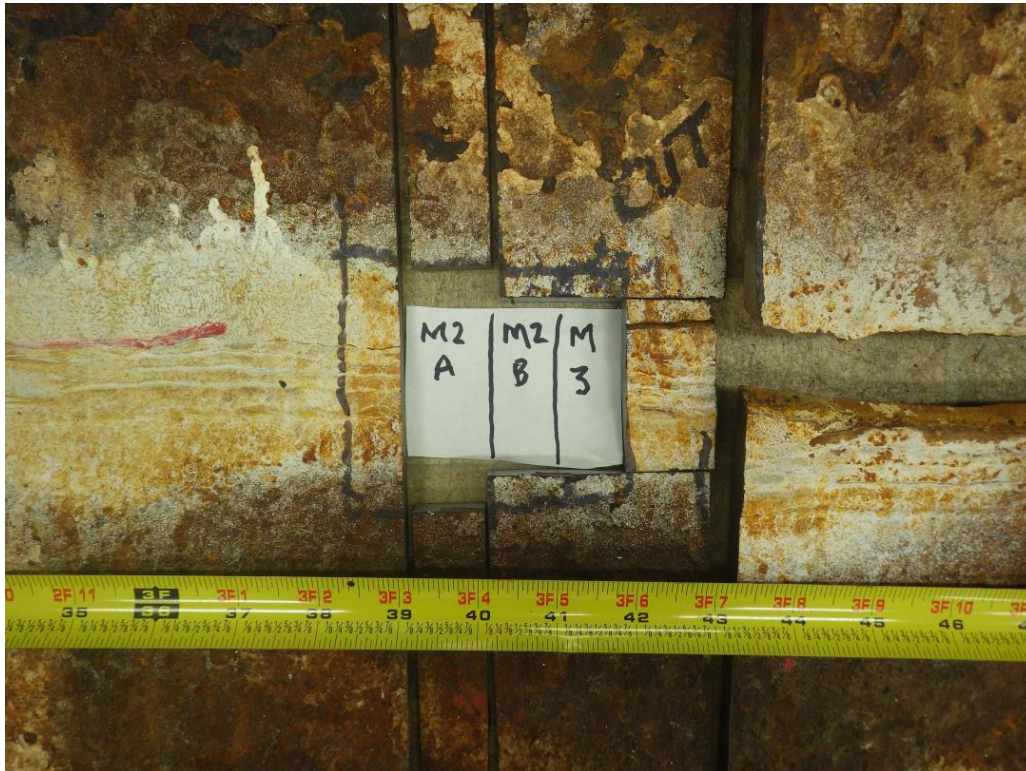
interplanar fracture then developed. Figure 16 shows the etched microstructure from the toe of the weld to the interplanar fracture. There were no unusual microstructures evident to account for the initiation of the original crack.

Figure 16 Photograph showing the location of micrographic section the 39 & 42 in. marks

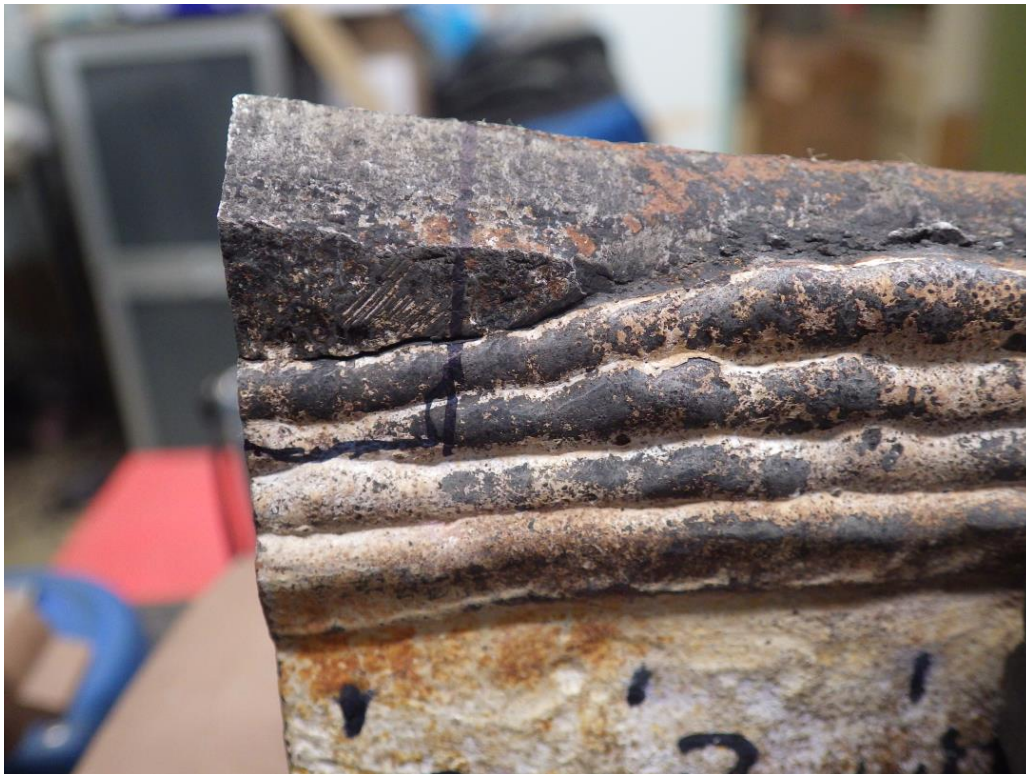
Figure 17 shows a crack in the M3 sample from the 42 inch location after etching. The crack morphology appears similar to that seen in the M1 sample, except that there appeared to be greater deformation opening the original crack. The lack of deformation along the fracture surface shown on the left indicates that the through thickness crack may have been present initially, with the interplanar crack developing later under stresses that caused the crack to open as in bending. The location of the interplanar crack was approximately 0.86 mm below the plate surface.

Figure 17 Photograph showing the location of a metallographic sample from near 42in location

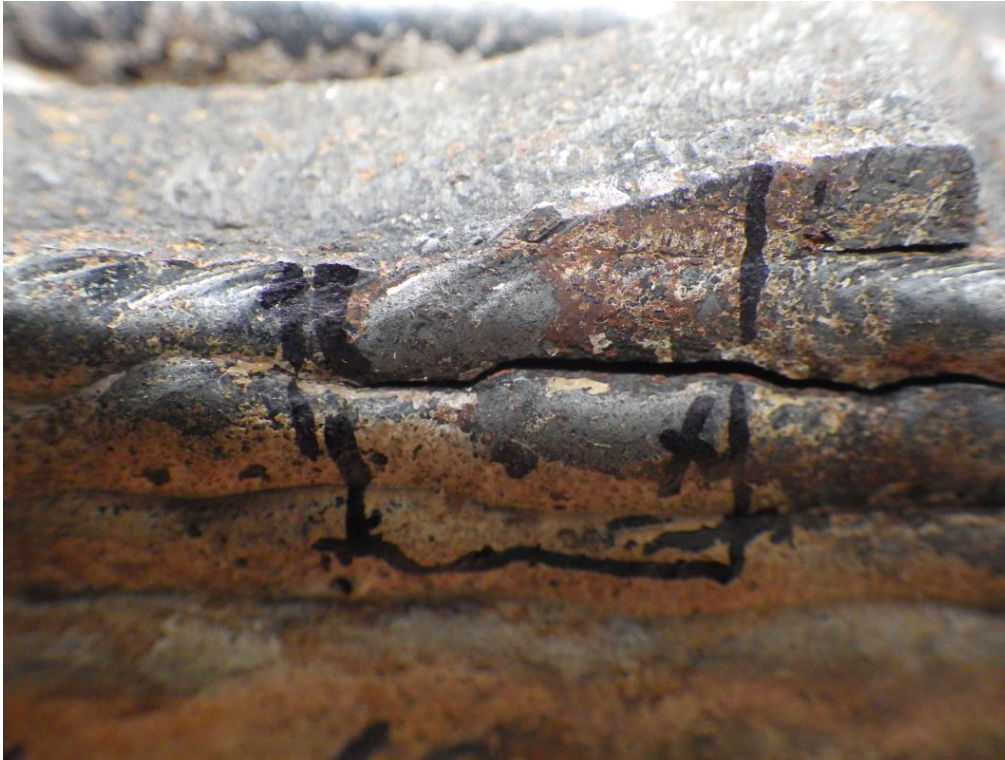
The crack in macro M4B shows a through thickness crack along with two short interplanar cracks propagating at approximately 0.72 mm below the plate surface as seen in Figure 18. The through thickness crack appears to have widened from its initial profile, but this appears to have been due to physical displacement and not due to corrosion. The M4B macro is shown etched, and with Vicker HV10 hardness points in the HAZ in Figure 19. The appearance of the crack in Figure 19 shows that the sides of the crack were likely offset by tension along the internal surface that was concentrated along the weld toe.

Figure 18 Photograph showing the location of a metallographic sample from near 69in location

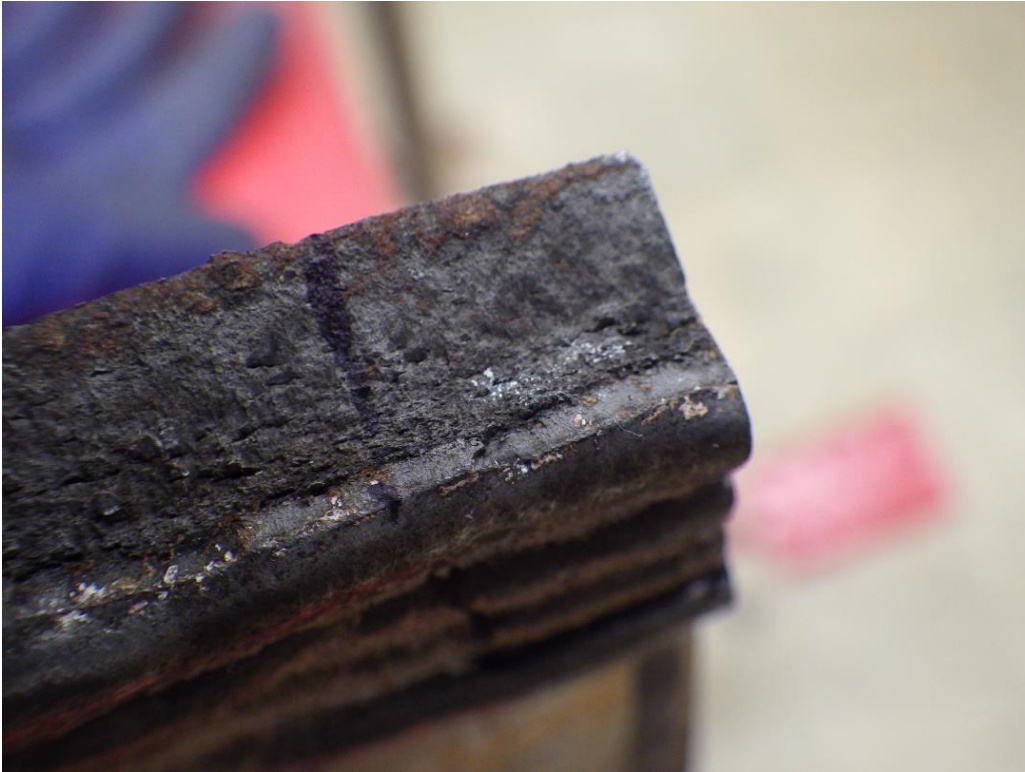
The etched microstructure in Figure 20 shows the MW42 sample. At this location a small through thickness crack developed along the toe of the weld, with the main fracture approximately 10 mm away. One thing of note is that the profile of the weld at this location is flatter than seen over the majority of the plate length. The crack displacement at this location appears to be due to tensile stresses along the internal surface of the plate, and not due to corrosion.

Figure 20 Photograph showing the location of a metallographic sample from near the 79 in. marks

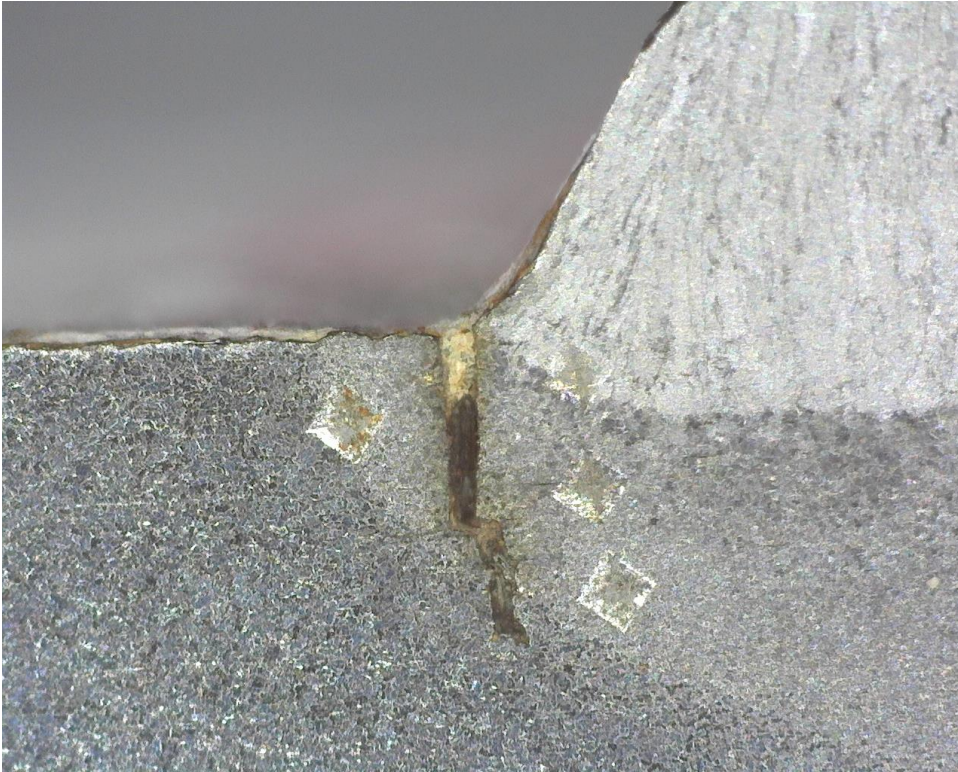
Figure 25 The crack in the M4B sample at the 86.5in location after etching & hardness testing

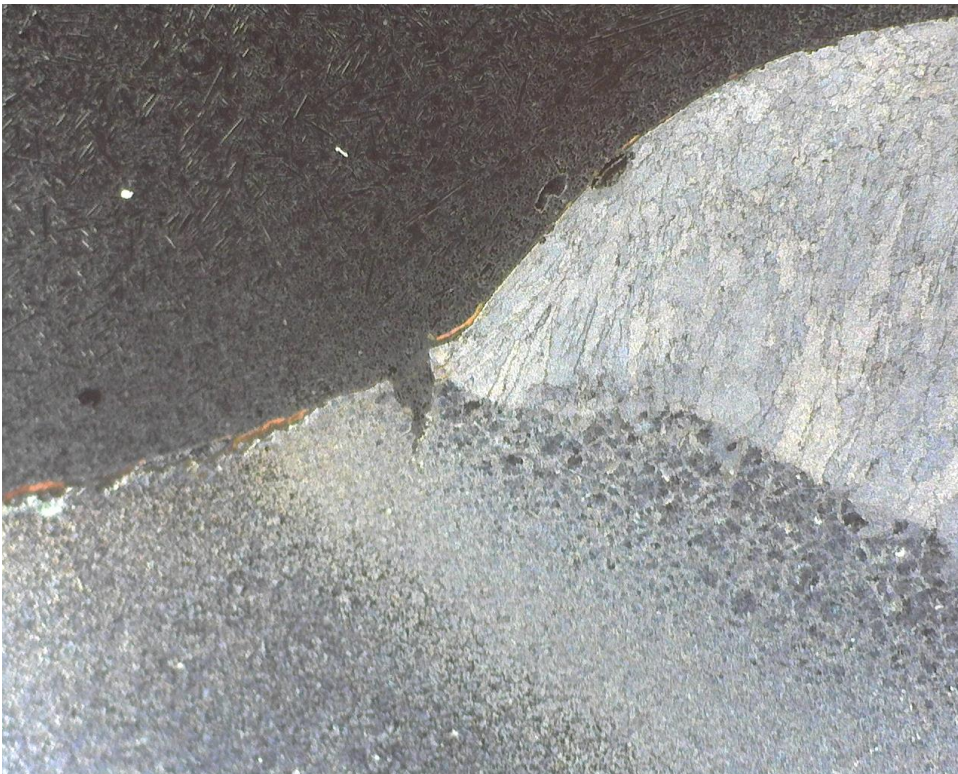
Figure 26 Photograph showing the crack in the MW42 sample at the 42in location after etching

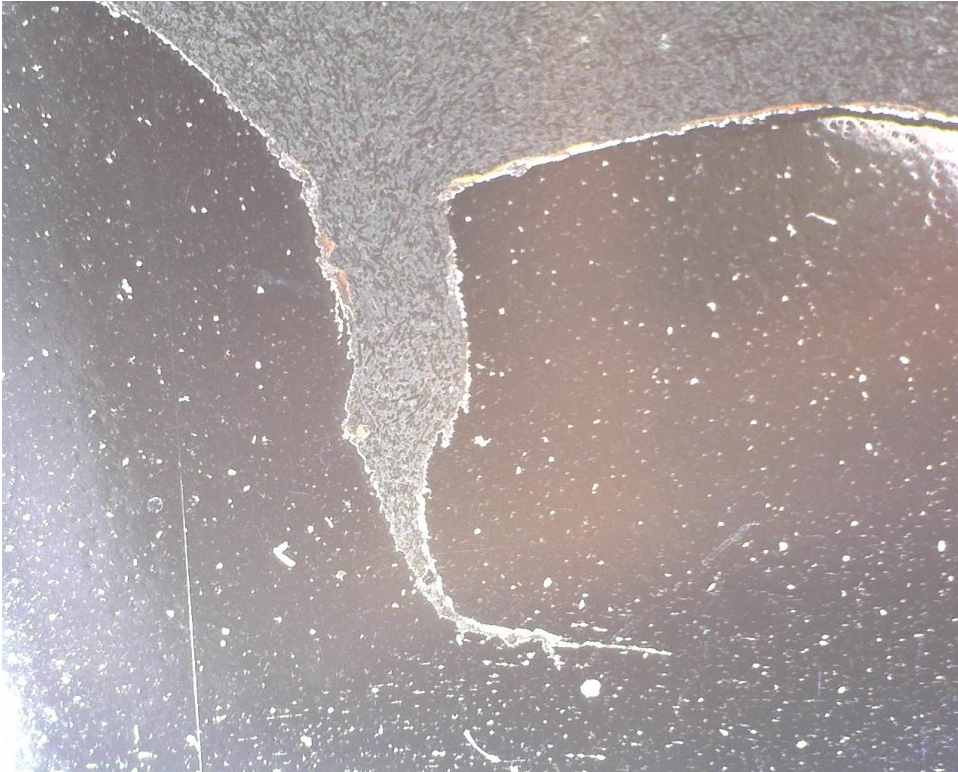
Figure 27 Photograph showing the crack in the MW69 sample at the 69in location, as polished
