1 Q. Please provide a copy of equipment-related root cause or causal analyses reports
2 conducted over 2016-2018.

CRACK INVESTIGATION AND REPAIR REPORT

This report is intended to summarize the site inspection and repair recommendations of a crack that developed in Penstock No.1 at the Bat d'Espoir hydroelectric development owned and operated by Newfoundland and Labrador Hydro (NL Hydro).

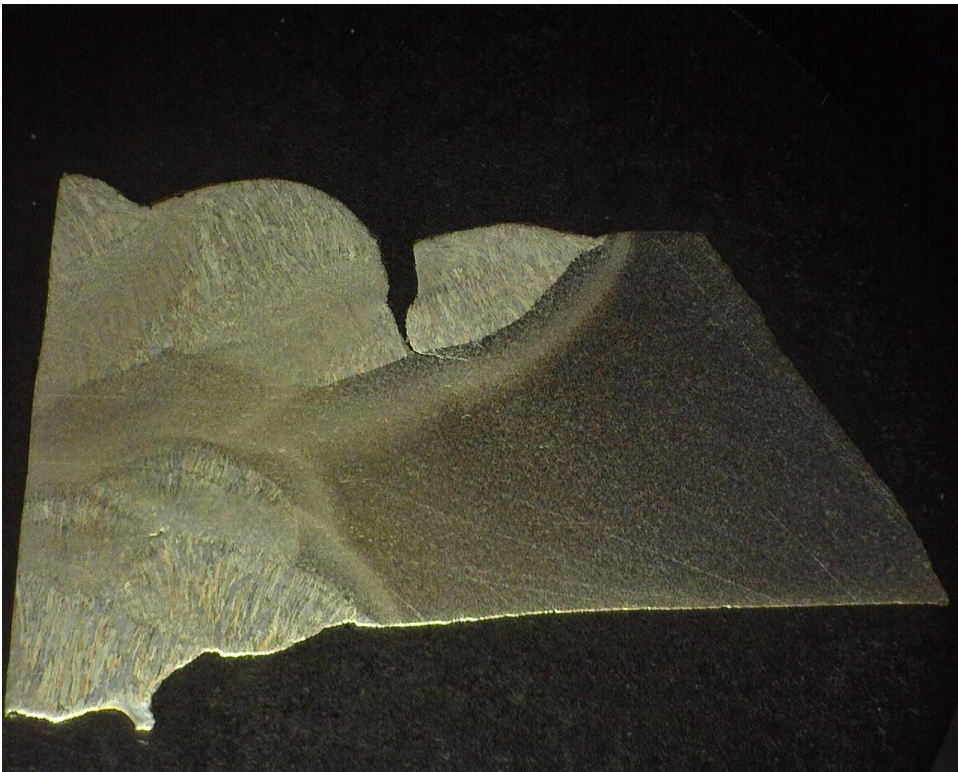
Figure 28 Macrograph showing the crack in the MW69 sample at the 69in location, etched

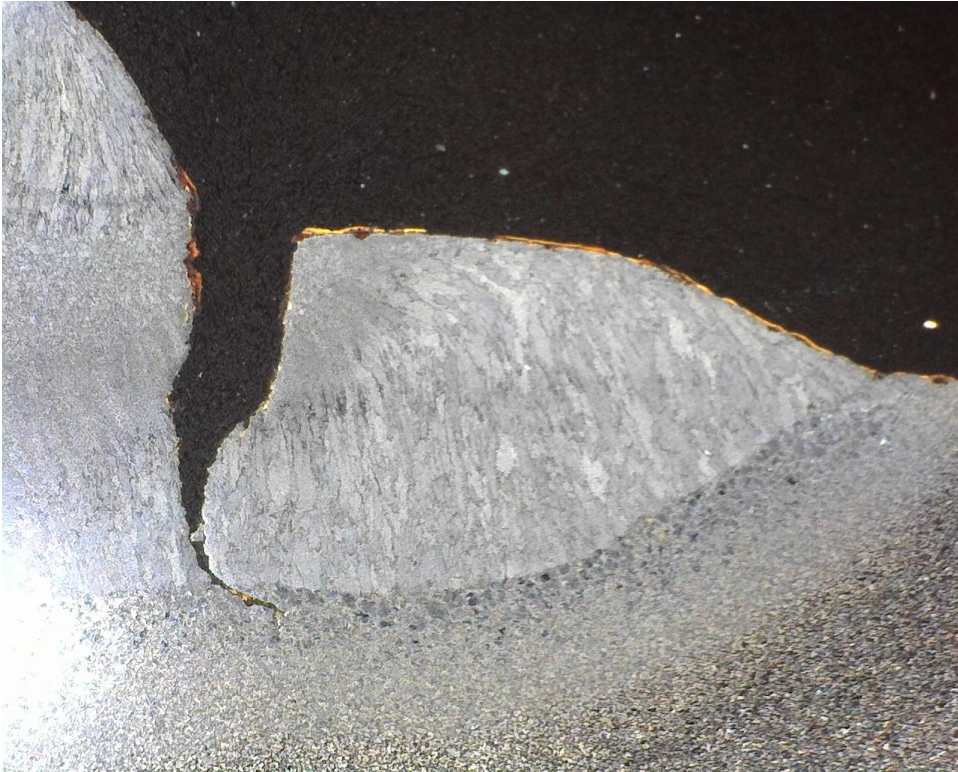
Figure 29 Macrograph showing close-up of the crack in the MW69 sample at the 69in location, etched

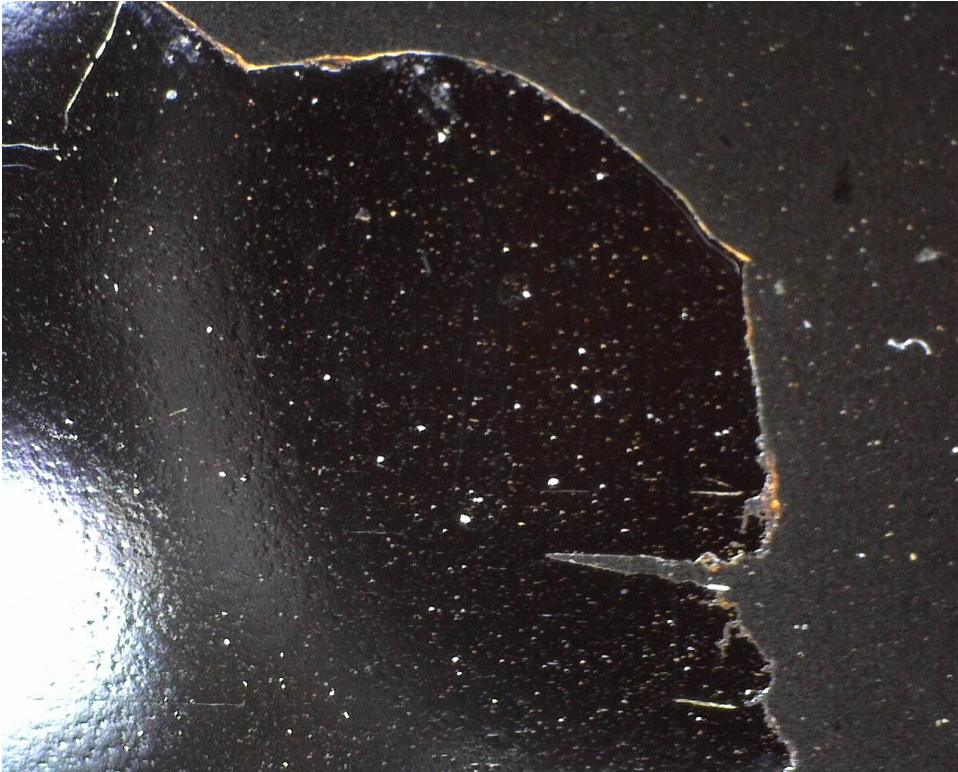
Figure 31 Macrograph showing the crack in the MW71 sample at the 71in location, unetched

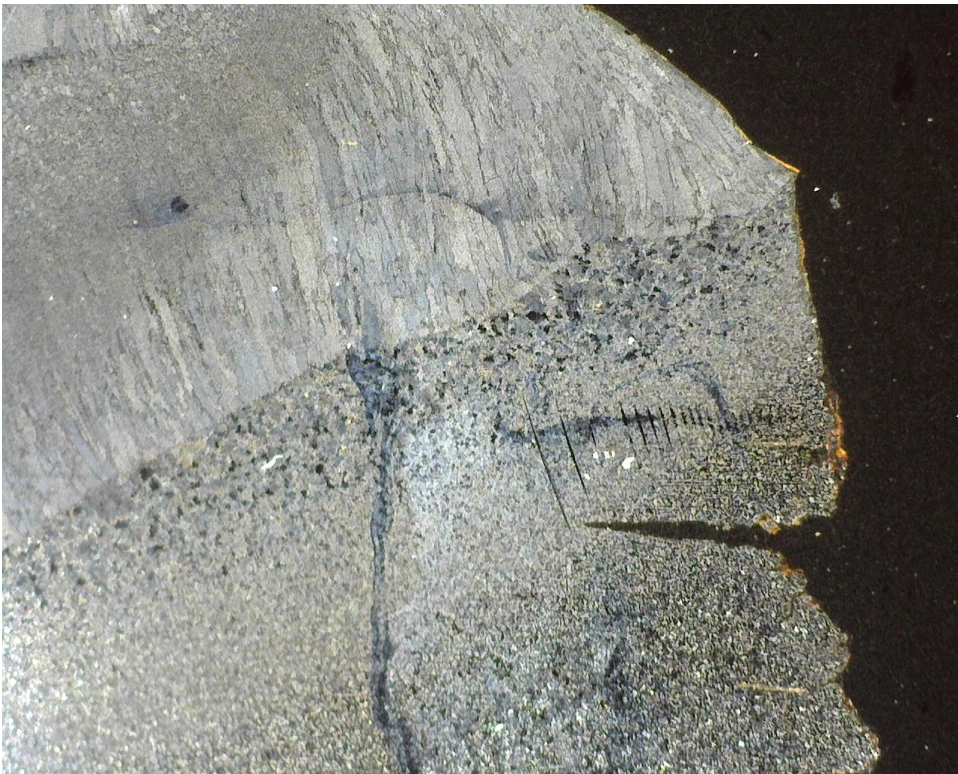
Figure 32 Macrograph showing the crack in the MW71 sample at the 71in location, etched

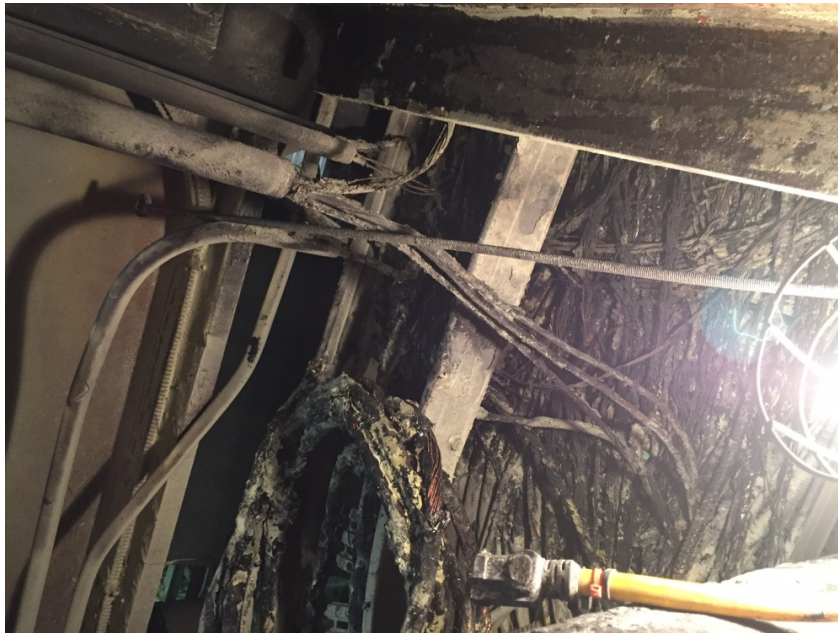
Figure 1 – Unit 2 Fire Damage (A)

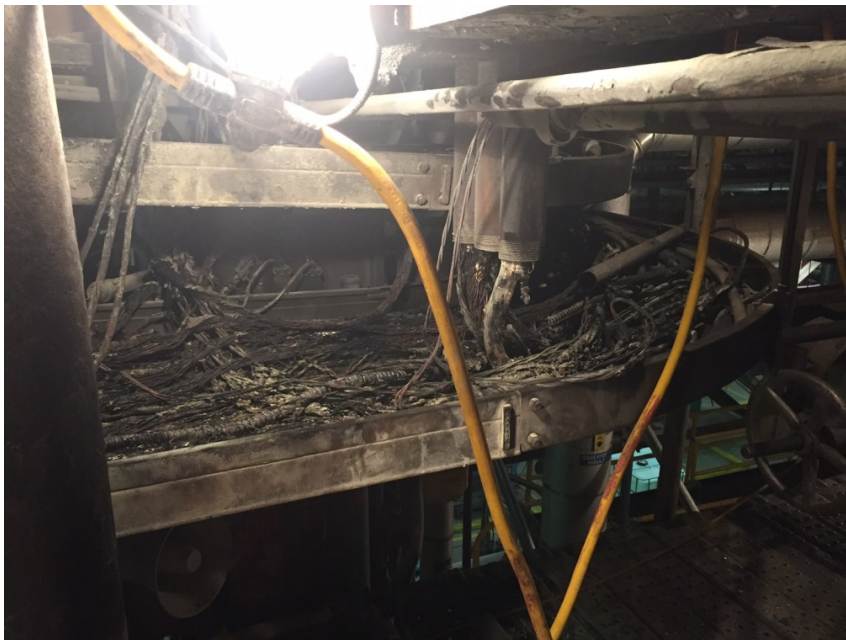
Figure 2 – Unit 2 Fire Damage (B)

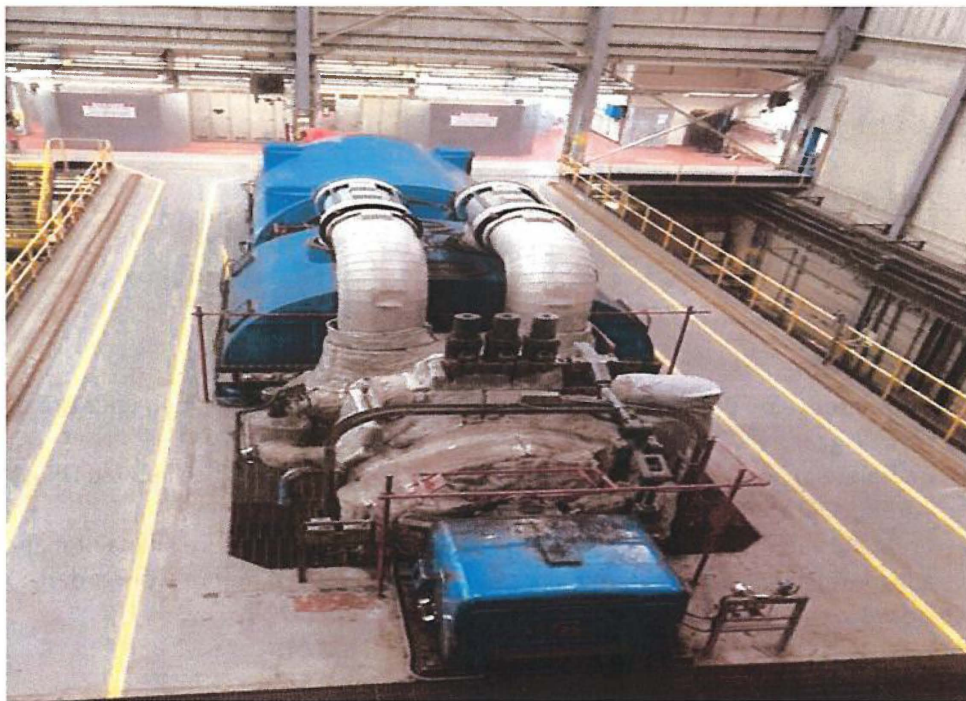
Unit 1 Turbine Generator

On February 22, 2018 Unit 1 was returning to Operation after extensive maintenance, when a fire occurred on the Turbine Bearing #2. The Plant evacuation alarm was initiated and ERT were notified immediately. Operations crew and ER Technicians extinguished the fire. There was significant smoke in the Powerhouse however it was eliminated within 20 mins of extinguishment and the air quality reported as good. There were no injuries or further equipment damage. The fixed fire protection on the unit did not activate, as there was insufficient heat in the vicinity of the sprinkler heads. The fire panel was inspected and the unit pre-action fire systems were active, with no damage.

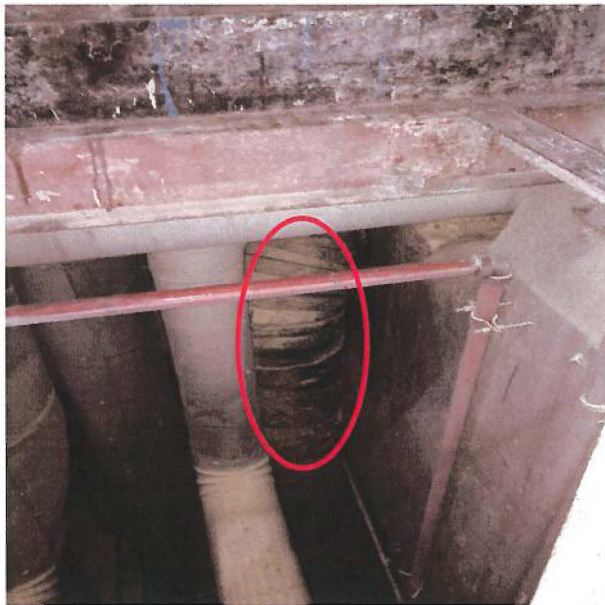
The Cause of the fire was a result of exposed Insulation that had absorbed Lube Oil and “flashed” when the unit was heating up. While Unit 1 had been offline for Maintenance repair, there was a period of time that the Turning Gear on the Turbine had been shut off but the Lube Oil pressure remained on the bearing. Lube Oil had leaked and was absorbed in a replaced section of pipe insulation below the bearing that did not have protective cladding. The source of the oil was Bearing #2. A visual inspection was complete following the incident, but there was no obvious identification of why the leak has occurred. If cladding had been present it is likely that the oil would have ran down the cladding and “pooled” at a location that could have potentially been observed by an Operator during completion of the Turbine Checklist.

Exposed Pipe Insulation

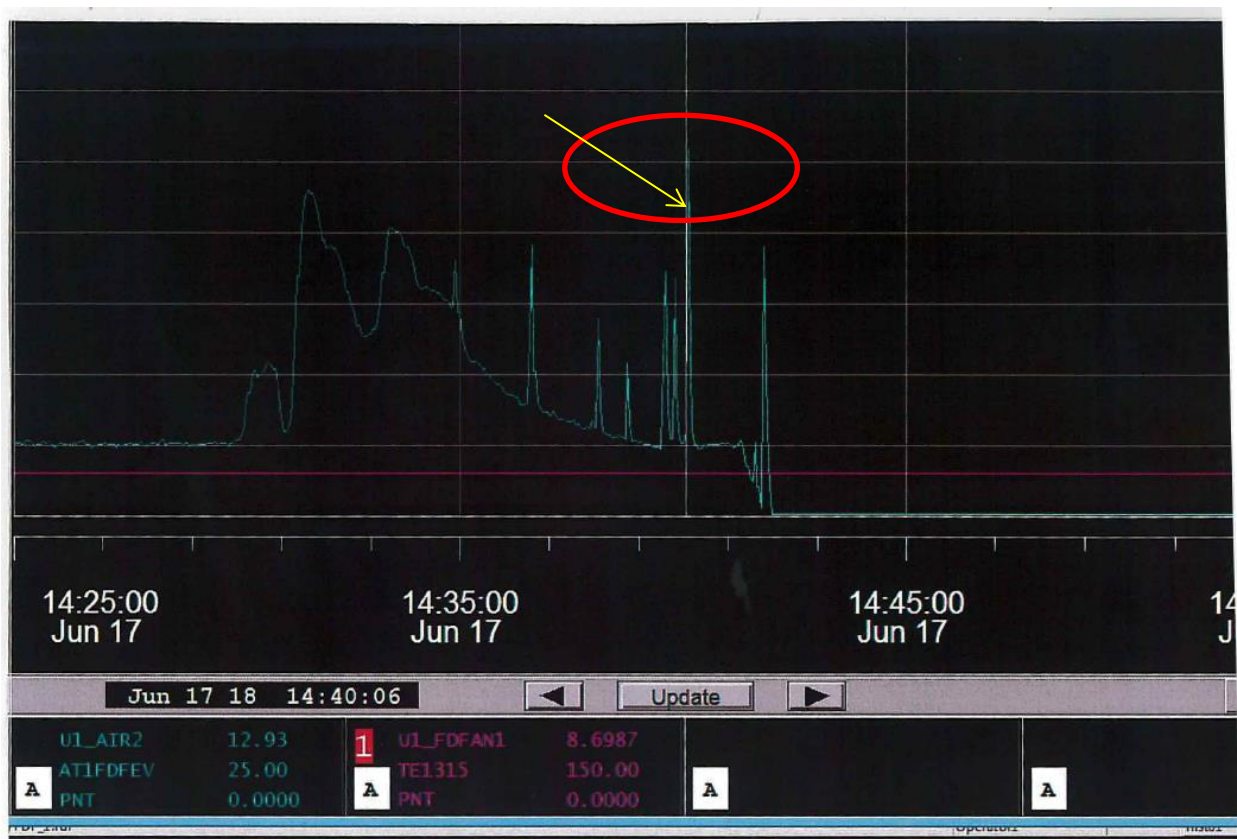
The above readings shown in the Table do not indicate a high vibration in the bearing.

The inboard vibration of the bearing had spiked to 12.93 microns prior to shut down as seen in the DCS print out. The alarm for high vibration is 7 microns and the trip is 20 microns. The DCS print showing the 12.93 micron vibration is as shown below:

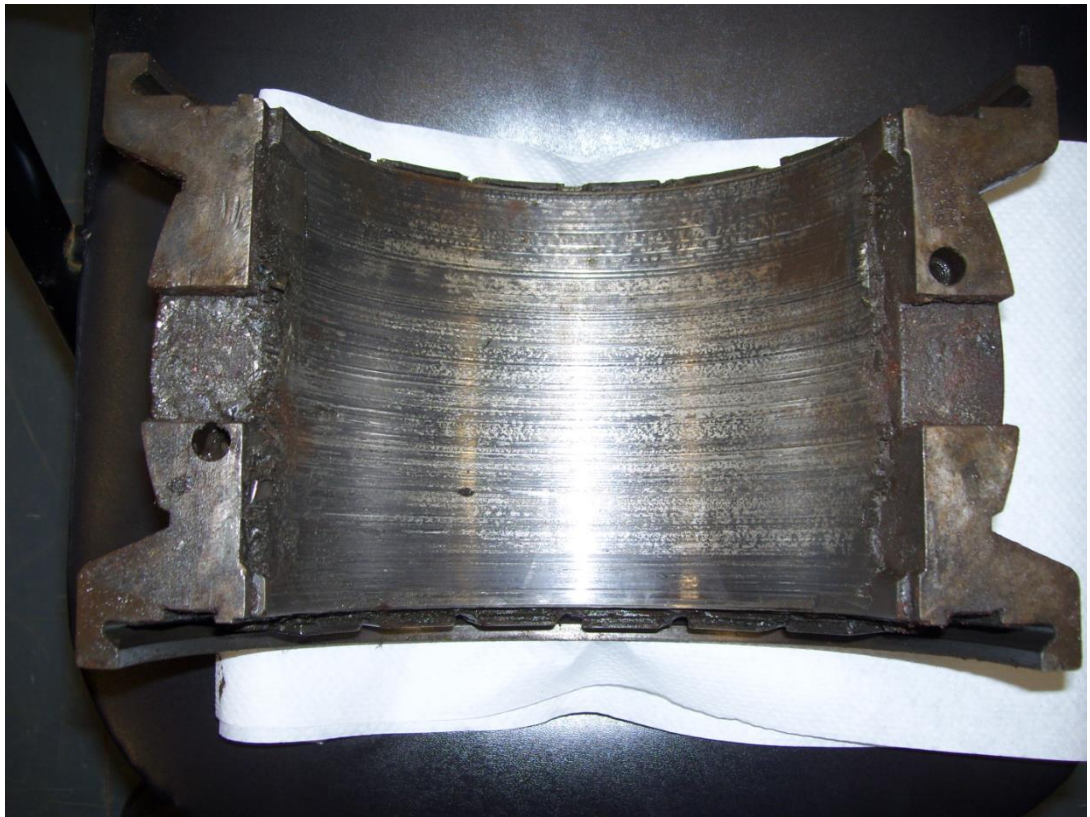
2.1.3 The scoring on the bottom half of the bearing

The scoring at the bottom half of the bearing indicates ingress of material between the journal and the babbit. The bearing housing is sealed by half an inch thick rope packing and hence there is no possibility of any material entering bearing. The scores were the result of liberated babbit getting between the journal and the bearing.

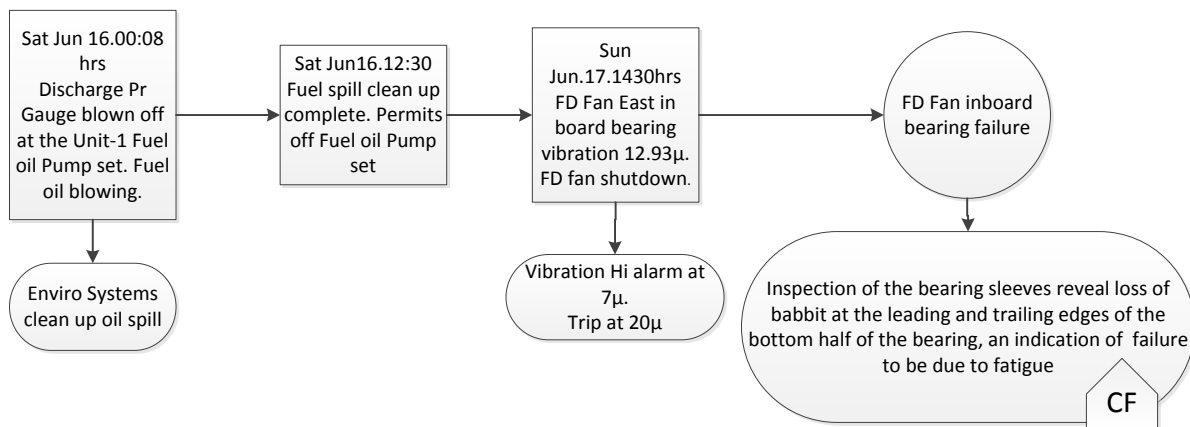
SNAP CHART OF UNIT-1 EAST FD FAN INBOARD BEARING FAILURE

1. Fatigue failure of babbit. Dye Penetrant or Ultrasonic testing of babbit during Boiler outage would have identified fatigue failure cracks .
2. Dirt in cooling water piping to the bearing. Flushing the cooling water piping during Boiler outage would have resulted in a larger cooling water flow to the bearing, thus lowering the bearing temperature which in turn would have increased the threshold limit of the stress levels on the babbit.

1. Plant equipment requires periodic review of preventative maintenance strategies based on the service life of equipment. Strategies should be revised as required.
2. FD fan PM should be upgraded.

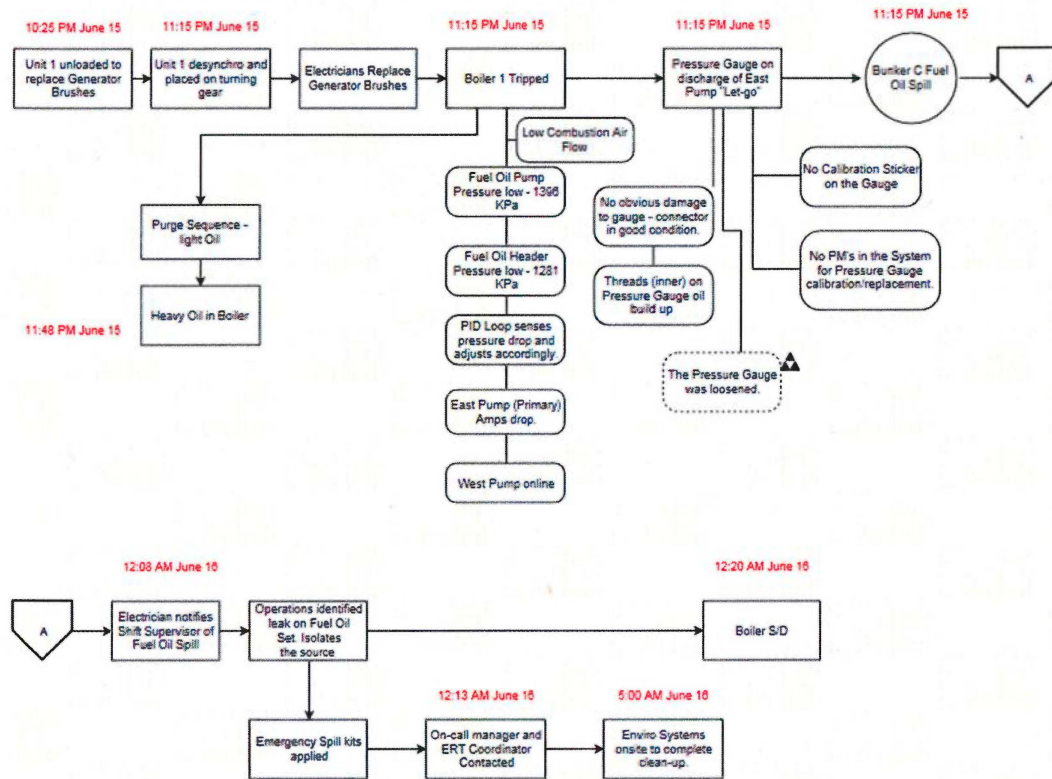
Figure 1: Snap Chart (Tap Root) – Sequence of Events

On June 16 2018, at 12:08 AM, the Electricians notified the Shift Supervisor that there was a Fuel Oil leak. Both the Shift Supervisor and Outside Operator went to investigate and discovered that the source of the Bunker C fuel oil was a Pressure Gauge that had "let-go" on the discharge of the Primary Pump (East) on Unit 1 Fuel Oil Set. The Shift Supervisor notified the Control Panel Operator, who removed the oil from the burner and shut down the pumps. Both the Shift Supervisor and Outside operator isolated the suction and discharge of the pumps, and closed the isolation valve on the Pressure Gauge that had "let-go". The Control Panel Operator shut down Unit 1 Boiler at 12:20 AM.

The Control Panel Operator removed heavy oil from the burner and shut down the pumps. Both the Shift Supervisor and Outside Operator isolated the suction and discharge of the pumps, and closed the isolation valve on the Pressure Gauge that had “let-go”. The Control Panel Operator then shut down Unit 1 Boiler.

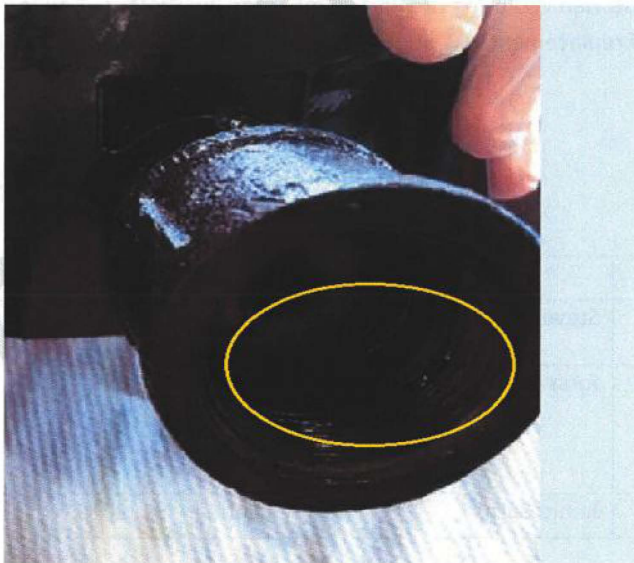
Photo 1: Pressure Gauge

Causal Factor: Loose Pressure Gauge Connection.

Inspection of the Pressure Gauge that had “let-go” and the connectors did not have any apparent thread damage – maintenance did not have to replace the coupling or nipple, only the pressure gauge. This would lead one to believe that the Pressure Gauge had been loosened. If the connection was tight when it “let-go”, then there would have to be thread damage to one or both of the components. Also, during the inspection of the Pressure Gauge, the threads closest to the gauge itself had a buildup of oil – see photo below.

The oil would indicate that there was not a complete connection and that the Pressure Gauge had been loosened or not tightened when installed.
