Re: Application for Approval of Refurbishment of the Hardwoods Gas Turbine Alternator Exciter

End Bearing and the Purchase of an Exciter Bearing Liner and Thrust Pads

Restoration of Hardwoods Gas Turbine Capital Spares

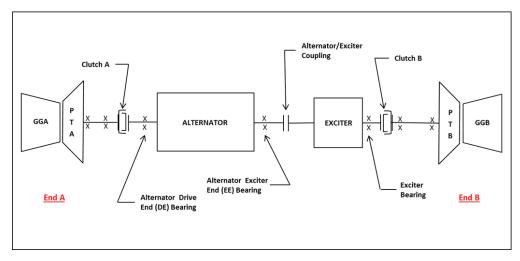
Figure 1: Hardwoods Gas Turbine Machine Sketch

- components including the alternator and exciter shafts and associated bearings.
