Re: 2019 Failure of Bay d'Espoir Penstock 1 and Plan Regarding Penstock Life Extension

Bay d'Espoir Penstock No. 1 – 2019 Failure Investigation Report

Newfoundland and Labrador Hydro
Bay d'Espoir Penstock No. 1 – 2019 Failure Investigation Report

668998-0000-40ER-0001
Revision 00
March 19 2020

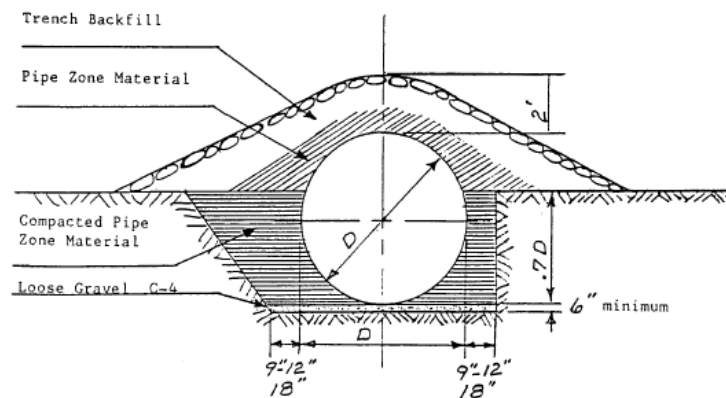
Figure 5-1: Typical trench installation for buried penstock (Ref. 1)

The design calculations show that the allowable stresses in penstock No. 1 are not exceeded at any location along the penstock. However, for the penstock portion between the intake and 49 m downstream of elbow 4A (Can 1 to Can 161), where multiple failures occurred in Penstock No 1, the minimum plate thickness required for handling and installation is not respected. The minimum plate thickness should be 14.3 mm (9/16") instead of 10.9 mm (7/16") as per original design. This should require adequate stulling and internal braces during installation to maintain roundness of the conduit within tolerance. For the upstream portion the penstock having a diameter of 5200 mm (17 ft), the allowable out-of-roundness should be less than 52 mm. The stulls and internal bracing should not be removed until backfill has been compacted to minimum high of 0.7 times the penstock diameter, as shown in Figure 5-1. To evaluate the impact of backfill properties on the penstock performance, stress analyses have been performed and results are discussed in Section 5.3 of this report.

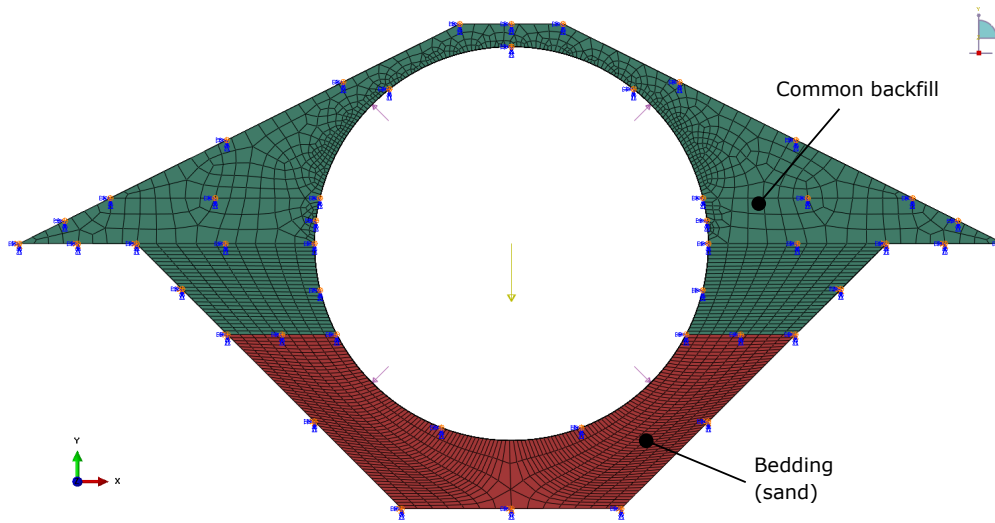
Figure 5-2: FE Model

Figure 5-2 presents the FE model for a typical 5.2 m (17 ft) diameter penstock section installed in trench backfill.

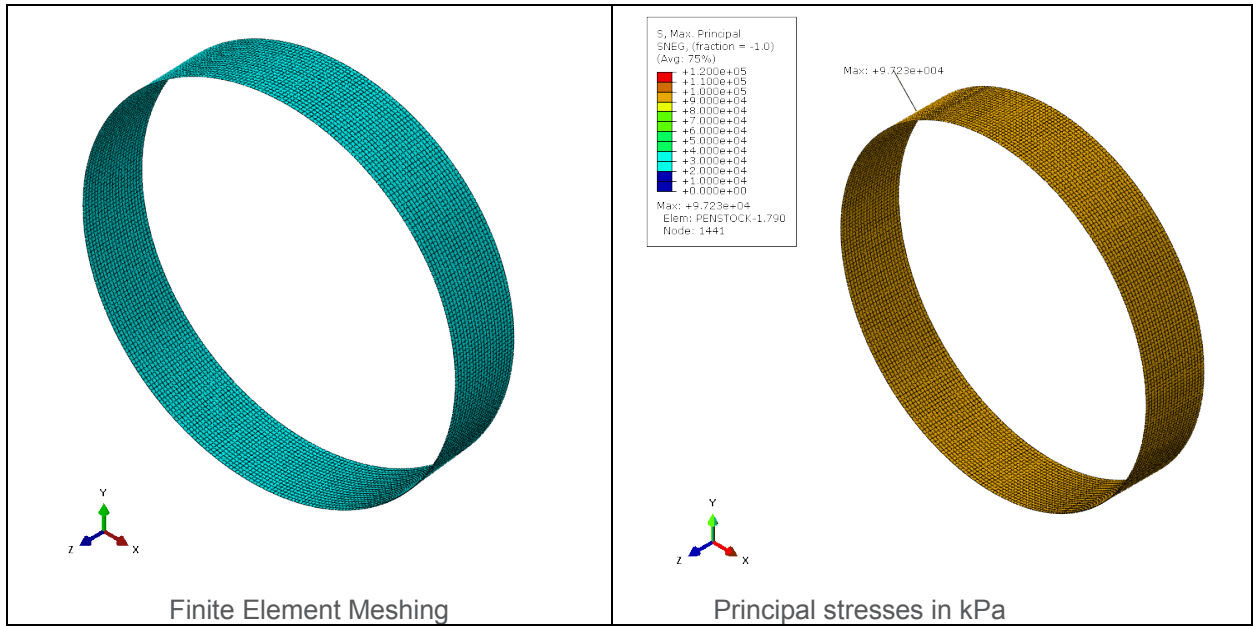
Figure 5-3 Model 1 - Circular steel pipe under internal pressure (no backfill)

Figure 5-3 shows the results for a circular steel pipe under internal pressure of 400 kPa with backfill. The membrane (hoop) stresses are of the order of 97 MPa, which is less than allowable value of 126 MPa for the membrane hoop stress.

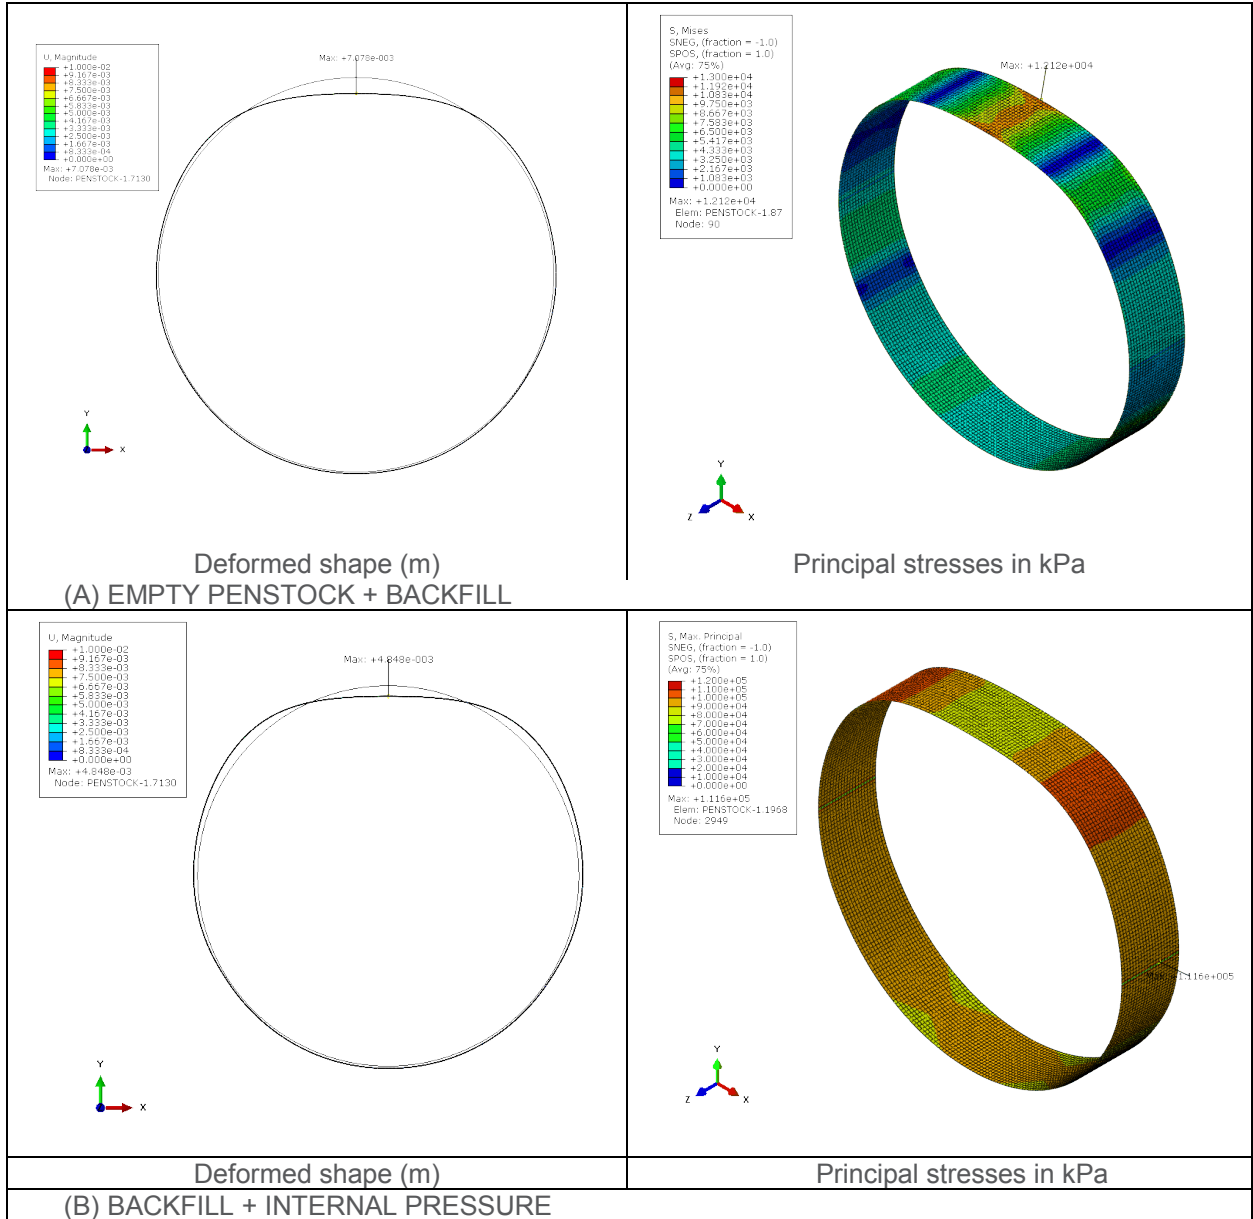
Figure 5-4: Model 2 - Penstock with backfill and under internal pressure

Figure 5-4 shows FE results for an empty steel penstock and under internal pressure of 400 kPa. The maximum membrane and the bending stresses are of the order of 121 MPa, which is less than allowable value of 190 MPa.

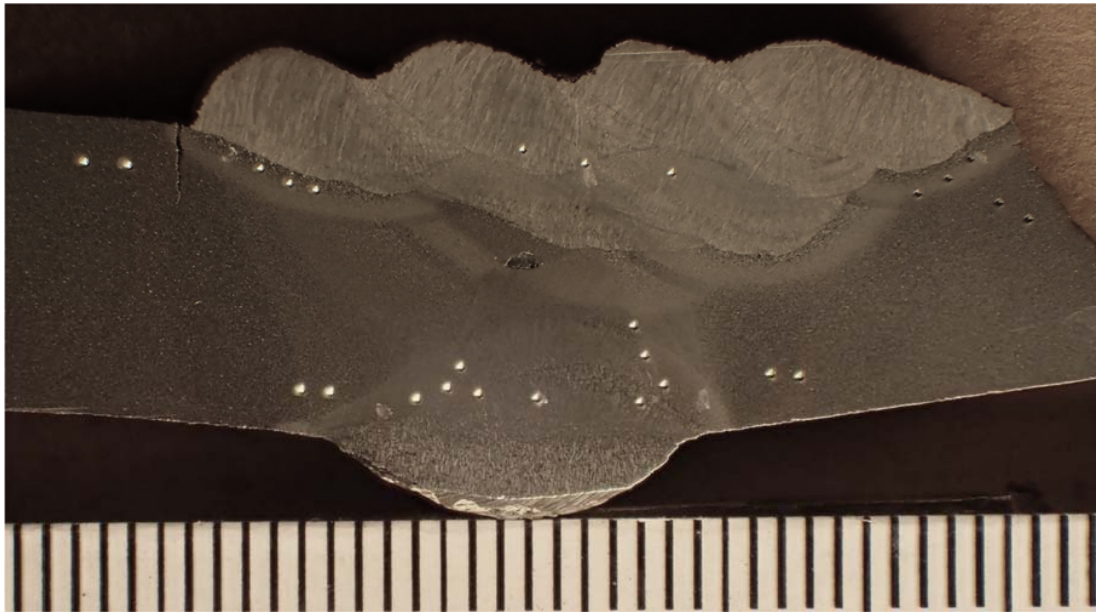
Figure 1 Macrograph of Hardness Profile

A macro-section was prepared through the weld and polished to a 1- μ m finish as per RPC SOP PM-0010 and etched using 5% Nital (5% Nitric Acid in Ethanol solution). A macro-examination was conducted up to 20x magnification under a stereo-microscope. The weld appears to be a double bevel joint. At the location of the macro-section, there are two separate cracks initiation from the same surface. Due to the limited availability of un-cracked material, the microsection was taken through one of the major visible through-wall cracks. As seen in Figure 1, one crack is through-wall and the other is a small linear crack, approximately 2.8 mm deep. Both cracks originate at the weld toe and for the smaller crack, there is a steep angle (transition) between the weld cap and penstock pipe surface potential serving as a stress-riser. There also appears to be lack of weld penetration within the double bevel joint.

Several Vickers' hardness readings were taken from the macro-section using a diamond pyramid indenter with a 10 kg load. Readings were taken in the parent metal, weld metal and heat-affected zone (HAZ) of the assembly. The maximum reading was 241 Vickers (HV₁₀) in the weld. A macrograph of the weld profile can be seen in Figure 1 and reading locations are illustrated in Figure 2. Hardness results are found in Table 3.

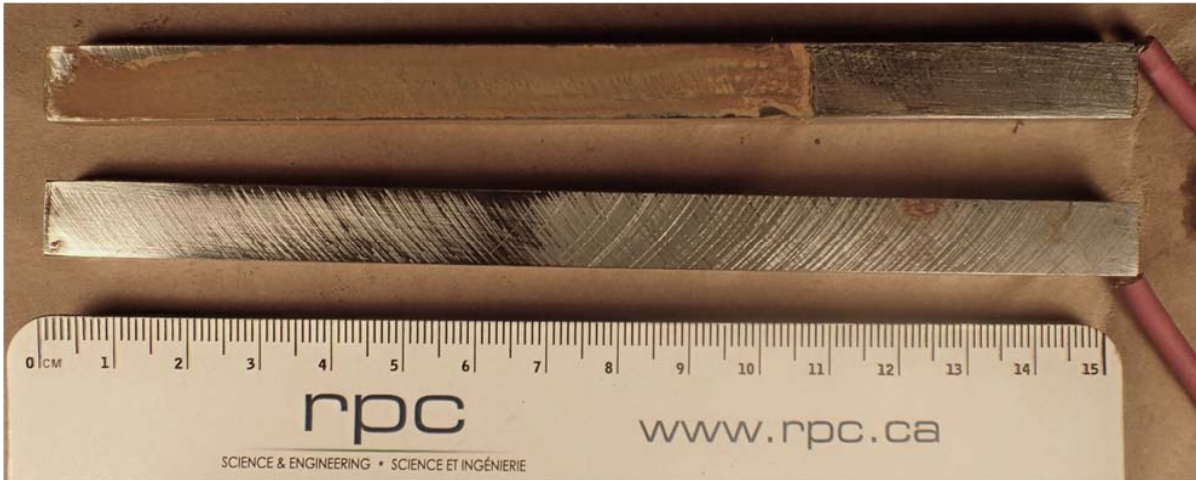
Figure 2 Samples at Conclusion of Testing. Weld Metal can be seen above and Parent Metal Below.

The samples were immersed in the electrolyte for a six-hour duration recording potential throughout the extent of testing. Figure 2 illustrates the samples condition at the conclusion to testing. Voltage readings were taken at two-minute intervals throughout the duration of testing, a comparative graph illustrates the potential generated during testing. The potential of both the weld metal and base metal were similar in the corrosive potential generated in the galvanic cell, with the weld metal being slightly more active.
