1 **Distribution Reliability Initiative, Volume III, Distribution - Appendix 3, Attachment B,**  
2 **pages 1- 2 (\$949,000)**

3  
4 **Q. How does Newfoundland Power balance the issue of cost and reliability as it relates**  
5 **to the performance of the distribution systems?**

**Newfoundland Power's Response to CA-85  
2003 Capital Budget Application**

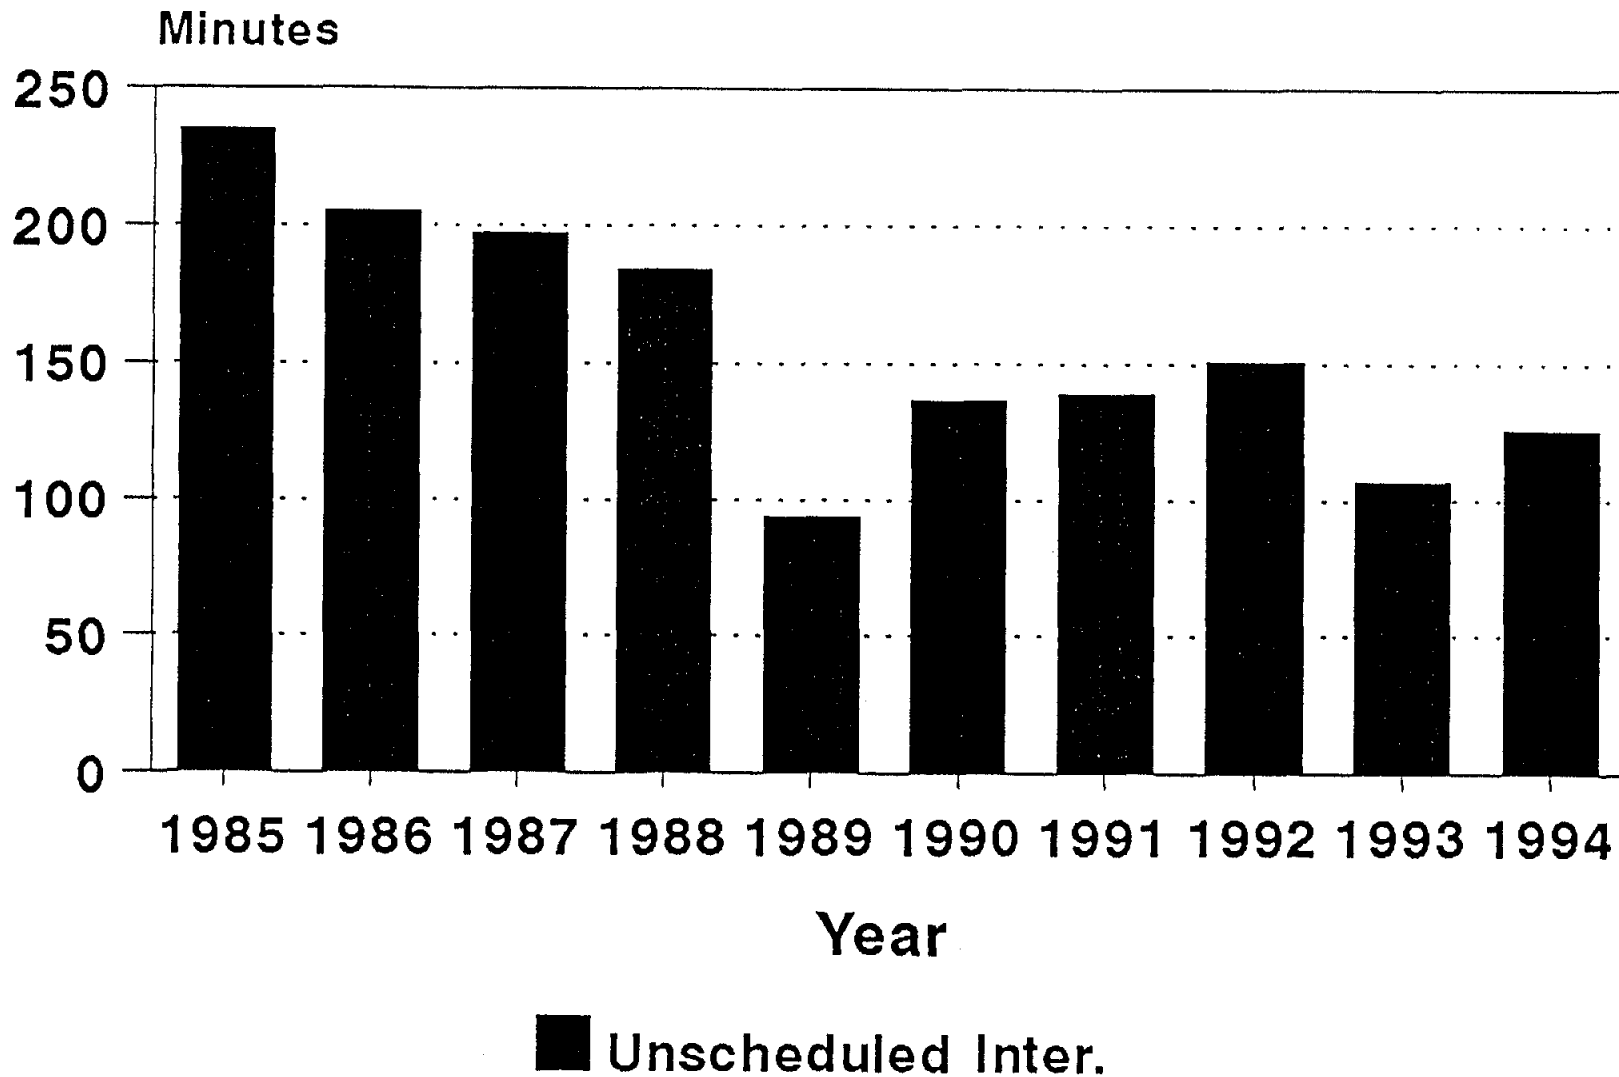
Fig # 2 (Excludes the Dec. 08 outage)

# Average Duration of Interruptions Branch

To permit a review of these outages in an historical context, the Company has provided a ten year graphic history of interruptions in this area. (Figures 1, 2 & 3). While the total number of interruptions appear to be high at first blush, it is noteworthy that the number of unscheduled outages for 1994 (excluding the December 8th, 1994 experience) was the lowest of the past ten years for this feeder (Figure 1). The average duration of these unscheduled outages was the third lowest for the past ten year period and the total unscheduled interruption time for 1994 was the second lowest for the time period (Figure 2 & 3).

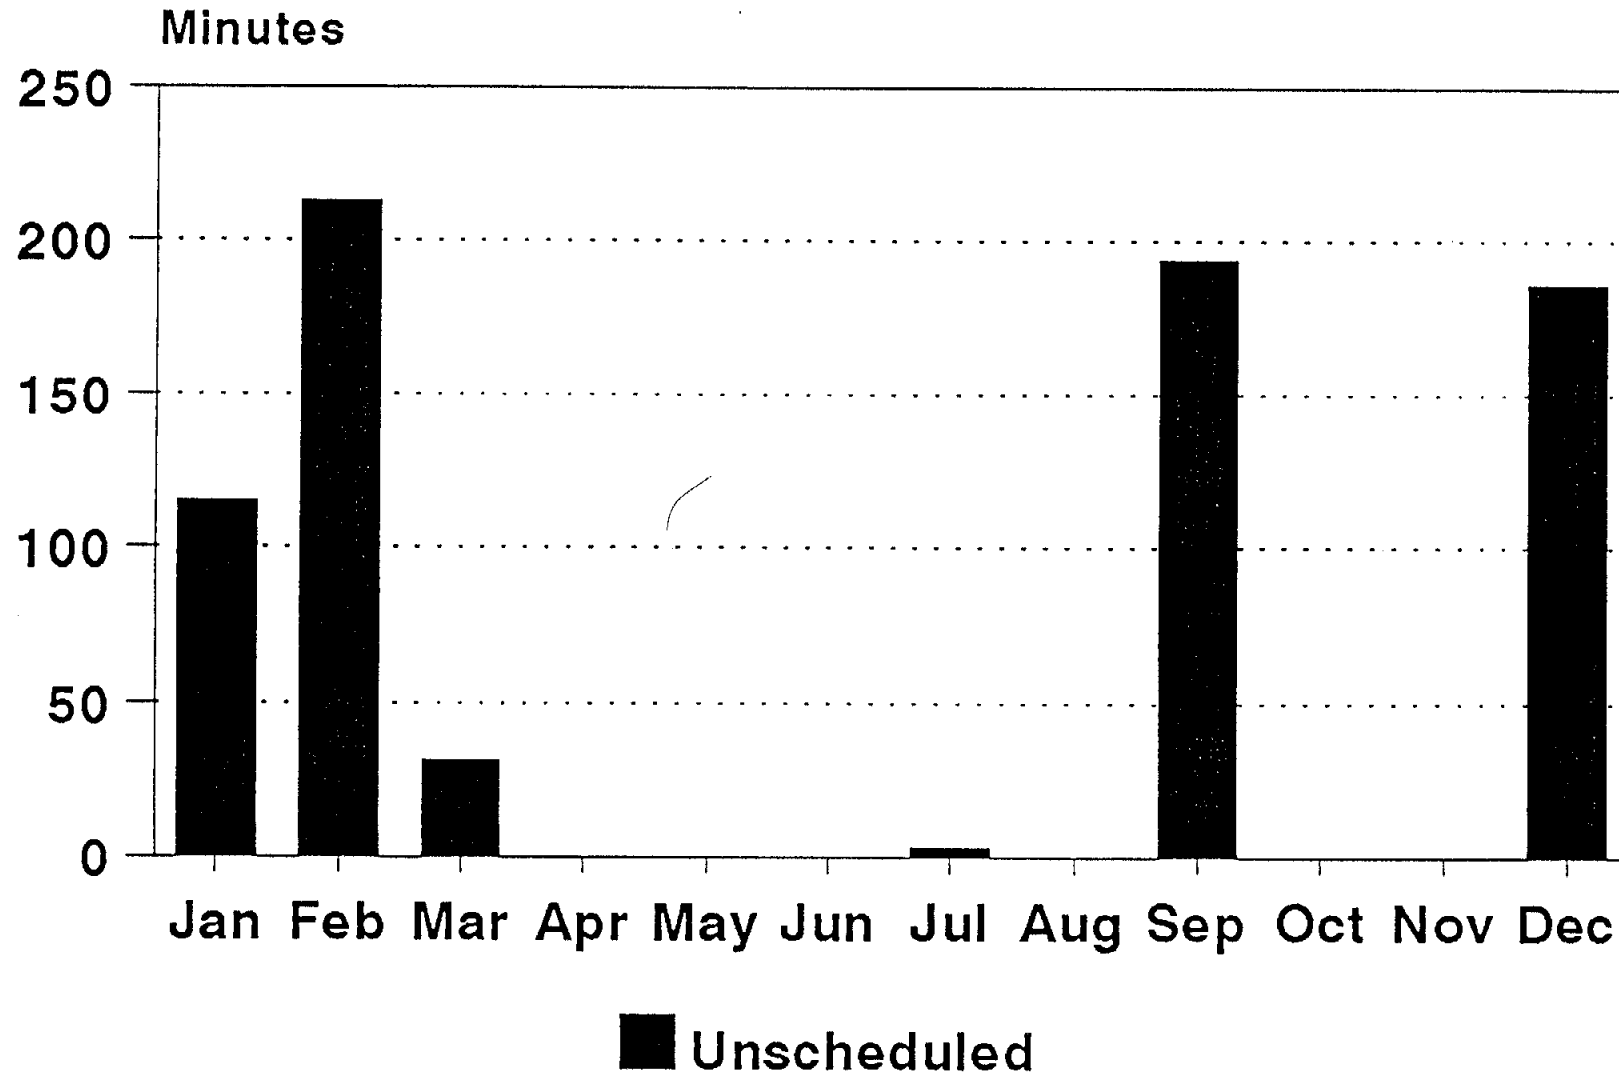
Fig. # 5 (Excludes the Dec. 08 outage)

# Average Duration of Interruptions

## Branch, 1994

Also provided are graphic depictions of the frequency, average duration and total interruption time for 1994 interruptions by month (Figure 4, 5 & 6). From these it can be seen that January and December had the highest number of unscheduled interruptions. This is due to the weather conditions at that time of year. High winds combined with icing place extra loading on the line.
