Re: An Application by Newfoundland and Labrador Hydro (Hydro) pursuant to Subsection 41 (3) of the Act for approval of a capital project to refurbish the stop logs at the Burnt Dam Spillway

# BURNT DAM SPILLWAY REFURBISHMENT OF STOP LOGS

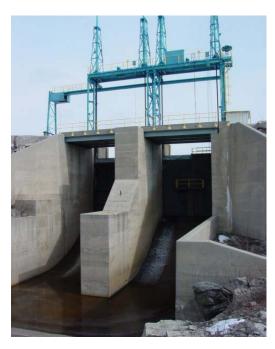
The Burnt Dam Spillway, shown in Figure 1, is a critical hydraulic structure in the Bay d'Espoir Development. It allows water from the Burnt Pond Reservoir, a small uncontrolled reservoir south of the Victoria Lake Reservoir, to be released in a controlled, non-destructive manner when needed for flood control. Water discharged from Burnt Dam Spillway is lost from the Bay d'Espoir Reservoir System, and not available for production of electrical energy at Granite Canal, Upper Salmon and Bay d'Espoir generating stations. The spillway consists of two sevenmeter wide steel gates which can release a combined 1,144 cubic meters per second of water at the maximum flood level.

Figure 1: Burnt Dam Spillway Structure

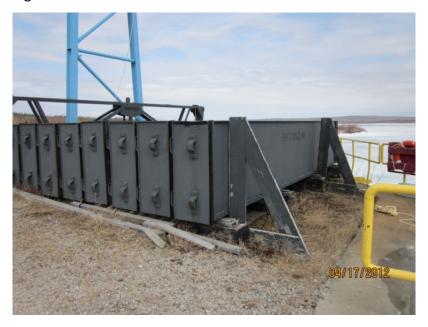
To complete the approved inspections and, if required, repair of the embedded parts a safe work site must be established. The establishment of a safe worksite is accomplished by installing the eight stop logs upstream of the control gates. Stop logs, as shown in Figure 2, are modular hydraulic gates used for the flow control and control structure isolation.

Figure 2: Burnt Dam Stop Logs - Current Storage Arrangement

In Burnt Dam, the stop logs are installed in dedicated slots upstream of the control gates to provide a safe work site in the gate well and to prevent spilling water when completing gate maintenance. The stop logs in Burnt Dam are constructed of steel and are supplied with a set of rubber seals. When the gates are installed in their slots, the seals compress, forming a water tight seal. The presence of leaks around the stop logs prevents work from being safely completed downstream of the stop logs. However, the stop log seals in Burnt Dam have deteriorated to the point that they do not effectively seal and leaks are occurring. The leakage between and around the stop logs is so severe that the approved inspections cannot be completed safely. The leakage of Burnt Dam stop logs into the worksite can be seen in Figure 3.

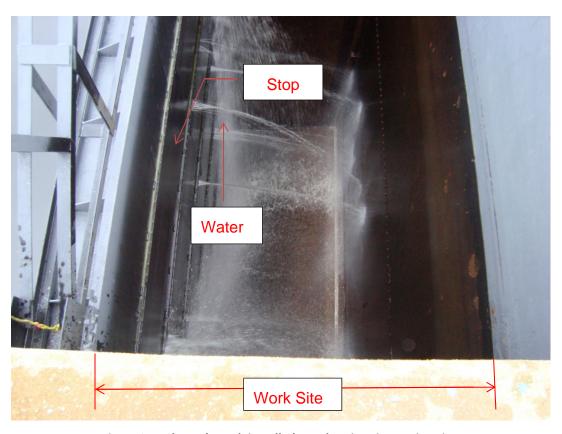
Figure 3: Leakage through installed stop logs into inspection site.

With the current condition of the stop logs, it is not possible to safely complete work on the gate and embedded parts. Therefore, Hydro is not able to complete the approved inspections as approved in Order No. P.U. 2 (2012). This will affect Hydro's ability to accurately determine
