**A REPORT TO  
THE BOARD OF COMMISSIONERS OF PUBLIC UTILITIES**

**Additions for Load Growth - Isolated  
Generating Stations**

L'Anse au Loup and Postville Diesel Plant

July 2015

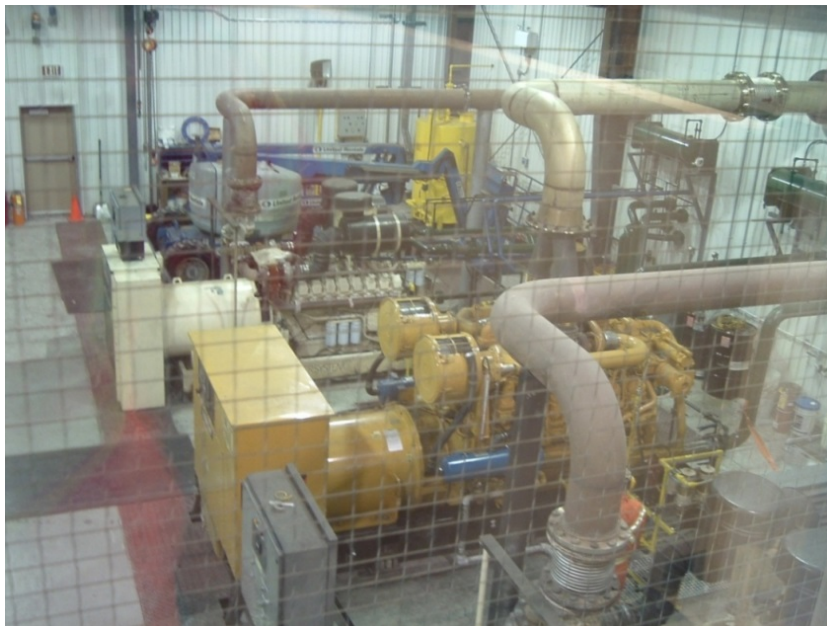
**Figure 3: Nain – Diesel Generators in Powerhouse.**

This proposed project is a continuation of a multi-year program to equip diesel plants with automatic fire protection systems. A water mist fire protection system will be installed where a spray of water and nitrogen produces a blanket of atomized water particles that absorb heat and smother the fire. This system will be used in the diesel generator main hall area (Figures 3 and 4) and other interior spaces requiring fire protection including the supervisory control room, battery room and the lube and coolant storage room.

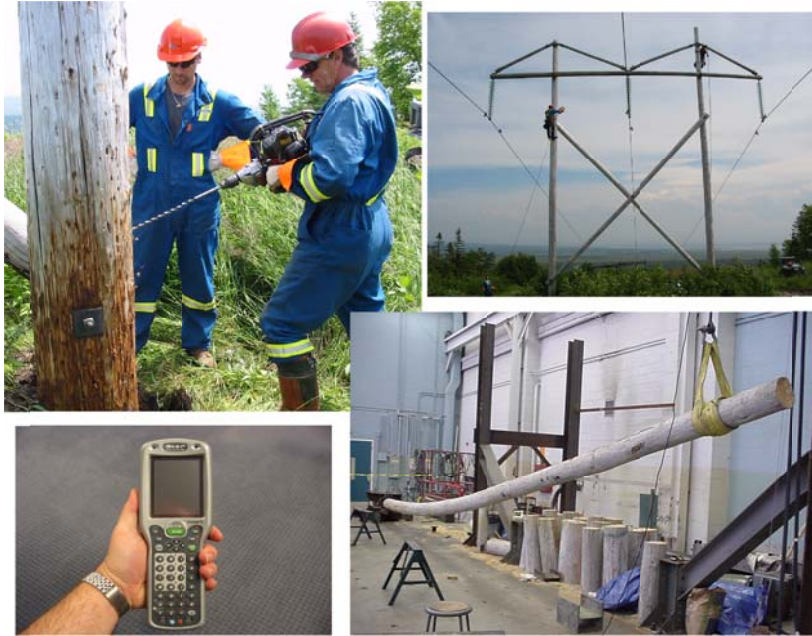
As wood poles age, their preservative retention levels decrease and the poles become increasingly subjected to deterioration by different agents including fungi and insects. Wood poles must be regularly inspected and treated in-situ to proactively identify and assess any deterioration. Prior to 2003, Hydro's pole inspection and maintenance practices followed the traditional utility approach of sounding inspections only. In 1998, Hydro began to collect core samples on selected poles to test for preservative retention levels and pole decay. The results of early tests raised concerns regarding the general preservative retention levels in the poles. This testing confirmed that there were poles in Hydro's system that had a preservative level below that required to maintain the required design criteria. During this period, certain poles were replaced because the preservative level had lowered to the point that decay had advanced and the pole was no longer structurally sound. These inspections and the analysis of the data confirmed that a more rigorous wood pole line management program was required. Figure 1 illustrates typical wood pole inspection techniques. Figure 2 shows typical wood pole inspection results.

**Figure 1: WPLM Inspection Techniques, Clockwise From Bottom Left: 1) Typical Field Data Collector 2) Cavity Measuring 3) Climbing Inspection 4) Destructive Testing at MUN**

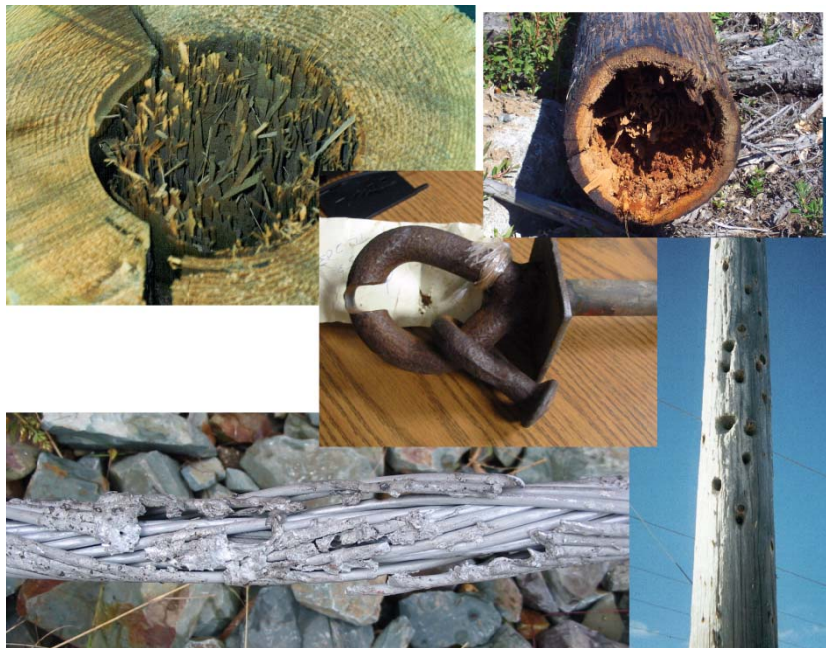
**Figure 2: Typical Wood Pole Inspection Results**

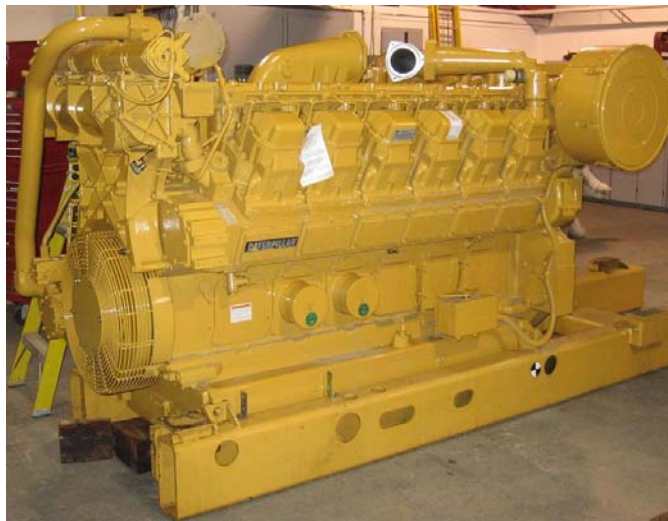
**Figure 1: Ramea Unit 2077**

Figure 1 below is a photo of Ramea Unit 2077 prior to its installation in the Ramea Diesel Plant.

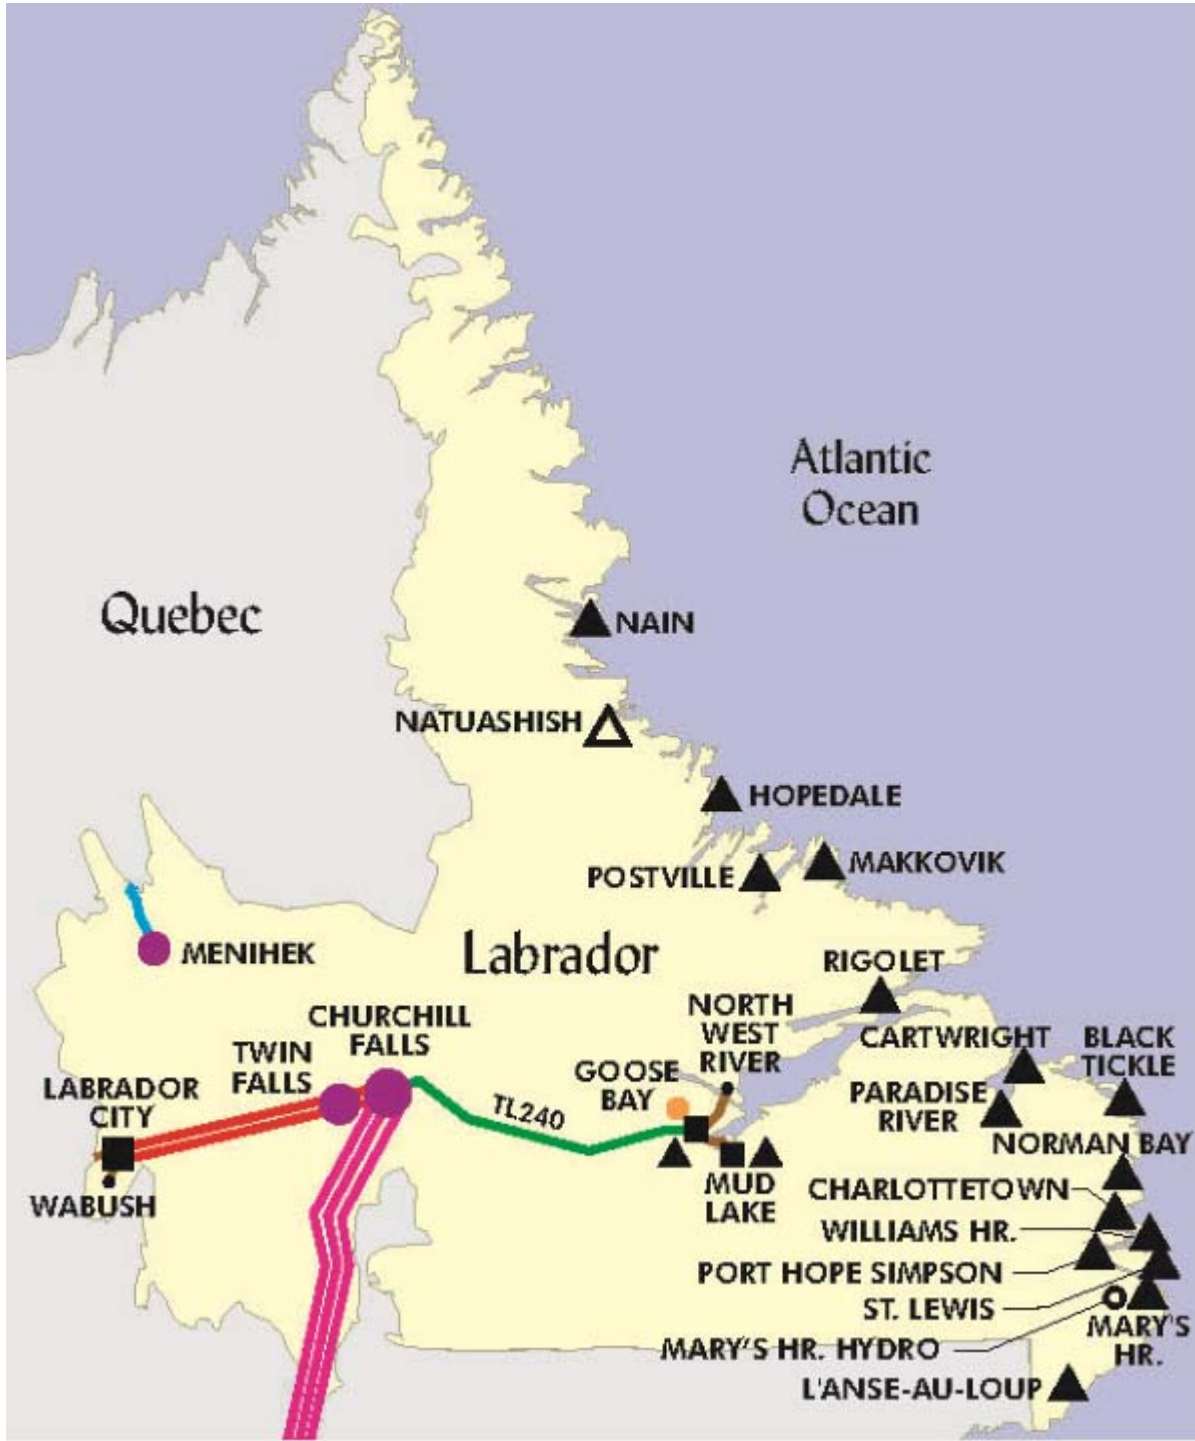
Figure 1: Labrador Generation and Transmission Grid

<sup>1</sup> Operations personnel from Hydro refer to the 138 kV transmission line as TL240. Operations personnel from Churchill Falls refer to the 138 kV transmission line as L1301

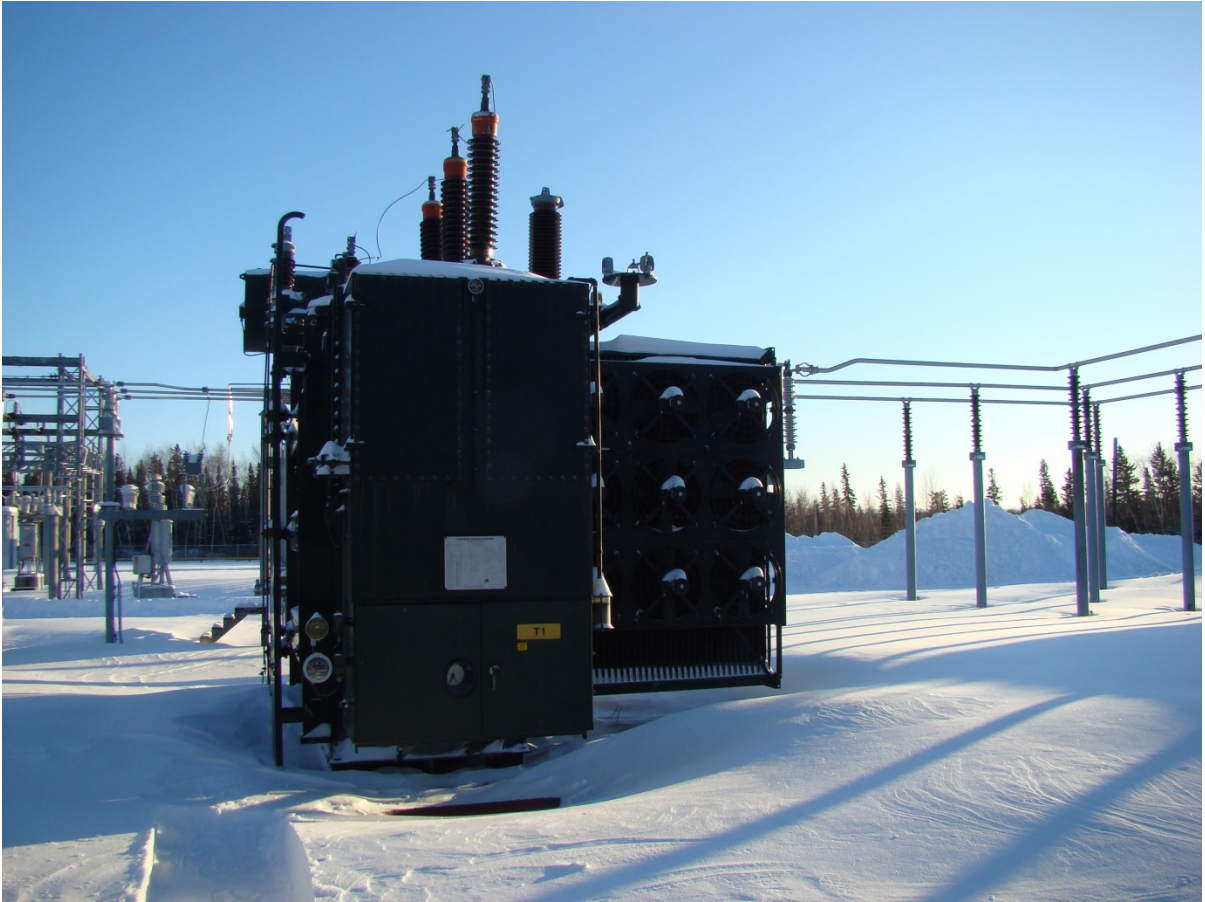
**Figure 2: Spare 15/20/25 MVA Transformer (Happy Valley)**

Figure 2 provides a photograph of the spare transformer located within the Happy Valley Terminal Station.

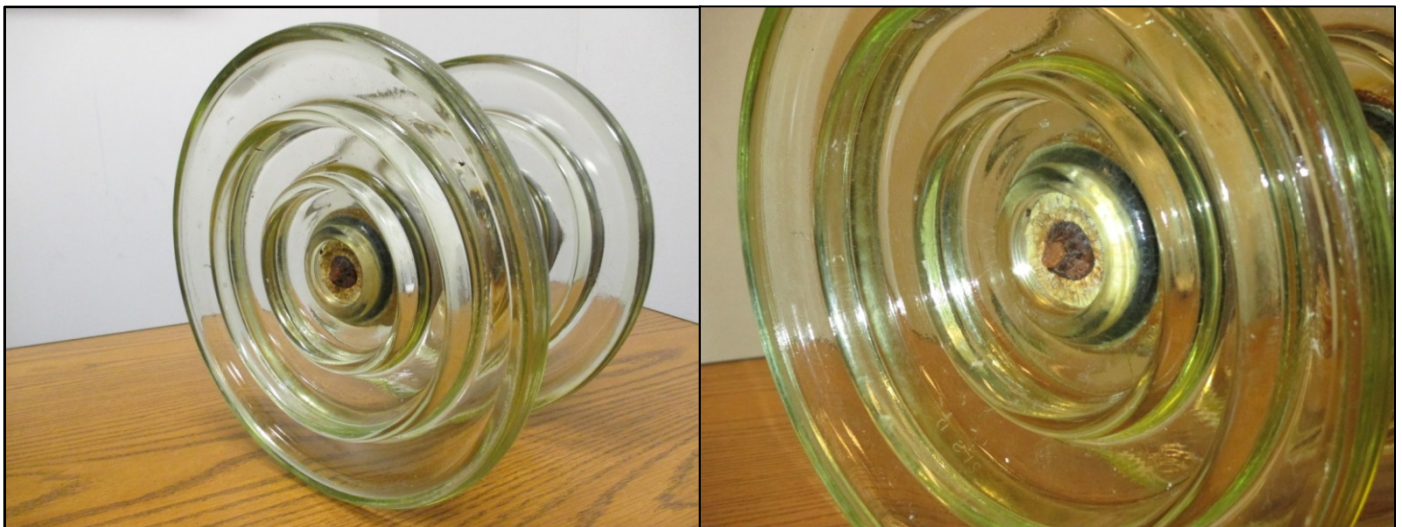
Throughout the 2013-2014 winter season, high winds and adverse weather conditions were experienced on many transmission lines in Hydro's system. These weather conditions escalated the insulator pin failures on both TL201 and TL203. The first failure of the winter season occurred on Structure 163 (TL203) on January 12, 2014. See Figure 2 below.

**Figure 2: TL203 – Structure 163 Pilkington Insulator Pin Corrosion**

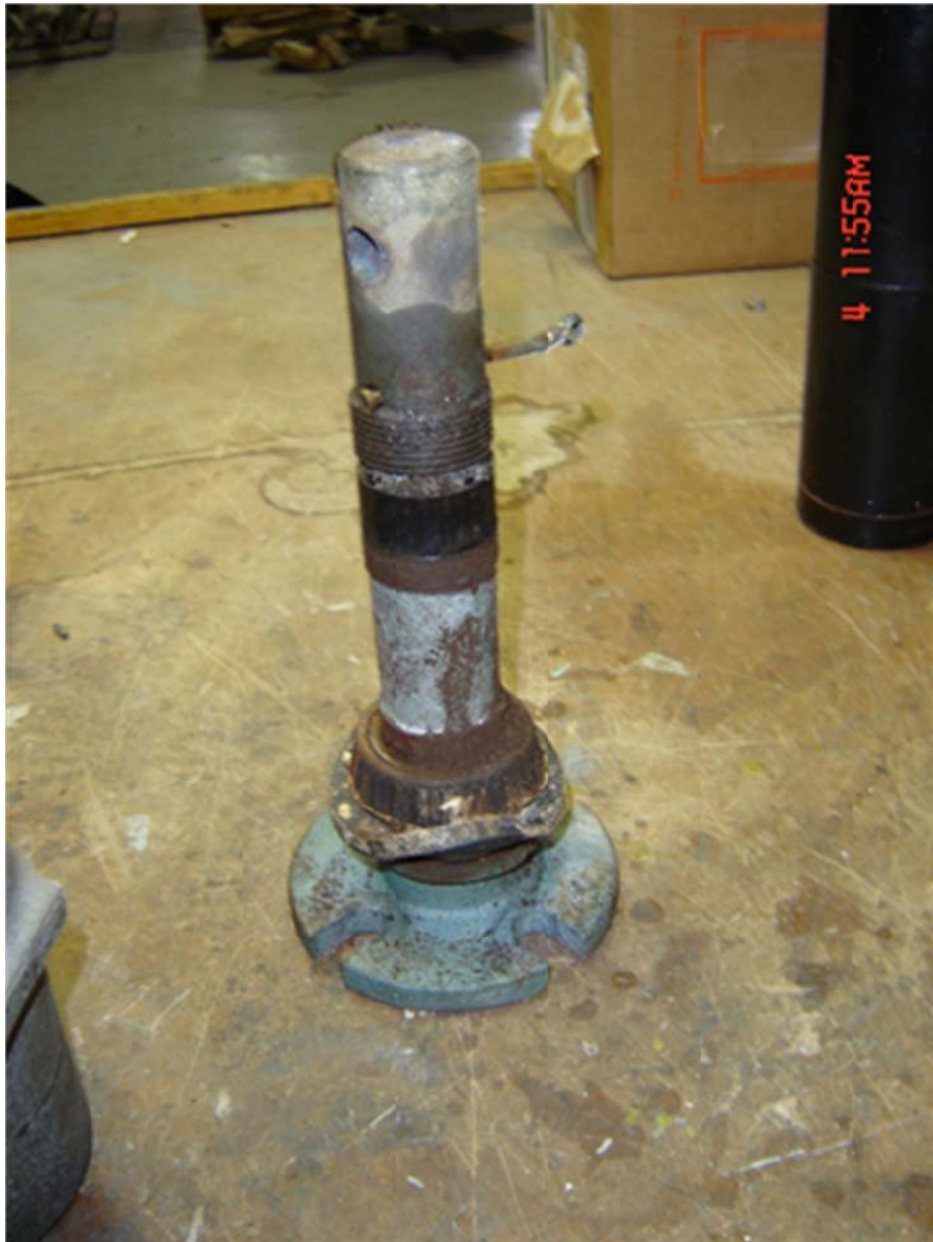
**Figure 2: Broken Gear Drive from 230 kV disconnect switch in Holyrood**

project proposes replacement of disconnect switches targeted for 2016. Appendix A contains a copy of the LTAMP, showing the next five years of planned disconnect replacements (2016 to 2020). The figures below show damaged or malfunctioning disconnect switches, which forms the basis for the need for replacement.

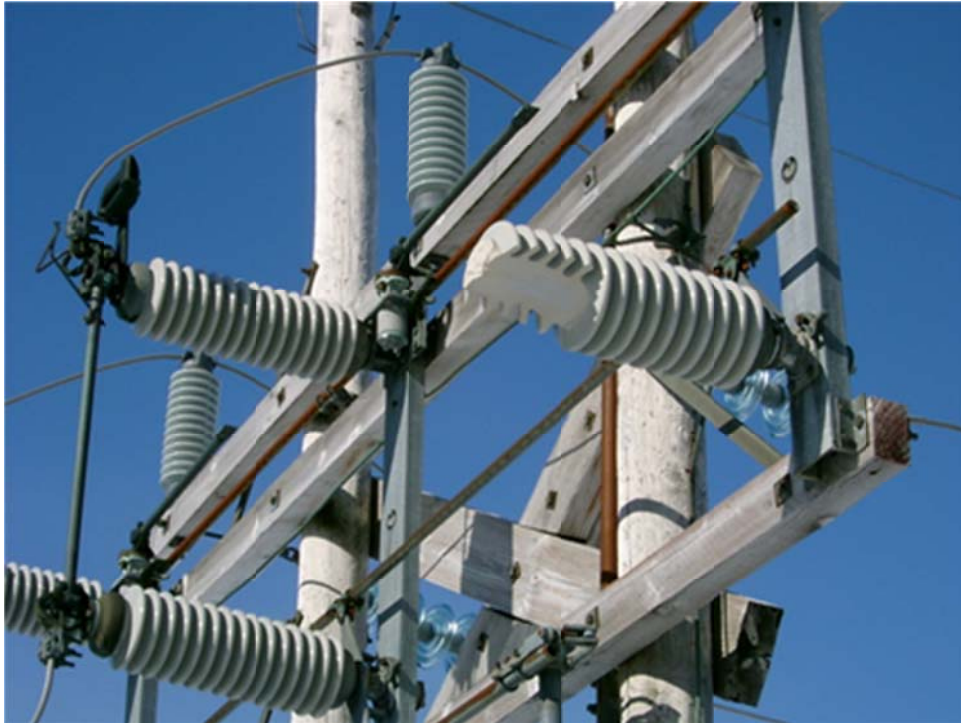
**Figure 3: Broken insulator on 69 kV disconnect switch in Barchoix**

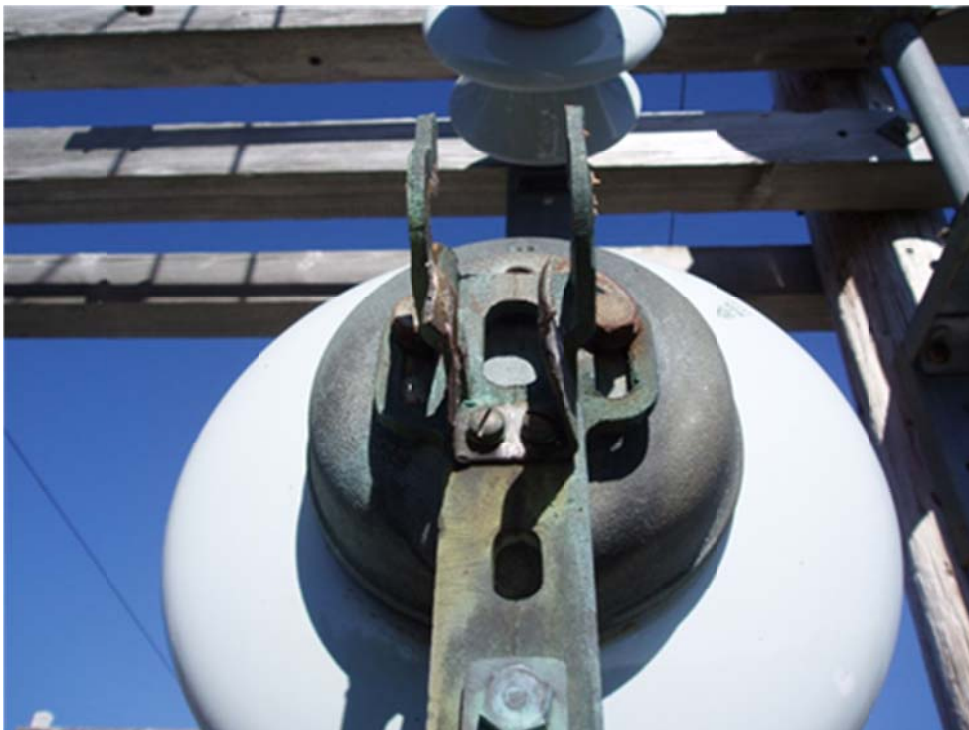
**Figure 4: Misaligned blade terminal on 69 kV disconnect switch in Holyrood**

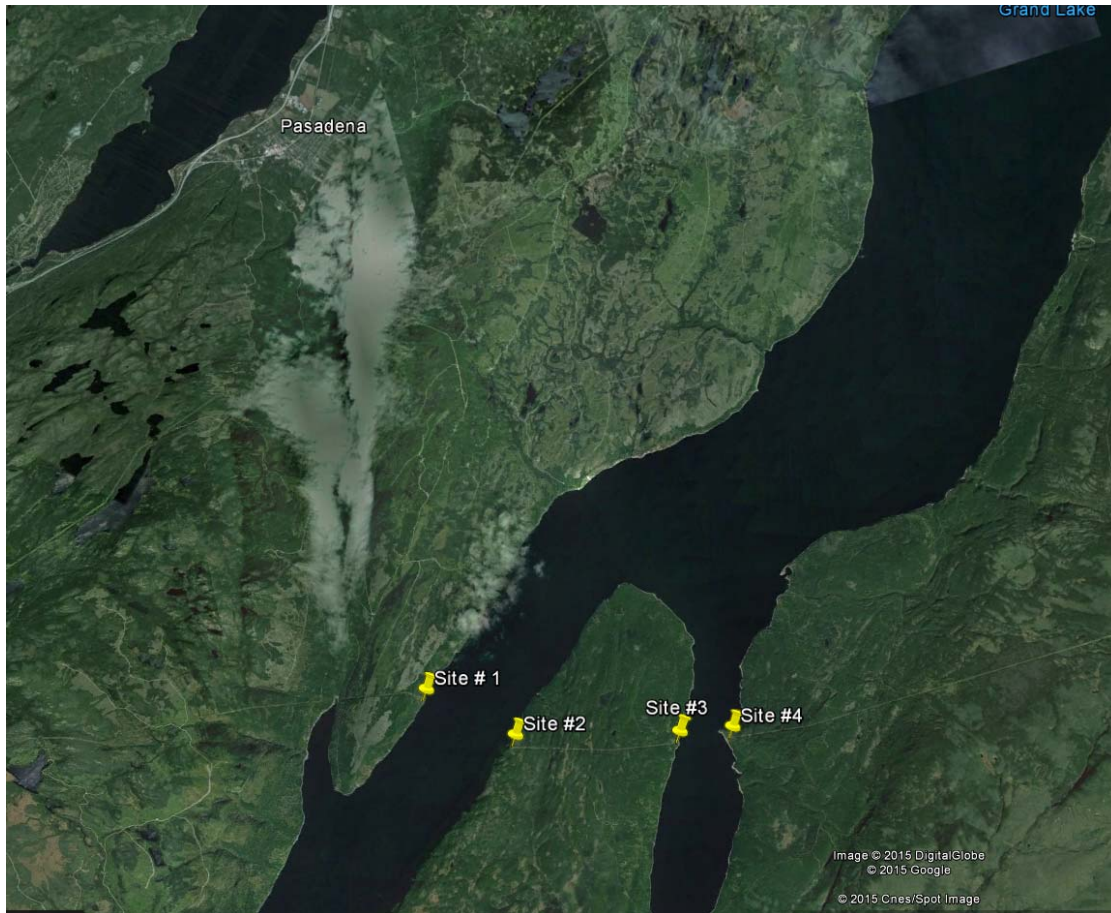
**Figure 1: Site Map – Grand Lake**

Figure 1 shows the site map of the four sites and spans a section of Grand Lake.

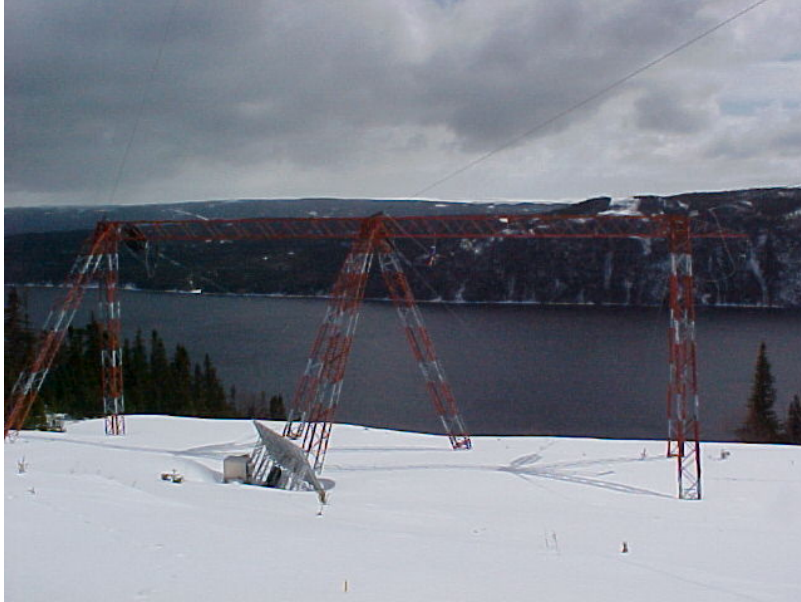
**Figure 2: Site #1 crossing structure**

Originally, the four transmission line spans had numerous coloured balls that were suspended from the transmission line along with the four crossing structures being painted with a checkerboard pattern with international orange and white for daytime identification, and painted shore markers to identify the presence of a catenary<sup>1</sup> obstruction. These criteria were required to meet Transport Canada Standard 621.19 “Standard Obstruction Markings”. In the 1980’s, the suspended balls were becoming problematic as they required regular replacement due to the high vibration levels the balls created on the transmission line spans. In 1993, the coloured balls were completely removed and an aircraft obstruction lighting system was installed on each of the four crossing structures to maintain compliance with Transport Canada regulations. Figure 2 shows site #1 crossing structure and Figure 3 shows the flash head on the painted structure.

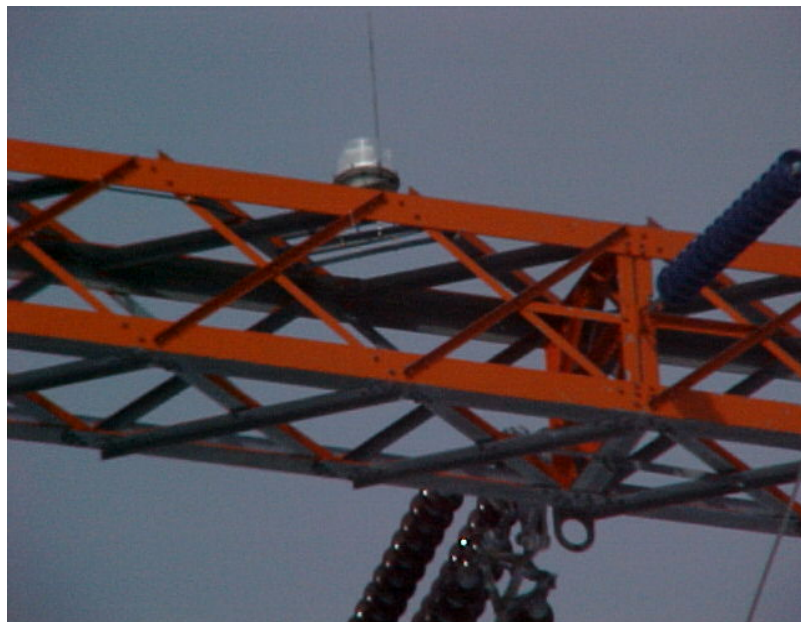
**Figure 3: Flash Head on the 230kV structure**

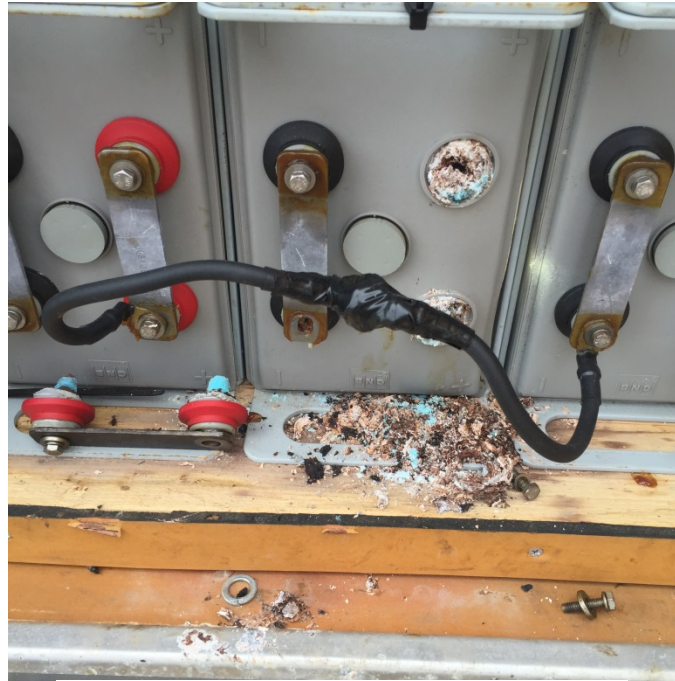
**Figure 4: Failed VRLA Battery at Site #2**

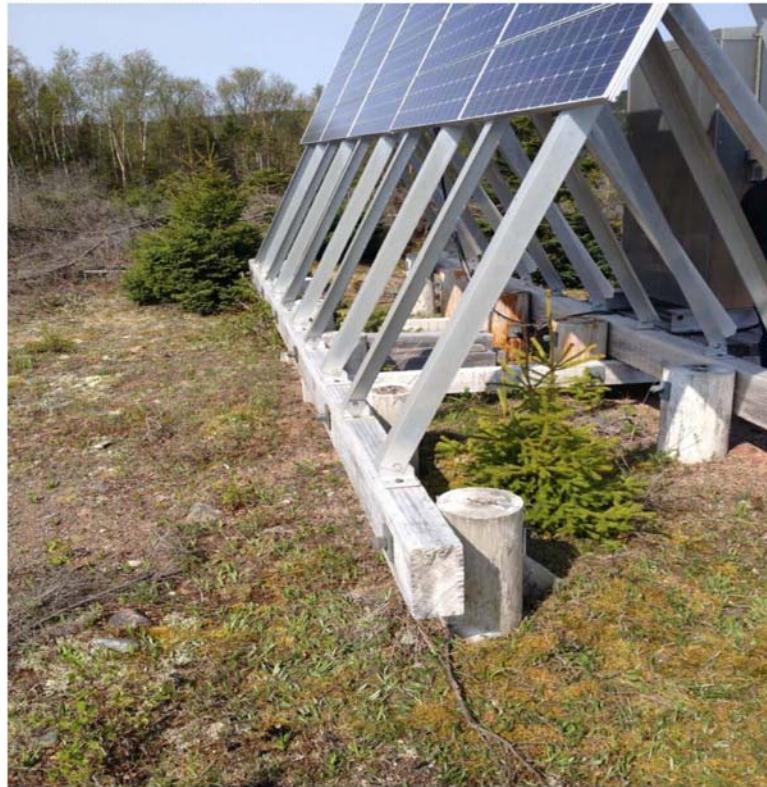
**Foundation** – wood piles with wood cross beams. The overall condition of the foundation is acceptable to reuse.

Figure 1 - Site 1 Foundation

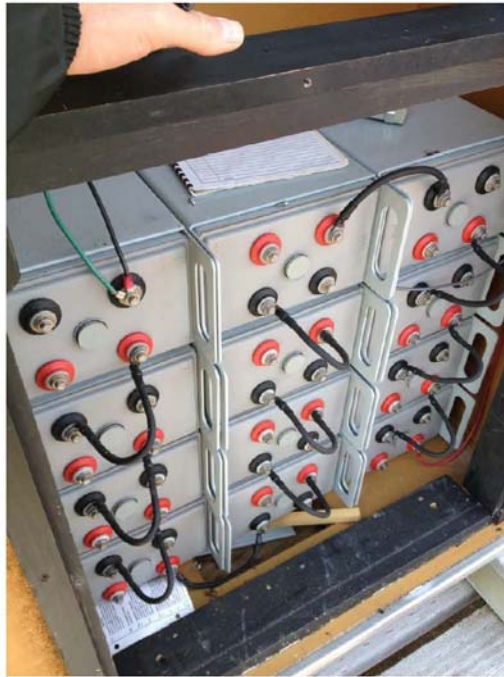
These batteries were replaced around 2006 making them about 10 years old. Cell #1 shows a much lower voltage than the rest of the cells, indicating a possible degradation of this cell.

**Figure 3 - Site 1 Batteries**

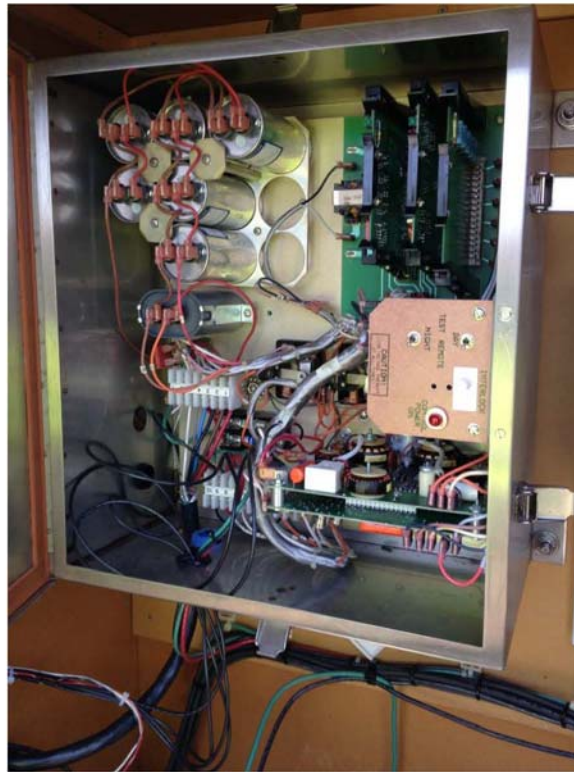
**Figure 4 - Light Controller**

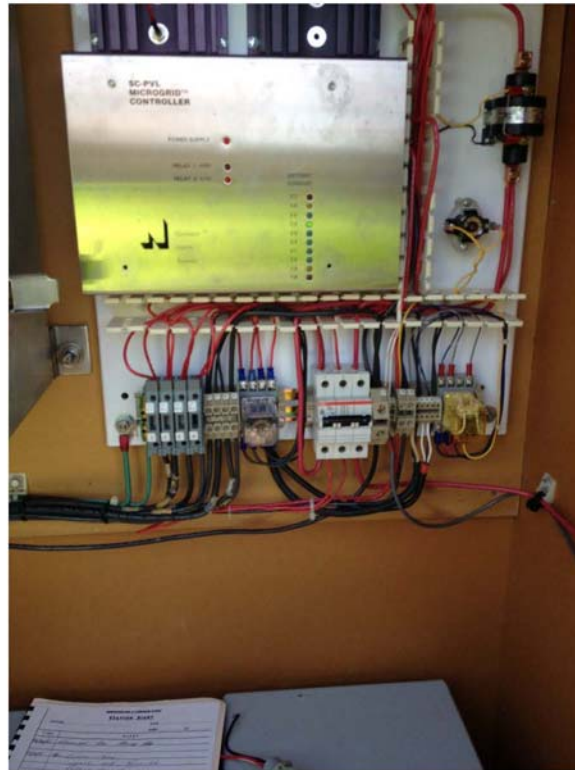
Figure 5 - System Controller

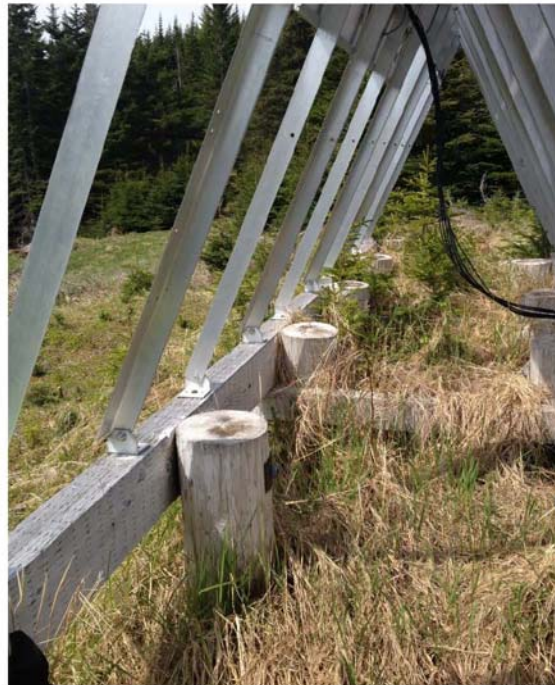
**Foundation** – wood piles with wood cross beams. The overall condition of the foundation is acceptable to reuse.

Figure 6 - Site 2 Foundation

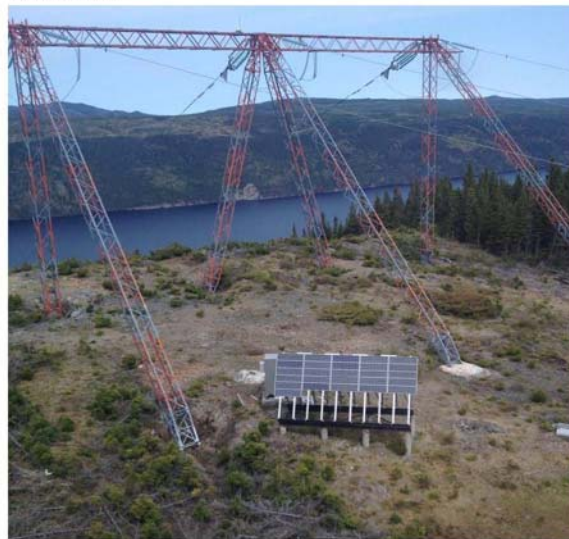
Figure 7 - Site 3 Aerial

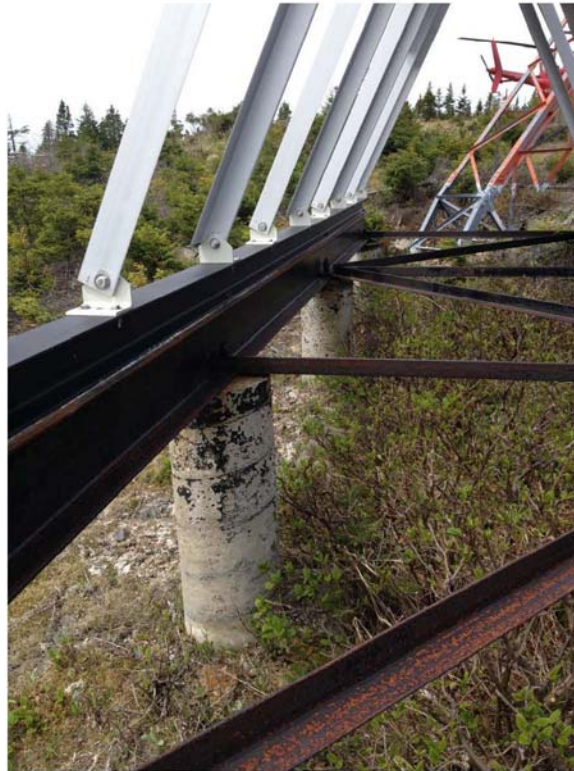
**Foundation** – steel frame on concrete pillars. PV array mounted on 4" aluminum I beam bolted to steel.

Figure 8 - Site 3 Foundation

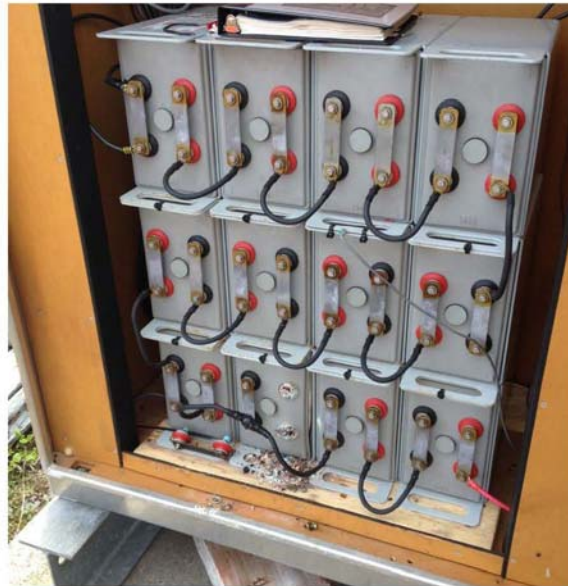
One cell's terminals had corroded away and was completely bypassed. This raises the other cell's voltage up to a level higher than recommended since the controller attempts to maintain a total system voltage.

**Figure 9 - Site 3 Batteries**

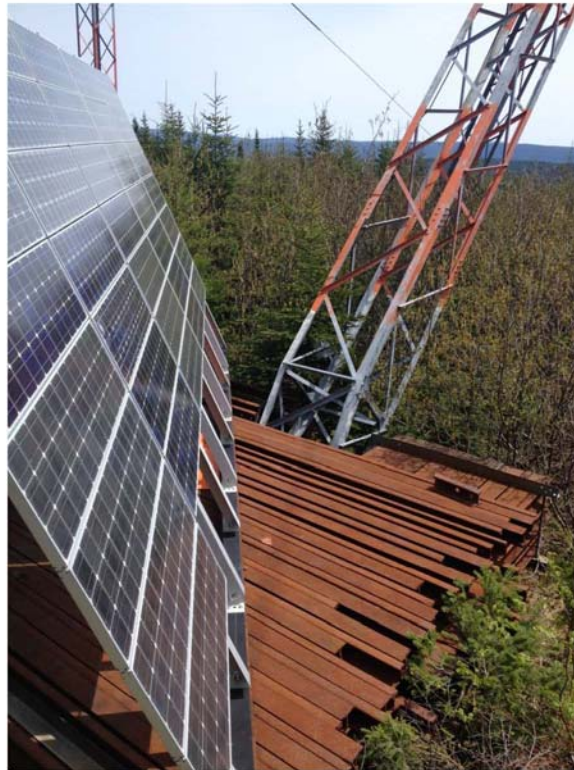
Foundation – steel frame consisting of railroad rails. PV array mounted on 4" aluminum I beam bolted to steel, which is welded to the railroad rails.

**Figure 10 - Site 4 Foundation**

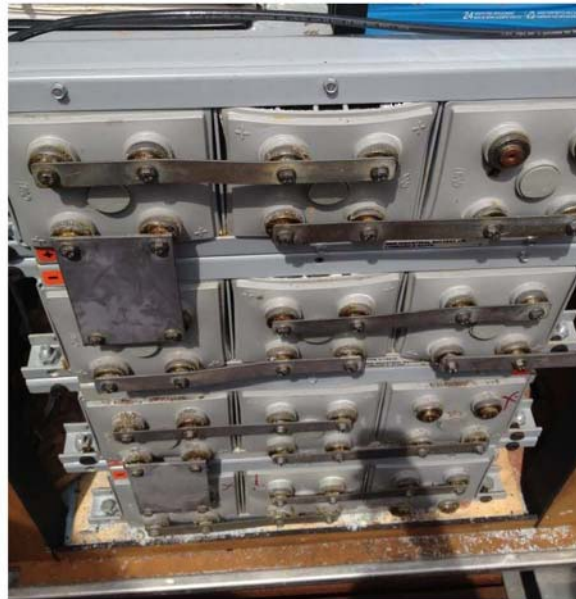
The originally installed GNB batteries here were not in use, they had been replaced with 2- 12 volt 100 AH deep cycle marine batteries.

Figure 11 - Site 4 Batteries

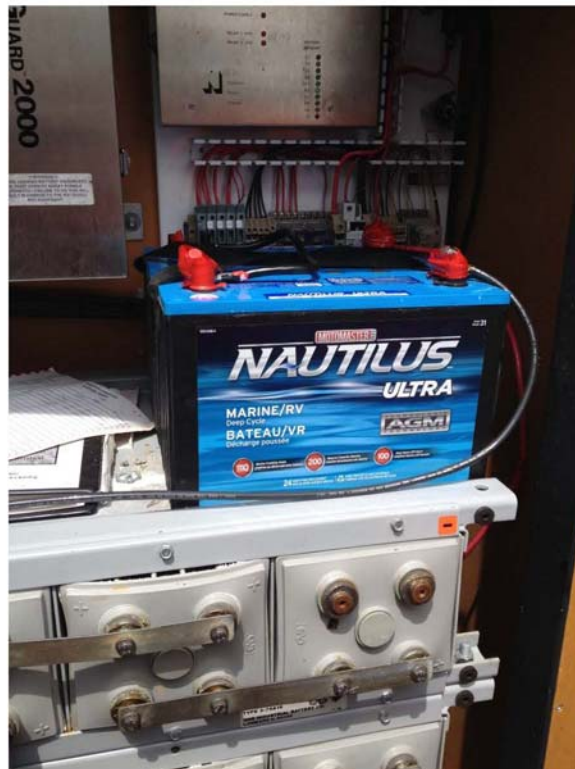
Figure 12 - Site 4 Replacement Batteries

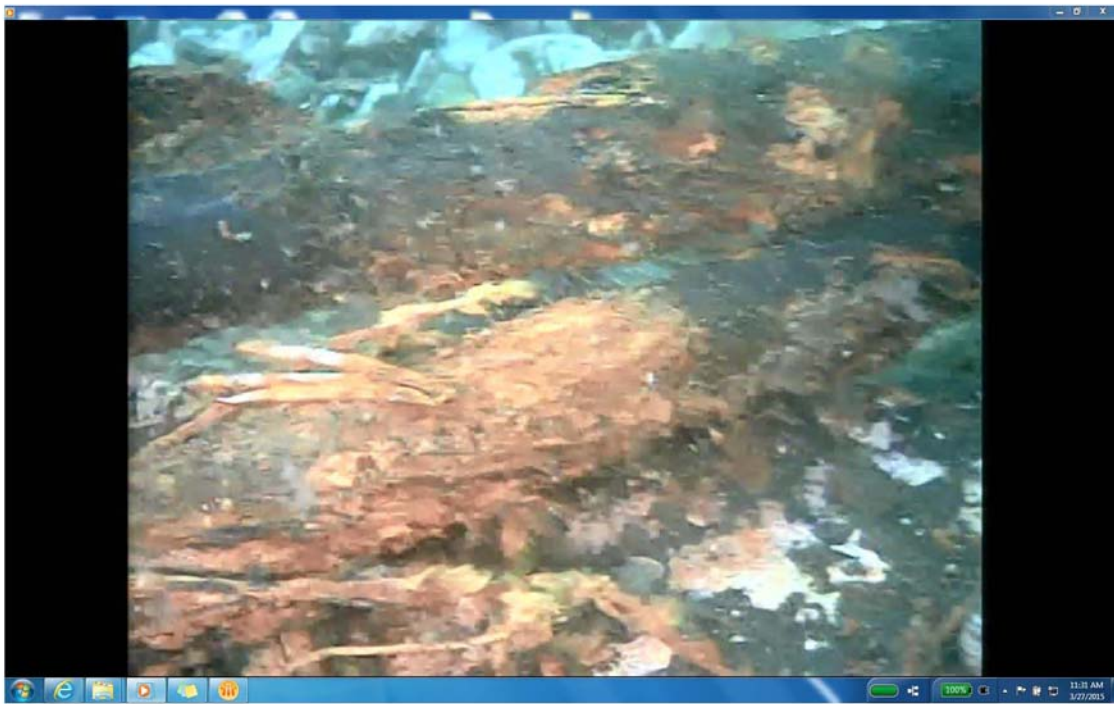
### **Pilley's Island to Long Island Submarine Cable**

This image shows a section of cable with moderate damage to the outer covering, but little damage to wire armour. No visible damage exists past the wire armour.

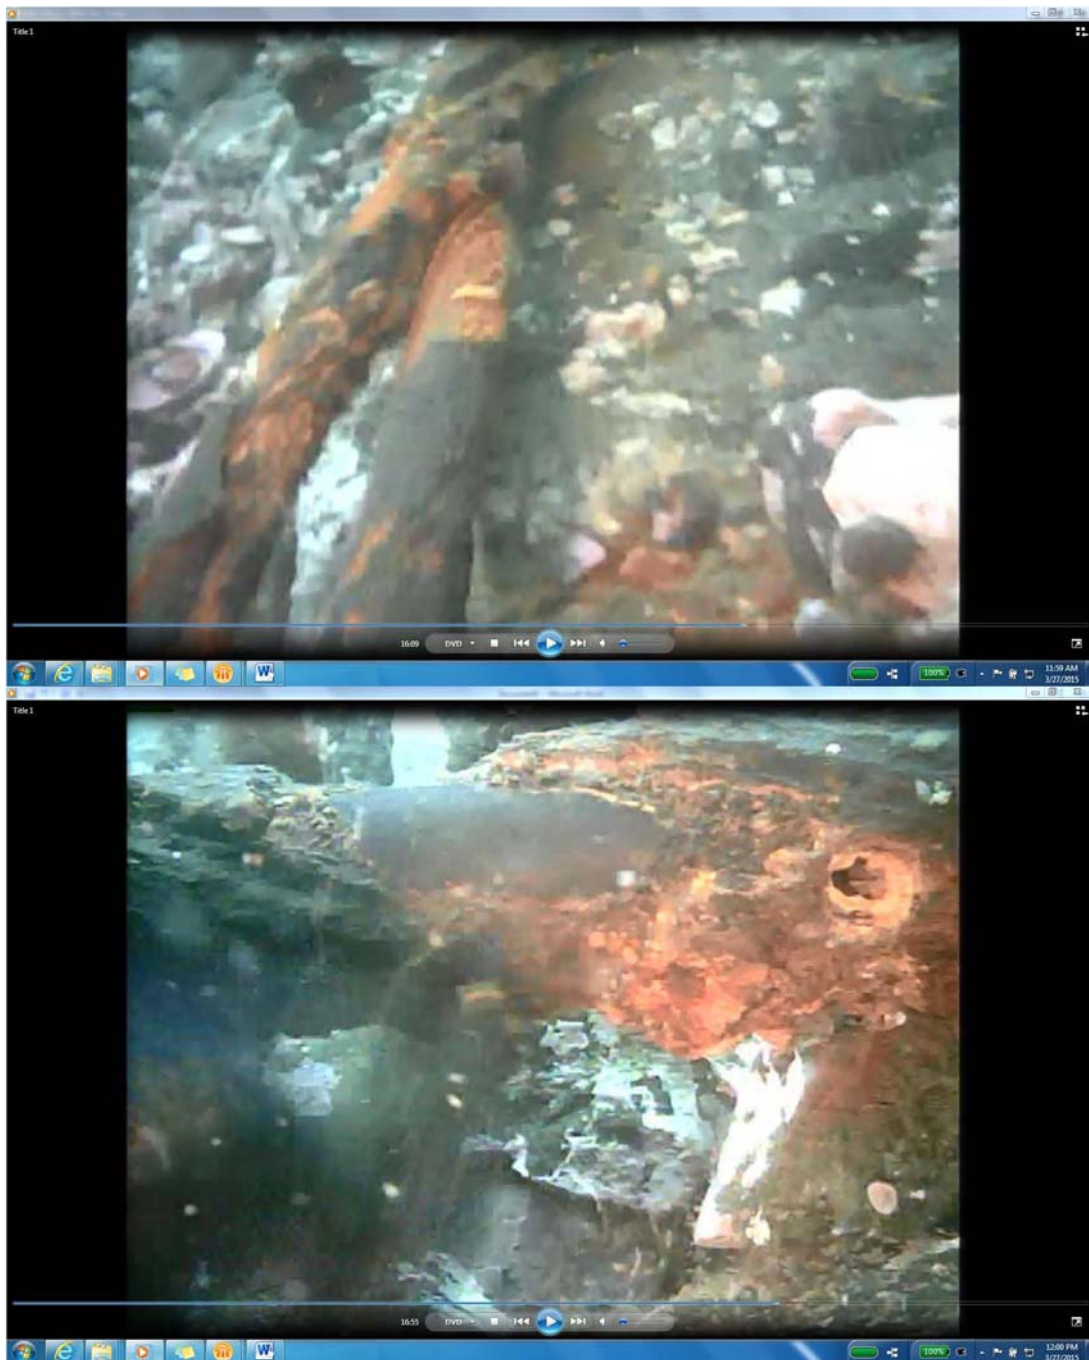
### **Pilley's Island to Long Island Submarine Cable**

The top image above shows two cables entangled due to being dragged over each other by the iceberg. The bottom image shows a cable which has been damaged in a section down past the covering and the wire armour to the polyethylene jacket.

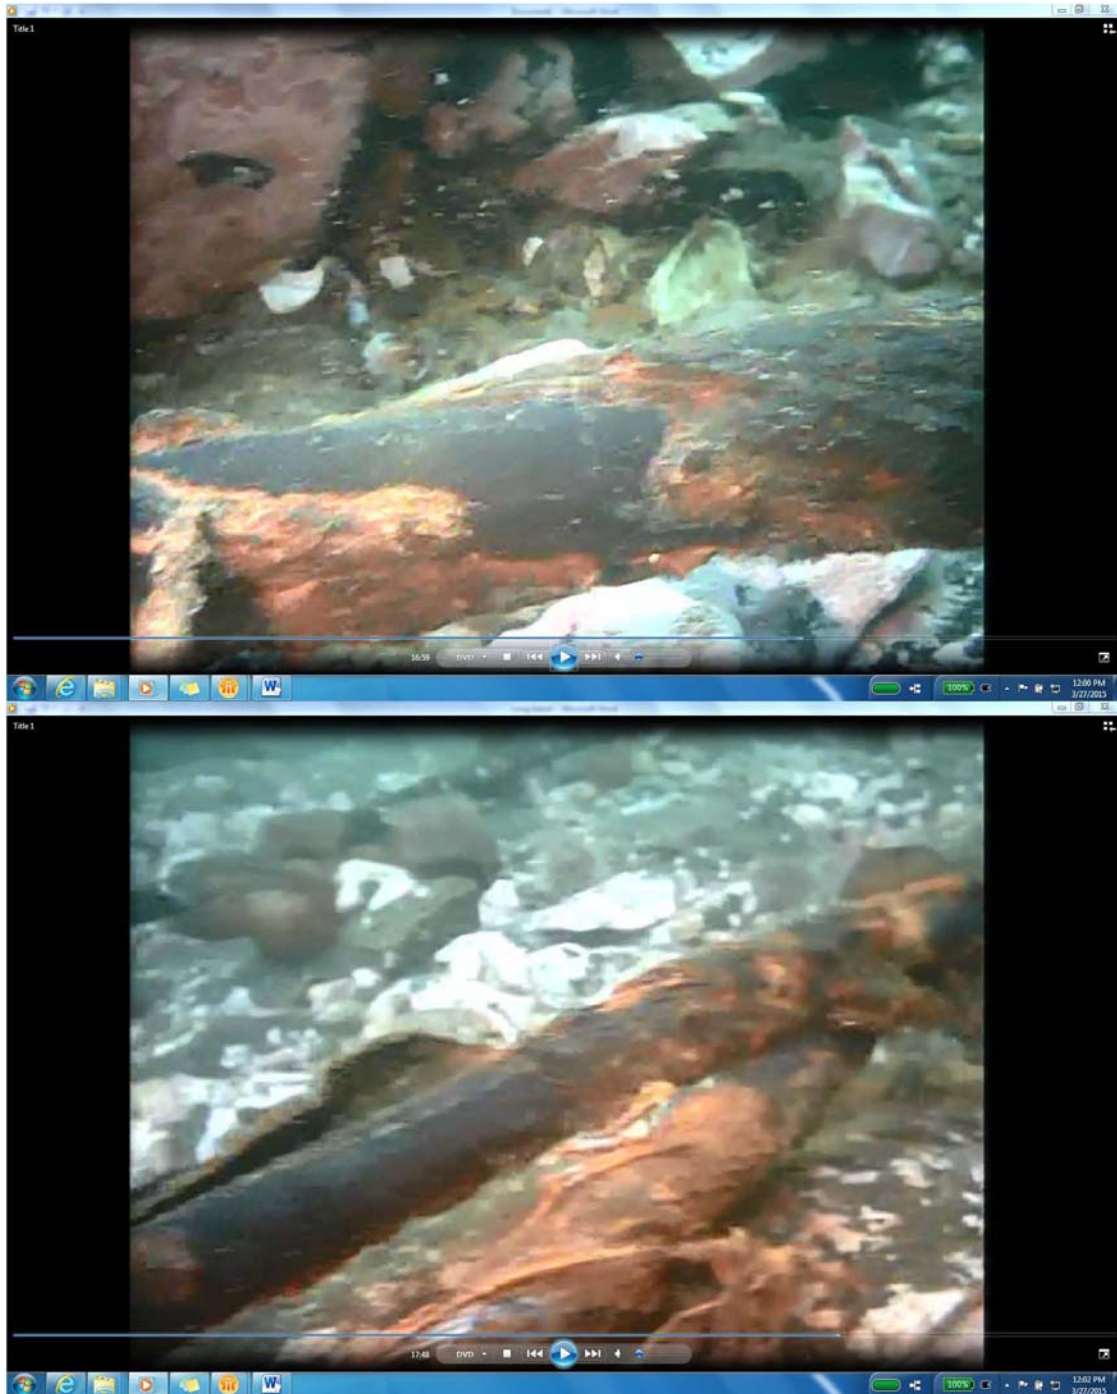
### **Pilley's Island to Long Island Submarine Cable**

The bottom image above shows a different section of the two cables entangled due to being dragged over each other by the iceberg. The top image shows a different view of the same cable on the previous page, which is damaged down to the polyethylene jacket.

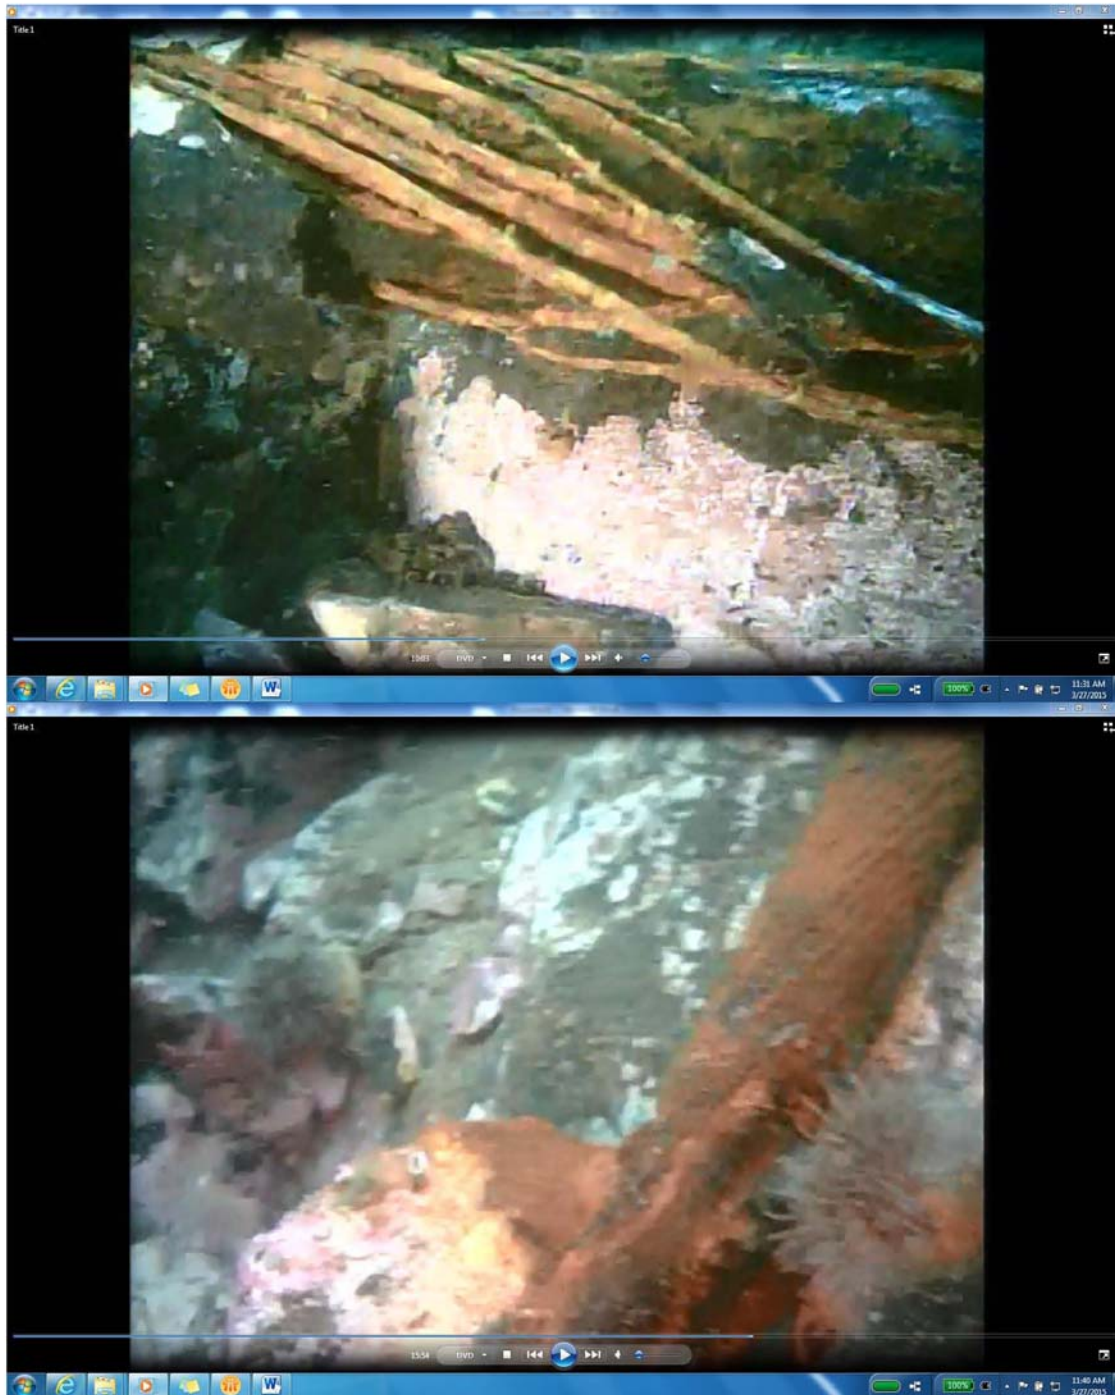
### **Pilley's Island to Long Island Submarine Cable**

The top picture above shows a cable which has wire armour which is badly damaged and has begun to unravel. The bottom picture also shows a cable with a damaged wire armour but it has not become unraveled as of yet.
