**A REPORT TO  
THE BOARD OF COMMISSIONERS OF PUBLIC UTILITIES**

**Additions for Load Growth - Isolated  
Generating Stations**

L'Anse au Loup and Postville Diesel Plant

July 2015

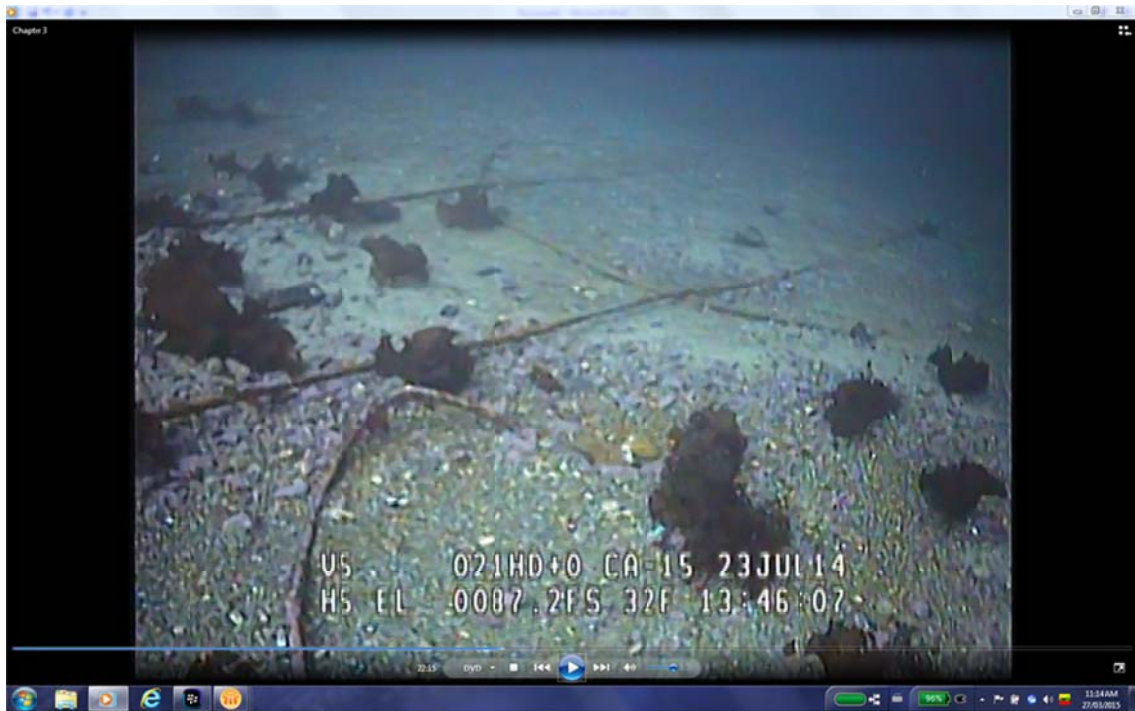
### **Pilley's Island to Long Island Submarine Cable**

The picture above shows one cable which has been dragged across the floor of Long Island Tickle and over two of the other cables in this area.

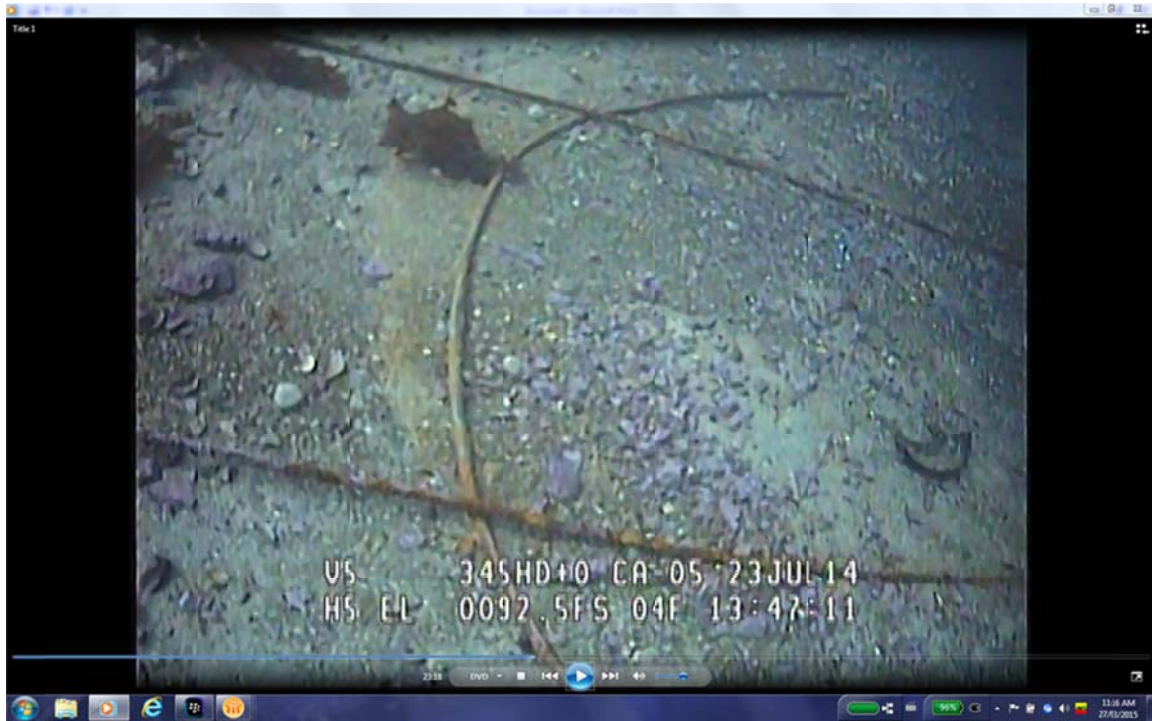
### **Pilley's Island to Long Island Submarine Cable**

This picture shows a better view of the cables which have crossed over each other in the picture on the previous page of this report. Iceberg contacted the cables and dragged them for a distance, causing them to entangle.

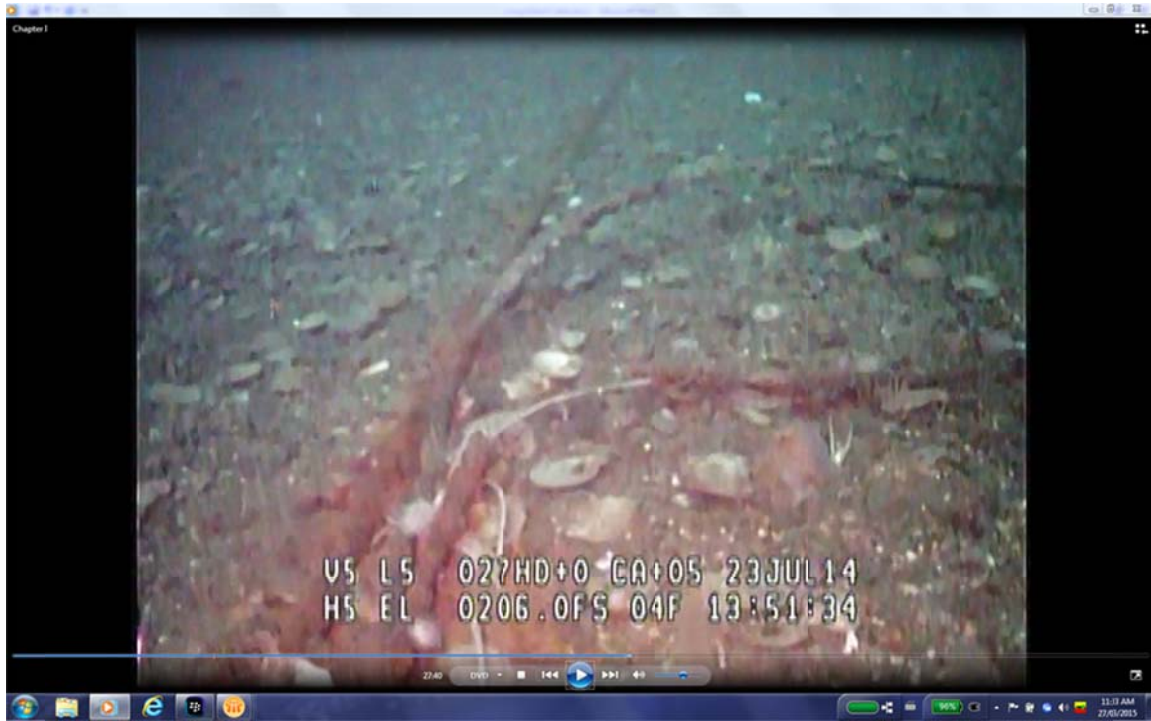
### Pilley's Island to Long Island Submarine Cable

The picture above shows another section of cables which have become entangled after being contacted by iceberg. This picture shows one cable (left) which is not overly tangled whereas, the other two cables (right) are severely tangled.

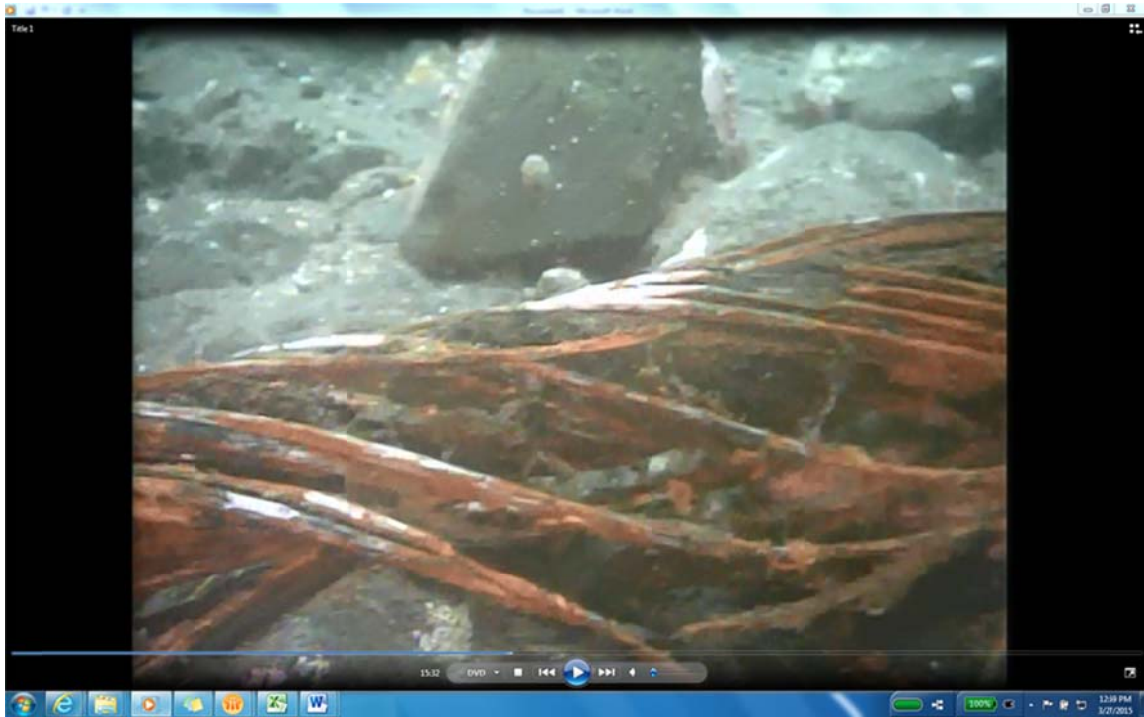
### **Pilley's Island to Long Island Submarine Cable**

The above picture shows a cable where the covering is gone, the wire armour has been so badly damaged that it has unraveled, and damage is visible on the polyethylene jacket.

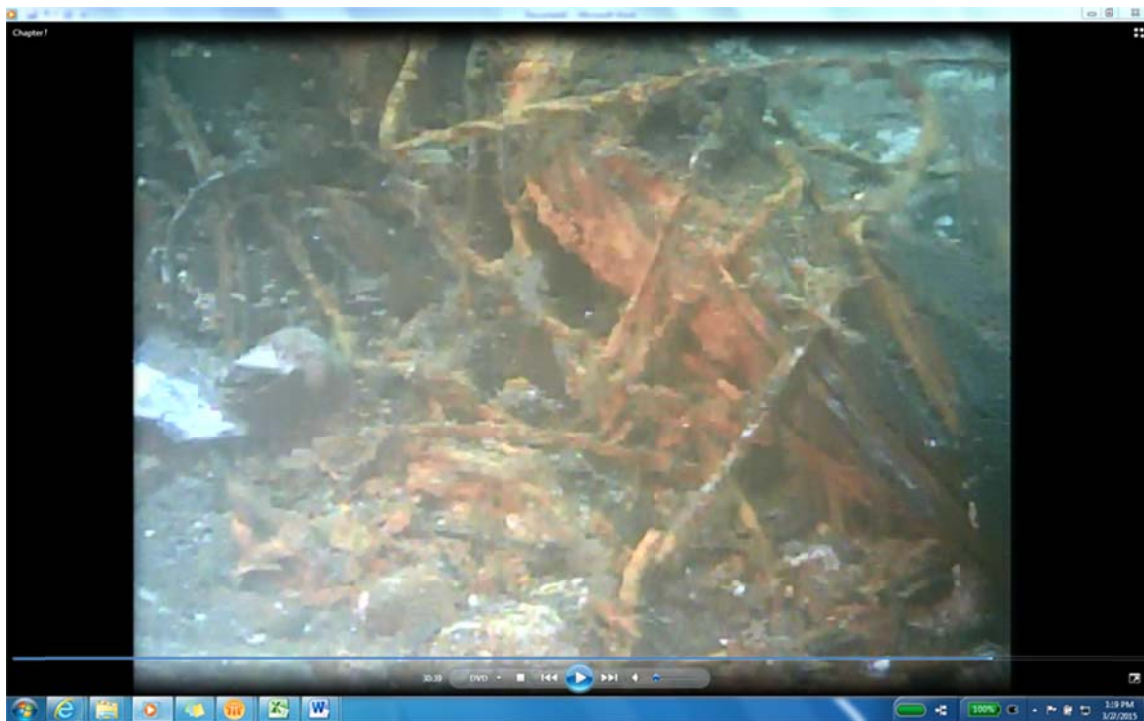
### **Pilley's Island to Long Island Submarine Cable**

This image shows a section of a cable where the covering and wire armour have been completely destroyed, the polyethylene jacket is highly visible, and the damage continues to the concentric neutral.

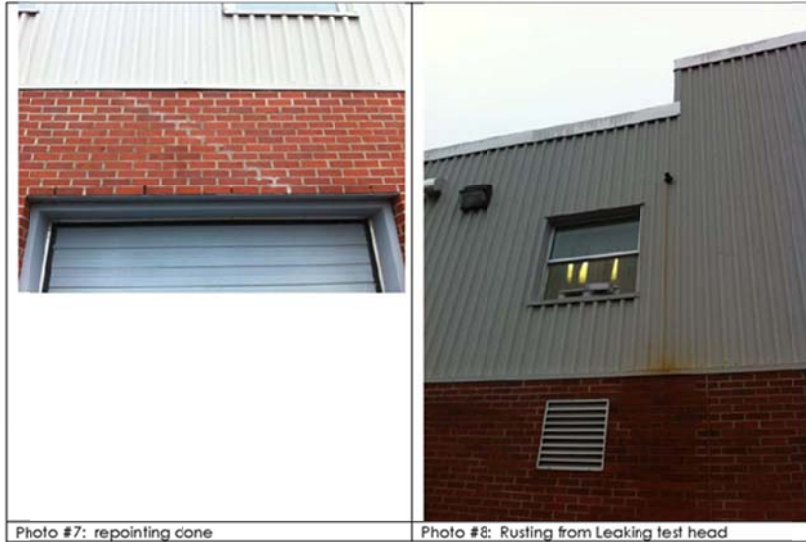
Photo #7: repointing cone

Photo #8: Rusting from Leaking test head

Photo #7: repointing done

Photo #8: Rusting from Leaking test head

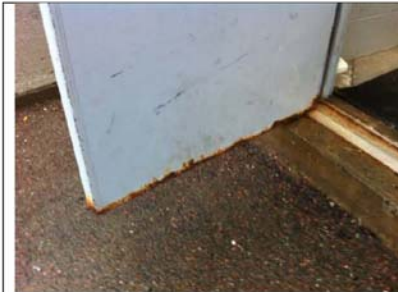
Photo #9: Exterior Door

Photo #9: Exterior Door

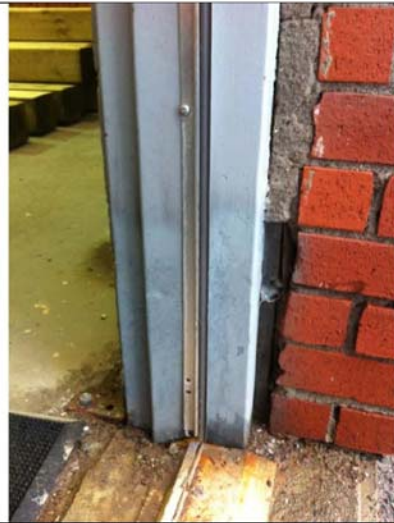
Photo #10: Exterior Door Jamb

Photo #10: Exterior Door Jamb

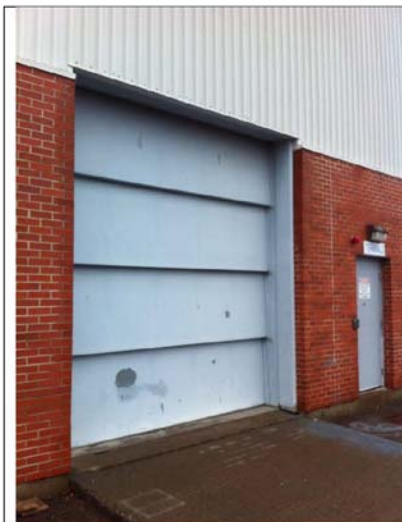
Photo #11: Overhead Accordion Door

Photo #11: Overhead Accordion Door

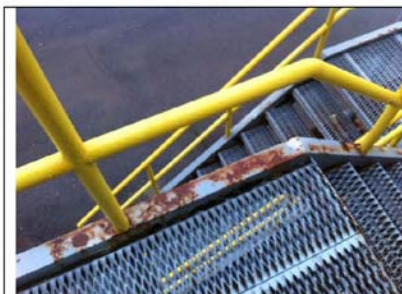
Photo #13: Rusting Stair Stringer

Photo #13: Rusting Stair Stringer

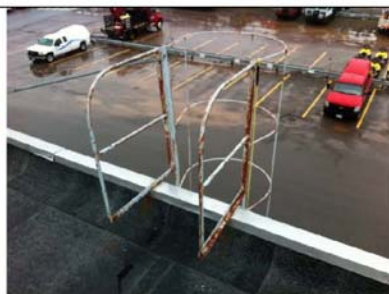
Photo #14: Roof Access

Photo #14: Roof Access

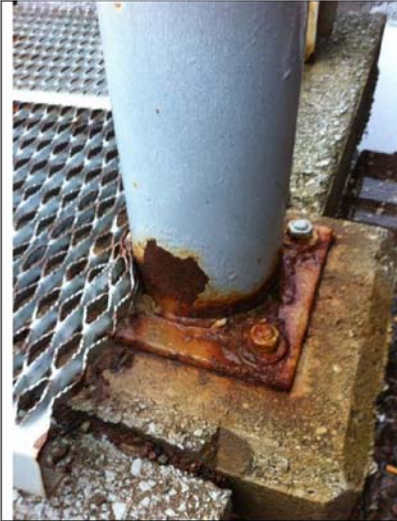
Photo #15: Ground Connection on Stair

Photo #15: Ground Connection on Stair

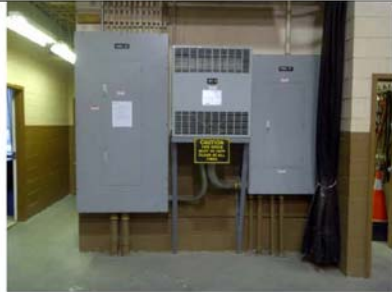
Photo #16: 600V equipment Exposed directly to Shop

Photo #16: 600V equipment Exposed tdirectly to Shop

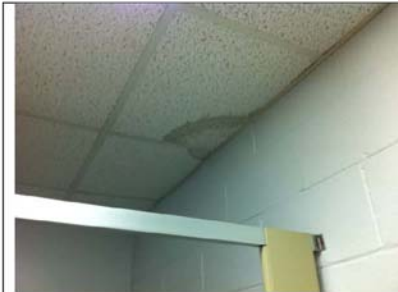
Photo #19: Stained Ceiling tile

Photo #19: Stained Ceiling tile

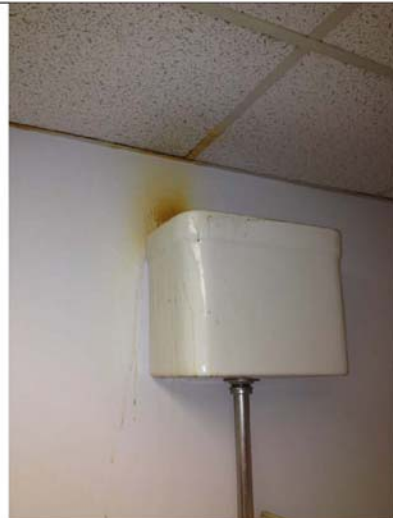
Photo #20: Urinal tank

Photo #20: Urinal tank

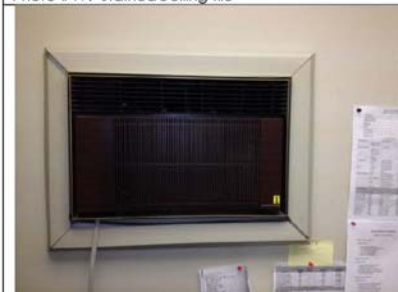
Photo #21: Office A/C

Photo #21: Office A/C

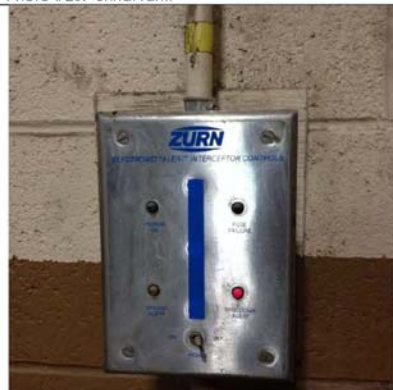
Photo #22: Zurn Alert

Photo #22: Zurn Alert

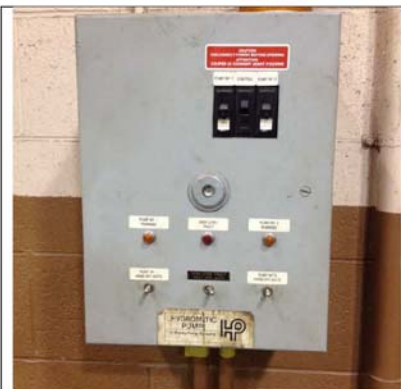
Photo #23: Duplex Oil Water system

Photo #23: Duplex Oily Water system

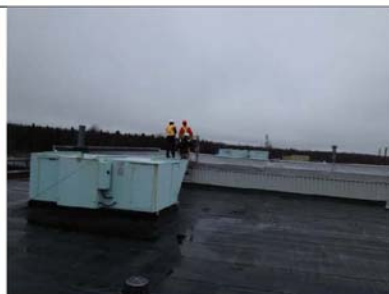
Photo #24: Roof top units

Photo #24: Roof top units

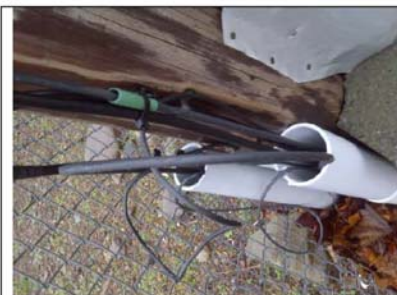
Photo #25: No weatherheads

Photo #25: No weatherheads

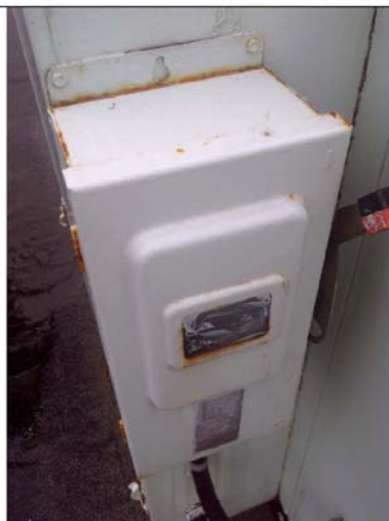
Photo #26: Rusting Disconnect

Photo #26: Rusting Disconnect

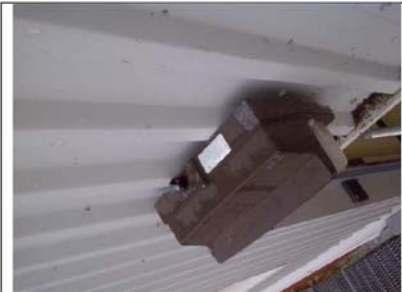
Photo #27: Wall Pack

Photo #27: Wall Pack

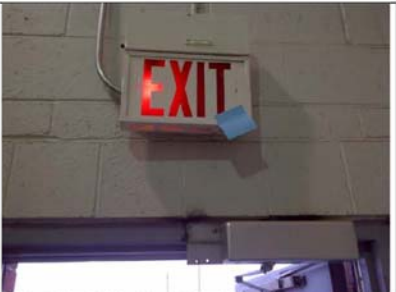
Photo #28: Exit Light with Faulty Test Switch

Photo #28: Exit Light with Faulty Test Switch

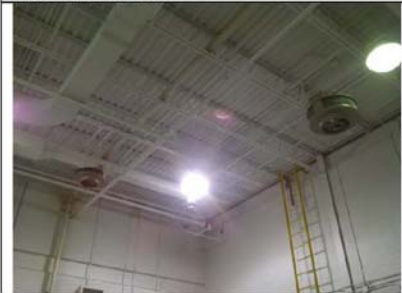
Photo #29: Metal Halide High Bays

Photo #29: Metal Halide High Bays

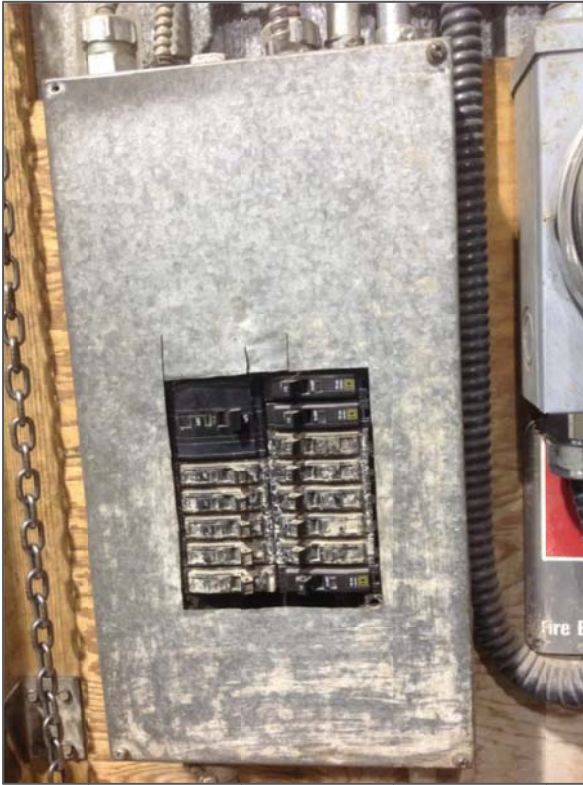
**Photo 1: New panelboard required**

A condition assessment was completed in 2014 at the Wabush Line Depot building. See Appendix C for the condition assessment. The recommendations from this assessment include replacement of aluminum windows and doors, replacement of the water service line to the facility, installation of a humidification system as per code to prevent dry air sparking in the work shop, installation of exhaust ventilation in service garages as per code requirements and replacement of electrical panel boards and associated wiring due to age and deteriorated condition. Photos 1, 2, 3, and 4 below show examples of some of the issues outlined in the condition assessment.

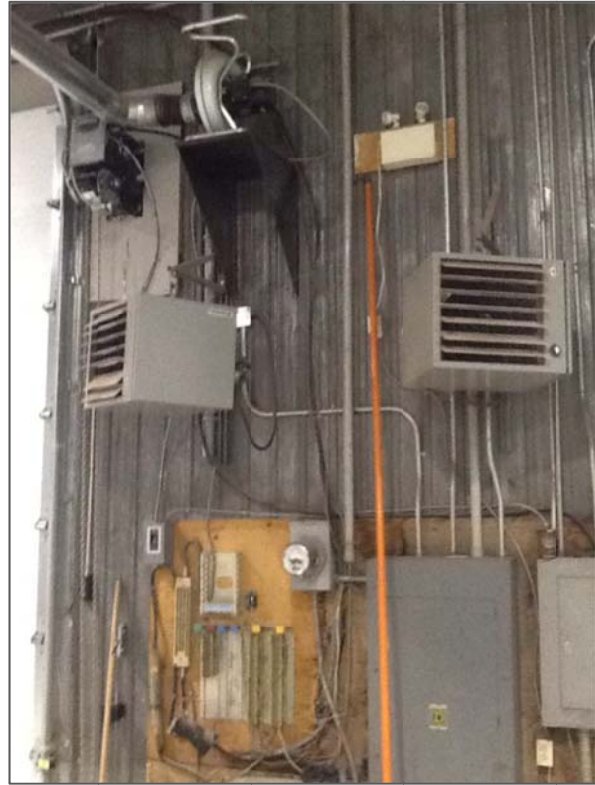
**Photo 2: Welding shop heaters in poor condition**

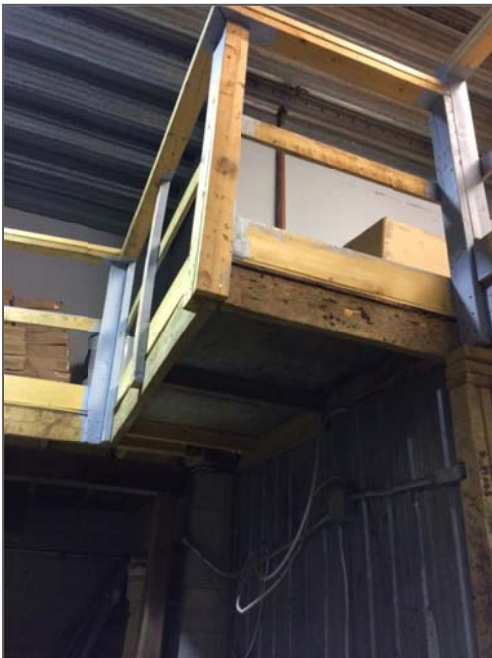
**Photo 3: Mezzanine is structurally unsafe**

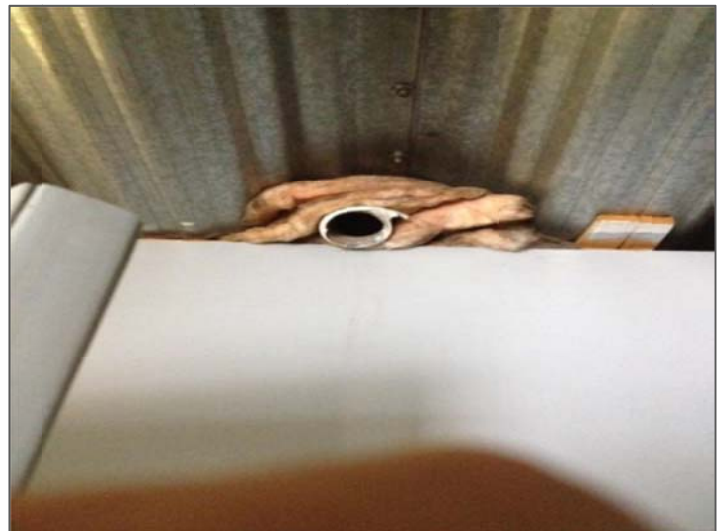
**Photo 4: Washroom exhaust fan to be properly ducted to outdoors**

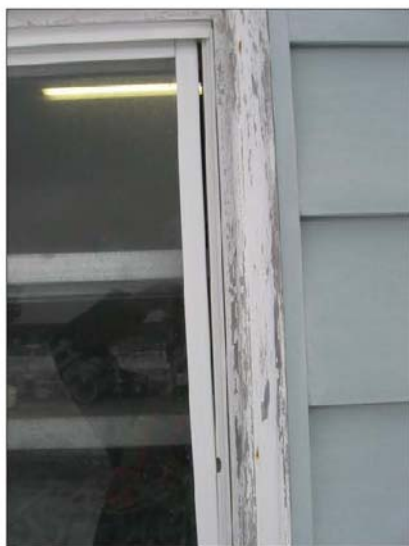
**Figure 1: Window has Separated from Frame**

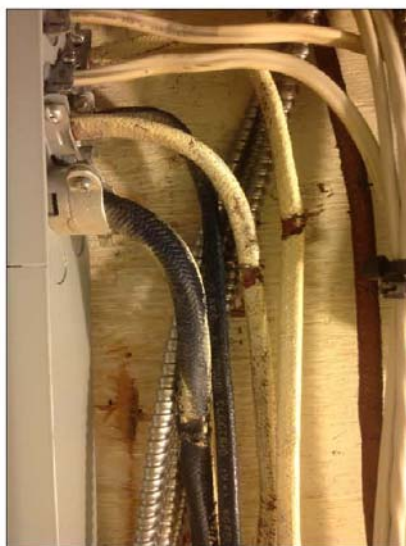
**Figure 2: Canvas Wire is a Code Violation**

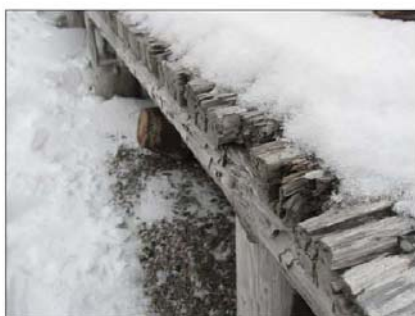
**Figure 3: Rotten Storage Ramp Deck**

recommended the replacement of a storage shed (see Figure 3) and storage ramp (see Figure 4) at Springdale since both are dilapidated and unsafe for workers to use. In general, operations personnel have identified that the infrastructure at these three line depots is indicative of other line depot infrastructure of similar age, suggesting a program to refurbish these facilities is in order.

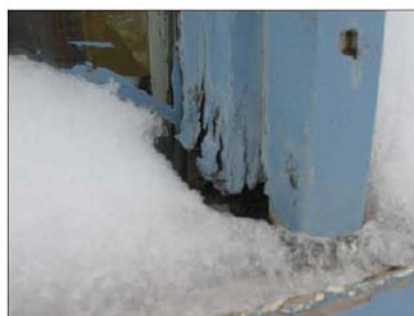
**Figure 4: Rotten Sill and Siding – Storage Building**

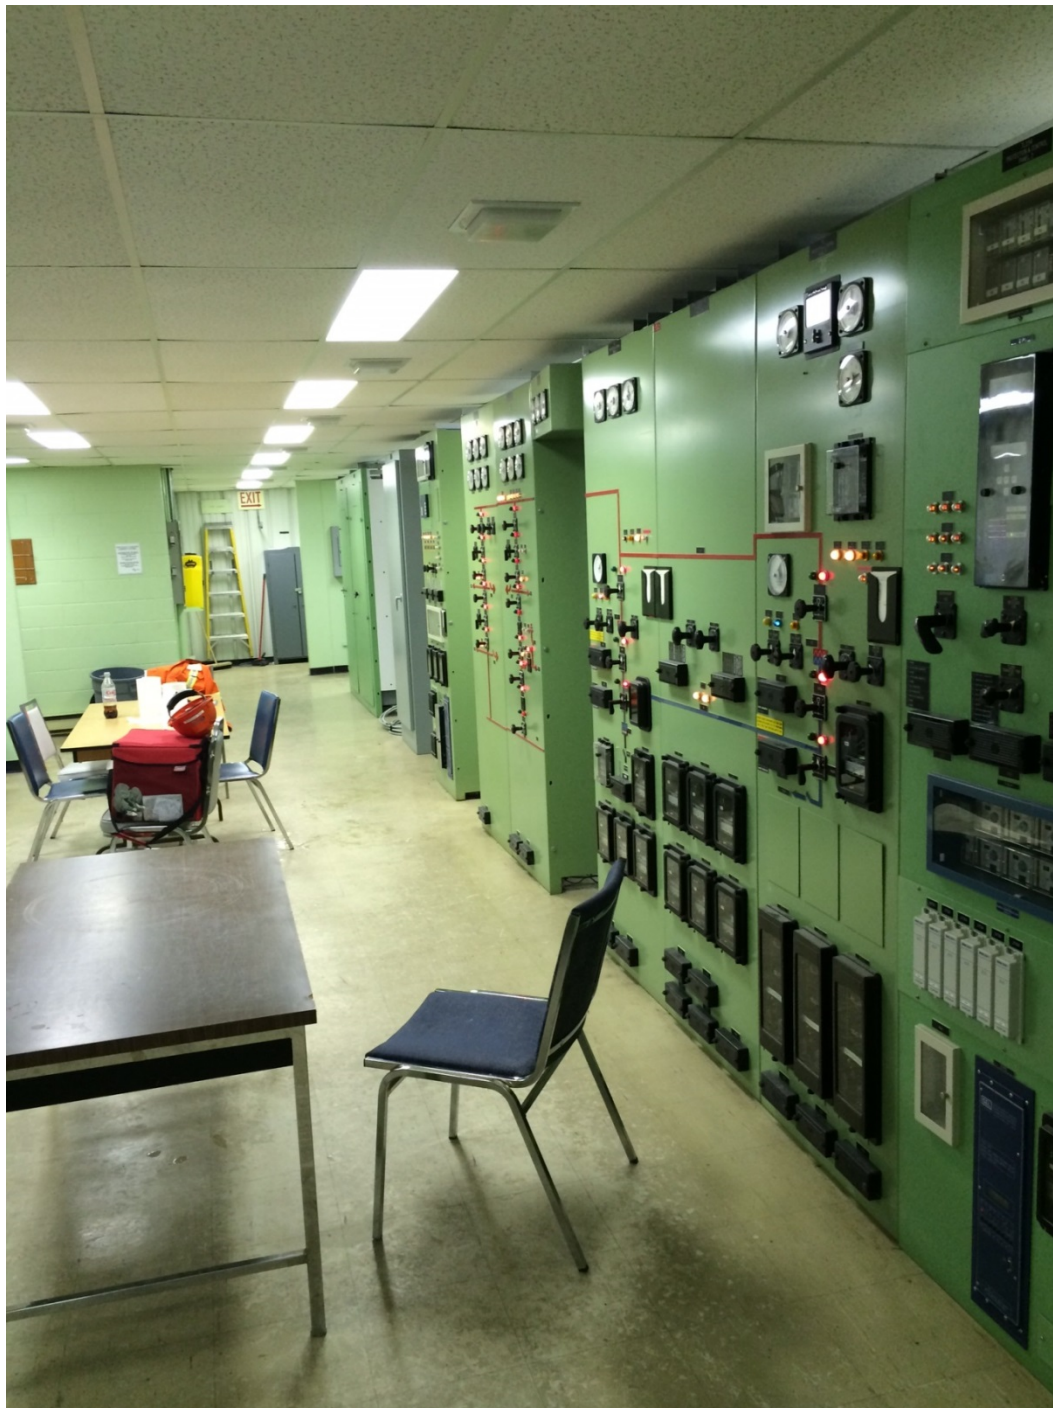
**Figure 1: Bay d'Espoir Terminal Station – Control Panels and Cable Trays**

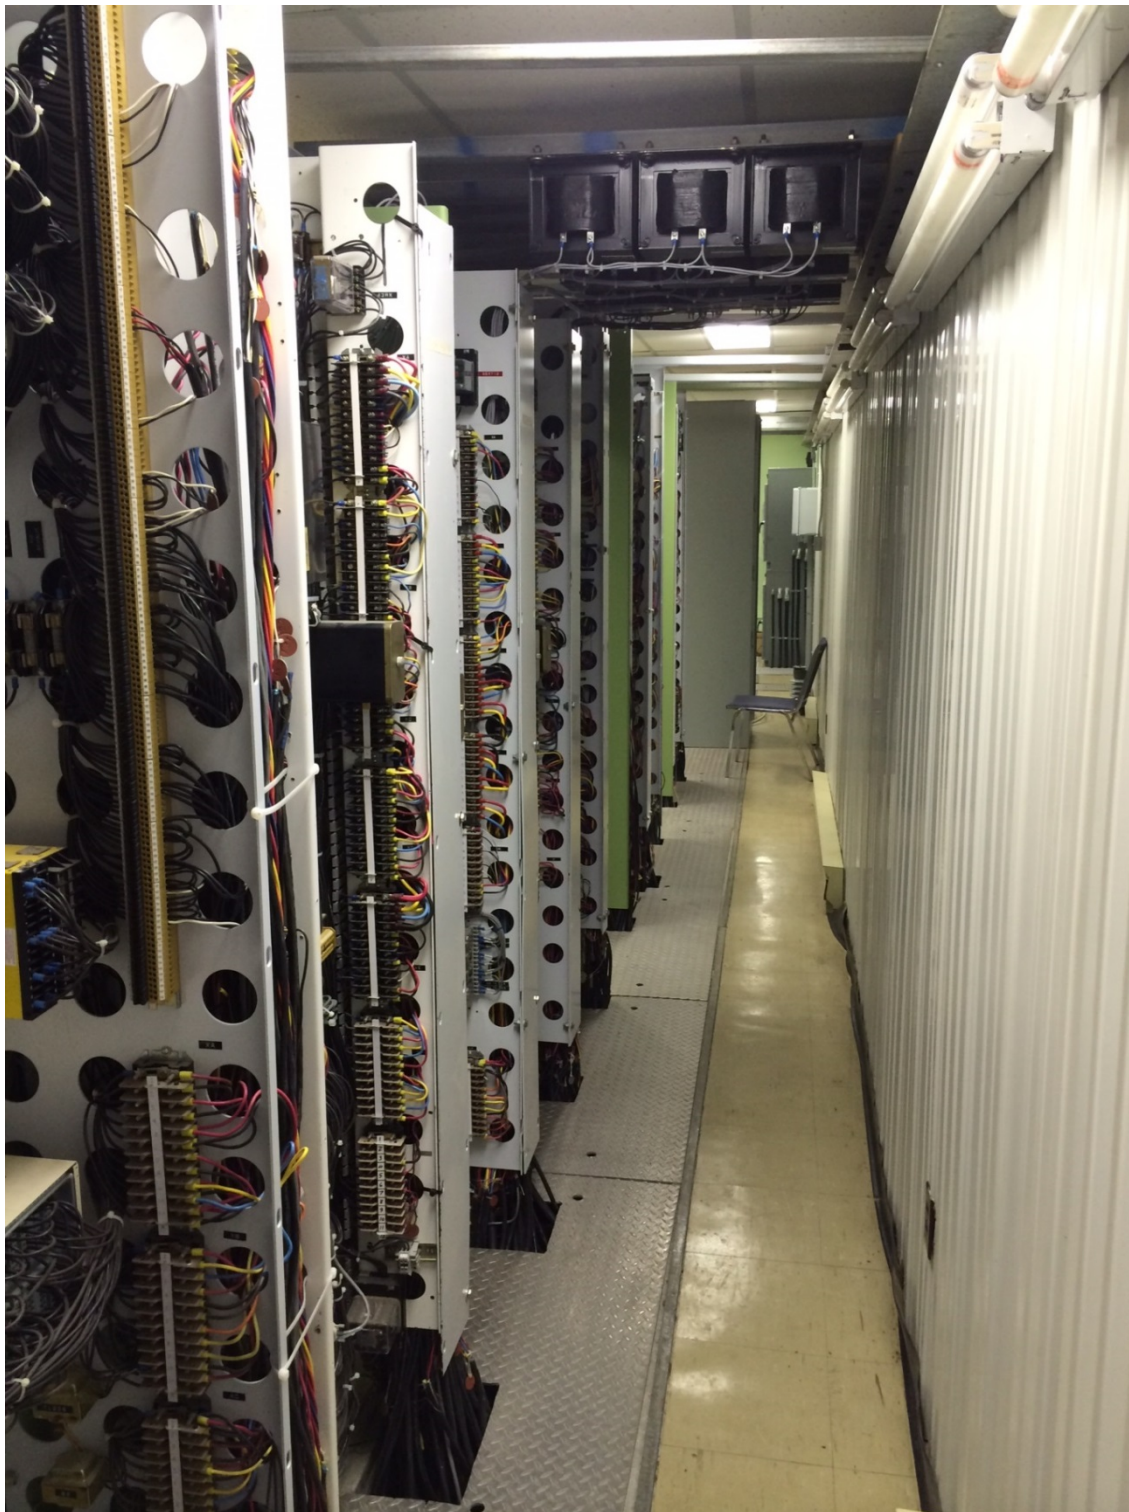
**Figure 2: Bay d'Espoir Terminal Station – Inside Control Panels and Cable Trench**

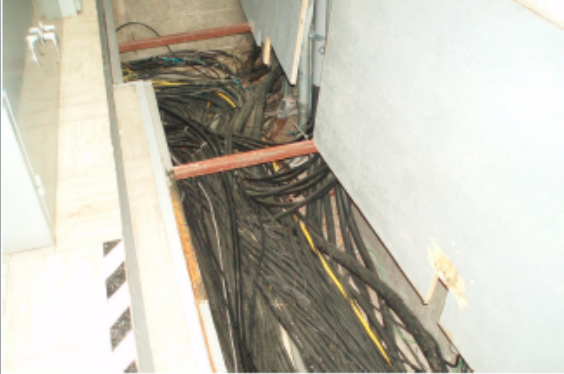
| | <p data-bbox="683 905 1081 930"><b>Cables under False Floor of Control Room</b></p> |
| <b>Technical Detail</b> | The control room features control cabinets, a combustible false floor, and a significant combustible loading underneath due to a concentration of cables. |

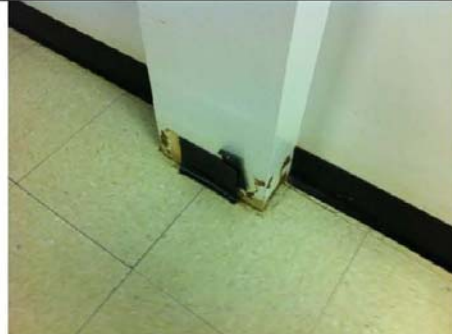
Photo #18: Base requiring replacement

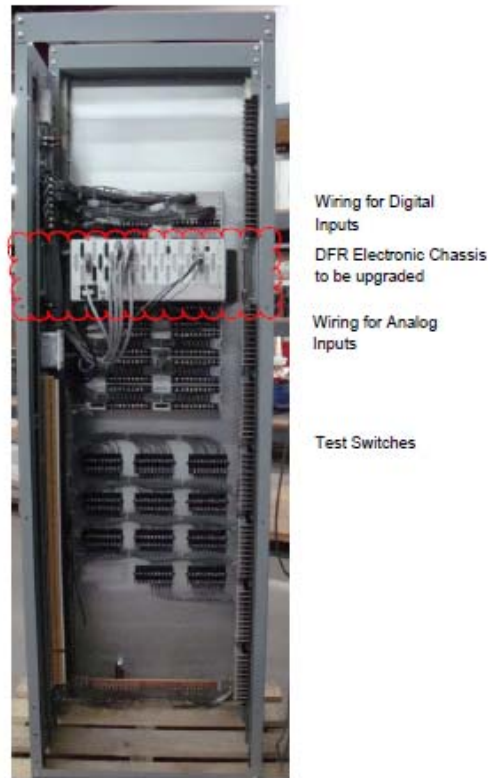
The extensive upgrades include the replacement of obsolete electronic components in the electronic chassis of the DFR, including the hard drive, host processor, RAM memory, internal modem and the Ethernet interface module. The electronic chassis can be seen in Figures 1 and 2 below of the front and rear of the DFR cabinet.

**Figure 2: Mehta Tech DFR Cabinet Layout – Rear View**

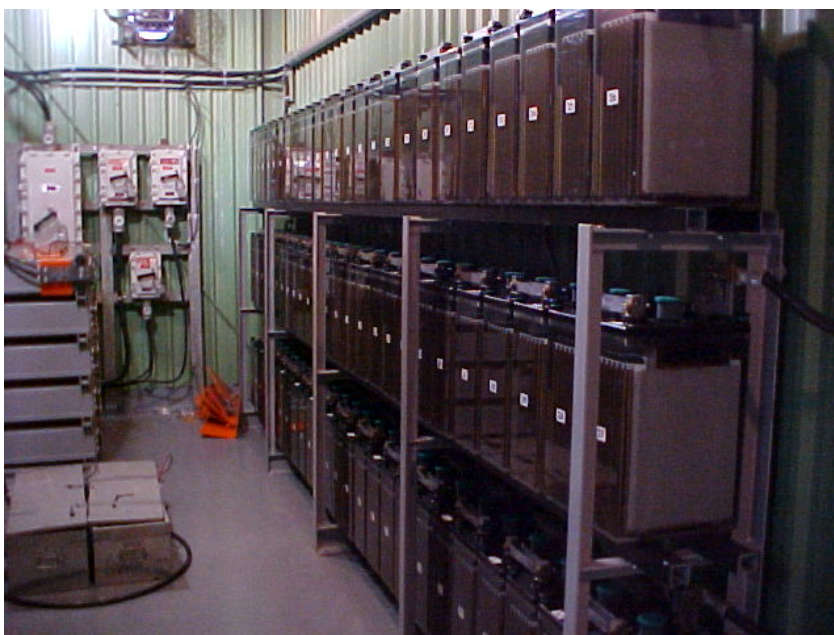
Two types of stationary batteries are in use today. The flooded-cell battery shown in Figure 1 is the most common type. It consists of a series of individual cells connected together to supply the required voltage, either 48V or 125V DC, depending on the application. Each cell has rectangular plates of lead-calcium alloy bathed in a sulfuric acid electrolyte. The battery is large, heavy, and unwieldy; however, it has the advantage of high reliability and a typical service life of 18-20 years. If an individual cell fails, the battery continues to operate, although at diminished capacity. This type of battery has three disadvantages: Flooded-cell batteries emit small amounts of hydrogen gas during charging, and therefore require battery room ventilation; the battery requires regular maintenance to ensure the battery electrolyte does not deplete during operation; and the Battery container may fail causing potentially dangerous spills of sulfuric acid. To date, Hydro has only experienced one very minor leak from a cell two years ago which was replaced with a new unit. Also, in one shipment of cells, there was a missing cap resulting in some leakage during shipping. The spilled acid was neutralized without incident.

**Figure 1: Flooded-cell battery (Stephenville)**

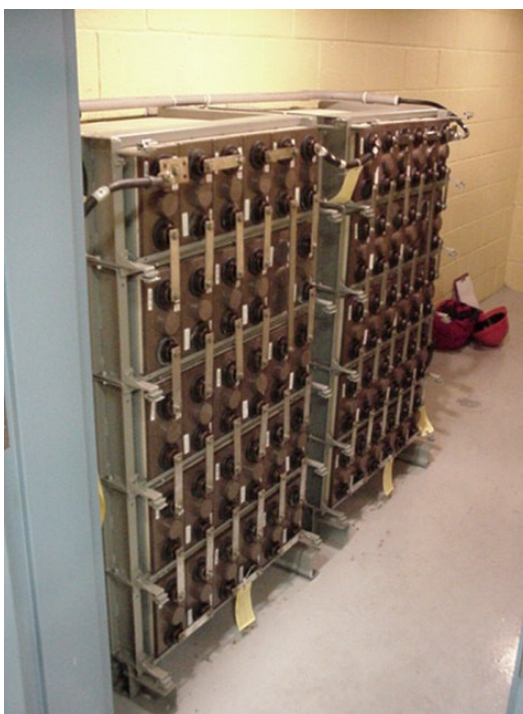
In an effort to develop a smaller battery with less maintenance and less exposure to dangerous chemicals, manufacturers introduced a type of battery, known as Valve Regulated Lead Acid (VRLA), shown in Figure 2. These batteries hold the electrolyte suspended in a gel or paste and utilize a sealed container which reduces the chance of spill and prevents hydrogen escaping to the atmosphere. Unfortunately, once in operation they soon demonstrated several significant disadvantages. In practice, VRLA batteries have only seven to ten years of service life, which is approximately half of the flooded-cell battery service life. The batteries can experience a condition known as “thermal runaway”, which is overheating that could lead to an explosion. Hydro has not experienced an explosion, but several sites (eg: St Anthony airport) with VRLA cells have experienced overheating and swelling which is a dangerous state. The cells were replaced before total failure. When a cell fails, it fails with an open circuit, meaning that the failure of one cell can cause the whole bank to fail. For these reasons, many users still use flooded-cell batteries.

**Figure 2: VRLA battery (Hinds Lake)**

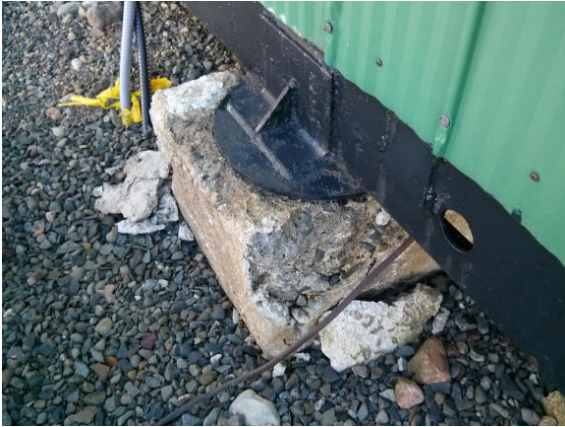
**Figure 2: Cracked Concrete Foundation**

The microwave shelter at Sandy Brook Hill was constructed in the late 1970's. It is a timber building with metal siding, concrete foundations and metal roof with ice shield. The building is between 35 and 40 years old and has not had a significant upgrade since it was built. A condition assessment revealed cracked concrete foundations (see Figure 2) and worn siding with some corrosion present (see Figure 3). In addition, sheeting behind the siding was exposed and damaged (see Figure 4) and seals were poor around siding extrusions (see Figure 5).

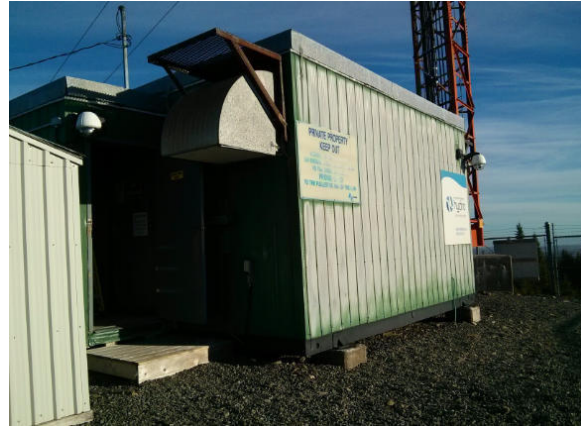
**Figure 3: Weathered Siding**

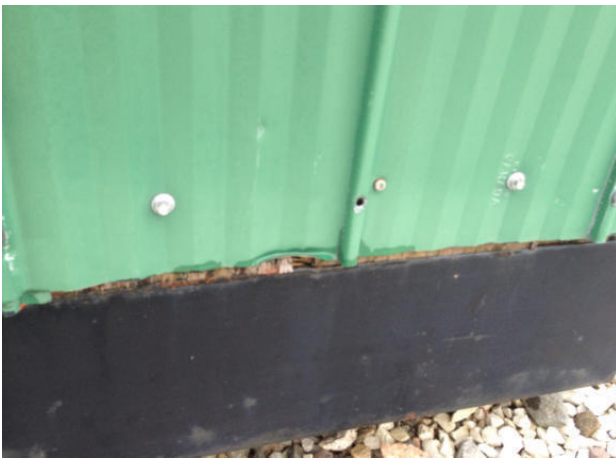
**Figure 4: Exposed and Damaged Sheeting**

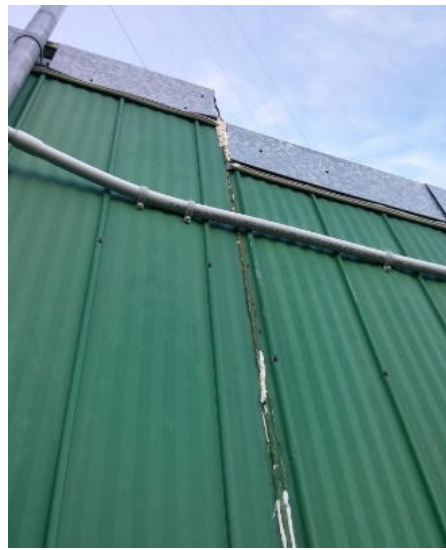
**Figure 5: Poor seals in siding and roof**
