**Re: Newfoundland and Labrador Hydro - The Board's Investigation and Hearing into  
Supply Issues and Power Outages on the Island Interconnected System – Rolling 12  
month performance of Hydro's generating units**

Quarterly Report on Performance of Generating Units  
For the Quarter ended June 30, 2017

*A Report to the Board of Commissioners of Public Utilities*

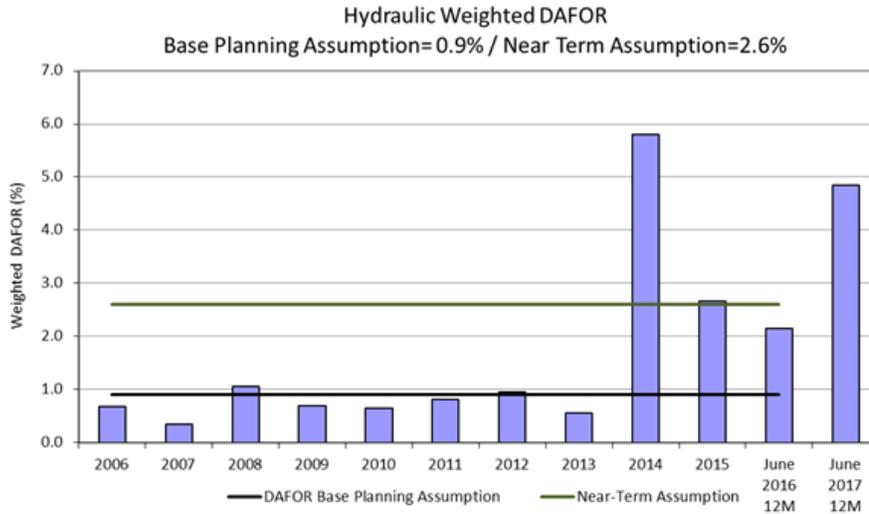
**Figure 1: Hydraulic Weighted DAFOR**

1 Considering the individual units’ performance, the assumed Hydro generation base planning  
 2 DAFOR was materially exceeded for Bay d’Espoir Unit 1 and Bay d’Espoir Unit 2. Also, there  
 3 were exceedances compared to base planning assumption for Bay d’Espoir Unit 6, Granite  
 4 Canal, Cat Arm Unit 1, Hinds Lake and Paradise River for the current period.

24 Note that the data for 2006 to 2015 in Figures 1, 2 and 3 are annual numbers (January 1 to  
25 December 31), while the data for 2016 and 2017 are 12-month rolling numbers (July 1 to June  
26 30 for each year).

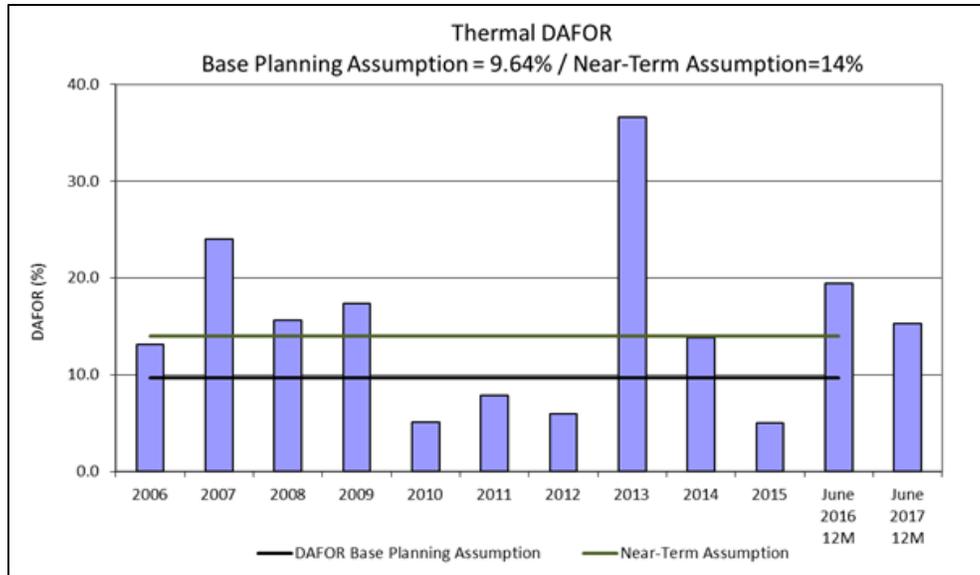
Figure 2: Thermal DAFOR

1 For the 12-month period ending June 30, 2017, the weighted DAFOR for all thermal units, of  
 2 15.27% is above the assumed Hydro generation base planning DAFOR value of 9.64%, and  
 3 comparable to the near-term assumption of 14.00%. Unit 1 DAFOR was 21.33% and Unit 2  
 4 DAFOR was 26.46%.The performance for both Units 1 and 2 was above the base planning  
 5 assumption of 9.64% and the near-term assumption of 15% (Unit 1) and 10% (Unit 2). Unit 3  
 6 DAFOR was 3.29%, which is better than the base planning assumption of 9.64% and near-term  
 7 assumption of 18.0%. The majority of the 15.27% DAFOR for the plant is due to deratings from  
 8 airflow issues in the 2016/2017 winter season and deration after the replacement of failed  
 9 boiler tubes in 2016.

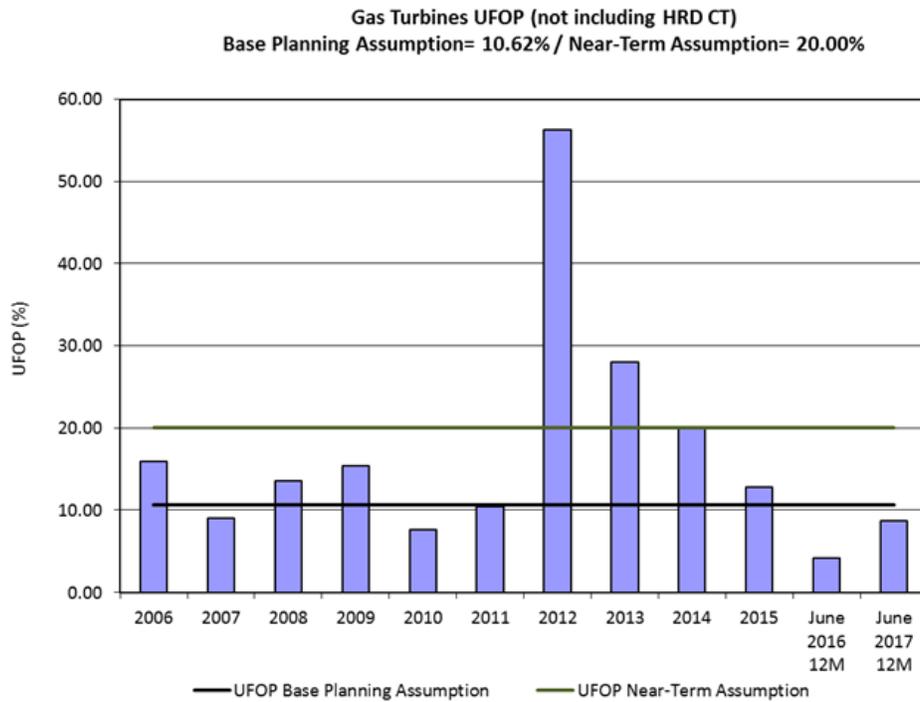
**Figure 3: Gas Turbine UFOP**

- 1 The Hardwoods unit UFOP was primarily affected by the following events in the reporting
- 2 period:
  - 3 • On October 3, 2016, the Hardwoods gas turbine tripped due to a loss of fuel pressure
