Re: Updated Integrated Action Plan

This action was to complete a risk/reward review of the option of requiring that all 230 kV terminal station transformers be equipped with their own 230 kV breakers. As noted in the Report, this analysis was part of Hydro's 2016 work plan, to be completed on December 31, 2016.

SINGLE LINE DIAGRAMS OF FIVE STATIONS
SHOWING RELIABILITY IMPROVEMENTS

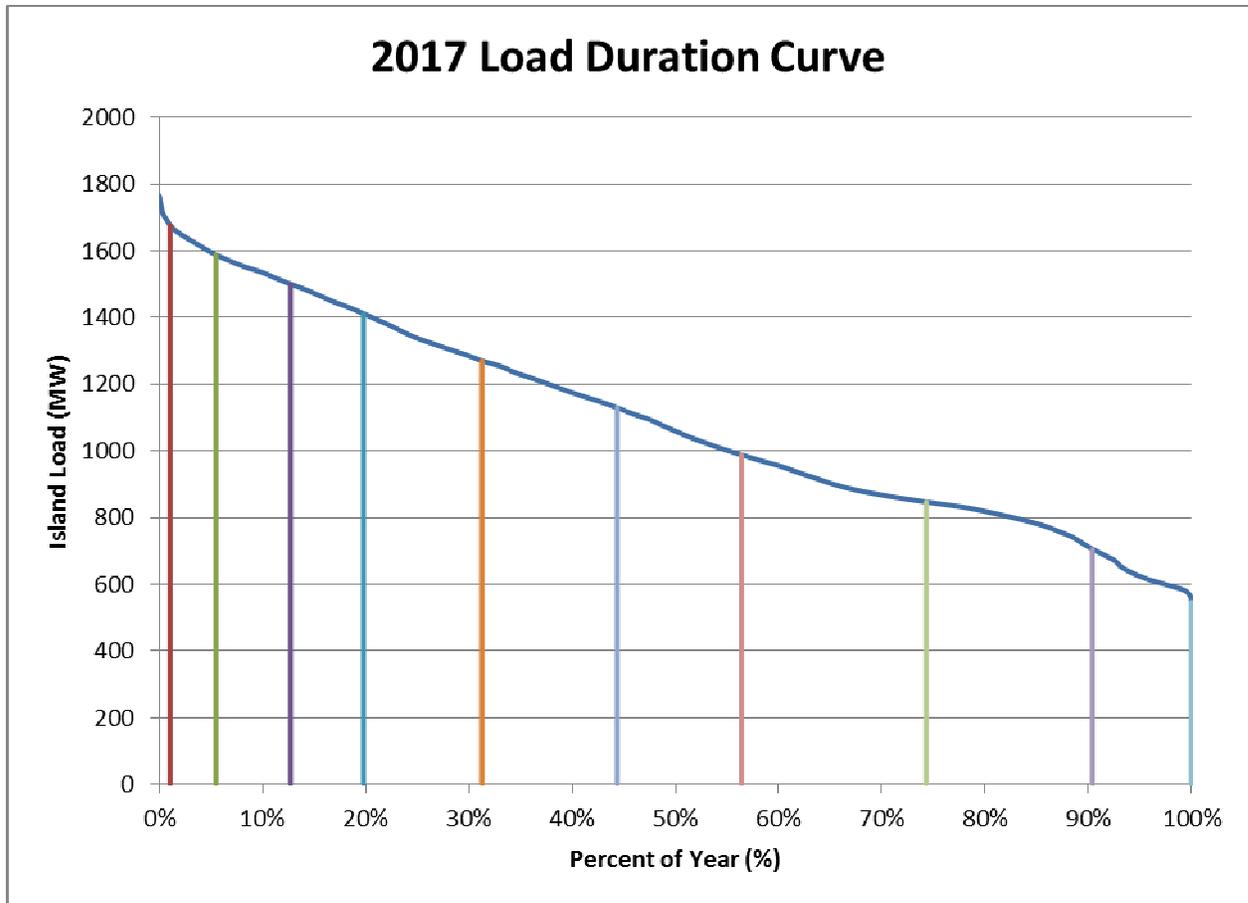
Figure 1
2017 Load Duration Curve with 10 Representative Load Profiles

The load flow and stability analysis were performed on ten separate cases representing typical load flow configurations throughout the year, with Island load ranging from light load to peak load. Figure 1 below shows the expected 2017 Island Load Duration Curve with ten loading scenarios. Table 1 below outlines these ten cases as a percentage of peak load vs. time duration. The 2021 Peak load flow case was used as the base case of analysis. The 2021 Peak Island load was adjusted based on Table 1 percentages to arrive at the ten cases for the subsequent analysis.
