**A REPORT TO
THE BOARD OF COMMISSIONERS OF PUBLIC UTILITIES**

**QUARTERLY REPORT
ON
PERFORMANCE OF GENERATING UNITS
FOR THE QUARTER ENDED JUNE 30, 2016**

NEWFOUNDLAND AND LABRADOR HYDRO

JULY 15, 2016

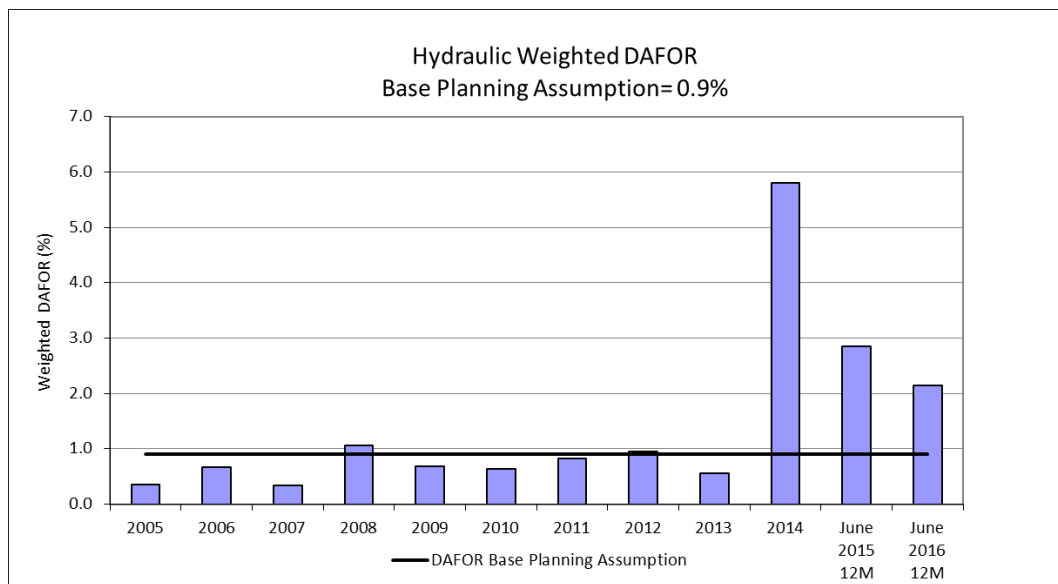
Generating Unit	Maximum Continuous Unit Rating (MW)	12 months ending June 2015 (%)	12 months ending June 2016 (%)	Hydro Generation Base Planning Assumption (%)
All Hydraulic Units - weighted	954.4	2.85	2.15	0.90
Hydraulic Units				
Bay D'Espoir 1	76.5	13.75	17.69	0.90
Bay D'Espoir 2	76.5	0.00	7.44	0.90
Bay D'Espoir 3	76.5	0.00	0.00	0.90
Bay D'Espoir 4	76.5	0.23	0.11	0.90
Bay D'Espoir 5	76.5	0.00	3.36	0.90
Bay D'Espoir 6	76.5	15.39	0.00	0.90
Bay D'Espoir 7	154.4	0.84	0.00	0.90
Hinds Lake	75	0.30	0.05	0.90
Upper Salmon	84	1.17	0.00	0.90
Granite Canal	40	0.37	1.83	0.90
Cat Arm 1	67	0.60	0.01	0.90
Cat Arm 2	67	1.91	0.21	0.90
Paradise River	8	0.00	0.31	0.90

1 Considering the individual units performance, the assumed Hydro generation base planning
2 DAFOR was materially exceeded for Bay d’Espoir Unit 1. Also, there were exceedances
3 compared to base planning assumption for Bay d’Espoir Unit 2, Bay d’Espoir Unit 5, and
4 Granite Canal for the current period.

6 The Bay d’Espoir Unit 1 DAFOR of 17.69% compared to the base planning assumption of
7 0.9% was the result of a forced extension of a planned outage. This one forced outage,
8 contributed 52% of the total DAFOR in this asset class. The planned annual maintenance was
9 scheduled from April 26, 2015 to May 15, 2015. The extension is the unanticipated result of
10 having to replace the turbine bearing. It was identified in the annual work plan to check the
11 turbine bearing clearances due to an increase in bearing temperatures. The bearing
12 clearances were checked and damage was found to the turbine bearing. Therefore it was
13 replaced with a new bearing. Vibration issues continued to be experienced at the unit after
14 the bearing was replaced, which extended the planned outage. Two vibration experts,
15 Hydro’s Project Execution and Technical Services personnel, as well as the Original
16 Equipment Manufacturer were retained to troubleshoot the issue, with the unit eventually

26 The Bay d’Espoir Unit 2 DAFOR of 7.44% compared to the base planning assumption of 0.9%
27 was the result of a forced outage, caused by a leak in Penstock 1, which supplies both Units 1

7 The Bay d'Espoir Unit 5 DAFOR of 3.36% compared to the base planning assumption of 0.9%
8 was the result of a forced outage after the completion of planned annual maintenance. The
9 planned annual maintenance was completed from May 27, 2015 to August 7, 2015. Upon
10 starting the unit, a stator ground fault occurred, which required five days to repair before
11 the unit was placed into service on August 12, 2015.

13 The Granite Canal unit DAFOR of 1.83% compared to the base planning assumption of 0.9%
14 was the result of a forced outage after a lightning strike to transmission line TL263 which
15 connects the unit to the grid. A bearing issue (low water flow on the shaft seal) was
16 experienced on the restart of the unit. From August 10, 2015 to August 14, 2015, the unit
17 incurred forced unavailability while repairs were completed to resolve this issue. From
18 December 16, 2015 to December 17, 2015, the unit experienced forced unavailability due to
19 debris on the intake trash rack.

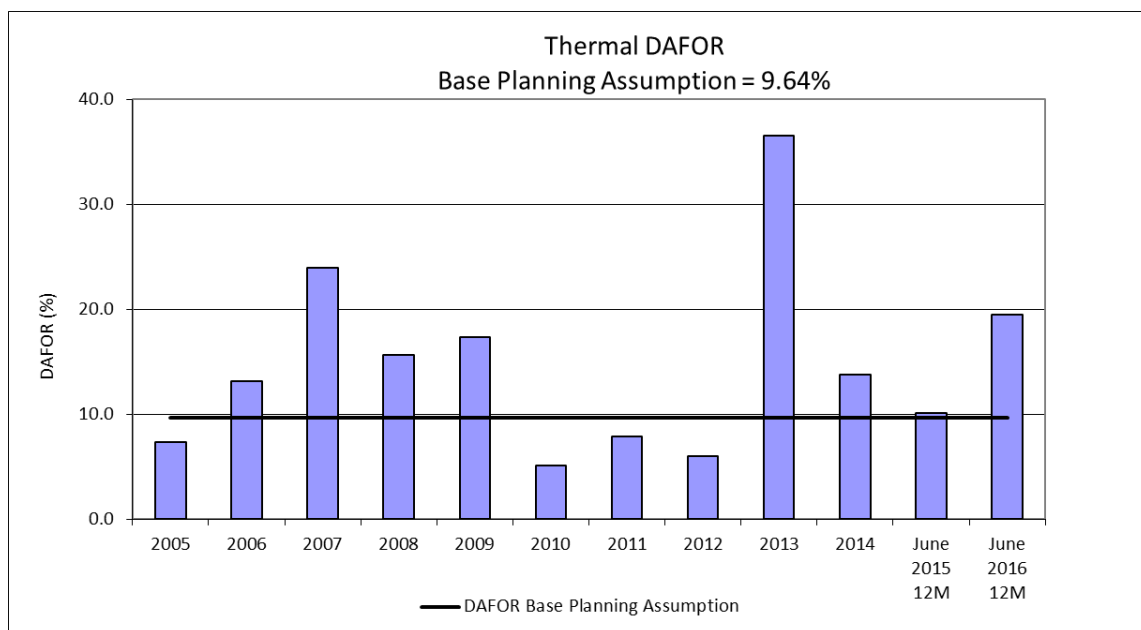
Generating Unit	Maximum Continuous Unit Rating (MW)	12 months ending June 2015 (%)	12 months ending June 2016 (%)	Hydro Generation Base Planning Assumption (%)
<i>All Thermal Units - weighted</i>	490	10.06	19.45	9.64
Thermal Units				
Holyrood 1	170	13.20	20.66	9.64
Holyrood 2	170	11.06	26.46	9.64
Holyrood 3	150	5.67	8.91	9.64

9 For the 12-month period ending June 30, 2016 the weighted DAFOR for all thermal units of
 10 19.45% is above the assumed Hydro generation base planning DAFOR value of 9.64%, and
 11 also exceeded the previous 12-month period rate of 10.06%. Unit 1 DAFOR was 20.66% and
