**A REPORT TO
THE BOARD OF COMMISSIONERS OF PUBLIC UTILITIES**

**QUARTERLY REPORT
ON
PERFORMANCE OF GENERATING UNITS
FOR THE QUARTER ENDED JUNE 30, 2015**

NEWFOUNDLAND AND LABRADOR HYDRO

JULY 17, 2015

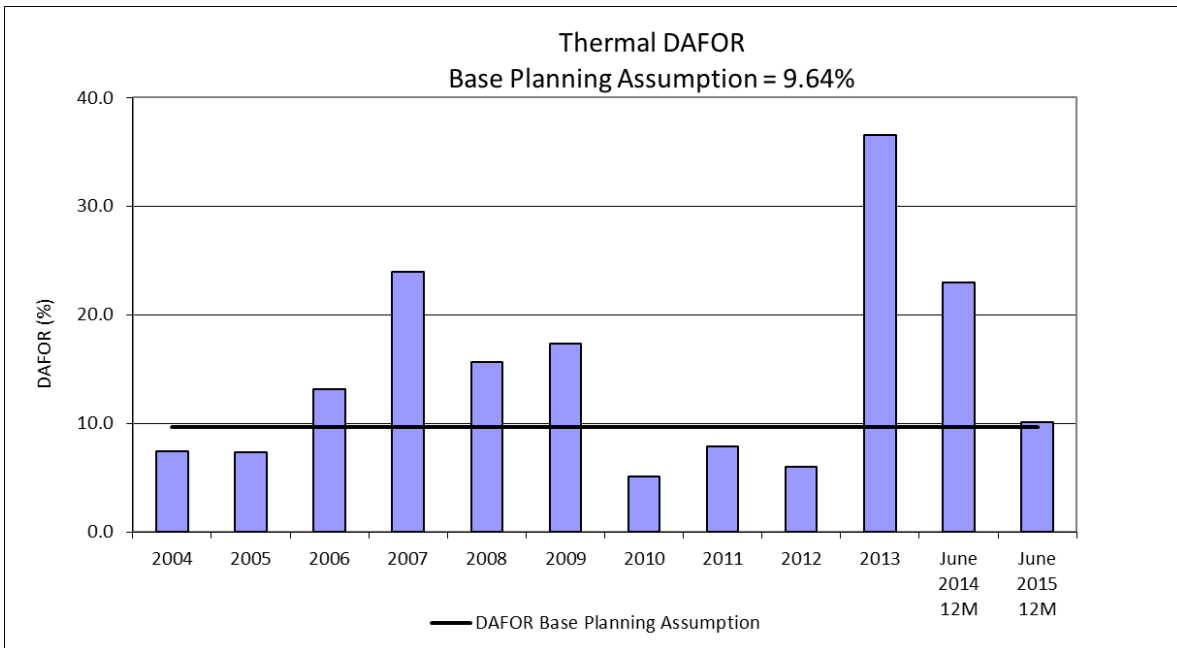
The thermal units forced outage rates are measured using the CEA metric, DAFOR. Detailed results for the 12-month period ending June 30, 2015 is presented as well as the data for the 12-month period ending June 30, 2014 and the Hydro Generation Base Planning Assumption for the forced outage rate.

For the 12-month period ending June 30, 2015, the weighted all thermal units DAFOR of 10.06% was not materially different than the assumed Hydro Generation Base Planning DAFOR value of 9.64%, and improved compared to the previous 12-month period rate of 22.99%. The variance compared to plan in the current period was attributable to exceedances for Units 1 and to a lesser extent, Unit 2.

Unit 3 DAFOR was materially improved compared to the previous period of 10.87% and finished the current period at 5.67% compared to plan of 9.64%.

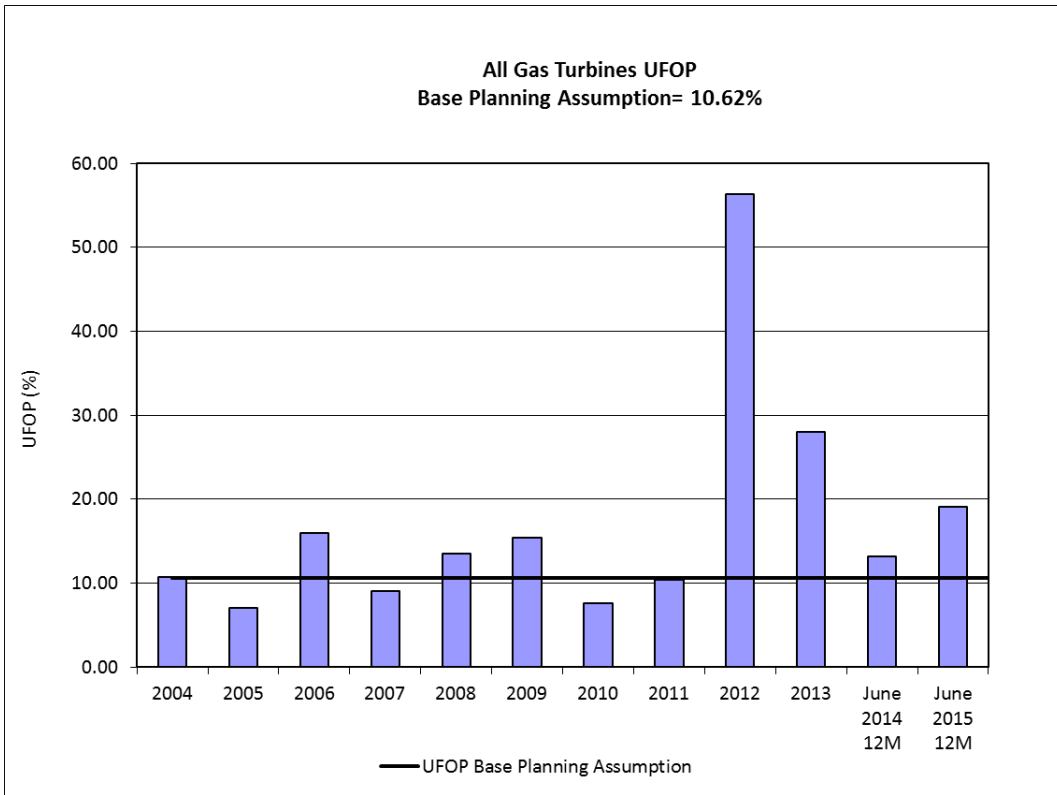
The All Gas Turbine Units UFOP base plan was exceeded in the current period due to the Hardwoods and Stephenville Gas Turbines UFOP.

From July 25 to September 25, 2014, a forced outage of Hardwoods Gas Turbine was the primary contributor to the unit’s UFOP. This outage was due to a grounding issue which caused a fire in the motor control center. The affected equipment was replaced. An investigation into the incident resulted in a number of recommendations, some of which are complete and others are in progress.

The Stephenville Gas Turbine experienced a forced outage from May 1, 2015 to May 27, 2015 due to an alternator bearing problem. The bearing was inspected, repaired, and all operating parameters checked and confirmed prior to return to service.
