Re: Newfoundland and Labrador Hydro - The Board's Investigation and Hearing into Supply Issues and Power Outages on the Island Interconnected System – Rolling 12 month performance of Hydro's generating units

**QUARTERLY REPORT
ON
PERFORMANCE OF GENERATING UNITS
FOR THE QUARTER ENDED SEPTEMBER 30, 2015**

NEWFOUNDLAND AND LABRADOR HYDRO

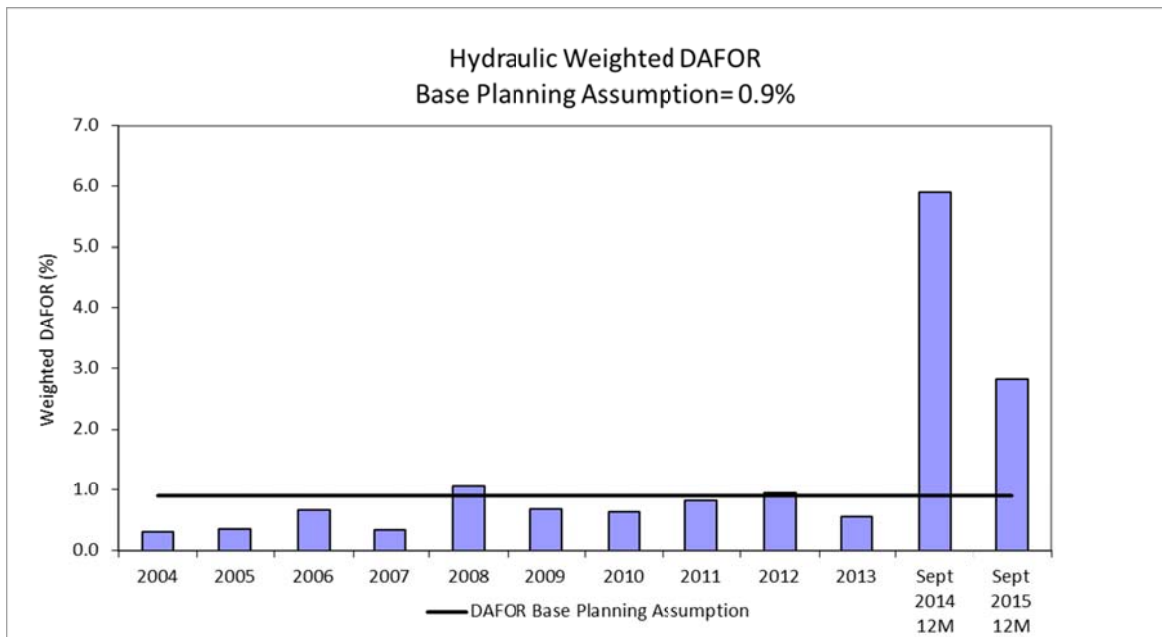
Generating Unit	Maximum Continuous Unit Rating (MW)	12 months ending September 2014 (%)	12 months ending September 2015 (%)	Hydro Generation Base Planning Assumption (%)
All Hydraulic Units - weighted	954.4	5.89	2.82	0.90
Hydraulic Units				
Bay D'Espoir 1	76.5	0.03	25.6	0.90
Bay D'Espoir 2	76.5	3.04	0.00	0.90
Bay D'Espoir 3	76.5	0.00	0.00	0.90
Bay D'Espoir 4	76.5	0.75	0.23	0.90
Bay D'Espoir 5	76.5	0.19	2.46	0.90
Bay D'Espoir 6	76.5	58.59	0.00	0.90
Bay D'Espoir 7	154.4	2.08	0.00	0.90
Hinds Lake	75	0.11	0.32	0.90
Upper Salmon	84	1.27	0.98	0.90
Granite Canal	40	1.53	1.51	0.90
Cat Arm 1	67	0.00	0.63	0.90
Cat Arm 2	67	1.39	1.42	0.90
Paradise River	8	0.65	0.19	0.90

1 The weighted "All Hydraulic Units" DAFOR was 2.82% for the current 12 month period
2 ending September 30, 2015. The forced outage and derating of Unit 1 at Bay d'Espoir was
3 the primary contributor to the DAFOR of 2.82% as compared to a base planning assumption
4 of 0.9%.

11 The Bay d'Espoir Unit 1 DAFOR of 25.6% compared to the base planning assumption of 0.9%
12 was the result of a forced extension of a planned outage. The planned annual maintenance
13 was scheduled from April 26 to May 15, 2015. The extension is the result of having to
14 replace the turbine bearing. It was identified in the annual work plan to check the turbine
15 bearing clearances due to an increase in bearing temperatures. The bearing clearances were
16 checked and damage was found to the turbine bearing, so it was replaced with a new
17 bearing. Vibration issues continued with the unit after the bearing was replaced, which
18 extended the planned outage. Two vibration experts, Hydro staff, as well as the Original
19 Equipment Manufacturer were involved in troubleshooting the issue, with the unit
20 eventually being returned to service at reduced capacity. The original turbine bearing was
21 reinstalled after being refurbished (with reduced clearances), and while the vibration issue

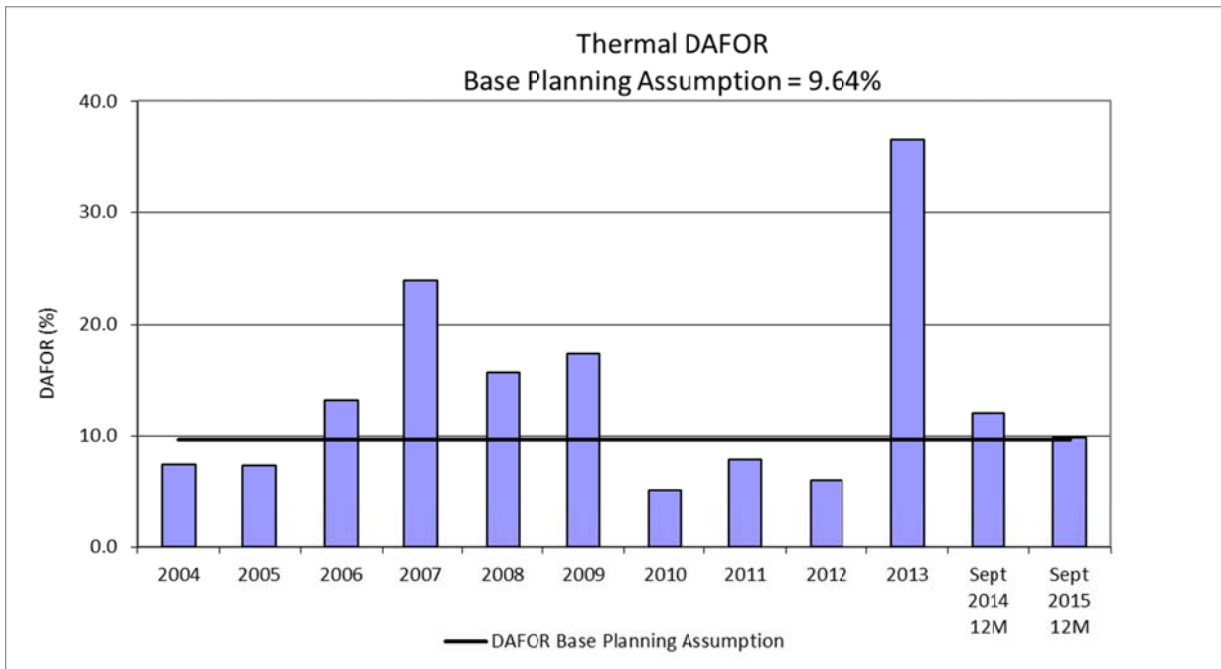
Generating Unit	Maximum Continuous Unit Rating (MW)	12 months ending September 2014 (%)	12 months ending September 2015 (%)	Hydro Generation Base Planning Assumption (%)
<i>All Thermal Units - weighted</i>	490	12.00	9.86	9.64
Thermal Units				
Holyrood 1	170	16.73	12.22	9.64
Holyrood 2	170	6.53	7.15	9.64
Holyrood 3	150	11.65	10.08	9.64

11 For the 12-month period ending September 30, 2015, the weighted all thermal units DAFOR
 12 of 9.86% was not materially different than the assumed Hydro generation base planning
 13 DAFOR value of 9.64%, and improved compared to the previous 12-month period rate of
 14 12.00%. The variance compared to plan in the current period was primarily attributable to

1 an exceedance for Unit 1 DAFOR. Unit 2 performance, at 7.15%, was better than the base
2 planning assumption of 9.64%. Unit 3 DAFOR improved compared to that of the previous
3 period of 11.65% and finished the current period at 10.08% compared to a plan of 9.64%.

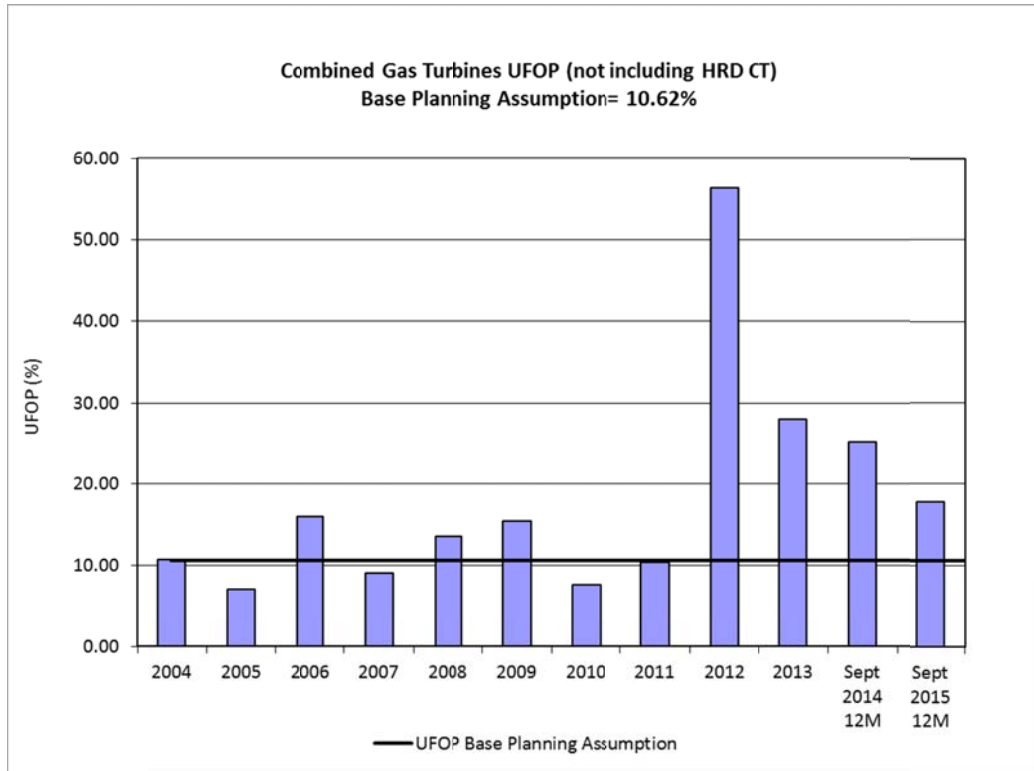
Combustion Turbine Units	Maximum Continuous Unit Rating (MW)	12 months ending September 2014 (%)	12 months ending September 2015 (%)	Hydro Generation Base Planning Assumption (%)
Holyrood CT*	123.5		5.01	5.00

*data presented from March to September 2015 only

3 The combined gas turbines UFOP base planning assumption was exceeded in the current
 4 period primarily due to the Hardwoods and Stephenville gas turbines' UFOP.
