Re: Reliability and Resource Adequacy Study Review – Labrador-Island Link Monthly Update – March 2021 – Board Questions – Hydro's Response

**Reliability and Resource Adequacy Study Review – Labrador-
Island Link Monthly Update – January 2021 Further Update**

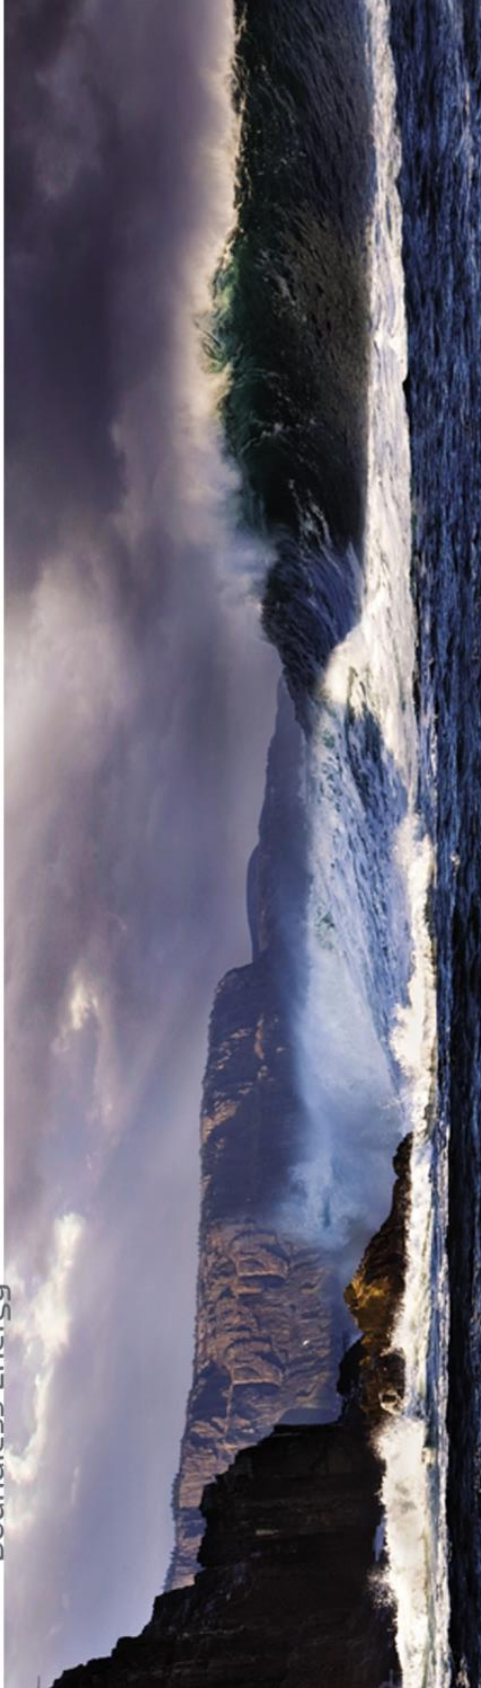
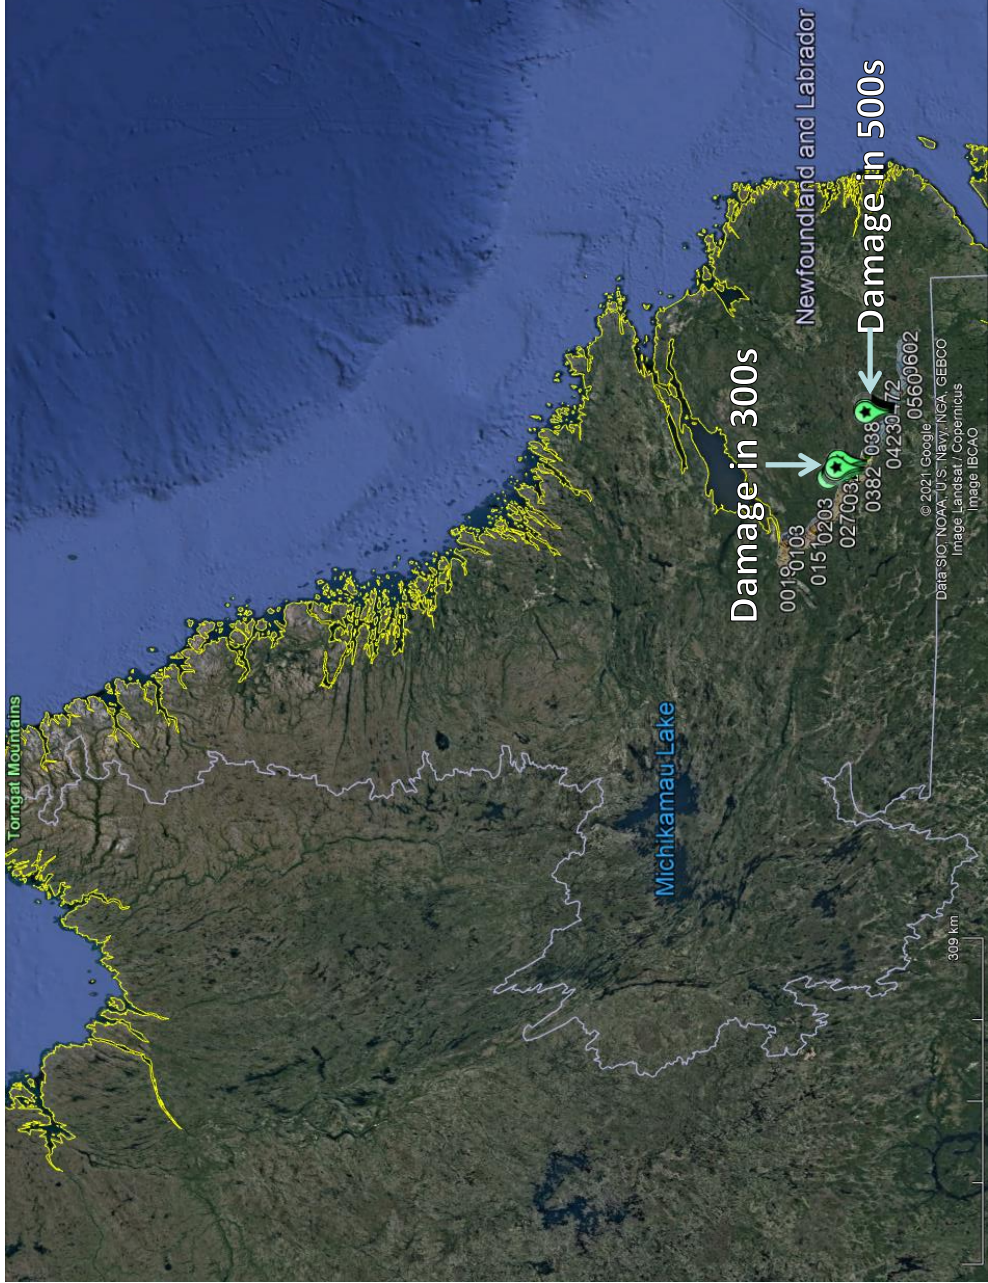
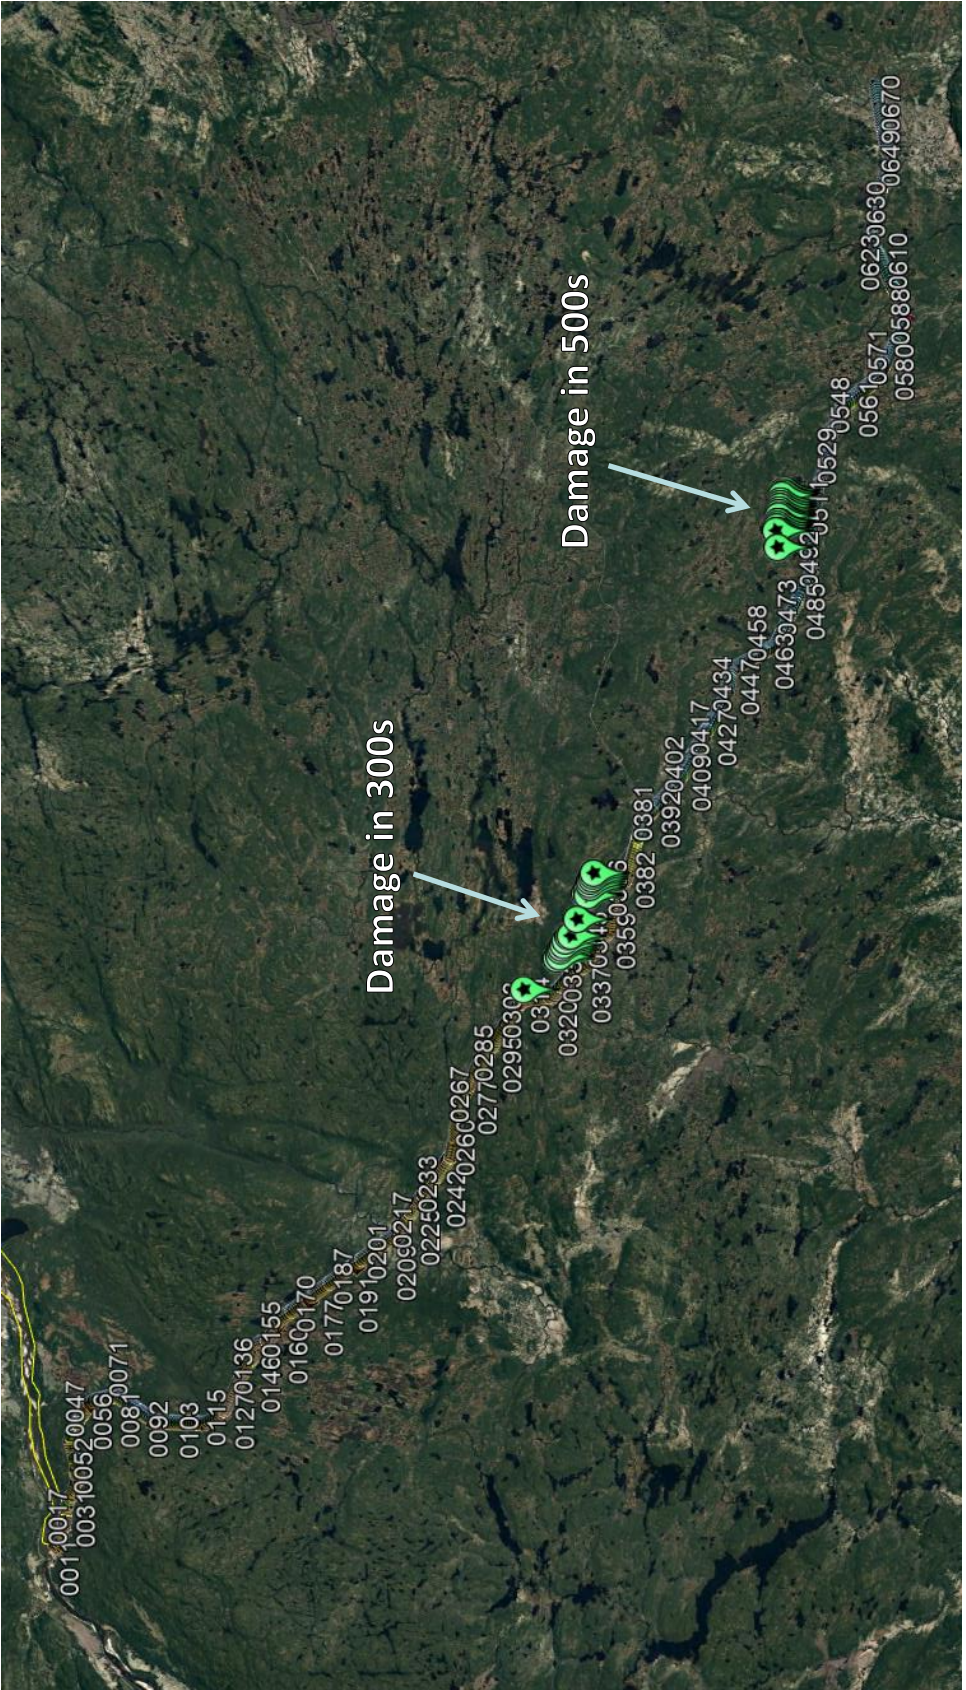
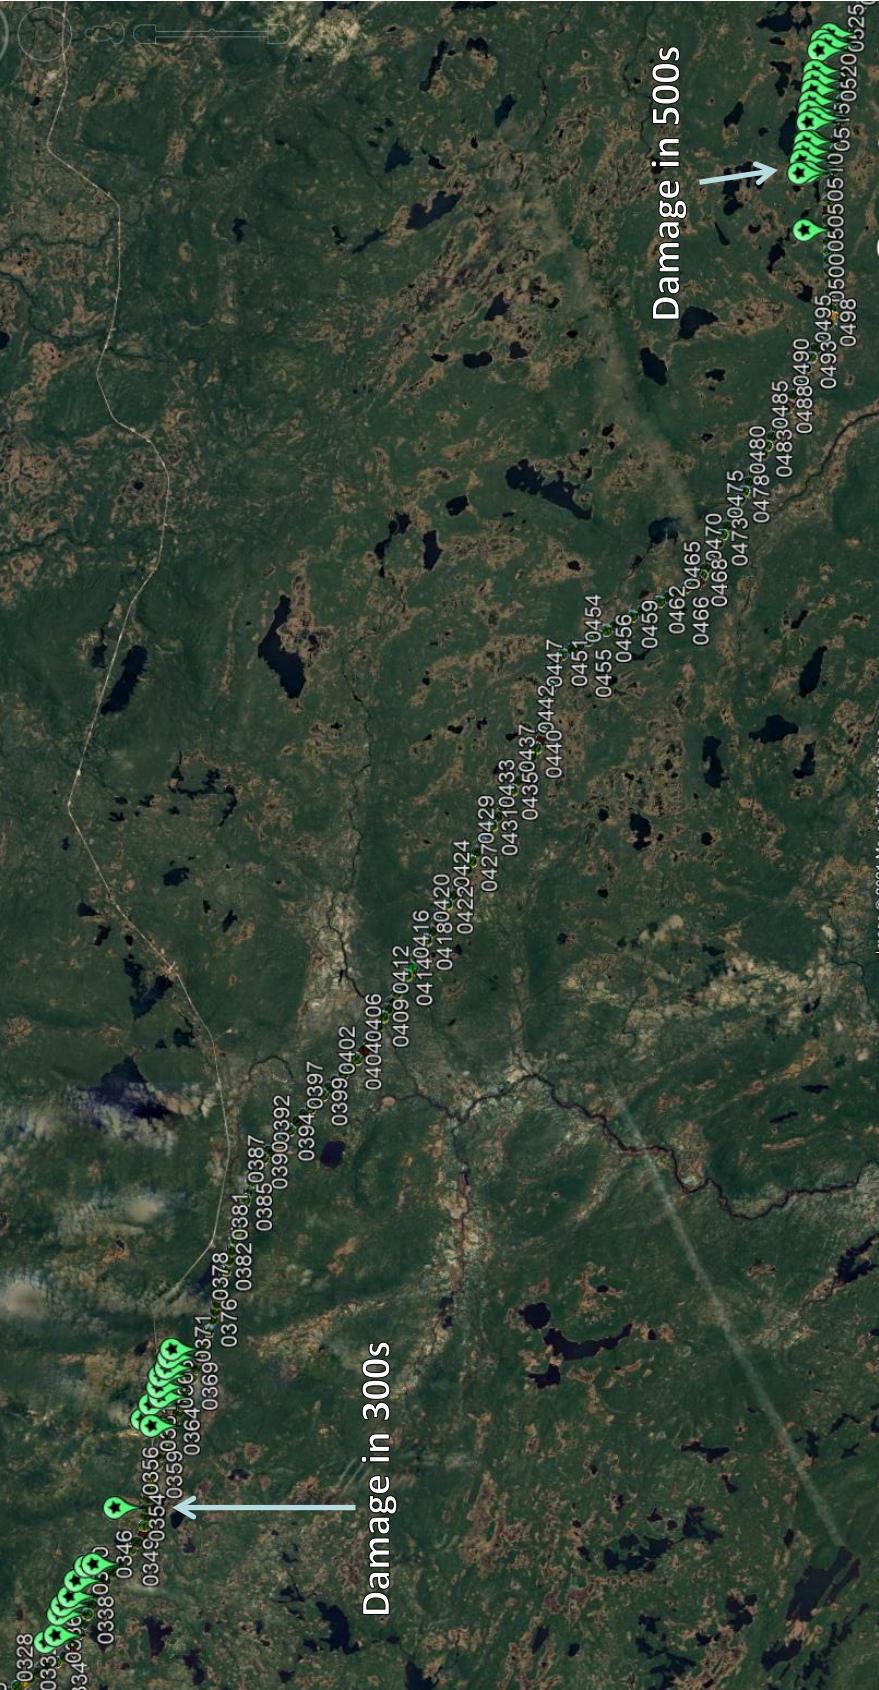
TL3501/2 Damage – January Ice Storm, 2021

TL3501/2 Damage

January Ice Storm, 2021

The February 4, 2021, Labrador-Island Link ("LIL") update noted that damage to the electrode line in Labrador was isolated to eight of 1,229 towers, which included eight damaged crossarms, and 16 areas of electrode line conductor damage that required repair, including one span where the conductor was broken and laying on the ground. It was also noted that the majority of the damage was isolated to the electrode line, predominately, electrode line one (EL1), with minor damage to electrode line two (EL2). Since that update, additional damage has occurred on EL1 and EL2. Currently, damage has been identified on 30 of 1,229 towers, which includes 29 spans that require conductor splicing, repair, or restringing, including four spans where the conductor has fallen to the ground, as well as 12 crossarms that require repair or replacement.

On February 7, 2021, while crews were repairing a section of conductor on EL1, a section of conductor on EL2 failed in the same vicinity resulting in notable shaking of the nearby towers and associated lines, which caused ice to fall in the vicinity of workers below. As a result of the safety incident, work activities were paused while the safe work plans were reviewed. A third party with experience removing ice from transmission lines has since been engaged to reduce the ice loading on the lines in order to minimize the risk of working on the repairs. Ice removal is expected to be complete on February 16, 2021. Once the ice has been largely removed, a detailed line inspection is planned to determine if further repairs will be required now or during the summer work season.
