2020 Capital Budget Application Technical Conference – Wood Pole Line Management

Presentation to the Board of Commissioners of Public Utilities

November 20, 2019

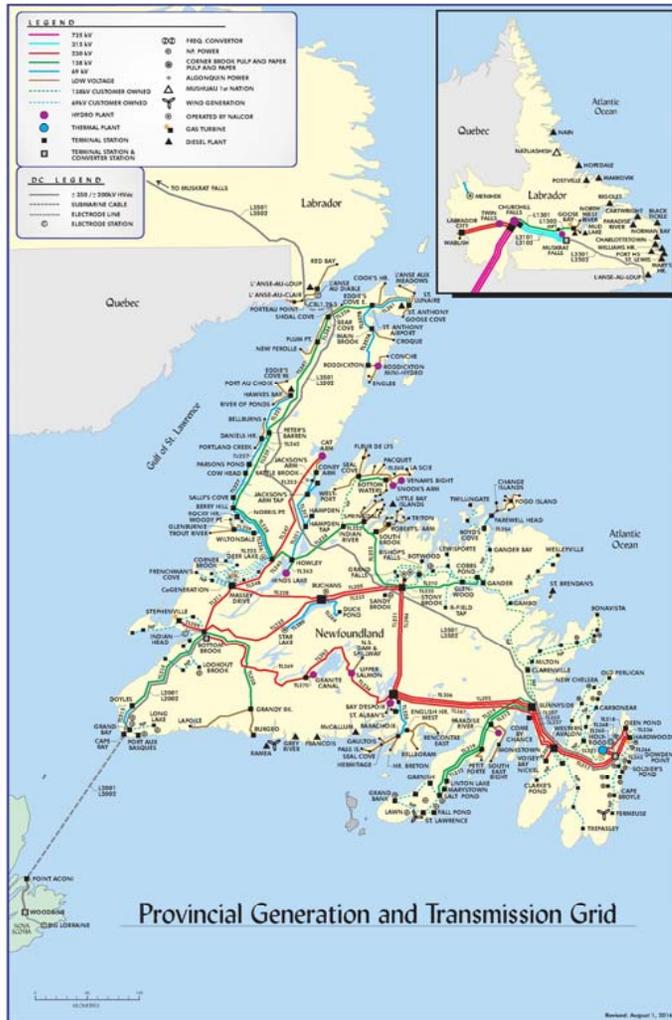
Hydro System Overview – Wood Pole Transmission

- 42 wood transmission lines
 - 20 looped, 22 radial
- Voltages
 - 69 kV
 - 138 kV
 - 230 kV
- Approx. 2,500 km
- Approx. 26,000 poles

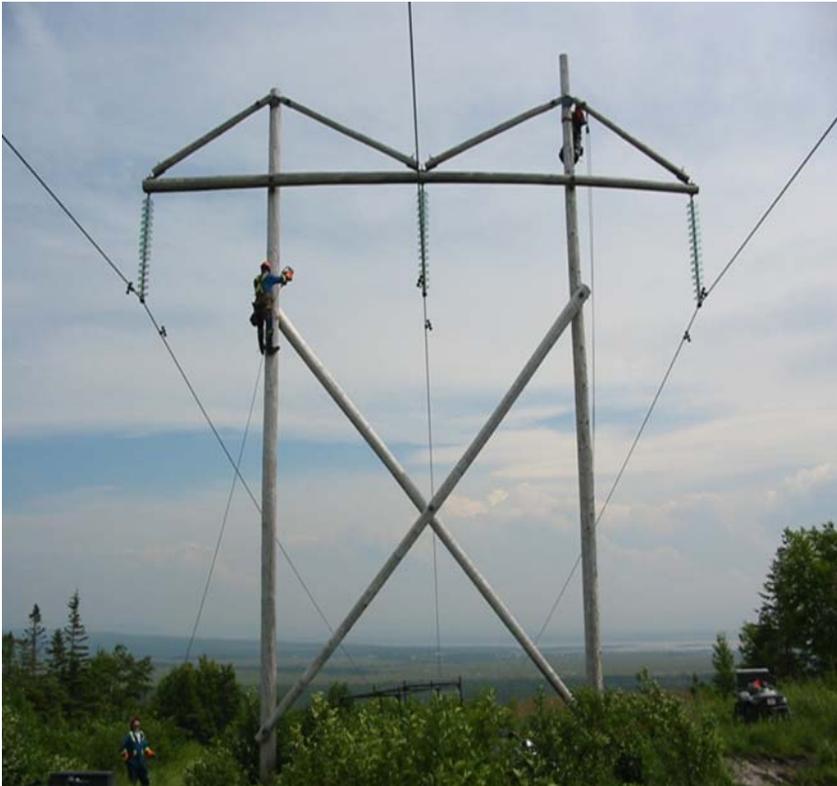
WPLM - Inspection and Treatment Process

- Groundline checked for decay.
- Full climbing inspection is completed at each structure
- Entire pole is inspected and sounded, with boring completed when decay suspected.
- Pole is treated at critical locations.
- Other components are inspected (i.e. crossarm, crossbraces, insulators etc.)
- Inspections performed by internal line crews.

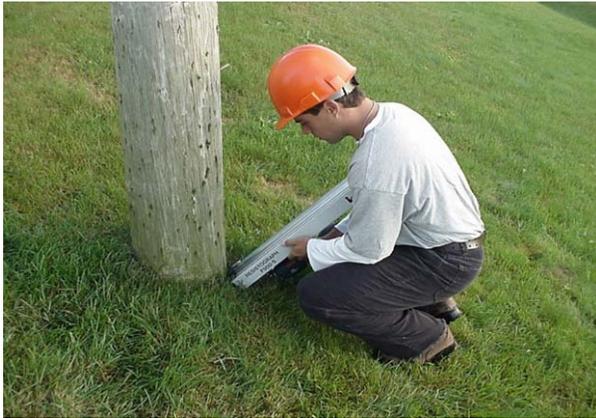
- Resistograph™
 - Used to measure the cross-sectional profile at any point on the pole.
 - Primarily a re-evaluation tool for rejected poles as required.
 - Accurate indication of internal pole condition.

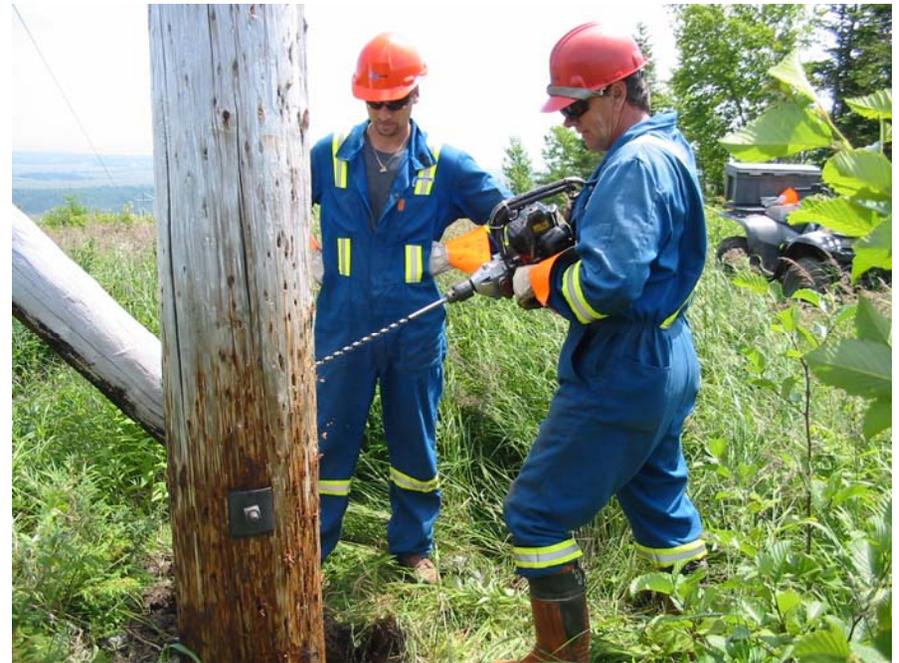
WPLM - Inspection and Treatment Process

- Boron Rod Treatment is applied in poles at:
 - Crossarm attachments
 - Crossbrace attachments
 - Kneebrace attachments
 - Guy attachments
 - Ground line

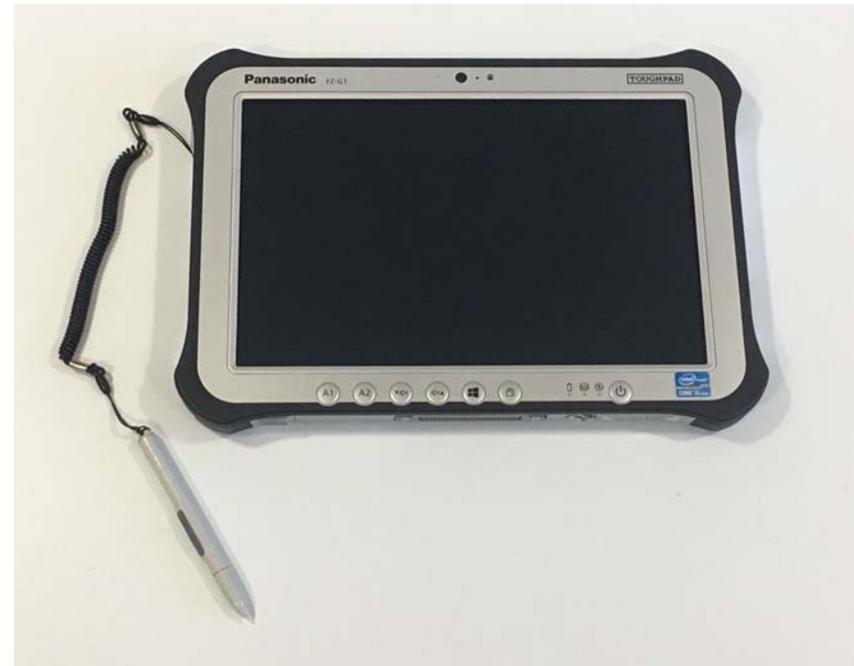
WPLM - Data Collection and Storage

- Panasonic ToughPad
 - Operates using Windows 10 and custom Graphical Information System (“GIS”) software.
 - Designed for field use.
 - Data synced directly to a GIS database, making data readily available and sortable after inspections completed.

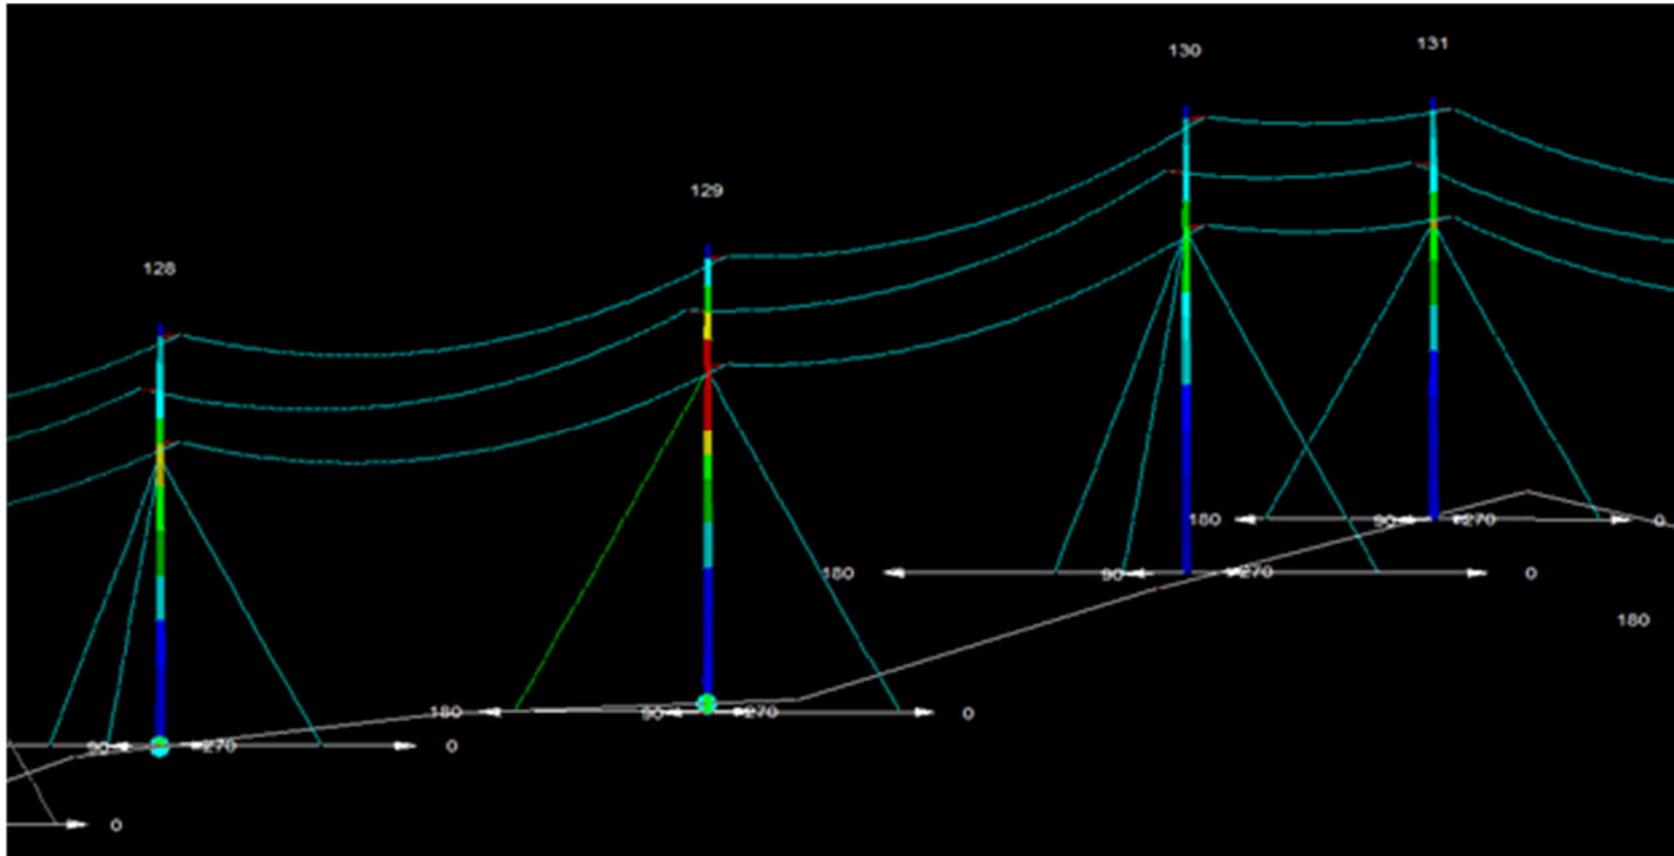
WPLM - Refurbishment Recommendations

- Field inspections are reviewed by engineering.
- Refurbishment is based on both assessed condition and engineering analysis.
- Factors considered include:
 - Extent and location of deterioration
 - Structure strength / capacity
 - Pole strength reduction based on past destructive testing.
 - Structural loading based on environmental conditions and geography of the line.

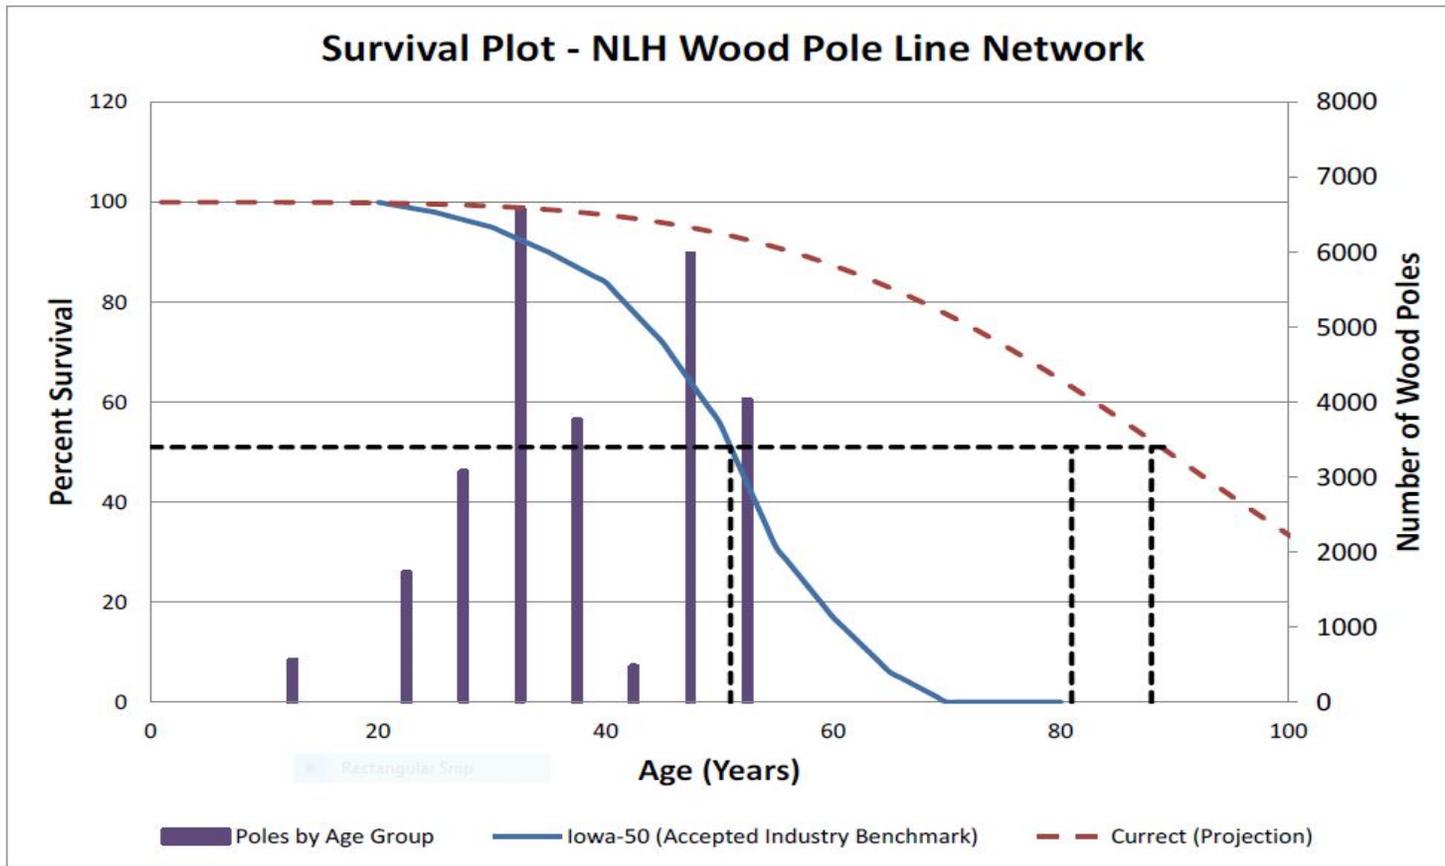
Survival Curves for Asset Management

- Pole replacement data is analyzed statistically to calibrate survival curves.

- Survival curves are used to predict future replacement rates and develop budget proposals and long term plans for each line.
