Re: Transmission System and Terminal Station Asset Management Execution Report

Transmission System and Terminal Station Asset Management Execution Report

A Report to the Board of Commissioners of Public Utilities

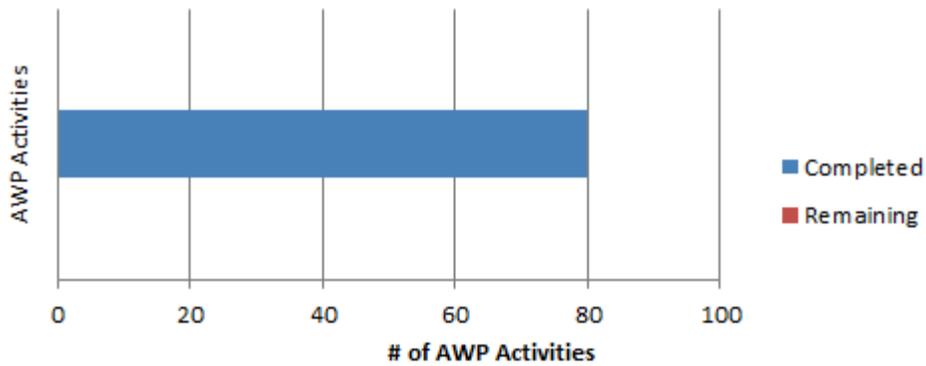
Figure 1: 2018 Transmission System AWP Activities for the Island Interconnected System (December 31, 2018)

8 As shown in Figure 1 to Figure 4, Hydro completed 100% of its planned 2018 transmission
9 system AWP and WR activities.

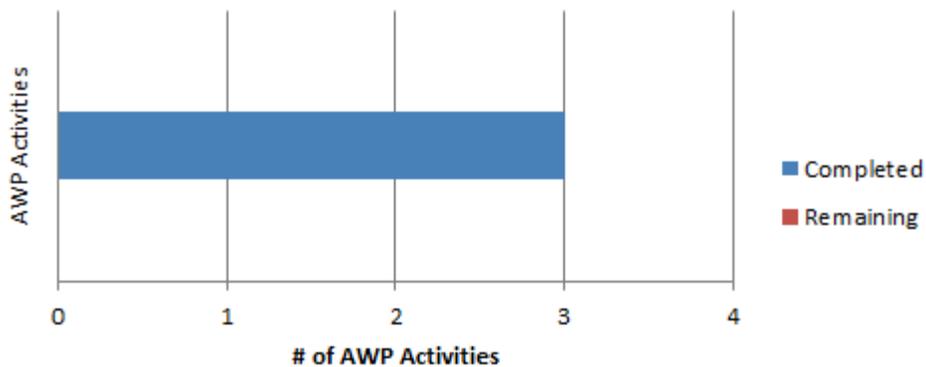
Figure 2: 2018 Transmission System AWP Activities for the Labrador Interconnected System (December 31, 2018)

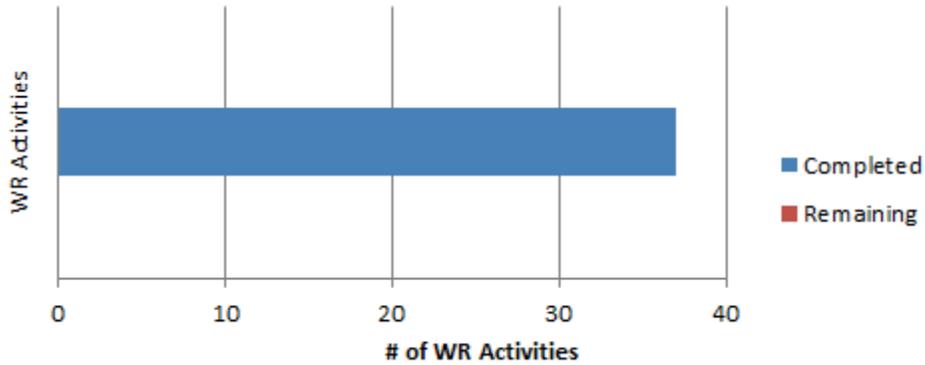
Figure 3: 2018 Transmission System WR Activities for the Island Interconnected System (December 31, 2018)

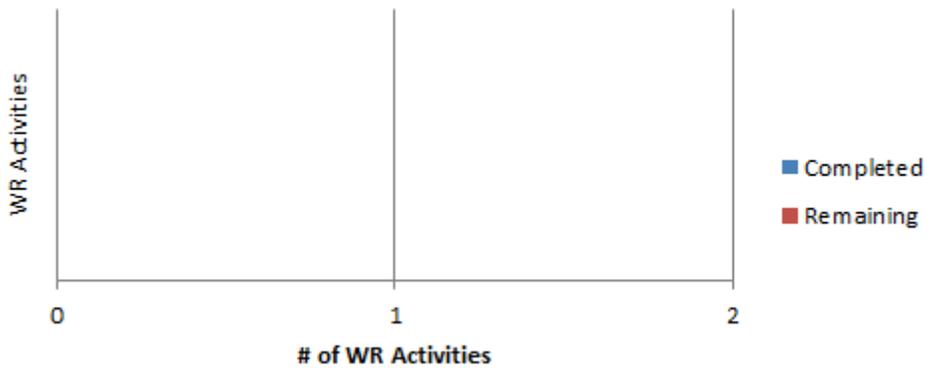
Figure 4: 2018 Transmission System Activities for the Labrador Interconnected System (December 31, 2018)

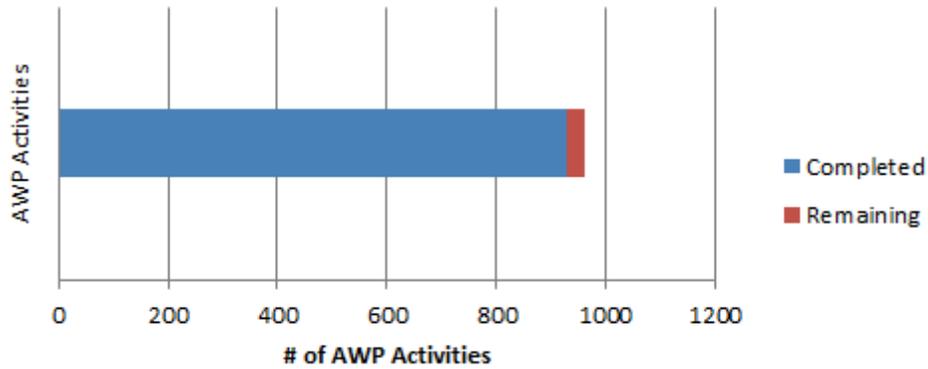
Figure 5: 2018 Terminal Station AWP Activities for the Island Interconnected System (December 31, 2018)

2 As shown in Figure 5 to Figure 8, Hydro completed 97% and 89% of its planned 2018 terminal
3 station Island Interconnected System and Labrador Interconnected System AWP respectively,
4 and 99% and 100% of its planned 2018 terminal station Island Interconnected System and
5 Labrador Interconnected System WR activities respectively as of December 31, 2018.

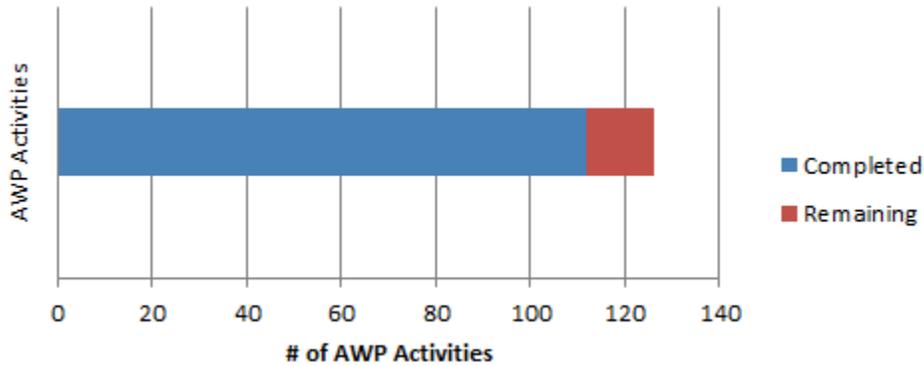
Figure 6: 2018 Terminal Station AWP Activities for the Labrador Interconnected System (December 31, 2018)

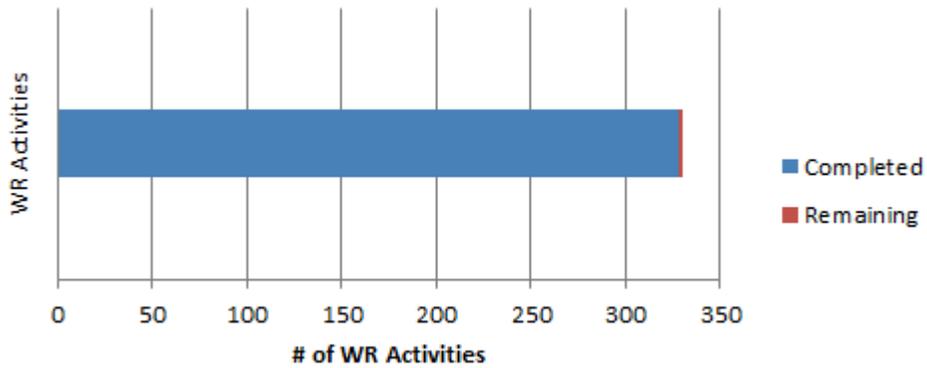
Figure 7: 2018 Terminal Station WR Activities for the Island Interconnected System (December 31, 2018)

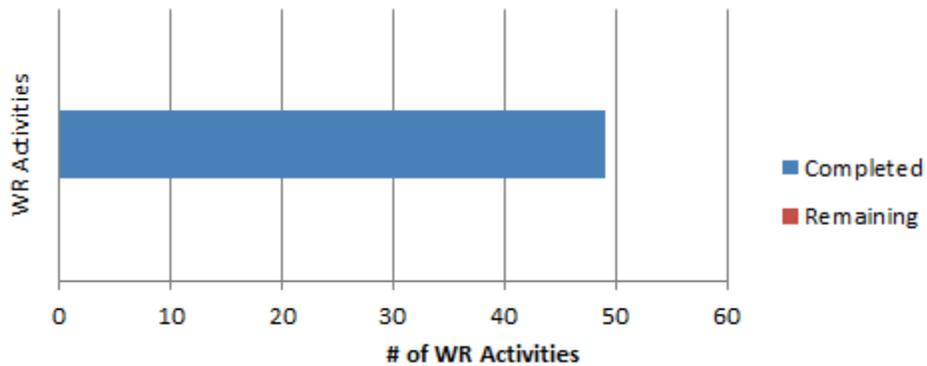
Figure 8: 2018 Terminal Station WR Activities for the Labrador Interconnected System (December 31, 2018)

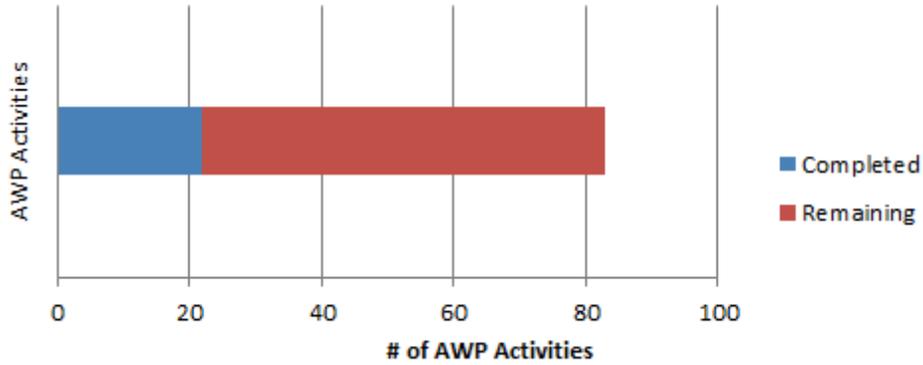
Figure 9: 2019 Transmission System AWP Activities for the Island Interconnected System (March 22, 2019)

28 As shown in Figures 9 to 12, as of March 22, 2019 Hydro has completed 26. 5% of its planned
29 2019 transmission system AWP activities and 30. 9% of its 2019 WR activities for the Island

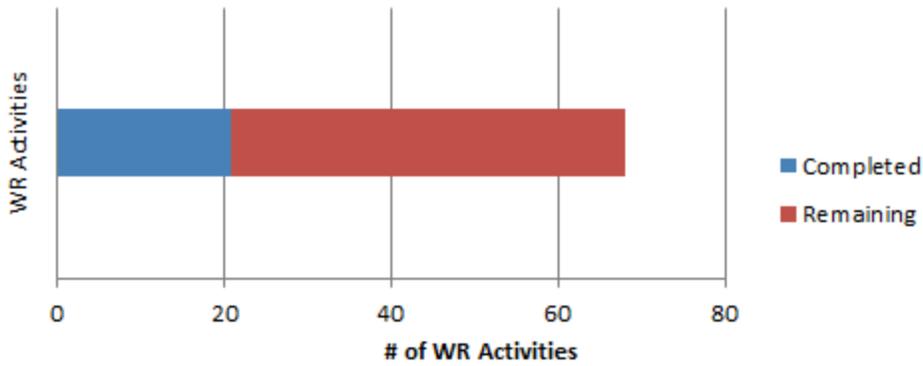
Figure 10: 2019 Transmission System WR Activities for the Island Interconnected System (March 22, 2019)

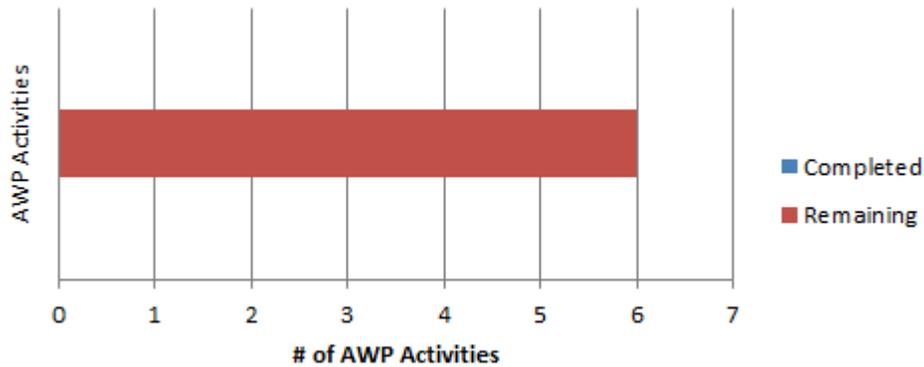
Figure 11: 2019 Transmission System AWP Activities for the Labrador Interconnected System (March 22, 2019)

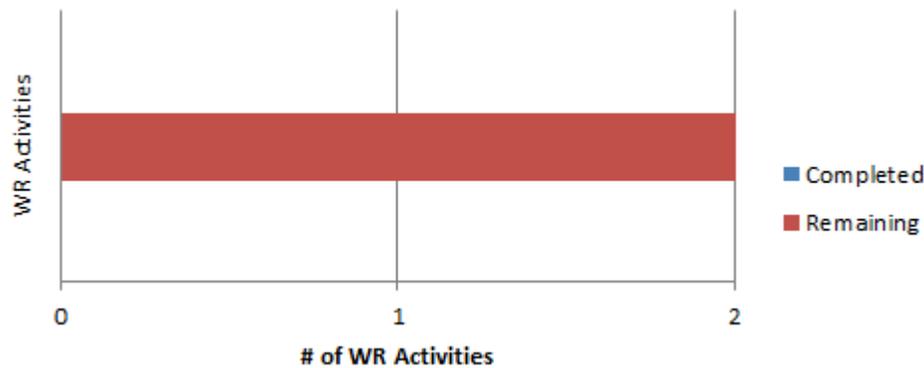
Figure 12: 2019 Transmission System WR Activities for the Labrador Interconnected System (March 22, 2019)

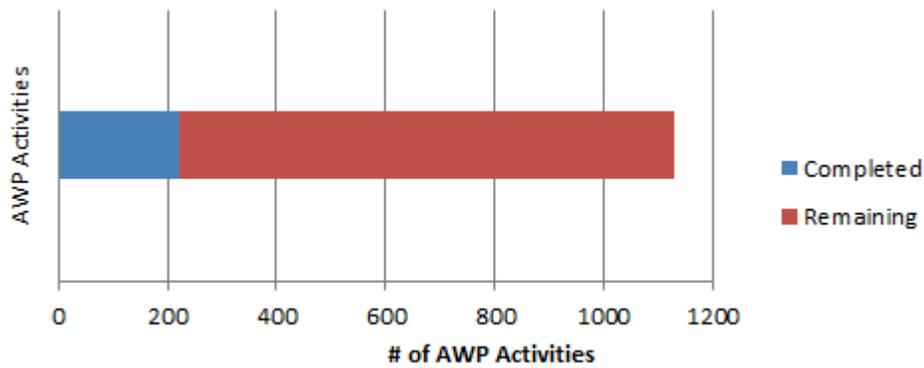
Figure 13: 2019 Terminal Station AWP Activities for the Island Interconnected System (March 22, 2019)

2 As shown in Figure 13 and Figure 14, Hydro has completed 19.8% of its planned 2019 terminal
3 station AWP activities and 17.1% of its 2019 WR activities for the Island Interconnected System
4 as of March 22, 2019. As shown in Figures 15 and 16, Hydro has completed 9.1% of its planned
5 2019 terminal station AWP activities for the Labrador Interconnected System as of March 22,
6 2019, and has not yet completed any WR activity.

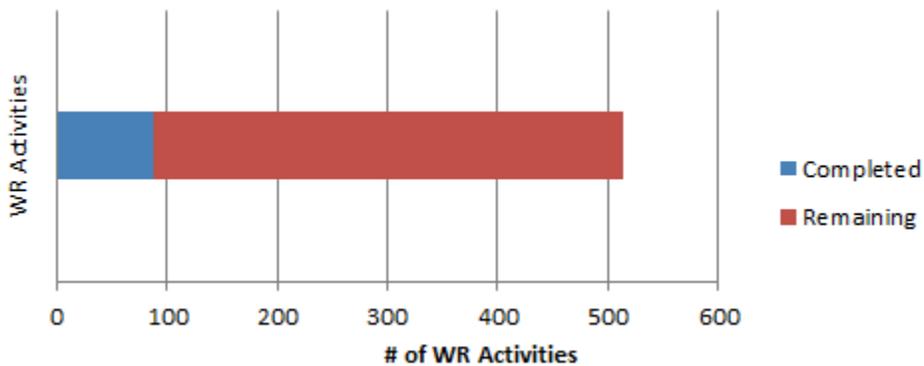
Figure 14: 2019 Terminal Station WR Activities for the Island Interconnected System (March 22, 2019)

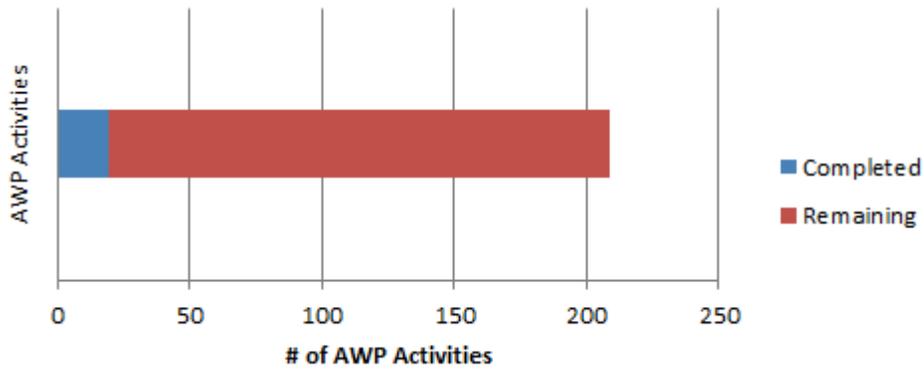
Figure 15: 2019 Terminal Station AWP Activities for the Labrador Interconnected System (March 22, 2019)

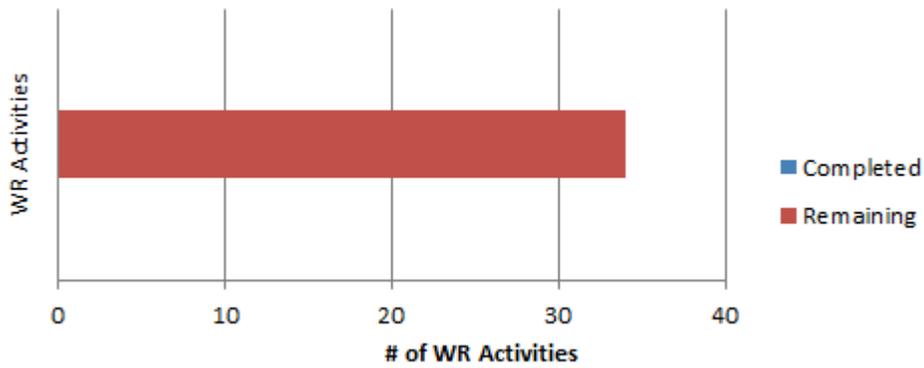
Figure 16: 2019 Terminal Station WR Activities for the Labrador Interconnected System (March 22, 2019)

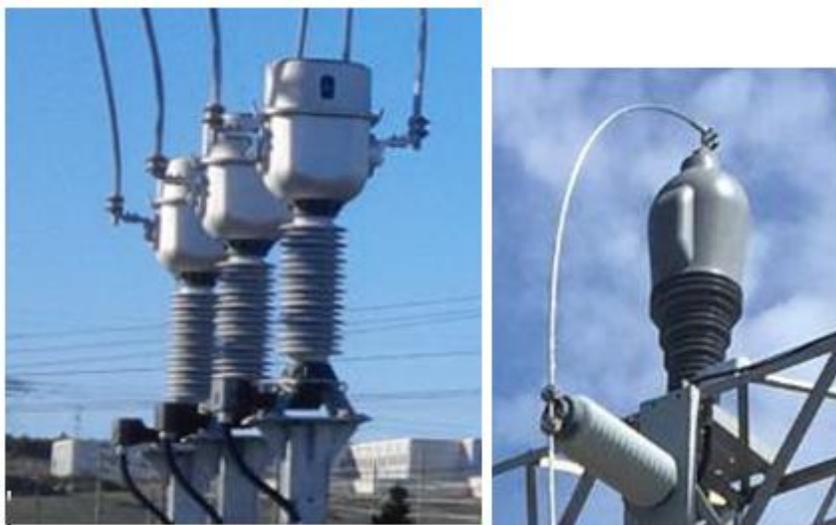
7
8 A high-voltage IT consists of a tank, bushing, and an insulated electrical primary and secondary
9 winding. The insulation system involves the use of insulating oil or dry type insulation and a
10 high voltage porcelain bushing, which allows the safe connection of the winding to high voltage
11 conductors. The winding is enclosed in a steel tank.

Figure 1: 69 kV Current Transformer (left) and Potential Transformer (Right)

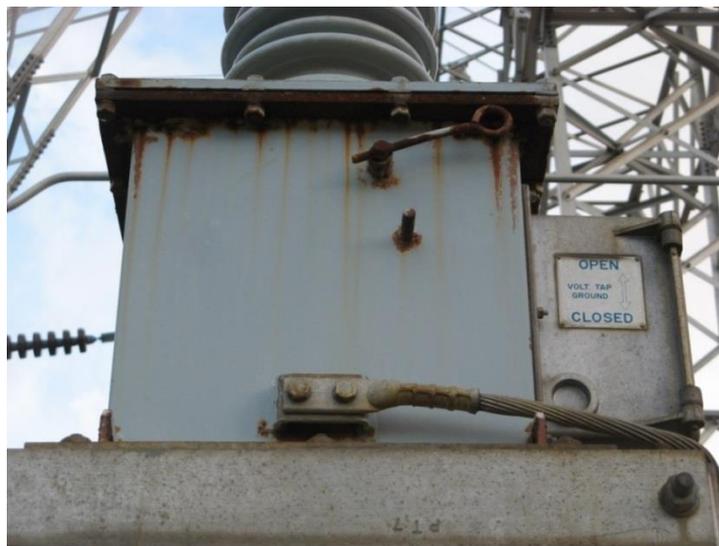
16
17 Physical deterioration involves conditions such as oil leaks, rusting, or small chips and cracks in
18 the insulation. Figure 2 shows an example of rusting on a PT tank.

Figure 2: Rusting on Potential Transformer

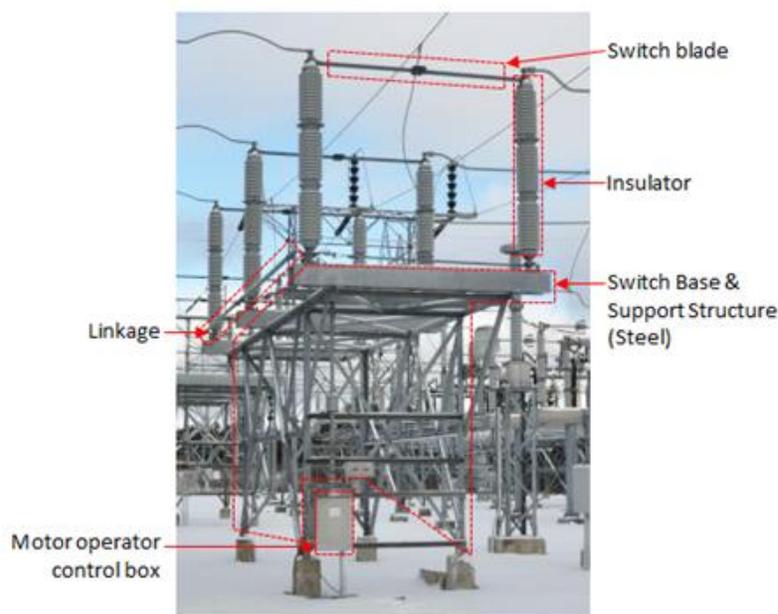
14 The basic components of a disconnect switch are the blade assembly, insulators, switch base
15 and operating mechanism. The blade assembly is the current carrying component in the switch,
16 while the operating mechanism moves it to open and close the switch. The insulators are made
17 of porcelain and insulate the switch base and operating mechanism from the current carrying
18 parts. The switch base supports the insulators and is mounted to a metal frame support
19 structure. The operating mechanism is operated either manually, by using a handle at ground
20 level to open and close the blade, or by a motor operated device, in which case the switch is
21 known as a Motor-Operated Disconnect (MOD). A disconnect and its associated components
22 are shown in Figure 3.

Figure 3: Various Components of a High Voltage Disconnect Switch

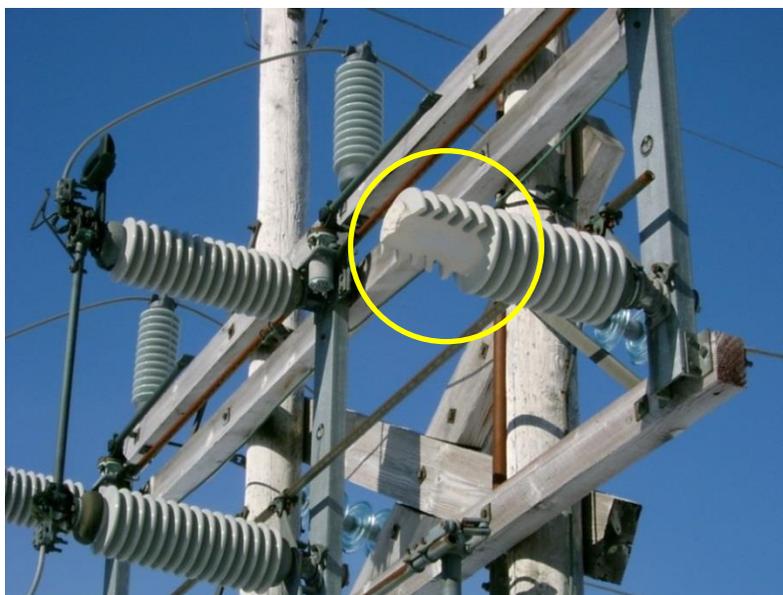
- 11
- 12 Figure 4 shows an example of a badly damaged disconnect switch.

Figure 4: Broken Insulator on 69 kV Disconnect Switch

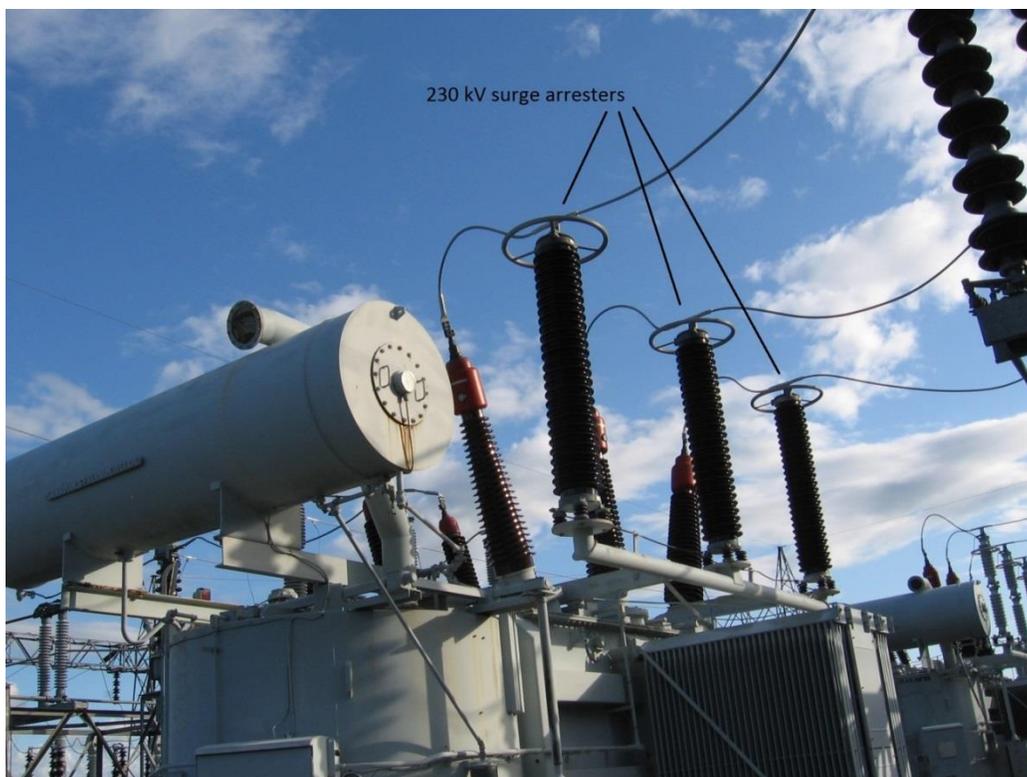
11 Figure 5 shows the arrestors on a 230kV power transformer.

Figure 5: Western Avalon Terminal Station Transformer T3 230 kV Surge Arresters

1 Surge arrestors can fail as a result of the cumulative effects of prolonged or multiple
2 overvoltages. When a surge arrester fails, it is not repairable and must be replaced
3 immediately; otherwise, the major equipment may be exposed to damaging overvoltages. The
4 older arrester designs have a higher incidence of failure than the newer designs.

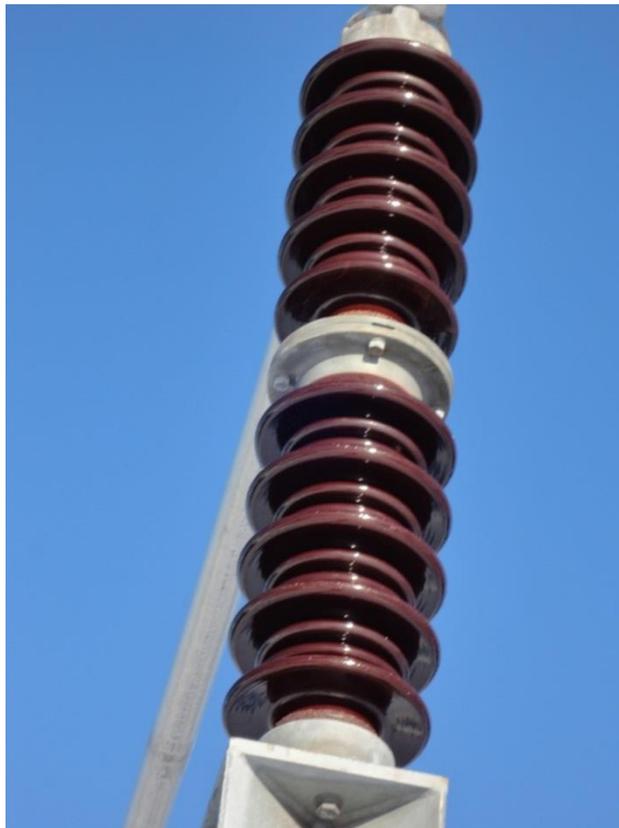
8 Insulators consist of insulating material such as glass, porcelain and metal end fittings to attach
9 the insulator to the structure and the conductor. The metallic hardware is mated with the
10 porcelain or glass insulator using cement. There are different styles of insulators (e.g. post, cap
11 and pin, suspension). An example of a suspension insulator is shown in Figure 6.

Figure 6: A Multi-cone type insulator prone to failure due to cement growth

1 For insulators using porcelain, cement is used in mating the porcelain and metal hardware.
2 Some older insulators have been damaged by a phenomenon known as cement growth. This is
3 a common problem in the utility industry. In such situations water is absorbed into the concrete
4 causing swelling of the cement during freeze/thaw cycles, placing stress upon the porcelain.
5 Over time, the increasing pressure caused by cement growth will crack or break the porcelain
6 resulting in insulator failure. In such situations, porcelain may fall presenting a safety hazard to
7 crews or damaging equipment below. Also, faults resulting in outages to customers often occur
8 when insulator failure leads to flash-over³. Insulator manufacturers have identified and
9 researched cement growth problems and have improved their cement quality to eliminate this
10 problem.

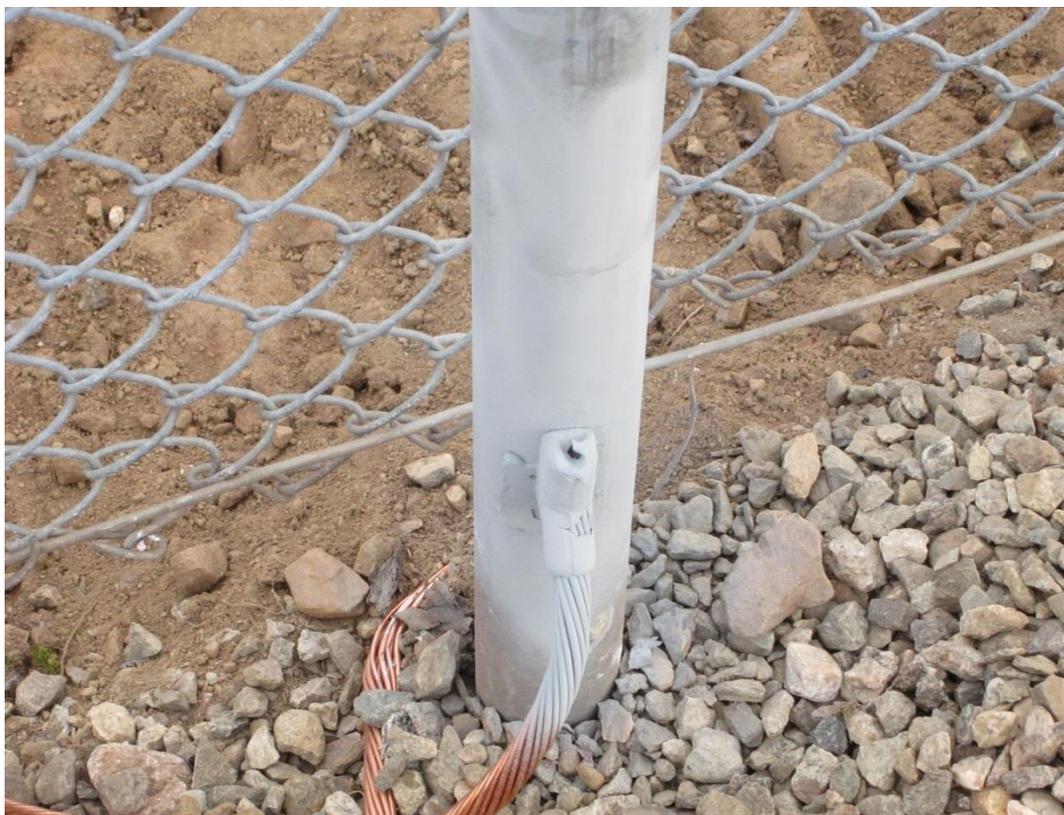
17 The grounding system in a terminal station or distribution substation consists of copper wire
18 used in the ground grid under the station, gradient control mats for high voltage switches, and
19 bonding wiring connecting the structure and equipment metal components to the ground grid
20 (Figure 7). In the event of a line to ground fault, electrical potential differences will exist in the
21 grounding system. If the grounding system is inadequate or deteriorated these differences may
22 be hazardous to personnel. These potential differences are known as step and touch potentials.
23 Effective station grounding reduces these potentials to eliminate the hazard.

Figure 7: Typical Grounding Connection on Terminal Station Fence

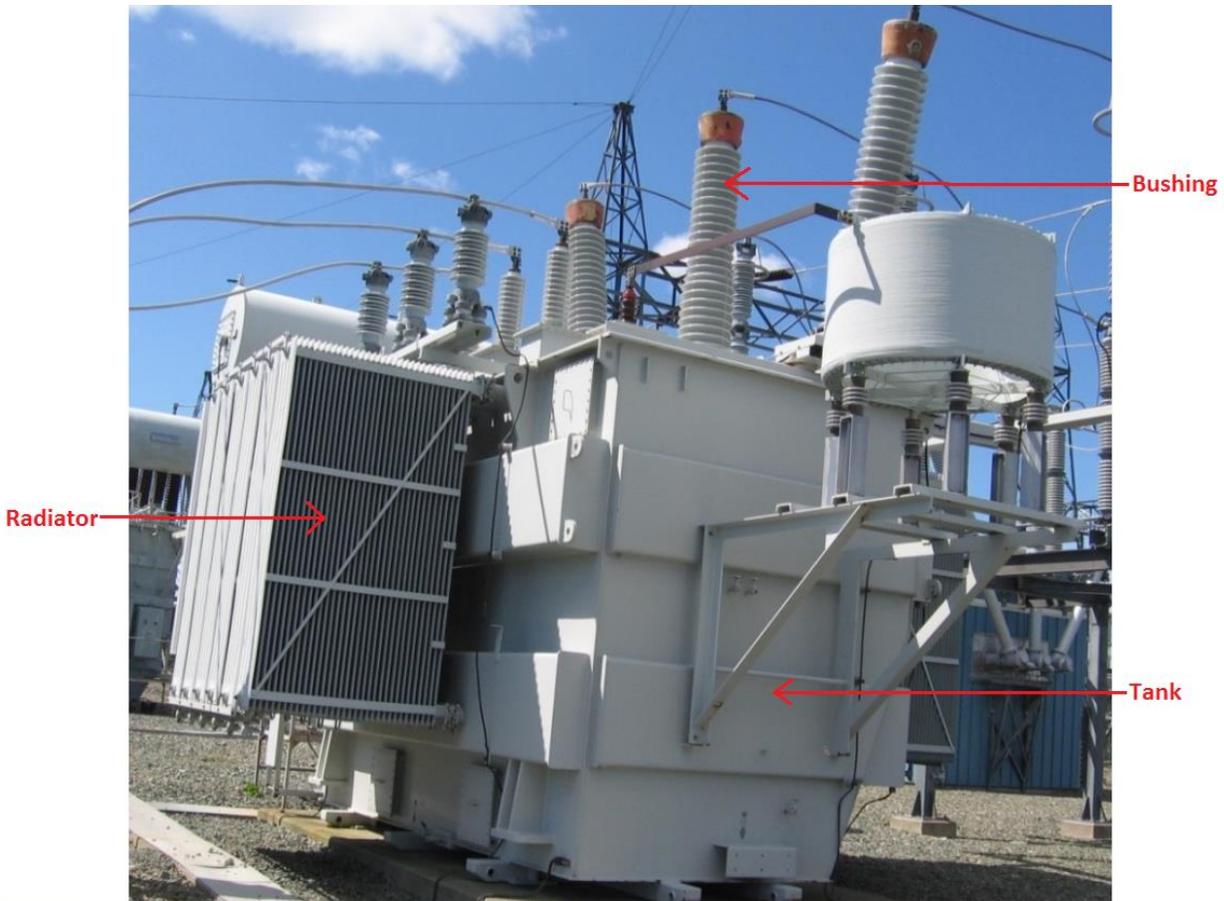
21
22 Figure 8 shows a picture of a 75 MVA, 230/66 kV power transformer at Hardwoods Terminal
23 Station.

Figure 8: Power Transformer

- 11 • Transformer steel tank, which contains the metal core and paper insulated windings
12 responsible for voltage conversion, oil which is part of the insulating system, and a
13 gasket system that keeps the oil from penetrating the environment;
- 14 • Bushings mounted to the top of the transformer tank that connect the windings to the
15 external electrical conductors;
- 16 • Radiators and cooling fans that remove heat for the transformer’s internal components;
- 17 • Load tap changer, which is attached internally or externally and is the device through
18 which transformer’s voltage is maintained at acceptable levels; and
- 19 • Protective devices to ensure the safe operation of the transformer, such as gas detector
20 relays, oil level and temperature relays and gauges.

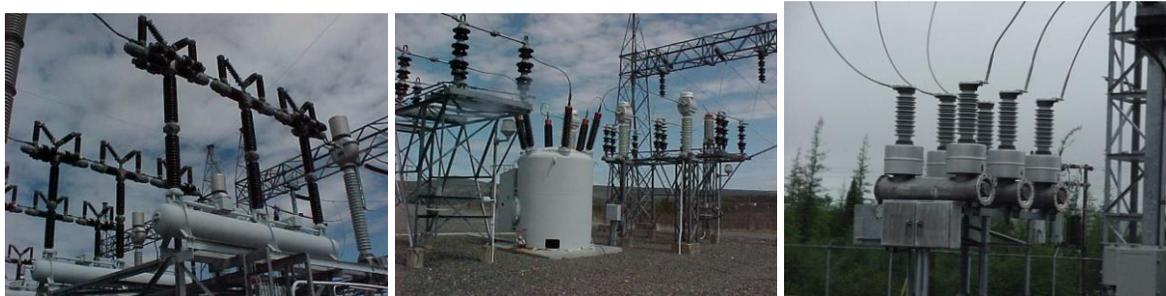
Figure 9: Circuit Breakers – ABCB (left), Oil (middle), and SF₆ (right)

3 2. Oil Circuit Breakers (OCB) - use oil to interrupt currents and typically are at least 36
4 years old at replacement. In the 2016 Capital Budget Application “Upgrade Circuit
5 Breakers – Various Sites (2016-2020)” project, approval was obtained for the
6 replacement of 10 OCBs up to 2020 that were not compliant with Environment Canada
7 PCB regulations. The remaining non-compliant breakers will be replaced before 2025.
8 From 2017 forward, any replacements not previously approved in the 2016-2020 project
9 will be included in the work conducted under this section of the Overview; and

10 3. Sulphur Hexafluoride (SF₆) Circuit Breakers - use SF₆ gas to interrupt current and
11 installation of these breakers started in 1979, including all new installations. In the 2016
12 Capital Budget Application “Upgrade Circuit Breakers – Various Sites (2016-2020)”
13 project, approval was obtained, until the end of 2020, for the mid-life refurbishment
14 and replacement of SF₆ circuit breakers with voltage rates 66 KV and above. From 2017
15 forward, any SF₆ replacements and refurbishments not previously approved in the 2016-
16 2020 project will be included in the work conducted under this section of the Overview.

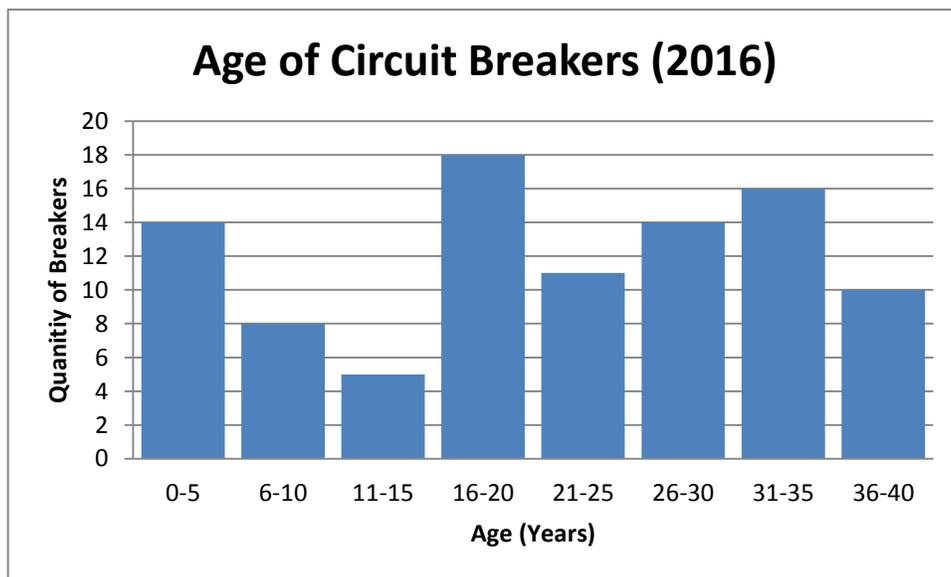
8 Figure 10 shows the age distribution of circuit breakers not approved for replacement prior to
 9 2017.

Figure 10: Age of Circuit Breakers Not Included in Ongoing Replacement Program

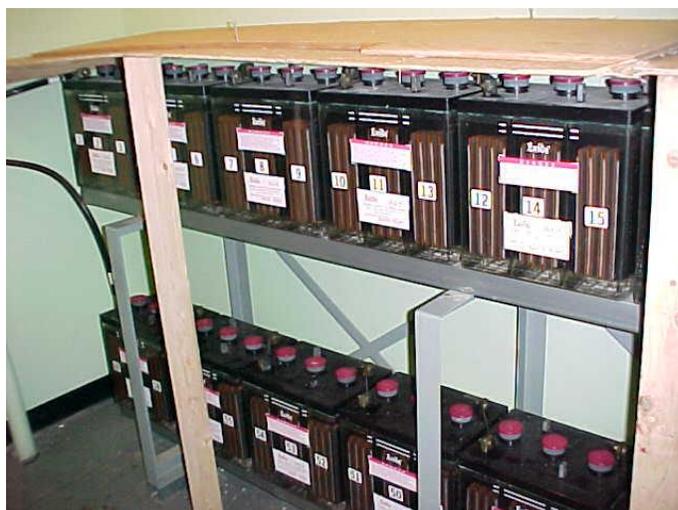
6 Battery banks and chargers supply direct current (DC) power to critical station infrastructure
7 such as circuit breakers, protection and control relays, disconnect switch motor operators, and
8 telecontrol equipment (Figure 11). Battery banks are designed to provide a minimum of eight
9 hours of auxiliary power to critical infrastructure in the event of a loss of AC station service
10 supply. The majority of Hydro's battery banks consist of lead-acid flooded-cell type batteries,
11 which have deteriorating capacity over time. Hydro adheres to IEEE 450 and 1188, which
12 recommends replacements of a battery if its capacity has fallen to 80% or less of its rated
13 capacity. The service life of flooded cell batteries is 18 to 20 years while valve regulated lead
14 acid (VRLA) batteries have a service life of 7 to 10 years.

Figure 11: 125 V Direct Current Terminal Station Battery Bank

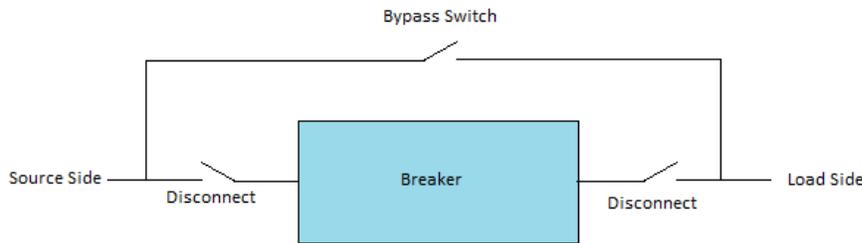
2 High voltage circuit breakers, with their associated protection and control equipment, are used
 3 to control the flow of electrical current to ensure safe and reliable operation of the electrical
 4 system (Figure 12). When a breaker is removed for maintenance, troubleshooting,
 5 refurbishment, or replacement, an alternate electrical path must be implemented to avoid
 6 customer outages. On radial systems⁴, this alternate path is accomplished using a bypass
 7 switch. When closed, the bypass switch allows electricity to flow around the breaker allowing
 8 the breaker to be safely de-energized, while maintaining service continuity.

Figure 12: Example of Bypass Switch Installation

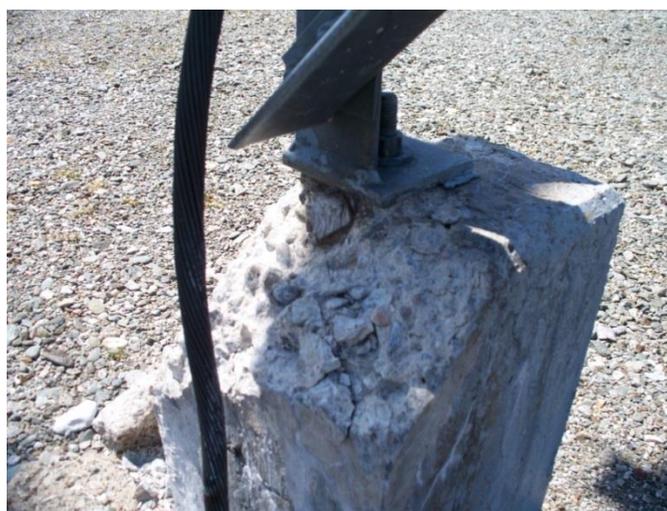
Figure 13: Structure B1T1 Bottom Terminal Stations

7
8 The service life of galvanized steel structures varies depending on the operating environment,
9 but can exceed 100 years, outliving the foundations on which they are built. A number of the
10 foundations in Hydro terminal stations have deteriorated significantly due to repeated
11 exposure to damaging freeze/thaw cycles, weathering, and age, leading to concerns over their
12 integrity. Degraded structure foundations are shown in Figure 13 and Figure 14.

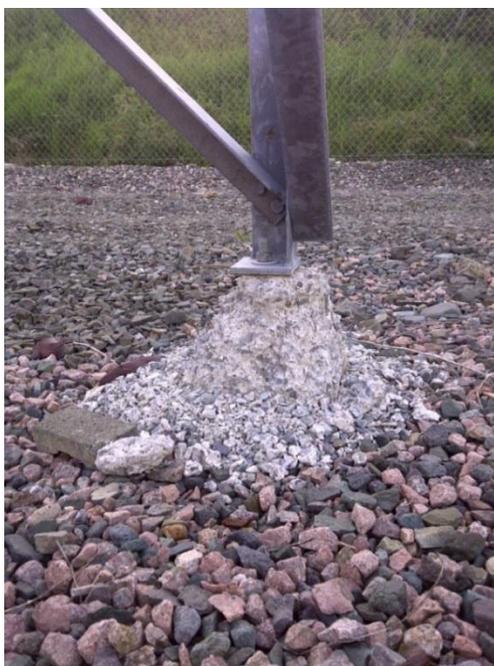
Figure 14: Structure L01L37-1 Western Avalon Terminal Station

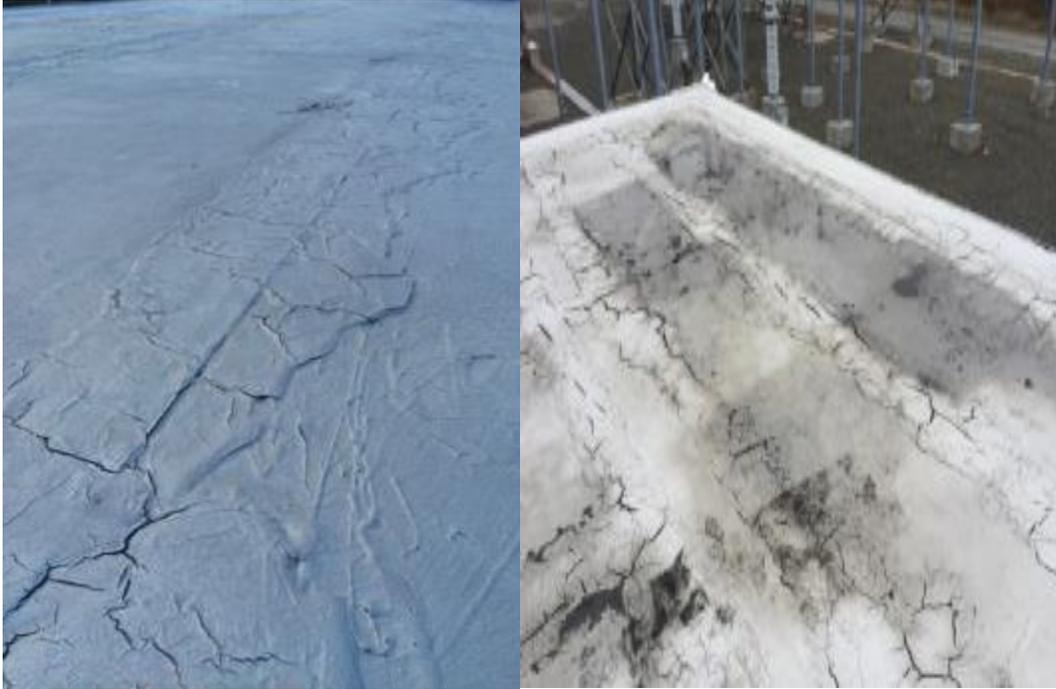
Figure 15: Terminal Station Control Buildings (Come By Chance and Sunnyside) showing cracking and deterioration of the roof membrane systems.

16
17 Typical refurbishment activities for control building involve replacement of the roof membrane,
18 siding, and doors and may also include replacement of electrical equipment (such as
19 distribution panels, transfer switches, or low-voltage disconnects), plumbing (such as water
20 service entries and internal plumbing), and HVAC (such as intake and exhaust fans, louvers,
21 heaters, and air conditioning).

22
23 Figure 15 and Figure 16 show deterioration at different control building locations.

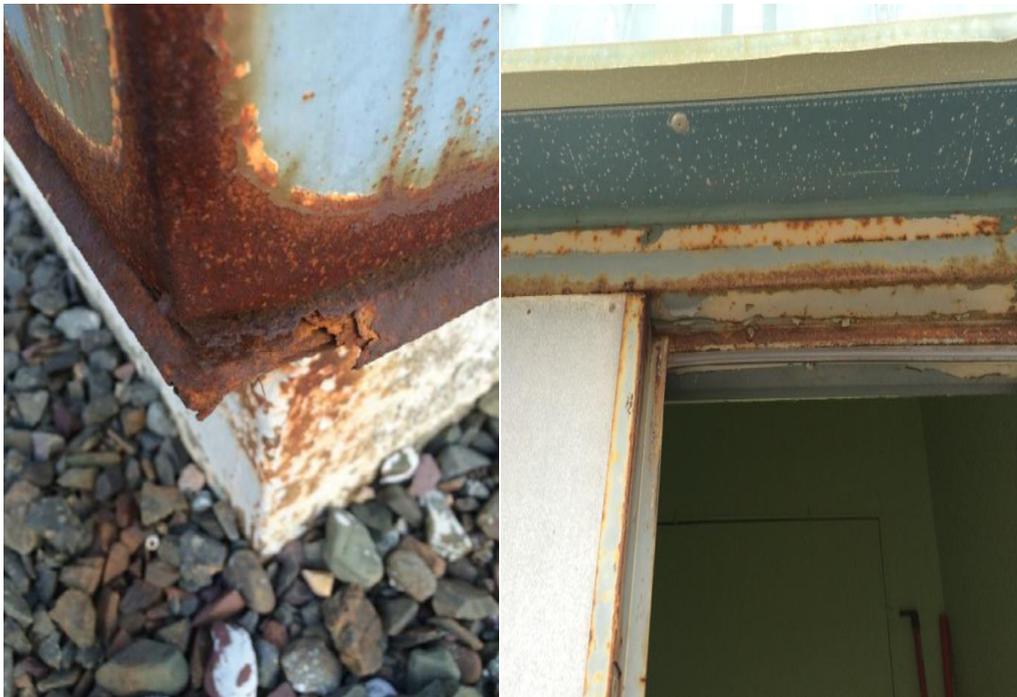
Figure 16: Building exterior cladding and doorways displaying severe rusting and deterioration

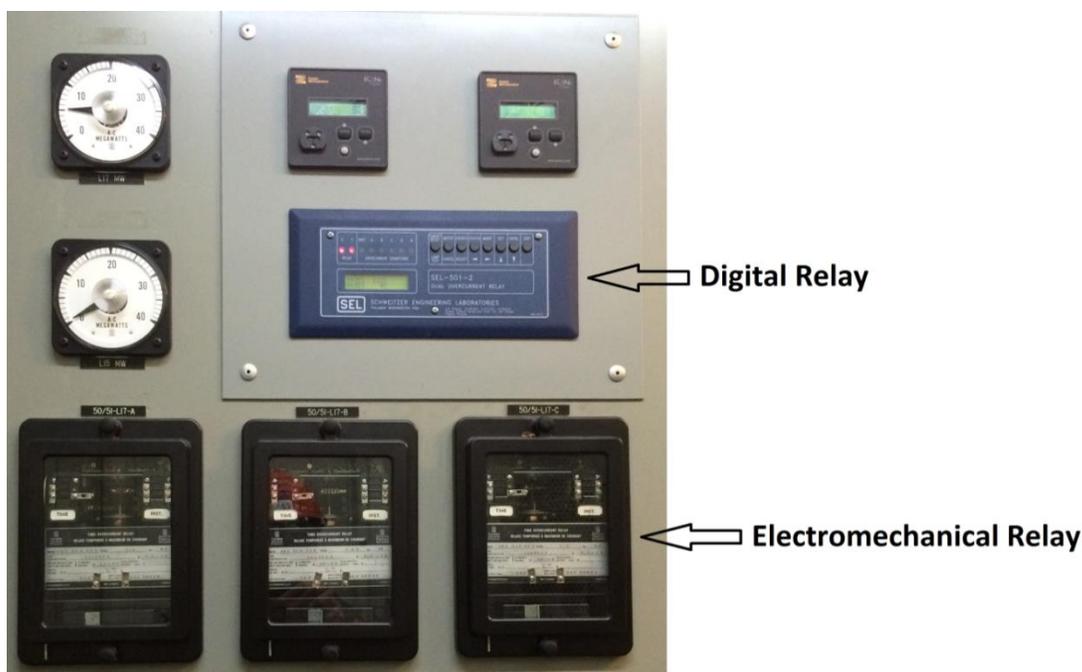
Figure 17: Digital and Electromechanical Relays

23
24 Older relays existing on Hydro’s system are the electromechanical and older solid state types
25 and lack features such as data storage and event recording capability. Modern digital
26 multifunction relays are used to replace these older style relays as they have increased setting
27 flexibility, fault disturbance monitoring, communications capability and metering functionality,
28 and greater dependability and security, thus enhancing system reliability. Digital and
29 electromechanical relays are shown in Figure 17.

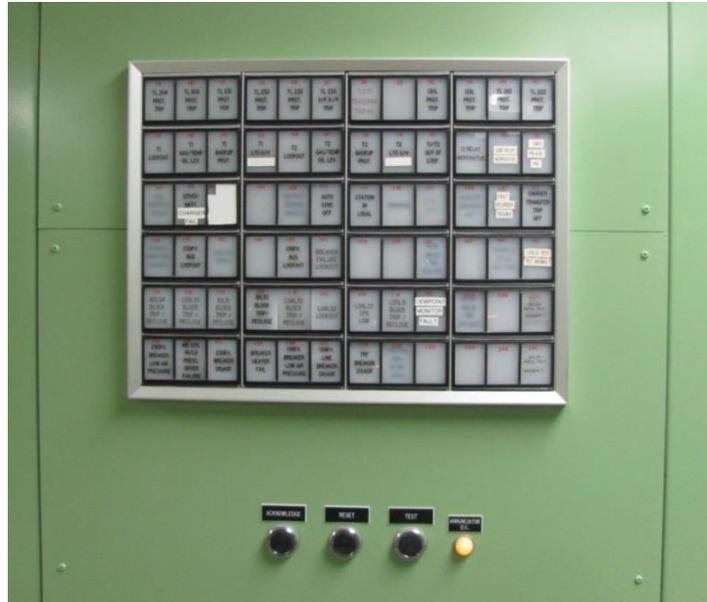
Figure 18: An annunciator commonly found in Hydro's terminal stations

21 requires attention and are communicated to the Energy Control Centre and/or displayed locally

22 on the station annunciator (Figure 18).
