Re: Transmission System and Terminal Station Asset Management Execution Report

Transmission System and Terminal Station Asset Management Execution Report

Terminal Station Asset Management Overview

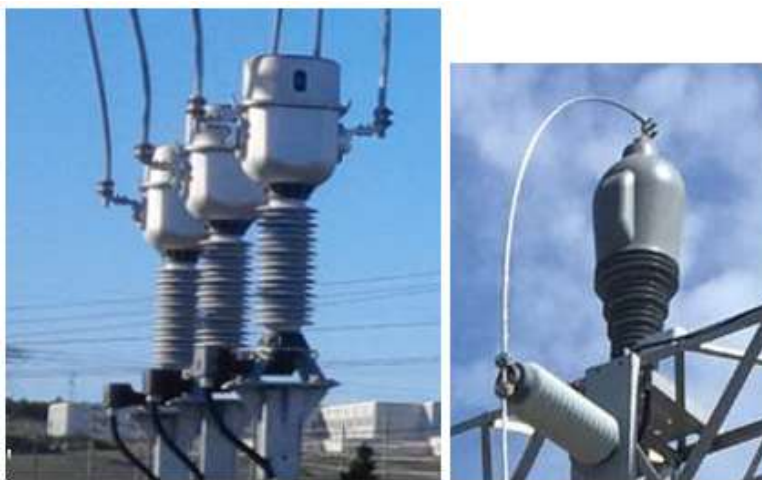
11 A high-voltage instrument transformer consists of an insulated electrical primary and secondary
12 winding, tank, and bushing components. The insulation system involves the use of insulating oil or dry
13 type insulation and a high-voltage porcelain bushing which allows the safe connection of the winding to
14 high-voltage conductors. The winding is enclosed in a steel tank.

Figure 1: 69 kV Current Transformer (Left) and Potential Transformer (Right)

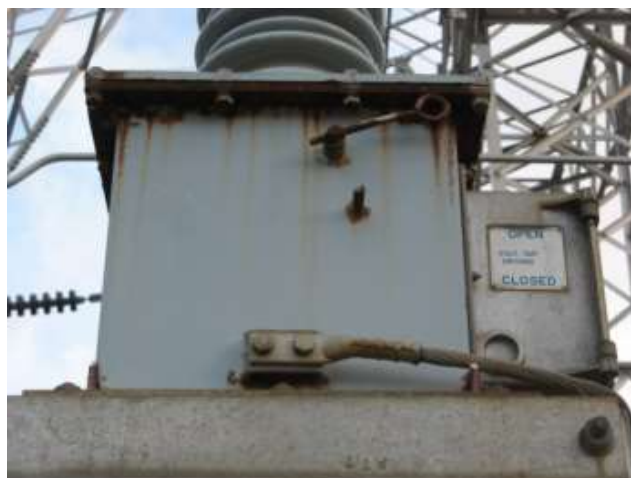
19 Physical deterioration involves conditions such as oil leaks, rusting, or small chips and cracks in the
20 insulation. Figure 2 shows an example of rusting on a potential transformer tank.

Figure 2: Rusting Potential Transformer

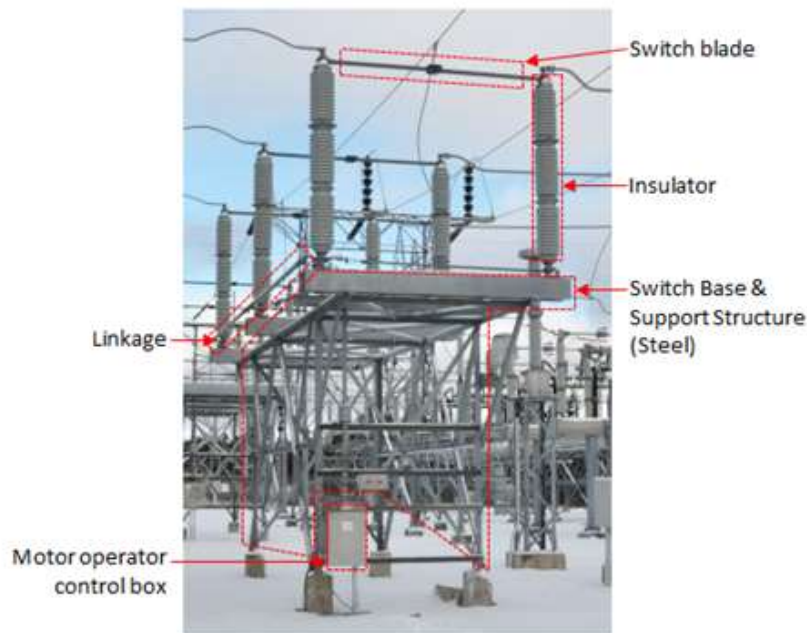
3 The basic components of a disconnect switch are the blade assembly, insulators, switch base and
4 operating mechanism. The blade assembly is the current carrying component in the switch and the
5 operating mechanism moves it to open and close the switch. The insulators are made of porcelain and
6 insulate the switch base and operating mechanism from the current carrying parts. The switch base
7 supports the insulators and is mounted to a metal frame support structure. The operating mechanism is
8 operated either manually, by using a handle at ground level to open and close the blade, or by a motor-
9 operated device, in which case the switch is known as a motor-operated disconnect. A disconnect and
10 its associated components are shown in Figure 3.

Figure 3: Various Components of a High-Voltage Disconnect Switch

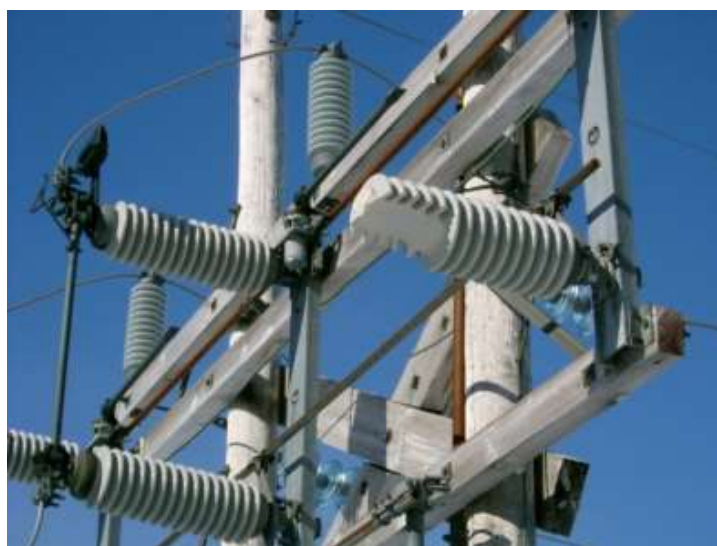
8 Figure 4 shows an example of a badly damaged disconnect switch.

Figure 4: Broken Insulator on 69 kV Disconnect Switch

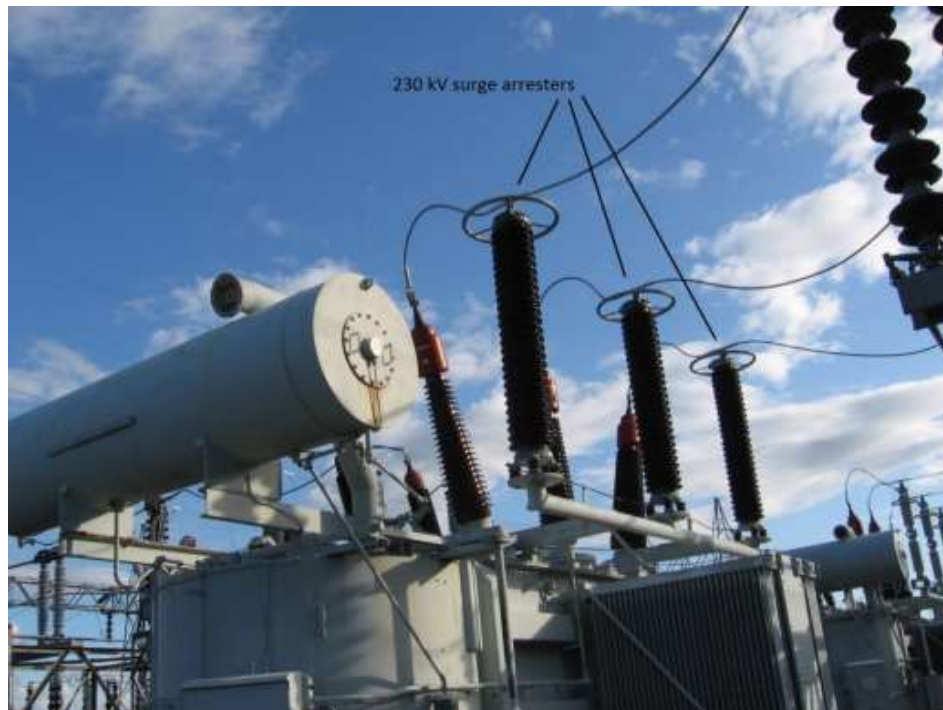
1 Figure 5 shows the arresters on a 230 kV power transformer.

Figure 5: Western Avalon Terminal Station Transformer T3 230 kV Surge Arresters

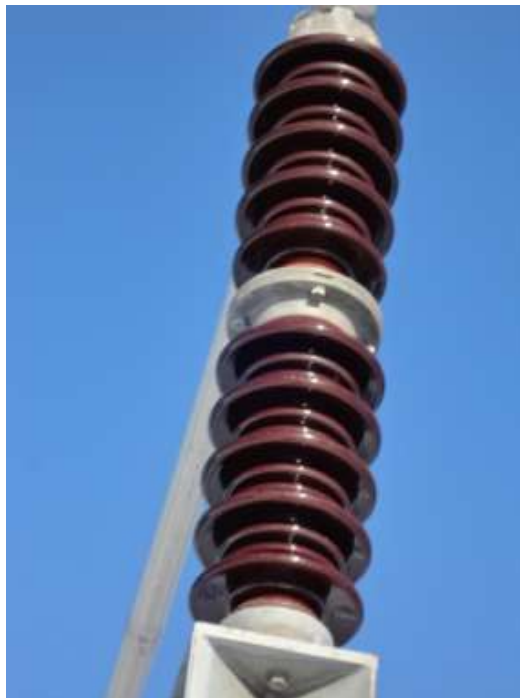
7 Insulators consist of insulating material such as glass, porcelain, and metal end fittings to attach the
8 insulator to the structure and the conductor. The metallic hardware is mated with the porcelain or glass
9 insulator using cement. There are different styles of insulators. An example of a station post insulator is
10 shown in Figure 6.

Figure 6: Multi-Cone Type Insulator Prone to Failure due to Cement Growth

1 For insulators using porcelain, cement is used in mating the porcelain and metal hardware. Some older
2 insulators have been damaged by a phenomenon known as cement growth. This is a common problem
3 in the utility industry. In such situations, water is absorbed into the concrete, during freeze/thaw cycles,
4 causing swelling of the cement placing stress upon the porcelain. Over time, the increasing pressure
5 caused by cement growth will crack or break the porcelain resulting in insulator failure. In such
6 situations, porcelain may fall presenting a safety hazard to crews or damaging equipment below. Also
7 faults resulting in outages to customers often occur, when insulator failure leads to flash over. Some
8 time ago, insulator manufacturers identified and researched cement growth problems and have
9 improved their cement quality to eliminate this problem.

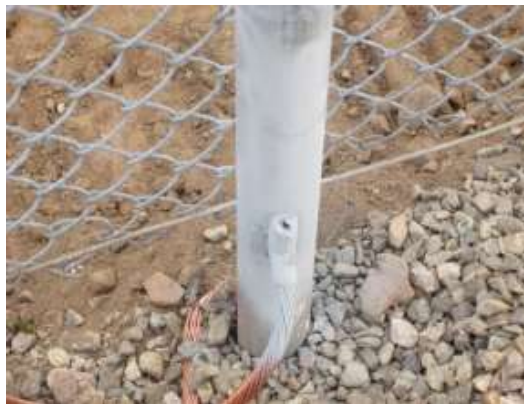
13 The grounding system in a terminal station or distribution substation consists of copper wire used in the
14 ground grid under the station, gradient control mats for high-voltage switches, and bonding wiring
15 connecting the structure and equipment metal components to the ground grid. In the event of a ground
16 fault, electrical potential differences will exist in the grounding system. If the grounding system is
17 inadequate or deteriorated these differences may be hazardous to personnel. These potential
18 differences are known as step and touch potentials. Effective station grounding reduces these potentials
19 to eliminate the hazard.

Figure 7: Typical Grounding Connection on Terminal Station Fence

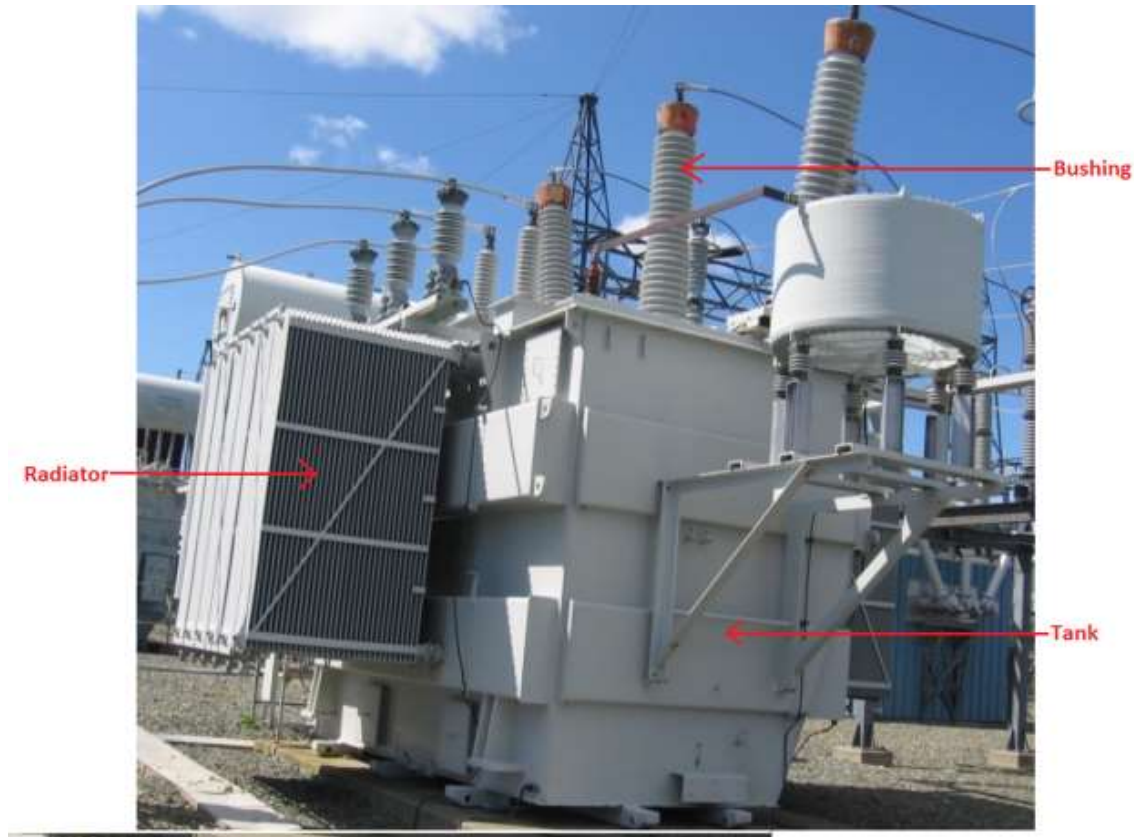
- 3 Figure 8 shows a picture of a 75 MVA, 230/66 kV power transformer at the Hardwoods Terminal Station.

Figure 8: Power Transformer

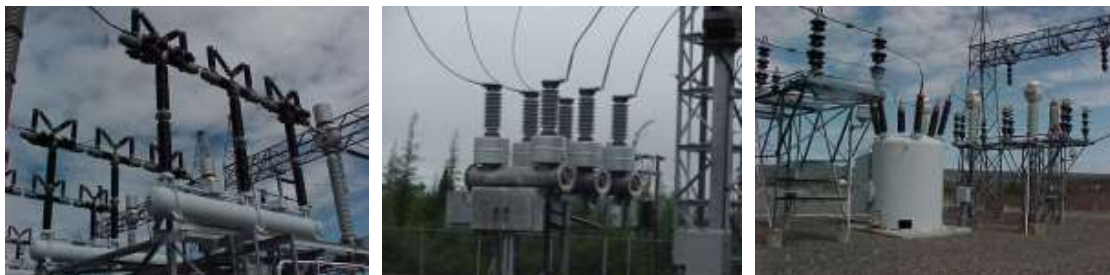
- 1 **3)** Sulphur hexafluoride (“SF₆”) circuit breakers use SF₆ gas to interrupt current and installation of
2 these breakers started in 1979 and continue for all new installations.

Figure 9: Air Blast Circuit Breakers (Left), SF₆ Circuit Breakers (Middle), and Oil Circuit Breakers (Right)

3 As presented in the 2016 CBA project Upgrade Circuit Breakers – Various Sites, SF₆ circuit breakers rated
4 at 138 kV and above are required to be refurbished after 20 years of service. In 2018, Hydro added 66
5 kV-rated breakers to also be refurbished after 20 years. Replacement of SF₆ circuit breakers rated at 66
6 kV and above will be planned after 40 years of service. However as SF₆ circuit breakers come due, a
7 further condition assessment will be completed to determine if more life can be achieved through other
8 means such as an overhaul. Some SF₆ circuit breakers may require replacement before the 40-year
9 service life period based upon their condition and operational history. Hydro expects to replace an
10 average of seven breakers and overhaul three breakers per year for the 5-year period from 2022 to
11 2026.

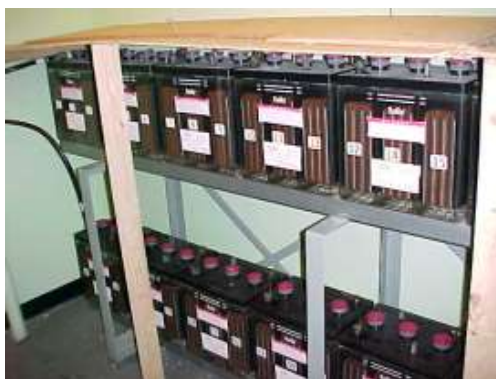
2 Battery banks and their chargers supply dc power to critical station infrastructure, such as circuit
3 breakers, protection and control relays, disconnect switch motor operators, and telecontrol equipment.
4 Battery banks are designed to provide a minimum of eight hours of auxiliary power to critical
5 infrastructure in the event of a loss of ac station service supply. The majority of Hydro's battery banks
6 consist of lead-acid flooded-cell type batteries whose capacity deteriorates over time. Hydro currently
7 completes discharge testing on criticality A and B battery banks (after 10 years and then every 5 years
8 for flooded cell and every 2 years for valve regulated) and will plan replacements if the battery bank's
9 capacity has fallen to 80% or less of its rated capacity. Also, due to the critical nature of battery banks,
10 flooded cell batteries are replaced after 20 years while valve-regulated lead-acid batteries are replaced

Figure 10: 125 Vdc Terminal Station Battery Bank

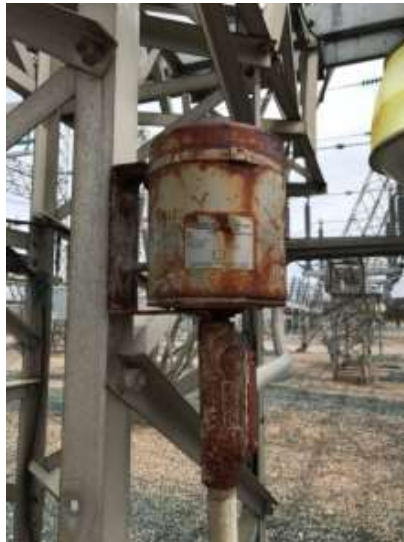
Figure 12: Corroded Ballast Requiring Replacement

8 Under this program, Hydro will replace deteriorated lighting systems as they become unable to provide
9 adequate illumination of the terminal station and have become obsolete or beyond repair. Hydro will
10 replace legacy lighting systems with modern, efficient lighting technologies whenever possible.

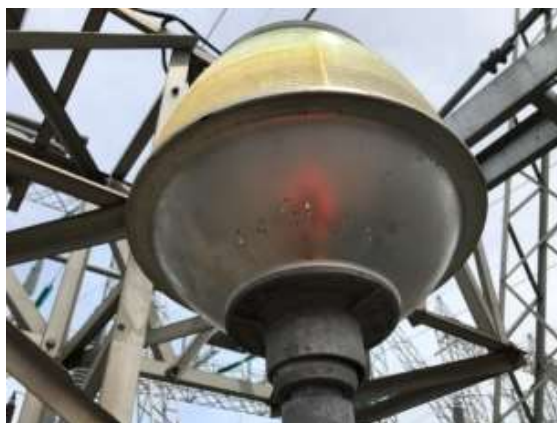
Figure 13: Light Fixture Showing Perforations due to Corrosion, Enabling Moisture Ingress

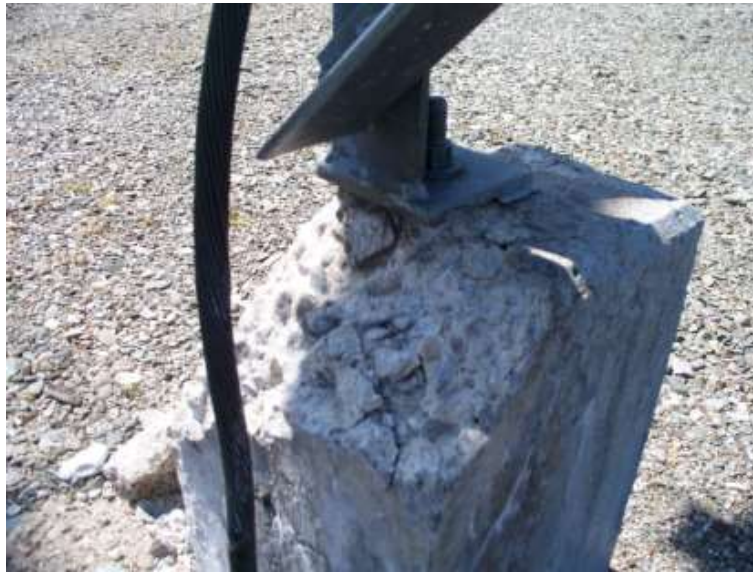
- 1 The service life of galvanized steel structures varies depending on the operating environment but can
- 2 exceed 100 years outliving the foundations on which they are built. A number of the foundations in
- 3 Hydro terminal stations have deteriorated significantly due to repeated exposure to damaging
- 4 freeze/thaw cycles, weathering, and age, leading to concerns over their integrity. Examples of degraded
- 5 structure foundations are shown in Figure 14 and Figure 15

Figure 14: Structure B1T1 Bottom Brook Terminal Station

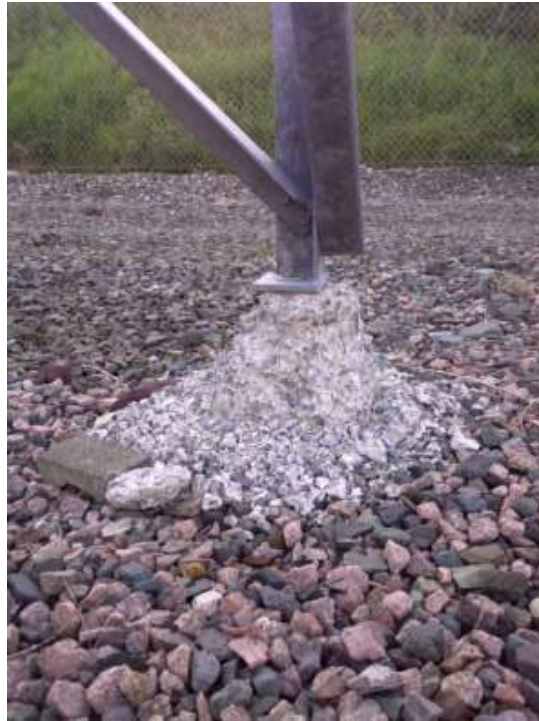
Figure 15: Structure L01L37-1 Western Avalon Terminal Station

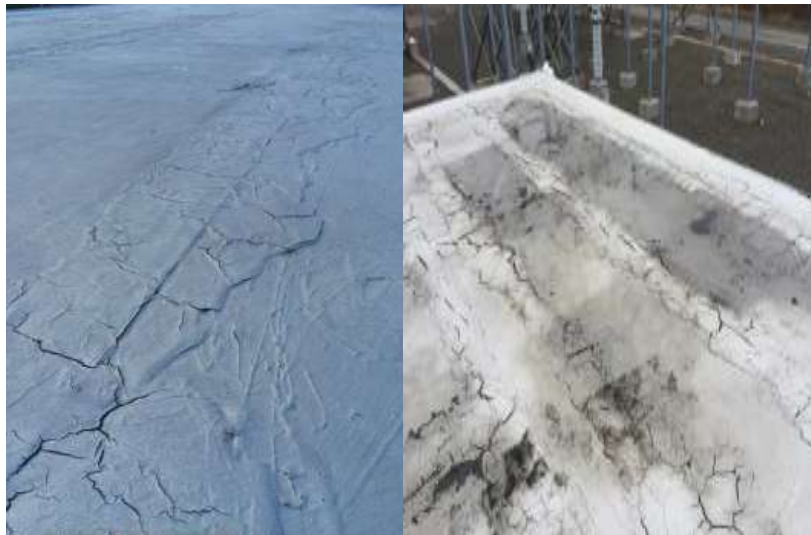
Figure 16: Terminal Station Control Buildings (Come by Chance and Sunnyside) Showing Cracking and Deterioration of the Roof Membrane System

13 Typical refurbishment activities for control building involve replacement of the roof membrane (Figure
14 16), siding, and doors (Figure 17), and may also include replacement of electrical equipment (such as
15 distribution panels, transfer switches, or low-voltage disconnects), plumbing (such as water service
16 entries and internal plumbing), and HVAC (such as intake and exhaust fans, louvers, heaters, and air
17 conditioning equipment).

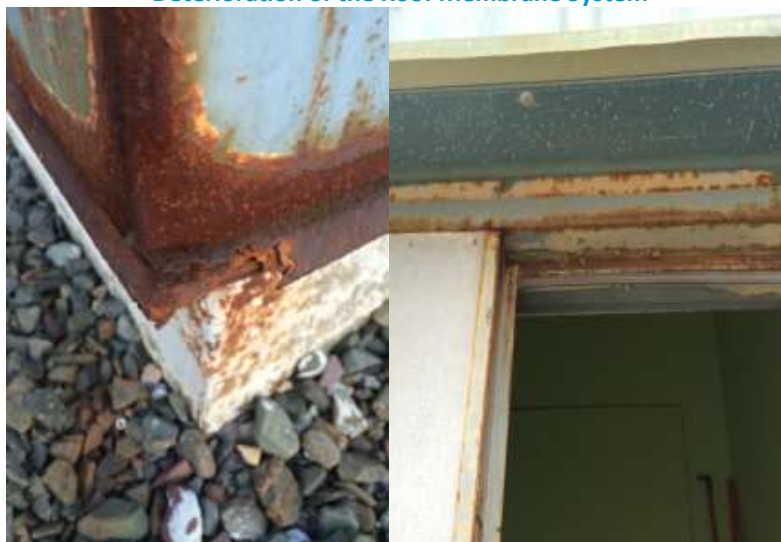
Figure 17: Building Exterior Cladding and Exterior Doorways Displaying Severe Rusting and Deterioration

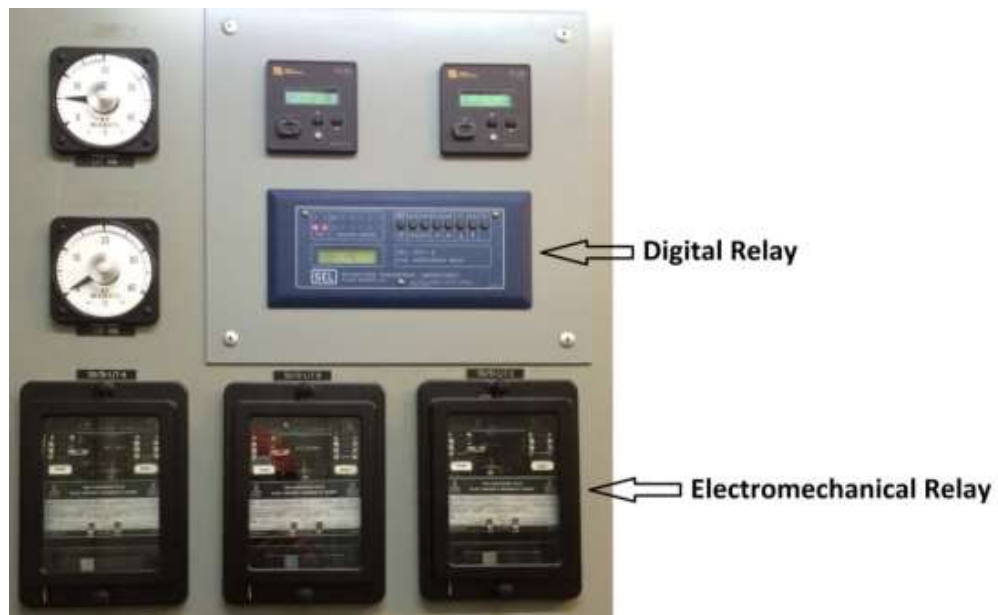
17 Older relays existing on Hydro's system are the electromechanical and older solid state types and lack
18 features such as data storage and event recording capability. Modern digital multifunction relays are
19 used to replace these older style relays as they have increased setting flexibility, fault disturbance
20 monitoring, communications capability and metering functionality, and offer greater dependability and
21 security, enhancing system reliability. Digital and electromechanical relays are showing in Figure 18.

Figure 18: Digital and Electromechanical Relays

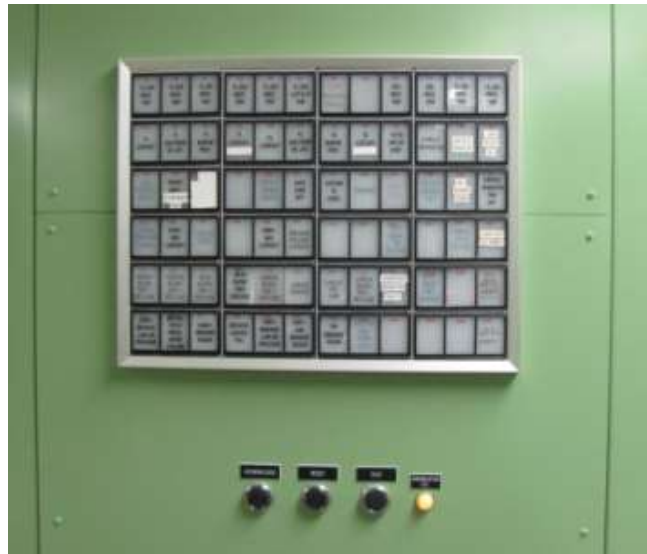
15 Alarms inform the Energy Control Centre (“ECC”) and operating personnel that equipment and relaying
16 requires attention and are communicated to the ECC and/or displayed locally on the station
17 annunciator.

Figure 19: Annunciator Commonly Found in Hydro Terminal Stations
