Re: Port Hope Simpson Diesel Engine Failure – Allowance for Unforeseen Items Final Report

Port Hope Simpson Diesel Engine Failure

Final Report

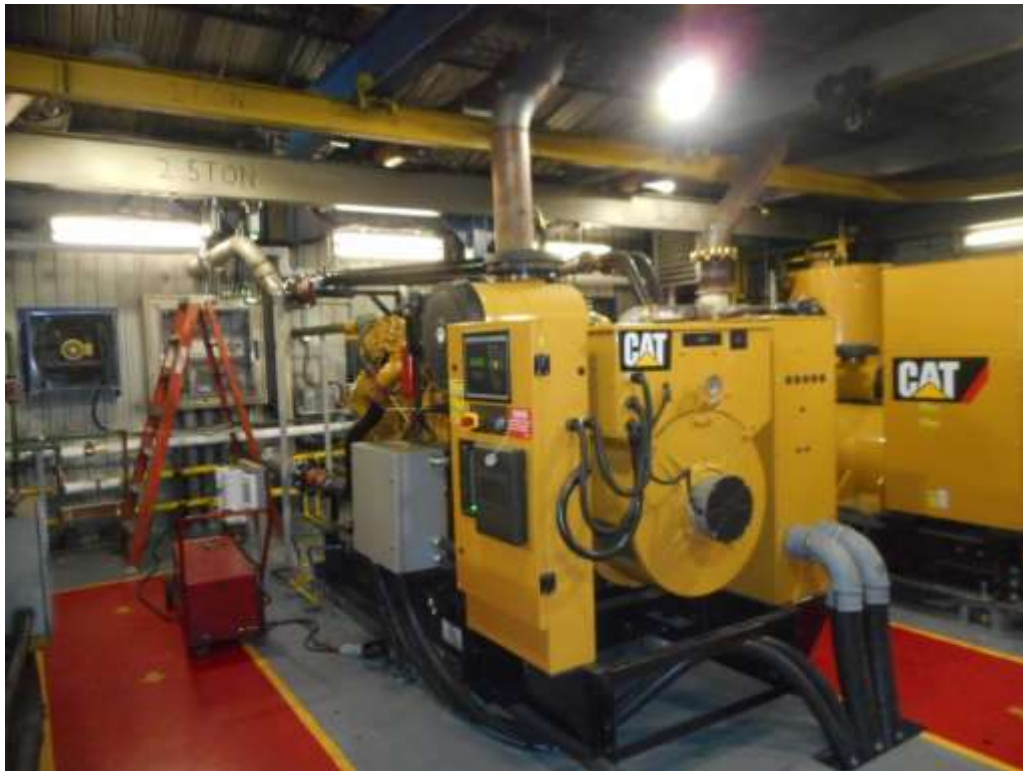
Figure 1: Unit 2099

11 Unit 2099 had approximately two years of operating history and had operated reliably until its failure on
12 September 8, 2020, when an exhaust valve dropped into the cylinder impacting the piston. Valve
13 adjustments are made annually during planned maintenance and Unit 2099 showed no signs of issues
14 during its most recent planned maintenance.

- Unit 2099 engine was removed from the genset;
- The engine from Unit 2093 was temporarily installed into the genset;⁷
- The new engine arrived from the vendor;
- The temporary engine from Unit 2093 was removed;⁸
- The new engine was installed into the genset;
- Exhaust, coolant lines, fuel lines, electrical cabling and controls were installed; and
- The new engine was commissioned.

Hydro engaged its regional maintenance staff in Labrador to complete this work. All identified work was completed and Unit 2099 was released for service on February 21, 2021.
