1 Q. Please provide a copy of the 2011 AMEC Consulting report on the condition  
2 assessment of the Holyrood Gas Turbine.

Holyrood Thermal Generating Station (Holyrood) Gas Turbine Condition Assessment & Options Study –  
Final Report

### Gas Turbine Condition Assessment & Options Study

December 19, 2011

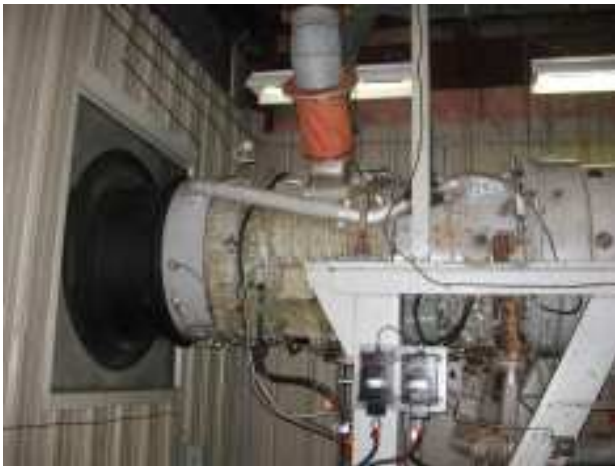
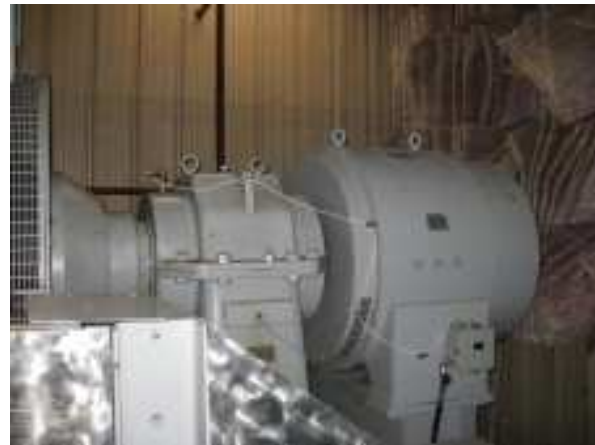
**FIGURE 2-1 GTG GAS ENGINE & GENERATOR**

The exhaust casing (volute) is a welded fabrication divided along the horizontal centreline. It turns the combustion gasses transversely to the machine and vertically upwards to the exhaust silencer.

The exhaust stack is constructed of heavy gauge steel plate with light gauge steel cladding on the exterior. The exterior cladding of the lower half of the exhaust stack is constructed of heavy gauge steel plate. This stack was replaced during the 1986 major upgrade. The snow doors on the exhaust stacks are pneumatically actuated and were a new addition in 1986 to reduce corrosion of the volute and power turbine from infiltration of snow and rain water which promoted corrosion within the unit. New limit switches installed on the doors in 2009 indicate the position (opened or closed) of each door at the control station.

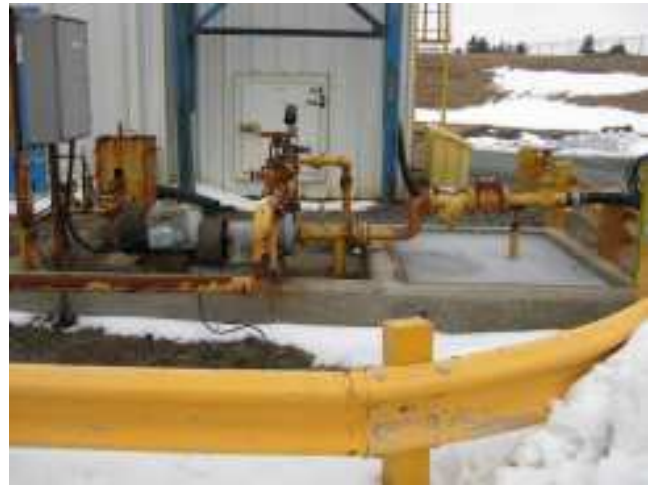
FIGURE 2-6 LIGHT OIL RECEIVING SYSTEM AND STORAGE TANKS

Some fuel forwarding pumps are located in a small enclosure to protect them from the elements. The concrete containment system in which the pumps sit was filled with approximately 4 inches of oily water at the time of the inspection.

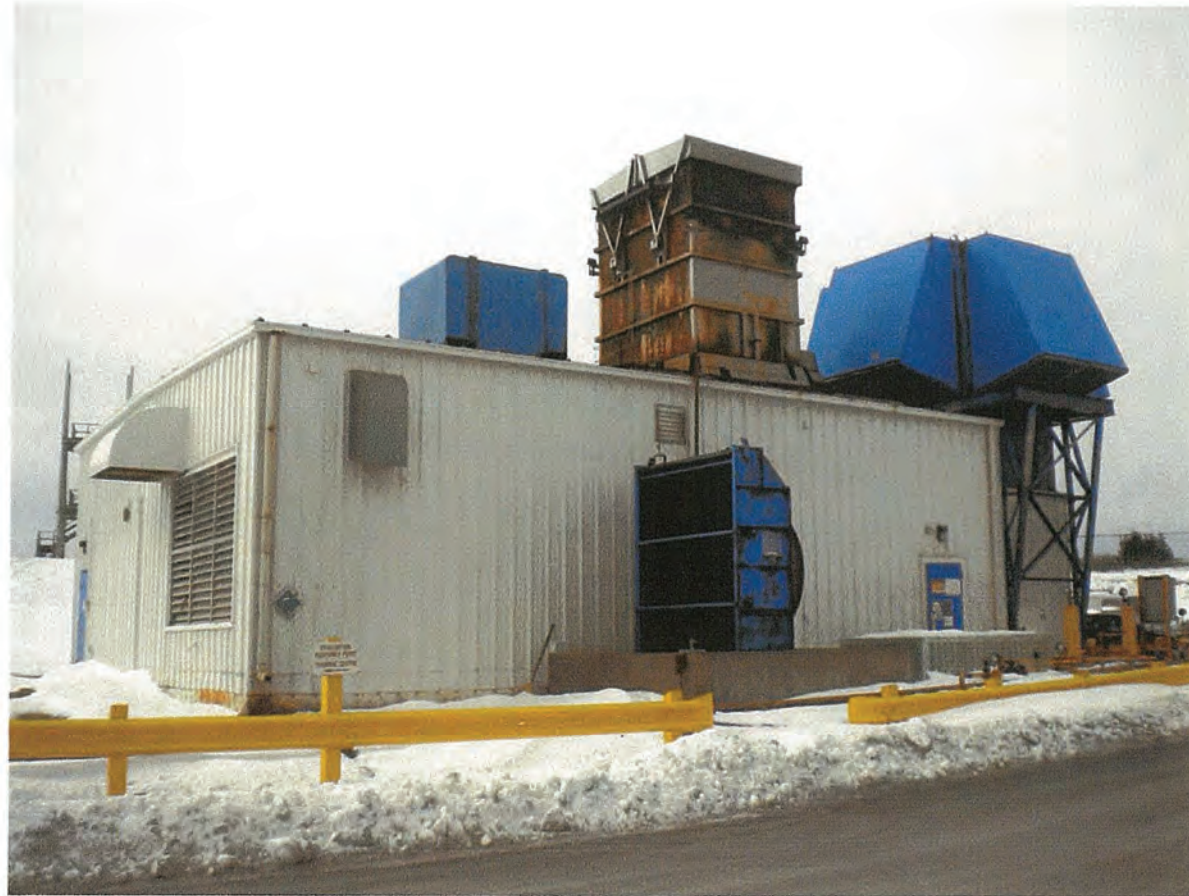
Figure 6 Holyrood GT – Black Start Unit at Holyrood Thermal Power Station

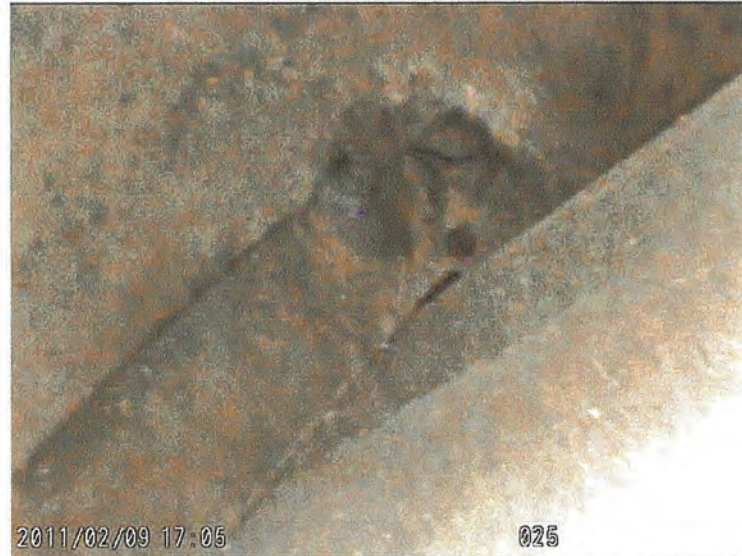
- (ii) There appears to be some weld repairs on the cone spokes inner downstream edges which may be starting to fail. Further checks need to be carried out on these welds to ensure security of the cone spokes is maintained. See Photo 3 & 4.

Photo 3. showing weld repair on cone spoke inner edge.

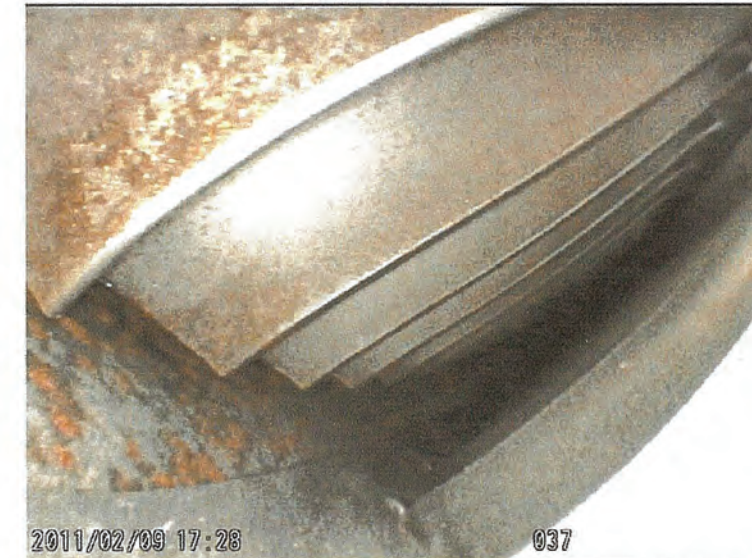
- (iii)
- (iv) The nozzle blade track is corroded, especially in the 4-8 o'clock position. See Photo 5 & 6. The corrosion appears to be heavy in places and if untreated may cause failure of the Nozzle segment and shroud.

Photo 5. Showing corrosion of the nozzle blade track and on Rotor blade.

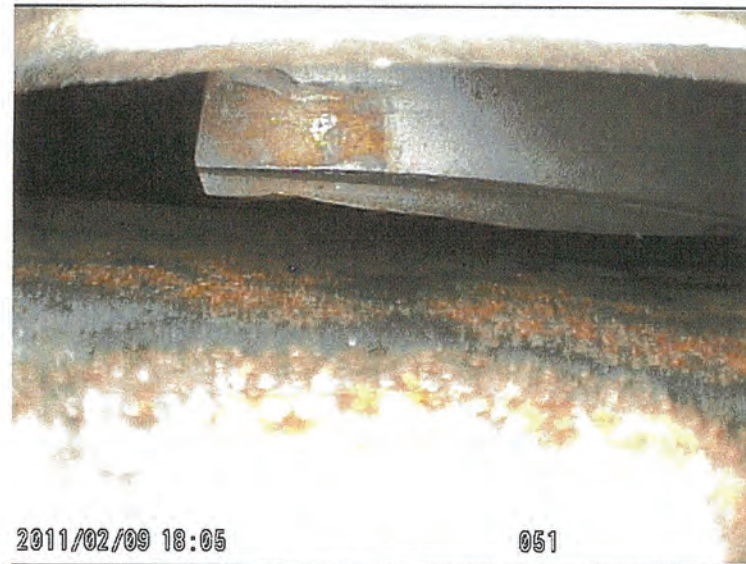
- (v) The blade tips seem irregular, as if the feather has rubbed the nozzle or eroded. All blades have a similar profile which indicates contact with another item, however there appears to be no evidence of a blade tip rub. See Photo 7 & 8.

Photo 7. Showing worn blade tips.

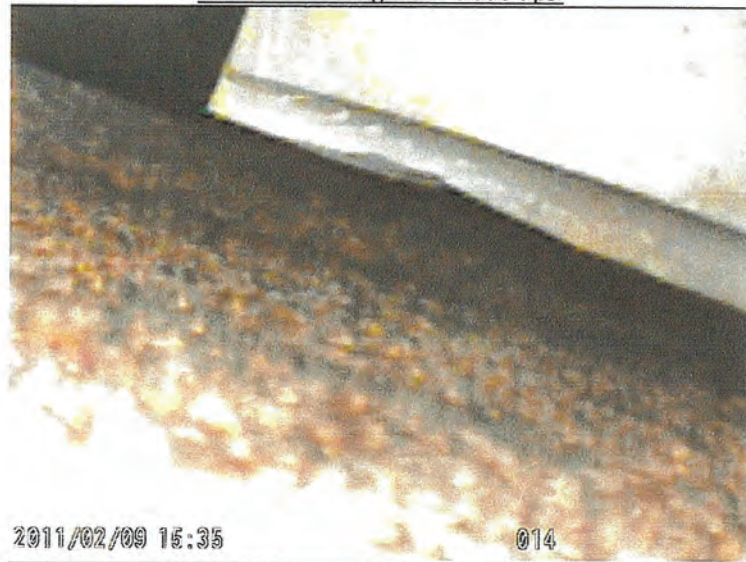
Photo 8. Showing worn blade tips. Note similar profile to Photo 7.

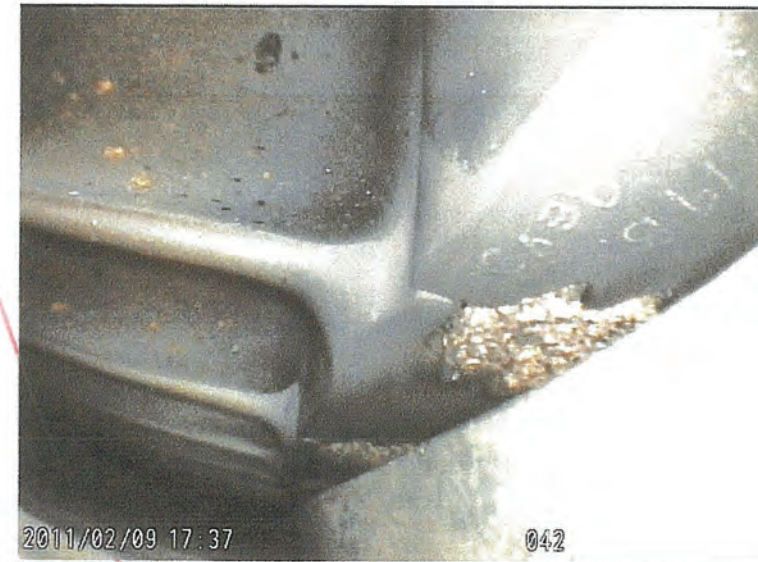
- (vi) There is general corrosion (mostly light) on the blading. See Photo 9.
- (vii) The rotor disc fir tree posts (for blades) are heavily corroded in the areas that are visible suggesting the remainder of the rotor disc is in a similar condition. These areas are subject to extreme stresses when the unit is in operation, and should be maintained in optimum condition. Failure of the fir tree root will have a catastrophic effect on the other components within the Power Turbine. See photo 10 & 11. Note on Photo 11 the corrosion appears to be propagating under the rotor blade shoulder. This may induce additional stresses on the blades, reducing operational life and increasing the potential for premature failure.

Photo 10. Showing fir tree root corrosion

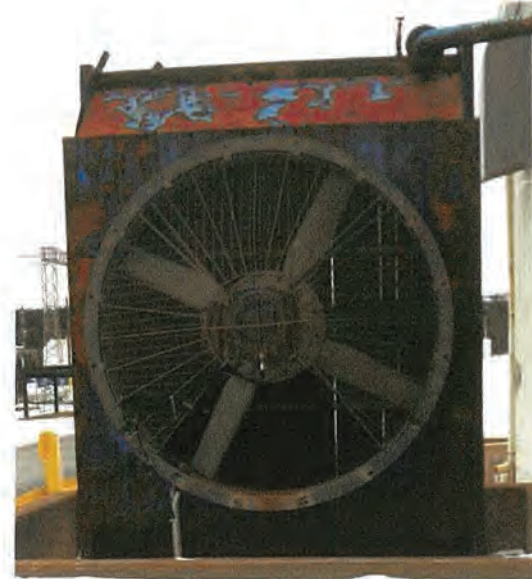
- Externally this fan unit is rusty on the outside, the stator frame and rotor shaft extension show signs of environmental corrosion but is mostly superficial.
- Disregarding the overall appearance, the motor appears to be in good shape with all screens and covers installed and conduit connectors in good physical condition. A screen was removed to gain access to the unit as shown in the picture above.
- Internally the inspection was limited due to accessibility. Therefore a full determination of condition cannot be made.

- Overhaul unit to steam clean stator.
- Perform a stator dip & bake to recover insulation integrity and improve PI factor.
- Recondition fan unit and motor frame.
- Paint fan unit and motor with epoxy paint to prevent corrosion.
- Check all mechanical fits and change bearings.
- Perform no-load run test and capture vibration trend data for future reference.
- Anti condensation heater installation is recommended to prevent moisture build-up.

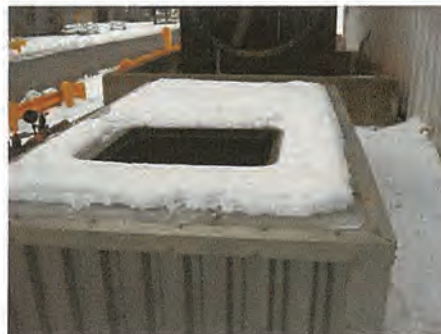
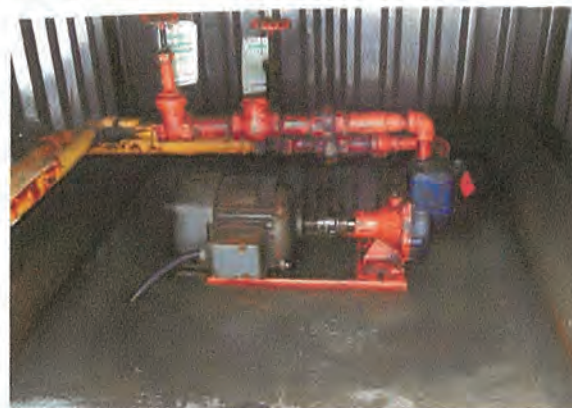
### Equipment Name: East Fuel Oil Motor

- Externally the motor appears to be in fair shape with some surface corrosion.
- All covers installed and conduit connectors in good physical condition.
- Internally the inspection was very limited due to accessibility. Therefore a full determination of condition cannot be made.
- This motor should not be confused with the 25 HP pump unit (25 HP pump unit is for pumping fuel to the storage tank not to supply fuel to turbine).
- Due to time limit and permitting issues, this motor was not run up for vibration analysis test.

- Overhaul unit to steam clean windings.
- Perform a stator dip & bake to recover insulation integrity and improve PI factor.
- Measure and record all mechanical fits and change bearings.
- Perform no-load run test and capture vibration trend data for future reference.
- Unit is installed in an area with a high delta in temperature (cold during idle, hot during operation). Anti condensation heater installation is recommended to prevent moisture build-up.

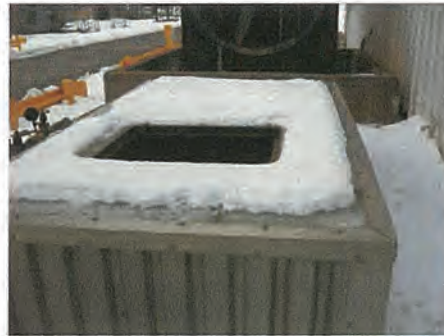
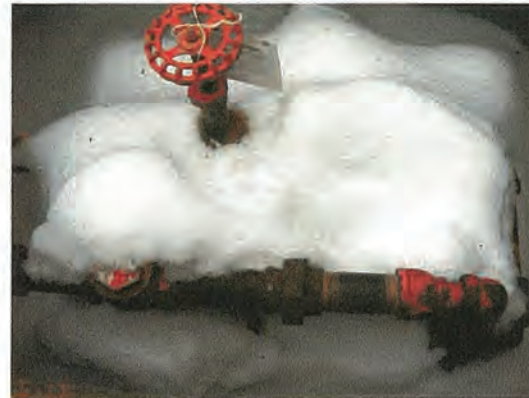
Equipment Name: West Fuel Oil Motor

- Hatch on enclosure was not in place and unit is covered in snow. Snow was removed to perform visual and tests.
- Externally the motor appears to be in fair shape with some surface corrosion.
- All covers installed and conduit connectors in good physical condition.
- Internally the inspection was very limited due to accessibility. Therefore a full determination of condition cannot be made.
- Due to time limit and permitting issues, this motor was not run up for vibration analysis test.

- Insulation Resistance to ground @ 1 minute = 1250 MΩ
- Polarization Index Test =  $\frac{10 \text{ minute reading}}{1 \text{ minute reading}} = \frac{1190 \text{ M}\Omega}{1250 \text{ M}\Omega} = 0.95$  Damp and dirty.
- Insulation Resistance and PI Factor could be skewed due to motor being covered in snow, temperature will affect the conductors.
- Phase to phase resistance:
  - Ø A to Ø B = 9.952 Ω
  - Ø A to Ø C = 9.938 Ω
  - Ø B to Ø C = 9.956 Ω

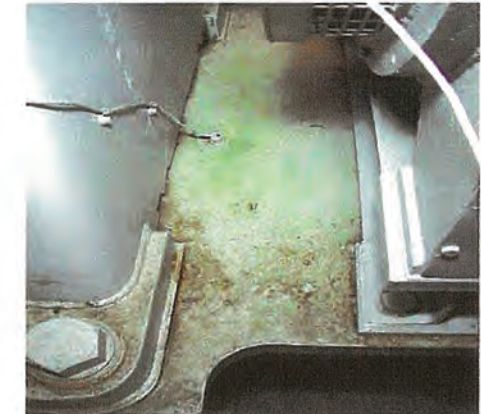
Leakage on bearing foundation

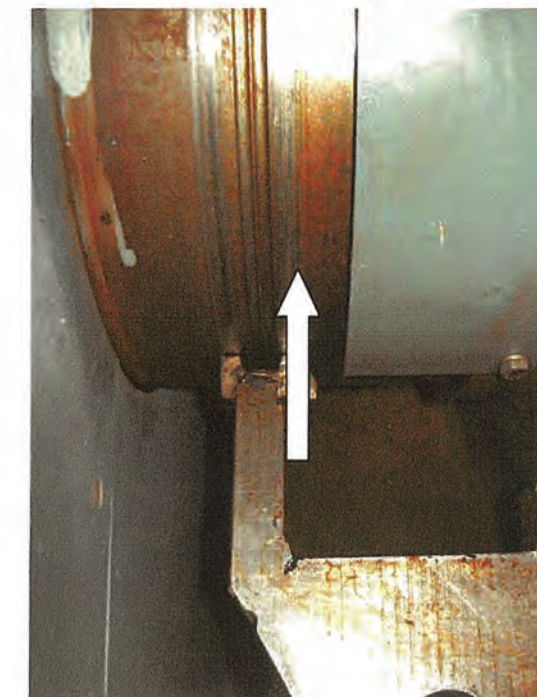
Outboard labyrinth seal and shaft seal  
(grooves wear marks)

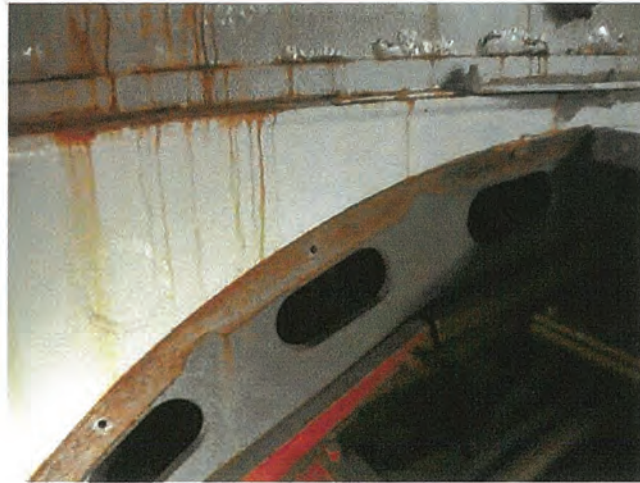
Roof top exhaust/ventilation is showing signs of corrosion and moisture ingress.

- Roof top exhaust/ventilation is corroded and rusted.
- Rust flaking from exhaust/ventilation is present on top of stator core and in bottom of generator enclosure.
- Rotor appears to be in good condition, connections and pole clamps appear to be solid and do not show signs of movement.
- Stator iron and wedging appear to be in good condition.
- Stator coils show signs of over heating and heating discoloration pattern is present in coil system.
- Stator insulation system appears to be degraded, dry and flaking throughout the unit.
- Fan blades have contact wear pattern on edge of blades. This coincides with the wear pattern on the fan cover.

- The exhaust/ventilation unit should be removed, reconditioned or replaced and a corrosion resistant coating applied to prevent future corrosion issues.

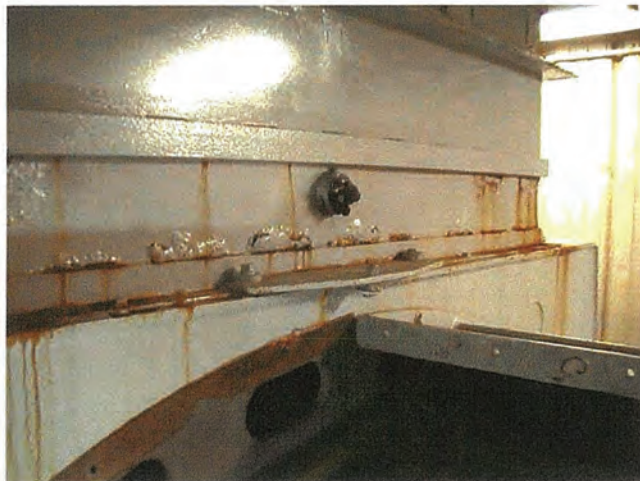
View #2 of the roof top exhaust/ventilation.

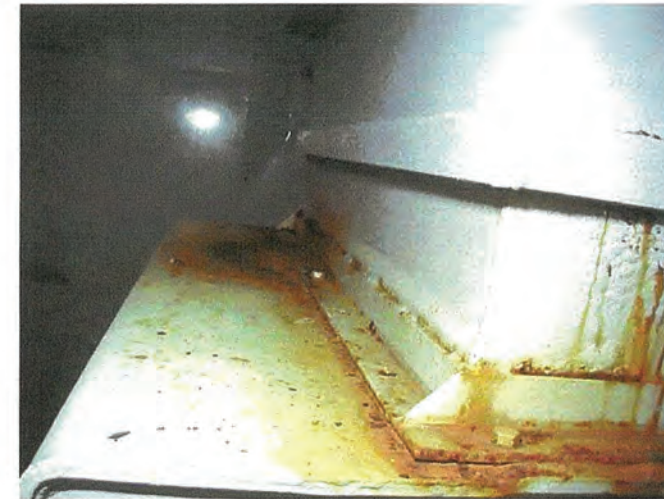
Roof top exhaust/ventilation paint flaking and corrosion.

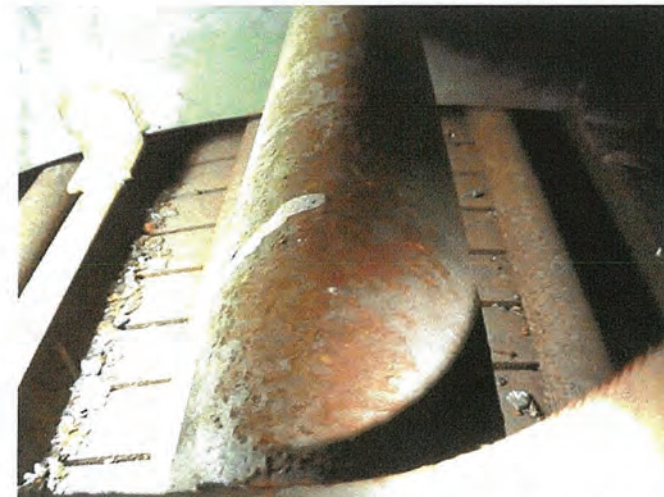
Rust flakes present on top stator core from exhaust/ventilation.

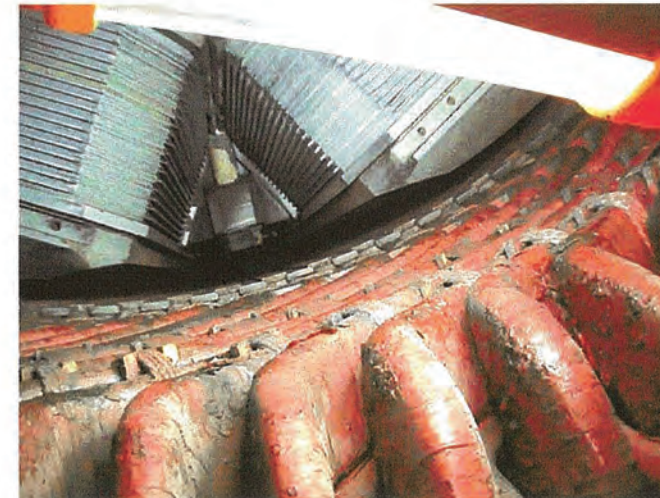
Connections between poles appear in good condition.

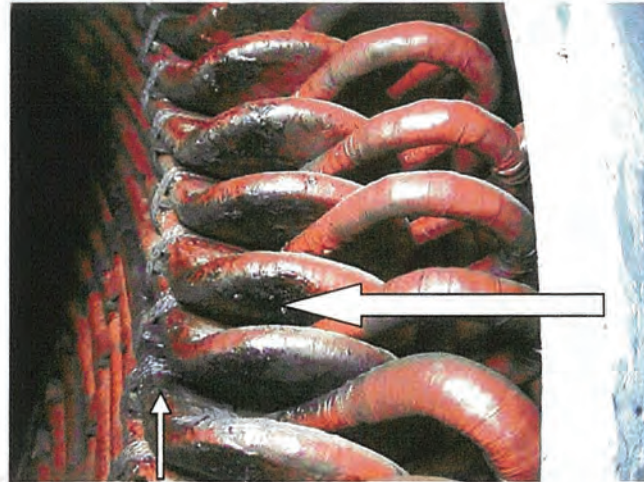
Over heating has occurred in the past: discoloration and resin melted at knuckles.

- Once readings have been improved the rotor should be sealed with a resin treatment to maintain the insulation system integrity.
- With star point of stator disconnected, the insulation resistance to ground of the stator winding is fair; however, the resistance between each phase is unbalanced (30% unbalance). Possible cause of undesirable readings could be Turn to Turn shorts in coil system or grounded coils cut out of coil system (discoloration in some coils are good indication).

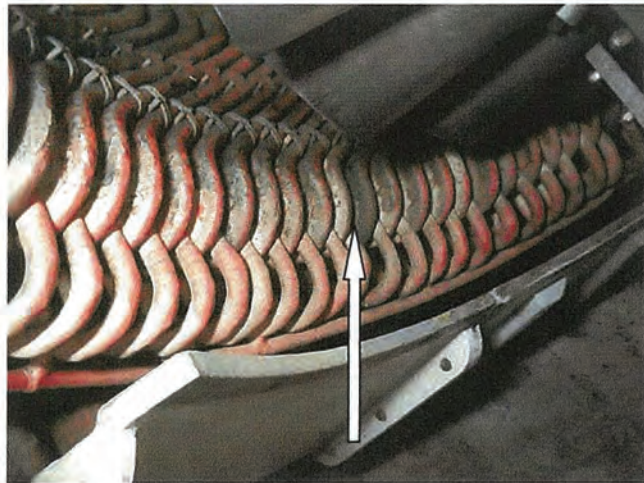
Discoloration heating pattern on some coils.

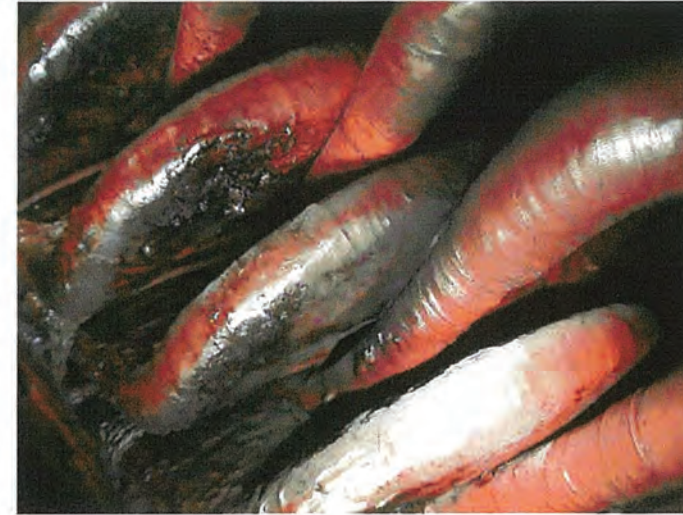
Resin present on knuckles is an indication of overheating.

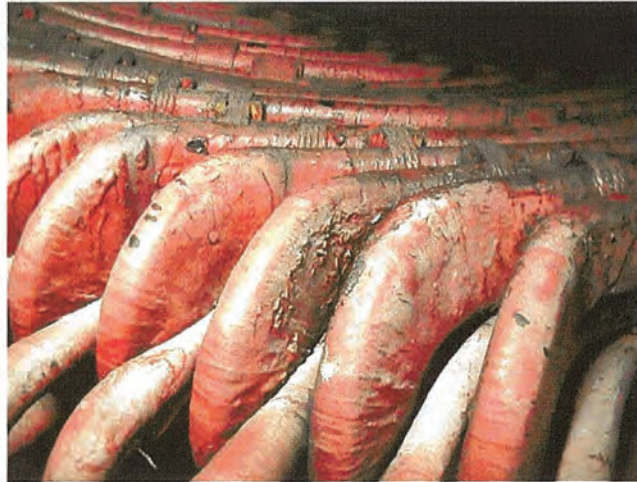
Dry brittle insulation

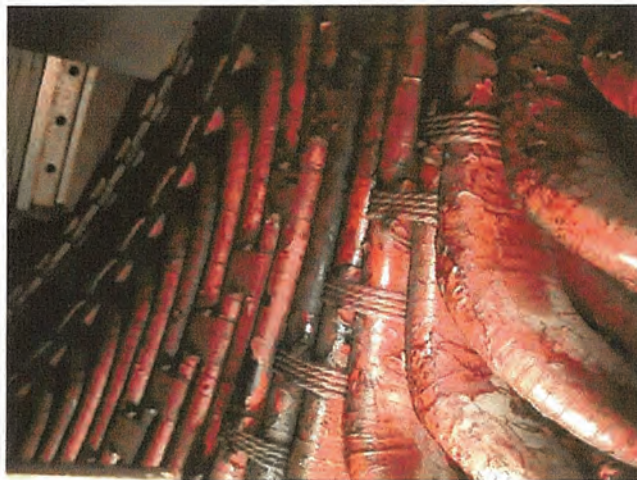
Dry brittle flaking insulation on coils

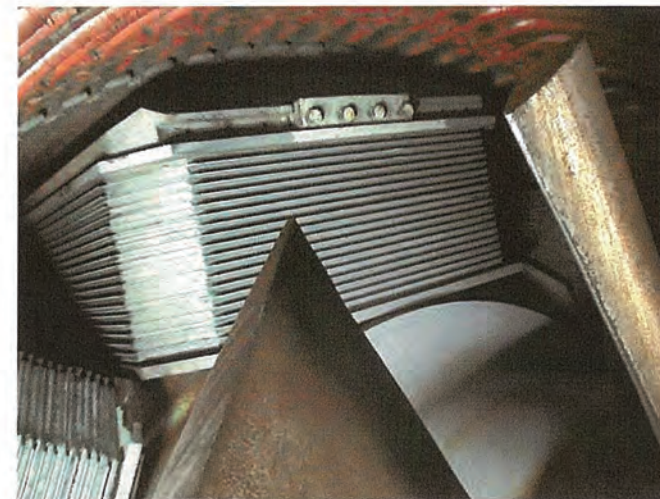
Rub mark on fan blade edge showing previous contact with fan cover.

- The fan blade assembly and fan cover should be reconditioned and adjusted to prevent future contact and wear.
- The rotor winding insulation resistance to ground is not in the desired range (only 2.95 MΩ @500 volts).

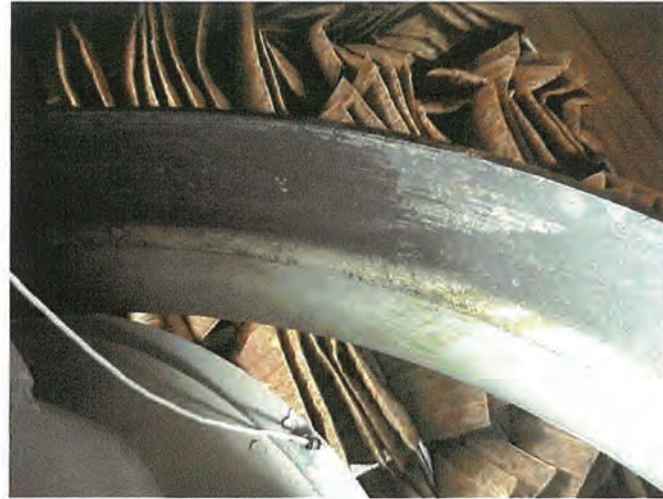
Wear marks on fan cover showing previous blade contact

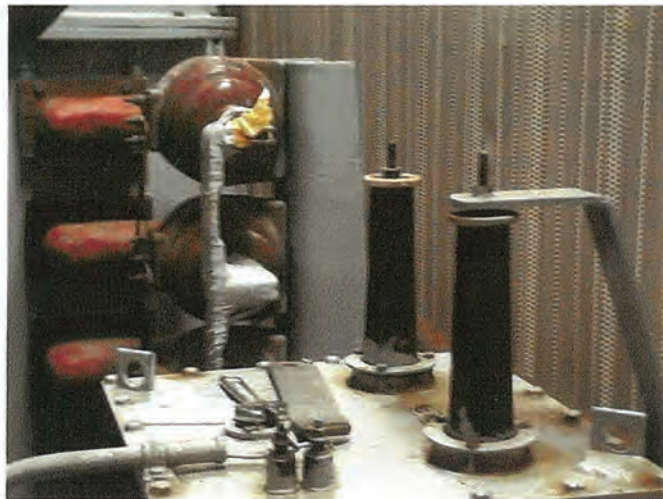
Star Point had to be disconnected from transformer for true reading.  
With this point connected insulation resistance to ground reading is 2000  $\Omega$ .

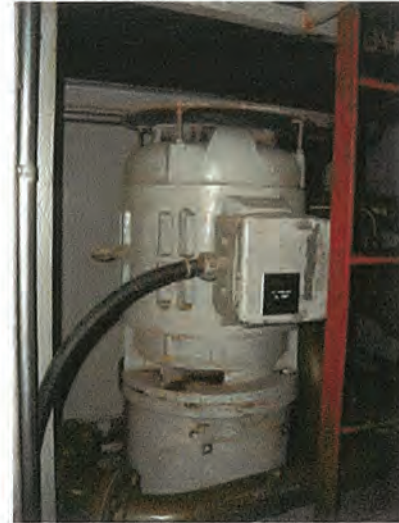
- Externally the motor appears to be in good shape with all covers installed and conduit connectors in good physical condition.
- Internally the inspection was very limited due to accessibility. Therefore a full determination of condition cannot be made.
- Due to time limit and permitting issues, this motor was not run up for vibration analysis test.

- Overhaul unit to steam clean windings.
- Perform a stator VPI to recover insulation integrity and improve PI factor.
- Measure and record all mechanical fits and change bearings.
- Perform no-load run test and capture vibration trend data for future reference.
- Unit is installed in an area with a high delta in temperature (cold during idle, hot during operation). Anti condensation heater installation is recommended to prevent moisture build-up.

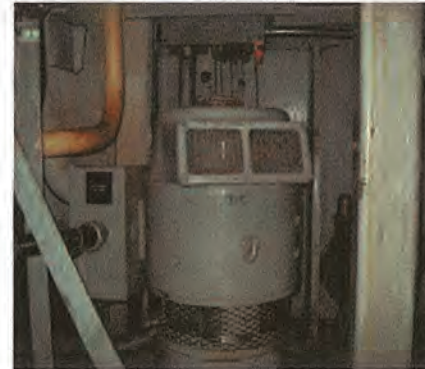
**Equipment Name:** DC backup lube oil pump motor

- Externally the motor appears to be in good shape with all screens and covers installed and conduit connectors in good physical condition.
- Internally the inspection was limited due to accessibility. Therefore a full determination of condition cannot be made. However, it was noted that the armature coils appeared to be dry with some signs of overheating at the armature riser section.
- Due to time limit and permitting issues, this motor was not run up for vibration analysis test.

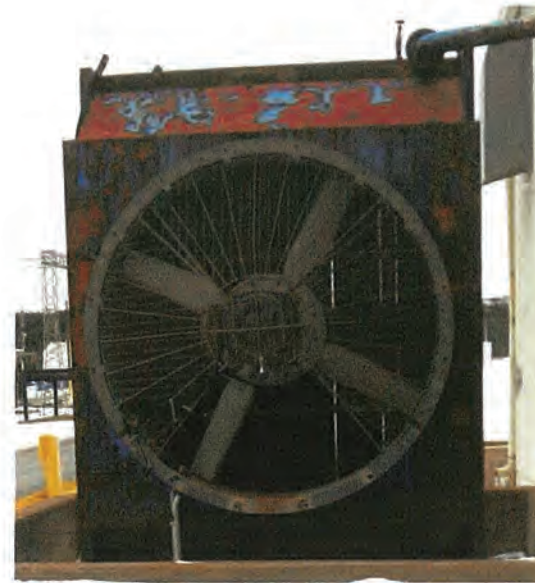
- Externally this fan unit is rusty on the outside, the stator frame and rotor shaft extension show signs of environmental corrosion but is mostly superficial.
- Disregarding the overall appearance, the motor appears to be in good shape with all screens and covers installed and conduit connectors in good physical condition. A screen was removed to gain access to the unit as shown in the picture above.
- Internally the inspection was limited due to accessibility. Therefore a full determination of condition cannot be made.

- Insulation Resistance to ground @ 1 minute = 5520 MΩ
- Polarization Index Test =  $\frac{10 \text{ minute reading}}{1 \text{ minute reading}} = \frac{7550 \text{ M}\Omega}{5520 \text{ M}\Omega} = 1.37$  Damp and dirty.
- Phase to phase resistance:
  - Ø A to Ø B = 404.5 mΩ
  - Ø A to Ø C = 403.7 mΩ
  - Ø B to Ø C = 406.4 mΩ
- Vibration analysis:
  - The vibration analysis test indicated dry anti-friction bearings on both ends of the motor; adding grease into the bearings was suggested after the assessment testing and prior to the screen being installed.
  - Small amount of couple imbalance indicated at NDE of motor due to large fan at the DE of the motor.

- Overhaul unit to steam clean stator.
- Perform a stator dip & bake to recover insulation integrity and improve PI factor.
- Recondition fan unit and motor frame.
- Paint fan unit and motor with epoxy paint to prevent corrosion.
- Check all mechanical fits and change bearings.
- Perform no-load run test and capture vibration trend data for future reference.
- Anti condensation heater installation is recommended to prevent moisture build-up.

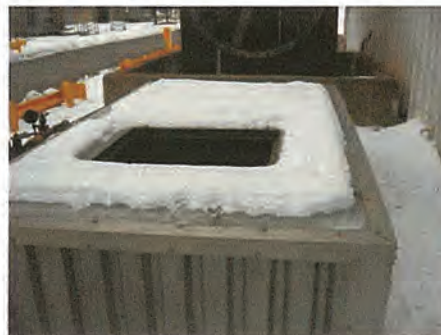
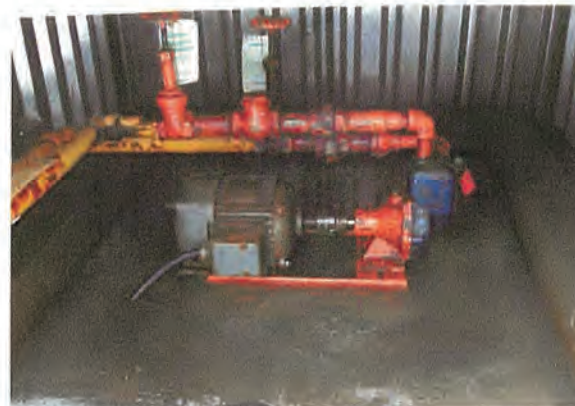
### Equipment Name: East Fuel Oil Motor

- Externally the motor appears to be in fair shape with some surface corrosion.
- All covers installed and conduit connectors in good physical condition.
- Internally the inspection was very limited due to accessibility. Therefore a full determination of condition cannot be made.
- This motor should not be confused with the 25 HP pump unit (25 HP pump unit is for pumping fuel to the storage tank not to supply fuel to turbine).
- Due to time limit and permitting issues, this motor was not run up for vibration analysis test.

- Overhaul unit to steam clean windings.
- Perform a stator dip & bake to recover insulation integrity and improve PI factor.
- Measure and record all mechanical fits and change bearings.
- Perform no-load run test and capture vibration trend data for future reference.
- Unit is installed in an area with a high delta in temperature (cold during idle, hot during operation). Anti condensation heater installation is recommended to prevent moisture build-up.

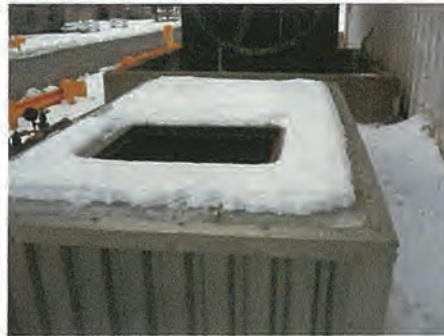
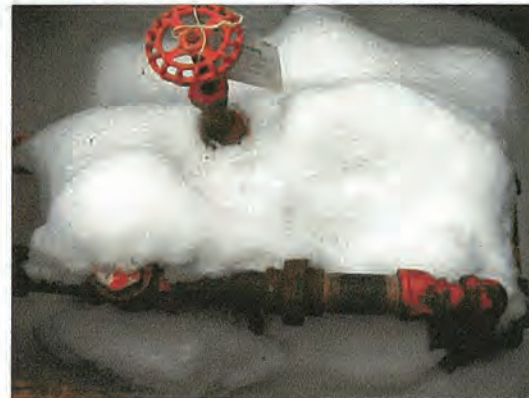
**Equipment Name:** West Fuel Oil Motor

- Hatch on enclosure was not in place and unit is covered in snow. Snow was removed to perform visual and tests.
- Externally the motor appears to be in fair shape with some surface corrosion.
- All covers installed and conduit connectors in good physical condition.
- Internally the inspection was very limited due to accessibility. Therefore a full determination of condition cannot be made.
- Due to time limit and permitting issues, this motor was not run up for vibration analysis test.

- Insulation Resistance to ground @ 1 minute = 1250 MΩ
- Polarization Index Test =  $\frac{10 \text{ minute reading}}{1 \text{ minute reading}} = \frac{1190 \text{ M}\Omega}{1250 \text{ M}\Omega} = 0.95$  Damp and dirty.
- Insulation Resistance and PI Factor could be skewed due to motor being covered in snow, temperature will affect the conductors.
- Phase to phase resistance:
  - Ø A to Ø B = 9.952 Ω
  - Ø A to Ø C = 9.938 Ω
  - Ø B to Ø C = 9.956 Ω

- Overhaul unit to steam clean windings.
- Perform a stator dip & bake to recover insulation integrity and improve PI factor.
- Measure and record all mechanical fits and change bearings.
- Perform no-load run test and capture vibration trend data for future reference.
- Unit is installed in an area with a high delta in temperature (cold during idle, hot during operation). Anti condensation heater installation is recommended to prevent moisture build-up.

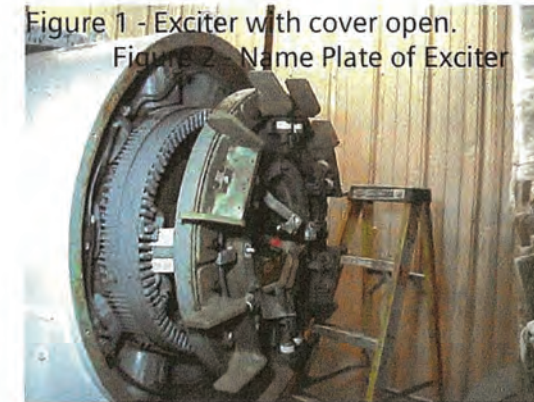
Figure 1 - Exciter with cover open.

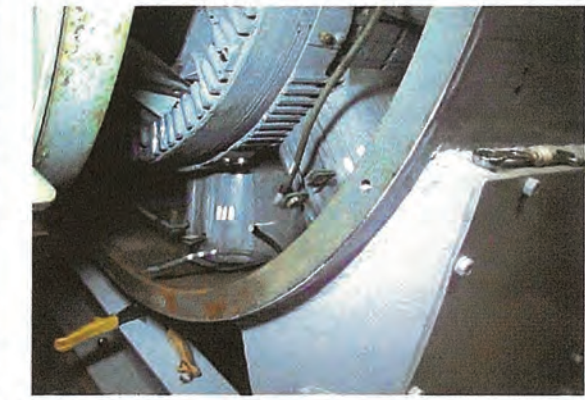
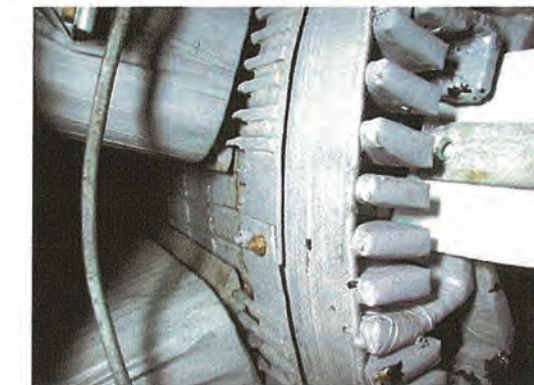
Figure 4 - Field supply to exciter

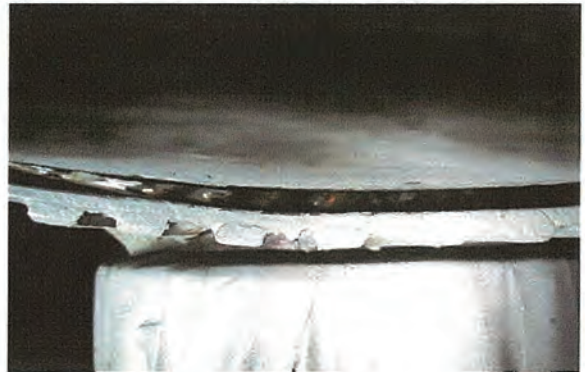
Figure 6 – View 2 air gap.

Figure 5 – Small air gap (shorting ring)

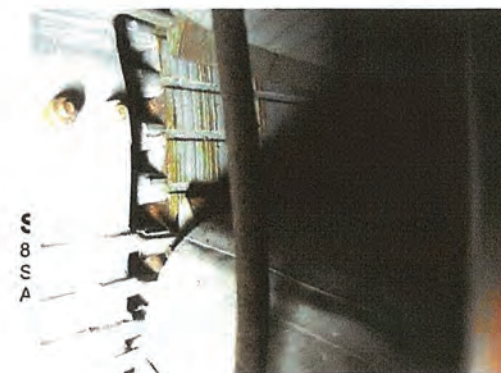
Figure 7 - Rust at the end of rotor iron

- All fasteners are in good condition and solid.
- All electrical connections are in good condition.
- The air gap between the rotor and stator of exciter are very even in both directions (within 4%) which indicate the wear on the main bearing is very minimal from the original.
- The rectifier is in good condition in both physically and electrically.
- The exciter field stator appears to be dry which coincides with the PI reading.
- There is evidence of condensation in the unit due to the surface rust and corrosion of the rotor iron and shaft, figures 7 & 8 above.

- Overhaul unit to steam clean windings.
- Perform a VPI on stator to recover insulation integrity on stator and improve PI factor.
- Rotor should have VPI treatment to maintain the PI factor and increase the reliability.
- While overhauling unit a recondition rotor iron and shaft to remove rust should be performed. Once complete and rust removed a coating from the VPI and epoxy paint should be applied to prevent future corrosion.
- Measure and record all mechanical fits.
- Unit is installed in an area with a high delta in temperature (cold during idle, hot during operation). Anti condensation heater installation is recommended to prevent moisture build-up.

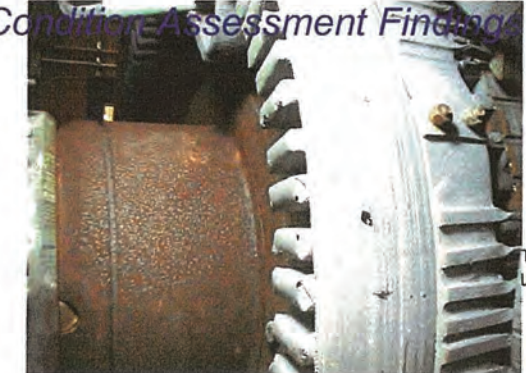
Figure 8 - Rusty exciter rotor shaft

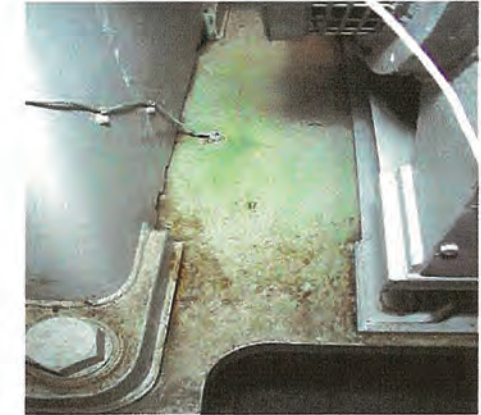
Leakage on bearing foundation

- All fasteners are in good condition and solid.
- This bearing is still in good physical shape despite some oil leakage through the labyrinth seals.
- The air gap between the rotor and stator of exciter are very even in both directions (within 4%) which indicate the wear on the main bearing is very minimal from the original.
- There is wear and grooving on the shaft seals at both ends of the bearing.
- Oil leakage was apparent from the residue left on the bearing housing and foundation under the bearing.

- Bearing shells should be removed and sent for recondition and polishing of Babbitt areas and faces.
- Several sets of bearing measurements should be conducted with the bearing clamped together (inboard side, middle and outboard side).
- Labyrinth seals should be adjusted to prevent further grooving and the shaft should be polished to remove present grooves.
- Inboard oil wiper should be replaced, near end of life.
- When installed in the housing a fit test should be performed to verify bearing contact with shaft.
- For future preservation the rotor should be turned on a monthly basis to prevent shaft marking and maintain an oil film in the bearing.

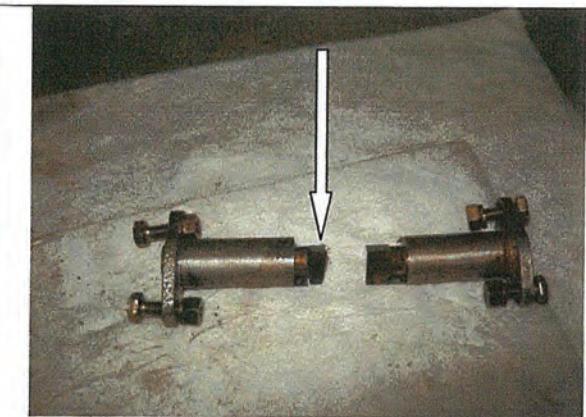
Inboard and outboard oil wiper comparison

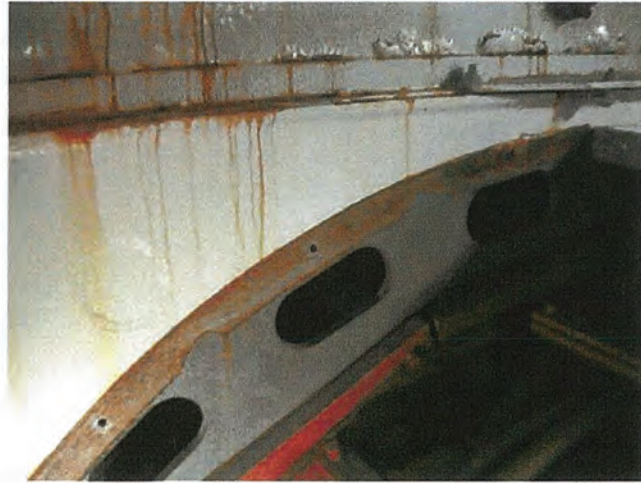
Roof top exhaust/ventilation is showing signs of corrosion and moisture ingress.

- Roof top exhaust/ventilation is corroded and rusted.
- Rust flaking from exhaust/ventilation is present on top of stator core and in bottom of generator enclosure.
- Rotor appears to be in good condition, connections and pole clamps appear to be solid and do not show signs of movement.
- Stator iron and wedging appear to be in good condition.
- Stator coils show signs of over heating and heating discoloration pattern is present in coil system.
- Stator insulation system appears to be degraded, dry and flaking throughout the unit.
- Fan blades have contact wear pattern on edge of blades. This coincides with the wear pattern on the fan cover.

- The exhaust/ventilation unit should be removed, reconditioned or replaced and a corrosion resistant coating applied to prevent future corrosion issues.

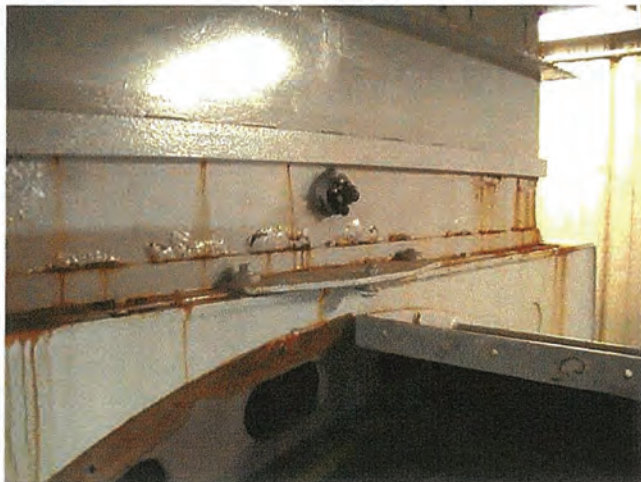
View #2 of the roof top exhaust/ventilation.

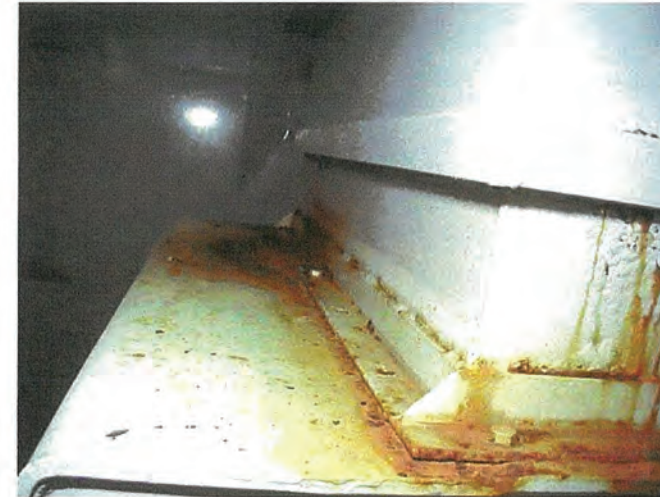
Roof top exhaust/ventilation paint flaking and corrosion.

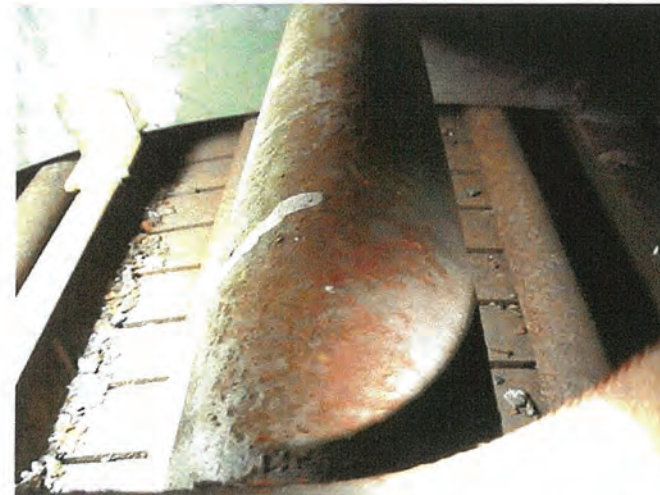
Rust flakes present on top stator core from exhaust/ventilation.

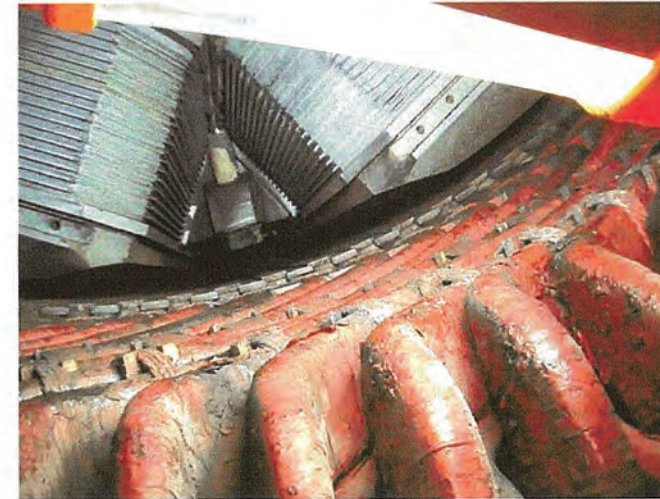
Connections between poles appear in good condition.

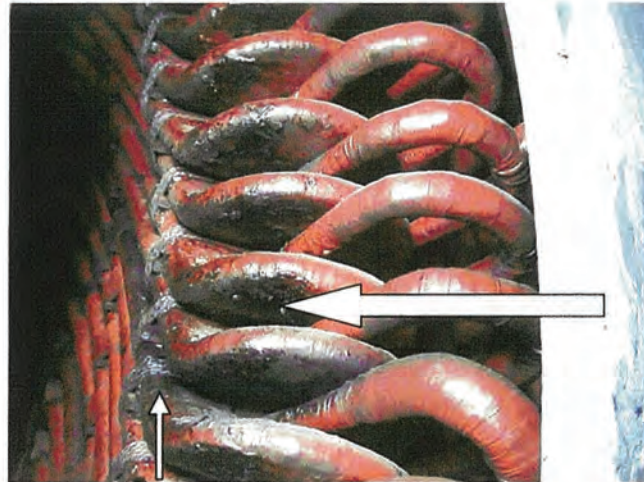
Over heating has occurred in the past: discoloration and resin melted at knuckles.

- Once readings have been improved the rotor should be sealed with a resin treatment to maintain the insulation system integrity.
- With star point of stator disconnected, the insulation resistance to ground of the stator winding is fair; however, the resistance between each phase is unbalanced (30% unbalance). Possible cause of undesirable readings could be Turn to Turn shorts in coil system or grounded coils cut out of coil system (discoloration in some coils are good indication).

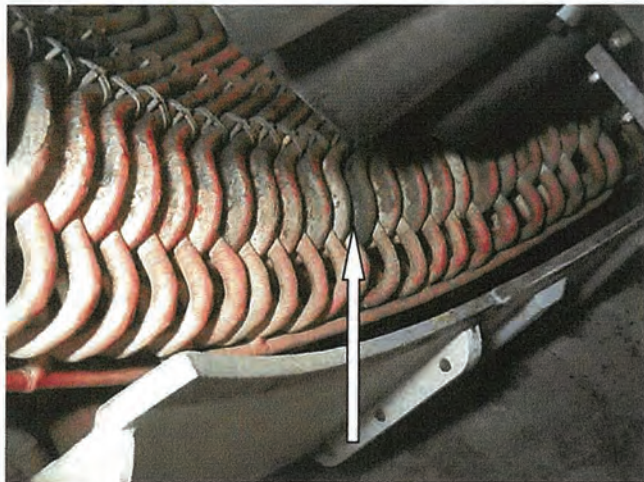
Discoloration heating pattern on some coils.

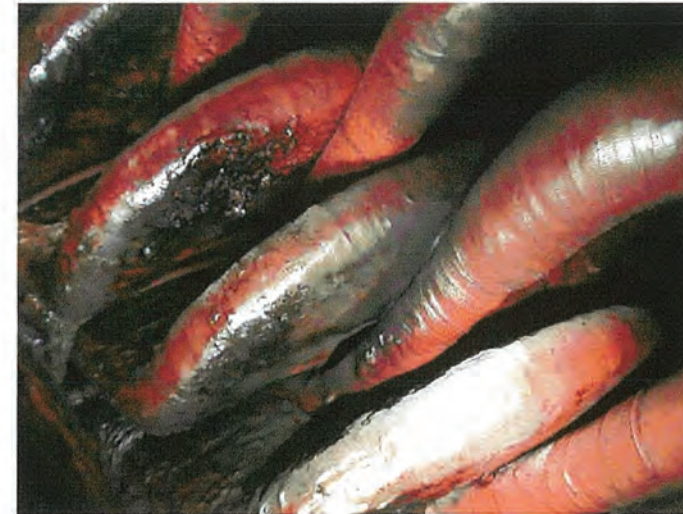
Resin present on knuckles is an indication of overheating.

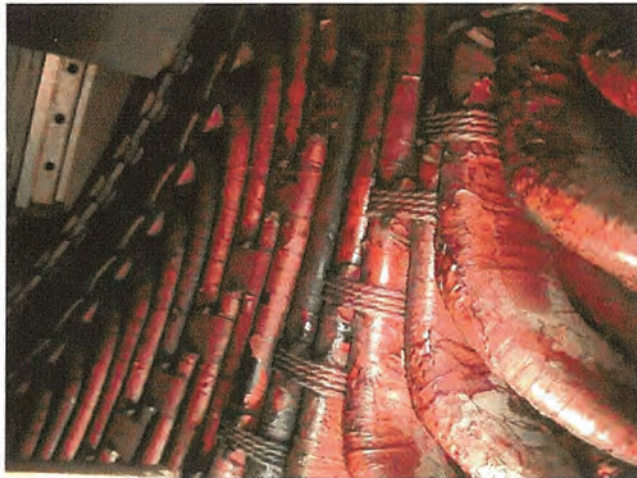
Dry brittle flaking insulation on coils

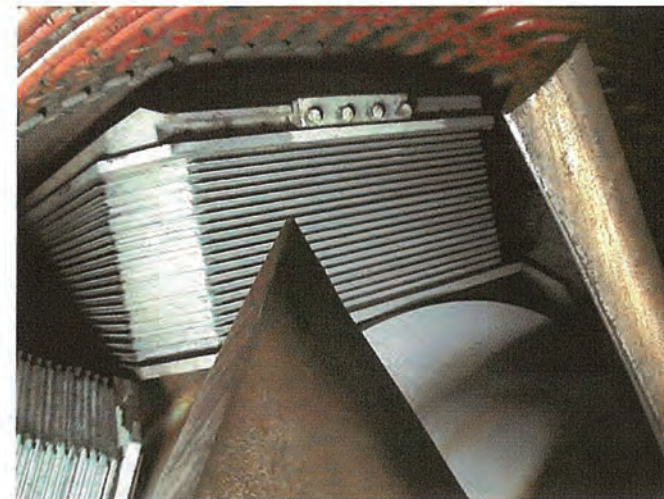
Rub mark on fan blade edge showing previous contact with fan cover.

- The fan blade assembly and fan cover should be reconditioned and adjusted to prevent future contact and wear.
- The rotor winding insulation resistance to ground is not in the desired range (only 2.95 MΩ @500 volts).

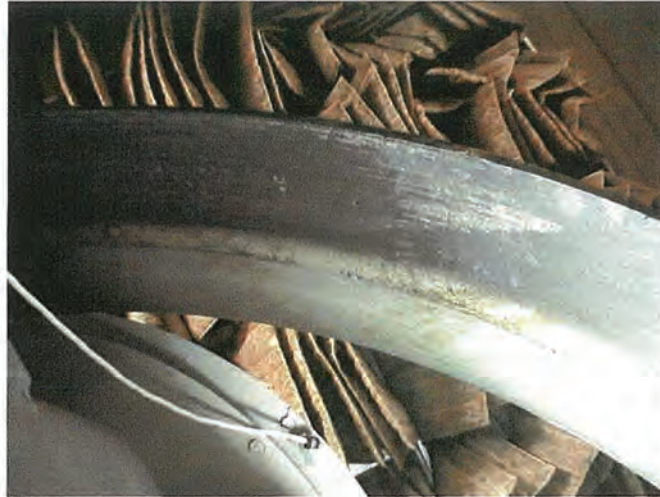
Wear marks on fan cover showing previous blade contact

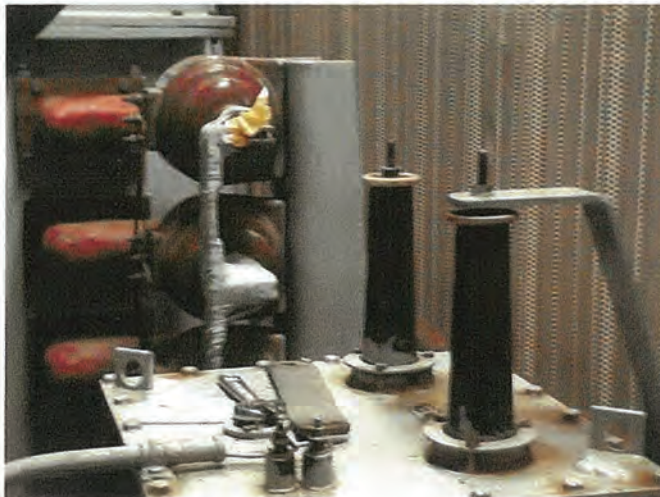
Star Point had to be disconnected from transformer for true reading.  
With this point connected insulation resistance to ground reading is 2000  $\Omega$ .
