1 Q. Please provide a copy of the 2011 AMEC Consulting report on the condition  
2 assessment of the Holyrood Gas Turbine.

Holyrood Thermal Generating Station (Holyrood) Gas Turbine Condition Assessment & Options Study –  
Final Report

### Gas Turbine Condition Assessment & Options Study

December 19, 2011

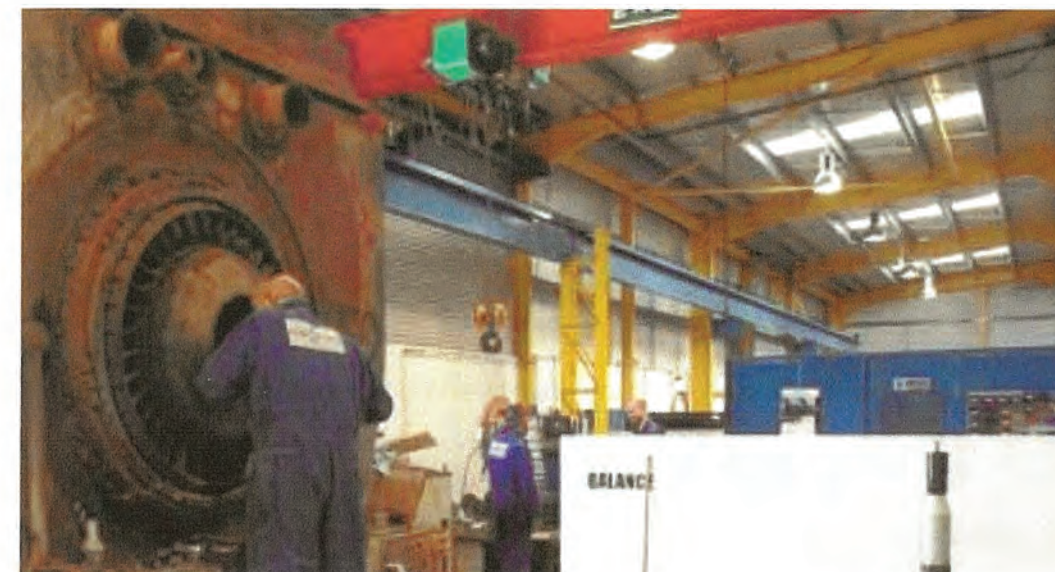
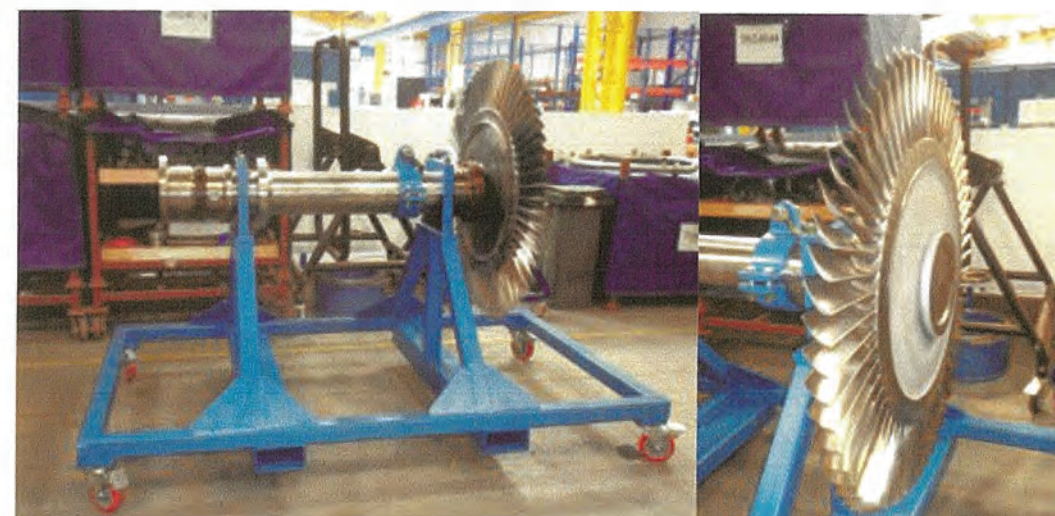
The Power Turbine and Gearbox have been relatively untouched since installation. To this end they have suffered typical cosmetic loss of material and coatings of the volute. Alba Power would propose to remove the Rotor and Nozzles and despatch for overhaul, while the remaining components including the gearbox would be overhauled locally. All bearings and seals would be reworked / replaced as available. (Following images of identical unit before and after overhaul at Alba Power)
