Re: Application to Supply and Install Runner – Unit 2 – Cat Arm Hydroelectric Generating Station

AB25-0356 REV A - Cat Arm - Unit #1 old runner wear analysis

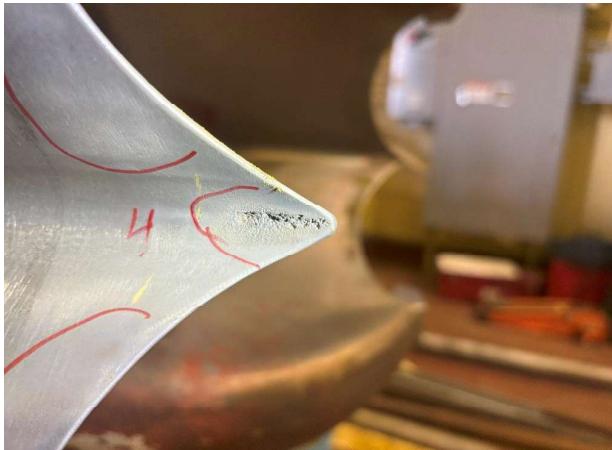
Cavitation area #4

Pictures of bucket #10

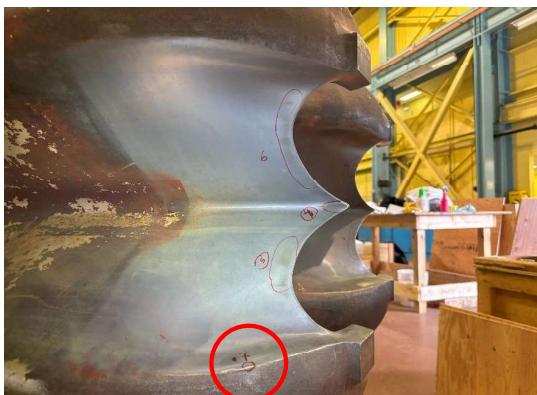
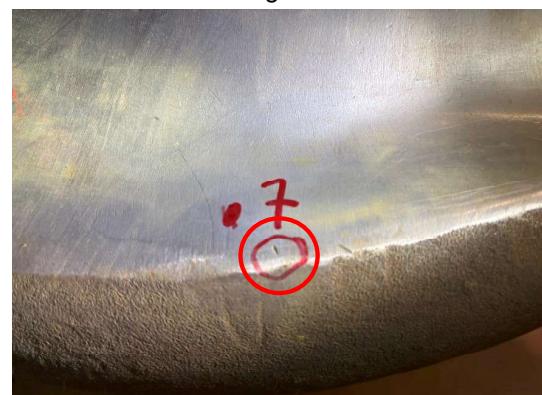
Bucket #2 ; Indication #7 in casting located in zone VI.

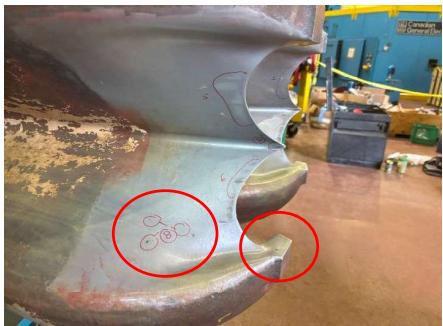
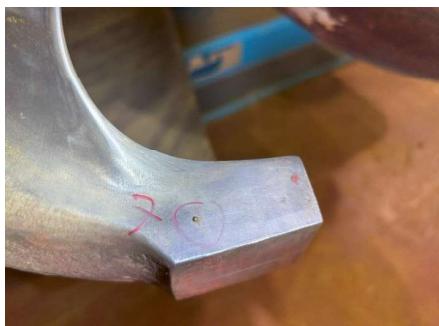
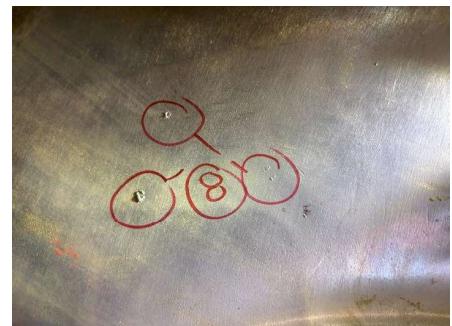
Bucket #4 : Indications #7 and #8, welding spatters

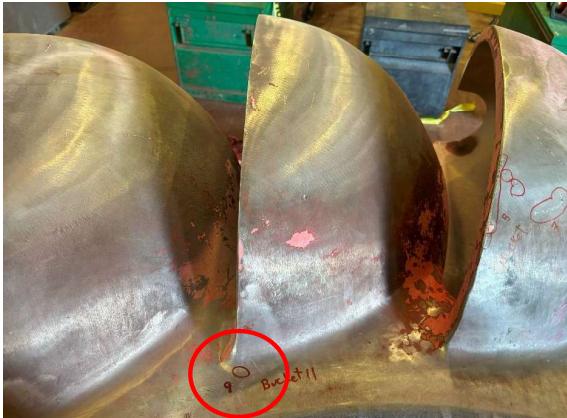
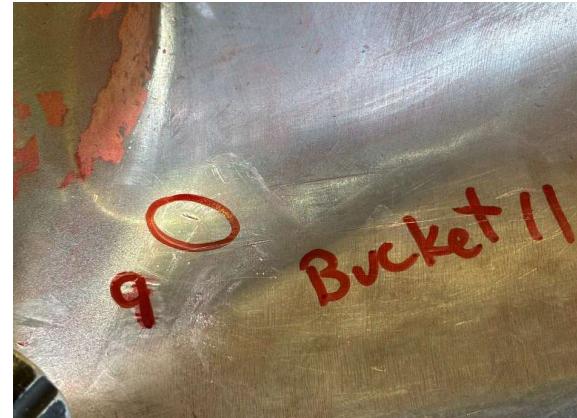
Bucket #11 ; Indication #7 and #8 ; welding spatters, no pictures.

Indication #9 ; scratch

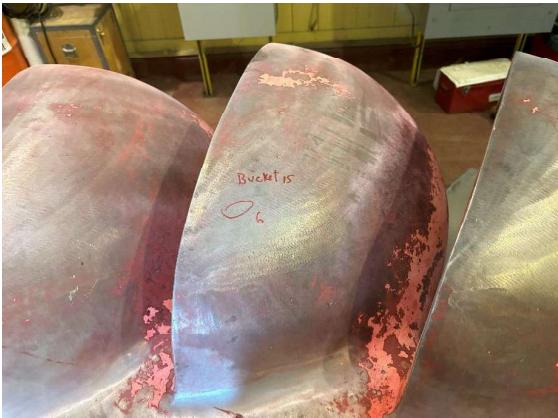
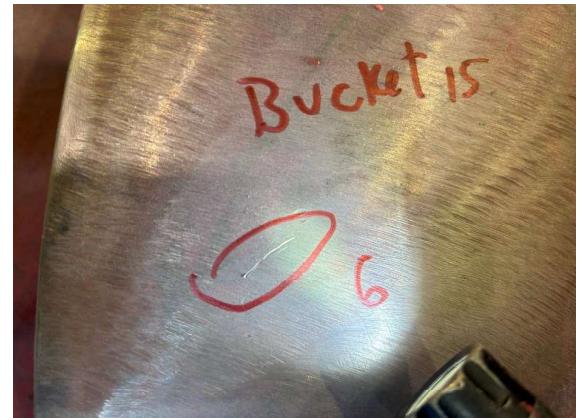
Bucket #15 ; Indication #6 ; scratch

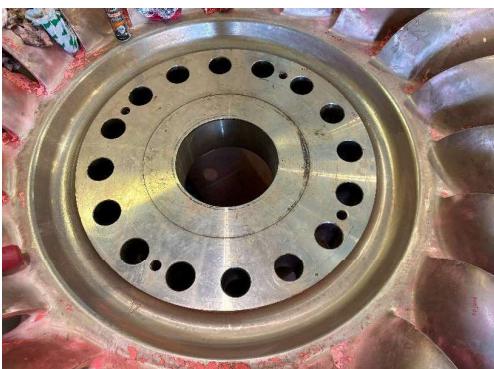
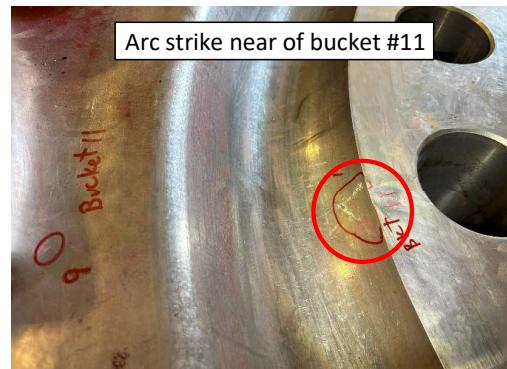
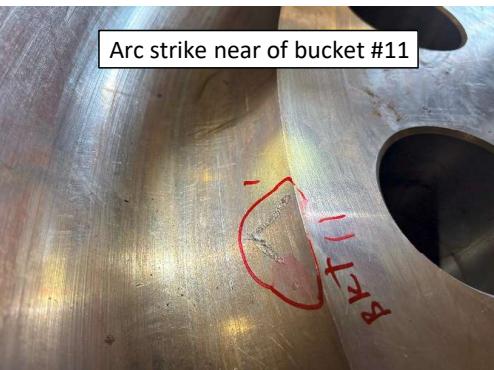
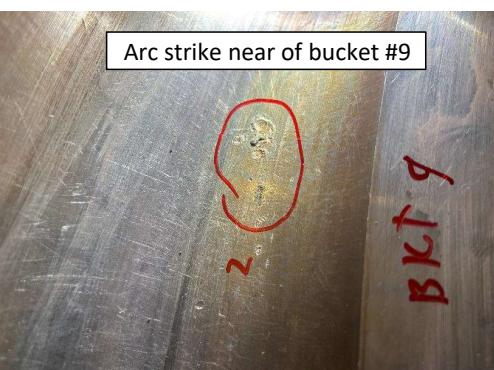
Visual inspection on center of runner (top) ; No crack found visually or by magnetic particle inspection.

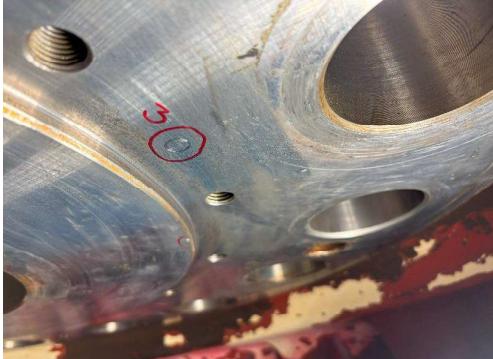
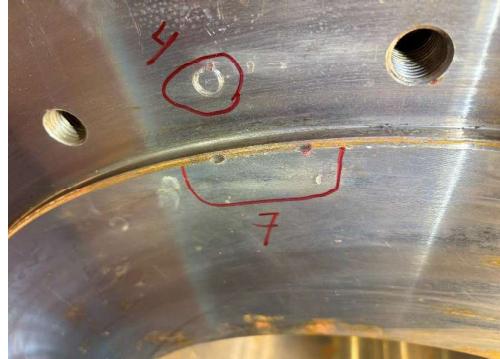
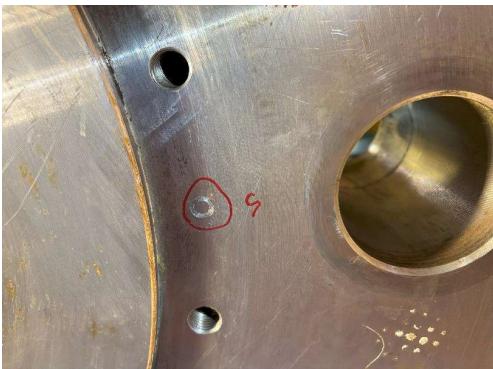
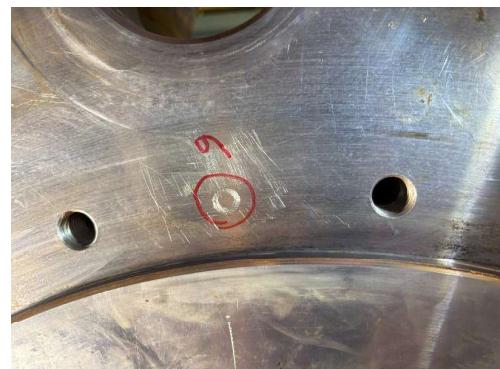
Visual inspection on center of runner (top) ; We found several tool marks and scratches under the runner.

Indications #3 to #19. See pictures below and next pages.

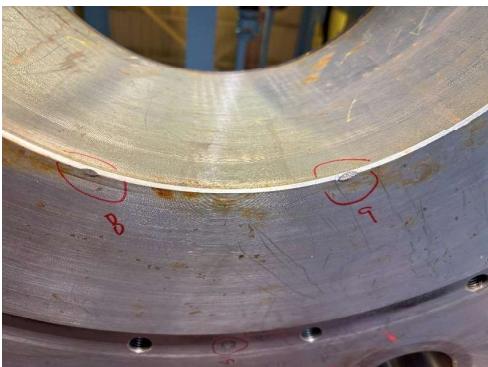
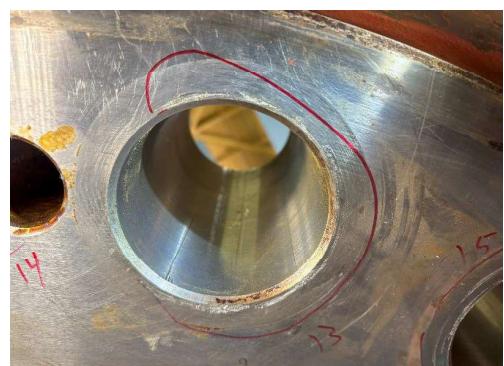
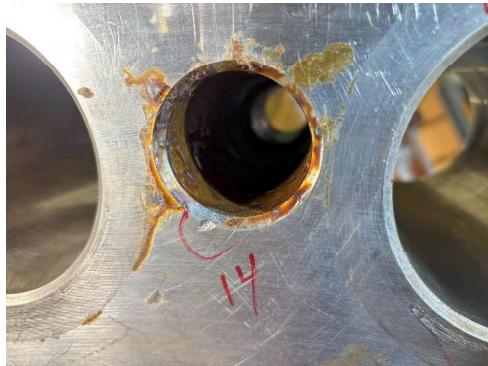
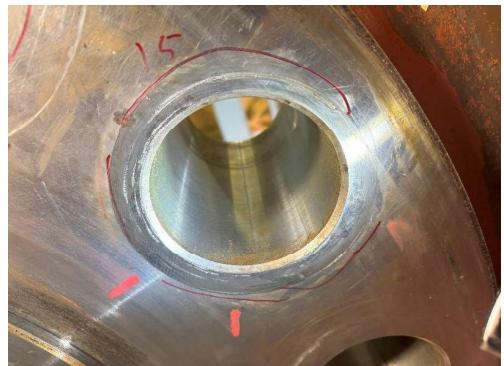
Pictures of indications found under the runner.

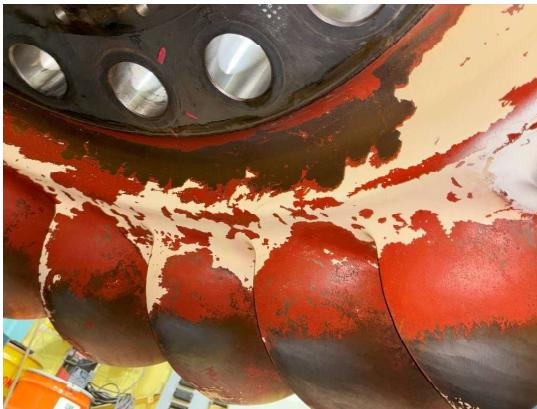
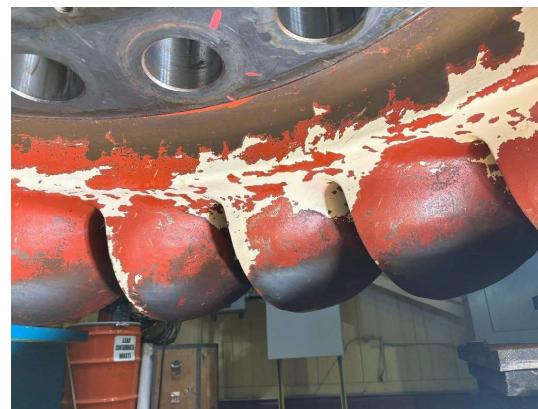
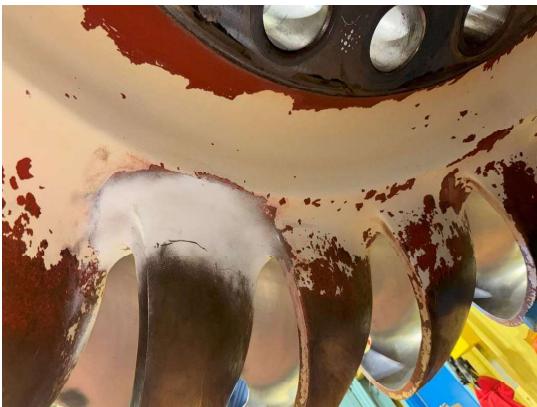
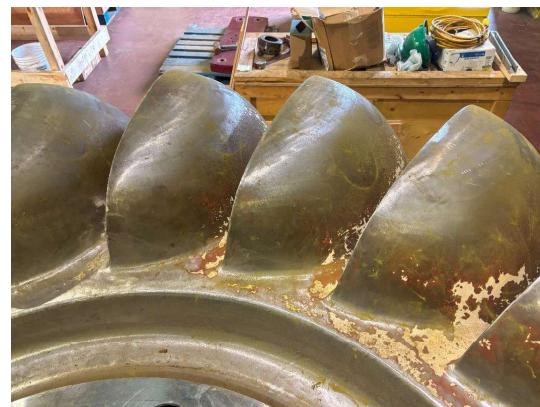
Pictures of areas inspected :

Paint present on surfaces on the bucket. Paint can hide indications.

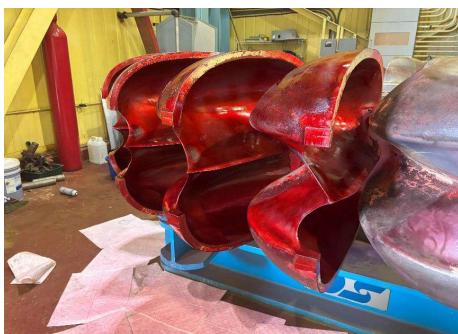
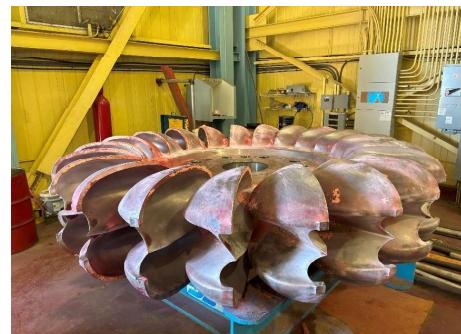
Liquid penetrant inspection was carried out on 100% of the surface of the all buckets on accessible areas.

Paint present in certains places, inspection not completed in these areas.

Results : Rejectable indications were found, see table and pictures next pages.

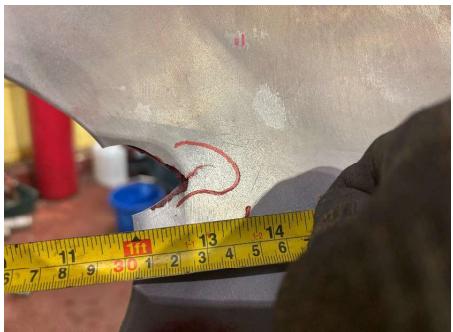
Bucket #1

Pictures of defect found : Crack into bucket #1, zone #1 ; 1.25"x1"

| Bucket #1 | | |
|---|---|---|
| 1 | Zone I | crack |

Indication #1 crack 1.25"x1"

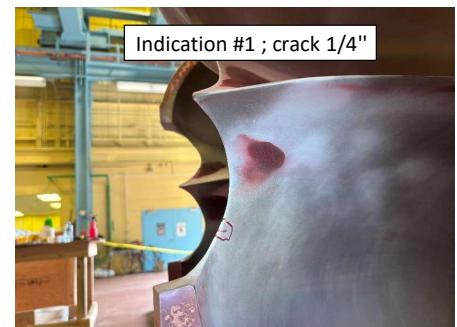
| Bucket #10 | | |
|---|---|---|
| 1 | Zone I | Crack lenght 1/4" |

Indication #1 ; crack 1/4"

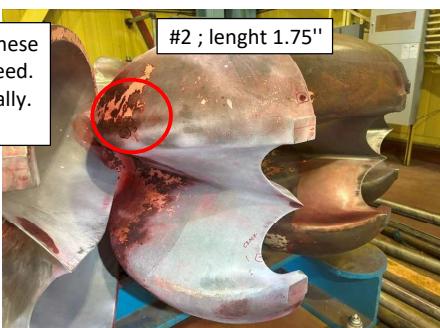
| Bucket #10 | | |
|---|---|---|
| 3 | Zone IX | 2 casting defects visually founded. No bleeding, indications noted in report. |

Indication #2 to #3 ; These indications did not bleed.
Indication found visually.
Noted in report

#2 ; lenght 1.75"

Indication #2 - #3 ; casting indications

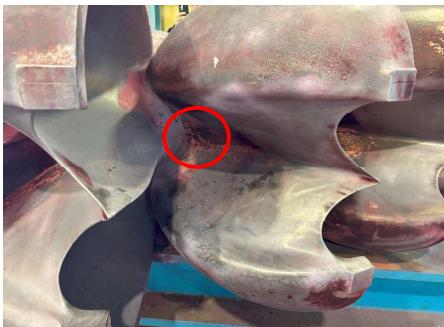
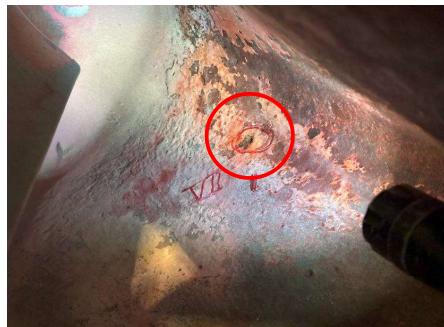
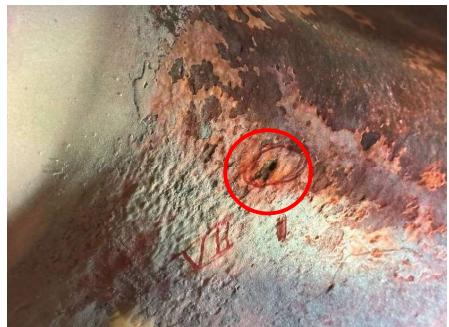
Bucket #12

Indication #1

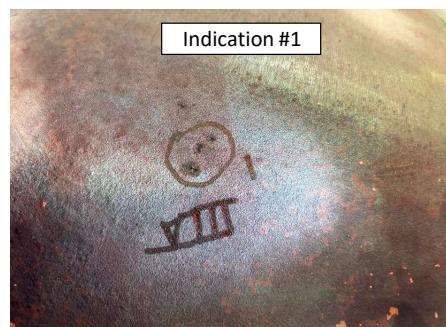
Bucket #12

Pictures of indications founded :
